**Church of St Anne, Bishop Auckland**

**Quinquennial Report**  
On the architect's inspection of

**24<sup>th</sup> July 2025**

**Sarah Harrison** RIBA

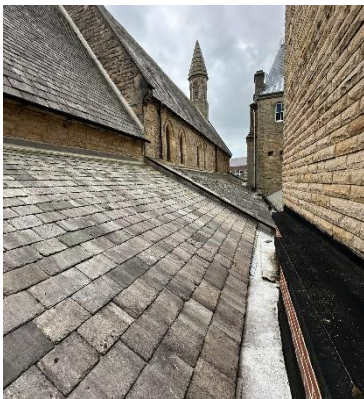
*Figure 1 – All north roofs*

- 6.1.2 Westmorland slate of random widths, laid in diminishing courses, to a very steep pitch. Generally, the condition remains good, with some moss growth towards the top.

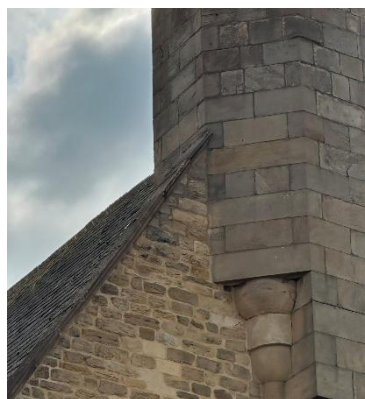
*Figure 2 – Coping to NW Nave*

- 6.1.4 Sandstone ridge tiles, all in good condition as far as can be seen from the limited view.
- 6.1.5 The flashing at the west end is reportedly 'Nicholson's Masterform' and appears in good condition, however the top coping stone appears not to be fully bedded, this should be checked and the joint re-pointed if seated correctly, or re-bedded<sup>1</sup>.

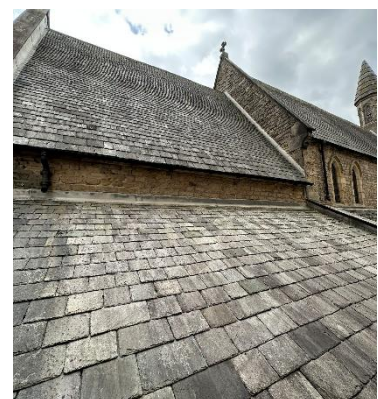
*Figure 3 – N Chancel and vestry*

- 6.2.1 As per the Nave, this has Westmorland slates in random widths and formed part of the re-roofing scheme. Some undulation, thought to be due to the differentiation in the thickness of the reclaimed slate, in addition to many slates with chipped corners. None appear broken enough to warrant replacement and given they were second-hand slates, this may have been their condition as fitted.
- 6.2.2 Ridge is again in sandstone and appears ok from the limited view.
- 6.2.3 Abutment flashings are neat and undisturbed.

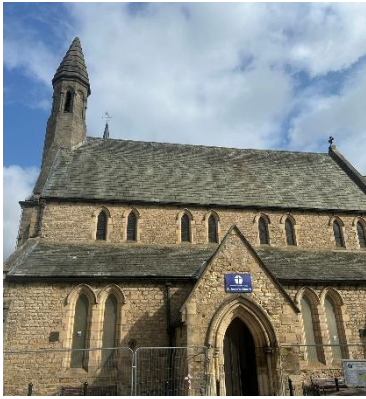
*Figure 4- South Nave and Aisle*

- 6.5.2 The condition is very poor, there are many areas of slipped slates, patches of historic replacement and is in desperate need of wholesale re-roofing<sup>3</sup>. There is water ingress internally and light is visible near the bell turret.
- 6.5.3 The junction with the bell turret has lead flashings and looks to be holding-up from ground level, however given the roof's condition this will need to be re-instated alongside the urgent re-roofing scheme.
- 6.5.4 The copings to the east have large gaps, particularly towards the top and at the finial, this should be checked for stability<sup>4</sup>. The flashing to the west is in lead and appears ok, to the east there appears to be some cracks in the flaunching.

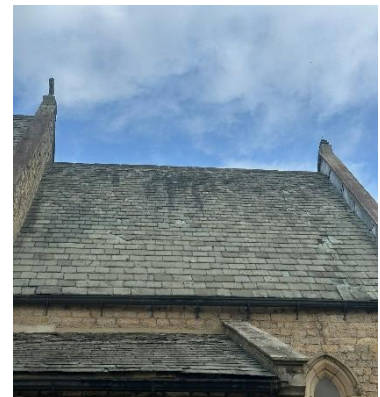
*Figure 7- Chancel South*

- 6.6.1 As per the South Nave and in very poor condition. Many slipped slates, leaving the sarking boards below exposed in several locations. The urgency of this replacement cannot be stressed enough as no action has been taken since the last inspection report which reported a poor and deteriorating condition, serious irreparable damage to the timbers internally could be caused if the roof continues to be left in this condition.
- 6.6.2 The finial to the east gable has an open joint to the rear, and this should be investigated at close proximity urgently<sup>5</sup>, access is good for a cherry-picker.

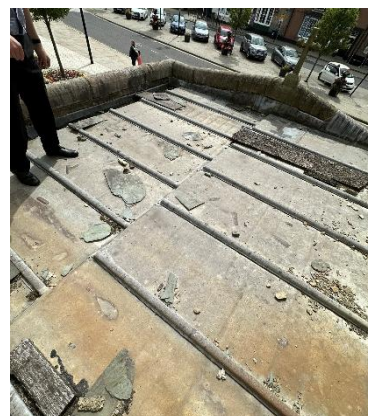
Figure 8 – SE lead roof (over WCs)

- 6.8.1 This roof is covered with lead in seven bays, with one drip, falling to the east. There are many patch repairs and a significant amount of debris on this roof, including large fallen slates. These have punctured the lead in a few locations, causing some dents and one split<sup>7</sup>. This will need to be properly repaired but only once the main roofs have been replaced.

- 6.8.2 It was reported previously that there was a crack in the lead to the southwest corner, it does not appear to have been repaired. There is also a crack to the north east corner, near the outlet. There is also some large vegetation growing in this location, this was partially removed at the time of the visit. The lead in this area will need repairs as another section has come loose completely.

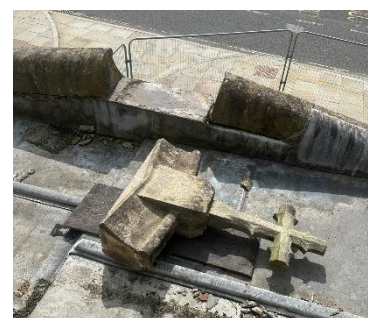
- 6.8.3 The flashings to the wall of the South aisle and the chancel are in fair condition, the mortar above is beginning to break away.
- 6.8.4 The middle stone to the south parapet was visibly loose and laid down at the time of inspection to prevent it from falling. This full parapet section requires urgent attention<sup>8</sup>.

Figure 9 – as item 6.8.4.

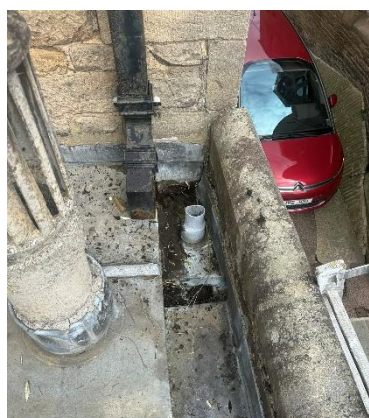
Figure 11 – SE Vestry & chancel

7.5 **SE Vestry (WC's)** – The rainwater hopper and outlet to the east side is completely blocked by vegetation. Some cleared but a thorough clear will be necessary. The downpipe from the chancel has a base section which is completely loose and simply sitting on the lead roof<sup>13</sup>.

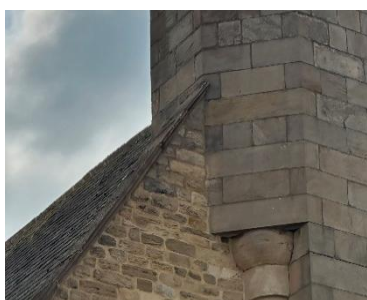
Figure 12 – N Aisle – W end

8.1.1 The coursed rubble masonry is generally in fair condition, although in some areas hard cement pointing has remained intact while the adjacent stone has weathered. Open joints are evident at low level on the north buttress and beneath the window, and these require repointing. See note regarding the coping in section 6.1, pictured here.

8.1.2 There is staining to the stone that indicates water may overflow onto this elevation from the parapet, though evident, it doesn't have appeared to deteriorate the condition of the stone or pointing.

8.1.3 The low-level iron ventilation grille is broken and needs to be replaced<sup>15</sup>.

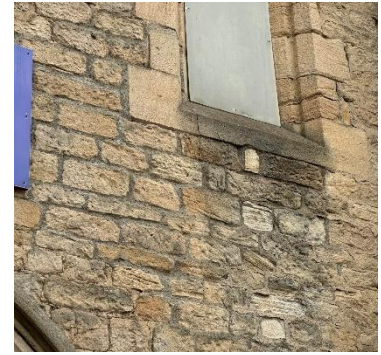
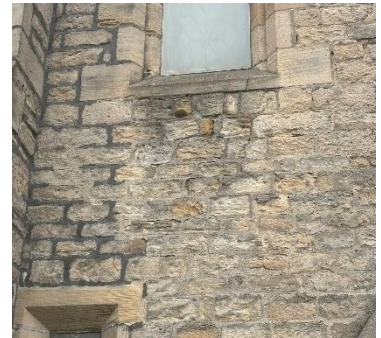
- 8.2.4 There are signs of former fractures around the large lancet windows, notably from the bottom right-hand corner of the north lancet extending towards the small rectangular window below, and at the lower left-hand corner of the south lancet. These should be monitored, as they may reflect similar structural movement<sup>17</sup>.

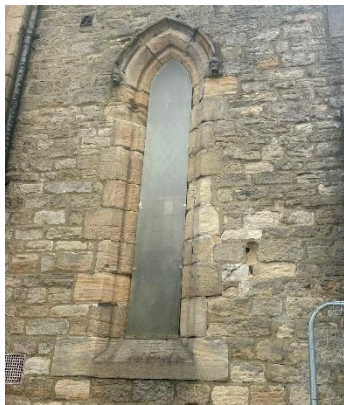
*Figure 15 – S side of lancet & cill*

- 8.3.6 On the south side of the lancet window there is an area of eroded stonework, with pointing that is unsightly and inconsistent. One stone in this location now requires replacement.<sup>19</sup>

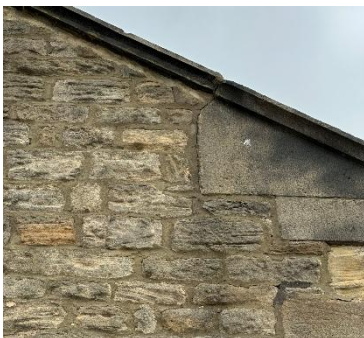
*Figure 16 – SW Kneeler*

- 8.3.7 There is a crack that runs up from the kneeler where is looks as if this stone may have moved, causing a gap in the coping, this should be pointed or re-set as required<sup>20</sup>.

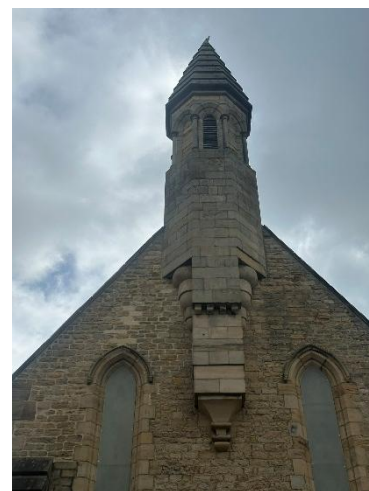
Figure 17 – Bell turret

- 8.4.2 The stonework is generally in good condition; however, one or two stones have lost their face (possibly due to incorrect bedding), and a past repair is evident where a stone face has previously failed. On the bottom right-hand side, above a corbel, a corner repair is visible which appears vulnerable and may break loose. Several of the larger stones above the corbels appear similarly bedded, and their condition warrants closer inspection<sup>21</sup>.

- 8.4.3 Two timber louvre blades are missing and require replacement in the south and east openings, a number of others have slipped which need fixing<sup>22</sup>.

- 8.4.4 A close inspection of the turret masonry was recommended at the last inspection but has not yet been undertaken; this is now overdue and should be arranged to inform future repair needs.

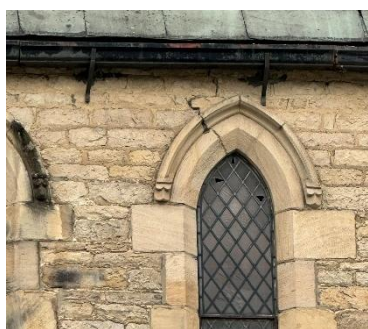
Figure 18 – Crack above lancet

8.5.2 As previously noted, there is a crack above the sixth lancet from the west which needs to be re-pointed and monitored for any progression. It appears though there may be a similar crack to the far westerly lancet and this should also be pointed and monitored as it was not previously highlighted.

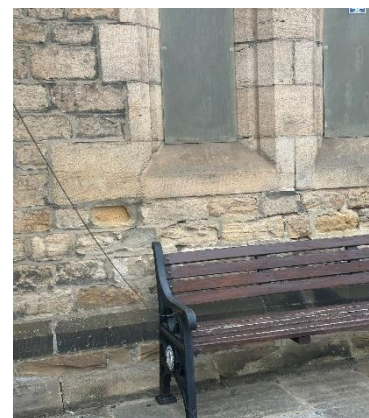
- 8.6.3 **Second Bay**: This bay shows similar deterioration, with extensive erosion below sill level. Approximately 3 m<sup>2</sup> of walling requires repointing, particularly beneath and around the window cills, where a large open joint is also present to the right-hand side of the sill and the buttress.

Figure 19 – second bay erosion

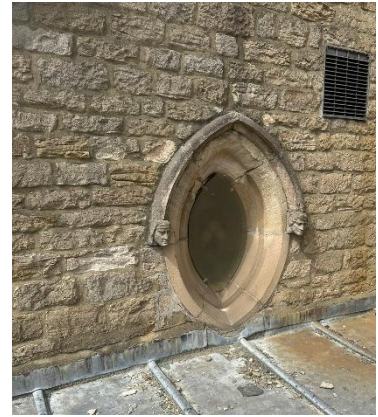
*Figure 20 – East return window*

- 8.6.6 **East Return Wall:** This contains a vesica piscis window. The wall is generally fair, but the moulded crown stone of the window arch is heavily eroded and has previously been mortared over. A few open joints at the head require re-pointing<sup>25</sup> as they are likely contributing to internal staining and water ingress. An open coping joint above this location also requires attention.

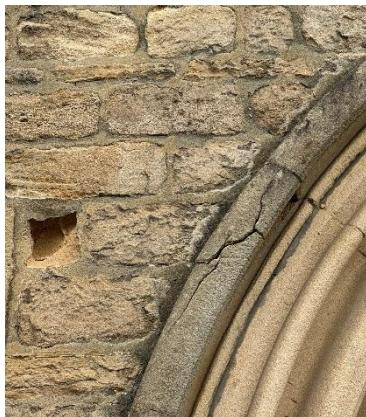
- 8.7.1 The fabric of the South Porch is of similar construction to the South Aisle. Large areas of the stonework are eroded, in places up to 25 mm deep, with deterioration accelerated by past repointing in hard cement mortar. In the long term, replacement of the most decayed stones will be required soon, as erosion is likely to continue. As a short-term measure, selective cutting out and repointing would improve condition. On the west elevation approximately 1.5 m<sup>2</sup> requires repointing<sup>26</sup>.

*Figure 21 – Hoodmould and erosion*

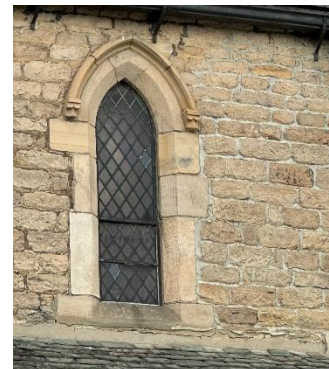
*Figure 28 – Clerestory window*

9.5 **South Clerestory** - The lancet windows are in reasonable condition there are several broken panes and replacement quarries, and the ferramenta requires painting. It is assumed that the metal hoppers do not open<sup>36</sup>.

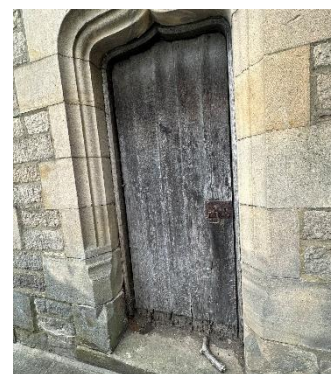
*Figure 29 – WCs door*

- The side doorway on the east elevation is set beneath an ogee-headed lintel and moulded stone surround, both in good condition. The timber door is oak boarded and in very poor repair. The threshold piece has come away (as noted at the last inspection), and the lower boards are now extensively decayed.<sup>39</sup>

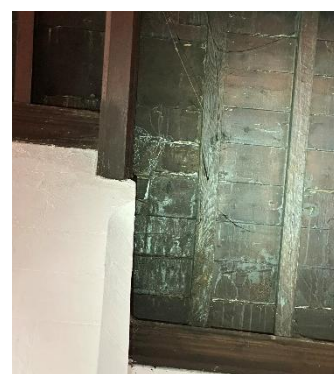
**14.1.1** There are further marks on the boarding at the extreme west end, a problem also noted at the last inspection. This was then attributed to defects in the west gable masonry and roof slating, which were repaired. However, staining remains evident, and similar marks are now also present at the east end. Both gables require areas of repointing, and once these works are undertaken, the condition should continue to be monitored. During future

*Figure 51 – Staining at mid N Aisle*

roof works, a closer inspection of these areas would be prudent to establish both the cause of staining and the condition of the timbers.<sup>46</sup>

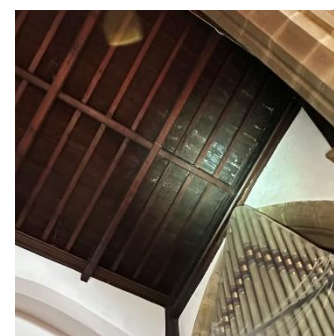
*Figure 52 – Staining at N Aisle E end*
