QUINQUENNIAL INSPECTION REPORT

BISHOP MIDDLEHAM, ST MICHAEL

**QUINQUENNIAL INSPECTION AND REPORT
June 2018**

David Beaumont BA (Hons) Grad Dip, RIBA, AABC

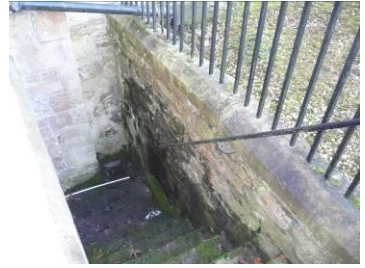
- Room contains Ideal Concorde CXA boiler with Grundfos pump with new stainless steel flue. Modern drainage to sink that was installed in the vestry in 2003 looks in good condition.
- 4kg powder extinguisher.
- Room contains a Miko DD8L Junior Meoco dehumidifier that drains to the external gully at the bottom of the steps, the gully is blocked.
- The stairs are rather damp and have a lot of moss on them and some open joints at the risers that have sunk a little bit. The return wall with the balustrade above very wet. Handrail is rusting significantly at the bottom of the slope. The balustrade above is in fair condition.

Recommendation: clear stair gully, clean down steps, repoint steps, remove lumber and brush down - but assess if there is asbestos dust first, repair door panel, decorate door

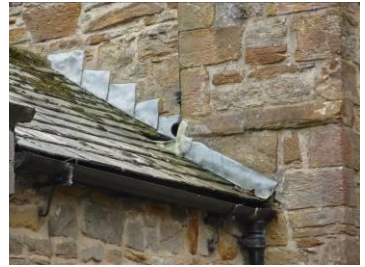
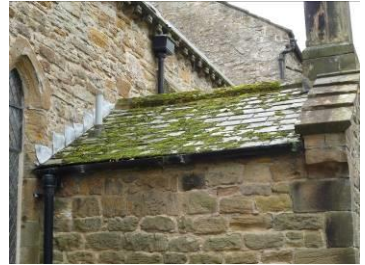
North Vestry:

- West slope:
 - Ridge – angled stone slate, bedding okay. North abutment flashing and soakers to rebated water table.

- South abutment - step flashing to chancel in leadwork that is okay. It has a back gutter by the buttress and this needs checking.
- General – Westmoreland slating has had some repair with tingles, looks okay.
- East slope:
 - Ridge – as west.
 - South abutment – as west.
 - North abutment – as west but the pointing is holding up here. Slight lift of the flashing to the chimney stack.
 - General – a lot of moss on the slating could do with being removed.

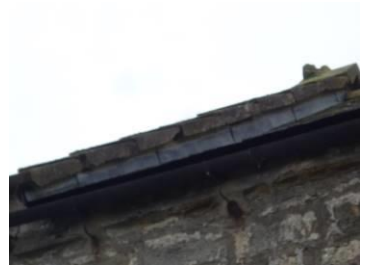
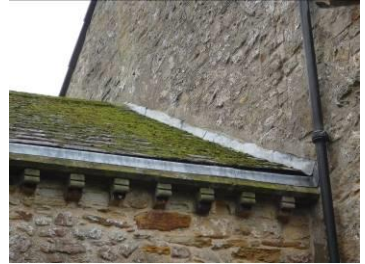
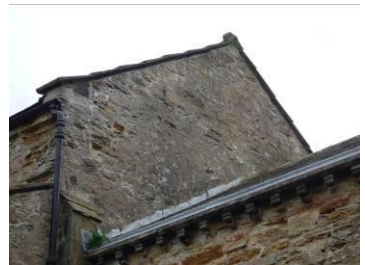
Chancel:

- North slope:
 - Ridge – angled stone, bedding okay.
 - East abutment – flashing, perhaps soakers. One area of bedding to the rebated water table missing.
 - West abutment – raking flashing with cement pointing. Three or four areas coming away, but is in position.
 - General – all the slating is in place, looks okay.
- South slope:
 - Ridge – as north.
 - West abutment – lead flashing, the pointing is holding up. There is a back gutter at the buttress and this has some vegetation in it.
 - East abutment – as north slope but small area of pointing missing up at the ridge and also midway along where the water table looks to be slightly uneven.
 - General – Westmoreland variable with and diminishing courses, in good condition.

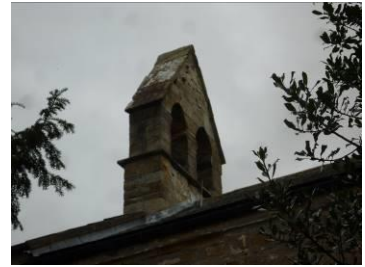
Nave:

- South slope:
 - Ridge – angled stone in good condition, as is the bedding.
 - West abutment – raking flashing at the bellcote. Minor area of pointing missing on the return to the water table.

- East abutment - raking flashings, not fully dressed back the wall and there are some gaps where driving rain can get behind them, but they have probably got soakers behind them.
- General – slating in good condition, though there is a slight kick up to some of the slates up by the ridge but don't really need any attention.

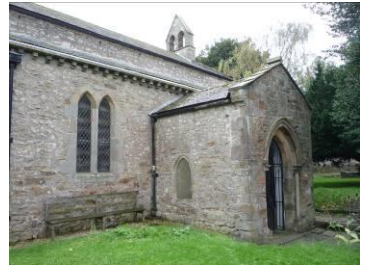
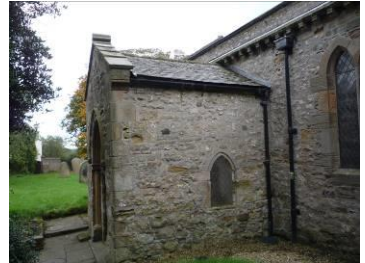
North porch:

- East slope:
 - Rounded top ridge tile perhaps – okay.
 - South abutment – raking flashing with soakers pointed in with cement. Slight crack but no action needed.
 - North abutment – to water table okay.
 - General – slating in good condition.
- West slope:
 - As east.

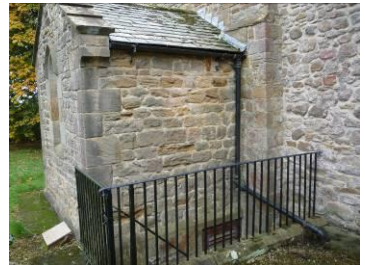
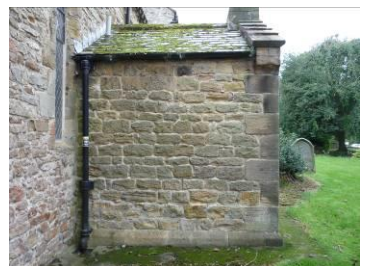
- West – Half round gutter leading to downpipe which discharges to open ground. This is wetting the retaining wall to the boiler steps and really needs a better way of discharging – perhaps to bring the pipes out on the northern side?
- East – half round gutter, possible leak midway along, planting at the top end. Cast iron circular downpipe to salt glazed gulley looks okay.

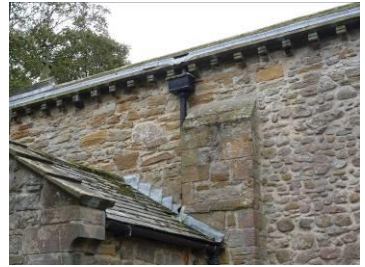
Chancel:

- North – parapet gutter. The gutter lining might have lead expansion joints. There is a covering of a joint in a lead piece, all of which it seems have cracked the weld on them and this then questions whether we actually have a water tight parapet? It

- South – same detail as the north but can see the cover flashing over the parapet joint isn't cracked – it is designed that way. Square head hopper to downpipe and salt glazed gulley in good condition.

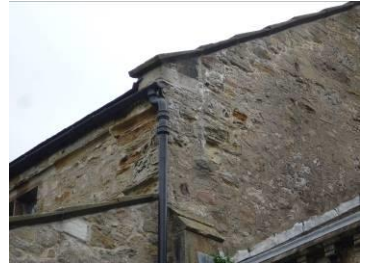
Nave:

- South – long run of gutter, half round. Looks okay but is a long way away from the roofing felt and the felt isn't dressed fully into the gutter suggesting there may be rainwater washing down the wall. To single downpipe at the east end which is okay. Leads into a cracked salt glazed gulley.

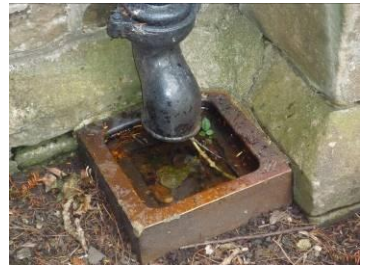
South aisle:

- Parapet gutter, same detail as chancel, to single hopper head with a rusty top to it. No lead protection to keep the leaves off here to circular downpipe, to salt glazed gulley in good condition.
- Further downpipe at the western end, rusting hopper head suggesting overflow. There is also a plant within it, leads to downpipe to blocked salt glazed gulley.

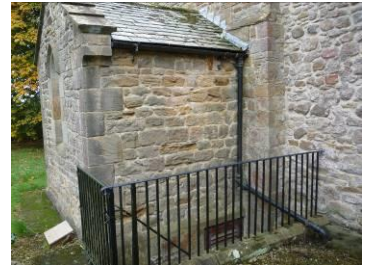
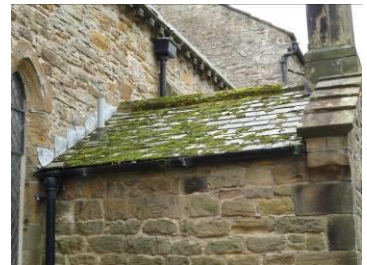
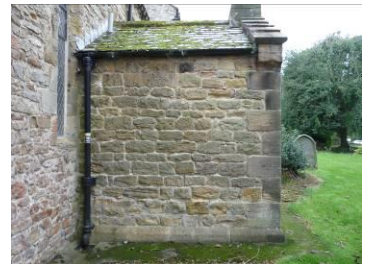
- West – couple of eroded stones but no real need for work yet. Some erosion to the pointing above the boiler house that does need doing. Below the stonework is brickwork to the boiler house steps. The plinth has open joints and the brickwork is sound but not pretty.
- North – water tables look okay. Large chimney at the apex has open joints to the stonework. Walling below this is in good condition. Single lancet in good condition. This has reasonably clear polycarbonate with obscure diamond pattern glazing behind that has plenty of cobwebs in it.
- East- coursed wall, has been patched with different mortar mixes over time and there are a couple of areas that could do with repointing – one below the gutter and another below that at the plinth level. There is also cement here which is spoiling it rather.

Recommendation: repoint open joints to walling and chimney stack

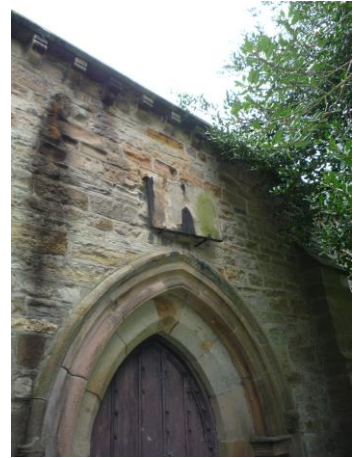
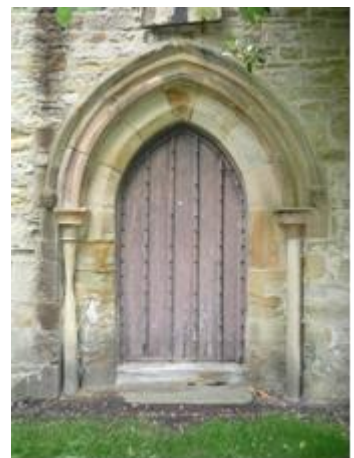
- Bay 2 – buttress as Bay 1. Marking from heating system overflow. Eroding stonework above the doorway. Lancet arch to doorway, hood mould okay. Inner order jambs are breaking down. Western nook shaft is wasting away and may snap soon. Suspect that the ground level has risen to obscure their shaft bases.

Door decoration breaking down and some parts of the moulding missing. Open joint at threshold.

Recommendation: deshale flaking stonework, repoint open joints, replace/repair nook shaft, repair missing door moulding, redecorate ferramenta

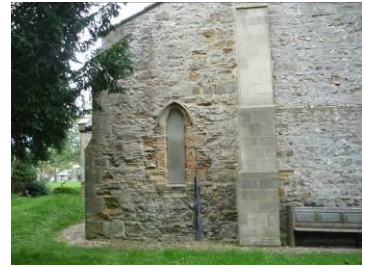
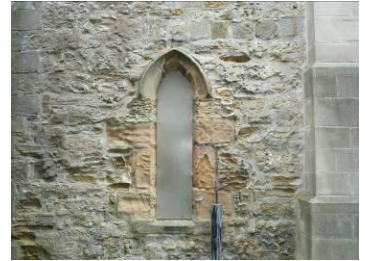
- East – water table okay. Walling generally sound, a couple of open joints as it meets the ground. Single lancet with shaling stonework at arch and jambs. Diamond pane obscure glass, unprotected.

Recommendation: repoint open joints,

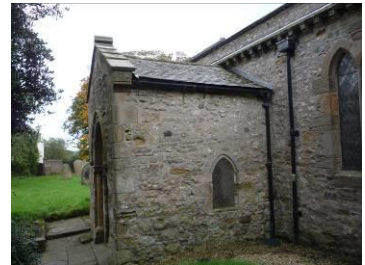
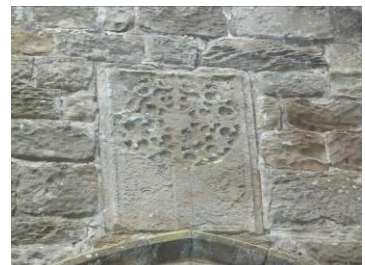
- West – heavily restored cement on the walling. Slight crack at the foot of the water table and eroded stonework below that. At lower level, a couple of eroded stones and open joints as it joins the ground. Single lancet window. Arch is beginning to split and laminate, partially caused by the fixings. Diamond pane obscure, rusting saddle bar, clear polycarbonate.
- North – water table okay. Walling generally sound apart from a couple of stones. Also within the walls are inset three tablets. Open joints as the wall meets the ground and a couple of weathered stones on the eastern jamb. Pointed arch doorway, slight movement to the keystone, open joints to it. Eastern nook shaft wasting away and there is not much left of the capital, though the base is good. The inner arch quite heavily honeycombed but can do for the moment.
- East – heavily restored with cement, only a couple

of minor open joints at the ground. Same pattern window as opposite side but in better condition. Has semi-obscure polycarbonate with diamond paned obscure glazing behind.

Recommendation: repoint open joints

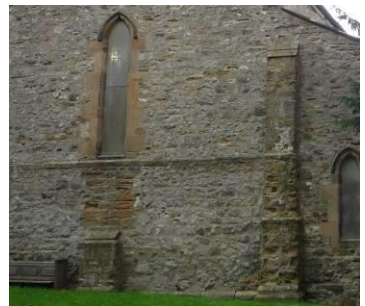
- West – heavily restored stonework and there are multiple areas of stone erosion to individual stones. Water table okay, open joints to the stub buttress and the plinth course. The string course is shaling and has open joints. Single lancet window looks okay. Has obscured polycarbonate behind pictorial glass. North buttress is modern and in good condition. South buttress stonework is shaling, cracking, honeycombed and degenerating and this is looking like a candidate for re-building.

Recommendation: arrange mason inspection of buttress and eroded stonework, repoint open joints, deshale string course

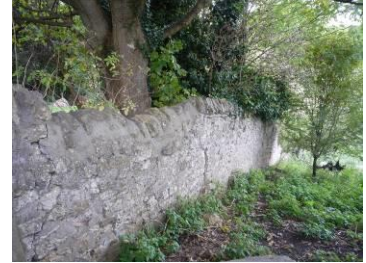
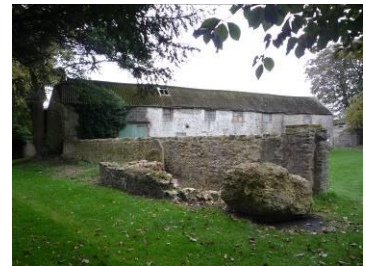
West boundary: Is made up of two parts:

- Southern end – magnesium limestone walling, quite tall running down to the bottom of the dene at the high point. Large sycamore threatening the wall. Three or four major cracks to it. It is vertical but there may well be a chance of it breaking up further in time. The middle and northern part of the west boundary is on to the adjoining farm. The stone wall is tall and has some open joints and ivy on it, obscuring the inspection.
- Part of the farm stables walls form the boundary. The more southern part of the wall has been heavily repointed in cement. It has a mixture of coping and consolidated stonework.

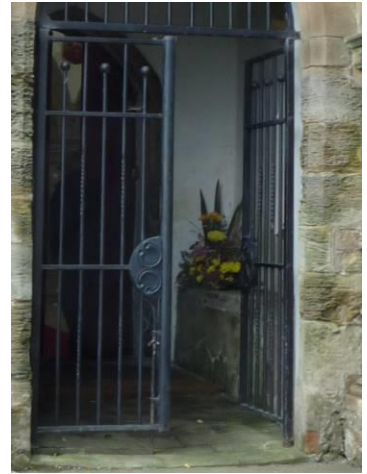
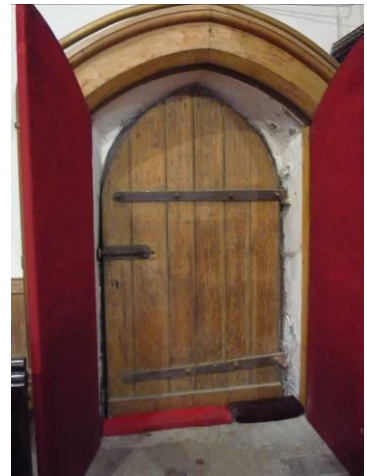
- Floor – slightly uneven paving flags, but fair. Pair of coir matting doormats at the doorway are a trip hazard. Slightly raised threshold and step down to the nave floor via a pair of double doors which really does give you the sensation of a trip hazard. Baize cupboard doors just about closing – the latch has been repaired in the past and just about catches.

Recommendation: sweep down walls and ceiling, change coir matting for low rubber egged matting to reduce trip hazard. Consider modifying the threshold
