**QUINQUENNIAL INSPECTION REPORT  
OF  
BISHOPTON, ST. PETER**

**DIOCESE OF DURHAM  
ARCHDEACONRY OF AUCKLAND  
DEANERY OF STOCKTON  
THE STOCKTON COUNTY PARISH**

**QUINQUENNIAL INSPECTION 2019 AND REPORT  
David Beaumont BA (Hons) Grad Dip, RIBA, AABC**

# REPORT ON THE 2019 QUINQUENNIAL INSPECTION

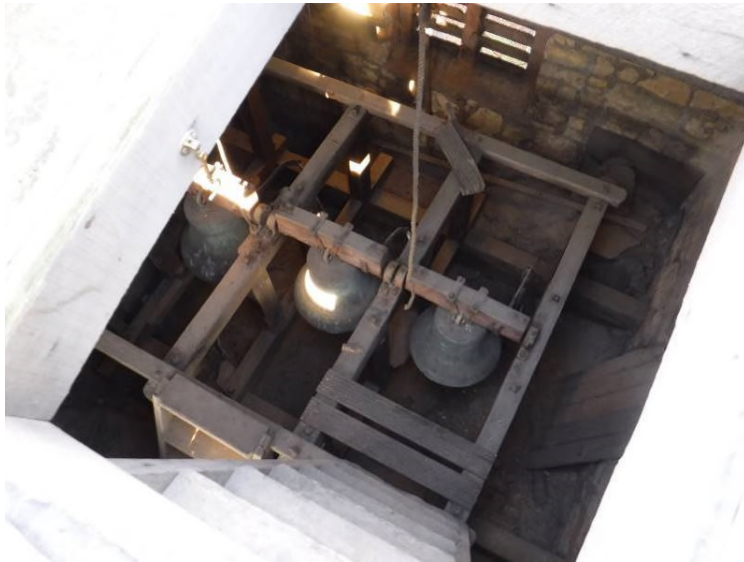
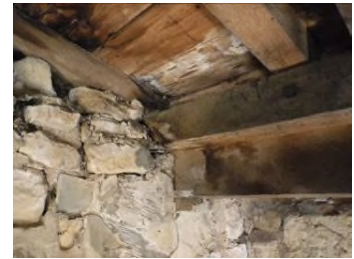
**C Belfry:**

- **Ceiling** – The raking flat roof is made of boarding with joisting, the boarding's a bit wet on the South East corner (that is the head of the parapet gutter). The gutter beam, which has been strengthened in the past, looks as if it might have a bit of rot in it. The lifting beam for the bells is rusting and really could do with being painted but it is not really causing any difficulties. The support beam for the clock weights looks ok. The base of the flagpole penetrates through the boarding and the bolts are rusting. Looks ok and I don't think there is going to be a problem with that.
- **Walls** – Random rubble, some open pointing, cracks in the South East corner as noted previously and they haven't moved and also on the South West corner. It will be worthwhile pointing those up so we can monitor their movement.

The sandstone quatrefoil belfry louvres are eroding significantly now, principally at their transoms and as a consequence a lot of the slate louvre sheets are becoming dislodged, are loose and a falling threat. There is external expanded metal mesh sheeting that looks in good order that is stopping them falling but only for so long. The louvres and tracery need repair now.

**Recommendation:** replace upper ladder, provide grab rails, mason assessment of repair needs of the louvres and belfry tracery, repoint wall cracking, sweep up floor and examine

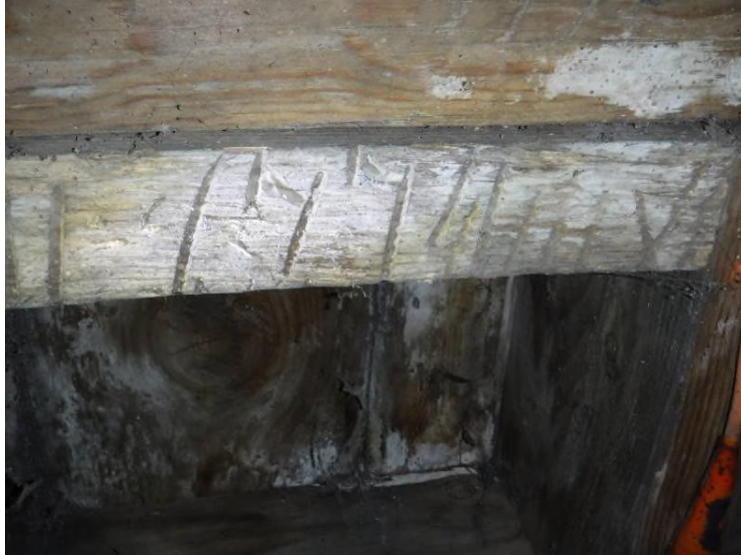
**C Clock Chamber:**

- **Ceiling** – Rot in the South West corner and the last joist and boarding into the wall looks pretty poor. The floor looks perhaps modern as it were though there is a date of 1774 carved into one of the joists, query is why is there

rot in that corner and not under the top of the box gutter? One floor joist cut away for the clock mechanism

**Recommendation:** look over the floor with a joiner to assess condition, also check the ceiling joists and damp corner.

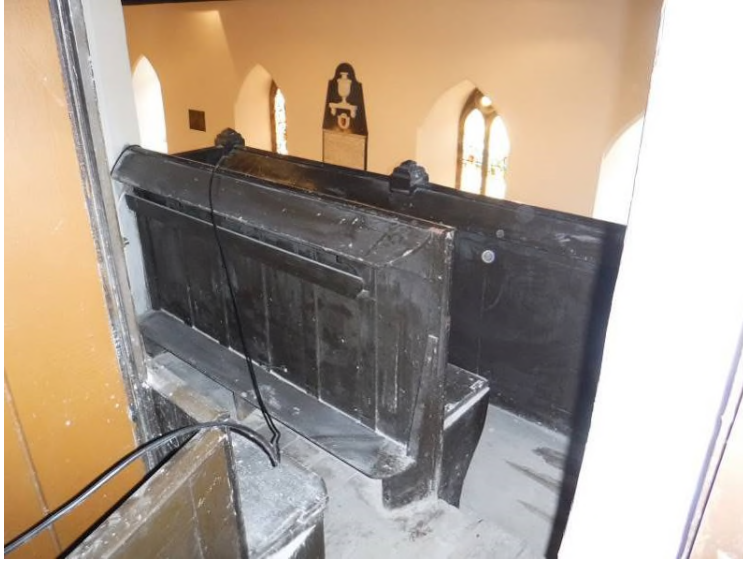
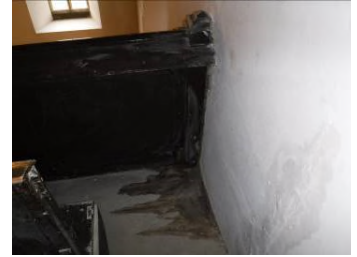
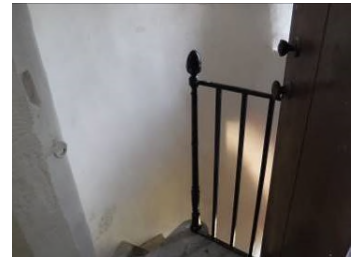
**C Gallery:**

- This has rot to the floor on the West side (wall is green outside from possibly overflowing rainwater pipe). The floor is unsafe and the space should be barrier taped off.
- It all needs a clean down as it's a mess from the decoration- perhaps considered unsafe by the decorators. It would be wise to repair the floor then clean up.
- A piece of timber on the ceiling that has not been decorated.

**Recommendation:** exclude access until repaired, repair floor, complete decoration and clean up

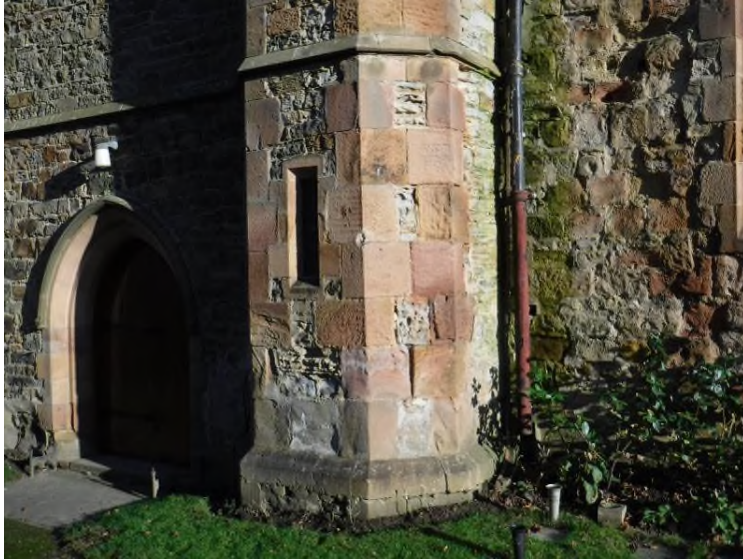
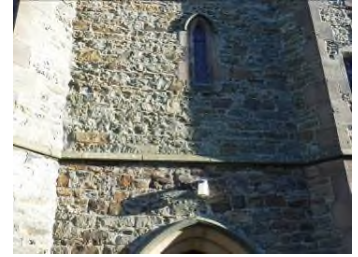
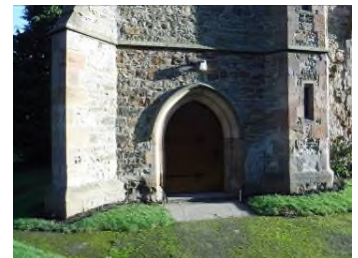
**West Elevation** – Slight cracking of the door head at the second stage, but nothing significant, this elevation has some erosion to it but it is generally ok, One bottom stone at the left of the door not looking so good and also the area where there is a cable coming in doesn't look so good there either.

**Recommendation:** the rest of the tower should be repointed to continue the 2016 repairs, in conjunction with a complete repoint of the other walls.

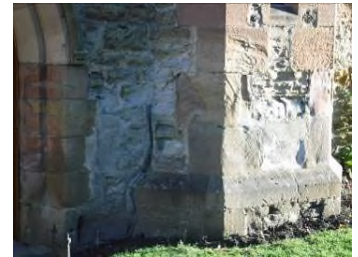
The stair tower stonework is quite gnarled and honeycombed but not really much different from the last time.

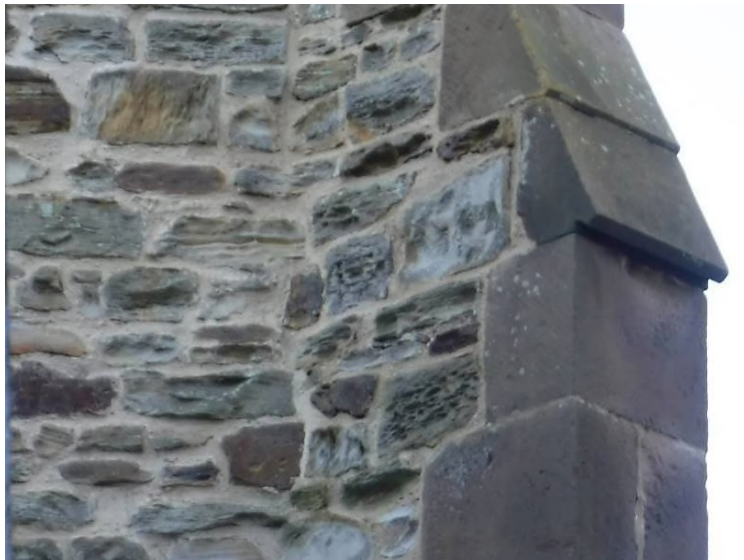
**East Elevation** – This was completely repointed down to the roofs, the bottom stage wasn't done, and it all looks fine.

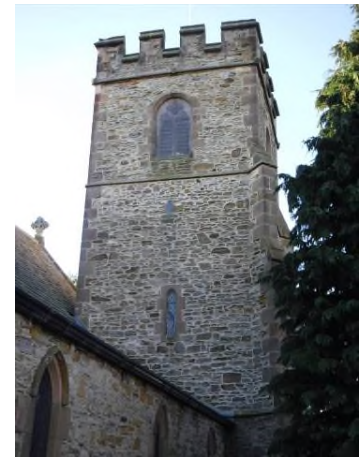
Some slight honeycombing to the stonework on the North East buttress.

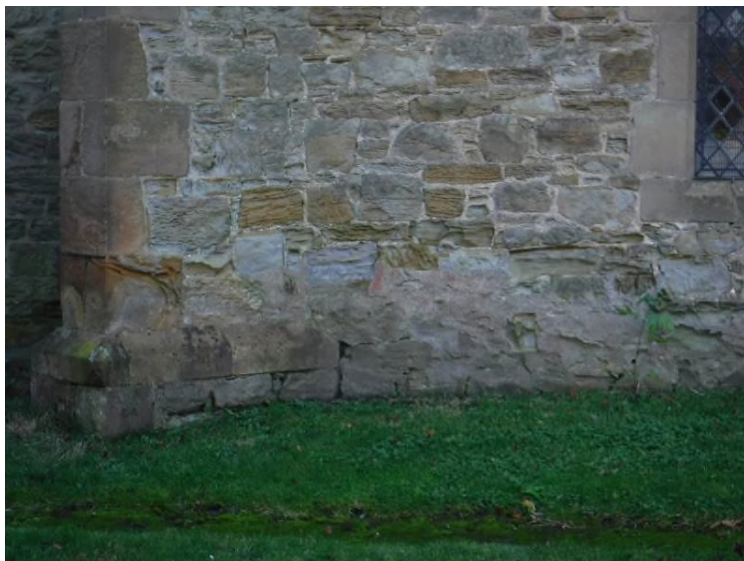
- C** **North Elevation** – Top stage repointed middle and lower stage not repointed, some honeycombing and eroded stonework but actually in fair condition, possible crack radiating up from the bottom stage lancet window perhaps?

Some slight open joints by the North East buttress both buttresses, there is also the start of a plant growing that needs to be removed, and also there is an area of rendering which is probably hiding poor quality stonework.

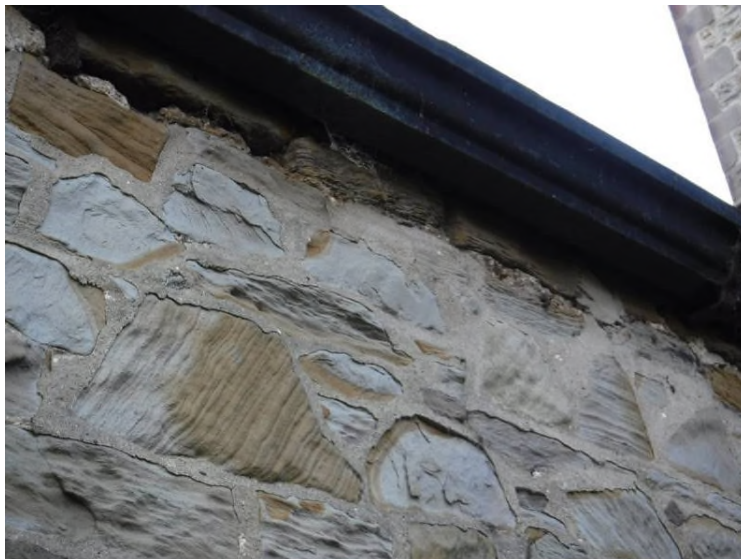
**B** **North Aisle:**

Gutter brackets rather rusty here, downpipe looks ok but the gulley appears to be silted up. Leak at the tower end of the gutter?

**Recommendation:** clean out gully, investigate possible gutter leak

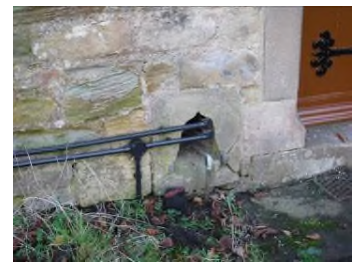
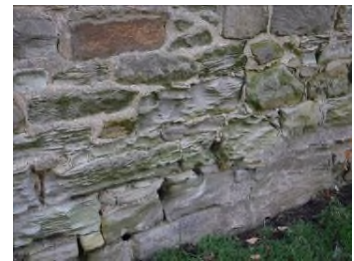
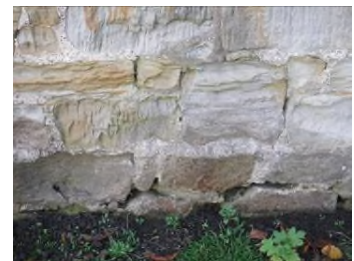
C **North Aisle:**

**Northside** – Rather random mixture of materials here being at the downpipes suggesting that there has been rainwater there, some erosion to some of that stonework, large hole where the pipework in coming through where there used to be a foot scraper, some green on the wall as well and quite a few holes in it. The eaves isn't very good, it is very patchy and there is some green on that as well. Window dressings of lancets are all ok.

At low level there is some erosion and open joints, rather green at the Tower end suggesting there might be a gutter leak.

**Recommendation:** repoint open joints and infill hole alongside vestry door

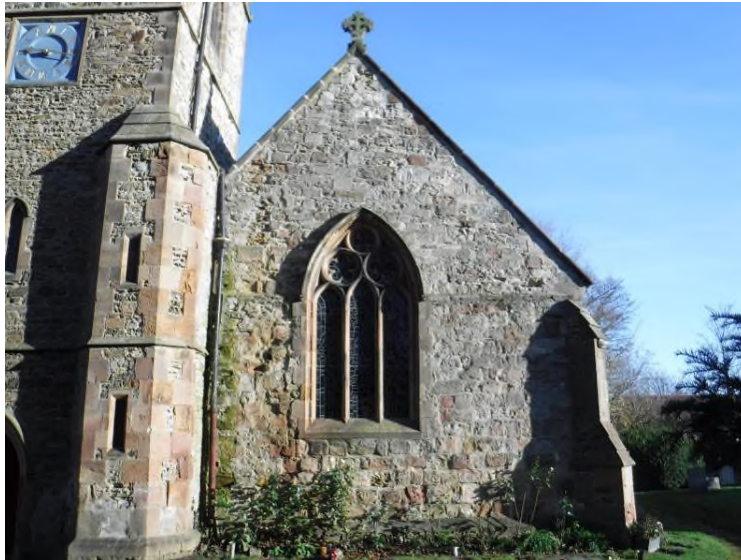
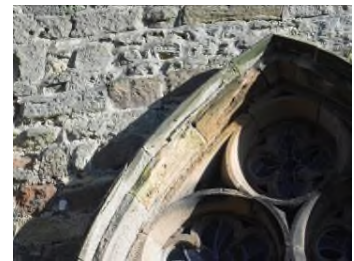
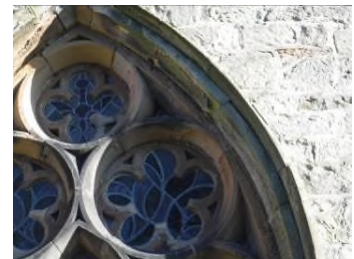
**C Nave:**

**Westside** – Water tabling all ok. Some green showing at the downpipe which is looking disjointed and not very vertical, there is also some mesh at the (former box gutter?) outlet which suggests there might be trouble there.

Slight movement at the buttress corner on the South West corner. One very eroded stone above the springing point of the arch, also area to the Northside of the arch stonework is quite eroded, there is also cement up there, leaking/blocked pipe is wetting the walls.

Below the springing line walling is just ok, it will do. There are open joints on the plinth course. Set within the wall is a large lancet window, 3 light. With pictorial glazing. Hood moulding beginning to fracture as is the intrados (inner arch). The Northern jamb is eroded but it is ok. The tracery within it is fundamentally alright but there is some cracking to the most Northern at the bottom of it, probably as a result of rusting dowels, the Southernmost upper is also beginning to crack, both top and bottom are cracking slightly and I wonder if it is the hardness of the pointing of the window. The 3 circular lights all have some elements of erosion and they have been patched in the past.

**Recommendation:** repoint open joints, stonemason to assess west window condition, allow for mullion and hood moulding repairs, rebuild part of the gable walling to the left of the window.

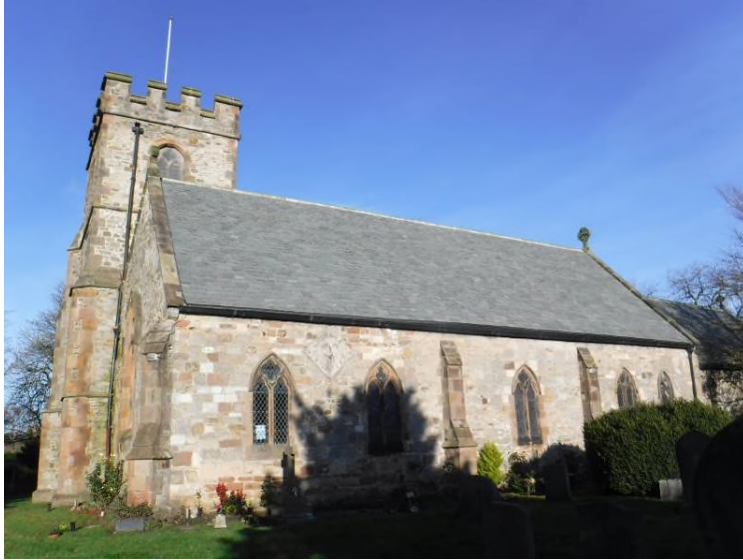
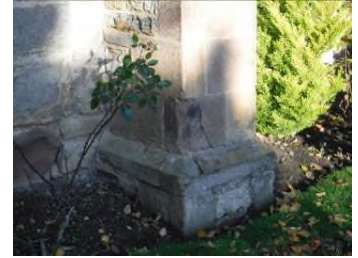
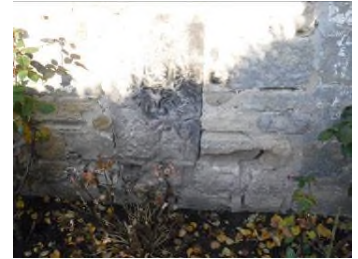
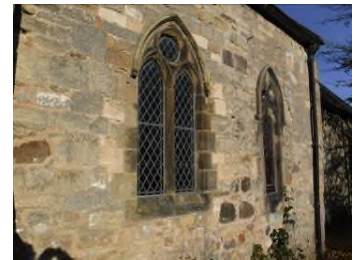
**C Southside**

–This is the Medieval wall made out of large units, surprisingly most of the stonework is generally ok though the mortar is hard and it is causing some erosion to the stones. There are grave slab covers and sundial built in and the low level items are very susceptible to damp and thus erosion. Repointing in lime would be an improvement- might they also be removed for their longer term preservation? No action without a Conservator’s Report first. The buttresses have open joints. There are five lancet windows in it and they are generally ok as is the glazing and the bedding around it. Window number four to the East is slightly eroded at the hood mould but not really a problem. The Eastern most window is losing its putty pointing.

**Recommendation:** repoint open joints

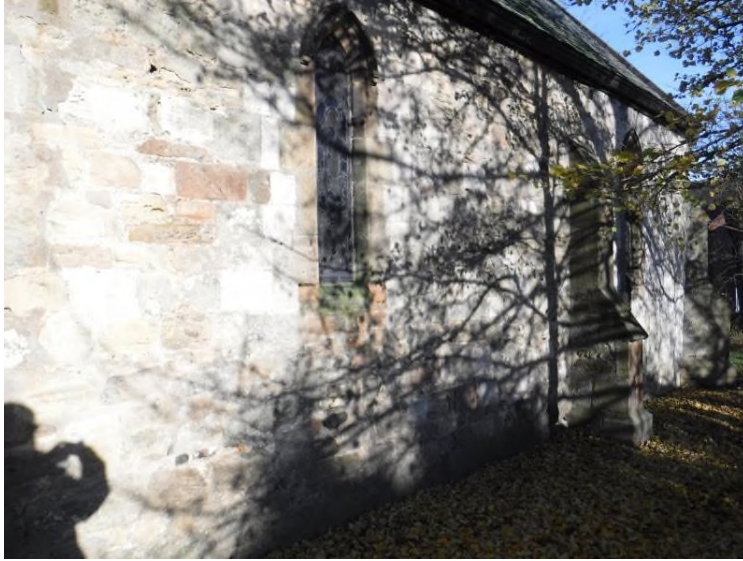
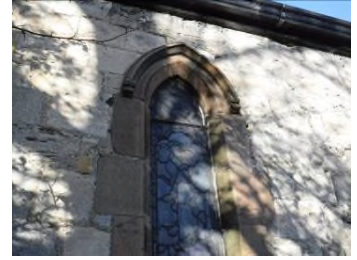
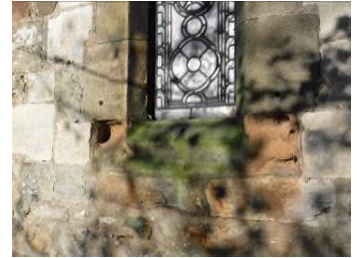
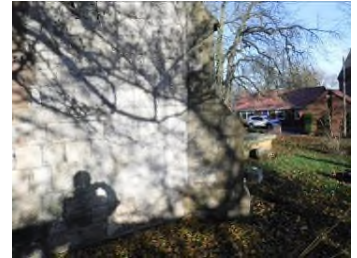
**Chancel:**

**Southside** – It is a mixture of limestone at the Eastern most end and a mixture of sandstone at the other. There are areas of cement pointing particularly in the corner to the Nave that are not so good. Buttresses are slightly cracking, the middle buttress is slightly cracking and is worst on the South East one that is dropping. Quite a bit of pocket erosion to the sandstone cill on 1 of the windows, probably a mortar repair would do for the moment rather than indent of new stone. It is happening to both of them and the frame is rusting to the Eastern most lancet top of the window.

**Recommendation:** address rusting window frames, repair guarding, infill holes in cills, repoint open joints,

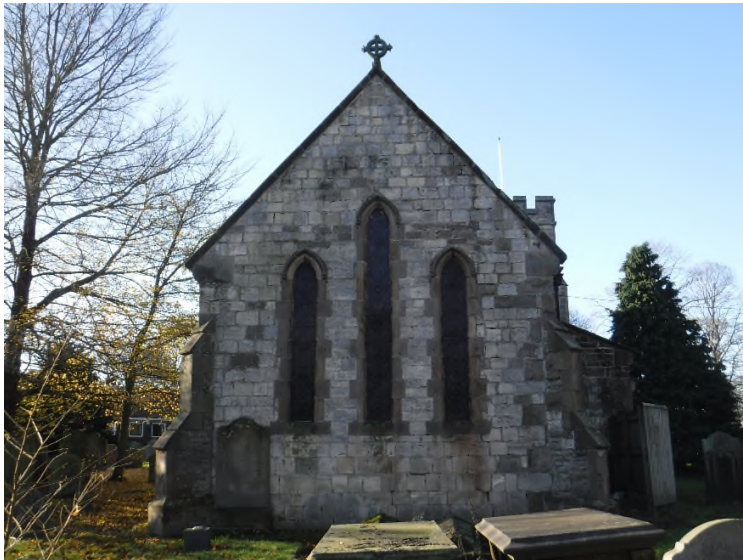
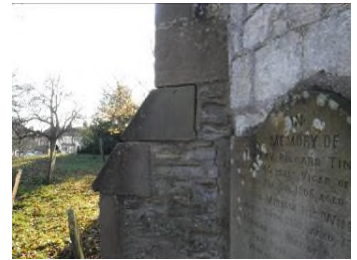
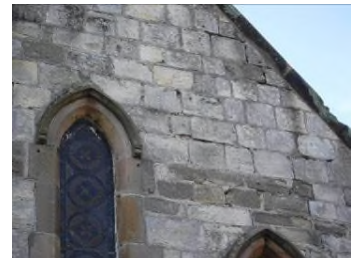
**Eastside**

–Quite a lot of open joints to the elevation. There is some movement in the South East corner but nothing major. The three lancets dressings are generally ok though the Northern most is a bit more worn than the others, the glass is protected apart from the middle whose upper section is missing.

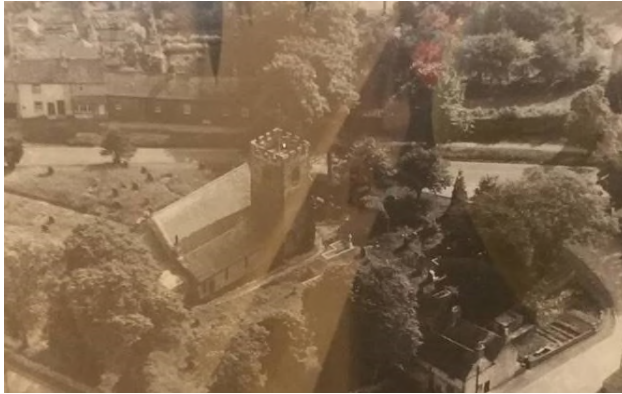
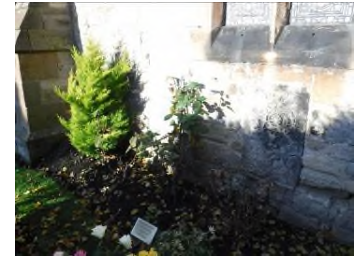
Closed graveyard with many memorials, some are leaning a bit some have erosion to them an inventory should be taken. Tarmac paths from the South and the West entrance generally ok, are a bit mossy, might be slippery in frost. Evergreen against the South Nave wall by a cross lab that is going to give problems in the future unless it's out now.

The graveyard walls retain the graveyard and they are cement pointed in many places there is quite a few open joints as well to them

**Recommendation:** remove evergreen on south nave wall, oil and paint double gates, cut back west yew and pine- or weed out the pine, remove ivy, remove the killed trees, repoint the walls- with lime

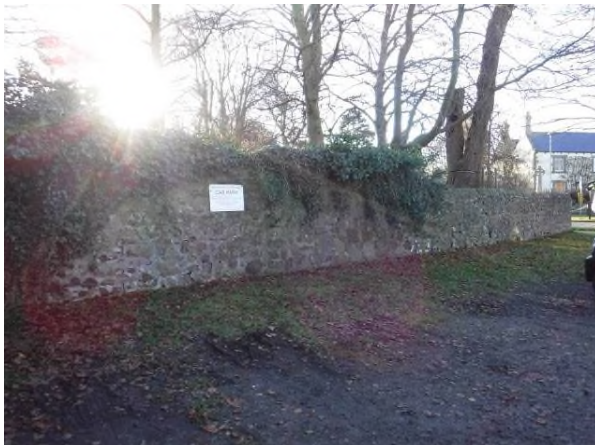
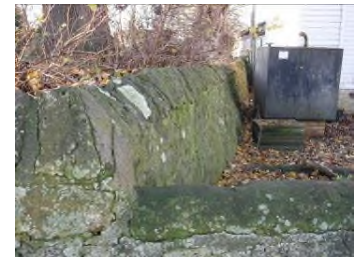
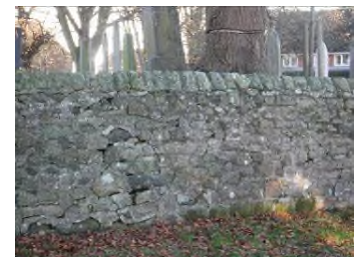
### Northside

Is partially shared with the Village Hall at the area of the carpark the stonework is open where there is another tree that's had a cut put in it.

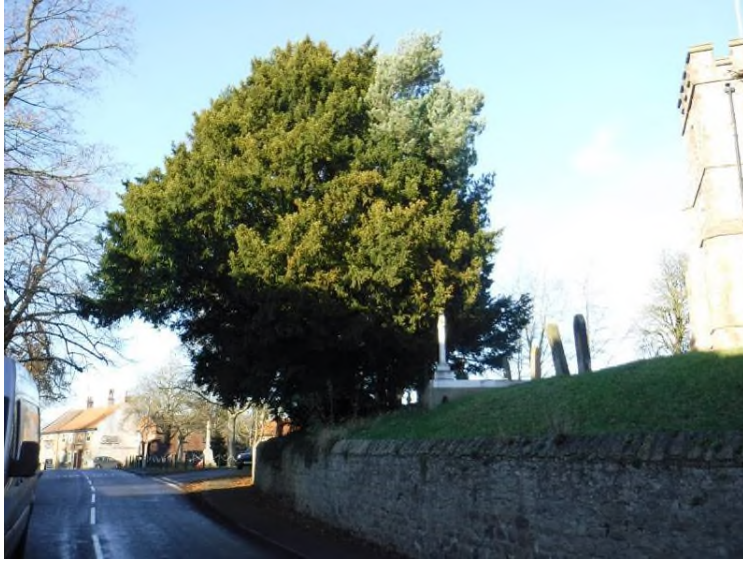
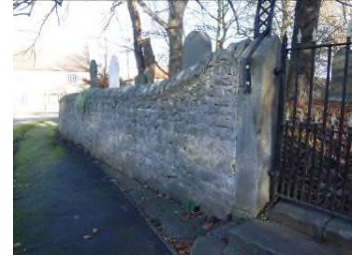
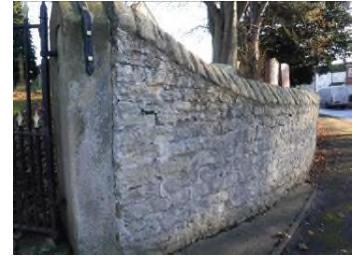
**Westside –**

Open joints all as a consequence of being in cement all the little bits are just chipping at the joints.

Double gates ok, rusty and could do with oiling and painting.

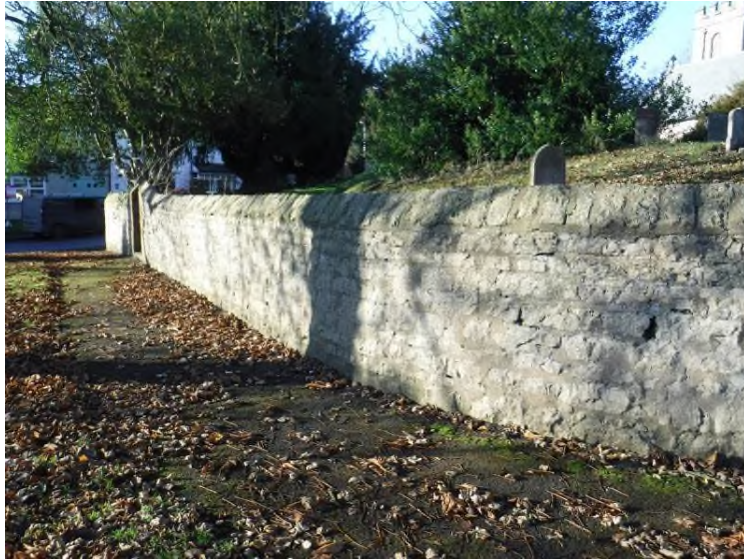
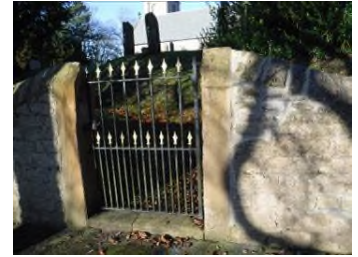
**Southside**

The cement repair to the South gate pier is particularly abominable in cement. Use lime!

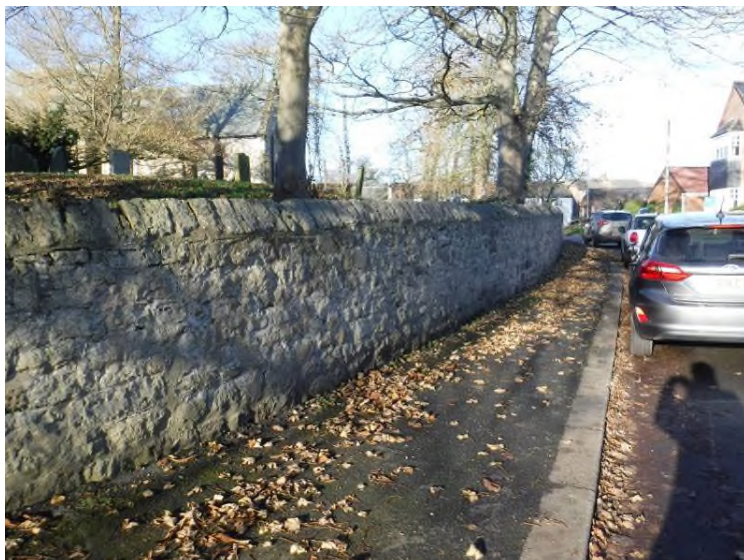
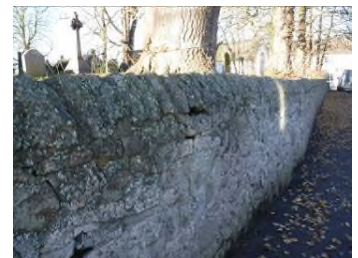
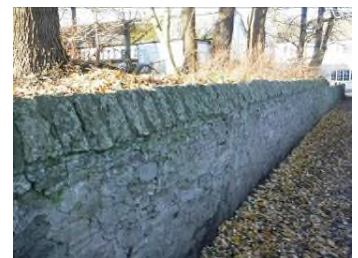
### Eastside

Wall bulging out a bit on the East end where there is a cut down bit of a tree which they haven't completely killed off.

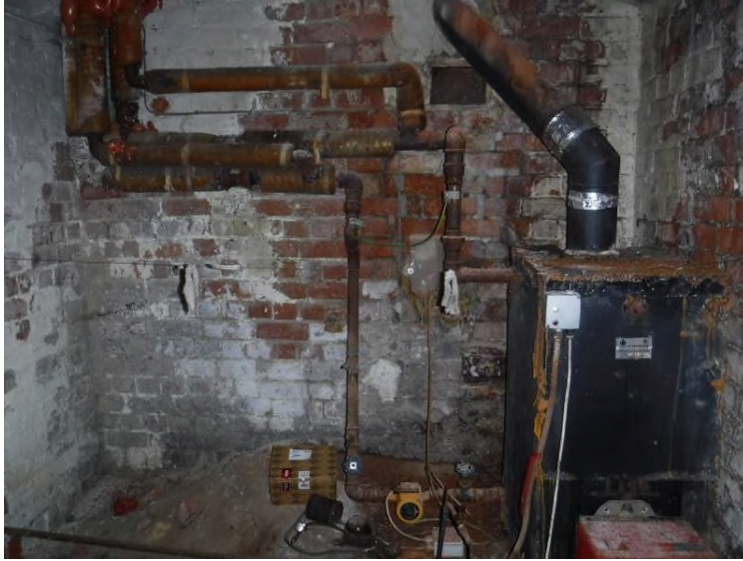
C **Boiler Room:**

Barrel vault ceiling in brick, as is the walls and floor. Relatively dry for a subterranean space, some spalling of brickwork, lime wash is coming away in places particularly on the Northern side, some open joints, there is a former coal chute looking a bit damp, part of the barrel is held up by a lintel stone that is eroding can't really tell if its adequate.

The door ironmongery needs renovating and the door easing in the opening. The light switch needs to be made sensible for illuminating the space.
