**QUINQUENNIAL INSPECTION REPORT
OF
BLACKHALL, ST ANDREW**

**DIOCESE OF DURHAM
ARCHDEACONRY OF SUNDERLAND
DEANERY OF EASINGTON**

QUINQUENNIAL INSPECTION AND REPORT

March 2023

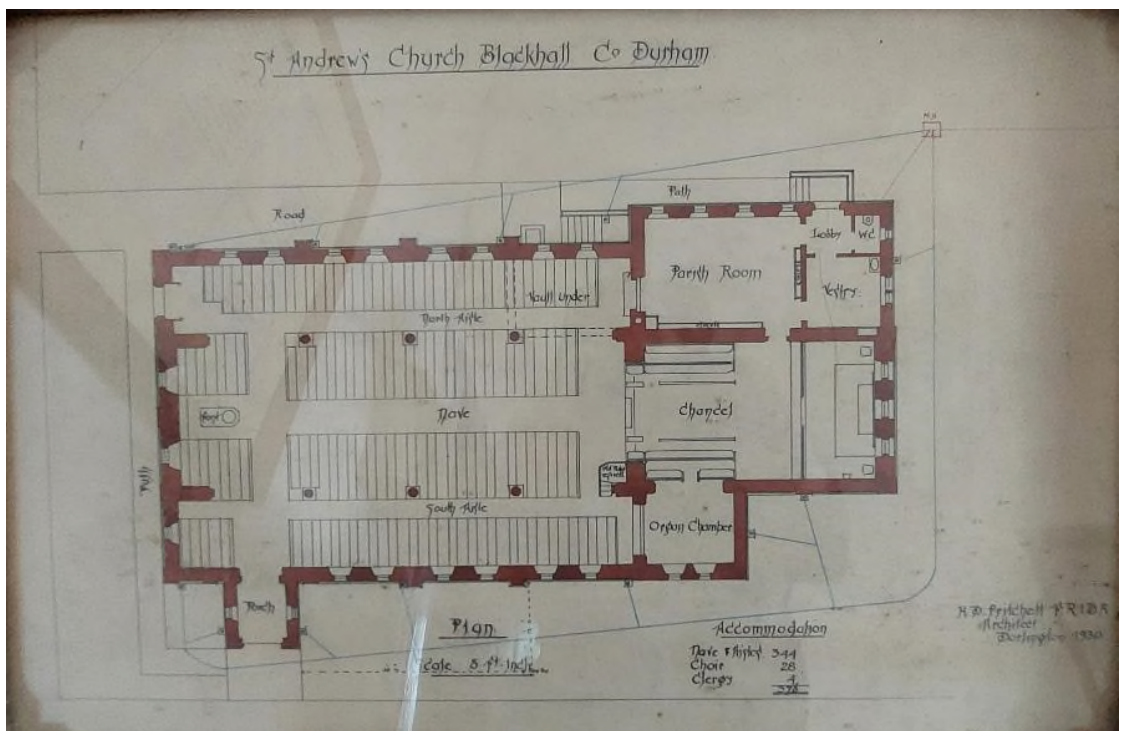
Original plan in Vestry, note combined drainage layout.

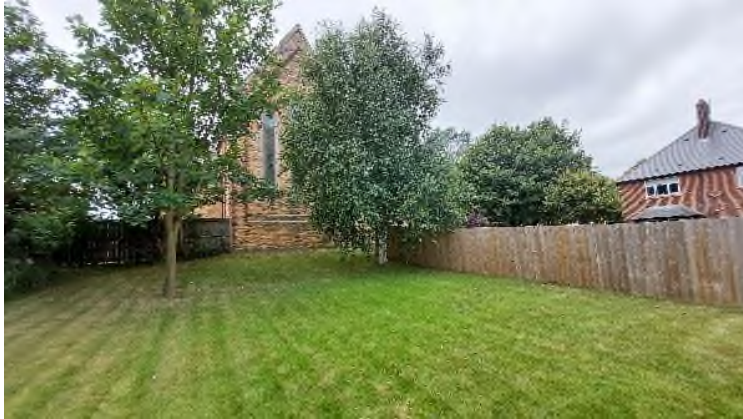
E **Trees:**

Two trees at the east end which are beginning to mature now, and they may reduce the light coming in at the east end window.

Recommendation: consider trimming branches

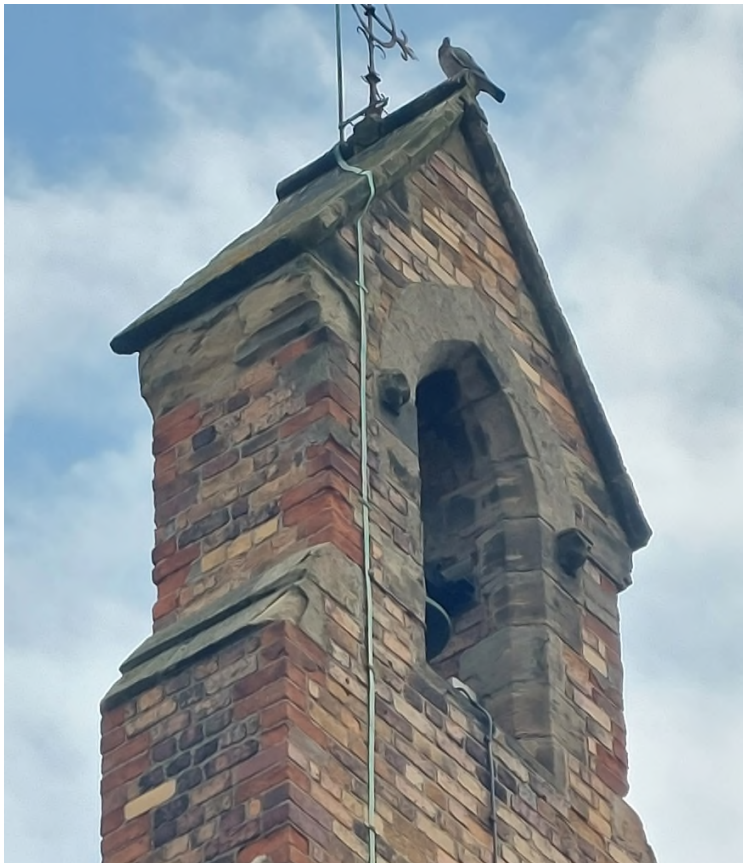
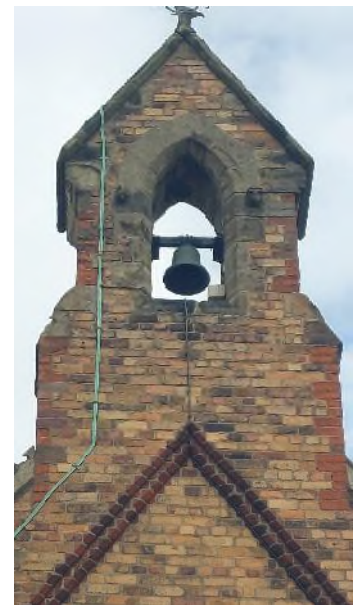
7.4.1 BELLCOTE

M Not much changed since the last QI, the cross remains rusty and there is erosion to the raking copings. The kneeler to the northside is heavily eroded. The bell within the opening seems ok, it is on recent new metal hangings it is electronically chimed. The brickwork around the opening seems ok.

Recommendation: inspect when carrying out roof covering repairs

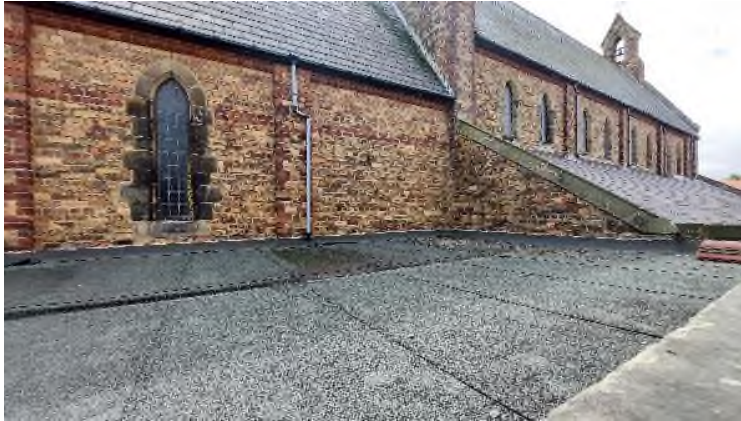
E Vestry:

Flat roof, swept down in the last couple of years, mineral felt looks ok. A slate at the chancel rwp outlet will reduce wear and tear on the covering.

Recommendation: slate at the rwp

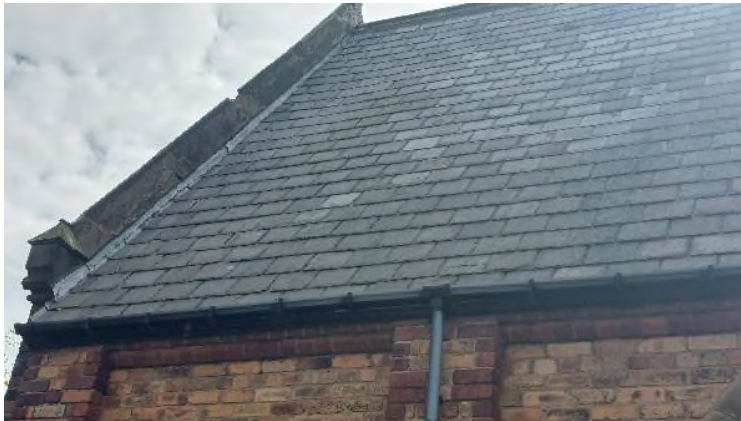
B Chancel:

North side –Ridge bedding looks ok, slating is good.

East abutment flashing is continuous lead. The watertable has a big notch out at the wall junction halfway down. Can't see the west junction to the nave gable.

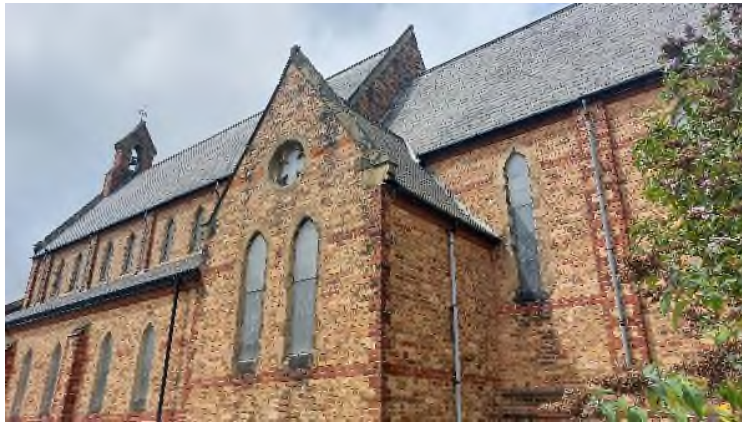
South side – Angled ridge with rolltop moulding most of those look in good condition, on cement bedding with a couple of areas loose particularly against the nave, it looks like a bit has broken off and as it skidded down the roof and it has broken the plastic gutter.

Much patched slating, mixture of heather and green some loses up at the ridge and possibly midway down. West abutment flashing stepped in leadwork ok. East abutment flashing continuous to the watertable in lead ok.

Watertables are chipped and there is a bit missing at the uppermost built-in element.

Recommendation: ecclesiastical roofer **to assess covering**

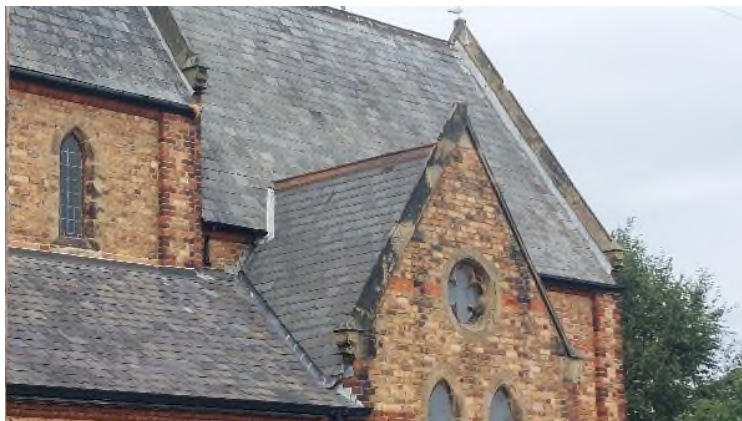
West face – All as east side. Watertable broken particularly at the walled in junction.

Recommendation: none

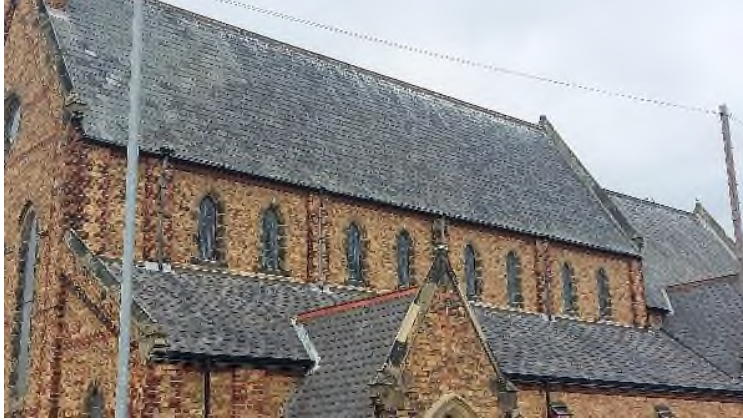
Nave:

South side – Ridge as chancel, bedding seems mostly sound, slate missing at the bellcote and a couple of other slipped slates.

West abutment flashing stepped at the bellcote and continuous at the watertable ok. Watertable here has a notch out at the apex close to the bellcote and here the inner face of the watertable is heavily eroded just as the lightning conductor wire turns the corner and there is a pocket here where rainwater can sit.

East abutment continuous over soakers ok, watertable looks ok here apart from a notch out just up by the apex.

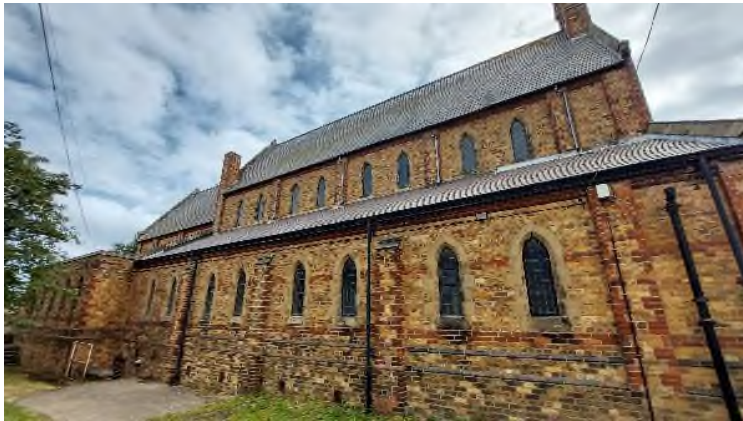
North side – Ridge bedding looks sound, slating looks generally ok, its worn than the south side, though there are some slipped slates up at the ridge.

East abutment continuous lead flashing under watertable leads down to back box gutter of flue chimney there is some grass growing in that. Watertable has big notch out at apex.

West abutment one stepped flashing missing at bellcoat at apex and has continuous lead flashing to watertable which has lost a little bit of moulding at the junction to the kneeler.

Recommendation: replace slipped slates

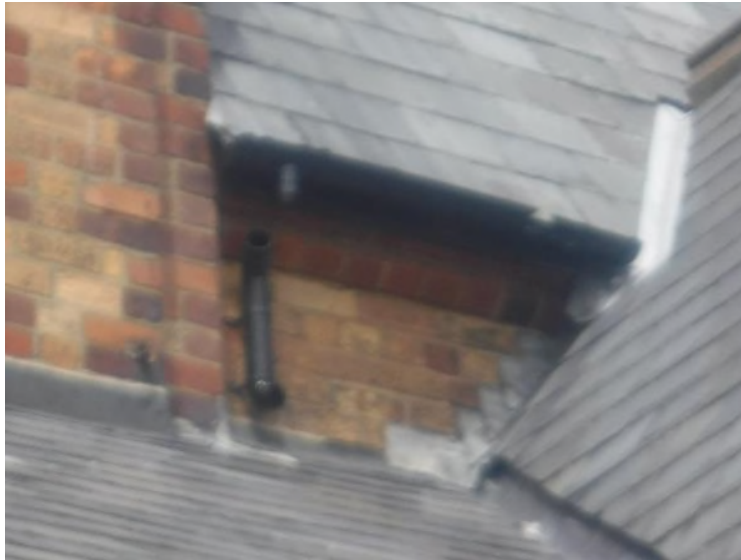
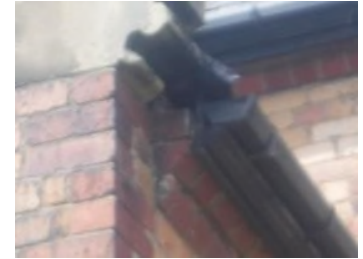
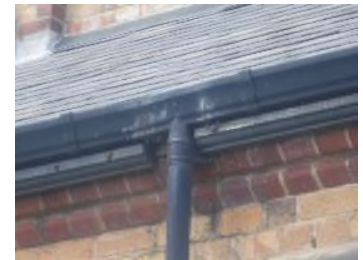
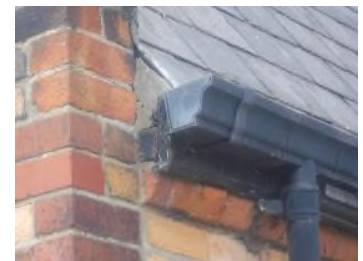
North Aisle, North side –Signs of water from failing guttering at the west end slight staining bwke, also at the eastern most downpipe position gutter has probably blocked or failed at that point, can also see it in the mid-point where there is a gutter junction.

We can see salt glazed gullies on the north side and they have got elementary slate covers and the western most is high out of the ground and not really making a connection with the gully which is overgrown with weeds and the porch is also original cast-iron. The south side also goes to salt glazed gullies and the pipes are a little high and their discharge is greening the walls slightly.

Recommendation: check all gutters are not leaking and pipes are running, repair accordingly, reset pipe discharge to gullies and fix covers

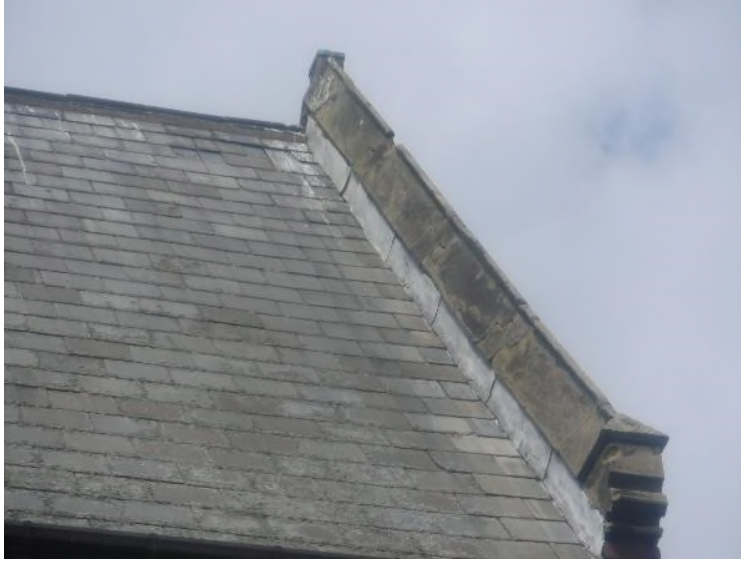
- **Chancel:**

South side – Brickwork ok, slight open joints at the lancet heads.

East side – Same design as the west gable, all the brickwork looks ok, couple of eroded stones below the middle window otherwise fine.

Recommendation: none

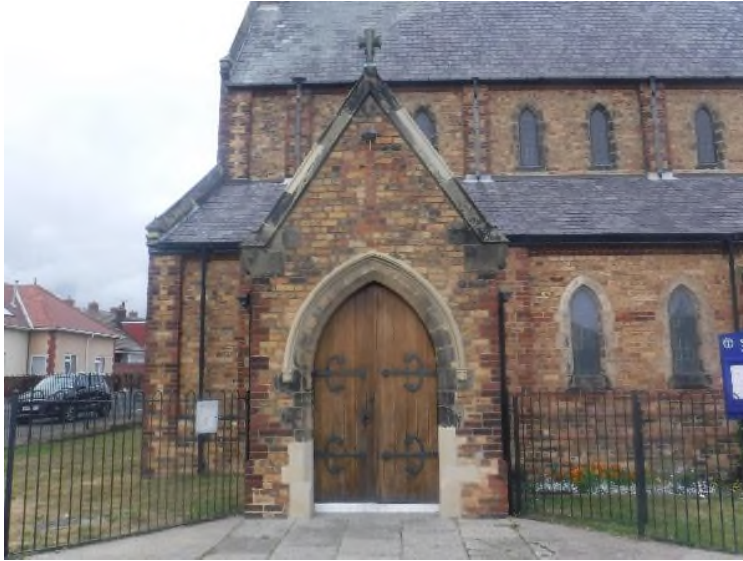
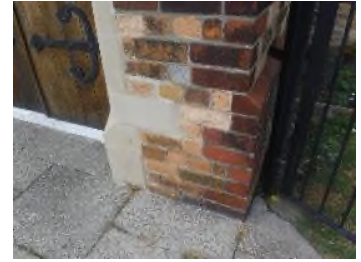
Porch:

East side – Oversailing eaves brick course under timber fascia, generally ok, one brick spalling, below that the walling brickwork is ok, paint marks on it from painting the guttering.

South side – Erosion to apex that forms the cross base over the arch doorway, a couple of light coloured stones eroding on the righthand side. Recent jamb and hoodmould repairs by David France.

Recommendation: none

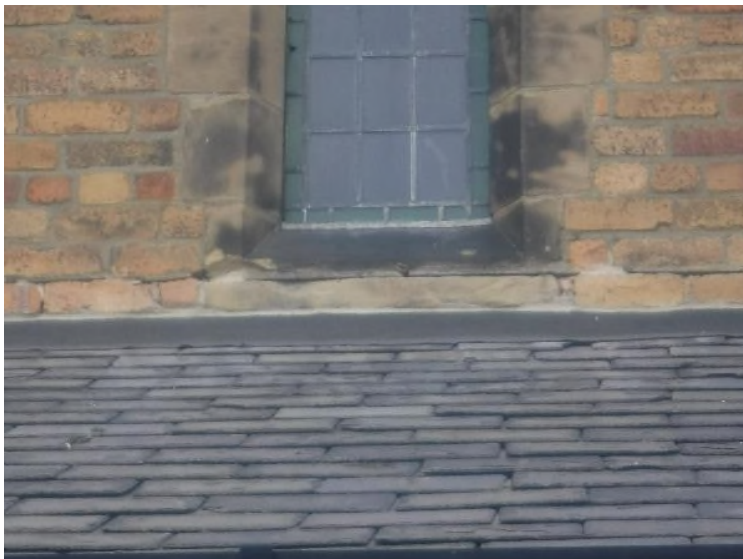
Nave:

South side – Open joints below the windows cills where the lead flashing used to cover. Looks like the original lead flashing tucked into the joint remains. Needs tidying up. Perhaps an additional taller replacement flashing?

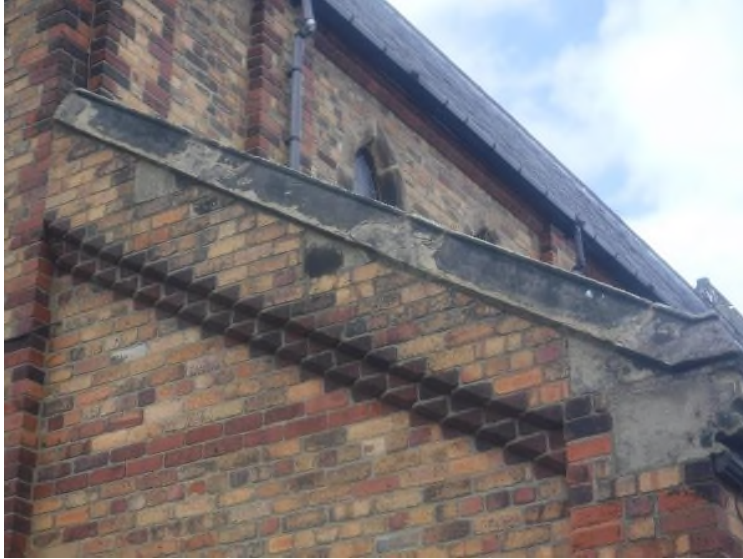
West side –

Gable nice, recessed brick detail parallel to the watertables, picked out in different colour looks ok, general walling looks ok no sign of cracking to it and the pilaster buttress is ok. Stringcourse stone moulding leading into the lancet arch is eroding.

North side – Open joints above the three eastern most clerestory windows, the worst being the central one. Some slight open jointing at one of the window cills above the flashing.

Recommendation: repoint open joints at clerestory windows when carrying out roofing repairs

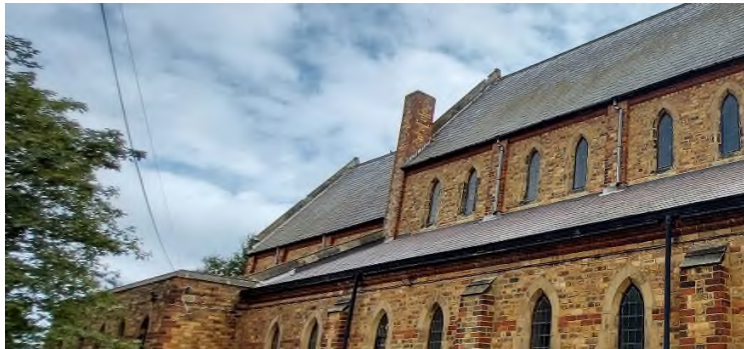
Chimney stack at the western end not easy to see its condition

Recommendation: check chimney condition when next on roof

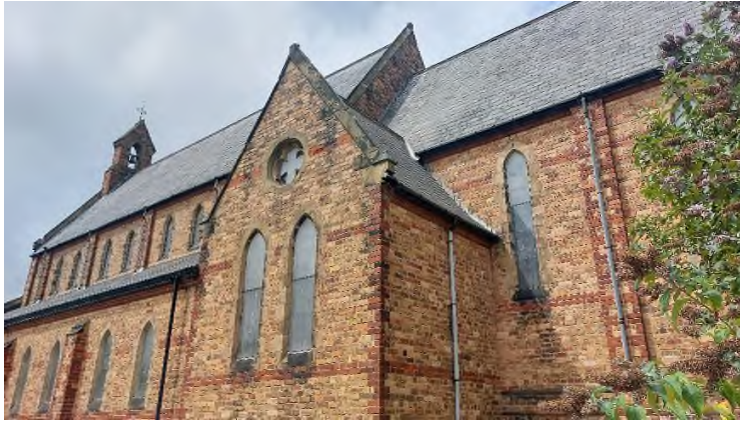
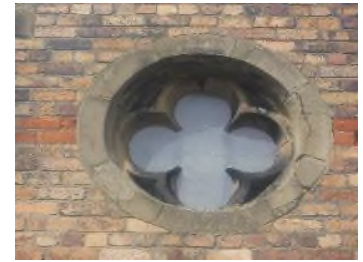
South Transept:

South side – Quatrefoil window has cracked ashlar circular surround on eastern side, below that a pair of single lancet windows with good polycarbonate and the ashlar is ok.

Recommendation: monitor

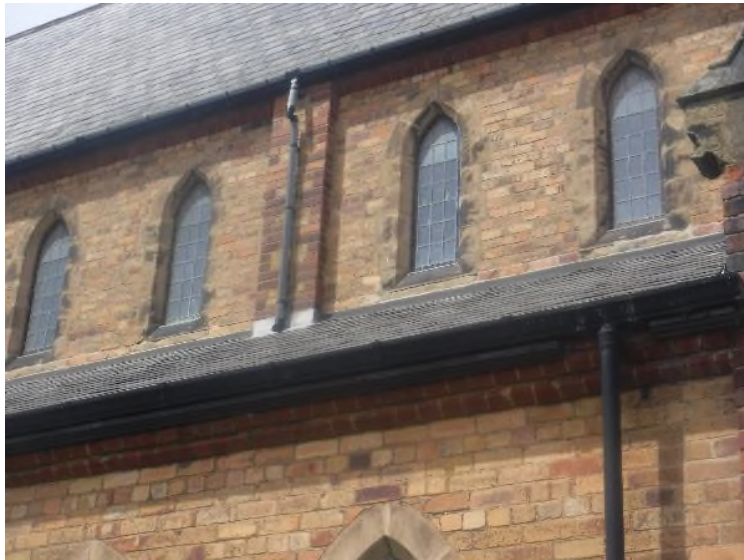
Nave:

South side – Four bays each containing two single lancets, unprotected glazing obscure rectangular comes with coloured margins.

Bay one – eastern most has had a glass repair and looks a little poor.

Bay Four – The eastern most has had blue margin replaced and looks to be siliconed in which is breaking down.

Recommendation: repair s side glass

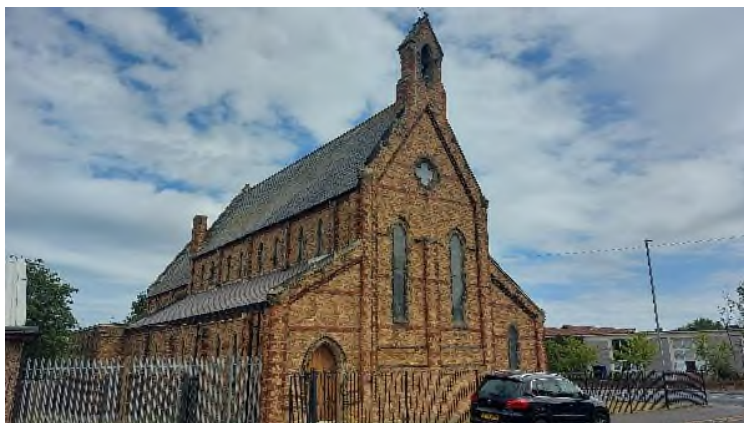
West side – Quatrefoil looks ok, slight erosion at five o'clock to the ashlar surround probably because there is an open joint where water is coming through. Below that pair of lancets with good polycarbonate. Northern has had repairs of the quarries in the past and margin glass looks a bit ham fisted, polycarbonate ok, eastern most also has had some repairs. Ashlar surrounds ok, hoodmould is weathering on both lancets and as they link into the horizontal stringcourse.

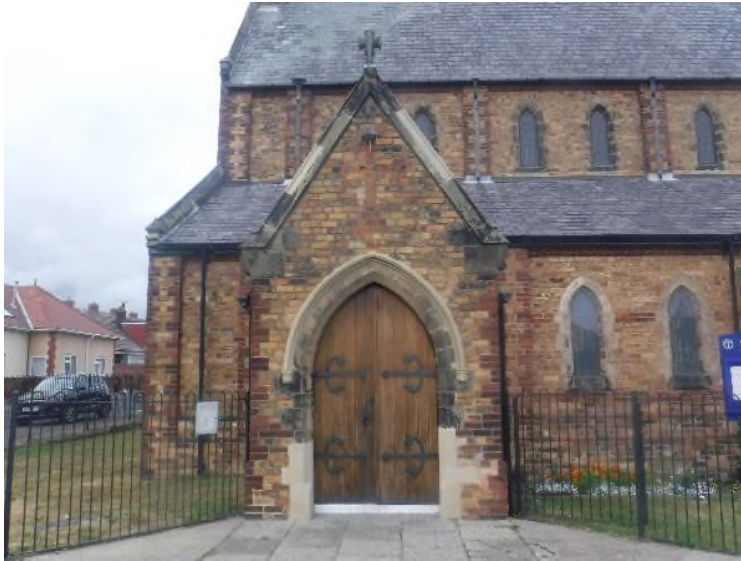
C **Porch:**

East side – Small rectangular obscure glass with polycarbonate, ashlar surround looks ok.

South side – Pair of oak boarded doors, door handle is missing and the keep for the lever and there is a 100mm step here.

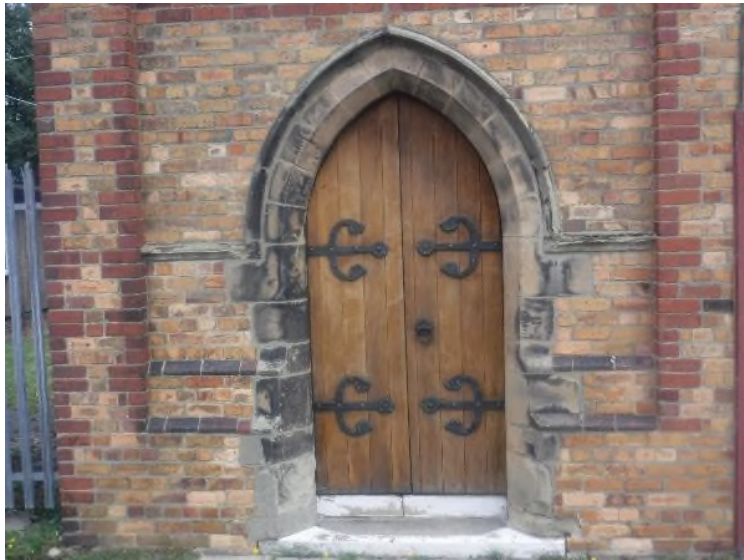
West side – Pair of heavy oak doors, the hinge is breaking one of the stones on the northside and there is also erosion to a lower piece, hoodmould has a couple of eroded pieces which link into the stringcourse, two steps up here.

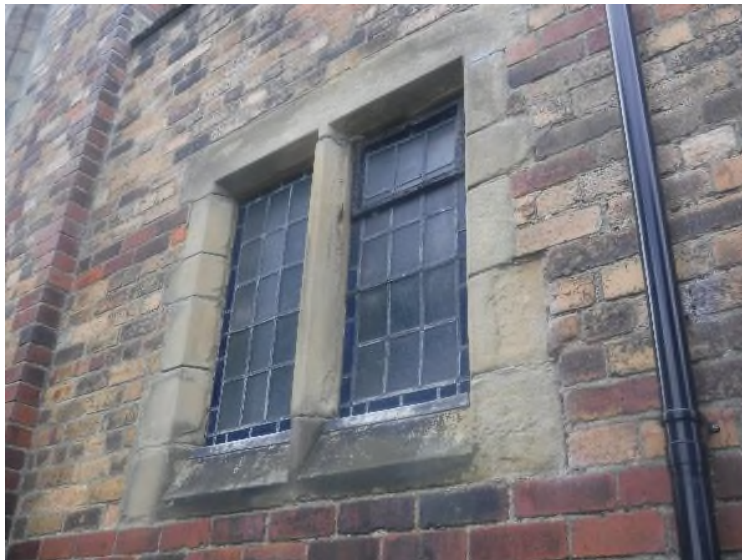
Pair of rectangular unprotected lights, one with heavy rusting ventilator buckling glass and the glass to its neighbour is buckling also.

Single light has major buckling to it and rusting ventilator, and it looks like the ventilator fixings have expanded so much that they are pushing out the northern most jamb stone underneath the lintel.

Recommendation: repair ventilators, update door draught stripping, decorate

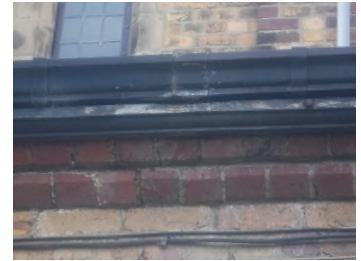
- E The gutters are on heavy timber fascias, and the decoration is breaking down on these.

Recommendation: redecorate if and when replacing guttering

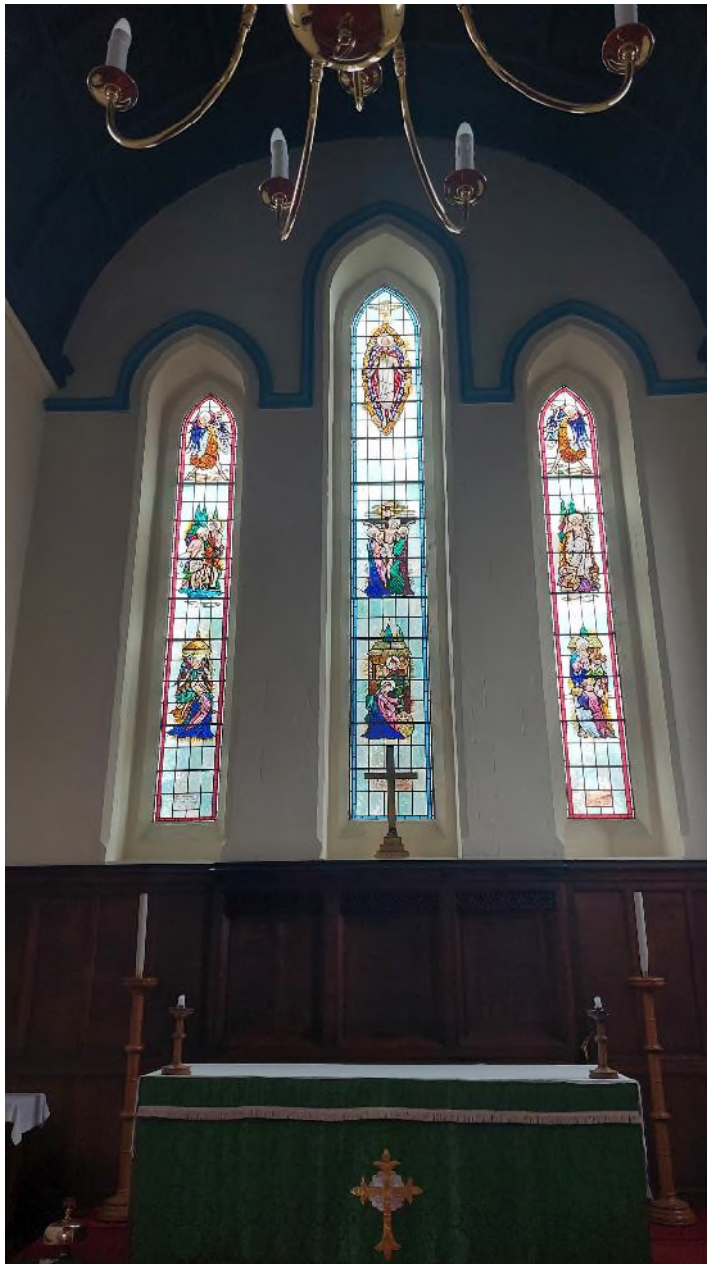
E Chancel:

East side – Pictorial triple light, ok.

South side – Pair of single lancets one with ventilator not opening, glass is obscure with coloured margins, cracked quarry to the eastern most.

Recommendation: repair buckling glass

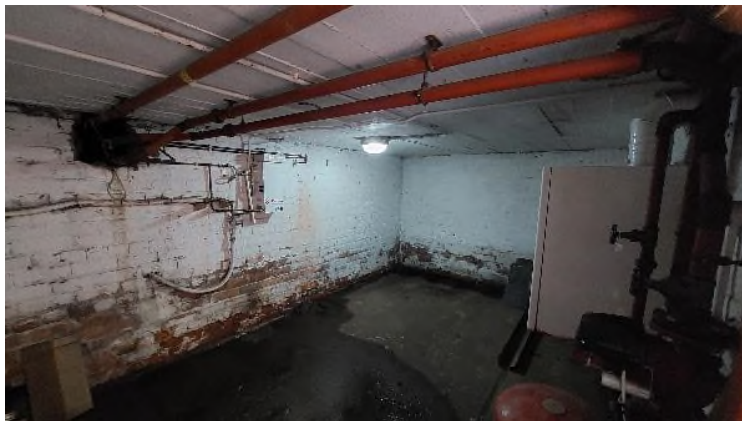
C BOILER ROOM:

Ceiling – Shuttered concrete some cracks in it but it is sound enough.

Walls – Painted brickwork some damp showing at the lower levels.

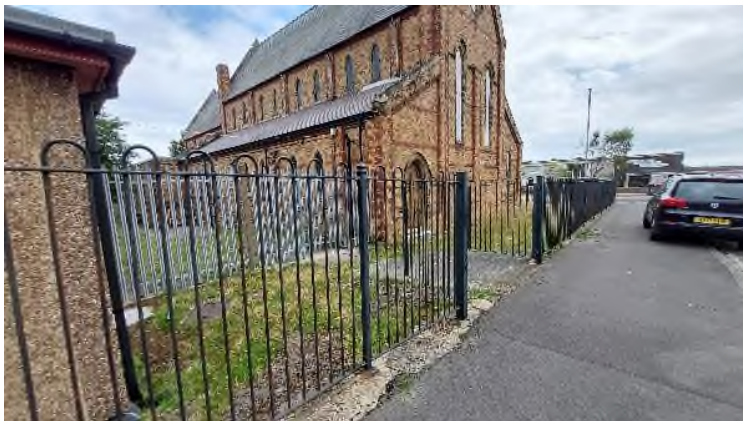
West side

– Railings, tarmac is a bit broken up at the drive entrance.

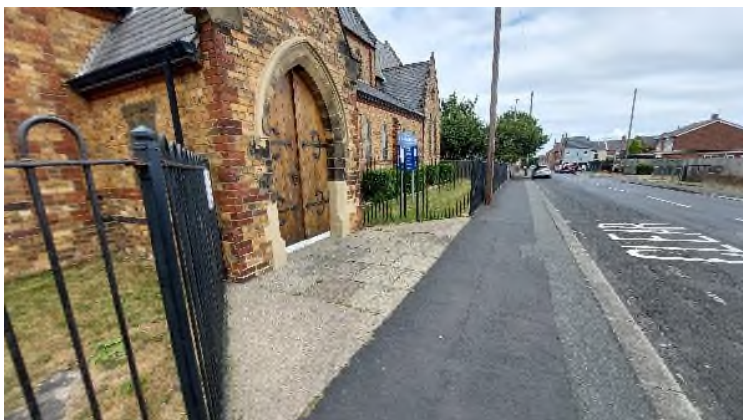
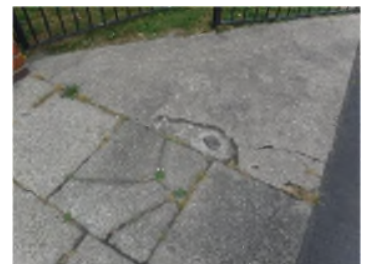
South side

The church is close to the footpath, the area is grassed with Laurel bushes kept very neat, the paving to the porch is in

concrete flags and there are some of which are broken there is also a trip hazard in the concrete junction to them that is missing.

Recommendation: repair south side paving, trim back east trees

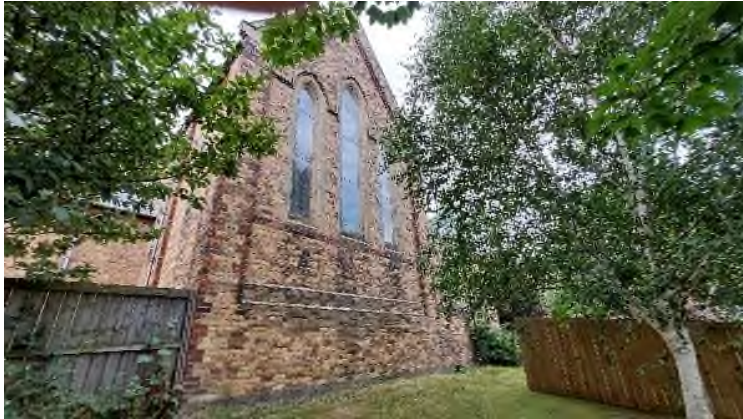
East side

– Garden now incorporated into the east part with domestic fencing, two trees in there that are beginning to grow well and are beginning to influence the light at the east they might need trimming.
