**QUINQUENNIAL INSPECTION REPORT
OF
THE CHURCH OF CHRIST THE KING, BEDE TERRACE,
BOWBURN,
CO DURHAM DH6 5DS**

**DIOCESE OF DURHAM
ARCHDEACONRY OF DURHAM
DEANERY OF AUCKLAND
CASOP CUM QUARRINGTON BENEFICE
PARRISH OF CASSOP QUARRINGTON**

**QUINQUENNIAL INSPECTION November 2017 and REPORT
July 2018**

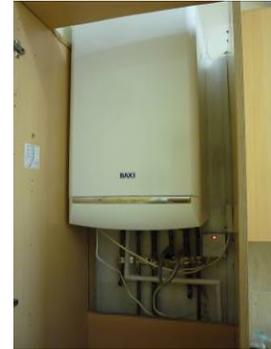
- D** **Heating:** By gas fired Baxi Duotec located in the kitchen, this is a new boiler installed in 2017. The former boiler, albeit not old, had parts that could not be replaced economically. The system is domestic and supplies low pressure hot water to circulation copper pipework and panel radiators. The church was warm during the inspection.
Recommendation: Place the gas testing certificate in the log book.

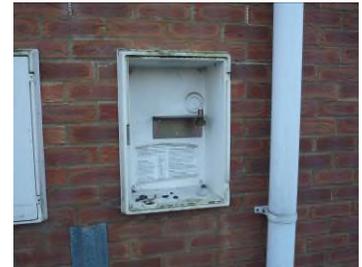
- D** **Gas meter:** Located on the north elevation. The church's original gas meter position is redundant and its box has no cover and this should be reinstated or the redundant case taken out.

Recommendation: Attend to redundant gas meter.

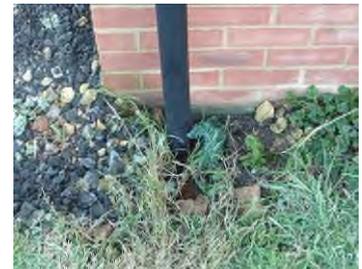
- B** **Rainwater Goods:**
Plastic half round gutters with circular downpipes. Gutters onto timber fascia in good decorative order. Downpipes go to gulleys some are slightly raised out of the ground others are low in the ground with rubbish around them and these should be checked for running.
Recommendation: clear around gulleys and check they are running

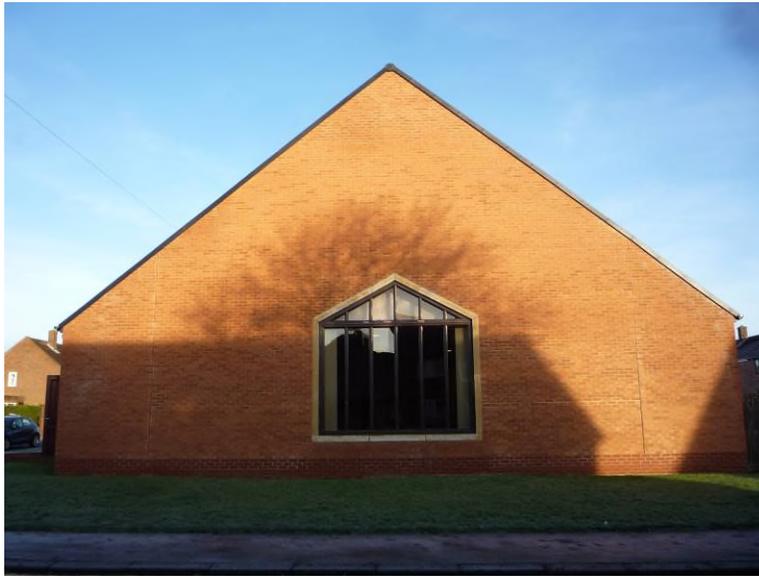
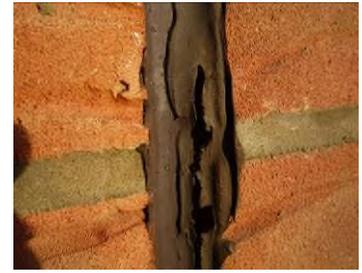
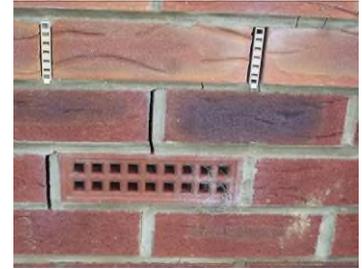
South Elevation – Large gable with feature window. Cracking is evident at lower level outboard of the expansion joints. The cracking suggests almost as if it is sinking at these two locations or it certainly is sliding outwards on the eastern side. The expansion gap tapers grows wider at the bottom and the silicon infill is stretched and the joint is now open. The joints has been patched to the brickwork and it looks like there is a further 3-4 mm movement since the last QI. At the south eastern corner just below the air brick one brick is displaced and it shows that the top part of this masonry is sliding outboard a bit. This could be as a consequence of tree removal 5 years ago or inadequate depth foundations or both. The movement is also on the east side of this corner at high level. The engineer has assessed and no action is planned. Keep under watch.

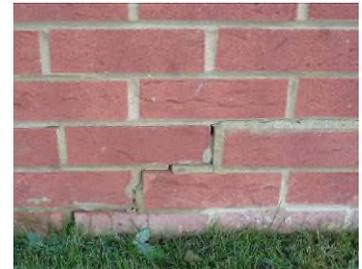
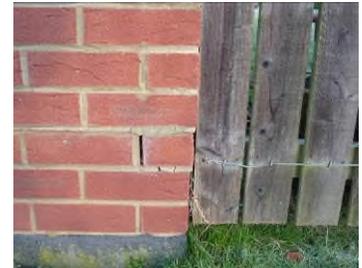
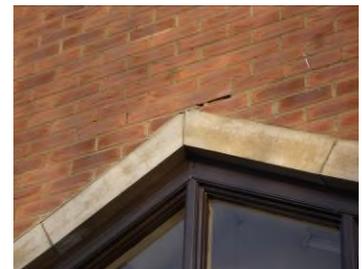
Open joint just above the apex of the window and it looks like the western raking lintel is dropping slightly but probably as a consequence of the differential movement. There is a settlement crack running from the bottom left hand of the cill running through the air brick, at the middle section there is diagonal cracking and that has split the air brick.

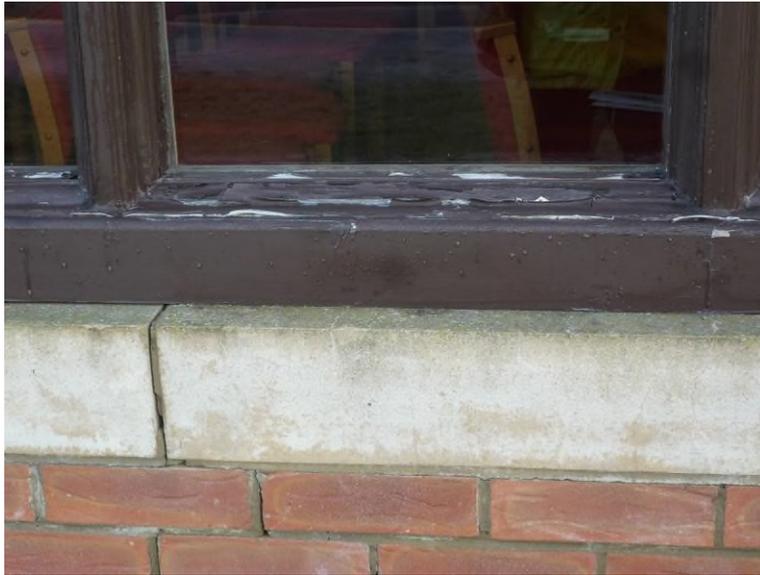
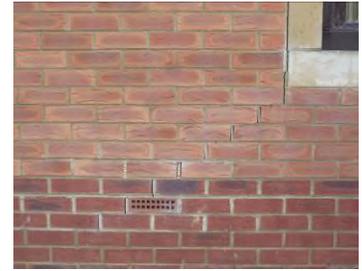
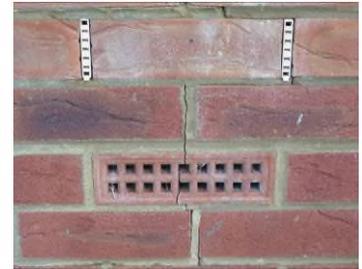
The window decoration is breaking down now.

Recommendation: monitor, consider joinery redecoration

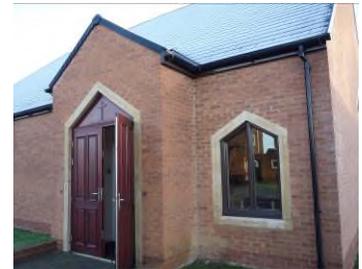
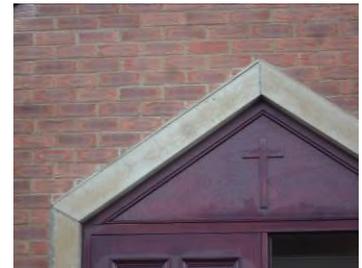
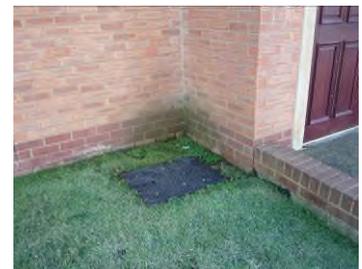
West Elevation – This features two porches and reading it from left to right: left hand porch ok; right hand porch has slight shrinkage to the raking lintel at the pointing close to the edge of the apex suggesting it is dropping. The threshold cement is breaking up. The doors have dowels in their framing and needs new decoration.

The wall features three windows, two of which are ok, the third which is at the southern end or right hand side has open joints at the apex, crack to the cill.

At the corners of the porches there is showing a bit of green mould and I wonder if there might be something wrong with the drainage at that point.

Recommendation: point up open joints, check drainage at the corner, redecorate door

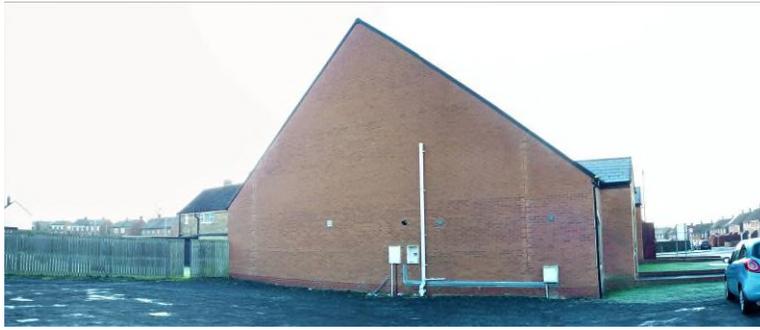
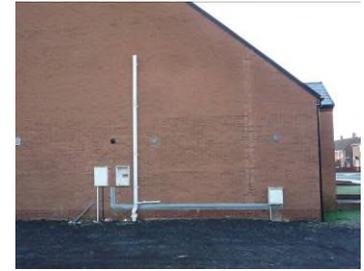
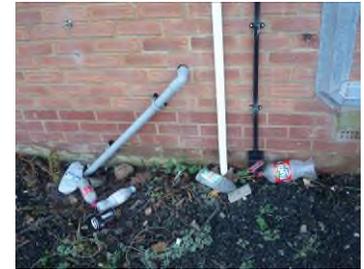
North Elevation – Same design as the south without any windows and there is no obvious cracking to this elevation. Has a miscellaneous collection of services and a redundant gas meter cupboard with the door missing.

Recommendation: tidy up and address the redundant gas meter cpd

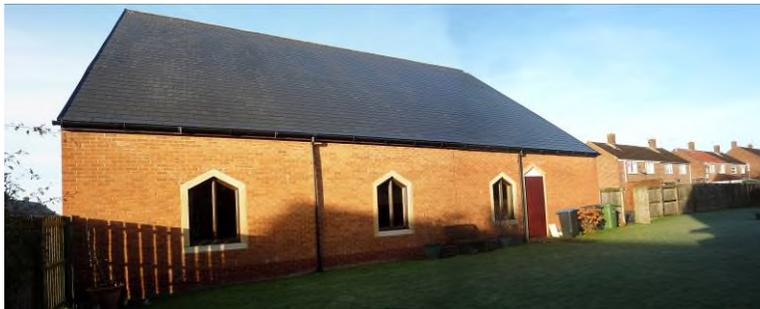
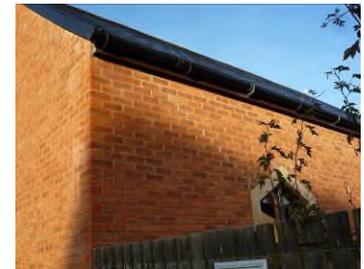
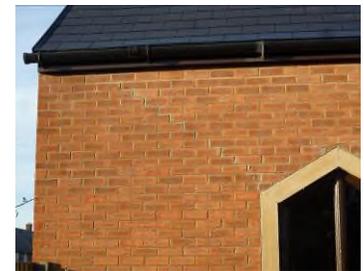
East Elevation – Pointed in diagonal cracking at the south east corner at high level. General elevation ok as are the windows though the decoration is beginning to break down on the cills.

Recommendation: redecorate cills

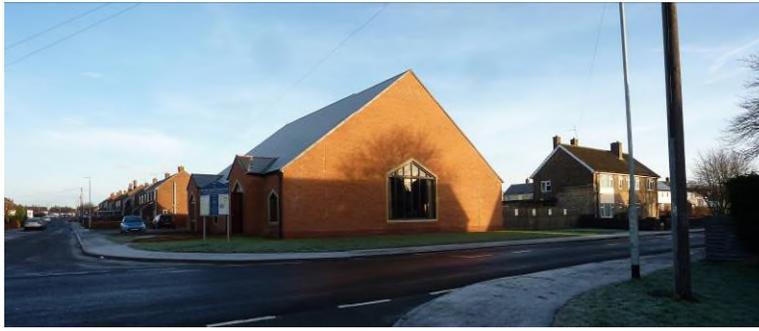
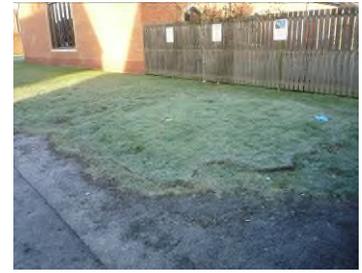
Grassed area in front of the church. To the east at the bus stop hexagonal remnants of the tower base now becoming overgrown with grass. Boundary fence here is in good condition and has notices on.

Recommendation: clear back grass from tower base

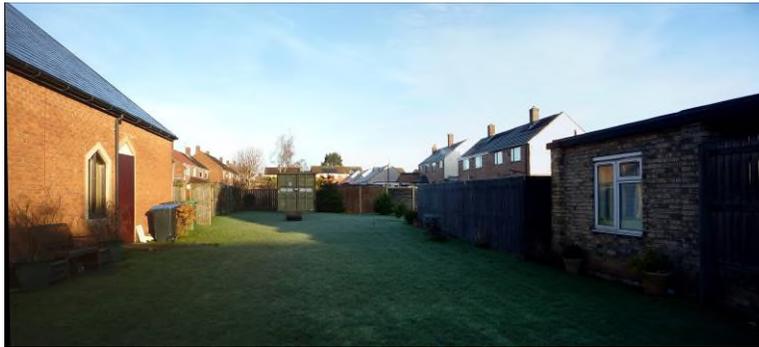
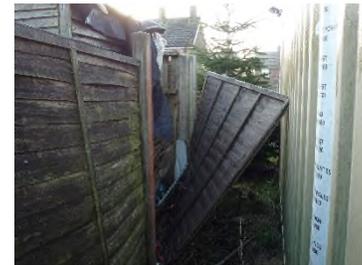
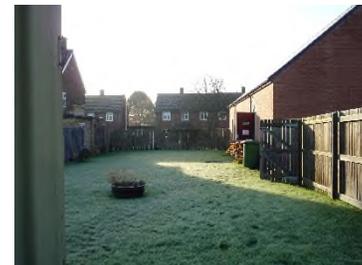
This has an L-shaped garden which is mostly grass with a concrete path that stops short, the building to its side is the former vicarage. Large sea container in the grounds, some shrubs and a bonfire patch. The fencing to the north side is poor, this looks like the responsibility of the home owner, one of the panels is broken and leaning against the sea container, the remainder fencing panels are all ok, apart from one open corner on the former vicarage site. The bins are rather loosely collected at the side of the doorway, it might be good to have a fenced bin store. The eastern gate bolt is stiff to go into the hasp and the padlock is rusting.

Recommendation: seek repair of neighbour fence, consider bin store, ease padlock and bolt

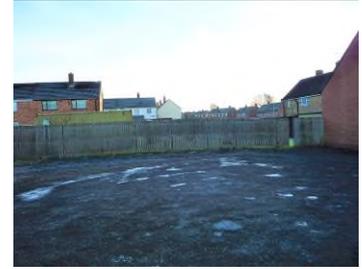
Large carpark area made of road plainings, slightly undulating, and the grass runs out, there is not proper edge to. There is some rubbish building up at the foot of the wall. The north boundary is a private dwelling fence in good condition.

Recommendation: tidy up

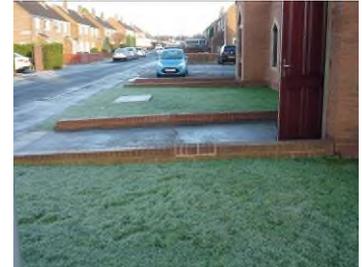
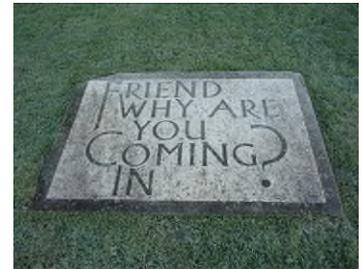
Grassed area to the entrance lobby's with tarmac ramped paths with a crack to the southernmost which has been filled in and is opening up again. The little stub walls are fair. Large tablet from the old church with the words 'Friend why are you coming in' it has a couple of chipped corners, the church are planning to relocate this at the south east corner of the rear garden.

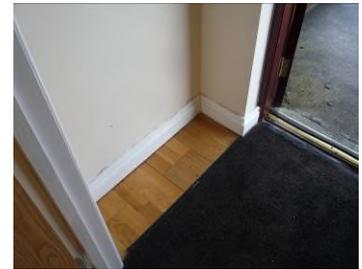
D **Entrance Porch:**
Slight cracking at skirting boards and at thresholds.

Recommendation: fill and paint

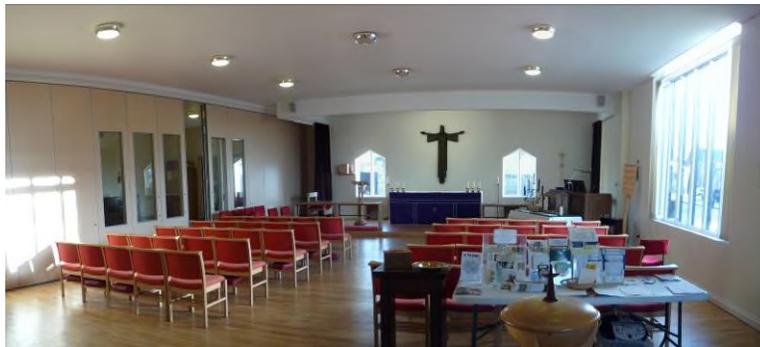
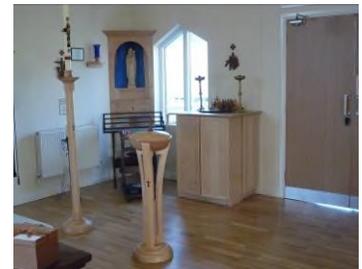
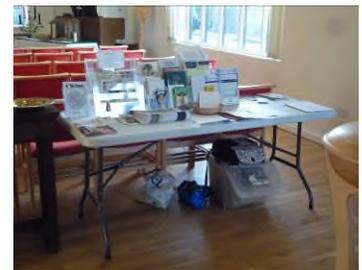
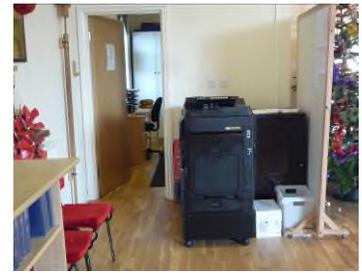
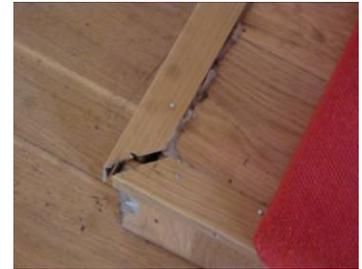
- Ceiling – Flat plaster board with surface mounted lights. With feature recessed downlights, two of the bulbs are out.
Recess at ceiling in the south window showing some slight cracking of the fill between the apex of the windows and the arch lining.
- Walls – Plastered and painted throughout, some slight cracking of the boards, there is some shear cracking at the junction to the ceiling on the south side.

- Floor – Engineered flooring which is showing some signs of wear now, it looks to have been screwed down at the entrance area with exposed screw heads. Platform edging coming away.

Recommendation: fill and paint at ceiling, fix platform edging

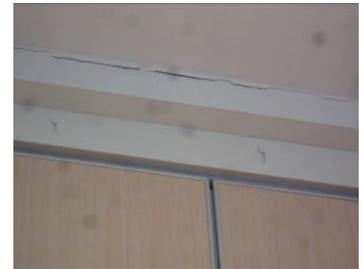
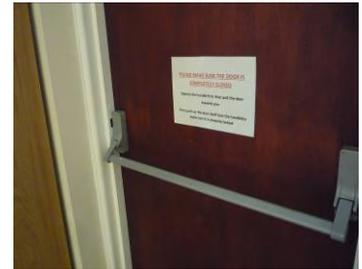
The entrance/exit into the garden catches in the frame, slightly warped, it doesn't latch easily.

Recommendation: ease door

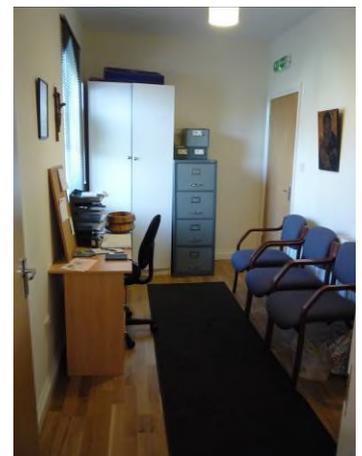
The door catches on the floor, edge of the door needs decorating.

Recommendation: ease and decorate door

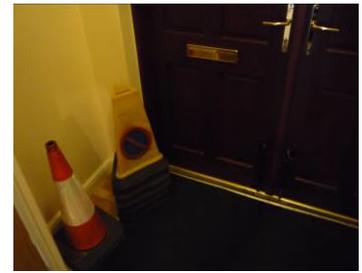
The bottom door bolts don't appear to engage with the floor.

Recommendation: ease door bolts to position

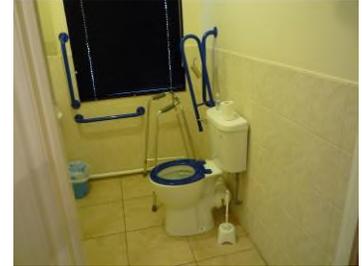
All ok apart from the flush handle is loose and the flush itself is inadequate.

Recommendation: fix cistern handle and flush action

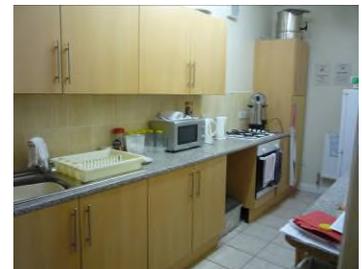
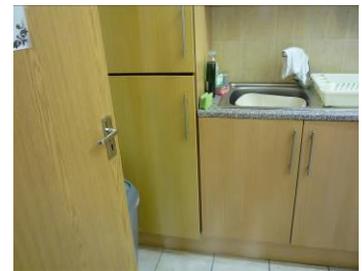
- Ceiling – Plastered ceiling.
- Walls – Plastered walls, with some hygienic boarding and back to counter ceramic tiling.
- Fittings – The fittings are generally ok though the door below the boilers does not fit properly and the boiler door above is also warped. The edges of the hatch doors require decoration as does the kitchen door. The architrave around the kitchen hatch into the hall is coming away.

Recommendation: fix back architrave, repair doors, decorate joinery

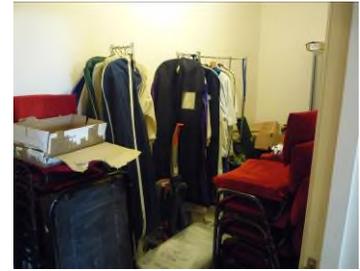
B Store:
 Heated space, contains a lot of vestments, choir robes and lots of other lumbar, desk, chairs and cleaning materials. Carpet is rucking on the floor, the door is just binding on the carpet slightly.

Recommendation: ease door
