Diocese of Durham

Quinquennial Inspection Report May 2019

St Peter's Church, Byers Green

Inspection of Churches Measure 1955

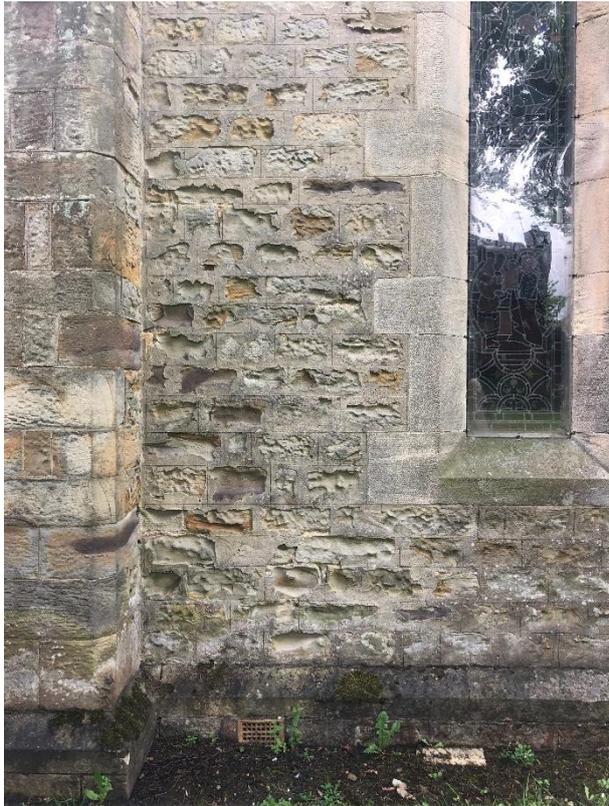
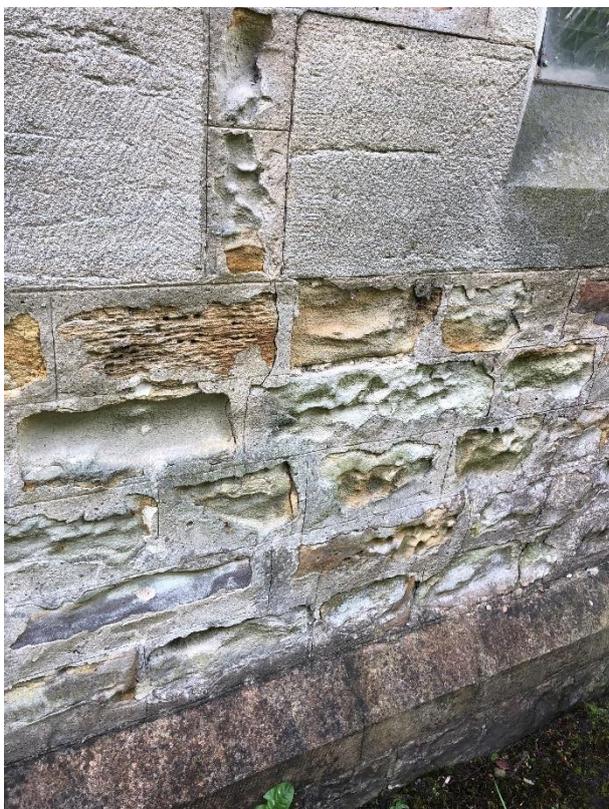
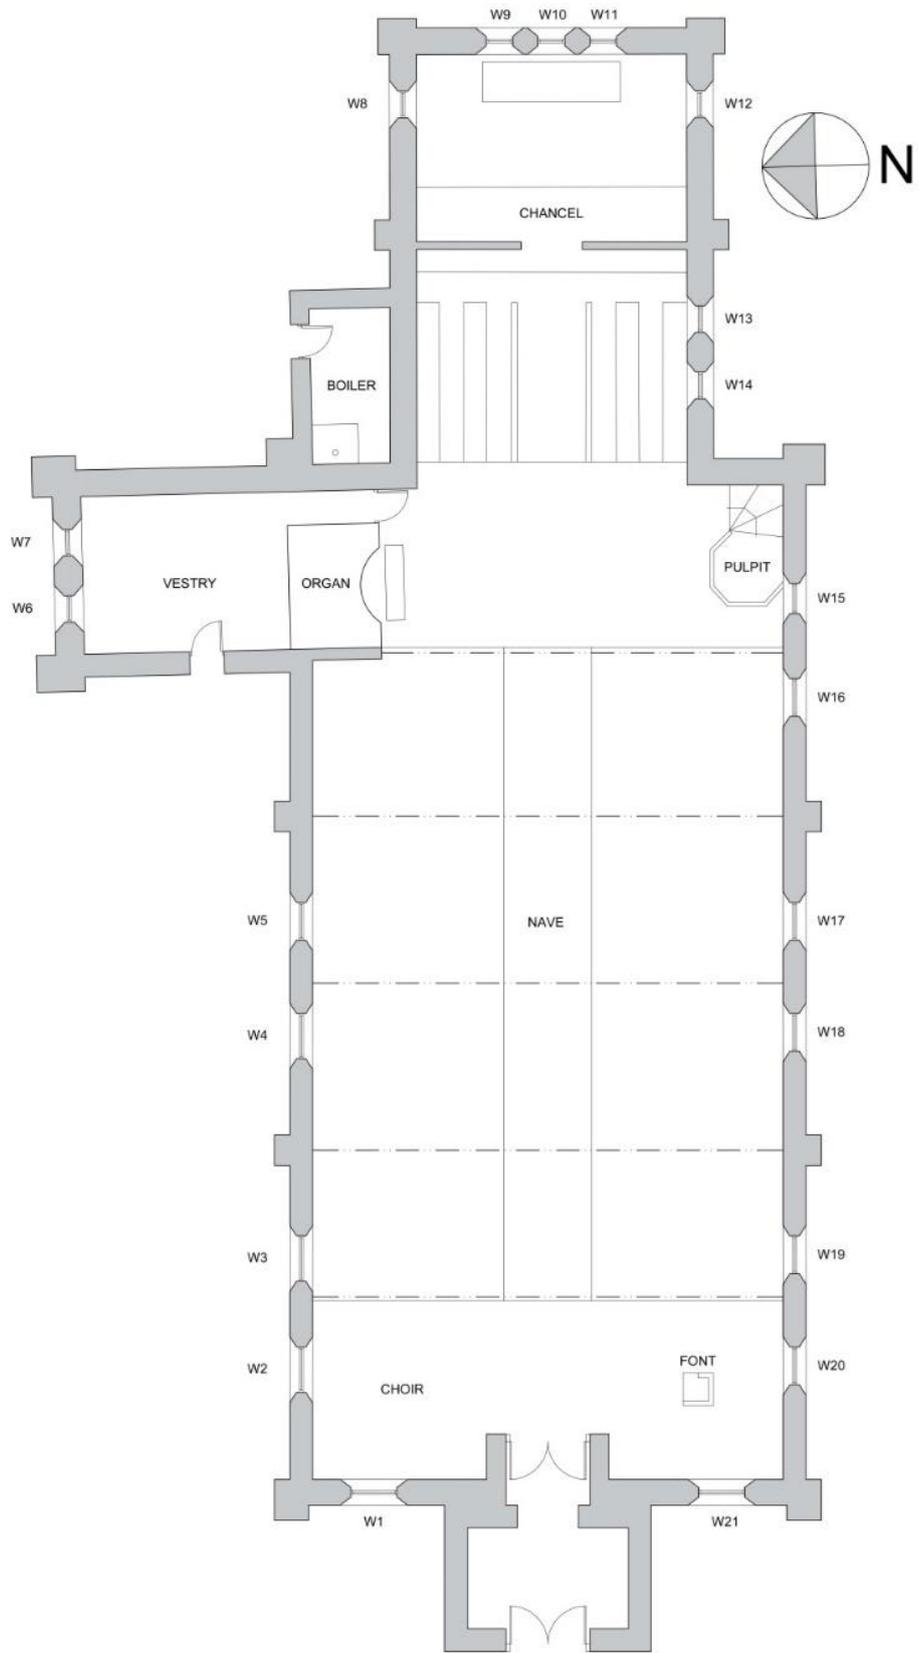
Images to show mortar defects.

4.2 The exterior of the Church is generally sound but there is a problem, referred to in the 2no. previous Q.I. reports, with some earlier repointing that needs to be addressed, urgently. Gutters and downpipes should be inspected annually and cleaned or maintained as necessary as well as an inspection of the fabric generally with particular reference to the cracks or structural movement identified in the report. If any change is noticed it should be reported to the inspecting Architect. This will help to prevent minor maintenance items develop into serious defects.

- ix) Nave - North Elevation: 9.2
Re-pointing, the hard cement-sand mortar shall be carefully removed, so as not to damage the stonework further. Any loose stone should be carefully brushed back to a sound face. The wall should then be re-pointed using a basic regular Naturally Hydraulic Lime mortar; NHL 3.5 with a local sand. Samples of and mixtures of sand should be tested to ensure a match in colour and texture to the original mortar. Sample mortar to be approved by Architect.

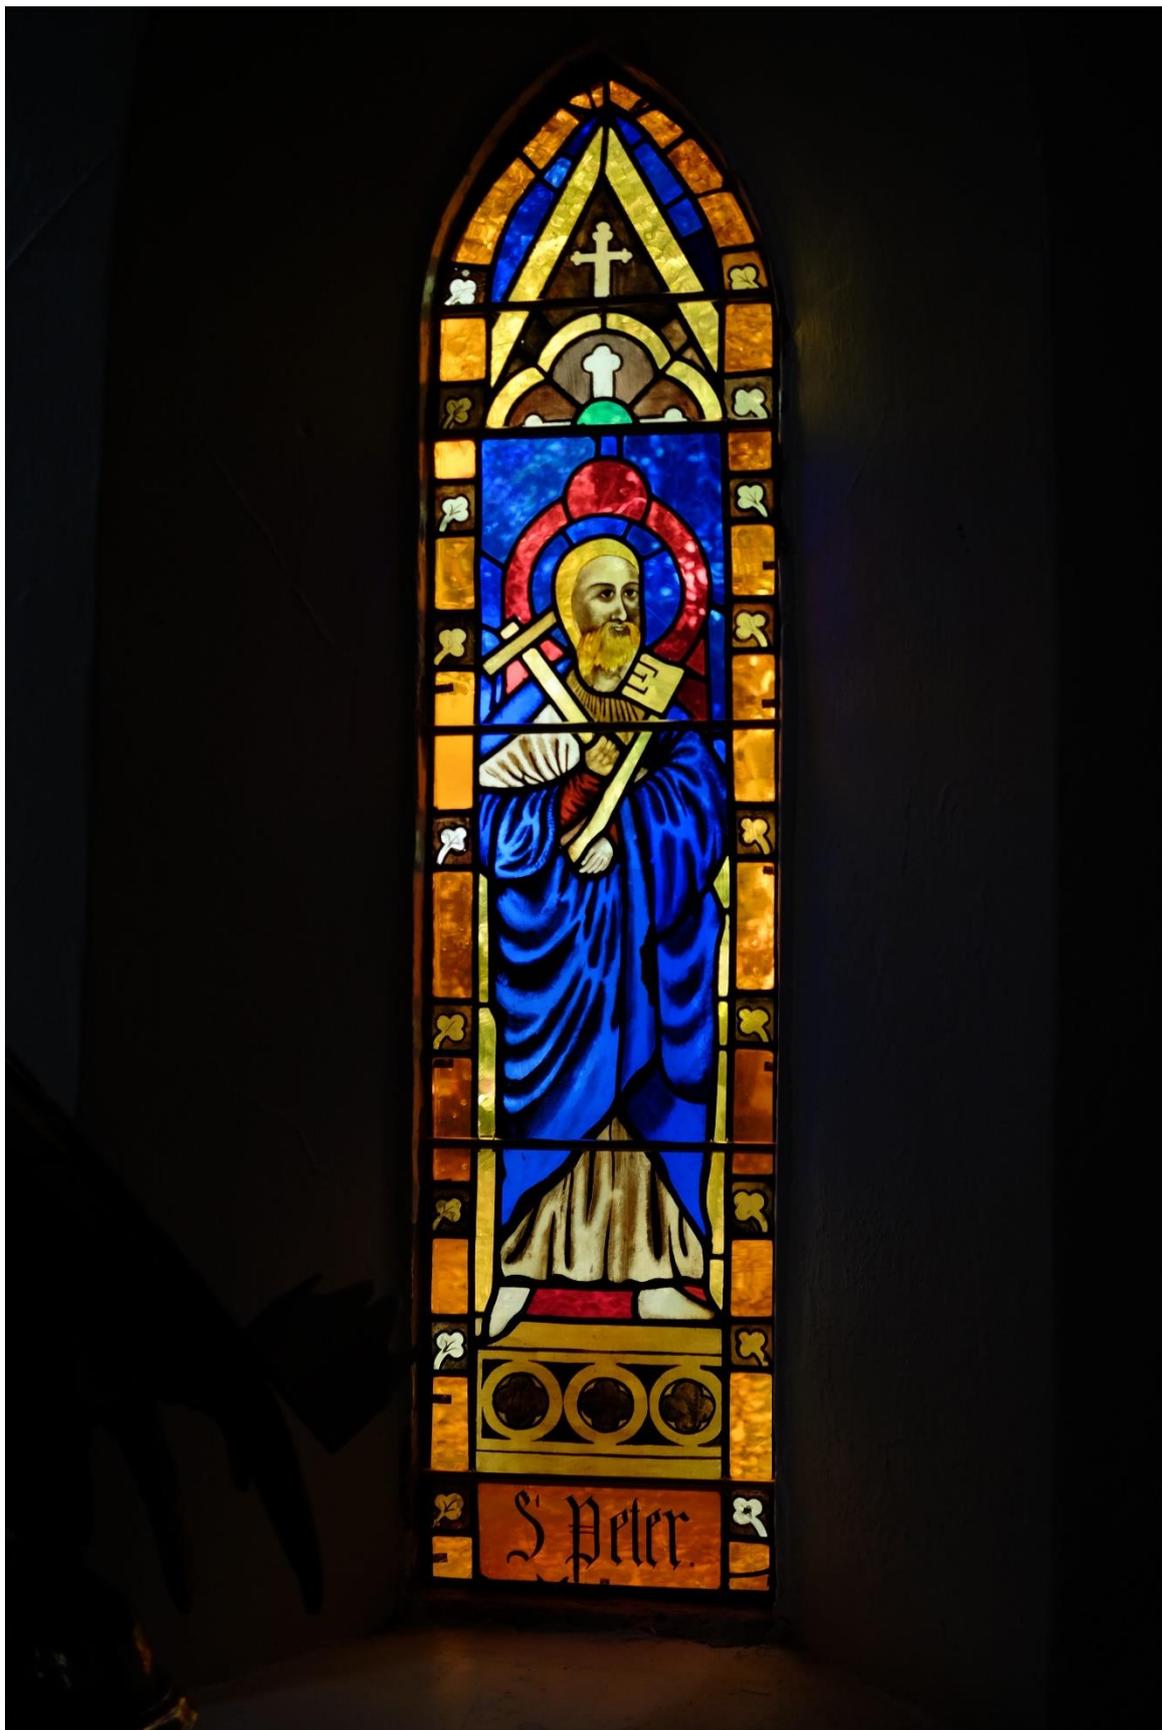
nii) – Window W8

Window W8 was restored by Jonathan and Ruth Cooke between September and November 2017 see appendix B for the detailed description of the repair and post repair image. Further detailed information of the repair / conservation work undertaken is detailed in their report. However the making good of plaster finishes and internal decoration work undertaken post conservation work has left deposits of plaster / paint on the surface of the window. Specialist advice should be sought regarding the removal of the deposits such to minimise the potential for damage.

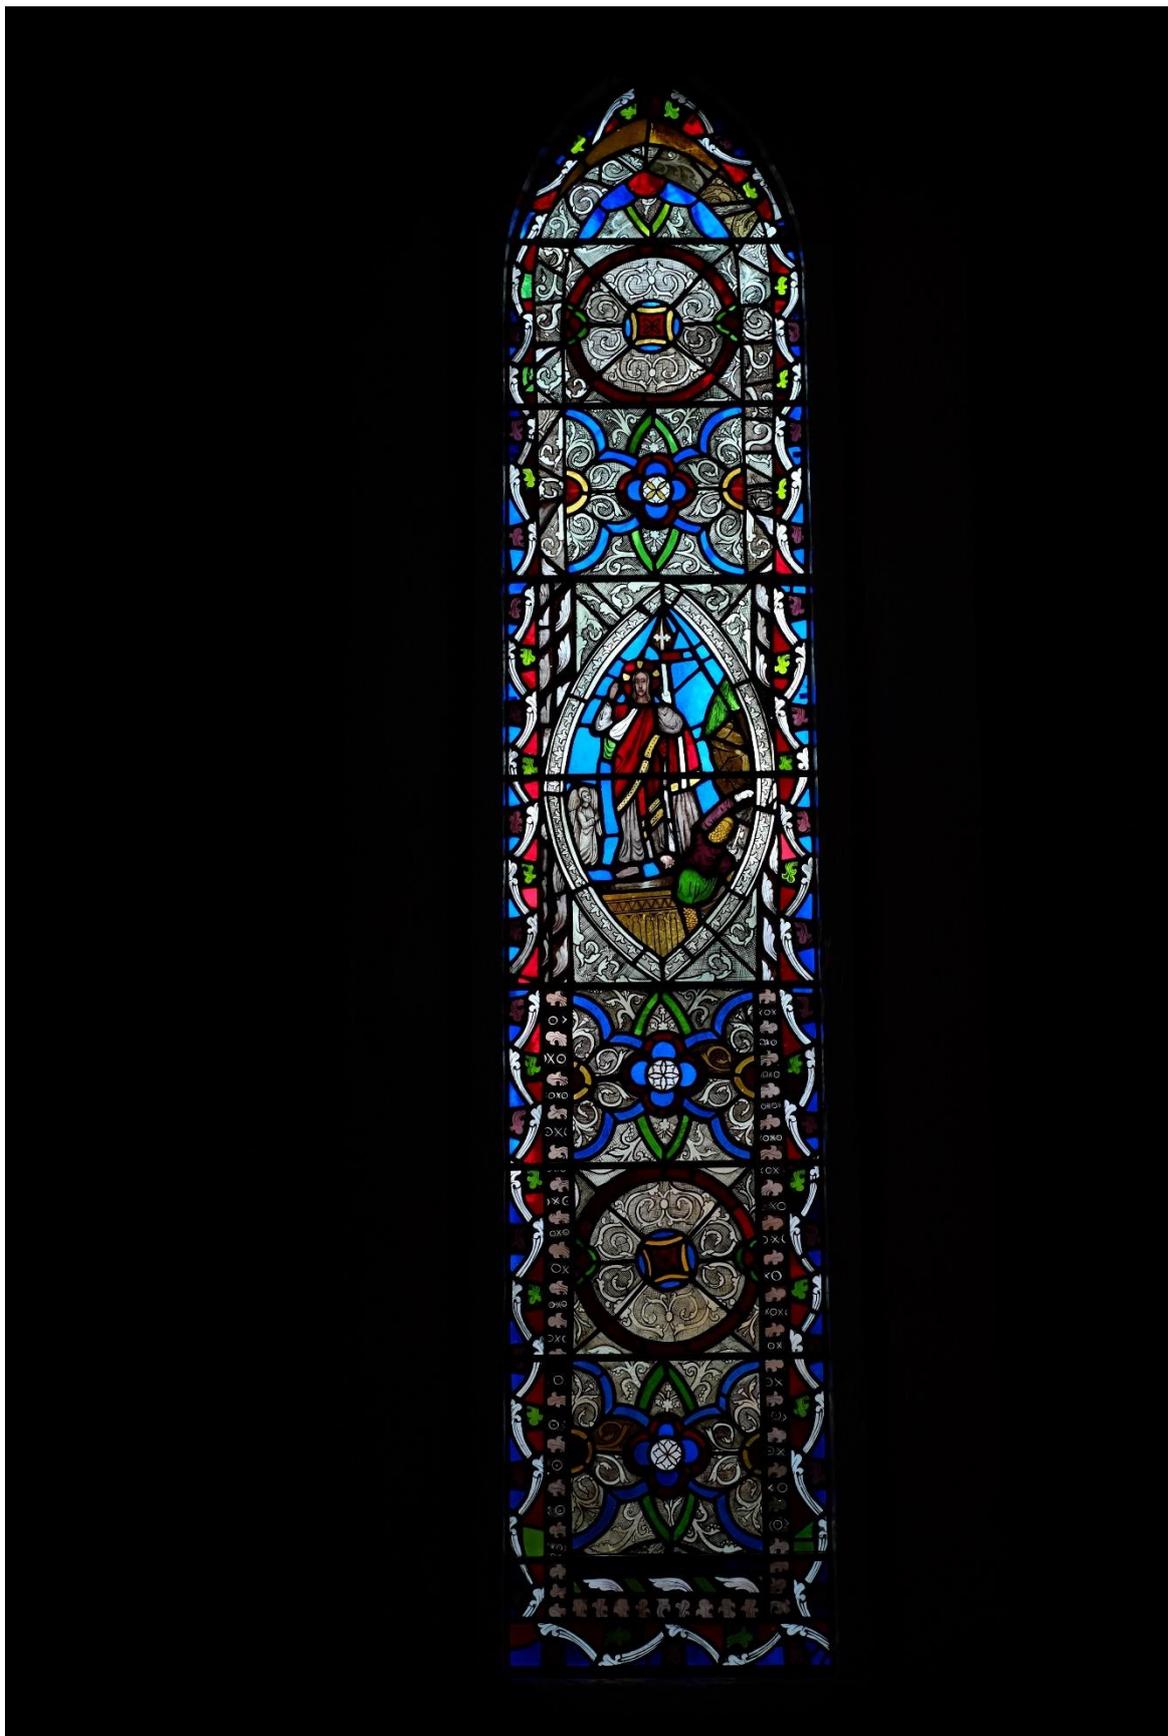
nvii) – Window W2

- a) The leaded light is bowing between the glazing bars.
- b) There is movement between the glass and the lead comes in places sufficient to allow daylight between them. N.B. This window previously had a thin metal plate set into the splayed cill stone with an inscription which was partially illegible. The metal was corroded around the edges and near the centre, it has been confirmed that the plate was zinc. This has now been replaced with a replica zinc plate with matching paint finish and lettering.

Window W2 was restored by Jonathan and Ruth Cooke between October and December 2016 see appendix B for the detailed description of the repair and post repair image. Further detailed information of the repair / conservation work undertaken is detailed in their report.

Substantial releading. A section of original lead work has been retained in each of the three panels, with some joint strengthening to ensure its integrity. No maker's mark was found in the channel of the leads.

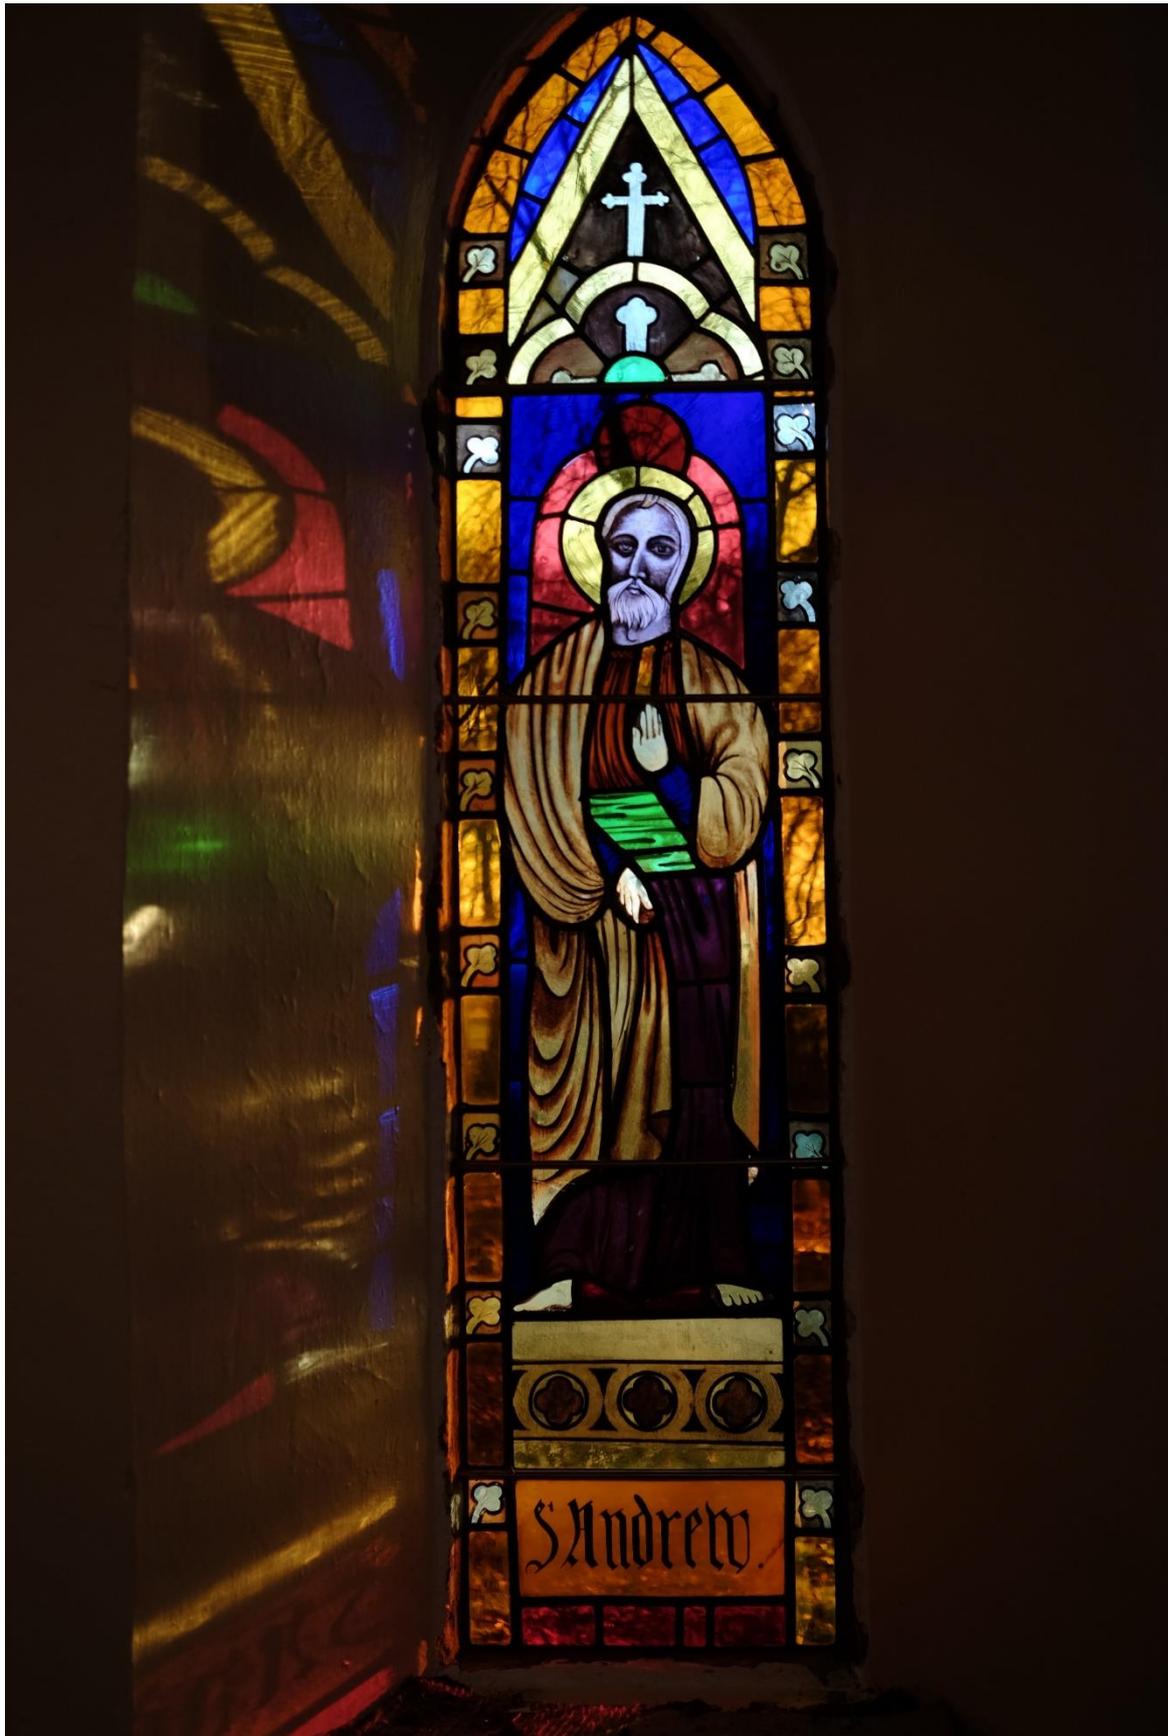
sii) – Window W12

Window W12 was restored by Jonathan and Ruth Cooke between September and November 2017 see appendix B for the detailed description of the repair and post repair image. Further detailed information of the repair / conservation work undertaken is detailed in their report. However the making good of plaster finishes and internal decoration work undertaken post conservation work has left deposits of plaster / paint on the surface of the window. Specialist advice should be sought regarding the removal of the deposits such to minimise the potential for damage.

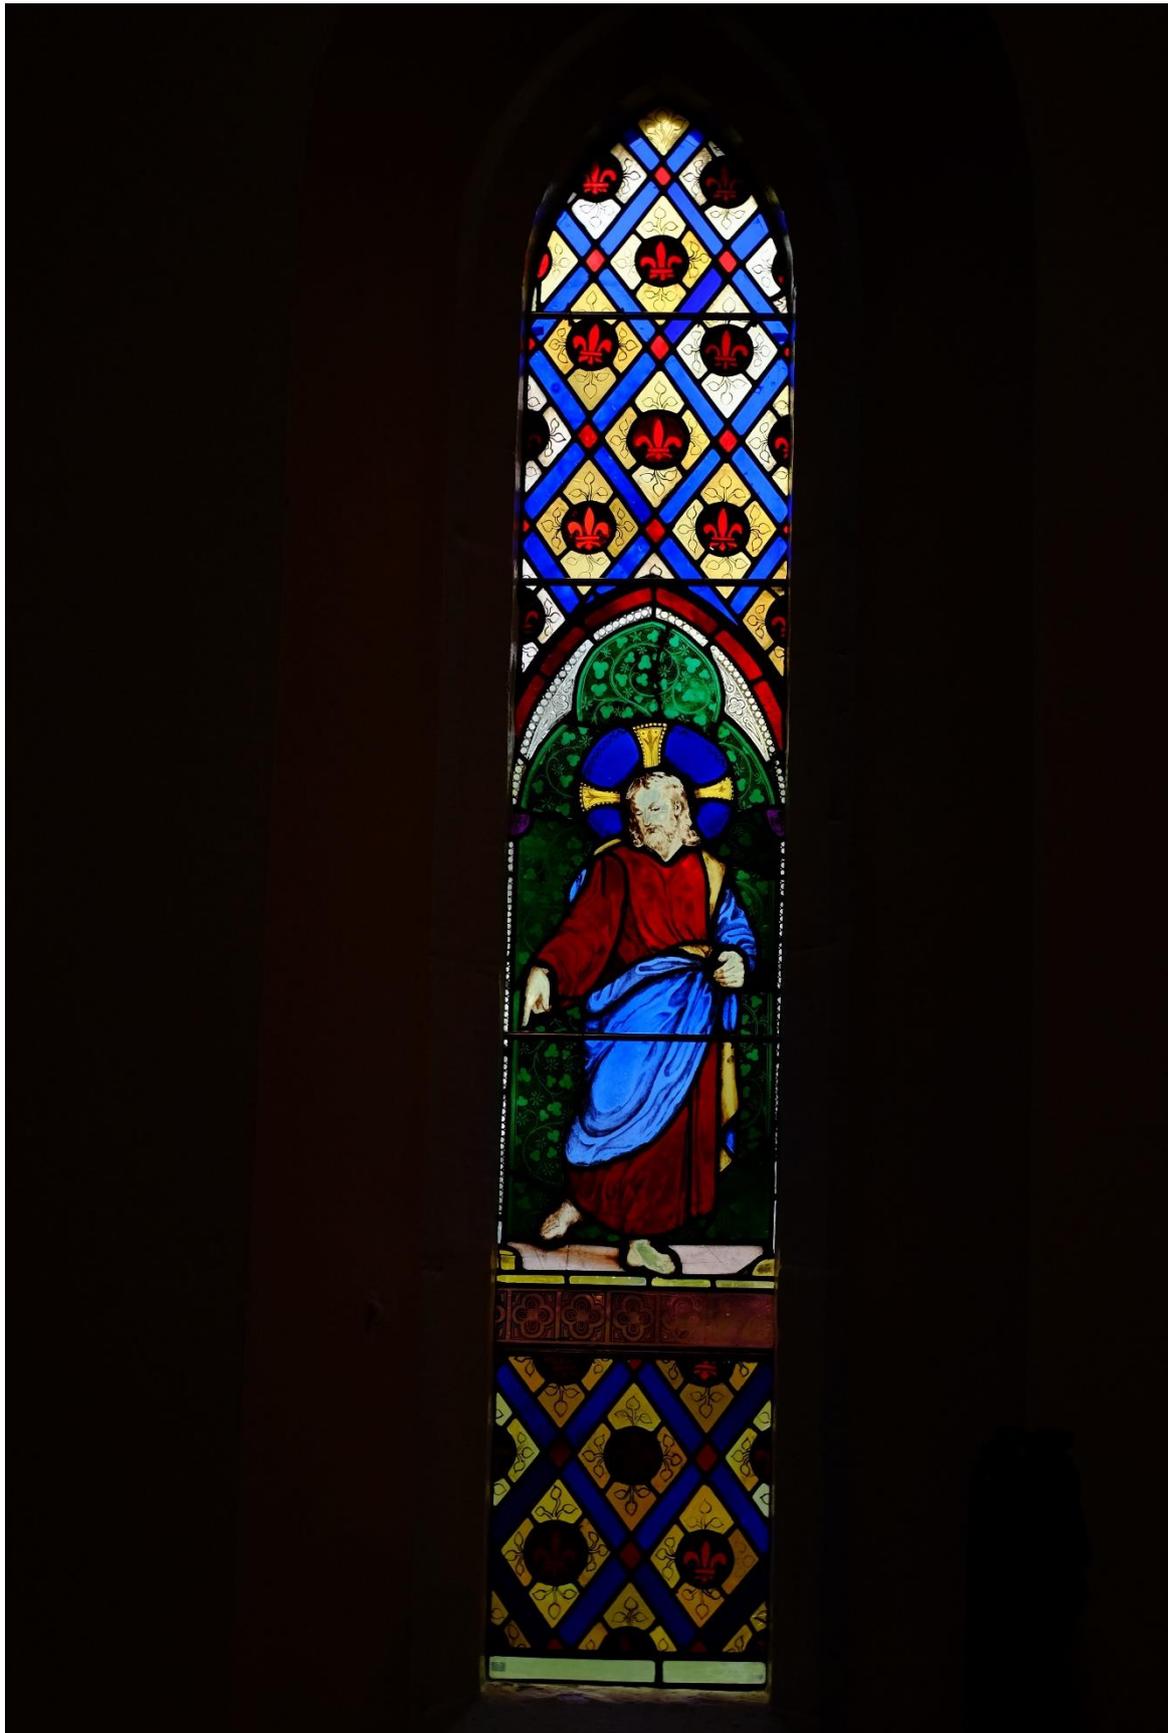
siii) – Window W13

Window W13 was restored by Jonathan and Ruth Cooke between December 2016 and January 2017 see appendix B for the detailed description of the repair and post repair image. Further detailed information of the repair / conservation work undertaken is detailed in their report. However the making good of plaster finishes and internal decoration work undertaken post conservation work has left deposits of plaster / paint on the surface of the window. Specialist advice should be sought regarding the removal of the deposits such to minimise the potential for damage.

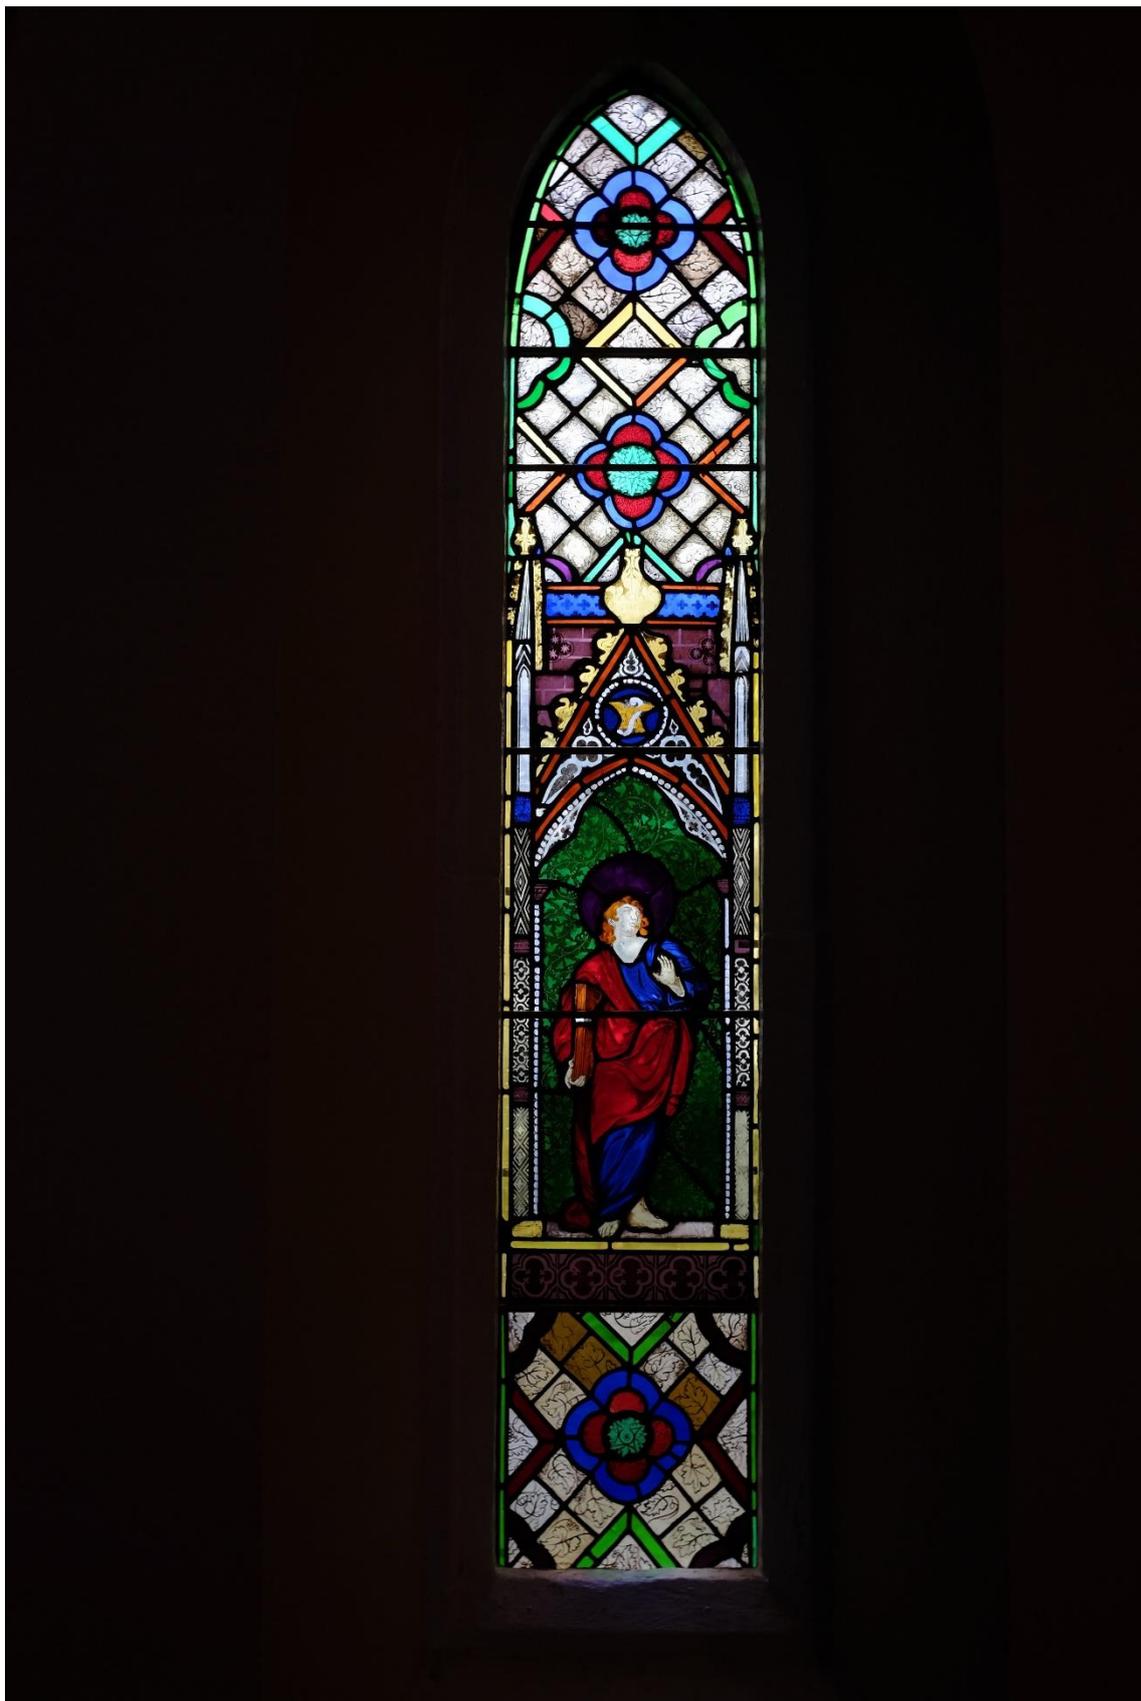
siv) – Window W14

Window W14 was restored by Jonathan and Ruth Cooke between December 2016 and January 2017 see appendix B for the detailed description of the repair and post repair image. Further detailed information of the repair / conservation work undertaken is detailed in their report. However the making good of plaster finishes and internal

decoration work undertaken post conservation work has left deposits of plaster / paint on the surface of the window. Specialist advice should be sought regarding the removal of the deposits such to minimise the potential for damage.
