# Quinquennial Inspection Report

**Church of St John the Evangelist**

**Chopwell**

**Date of inspection:** 3 October 2025; weather conditions - dry and overcast

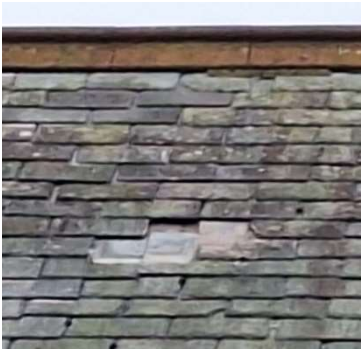
| 1.1 Roof coverings | | |
|---|---|---|
| <p>Condition</p> | <p>During the inspection the following were noted:-</p> <ul style="list-style-type: none"> <li>- localised missing bedding to ridge stones</li> <li>- localised open perpend joints to ridge stones</li> <li>- 2No missing slates on north slope (Nave) – see photo</li> <li>- 1No slipped slates on north slope (Chancel)</li> <li>- 2No missing slates on south slope (Chancel)</li> <li>- 2No rotated slates on south slope (Chancel)</li> <li>- many slates with broken corners</li> <li>- many slates have been replaced</li> <li>- verge pointing breaking away by Vestry roof</li> <li>- rafter feet in need of decoration to prevent rot</li> <li>- vegetation to Boiler House roof Organ pump roofs</li> </ul> | |

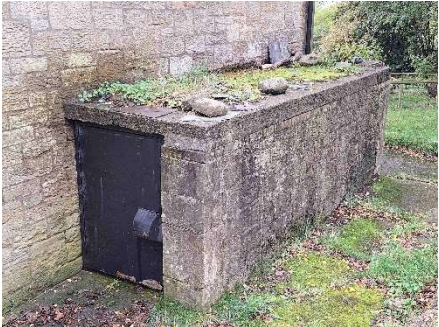
| 1.1 Roof coverings | | |
|---|---|---|
| <p>Repair needs</p> <p>Boiler House roof</p> | <p>The church has suffered in recent years from a number of slipped/ missing slates. Slating repairs have been undertaken regularly. This indicates that the nail fixings are rusting and further ongoing repairs are likely. It is therefore recommended that the church roofs be re-slatted (ideally within the quinquennium).</p> <p>In the short term, repairs to the above items should be made.</p> <p>The vegetation build up on the flat roof of the Boiler House need clearing.</p> <p>It is recommended that a flashing is fitted between the Boiler House roof and the adjacent wall to prevent water ingress and dampness in the Kitchen.</p> | <p>D/E</p> <p>B</p> <p>M</p> <p>C</p> |

| Category | Comment | Broad Budget Costs (excl VAT and fees) |
|---|---|---|
| C | Fit flashing to Boiler House roof/wall upstand (1.1) | £500 |

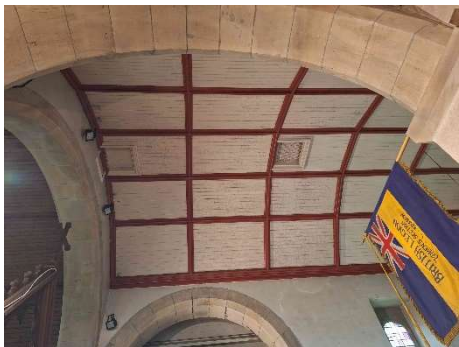
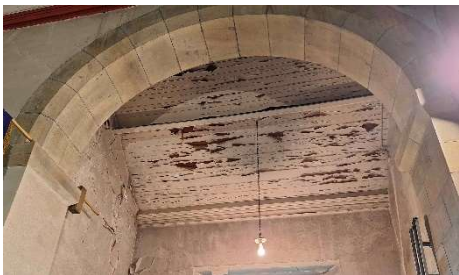
| <p>Condition/ repair needs</p> <p>Ceiling over Chancel</p> <p>Ceiling over Lady Chapel</p> | <p><u>Roof void:</u><br/>As access was not gained to the roof voids over the Chancel and Nave. The inspector cannot state that this area is free from defect. It is recommended that these voids are inspected periodically and any concerns should be raised with the architect.</p> <p><u>Nave:</u><br/>The timber boarded panelled ceiling and exposed part of the trusses appear to be in fair condition.</p> <p><u>Chancel:</u><br/>The decoration to the segmental timber boarded ceiling is in poor condition. Redecoration is needed.</p> <p><u>Lady Chapel and Organ Chamber:</u><br/>The decoration to the boarded ceilings is peeling (and thought to be rotten) due to damp from leaks. The cause of the damp ingress should be investigated and resolved. Following this the ceiling boards should be replaced and decorated.</p> <p><u>Kitchen and Vestry:</u><br/>The varnished pine boarded ceilings appear to be in fair condition.</p> | <p>D</p> <p>B<br/>D</p> |

| Category | Comment | Broad Budget Costs (excl VAT and fees) |
|---|---|---|
| B | Investigate and cure damp to Lady Chapel roof and ceiling (2.2) | ? |
| D | Redecorate Lady Chapel and Organ Chamber ceilings (2.2) | £1,500 - £2,500 |
| D | Redecorate Chancel ceiling (2.2) | £2,500 |

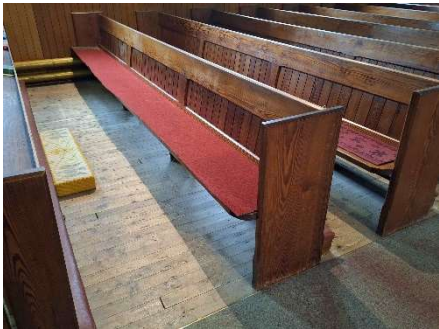
| <p>Condition / repair needs</p> | <p><u>Chancel:</u><br/>The encaustic tiles to the sanctuary and the pine boarding to the floor below the choir stalls are in fair condition. The carpets appear to be in fair condition.</p> <p><u>Lady Chapel:</u><br/>This has been re-floored in oriented strand board (OSB) and chipboard. This is unsightly and consideration should be given to replacing it in t and g softwood boarding.</p> <p><u>Nave:</u><br/>The pine boarded flooring by the pew areas are in fair condition along with the pews.</p> <p>The original timber floor on the front south side of the Nave has been removed and replaced in concrete without a floor finish. This looks unsightly and fitting a carpet is recommended.</p> <p>The carpet at the front of the Nave has been removed revealing small areas of beetle attack. These areas are understood to have been treated. Replacement of the carpet is desirable.</p> <p>A section of floor boarding at the rear of the rear of the Nave was replaced in 2017 after beetle attack was found below the previous carpet finish. Fitting a carpet is desirable.</p> <p><u>Vestry &amp; Kitchen:</u><br/>The concrete floor to the kitchen and Vestry have wood effect vinyl sheet floor and carpet tiles finishes respectively. The vestry carpet tiles are in poor condition. Consideration should be given to replacing them.</p> | <p>E</p> <p>E</p> <p>E</p> <p>E</p> |

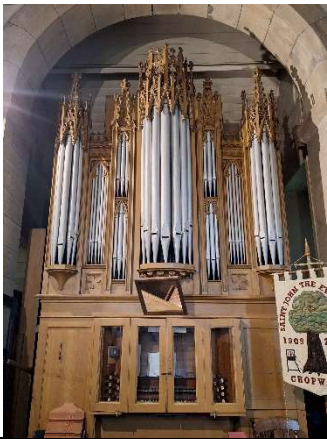
| <p>Condition</p> | <p>The organ dates from 1936 and was constructed by Nelson and Co. of Durham. A permanent replacement internal blower unit was fitted in 2010 to replace a temporary one. The external organ blower chamber is now redundant and the structure could now be removed.</p> <p>The organ is not working and will be costly to overhaul.</p> | <p>E</p> |

| Category | Comment | Broad Budget Costs (excl VAT and fees) |
|---|---|---|
| E | Consider removal of redundant external organ chamber housing (2.9) | £1,500 |
