**CLEADON PARK**  
**St MARK and St CUTHBERT**  
(4)

**QUINQUENNIAL REPORT**  
on the architect's inspection on

**20 November 2017**

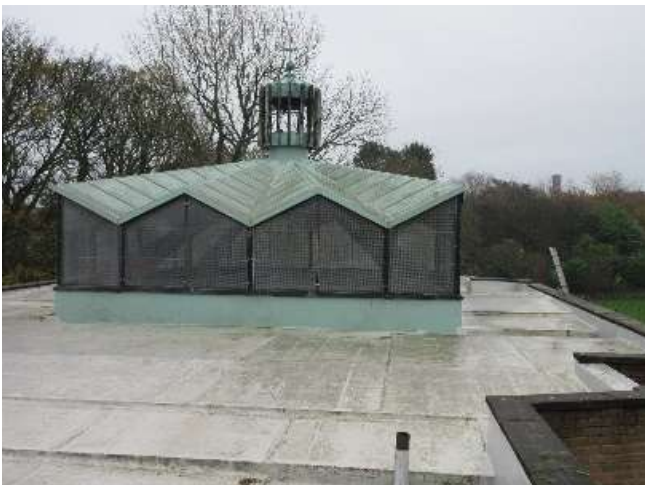
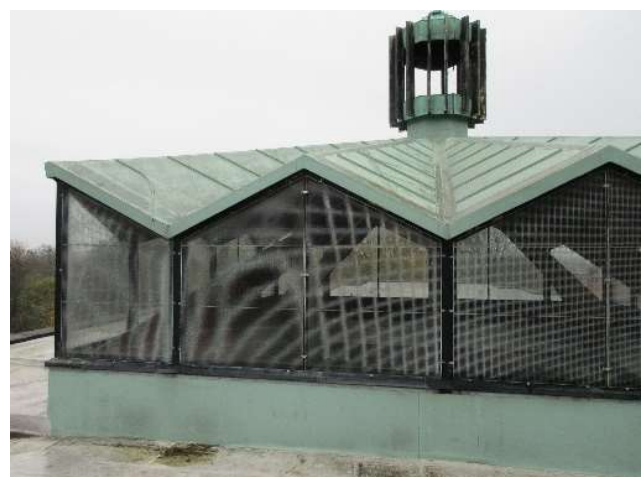
12. The square **lantern** is a shallow pyramid of folded timber boarding with many valleys. The boards are covered with green Sarnafil pvc membrane of similar appearance to the lost copper. All appears sound though one mock 'joint' upstand is coming loose. No spouts or gutters so the water discharges onto the Church roof below or onto the lantern glazing.

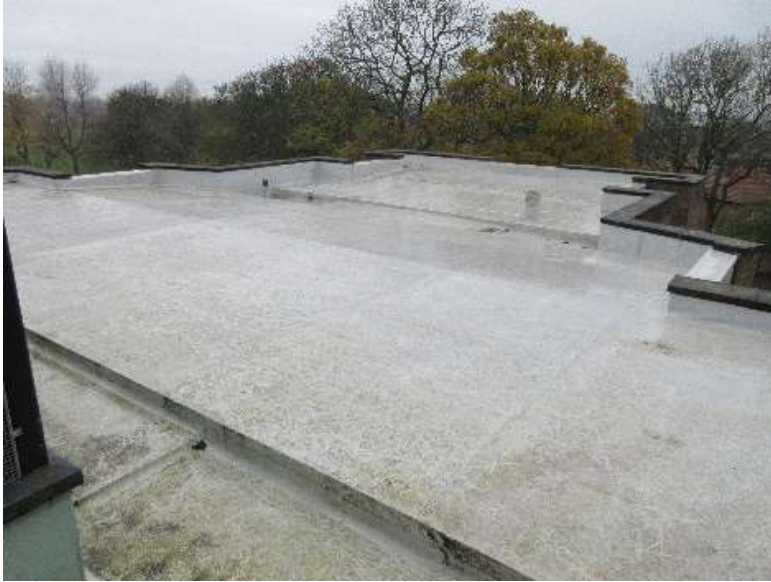
Sarnafil roof carried over designed gaps in coping

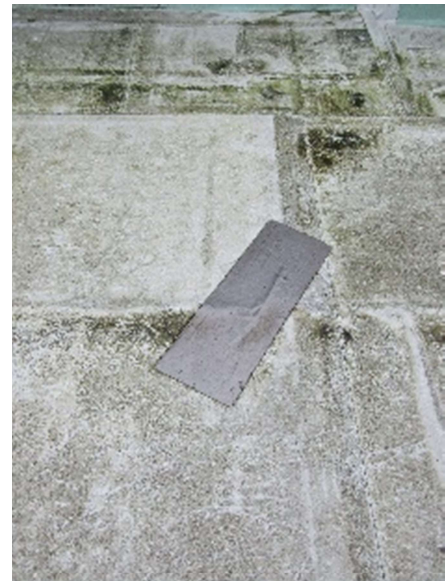
Since the last report a knife cut was repaired with Flashband which seems sound at present but is not best practice.

Flashband patch on Sarnafil

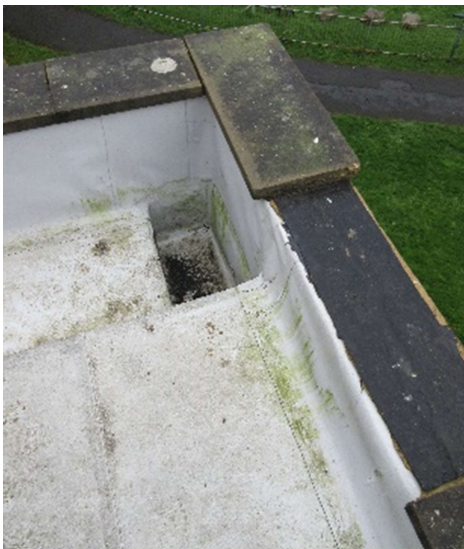
Some copings have been vandalised and the wallheads protected temporarily with damp proof course.

Felt patch where copings missing

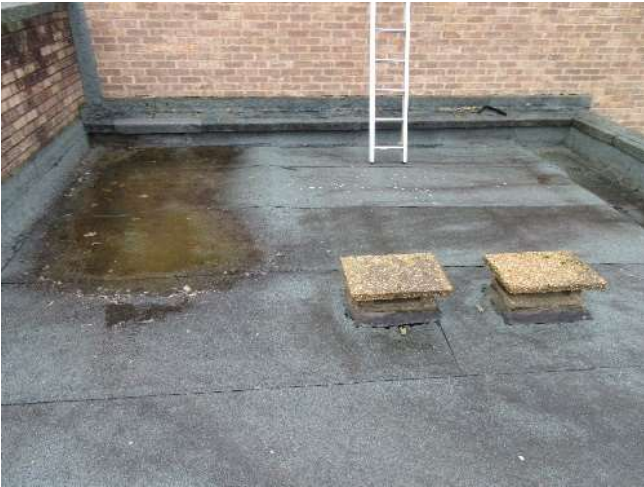
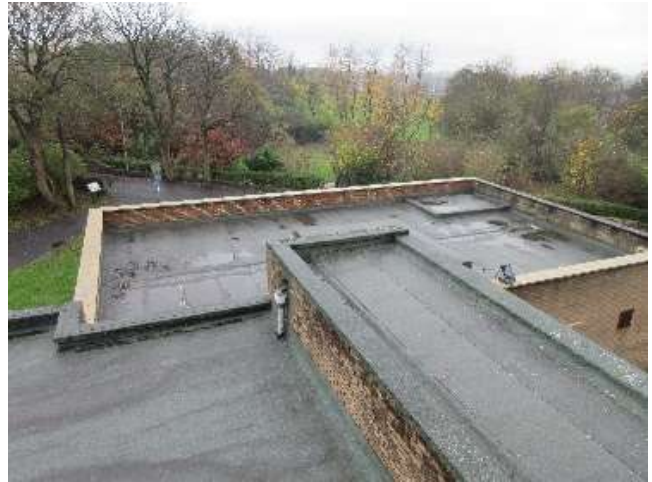
18. The concrete flat roofs over the **high stair**, lower **Vestry and Meeting** room have green bitumen felt in fair condition carried over the parapets and copings. Ponds over the landing and at the gutter. Larger ponds in Vestry corner next to Church. Blisters in the wide gutter. No known leaks at present. Felt badly damaged where it carries over the decayed copings at both roofs facing the Hall.

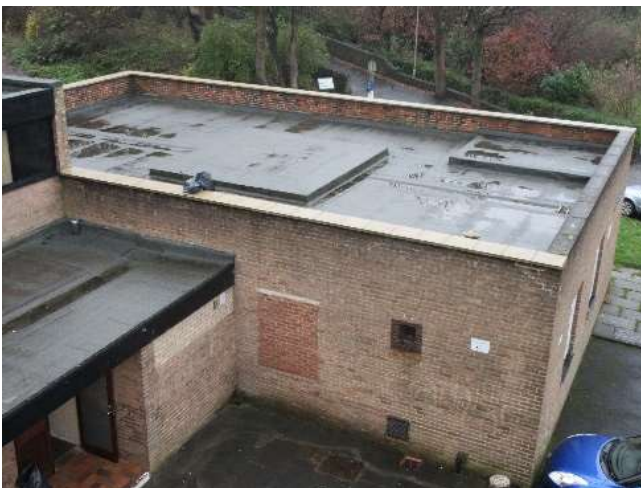
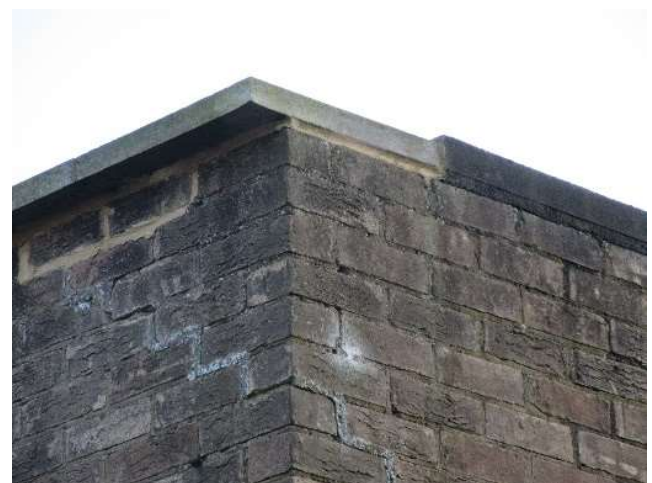
19. The **Hall** roof is the former concrete first floor, with raised timber decks filling a former stair opening in the W corner and an open centre well. Since last inspection new concrete copings have been fitted at all except the short NW side where earlier replacements are serviceable. Lack of overhangs at the N ends of the new copings may cause damp in the bricks.

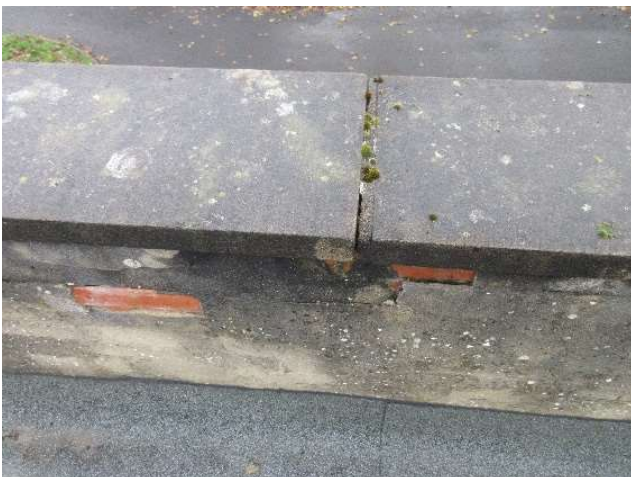
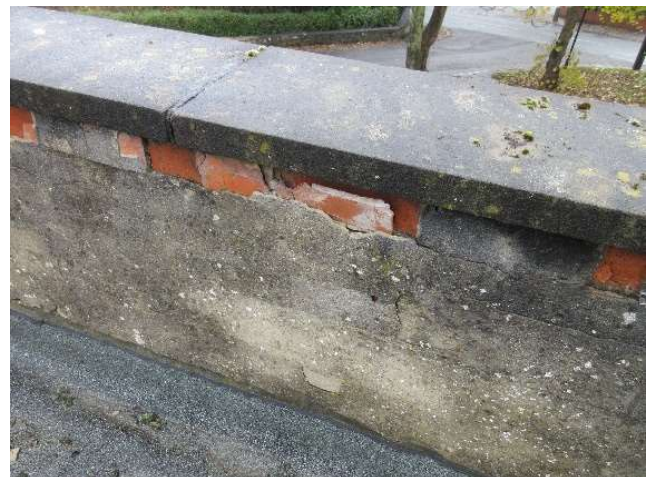
Roof enclosed by seven course brick parapet (rendered at NW). The NW render and some inner bricks are decayed. If not covered in a roof renewal soon the render should be repaired.

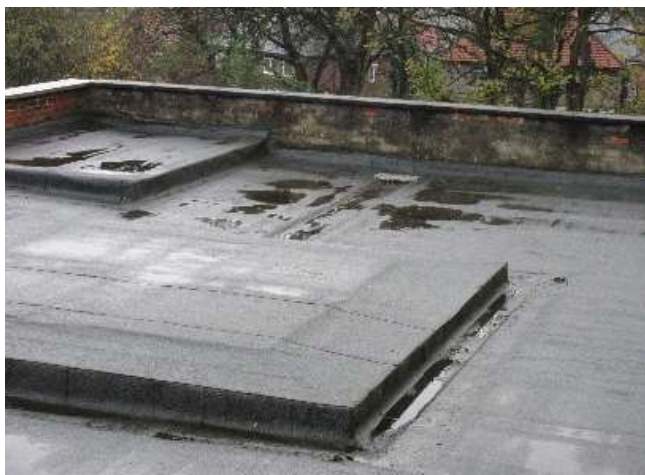
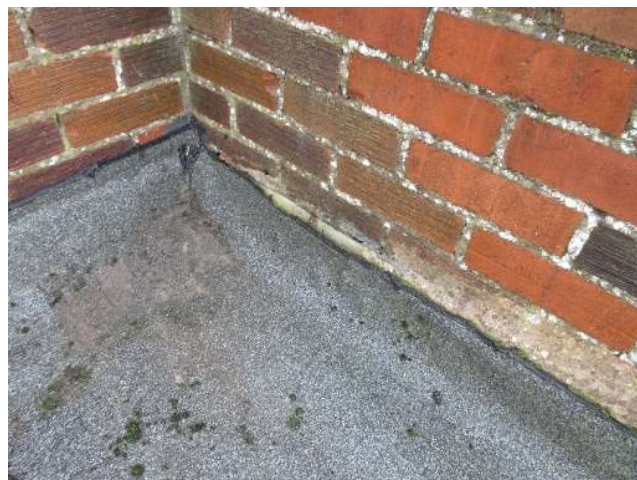
20. The Hall roof falls inwards to a centre gutter passing around the raised centre table to internal outlets at each end. The felt appears waterproof despite ponding at W and SE, at the former stair and the gutter NW of the centre table. Upstands mastic pointed to the brick walls. A short length of upstand at the S corner is loose from the wall and open to weather.

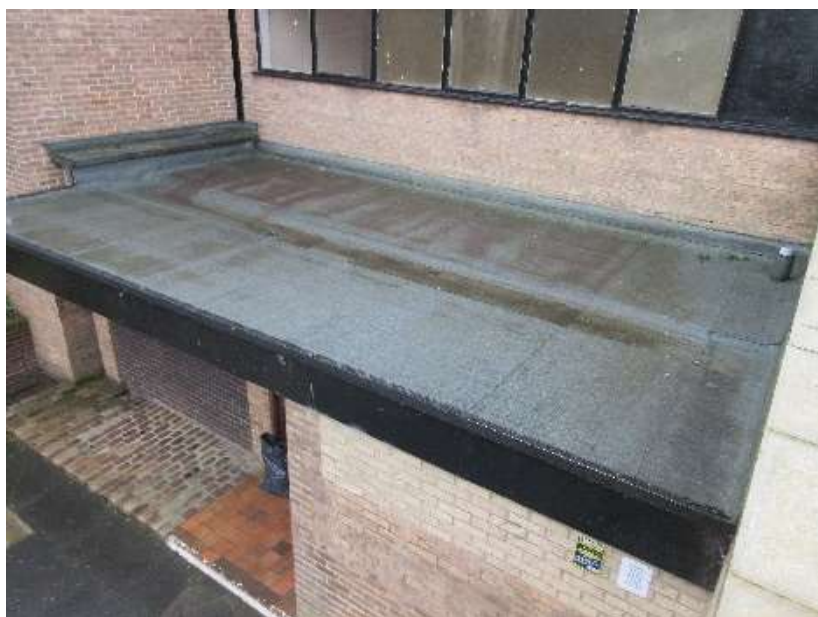
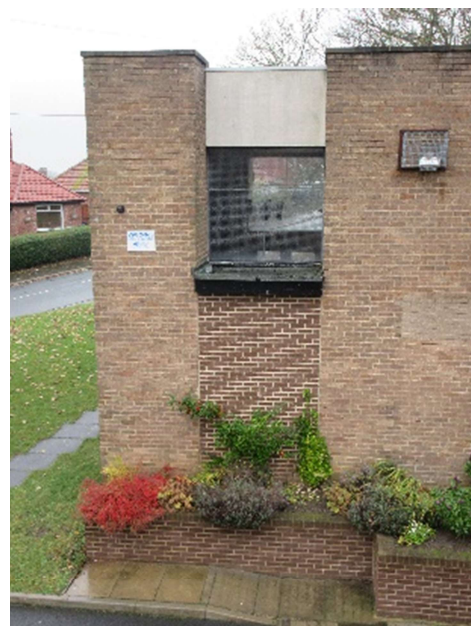
21. The lowest flat roof over the **Lobby** and **WCs** has green felt on timber deck with a centre gutter and outlet. Good condition but gutter ponded because the outlet now higher than the gutter. Aluminium trim along the open edge, now with discrete anti-intruder spikes.

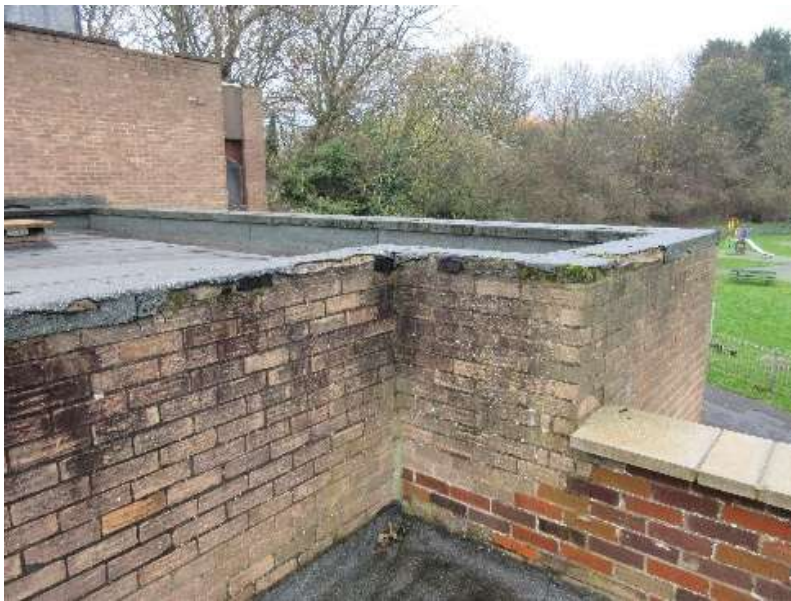
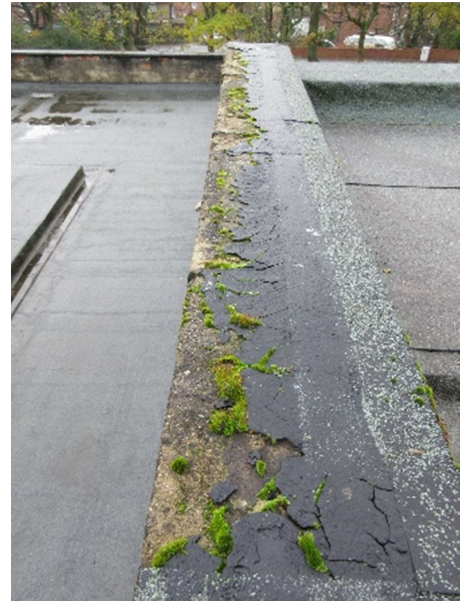
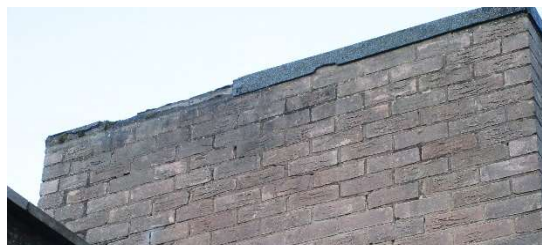
29. Cast stone copings in fair condition, now felt over with some coping decay at the mid-level roofs.

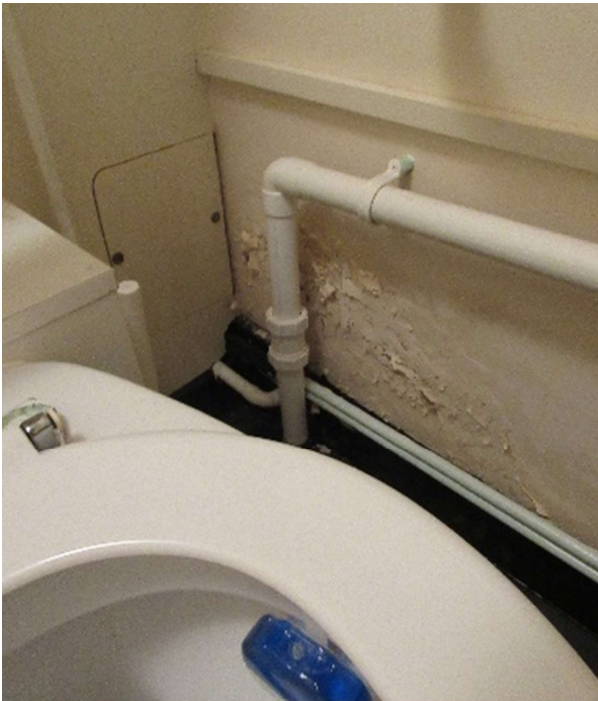
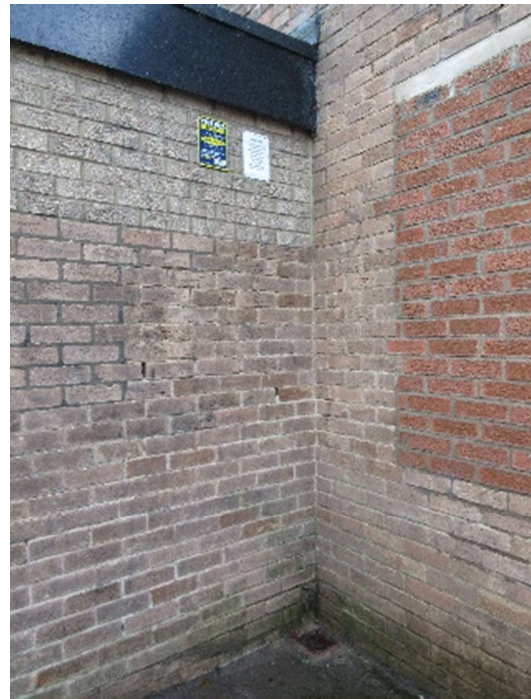
50. None at Church and part of the Hall lobby. Elsewhere good painted plaster. Half tiled behind Gents basins. Slight low level damp behind Ladies soil pipe and R of the lower accessible wc bowl seem associated with a rainwater gully outside which gets blocked, perhaps wetting the bricks enough to fill the cavity.

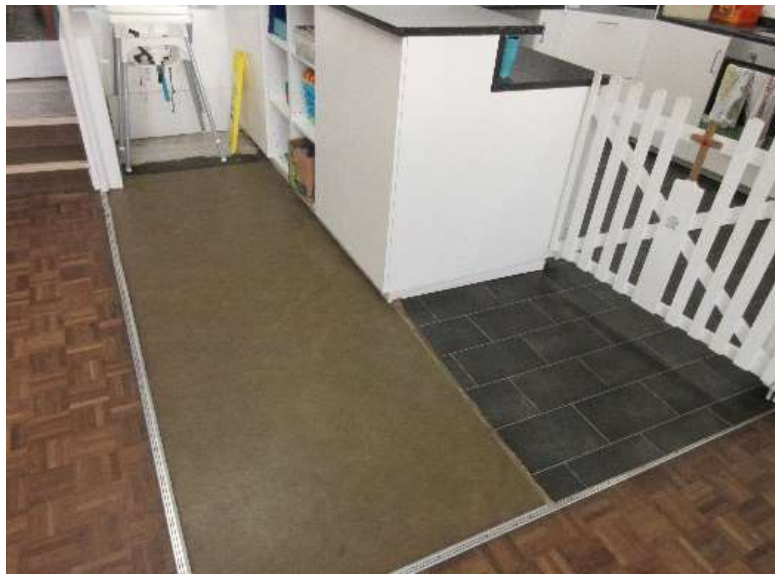
60. In the Hall good small hardwood blocks except mixed finishes around kitchen. At kitchen some bare screed and recent sheet laid over earlier lino with a loose taped edge which will get damaged. Better to finish all in one material with permanent edging.

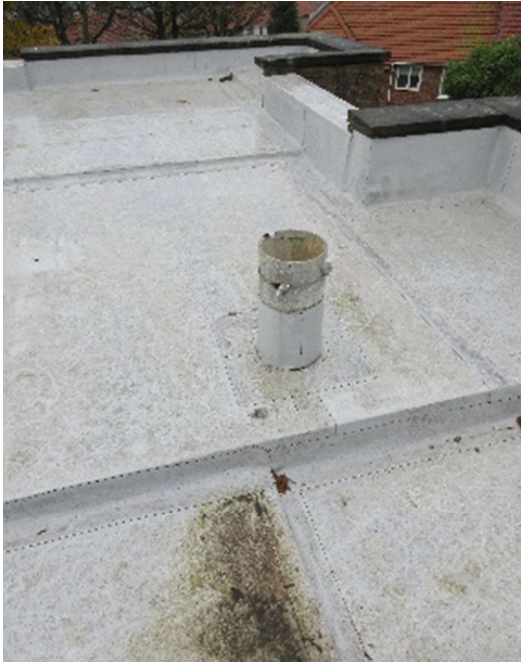
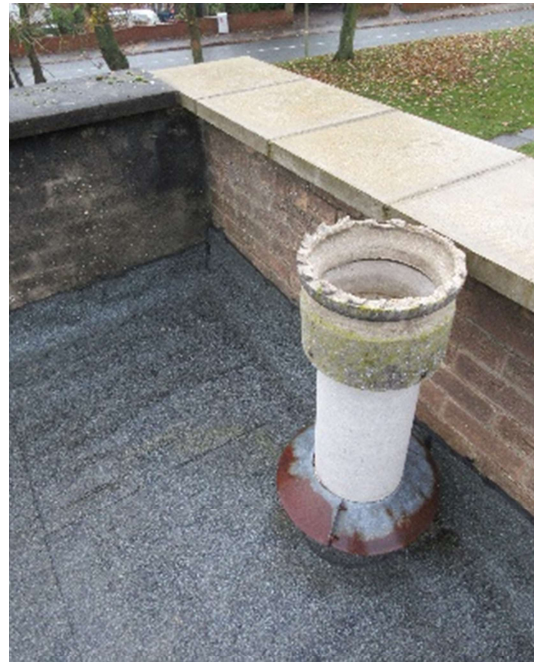
66. Warm air heating by separate gas furnaces off Church lobby (two) and in chamber at Hall, each with intake louvres through walls and asbestos cement flue pipes through the flat roofs. The Church flue pipe has again lost its rain cap. The Hall pipe remains open to the rain.

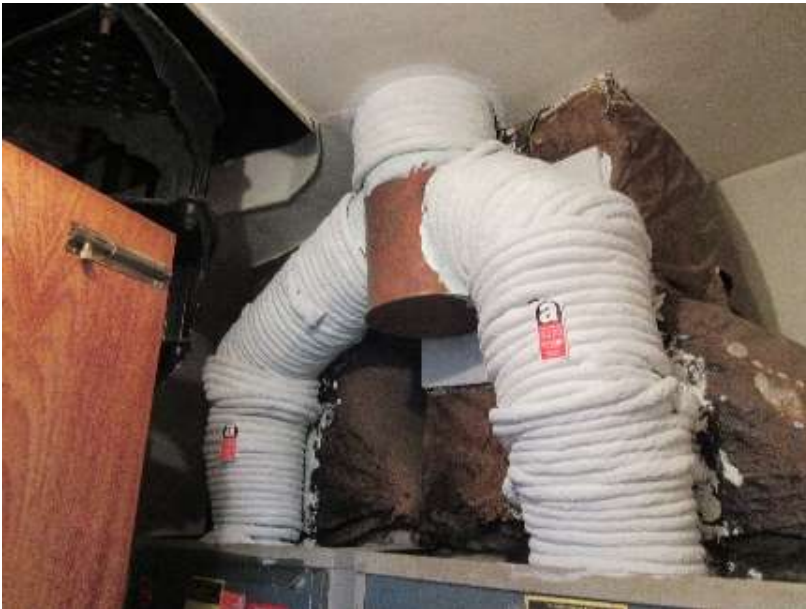
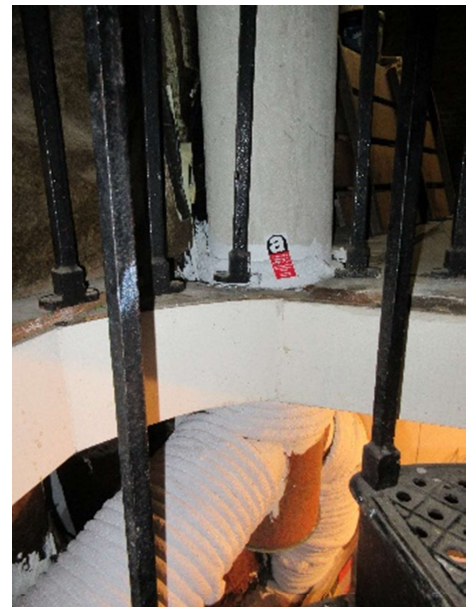
67. At Church the asbestos containing heat resisting rope seal between a metal manifold and the flue pipe now has painted encapsulation. The hot air duct in the Church boiler room has fibrous lagging. Similar at Hall not lagged.

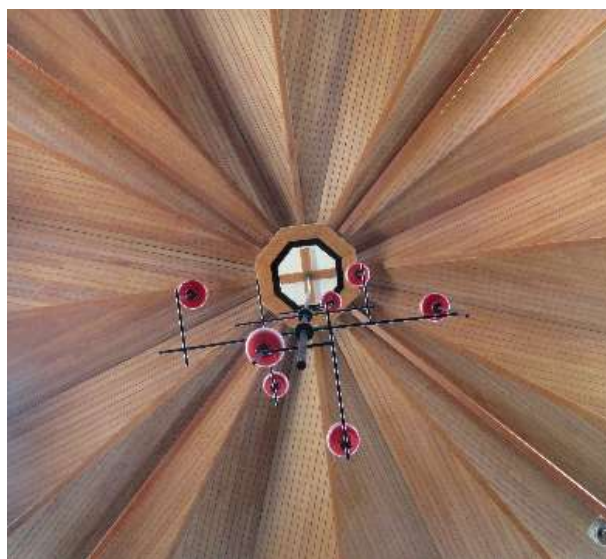
73. MICC wiring in the Church ceilings has been damp and not providing proper earth so the Church is lit with temporarily wired LED down floods around the lantern and each side of the entry doors.
74. Former lighting in Church (none now working) was:  
Recessed downlights in Church, Church lobby landing and outside the Church doors. Some small spots  
Around the lantern base a continuous strip of fluorescent lights.  
Special lighting:  
- in the Church lobby a small corona of up and downlight tungsten lamps  
- in church switches behind the president's bench controlled 4 floods around the lantern base, and groups of lights in two metal pendants with random bracketed glass shades one over the tabernacle with 3 white, the other central over the altar with 7 red.
