QUINQUENNIAL INSPECTION REPORT

CHURCH OF THE HOLY TRINITY
THE GREEN, CORNFORTH, FERRYHILL, Co. DURHAM, DL17 9JH

JULY 2022

Michael Atkinson Architecture + Heritage

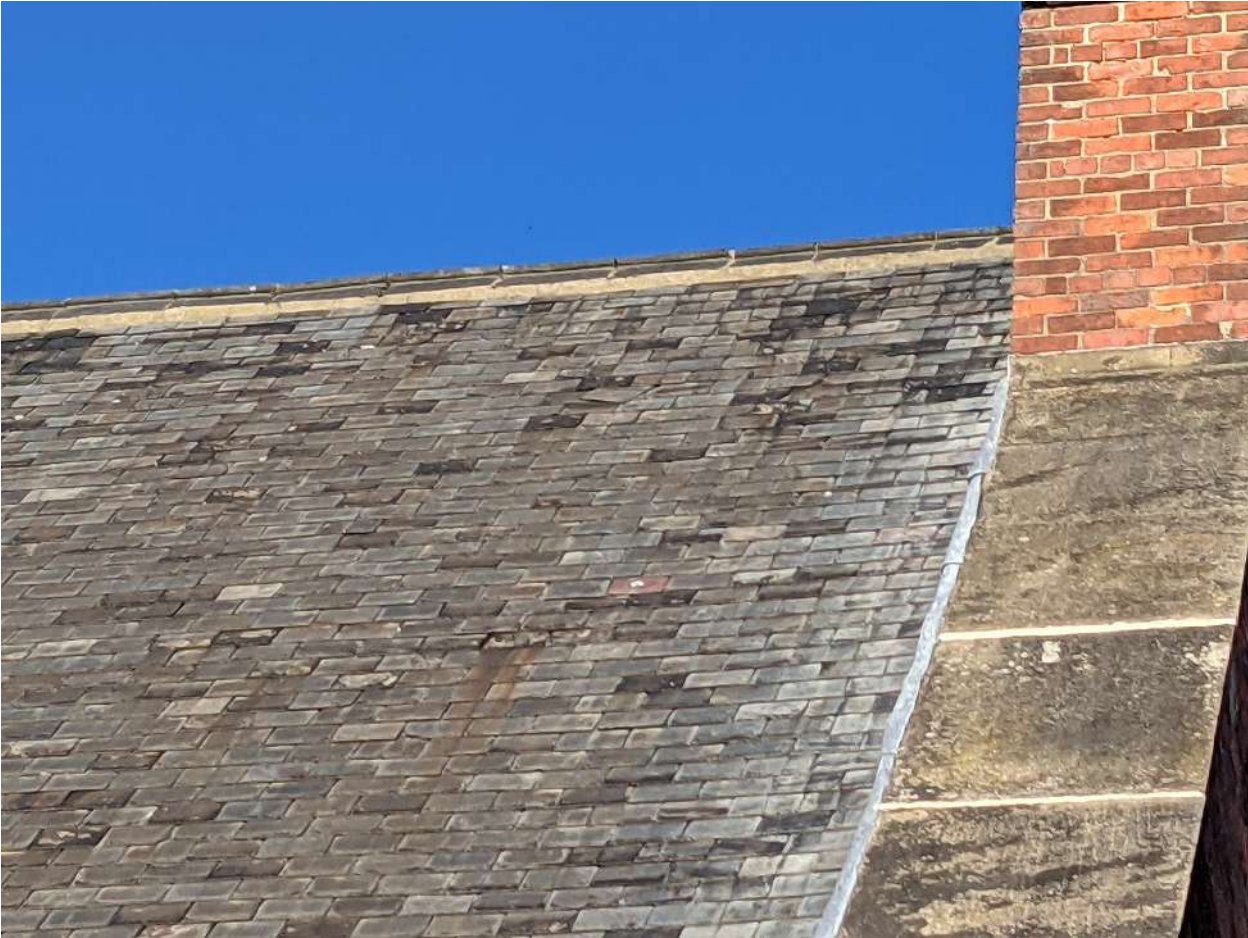
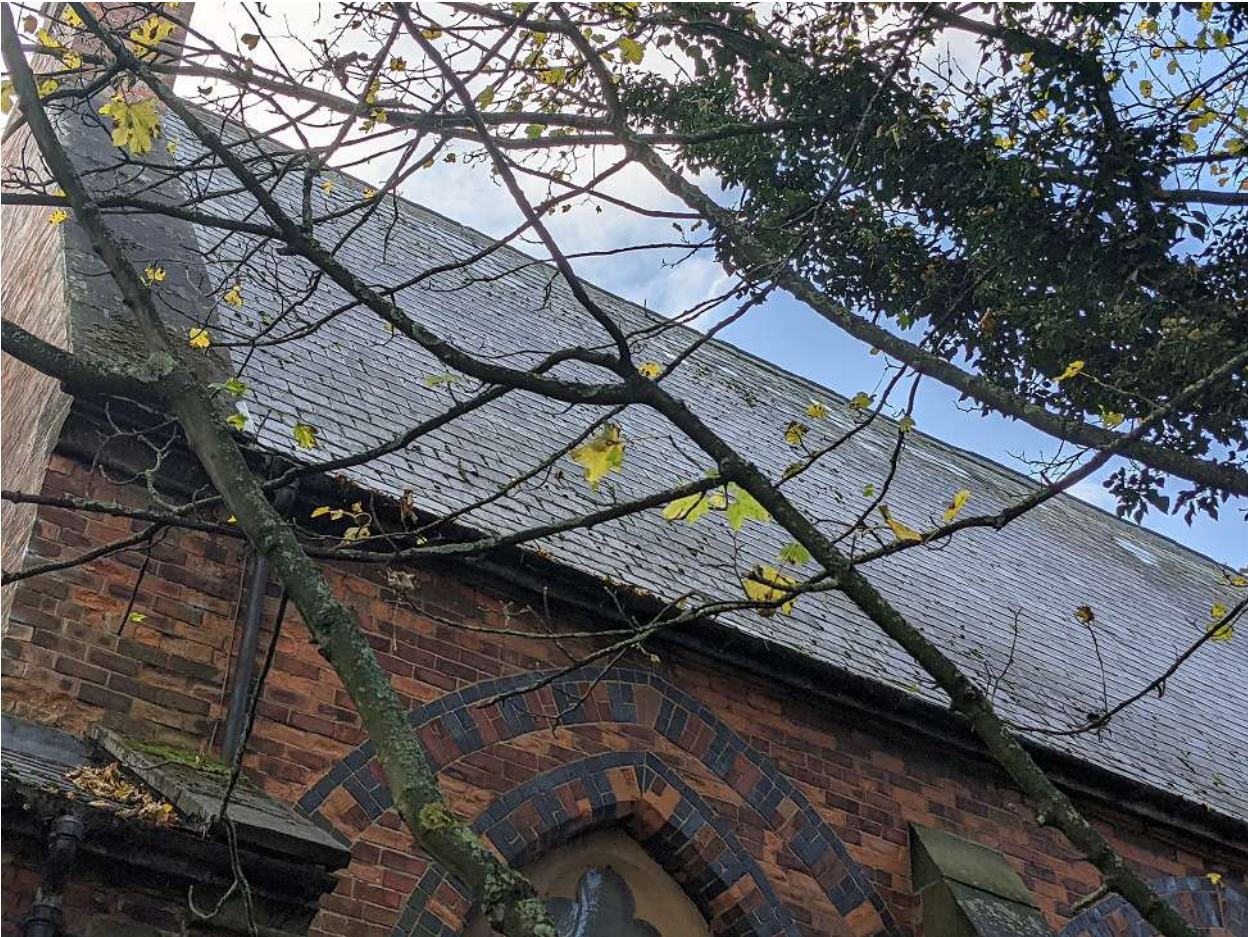
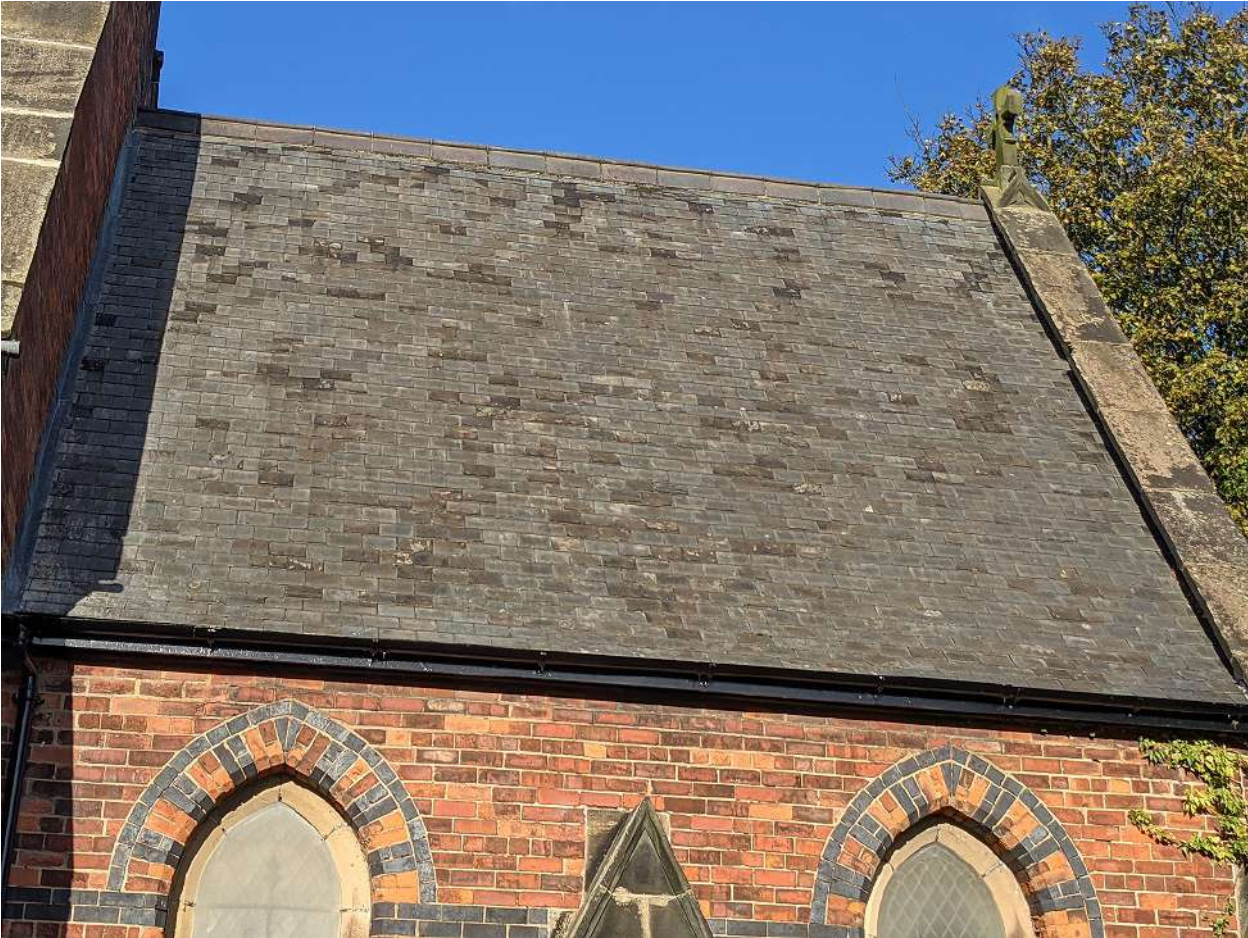
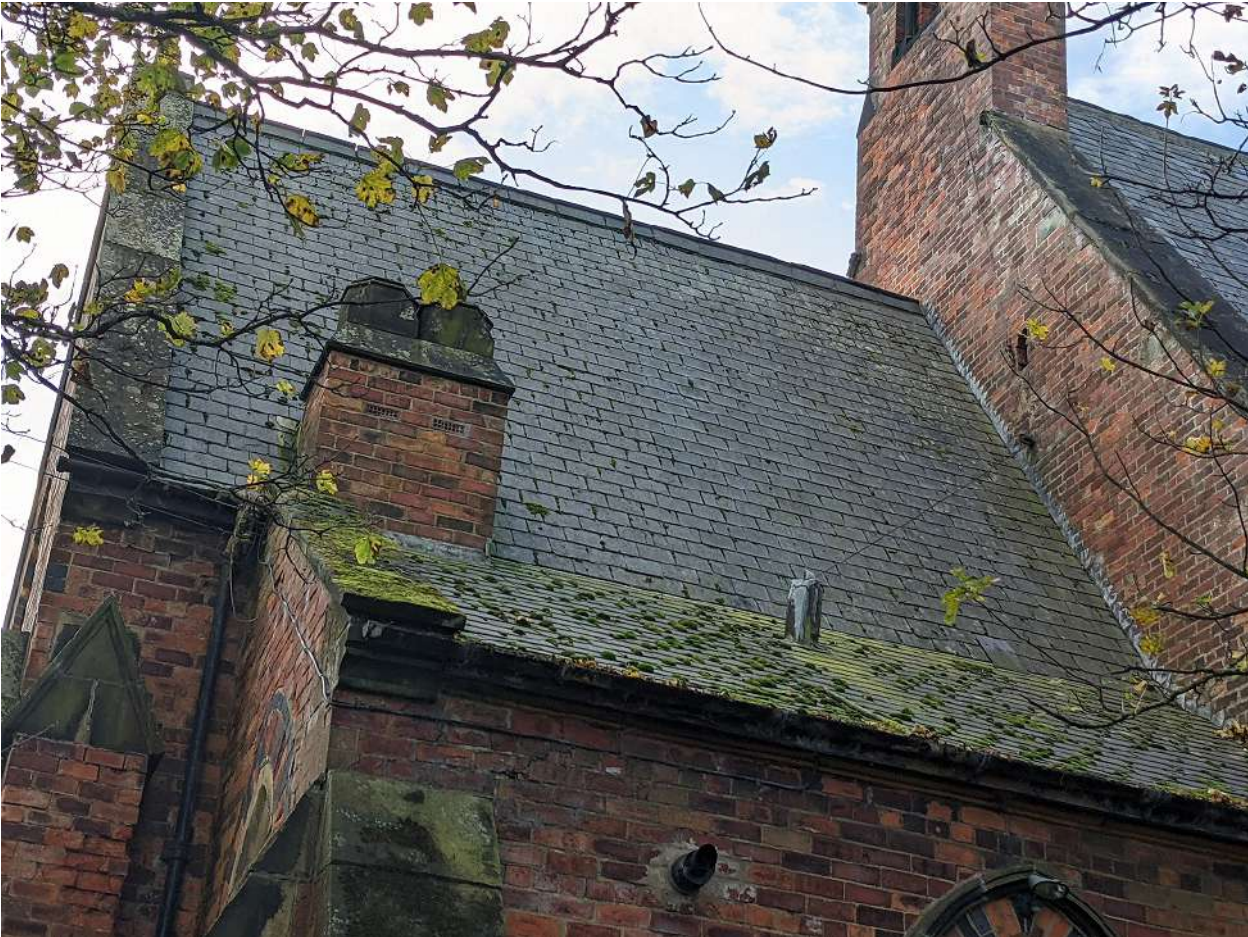
Mortar bedding to the ridge looks in a fair, satisfactory condition. The mortar bed is thin in places but looks to be largely intact without loss of any sections.

To the north slope there is evidence of moss build-up, greater across the shallower vestry roof at the junction of slates across this roof slope.

The condition of the lead flashing between the transition between chancel and vestry is difficult to assess from ground level as is the condition of the lead back gutter to the chimney stack. A lead collar rises roughly centrally out from the vestry roof covering which takes the bell rope, all appears to be in a satisfactory condition.

It is recommended that a drone survey of the roof covering is carried out every other quinquennium period, ie. in 5 years then every 10 years thereafter.

3.2.2 It is recommended that as a routine item of maintenance the roof should be examined and repairs undertaken on a twice yearly basis.

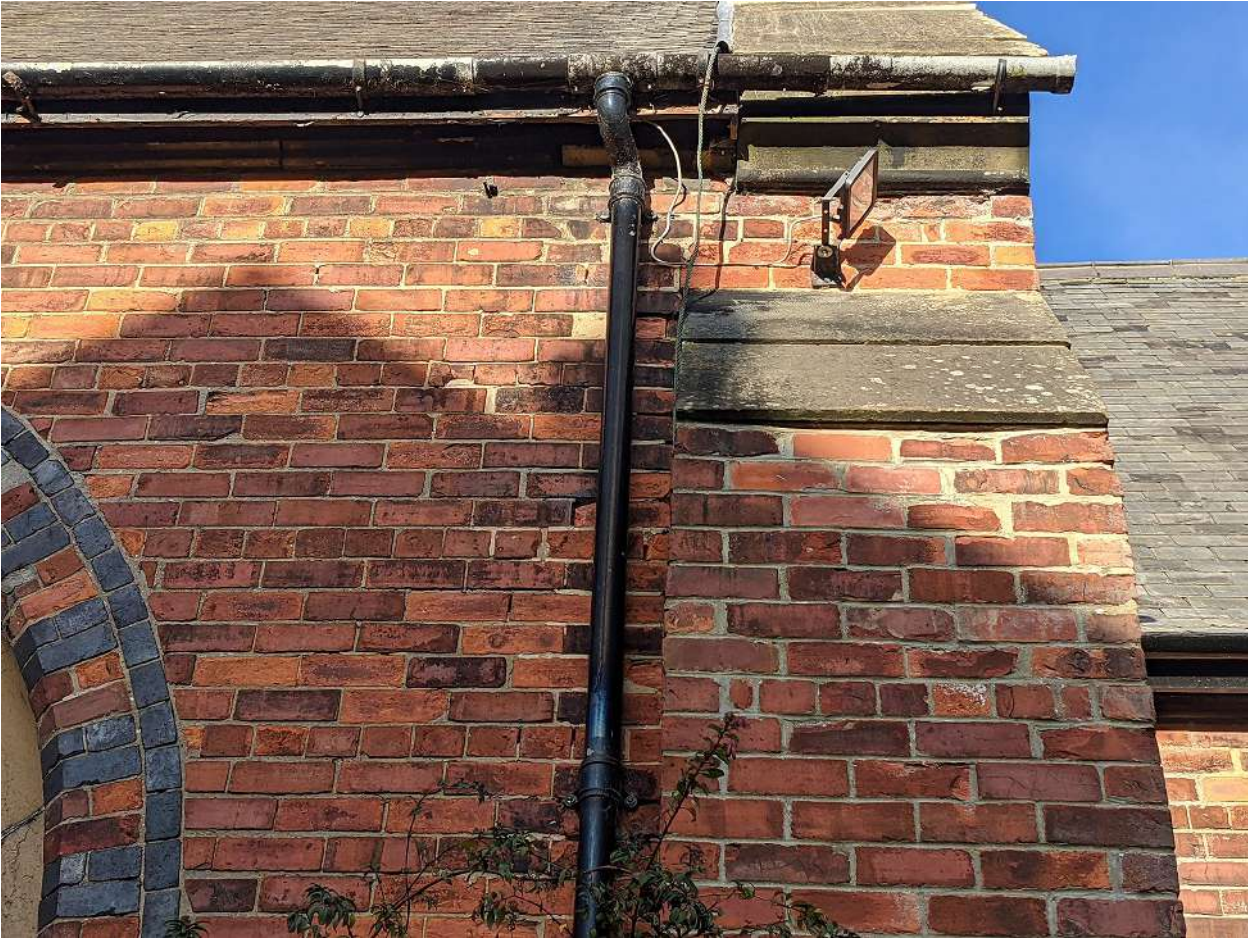
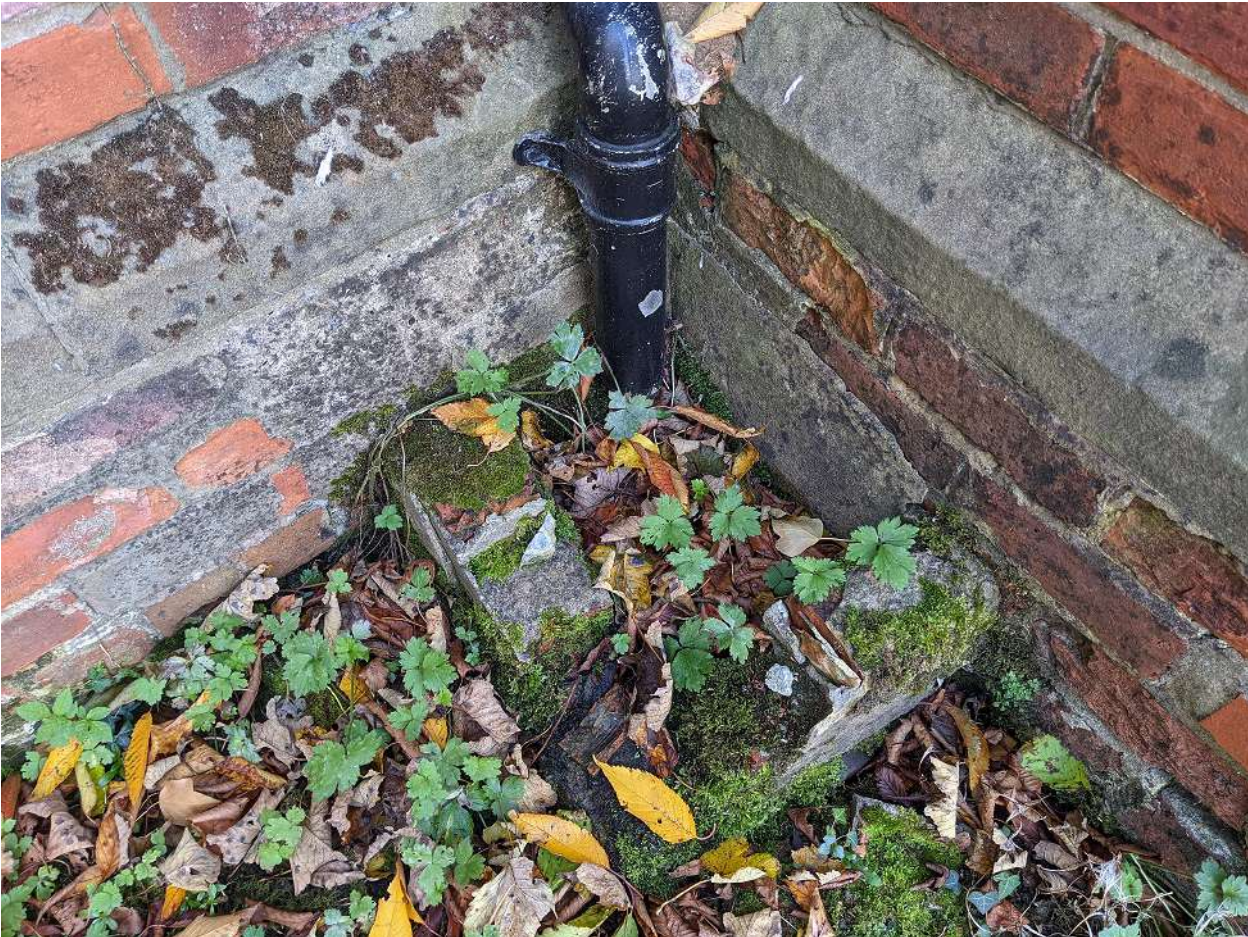
- 4.1.1 All gutters and downpipes appear to be in a sound, satisfactory working condition, albeit the gutter decoration is badly flaking in places. Gullies at ground level are choked with leaves and beginnings of ivy growth noted.

R2	It is recommended that the eaves gutters are replaced with cast iron, removing asbestos containing material and rainwater goods refurbished.
-----------	----------------------------------------------------------------------------------------------------------------------------------------------

M	4.1.2 It is recommended that as a routine item of maintenance the gutters and downpipes should be checked and cleared on a twice-yearly basis.
----------	------------------------------------------------------------------------------------------------------------------------------------------------

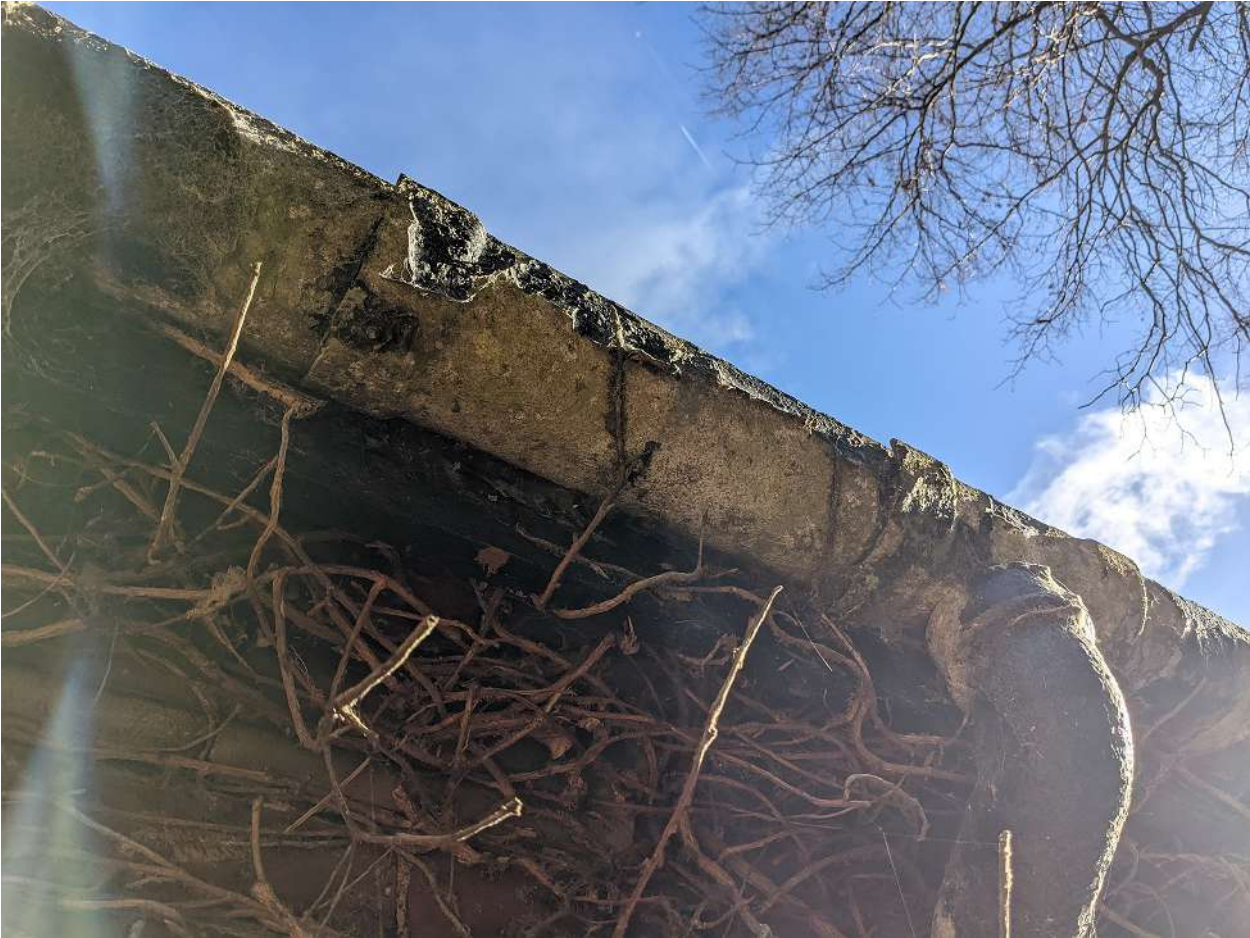
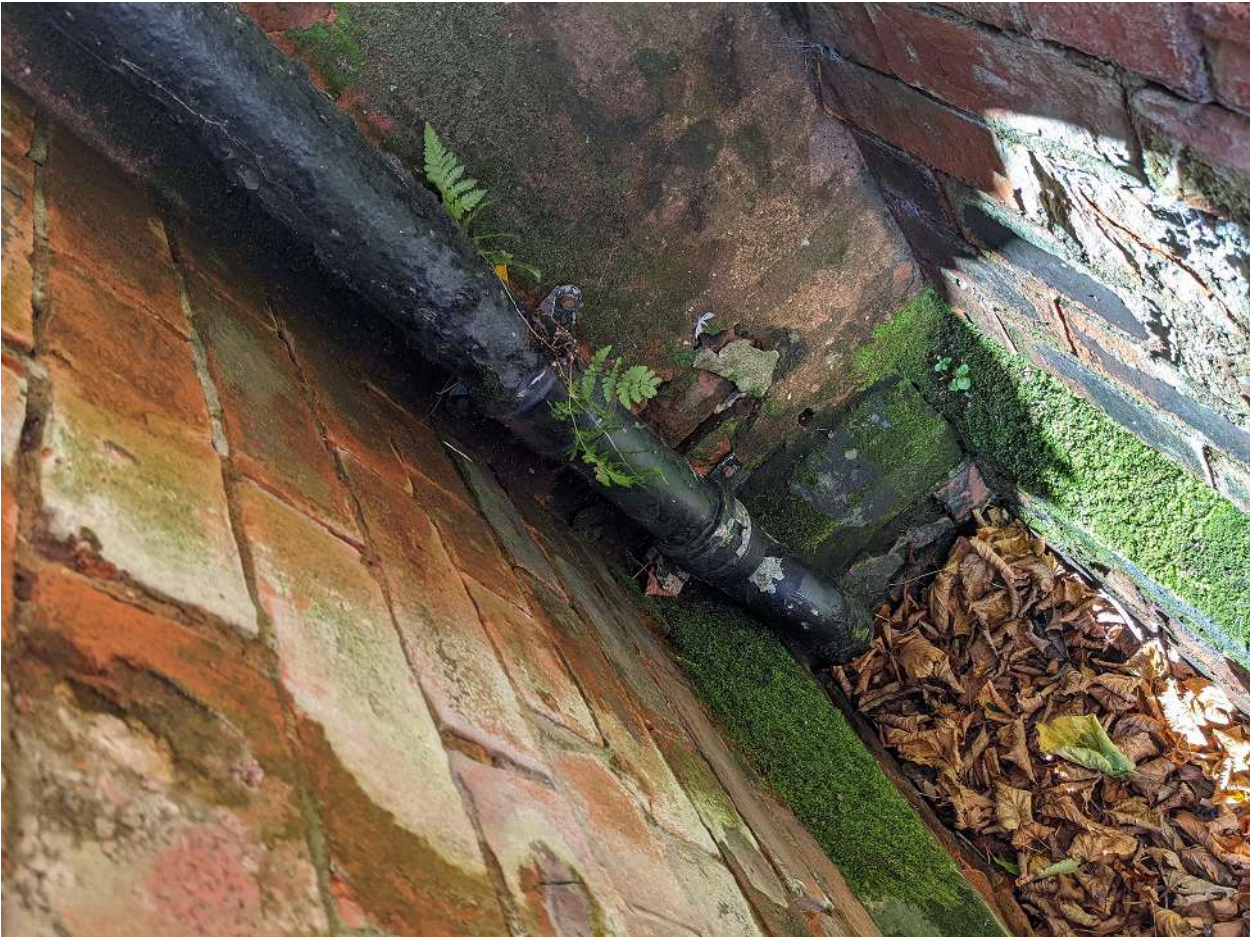
5.1.1 The below ground drainage was not tested as part of the inspection.

Previous QIR's have made comment of poor drainage to the bottom of the boiler house steps where a gully is understood to be located. At the time of inspection this area was covered in leaf debris and therefore it would be prudent to regular clear this area of leaves to ensure correct operation of the drainage gully.

R1	It is recommended that further investigations are made concerning the condition of this gully by an experienced drainage contractor.
-----------	--------------------------------------------------------------------------------------------------------------------------------------

M	5.1.2 It is recommended that as a routine item of maintenance the below ground drainage system is checked as a minimum twice yearly.
----------	--------------------------------------------------------------------------------------------------------------------------------------

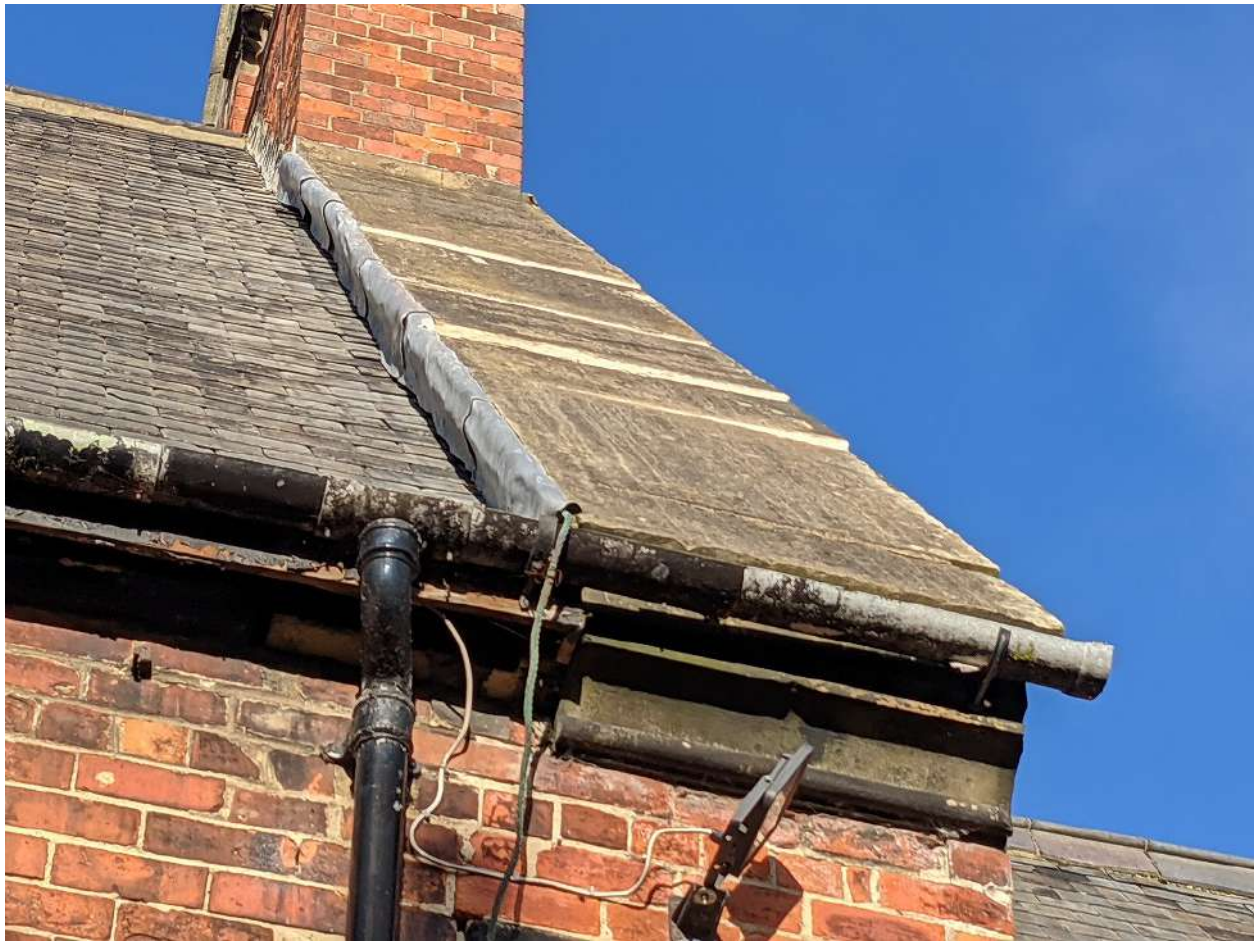
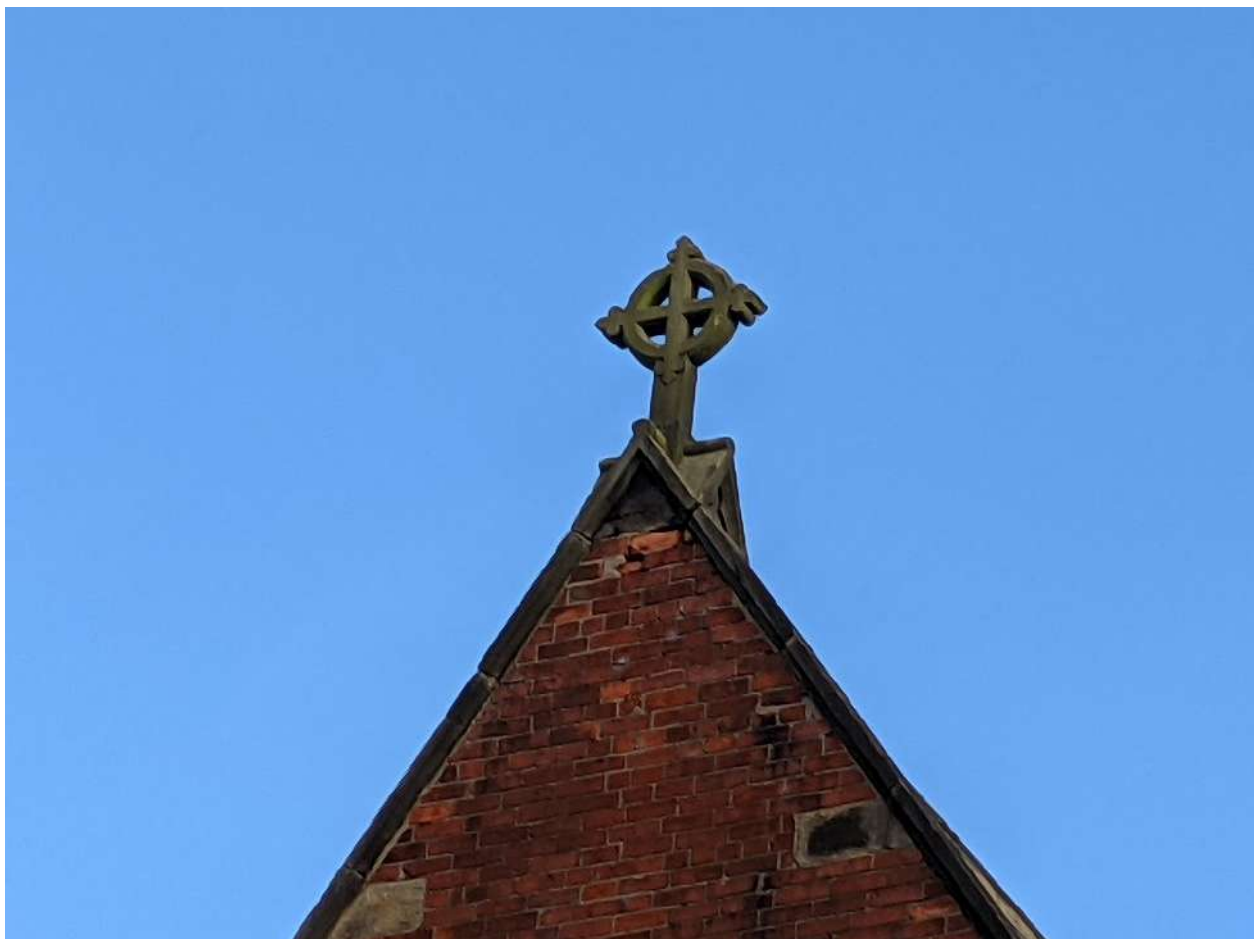
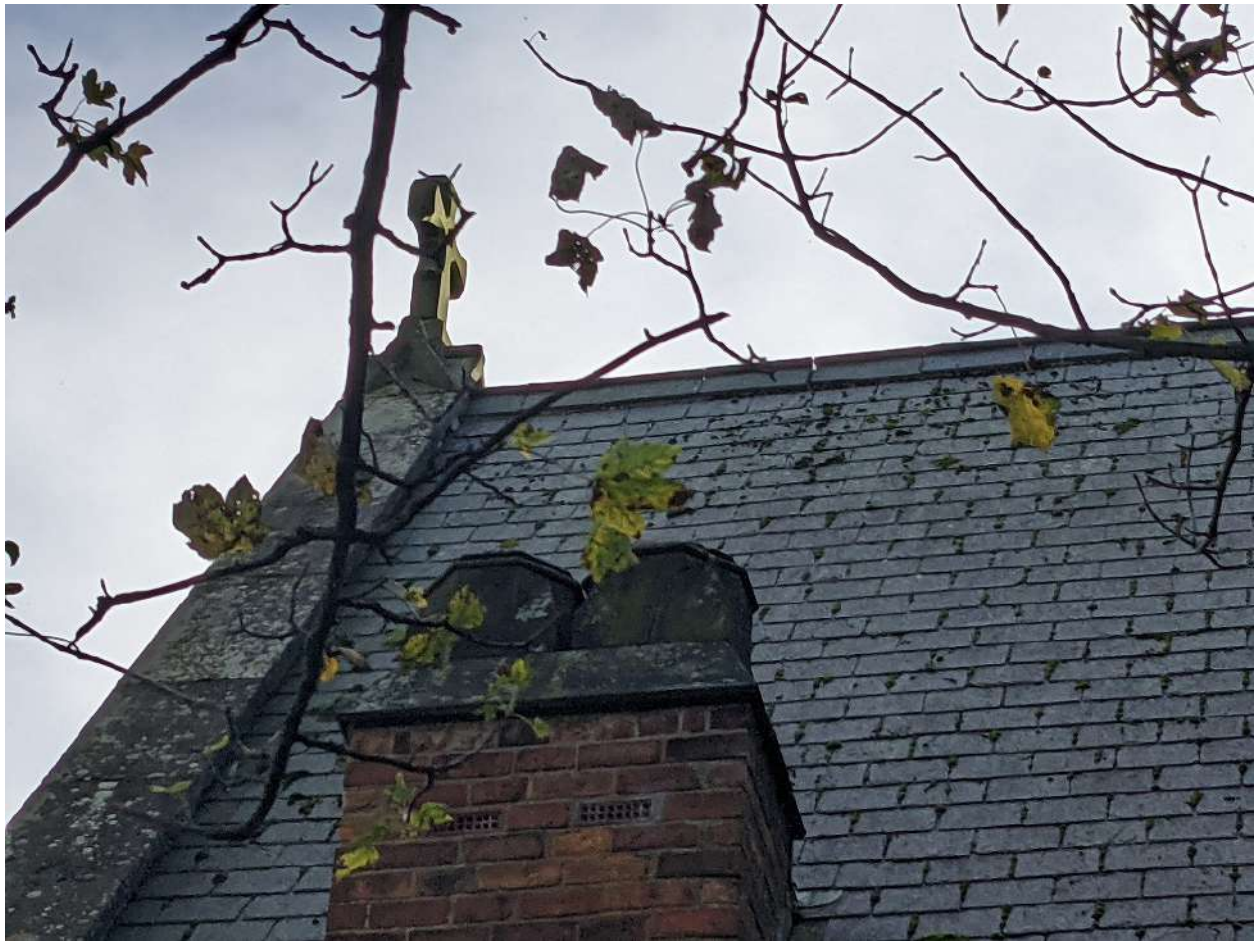
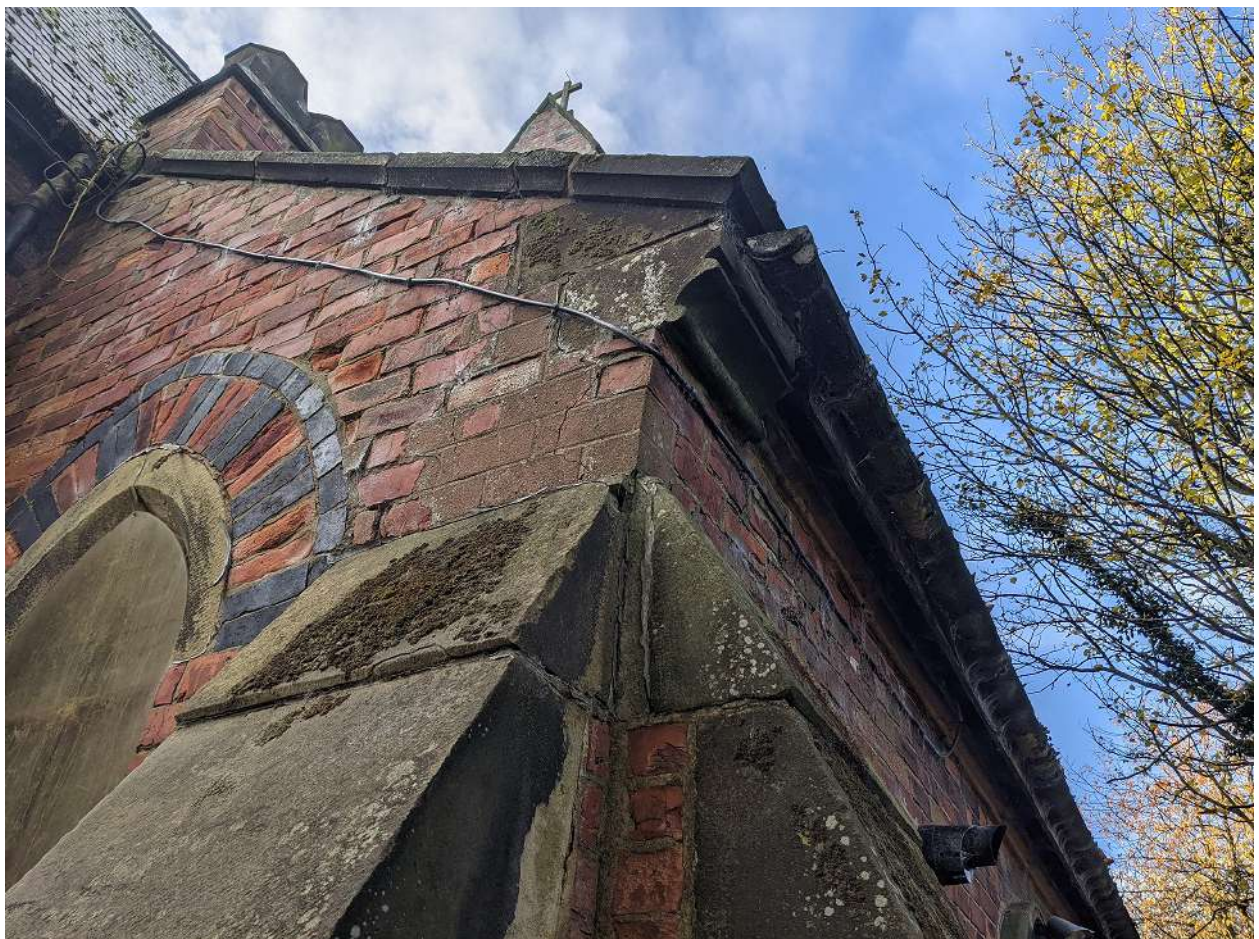
- 6.2.1 The water tabling appears to be in a sound, satisfactory condition.

A large degree of moss and algae build-up is noted on the top face of the water tabling to the vestry. Internally in this location there is deterioration to the decoration finish which suggests dampness.

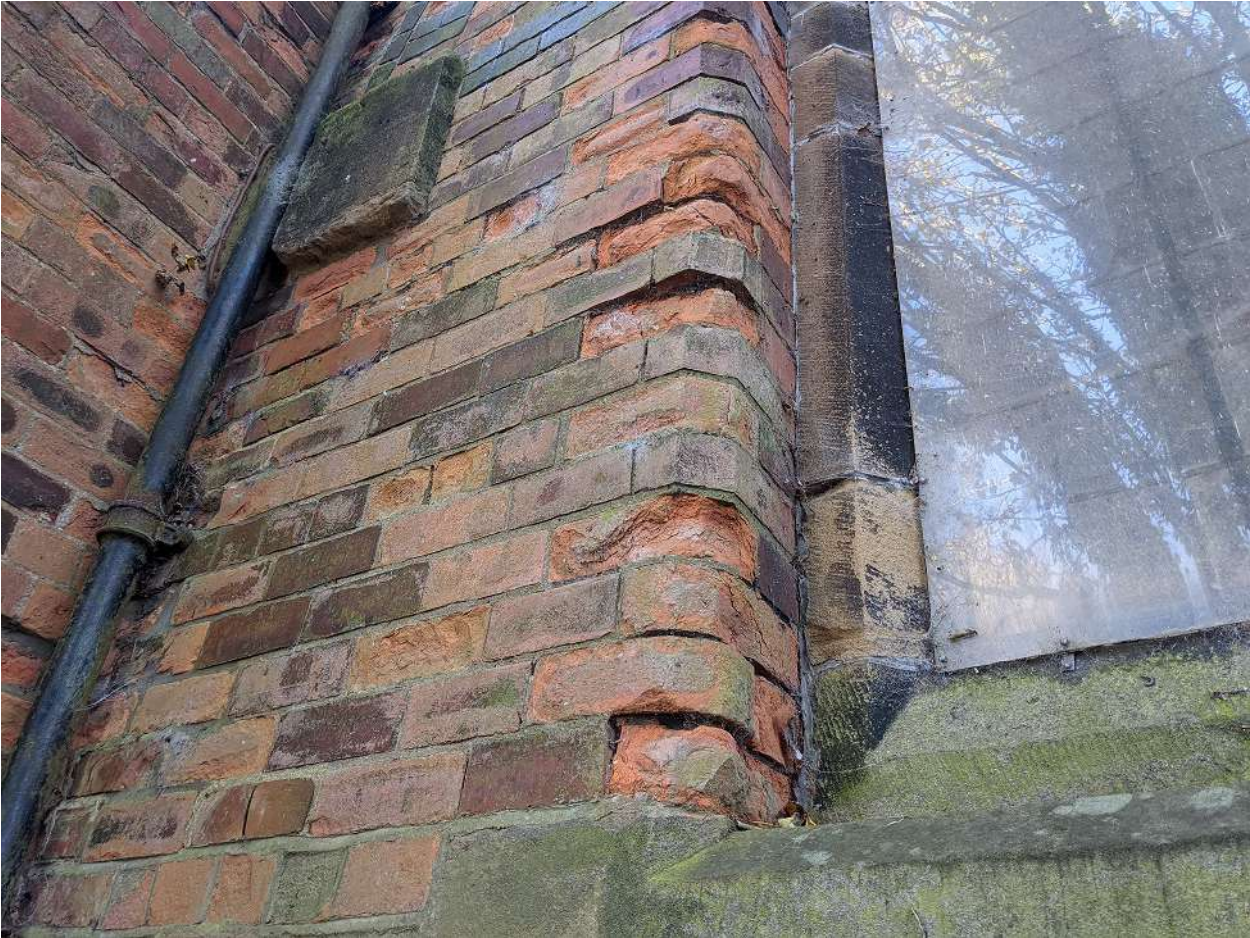
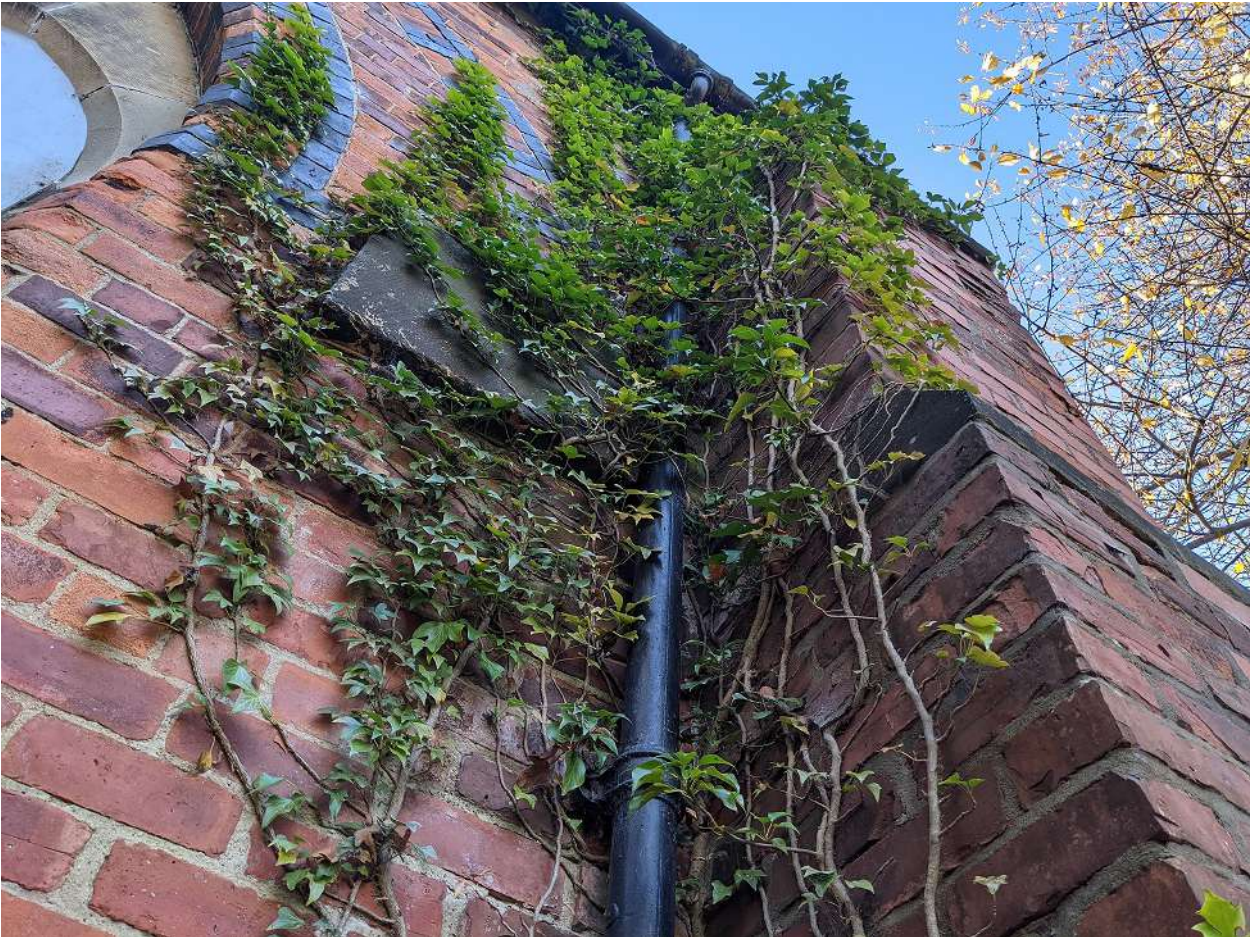
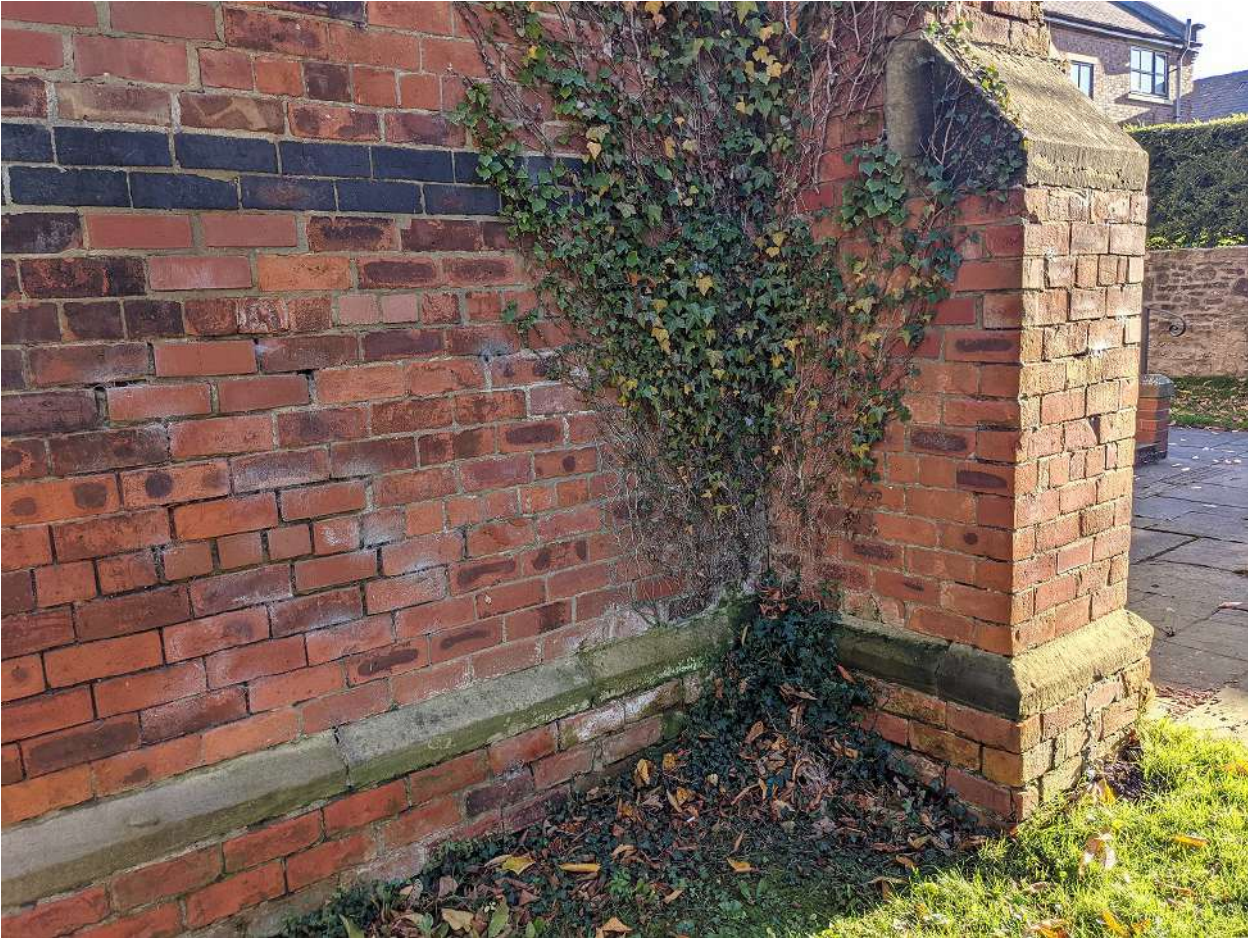
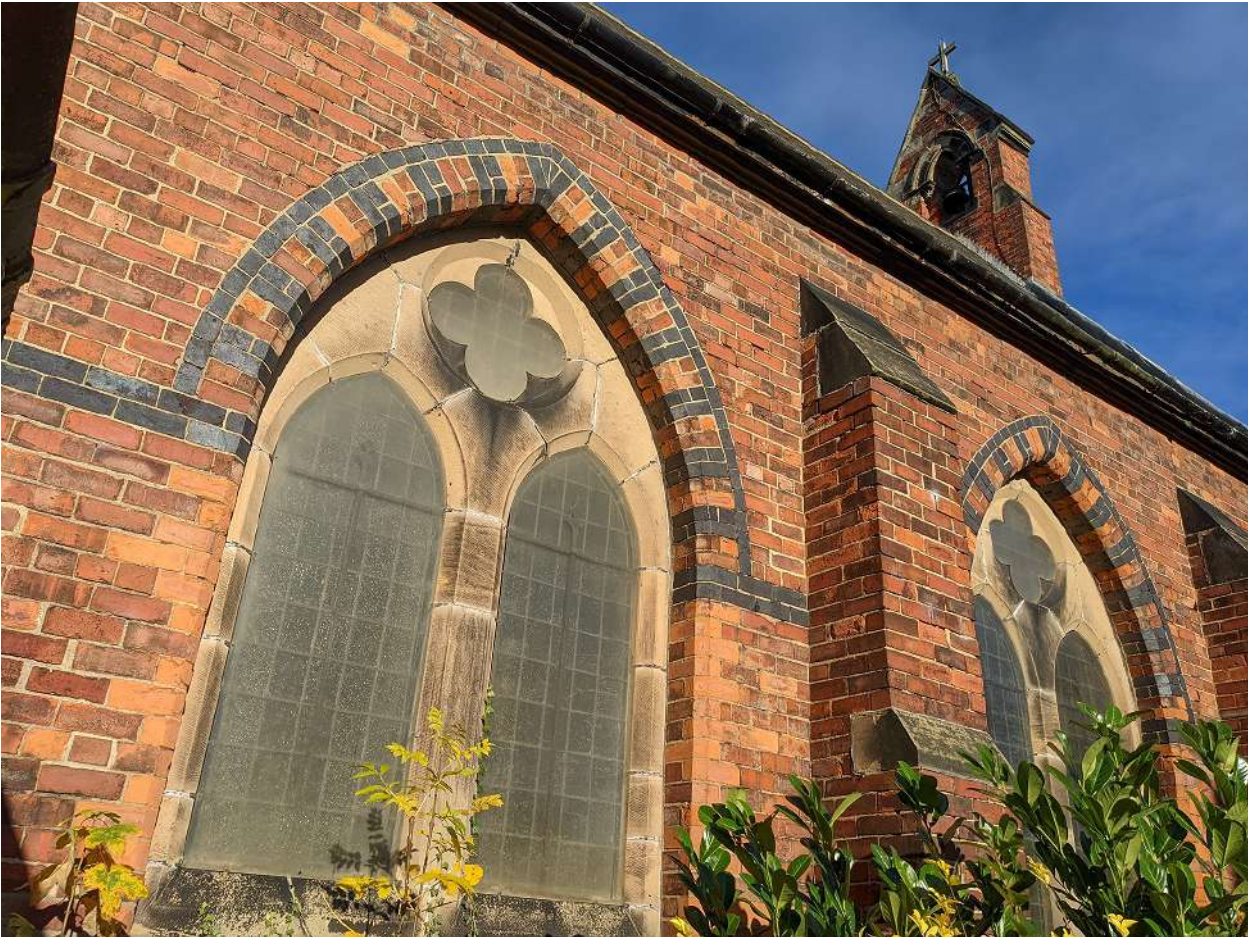
- 7.1.3 Ivy growth is observed to the north elevation (west end) which has grown up to eaves level, if left unattended it has the potential to be detrimental to the building fabric.

R0 It is recommended to cut back ivy growth.
