QUINQUENNIAL INSPECTION REPORT

CHURCH OF THE HOLY TRINITY
THE GREEN, CORNFORTH, FERRYHILL, Co. DURHAM, DL17 9JH

JULY 2022

Michael Atkinson Architecture + Heritage

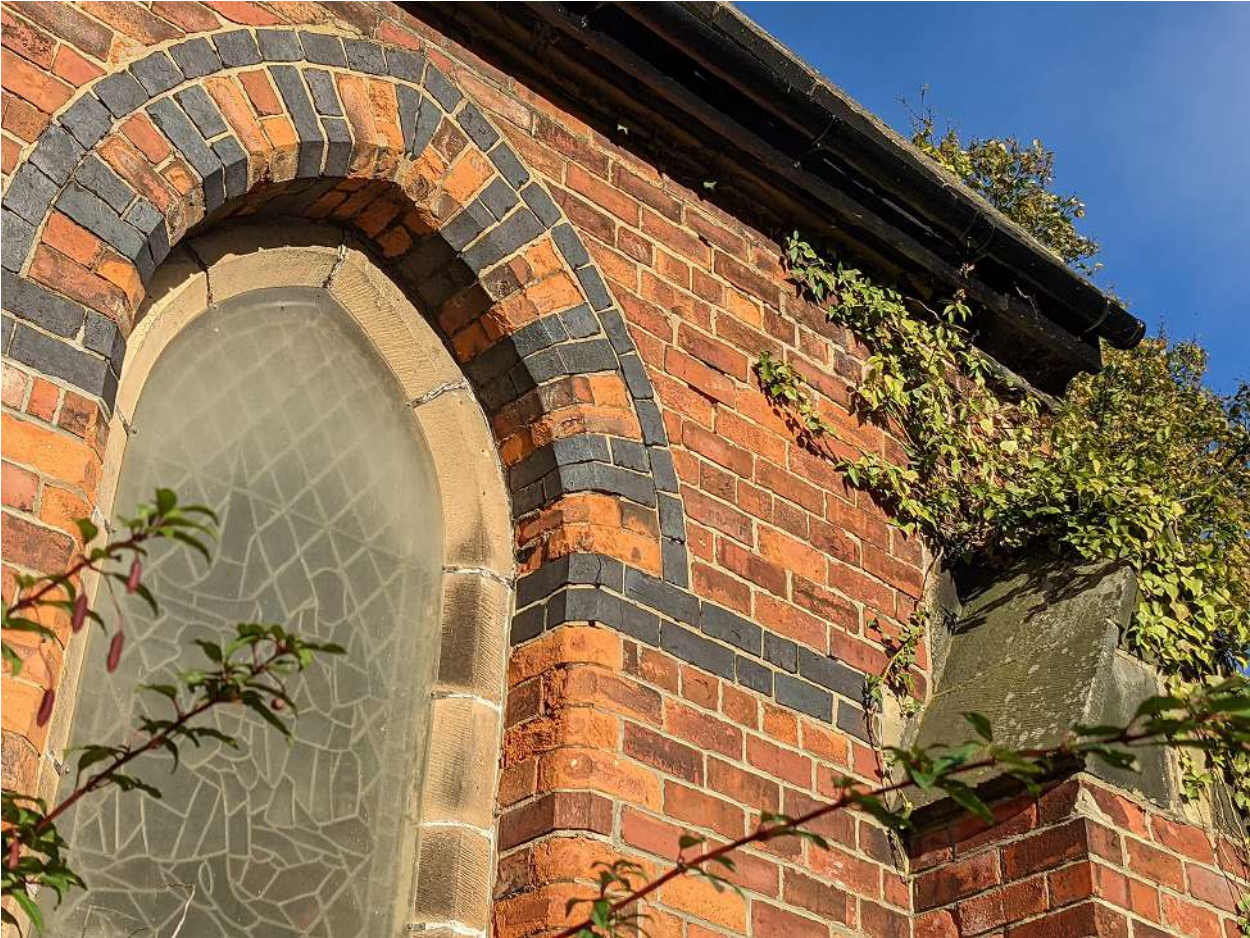
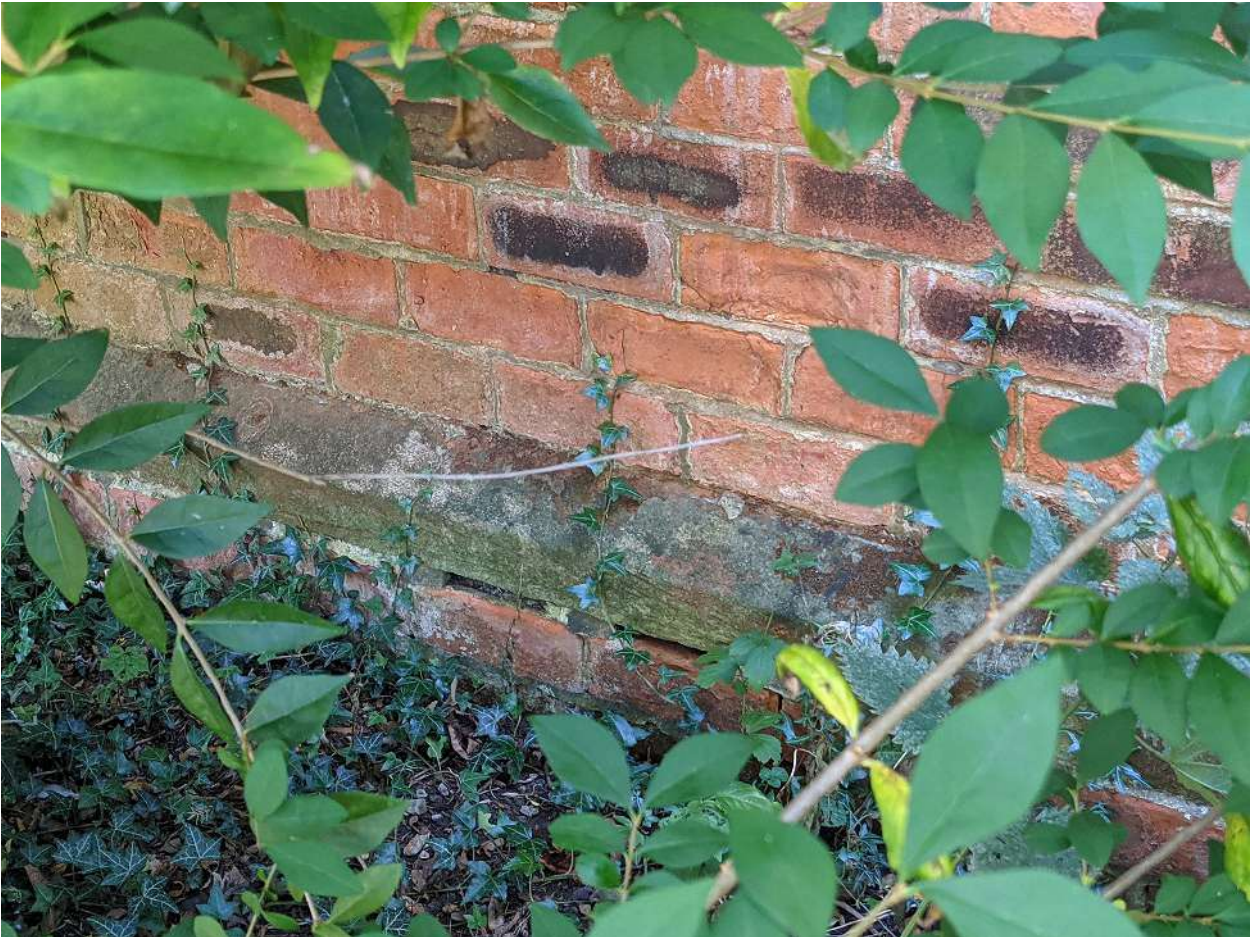
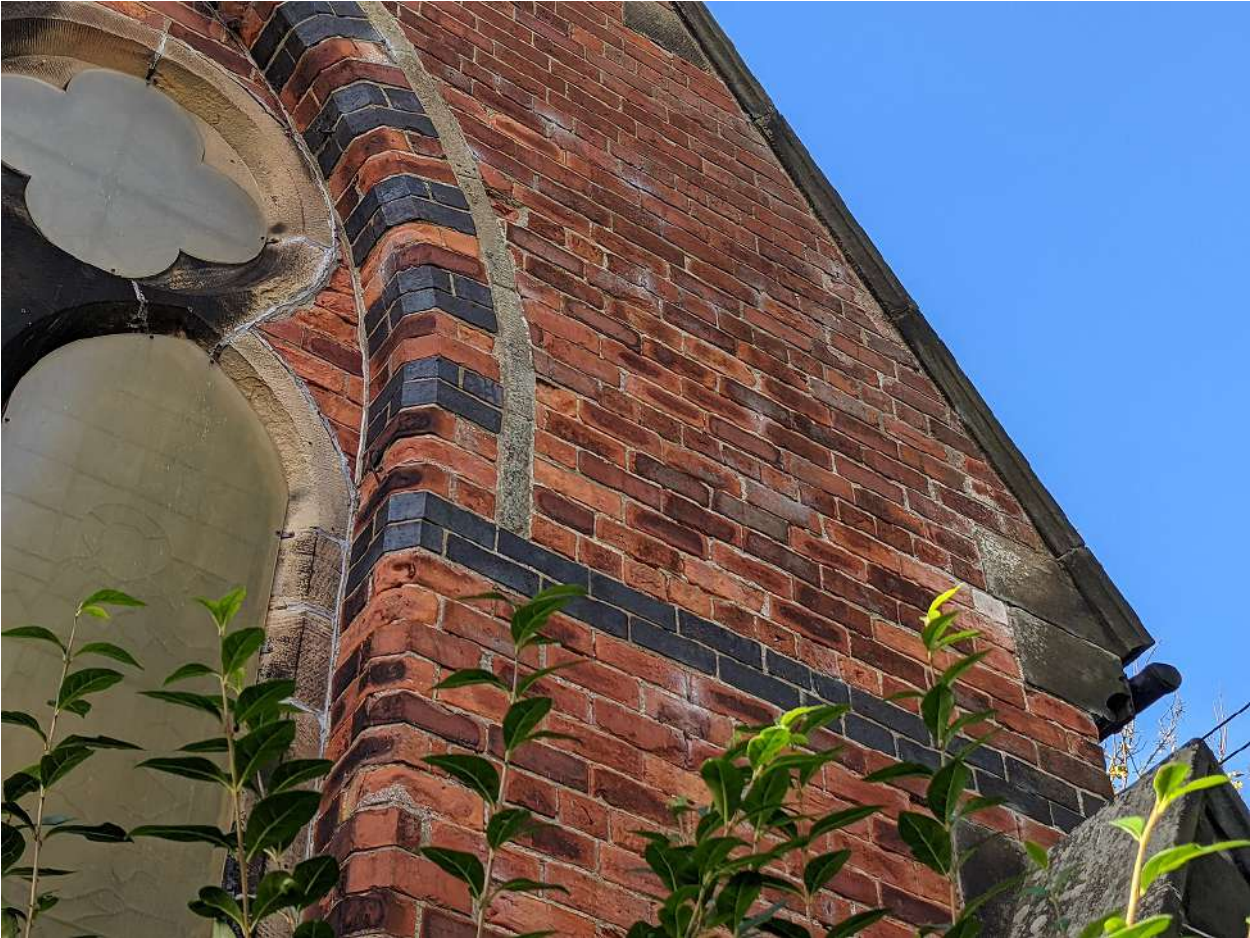
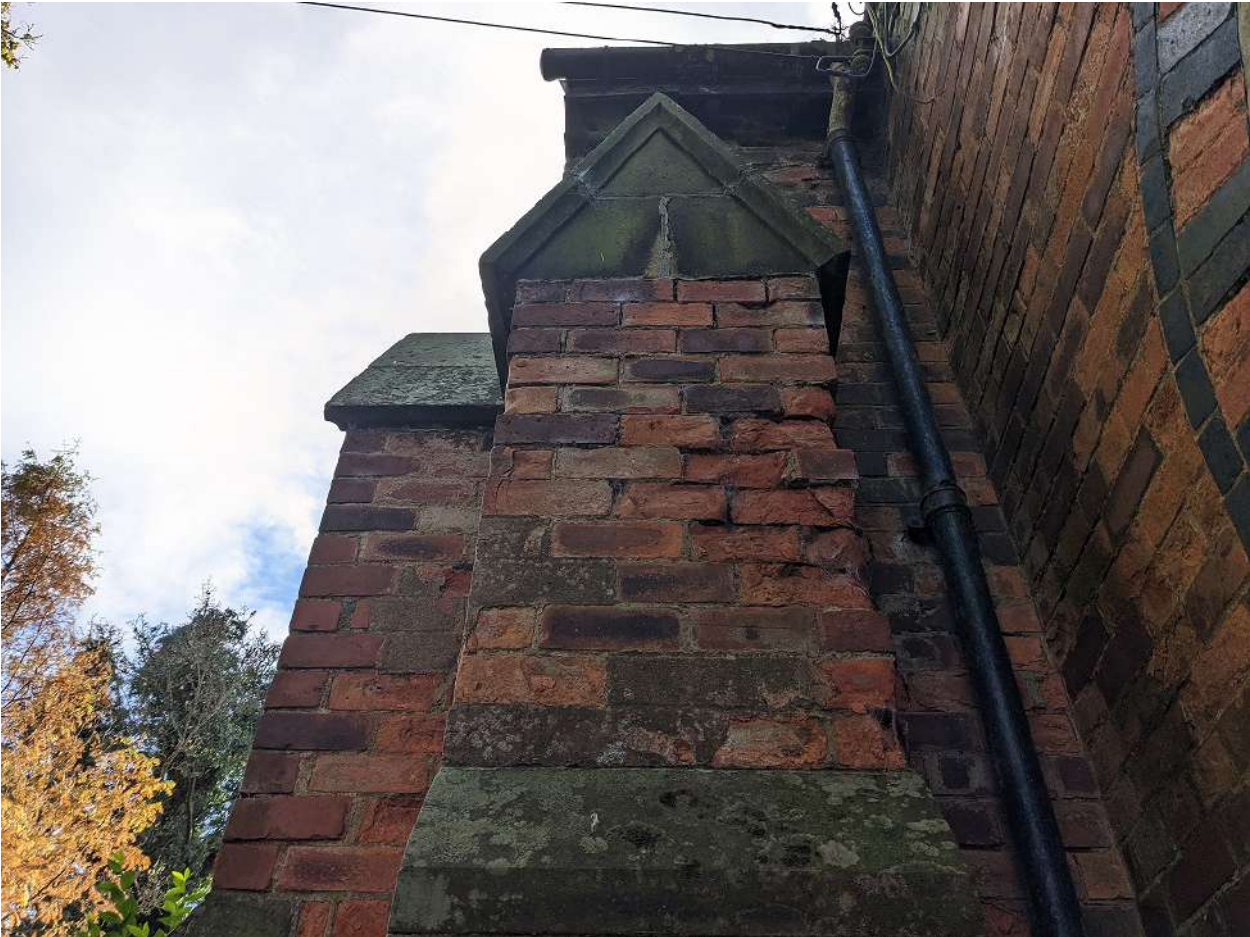
- 7.2.3 Plant growth is noted close to the walling fabric along the south and east elevations of the chancel which obscures a clear and unobstructed view of the walling fabric. This is worst at the southeast corner where plant growth has reached eaves level has begin to climb up the water tabling coping.

R0 It is recommended to cut back ivy growth.

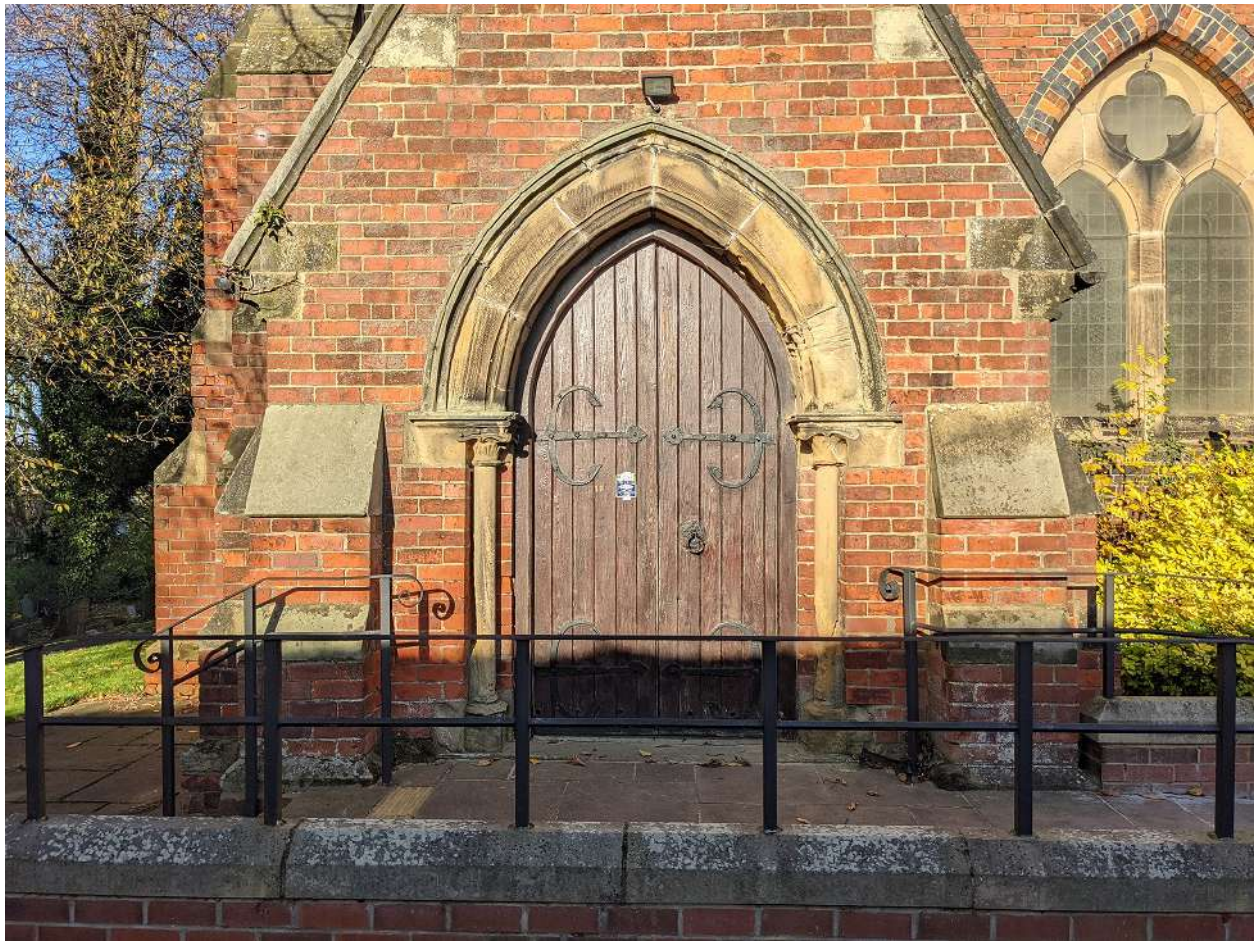
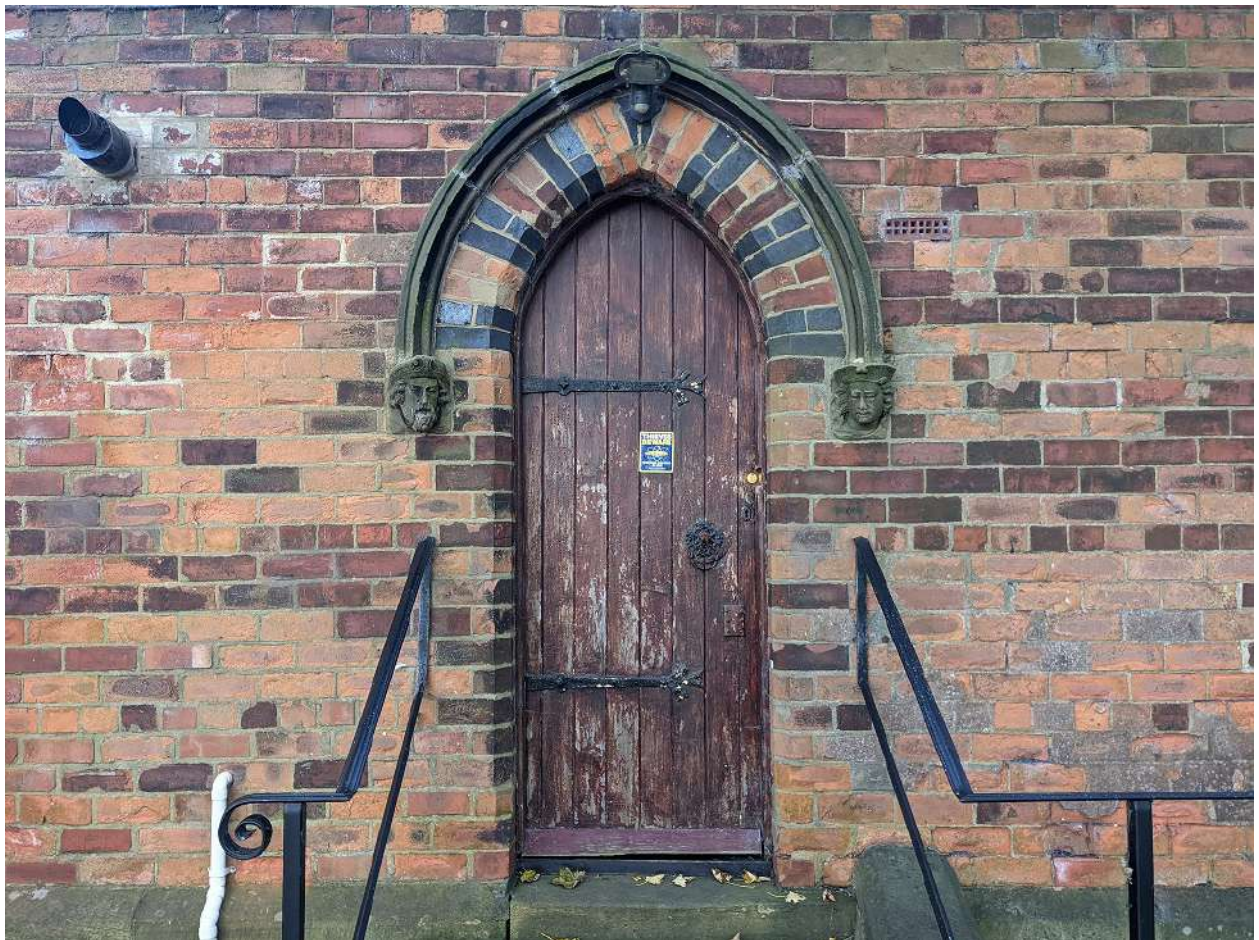
- 8.1.1 South entrance door is in a sound, satisfactory condition. Some deterioration of the stained finish is noted across the door face. The iron ring handle is wearing between the latch loop and handle.

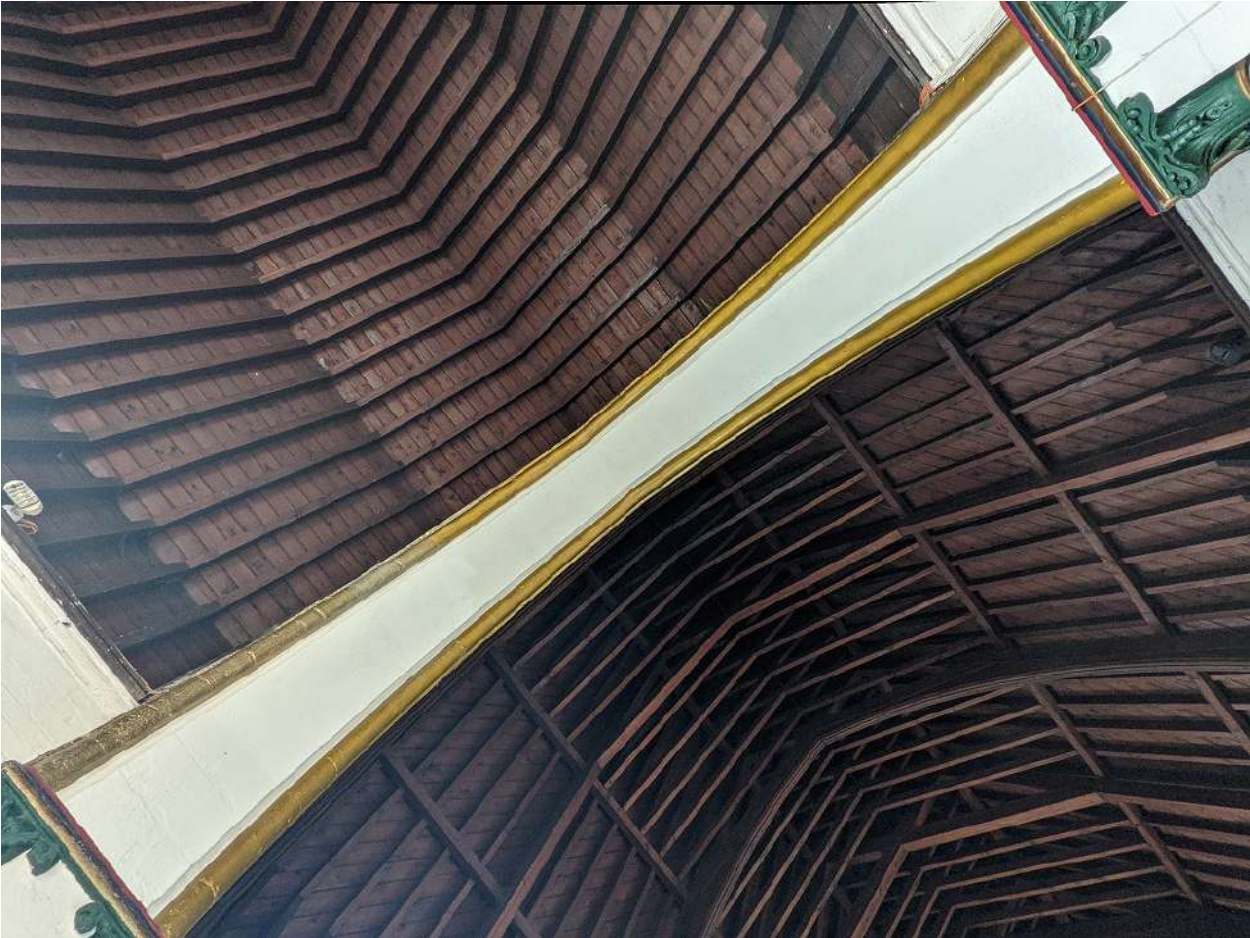
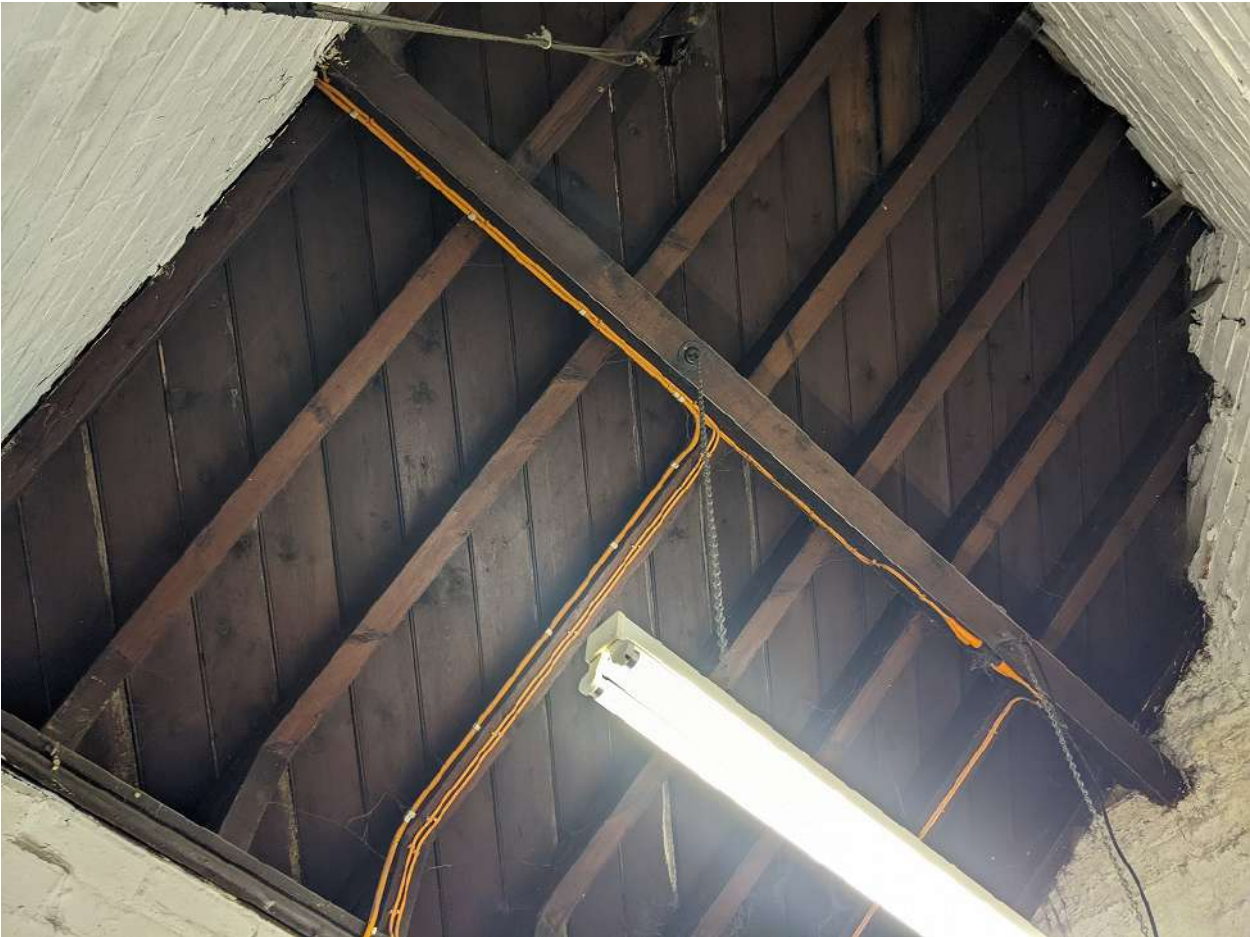
13.2.1 The roof structure and boarding are generally in a sound, satisfactory condition.

There is the occasional white staining to boarding, predominantly at the chancel west end at high level adjacent the chancel arch and across the vestry between junction of tongue and groove boards. This suggests that the chancel roof covering currently is more susceptible to water ingress.

M It is recommended as a routine item of maintenance that visual checks are undertaken twice annually for signs of water staining and or ingress.

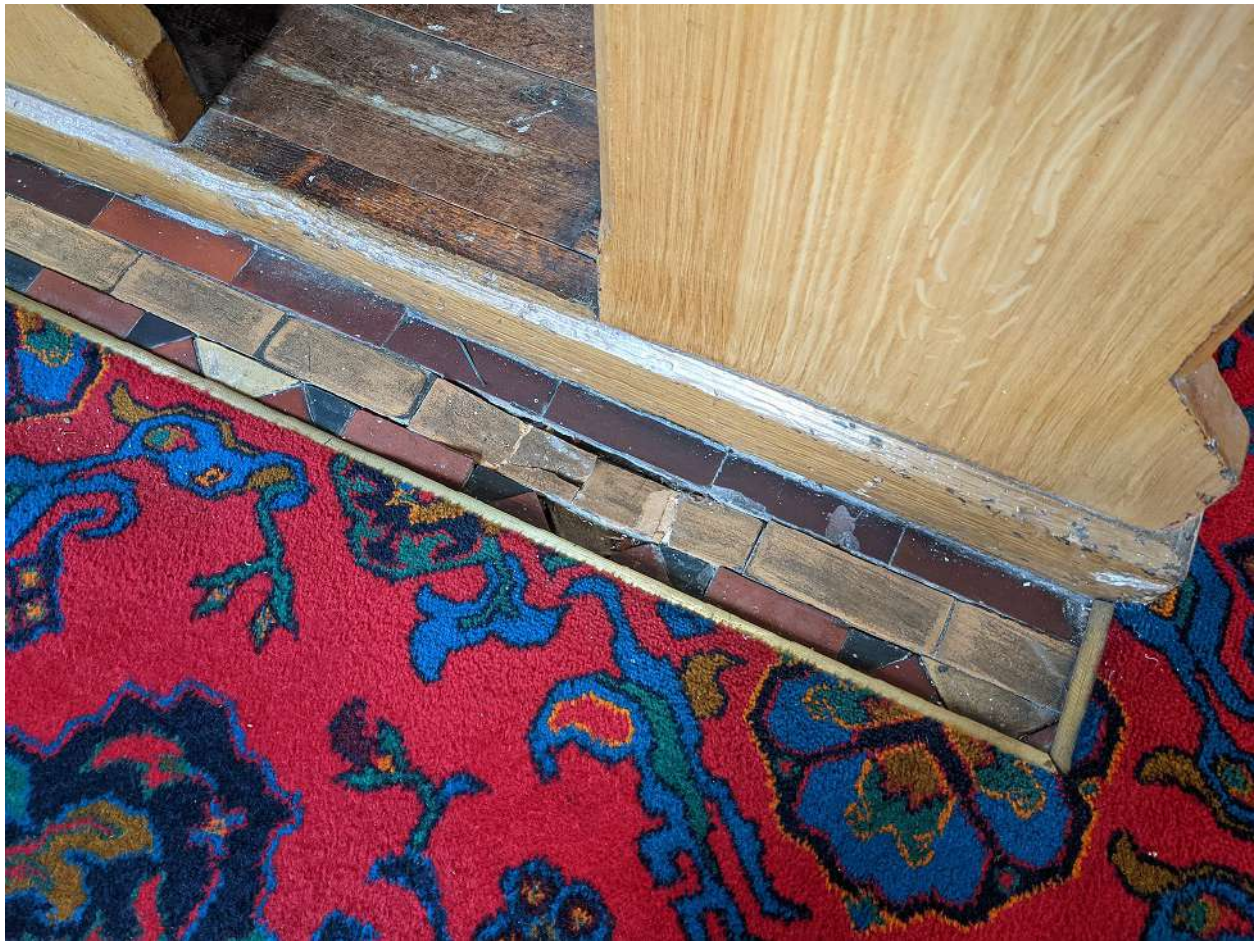
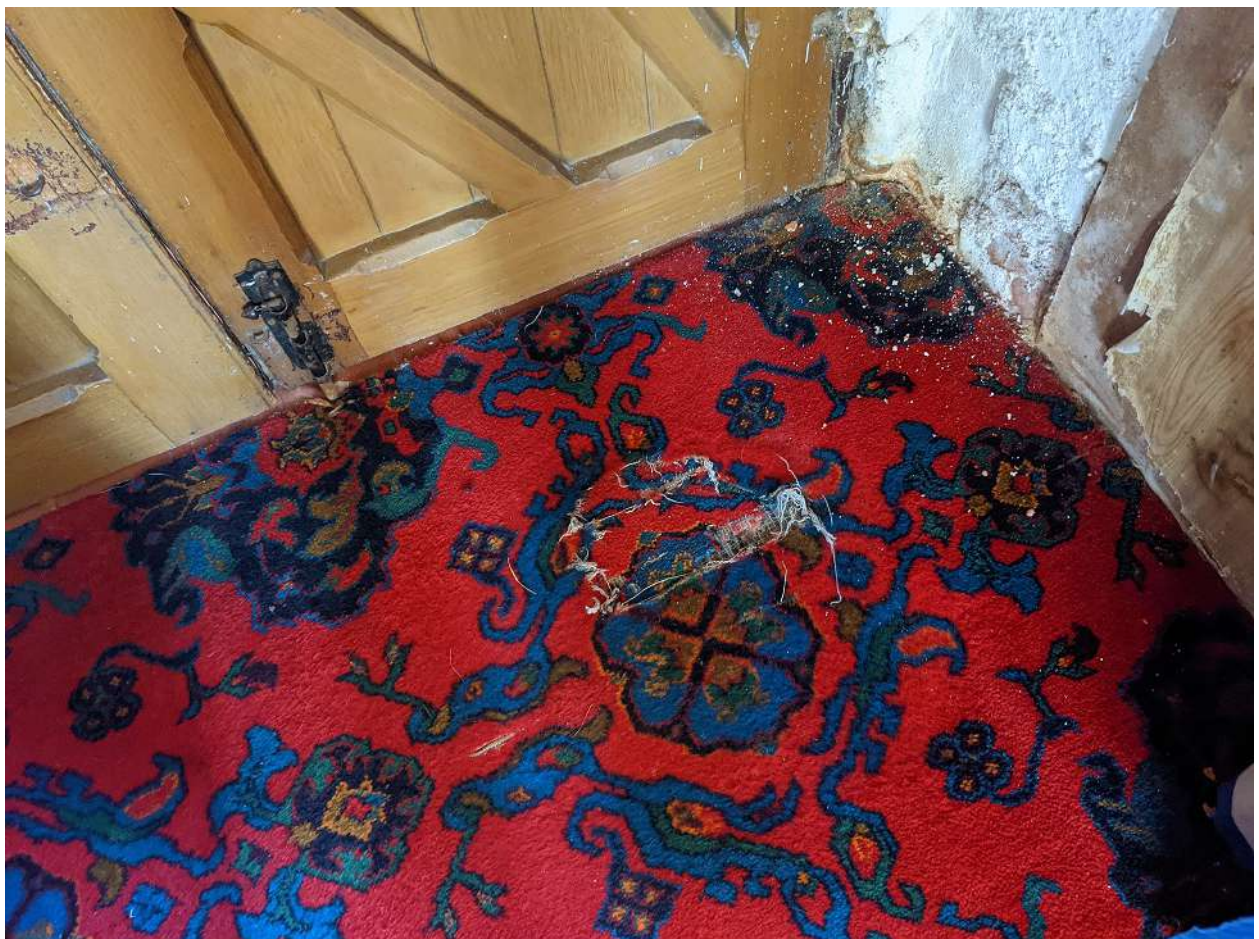
Previous QIR's have recorded disruption to an area of the chancel at the centre altar rail area, no investigation to date.

Previous QIR's have recorded that there were defects recorded within the timber board floor structure of the vestry, but all appears to be fixed now.

M It is prudent to make note that the next phase of renewing the carpet covering provides an opportunity of inspection of the floor beneath by the church architect.
