## QUINQUENNIAL INSPECTION REPORT

### **St Mary's, Coxhoe**

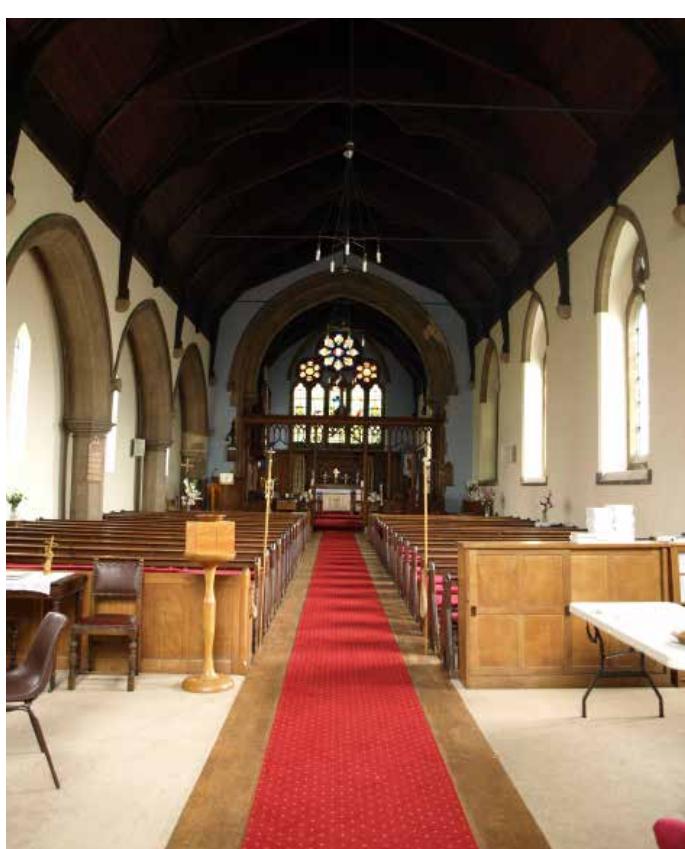
View from Nave to Chancel

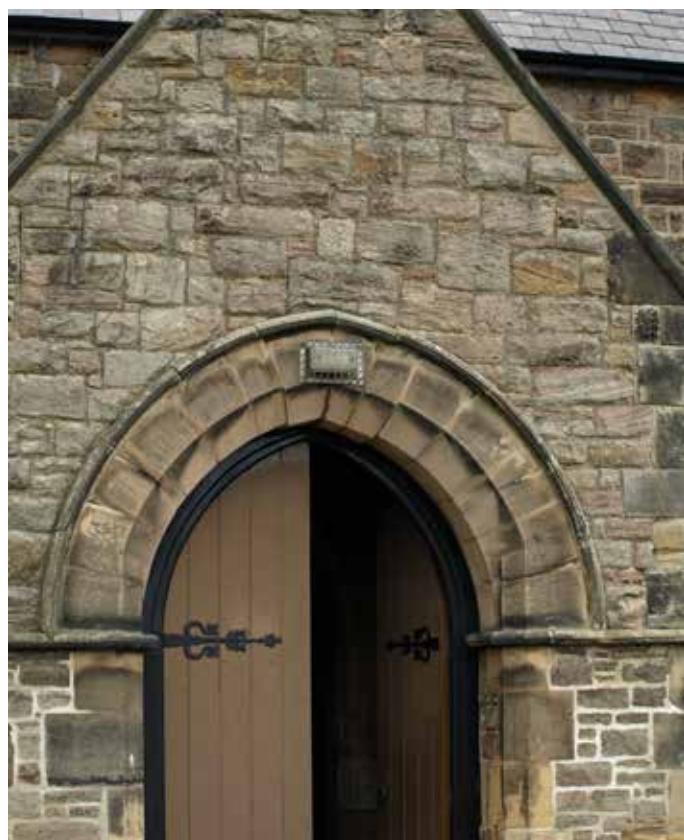
Porch doorway, with dropped voussoirs

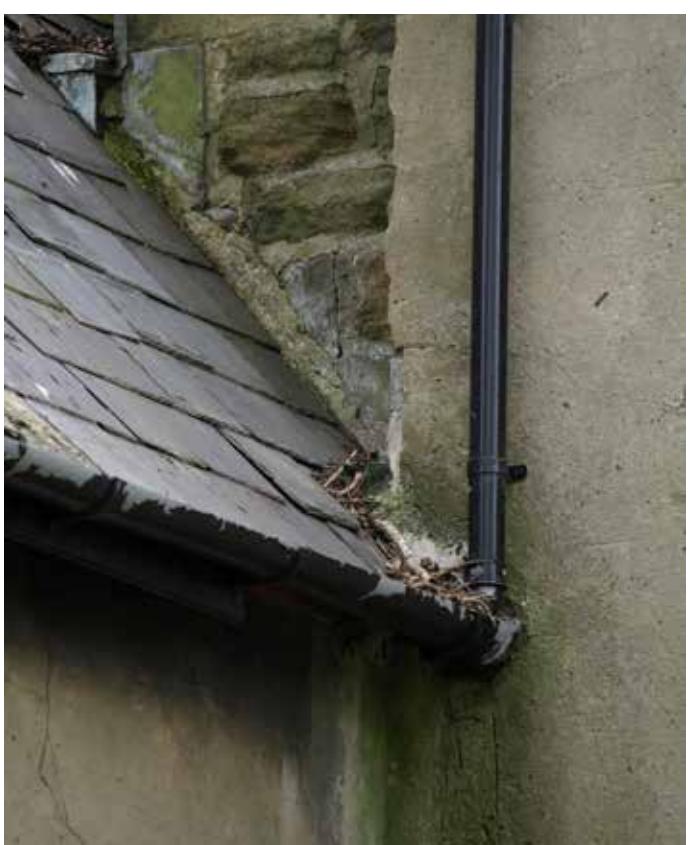
Gutter cleaning is needed frequently

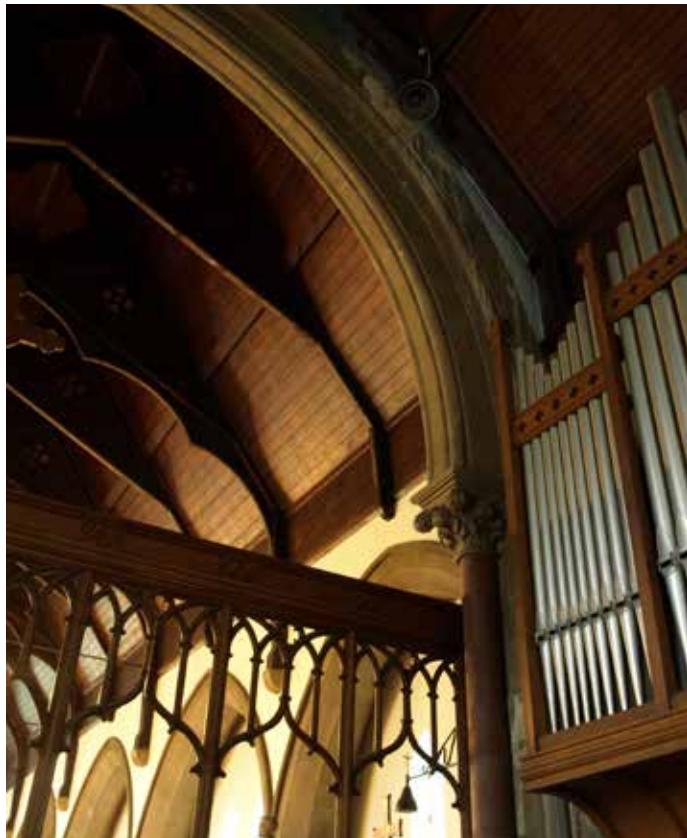
The church is notable for its high quality furniture and rood screen.

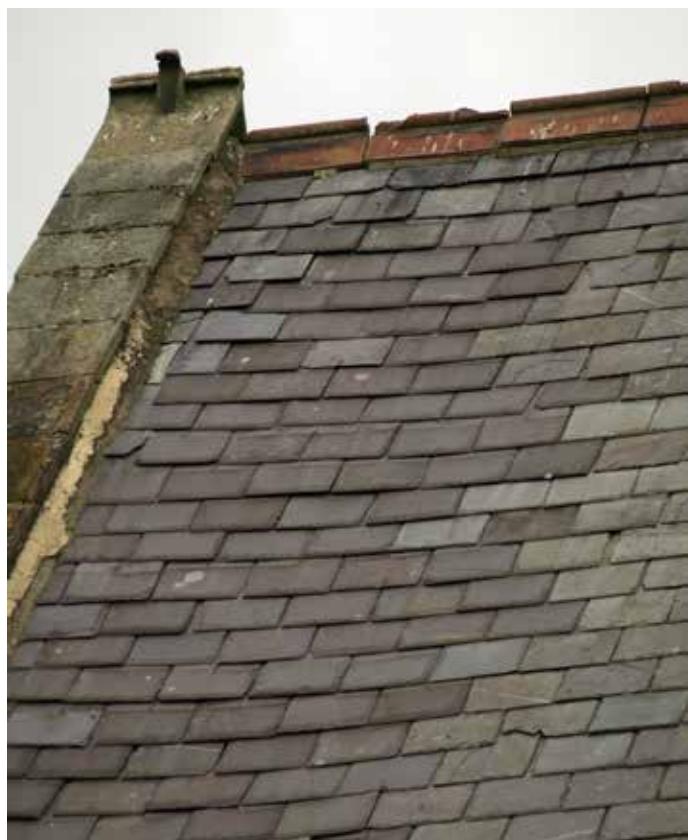
Poorly matched and laid slates, with many broken or slipped. Ridge tiles broken and poorly bedded and pointed.

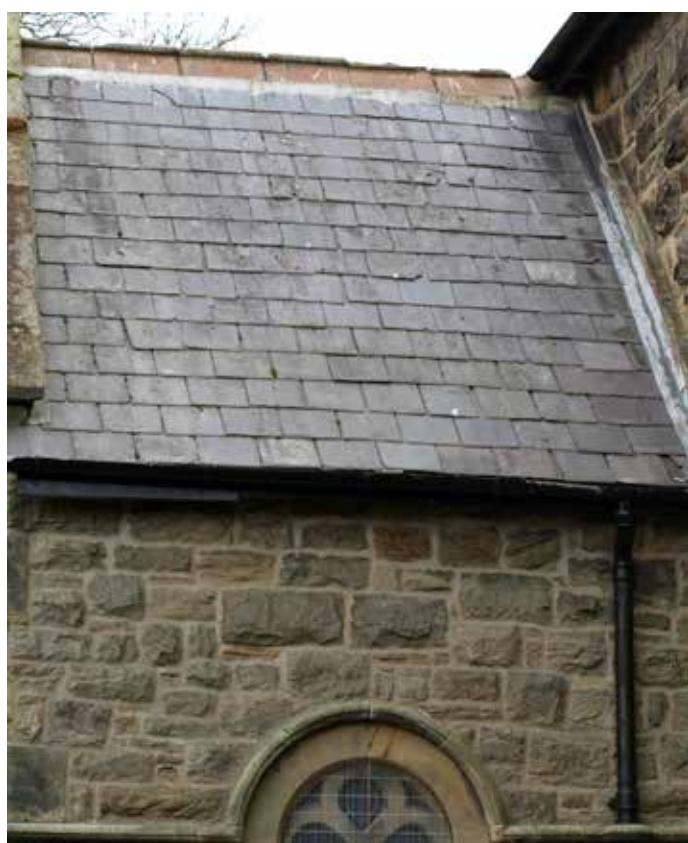
Porch roof: numerous slipped, broken and uneven slates

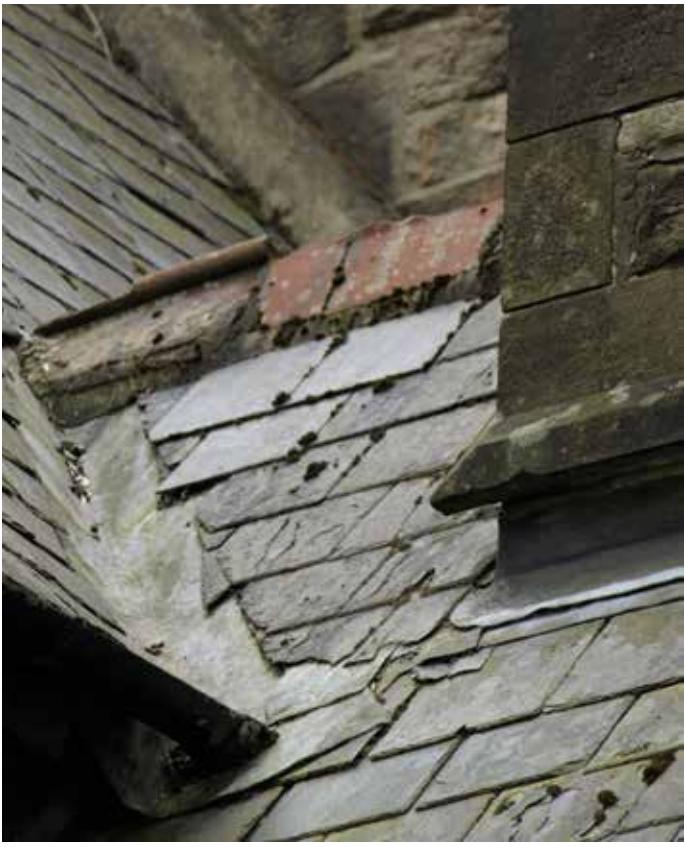
Vestry roof: broken & mismatched slates, broken ridge tiles

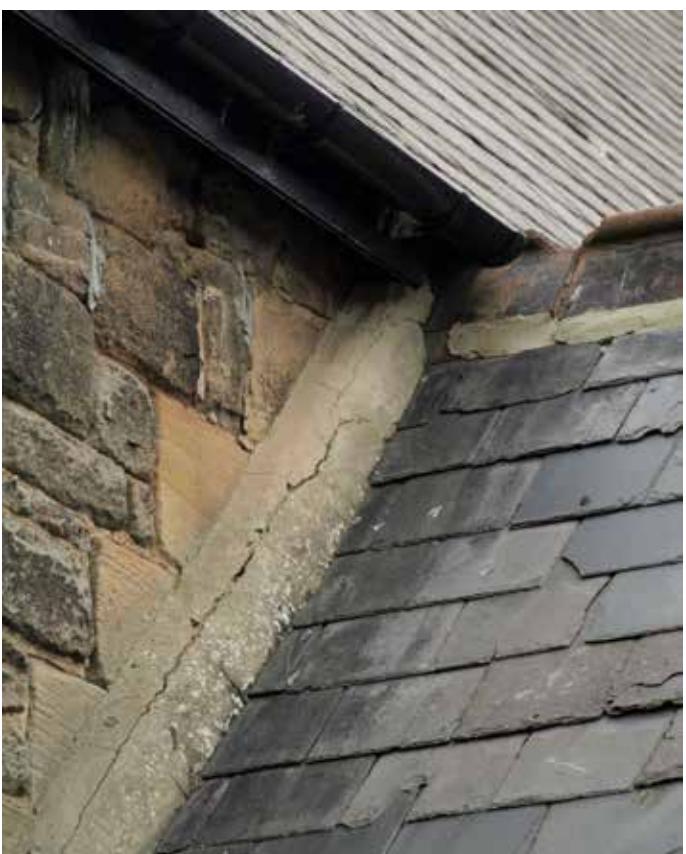
Abutment of Porch roof: cracked mortar fillet, cracked & broken slates, artificial slates incorrectly fixed

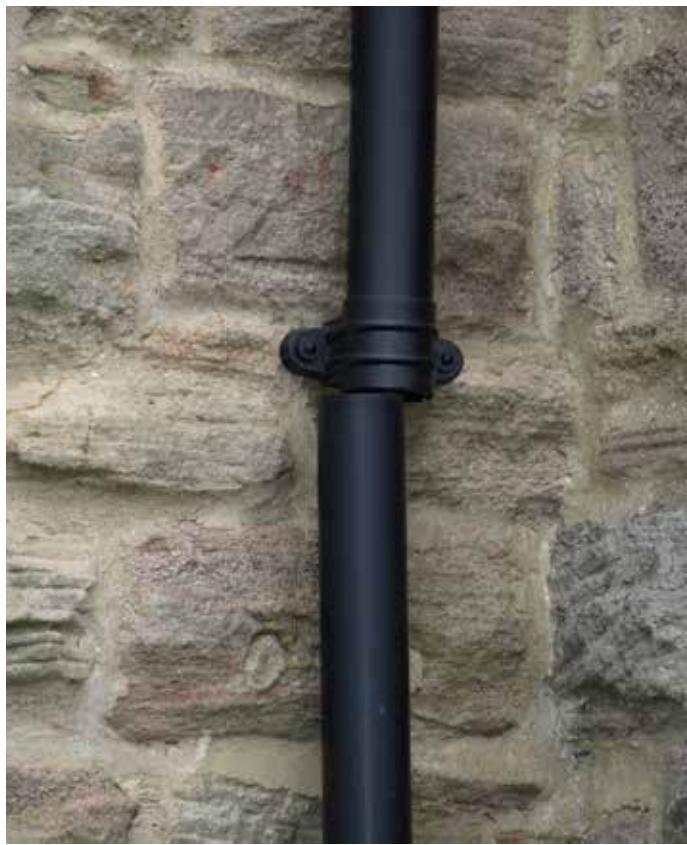
Nave south elevation: plastic rainwater pipe with failed fixings

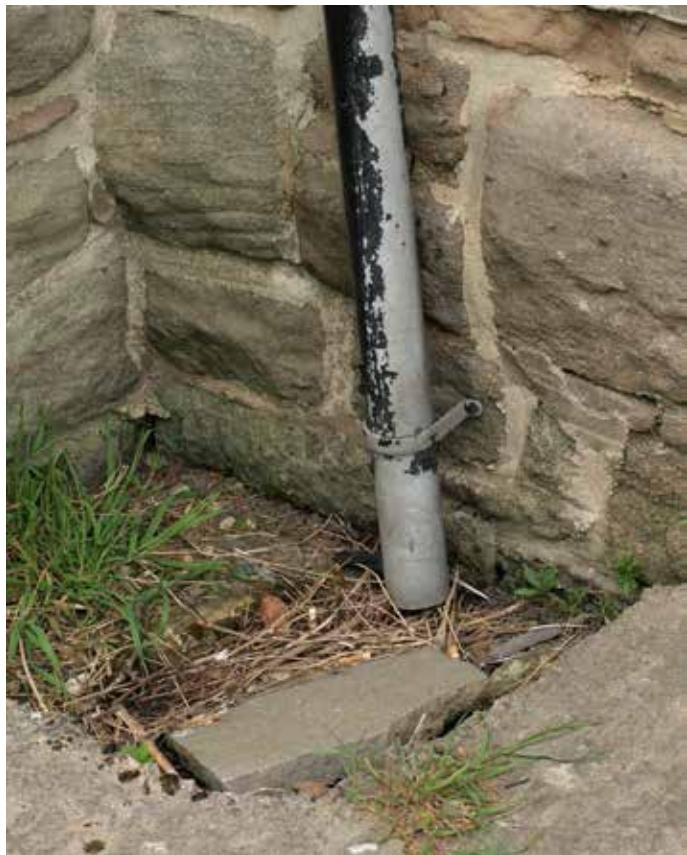
Plastic rainwater pipe with failing paint & rusting fixings, gully clogged with debris.

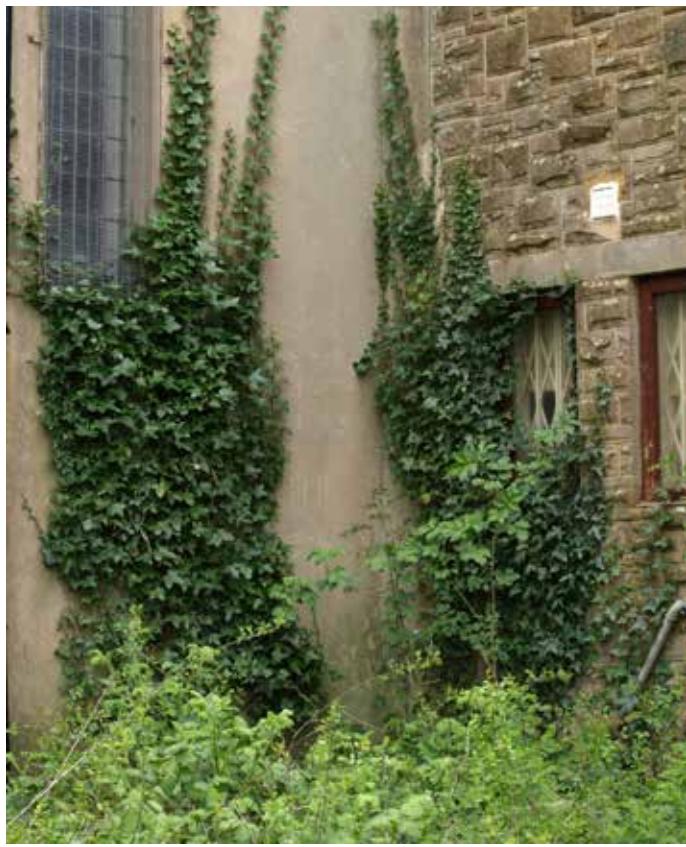
Encroaching vegetation holds dampness against the building, as well as causing mechanical damage to surfaces

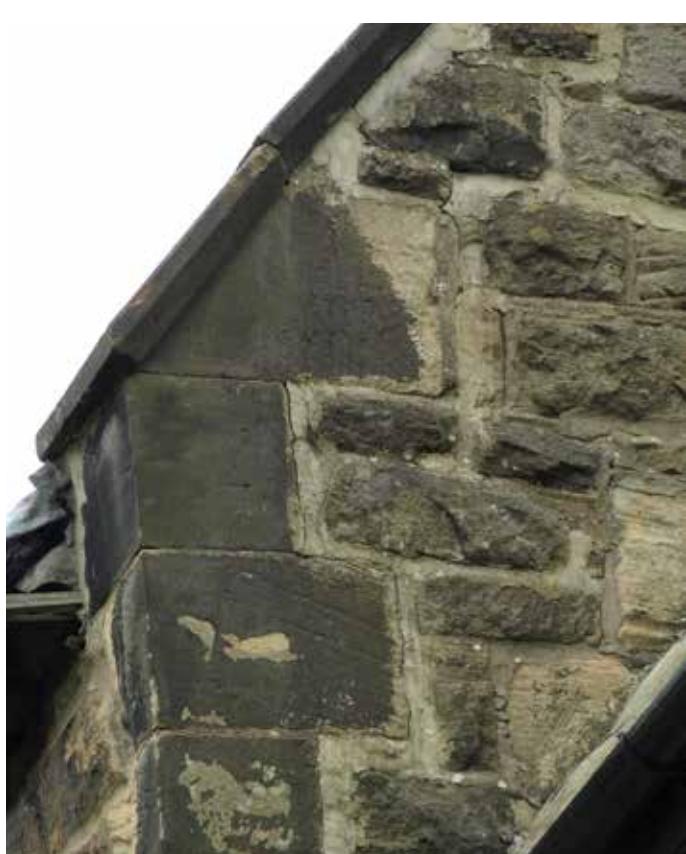
Kneeler to Nave: outward displacement. Coping above has been badly bedded and is misaligned. Numerous open joints.

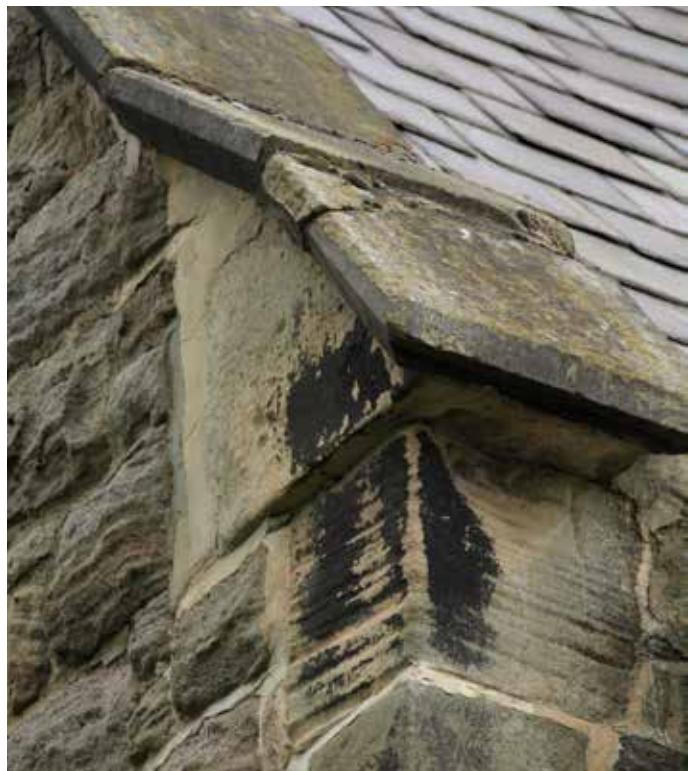
Nave south-west kneeler: rebuilt with very poor alignment. Needs to be re-built.

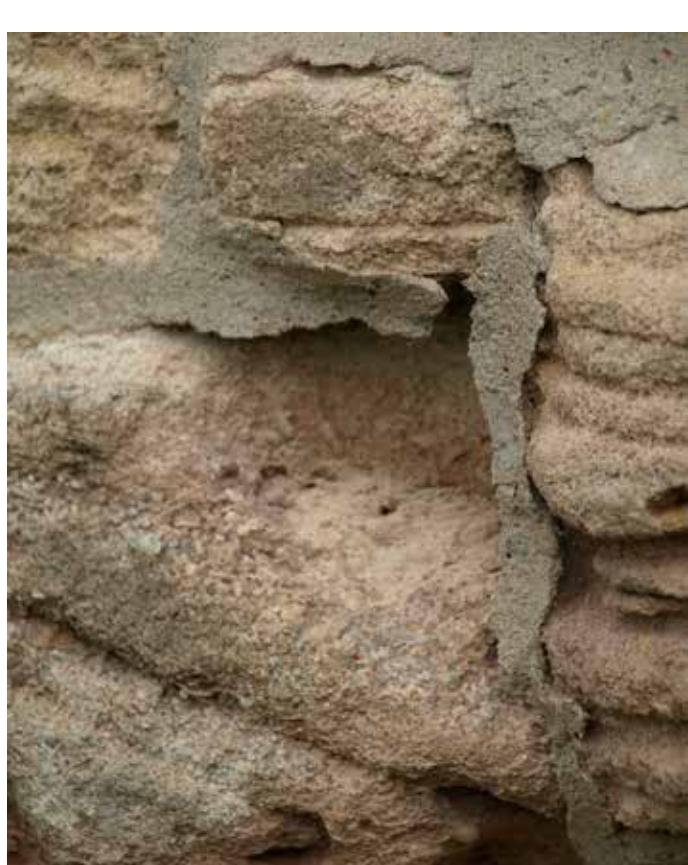
Hard cement pointing causes accelerated decay of soft sandstone. Only soft lime mortar should be used on traditional stonework

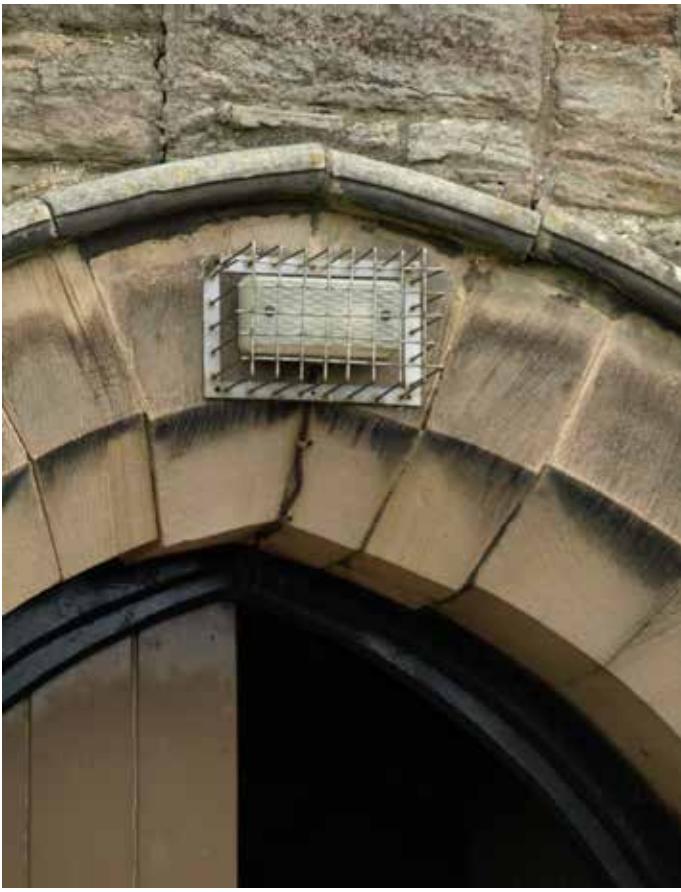
Porch gable: displaced voussoirs and open joints due to settlement, probably soon after construction.

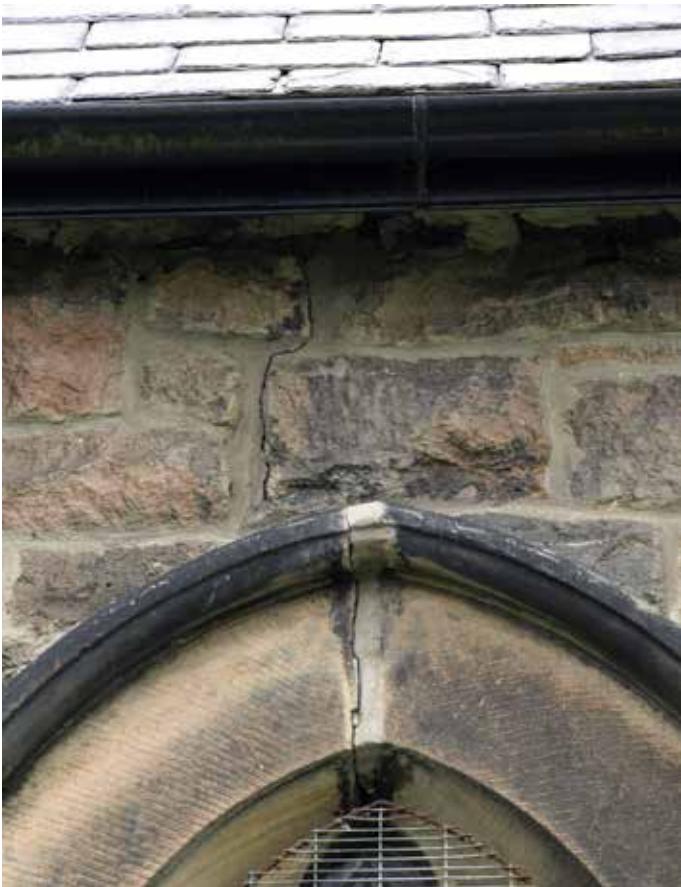
Minor cracks around features should be repointed so that their future movement can be easily detected.

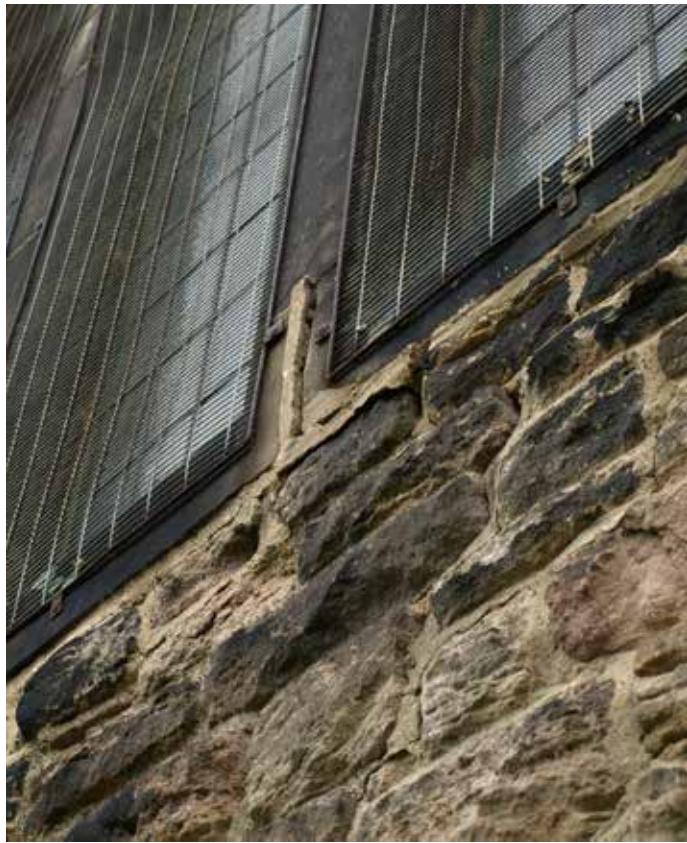
Pointing in very poor condition below the west window

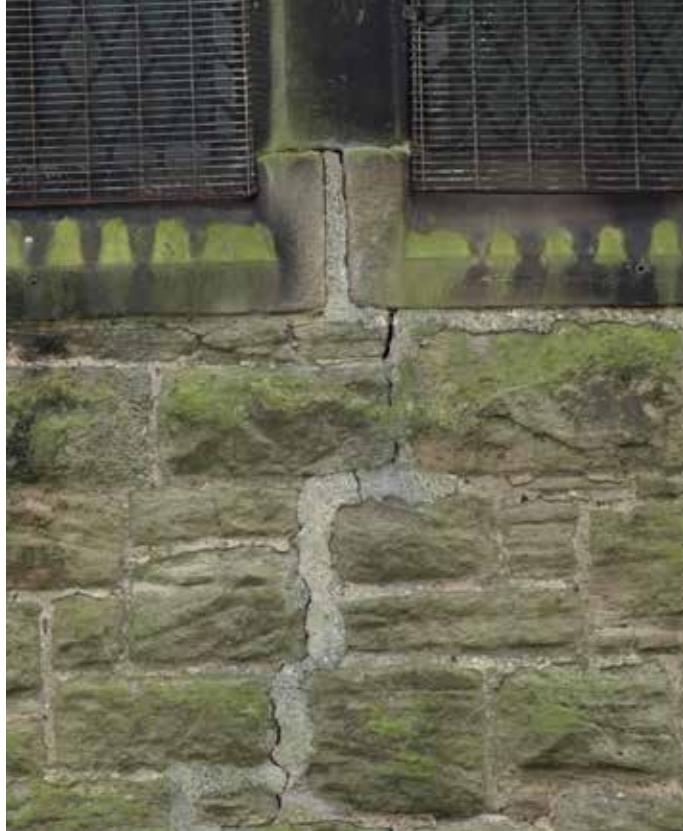
Vestry gable: cracks below the window need to be repointed

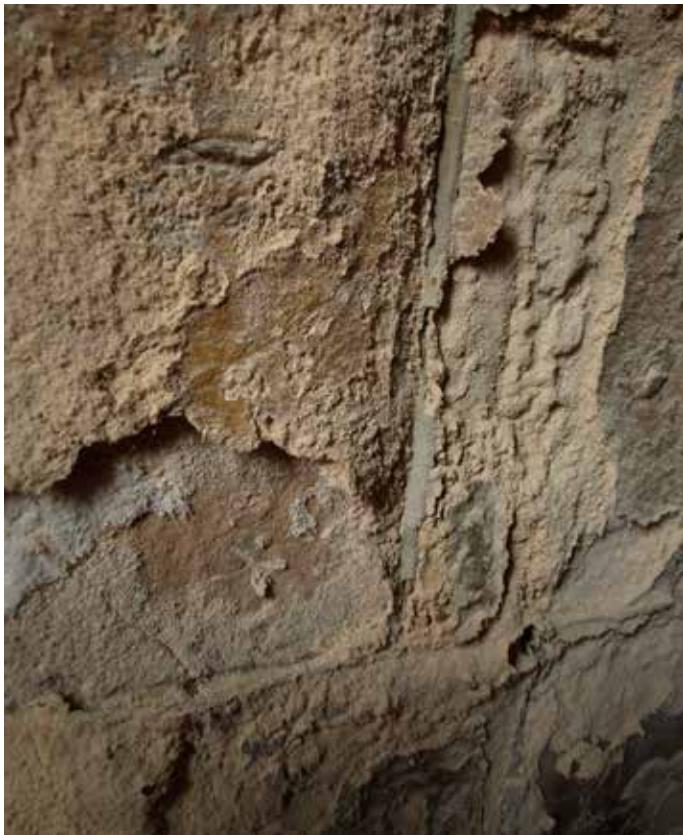
Porch: decay of the sandstone reveal to the doorway

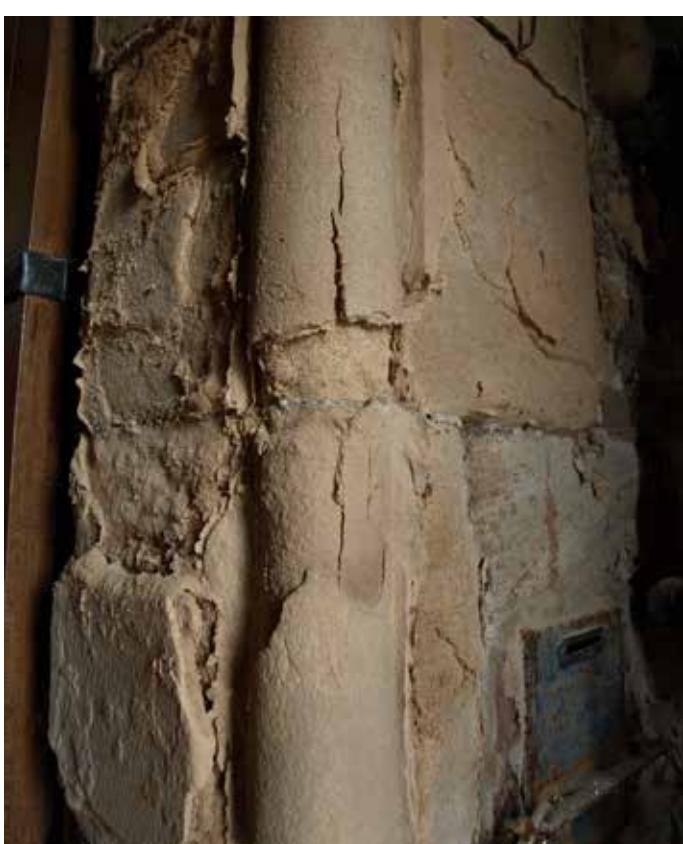
Porch: loss of sandstone surface due to water ingress and subsequent stone decay. All loose stone should be brushed off.

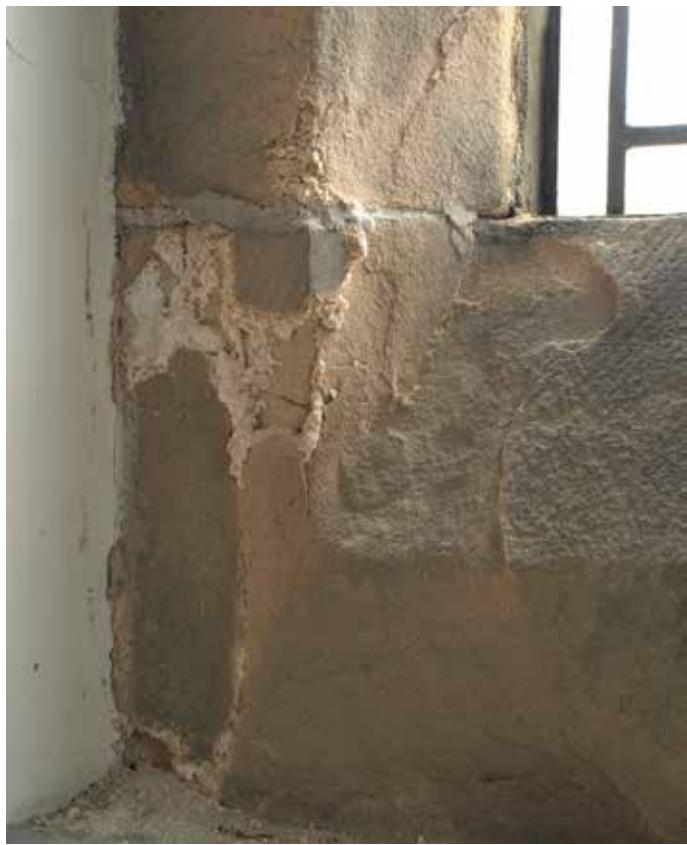
Window sIII: stone decay of sill due to water ingress at joints

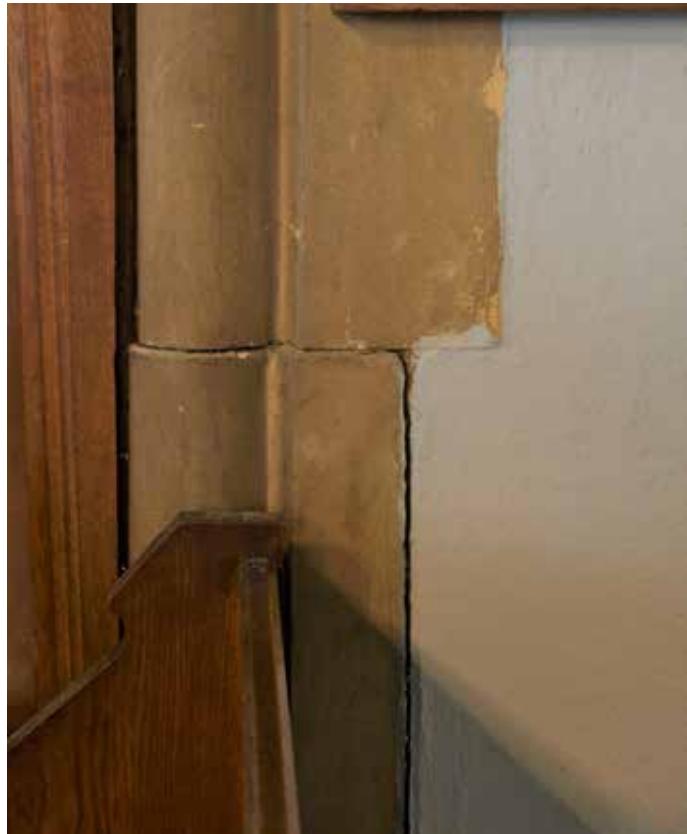
Chancel arch: historic displacement should be pointed up with lime mortar

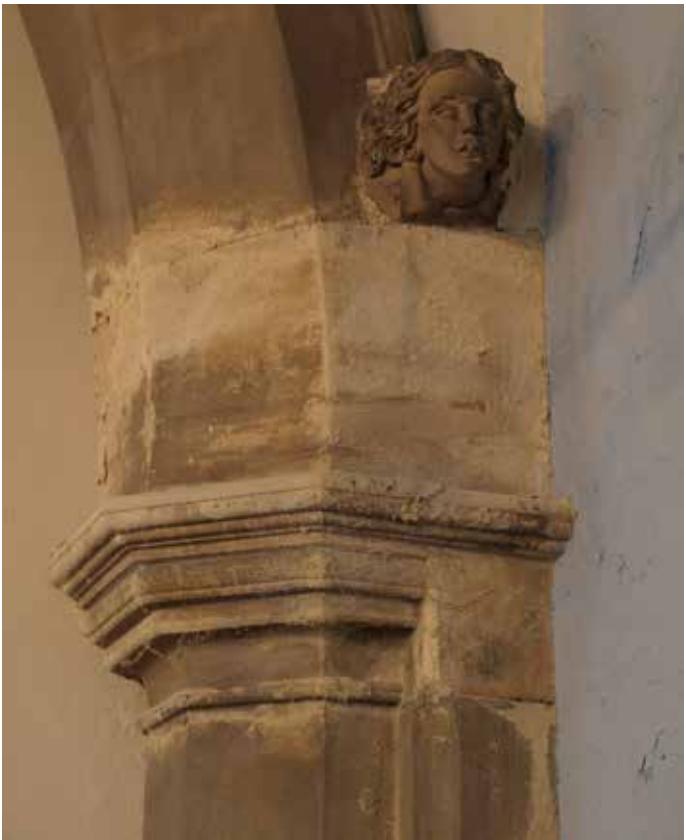
Stone decay to capital of Arcade due to historic water ingress, now drying out

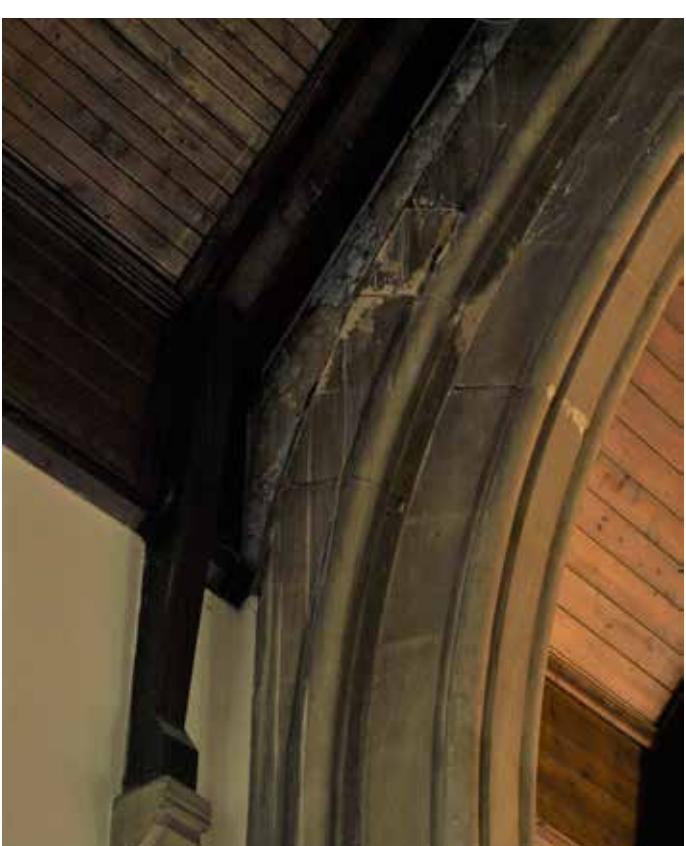
Chancel arch: historic water staining due to water ingress at copings or flashings above

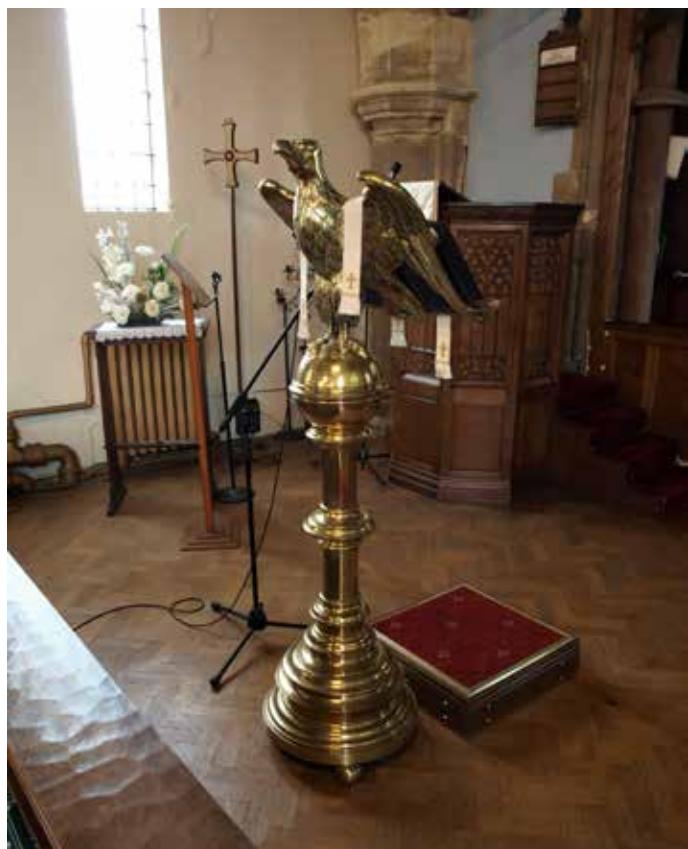
High quality fittings and fixtures against a backdrop of failing plaster and bubbling paint

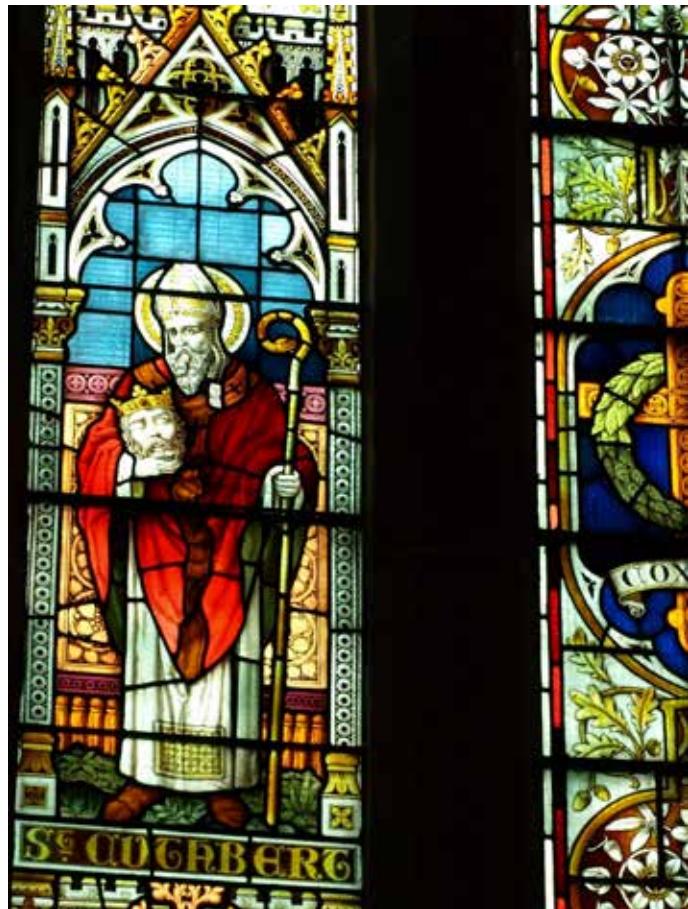
East window: St Cuthbert professionally repaired

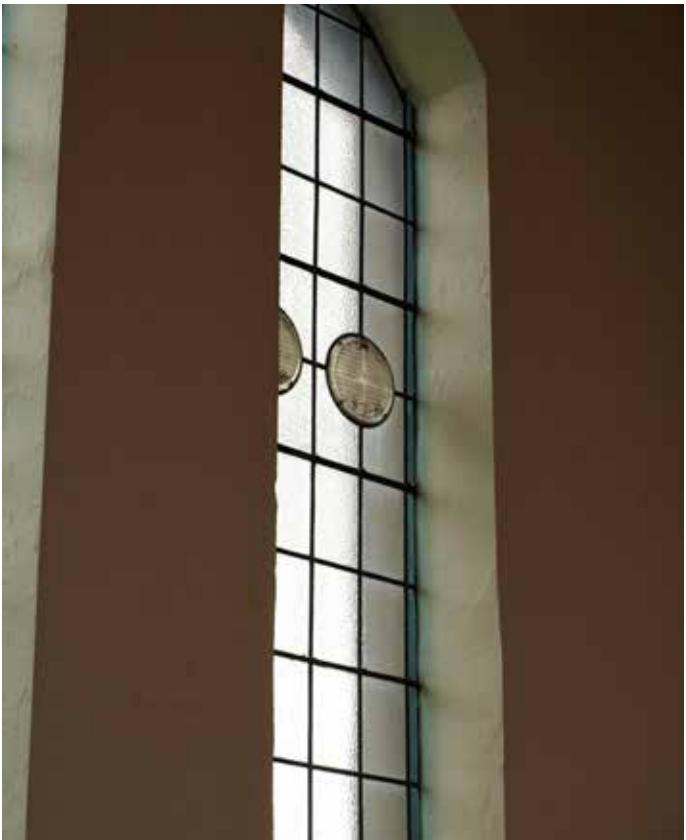
Incongruous plastic vents detract from the windows and should be removed

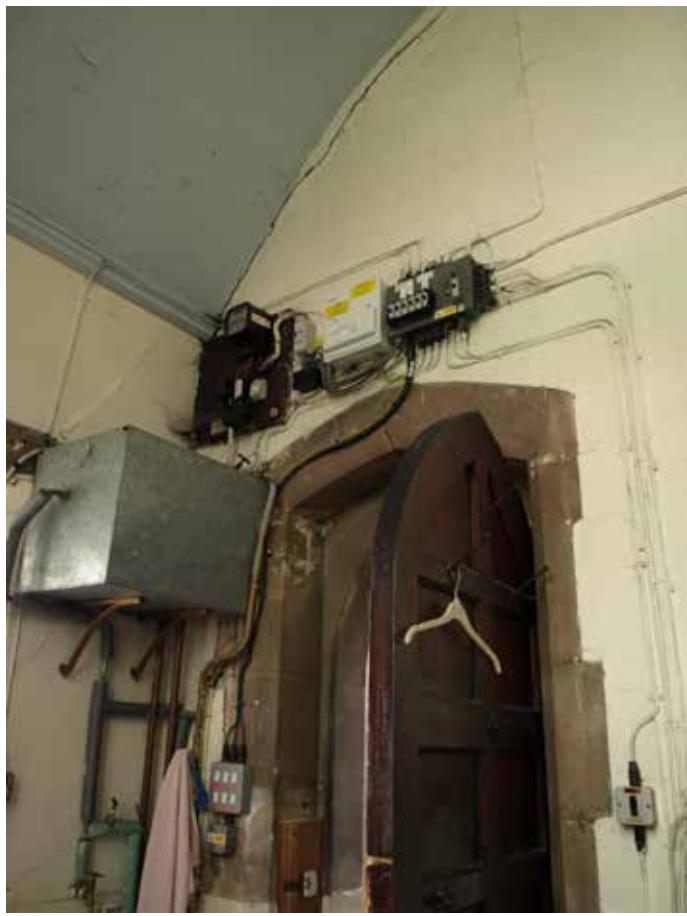
Vestry: note historic cracking at the angle of the ceiling

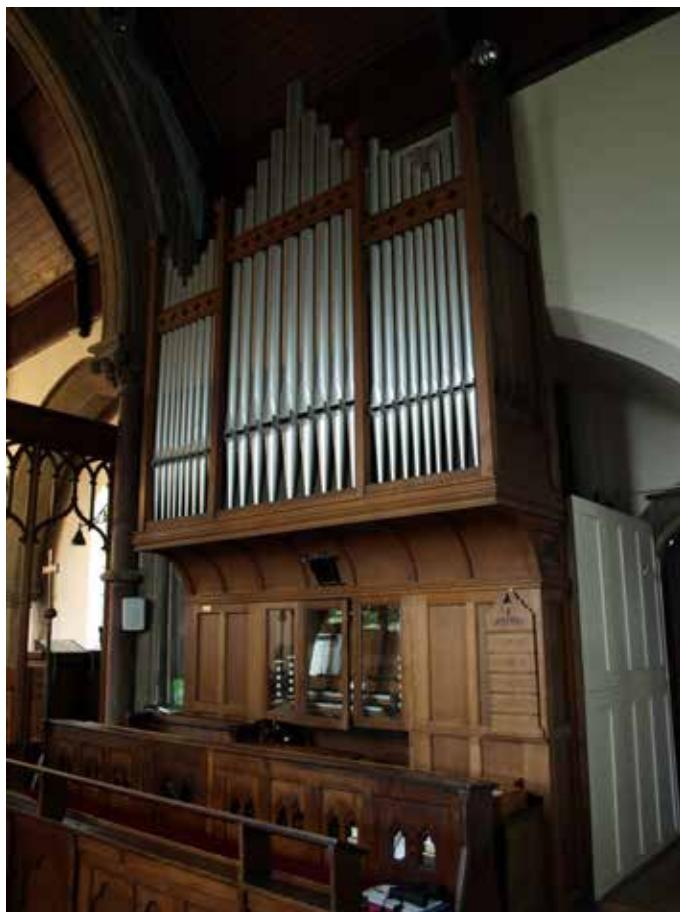
Organ in excellent condition

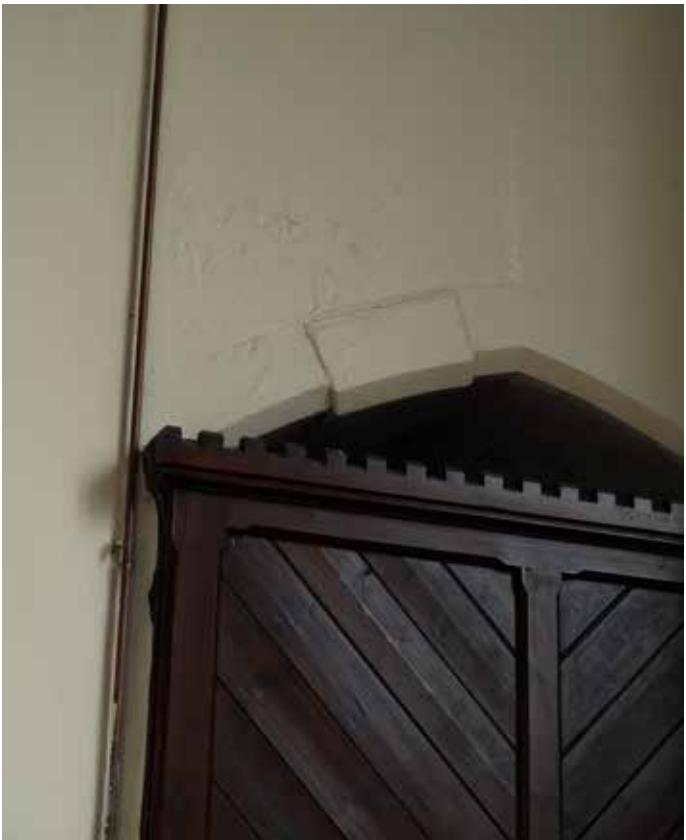
Porch draught screen & historic slipped voussoir above

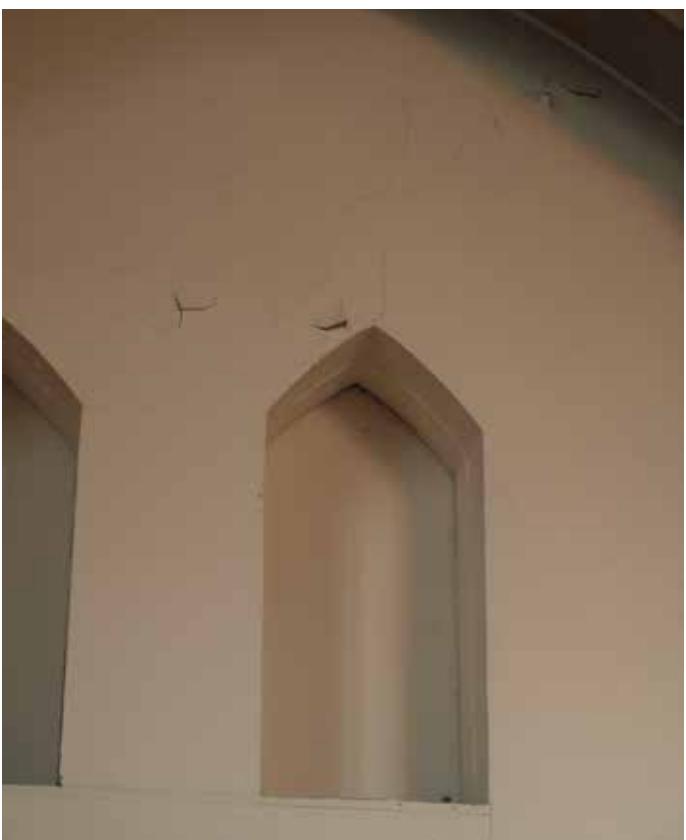
Surface damage at the abutment of the extension; dry at time of inspection

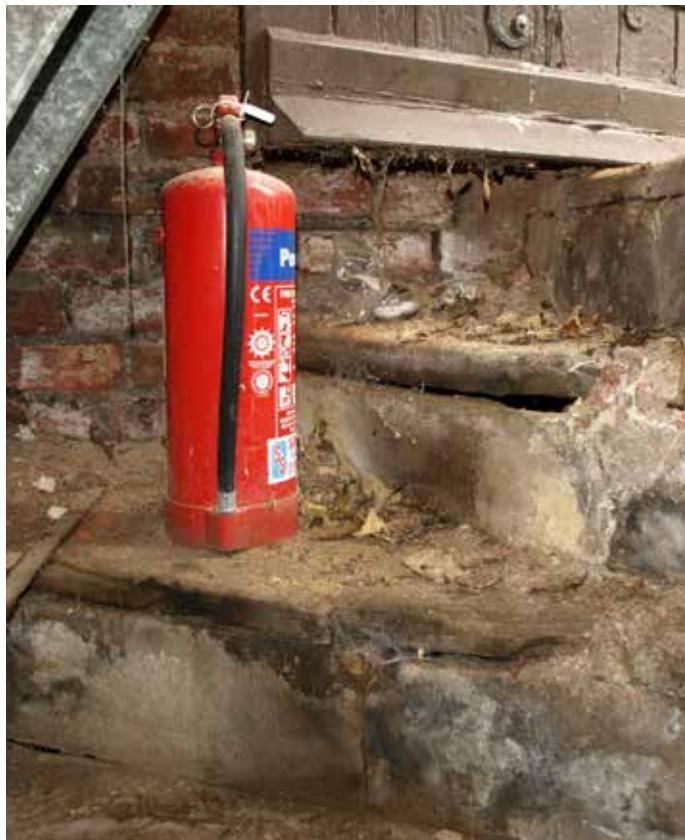
Fire equipment is regularly serviced. A wall bracket is recommended

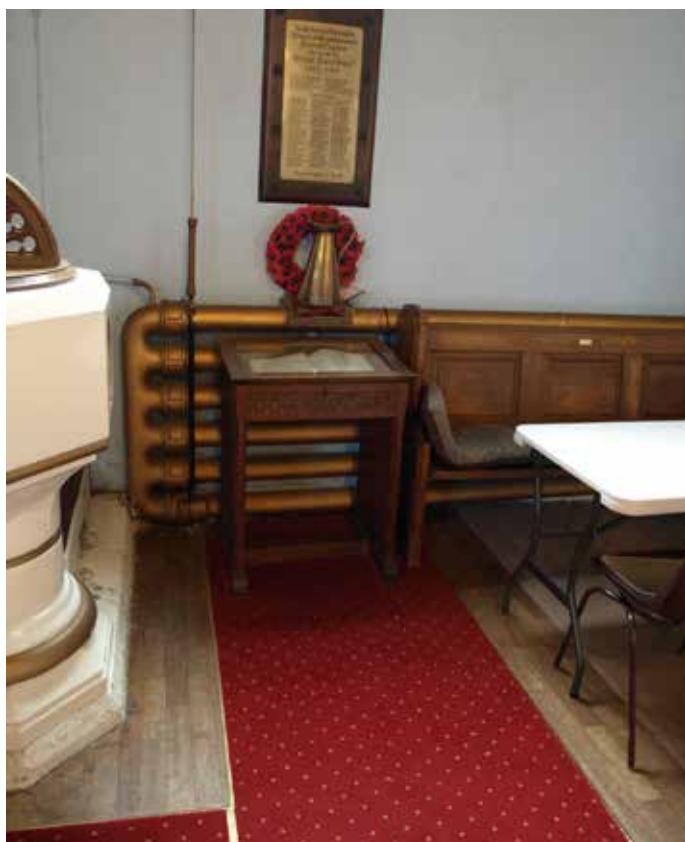
The heating system has a certain industrial charm, but it neither efficient nor economical to run

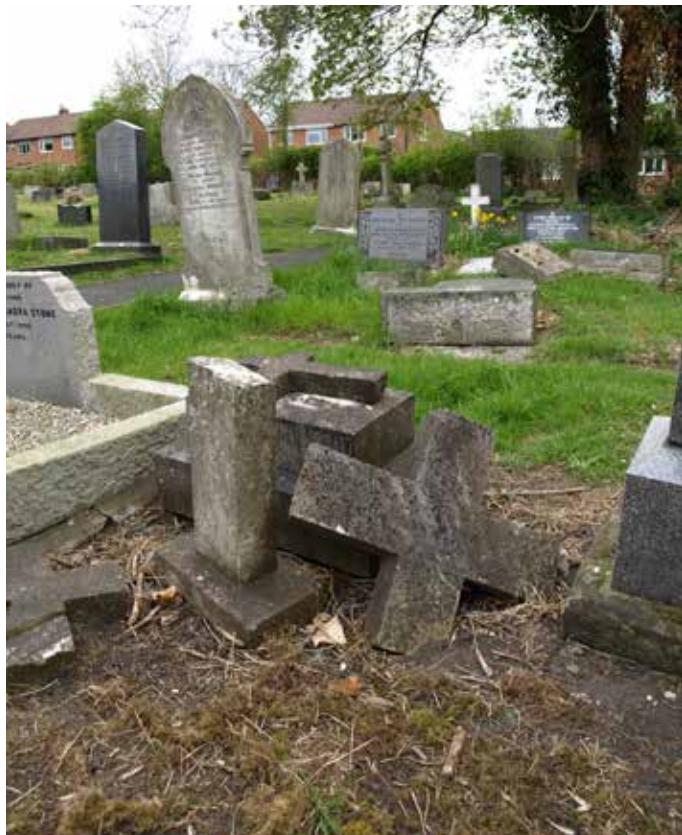
Damaged monuments and gravestones contribute to the air of neglect.

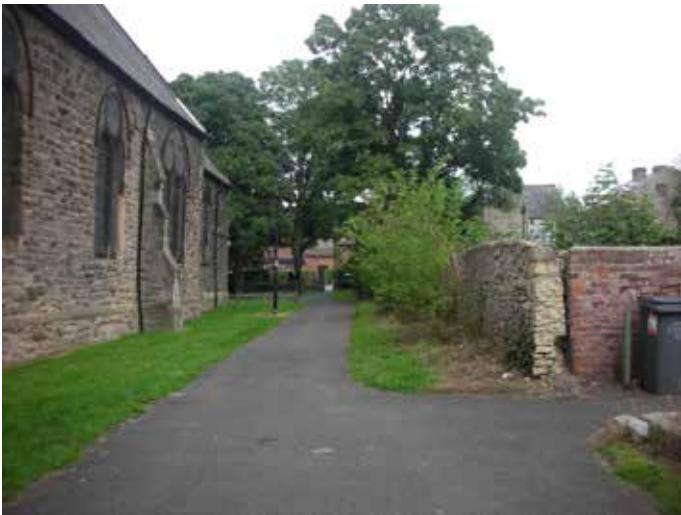
Southern and eastern boundary walls in poor condition

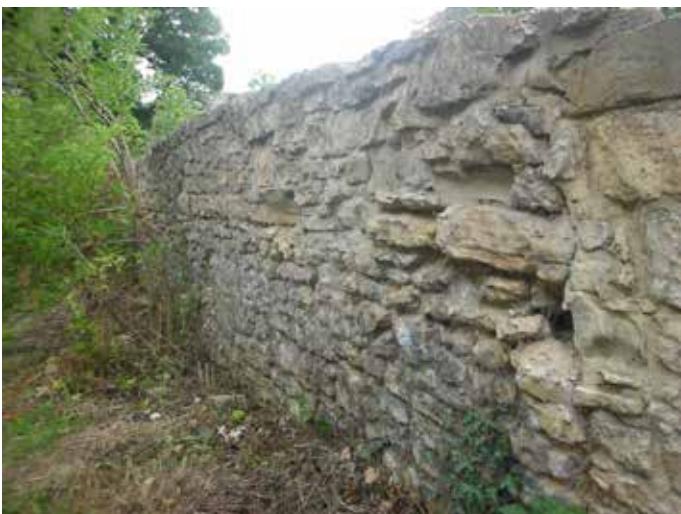
Southern boundary wall is soft carboniferous limestone which is being severely damaged by the cement pointing
