## QUINQUENNIAL INSPECTION REPORT

### **St Mary's, Coxhoe**

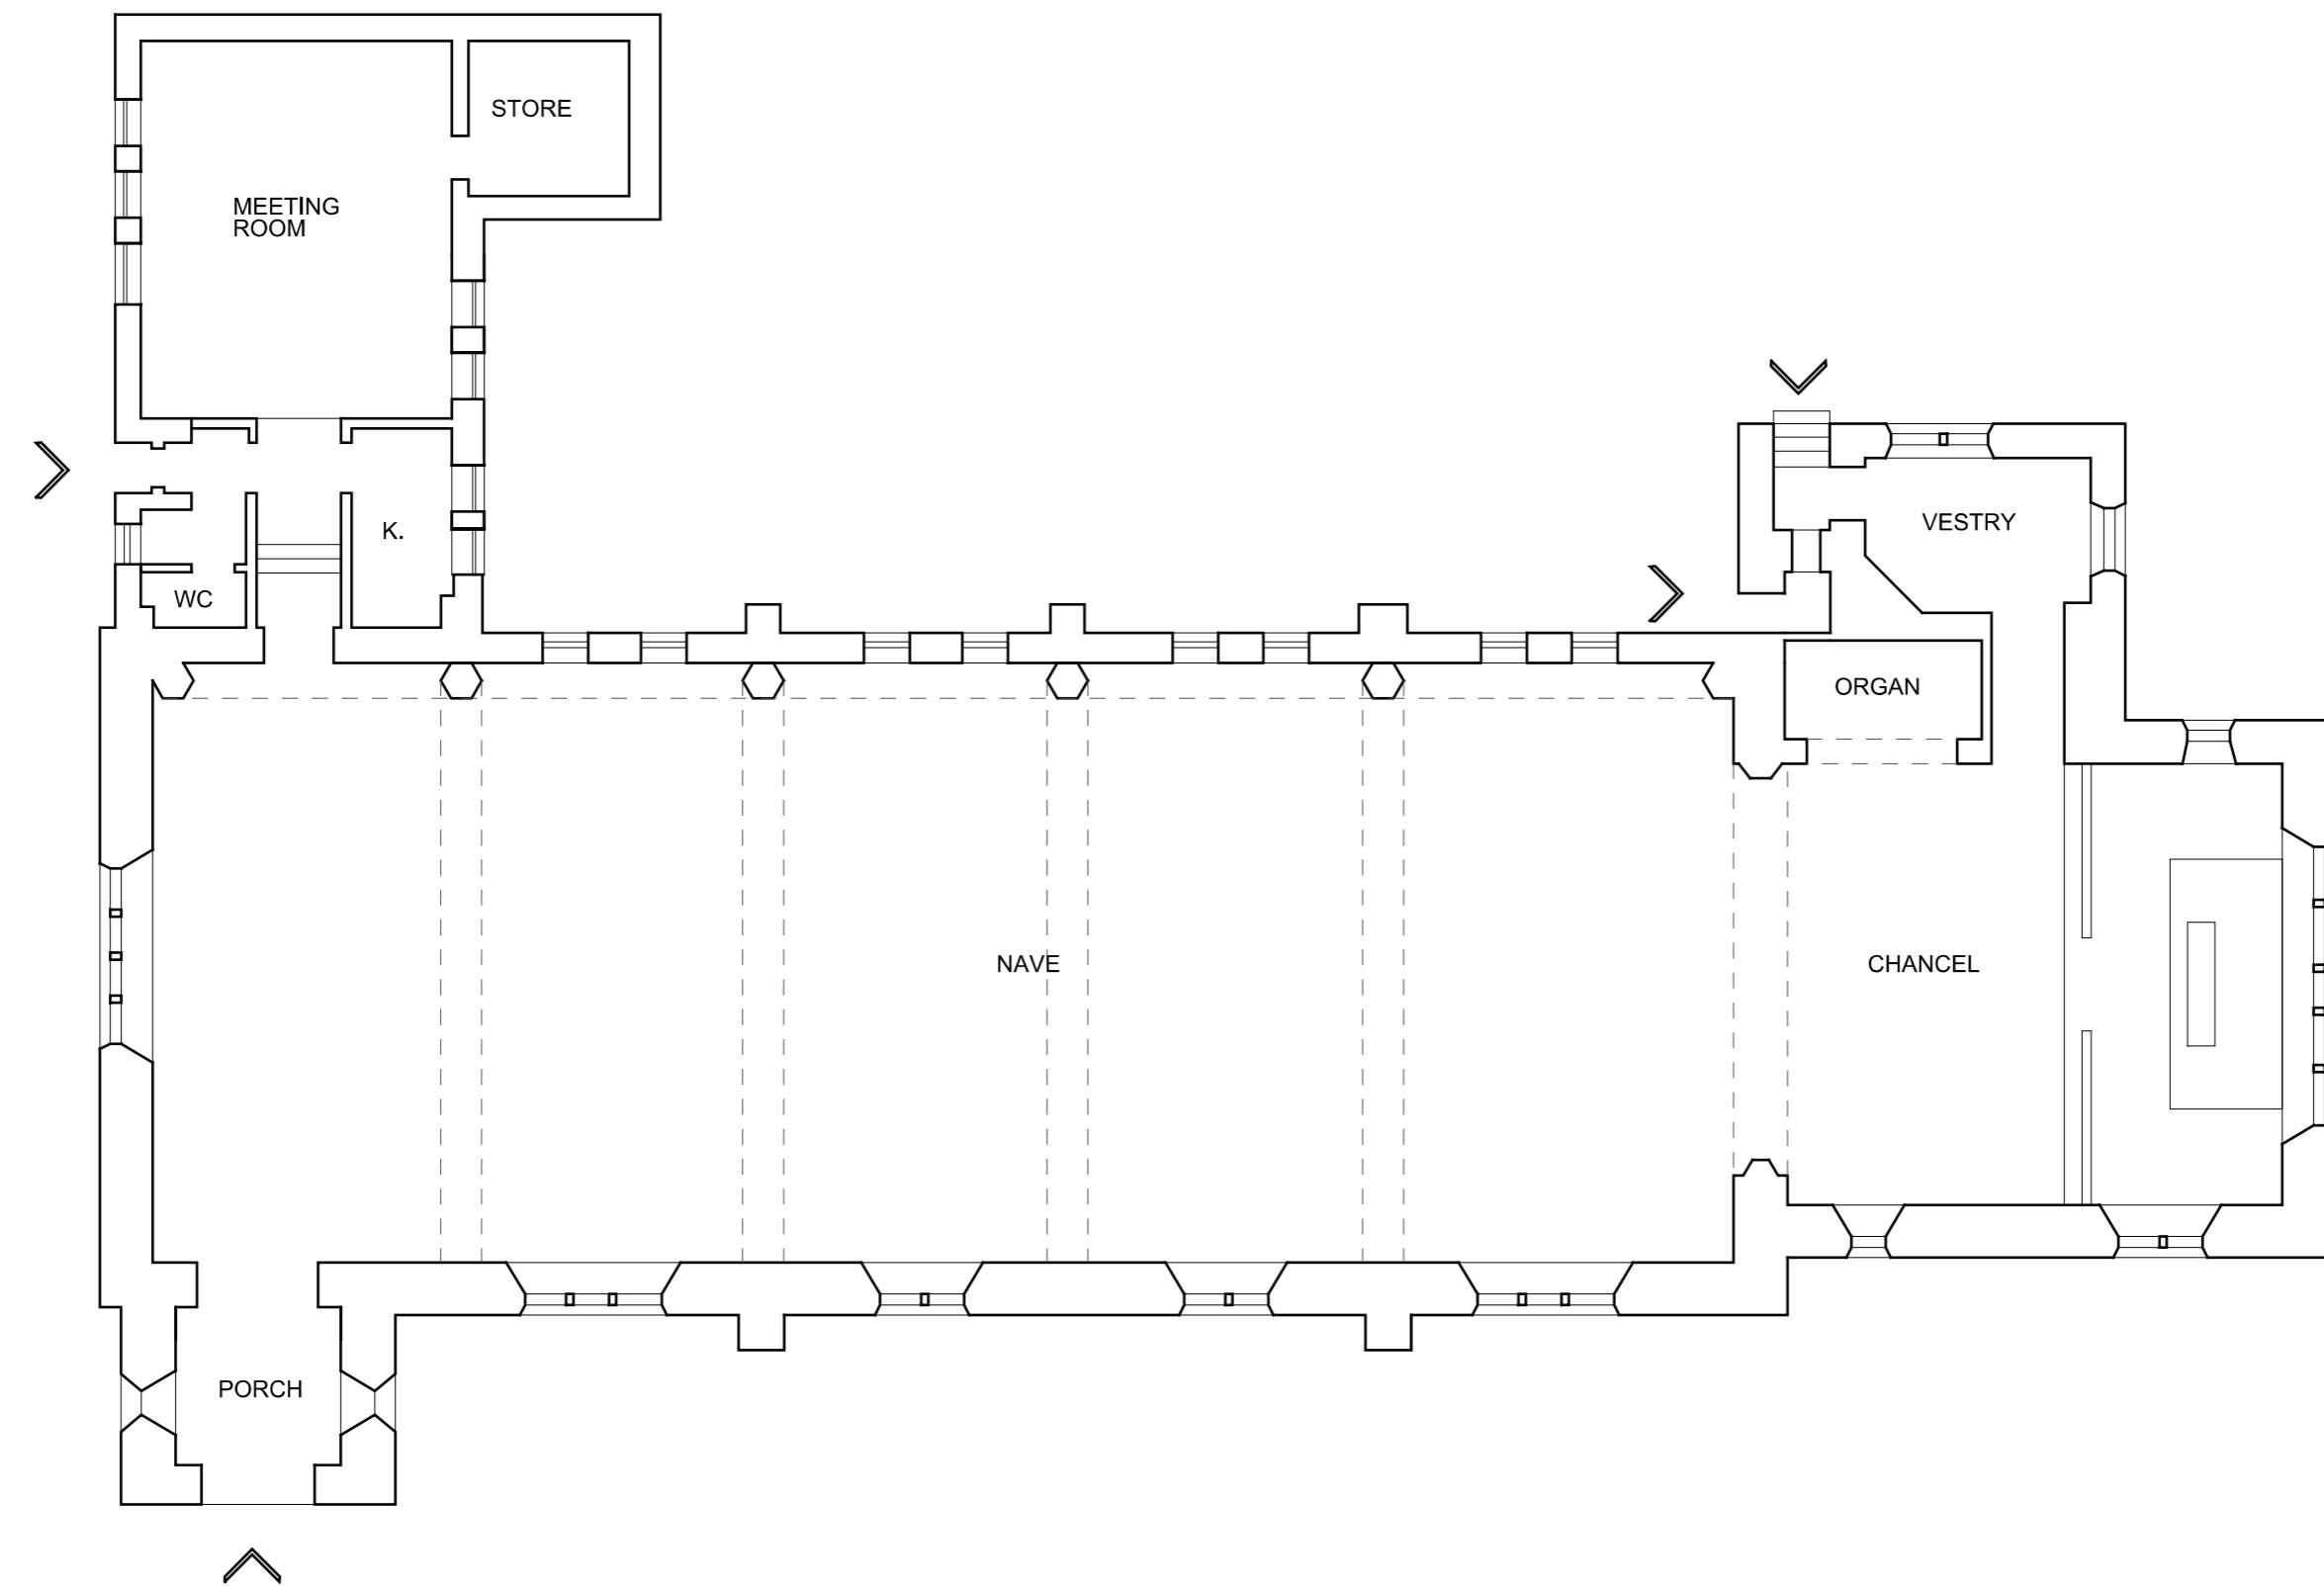
Do not scale from drawing.  
Dimensions are to be checked onsite.
