# Quinquennial Inspection Report

## Church of the Holy Spirit, Crawcrook, Gateshead, Tyne and Wear

**Date of inspection:** 22 April 2021. Weather conditions – dry and sunny.

**Ref:** 21012

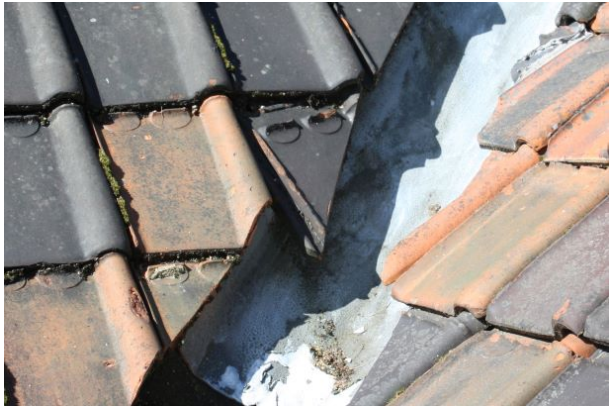
There is a missing tile near the valley on the west side of the church and a loose tile near the valley on the east side of the church. These tiles need replacement/ re-fixing, respectively.

Loose valley tile

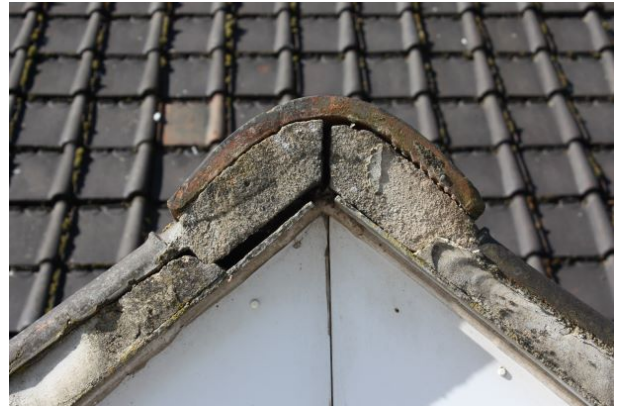
Cracked mortar bedding to gable ridge

Repair needs	<p>Replacement/refixing of missing/loose tiles by valleys of church.</p> <p>Re-bedding/repointing of ridge tiles on small east gables</p>	<p>B</p> <p>B</p>
<b>1.2 Rainwater goods and disposal systems</b>		
Condition	<p><u>Church:</u></p> <ul style="list-style-type: none"> <li>• cast iron gutters – decoration in fair condition but need clearing of leaves etc.</li> <li>• triangular flat roofs over bay windows recently re-covered in mineral felt. In good condition.</li> <li>• cast iron downpipes – decoration and anti-climb paint in fair condition.</li> <li>• cast iron hoppers - decoration in fair condition but east side hopper blocked with leaves.</li> <li>• Gullies – generally in fair condition.</li> </ul>

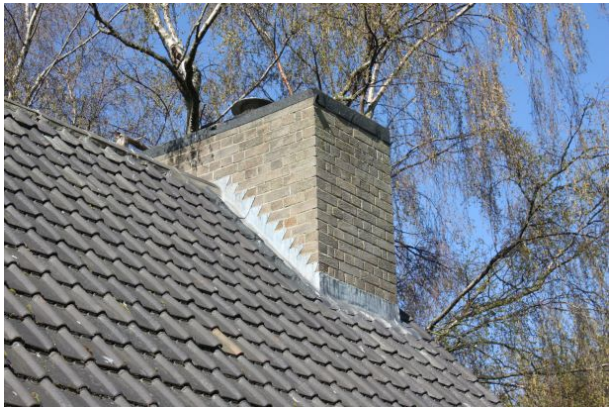
There is a torn flashing to the coping which needs repair or replacement. There is water staining on the internal facing brickwork of the sanctuary. This could be from past leaks but while the flashing is being repaired the lead flashings between the roof and the chimney stack should be checked and appropriate repairs made if needed.

Chimney stack with torn flashing to coping

<b>1.4 Crosses, chimney and flues</b>		
Condition / repair needs	<p><u>South gable cross:</u> In fair condition but see comments in 1.3</p> <p><u>Chimney stack and flue:</u> Felt flashing torn to capping. Needs repair or replacement. The flue and lead flashings to the stack should be checked at the same time.</p>	B B

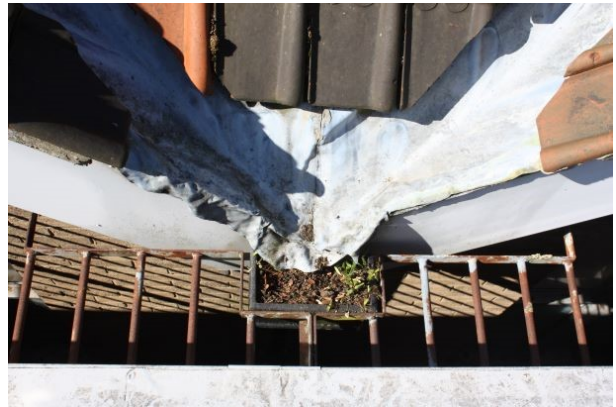
The hopper between the two small gables on the church east slope is solidly blocked with leaves. Gutters on the west side of the Church roof are also blocked with leaves. Clearing gutters and hoppers twice yearly is recommended.

Blocked hopper

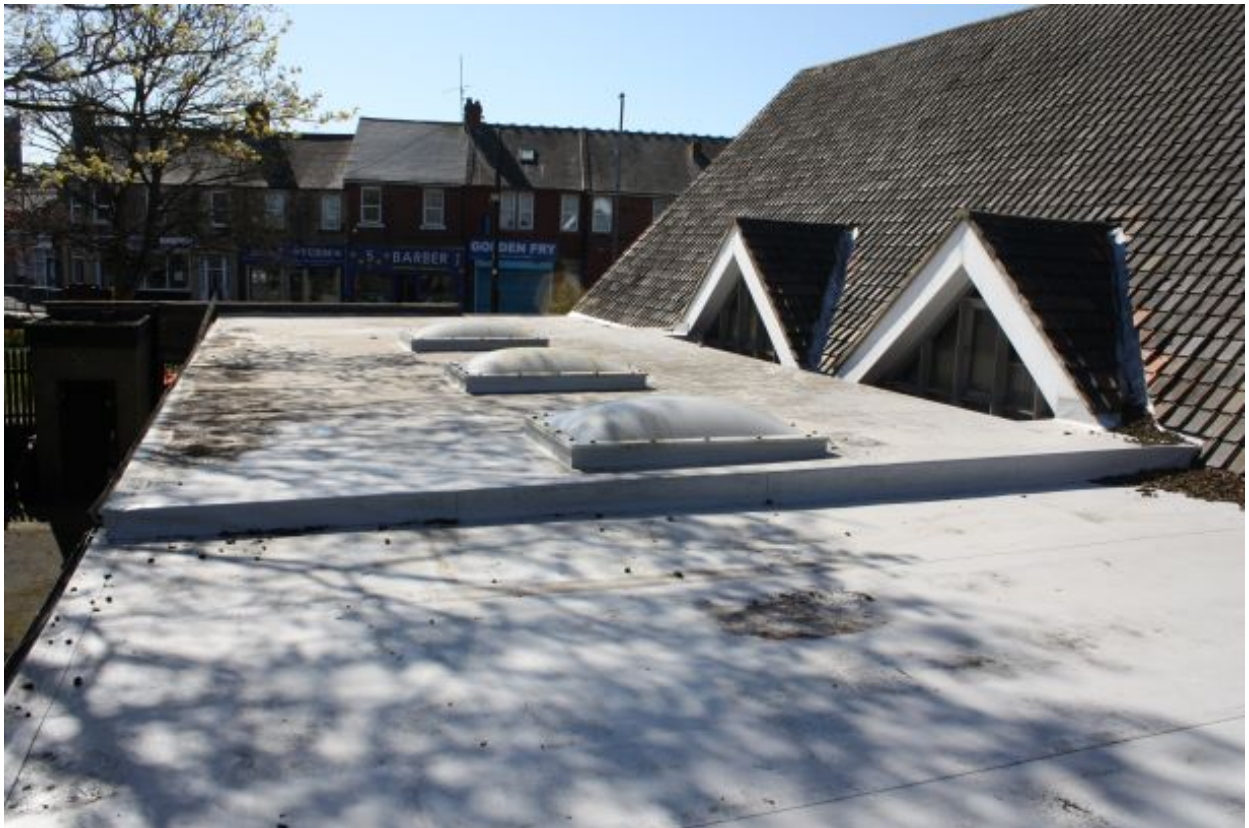
The gutters and downpipes on the east side of the Hall block take the drainage of the flat roof of the Hall together with most of the rainfall from the Church east roof slope. The rainwater goods are too small to cope with the volume of water in storm conditions, resulting in overflows from the gutters down the face of the wall in places. Replacement of the gutters and downpipes to those with a larger capacity is needed.

Flat roof of Hall block and pitched roof of Nave showing volume of water discharging into narrow gutters

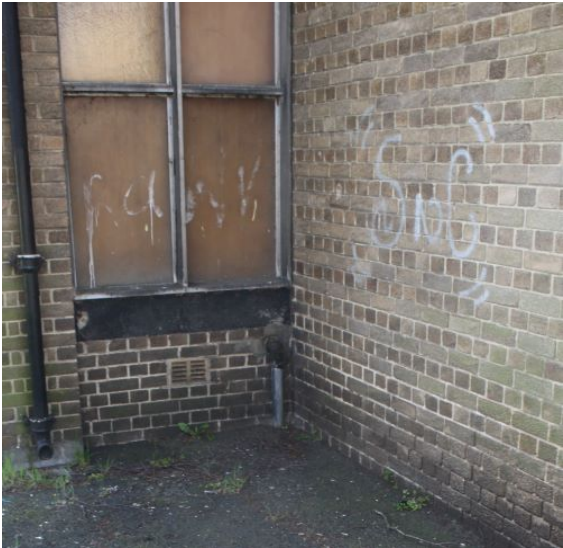
Graffiti to north west corner of Church

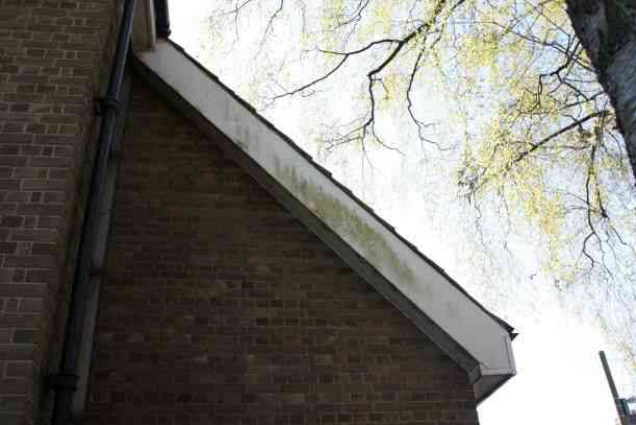
The PVC fascia and soffits are covered with green stains from the trees on the north side of the building. Cleaning off the stains would improve the appearance.

Green staining of gable fascia

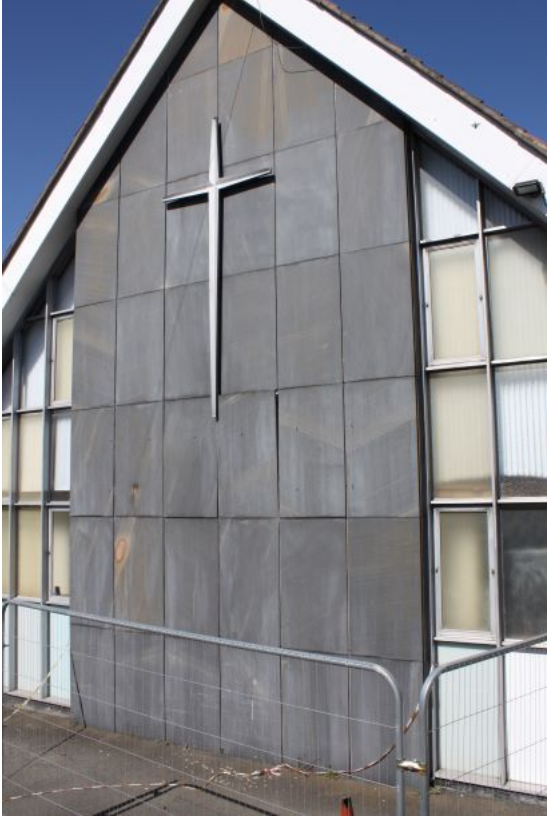
The loose slate cladding panels is the greatest concern. The slates are starting to de-bond from the background wall. One slate in the central row is leaning forward and only held in place by the cross feature. If the fixing to the cross feature gives way under the strain this slate and all those above it could collapse and crash to the ground. Dismantling of the slate cladding by a specialist needs to be carried out urgently for safety reasons. The PCC have been in discussion with the architect about possible alternative facing materials. Whatever is chosen will need planning approval and faculty consent.

Loose slate cladding to south gable

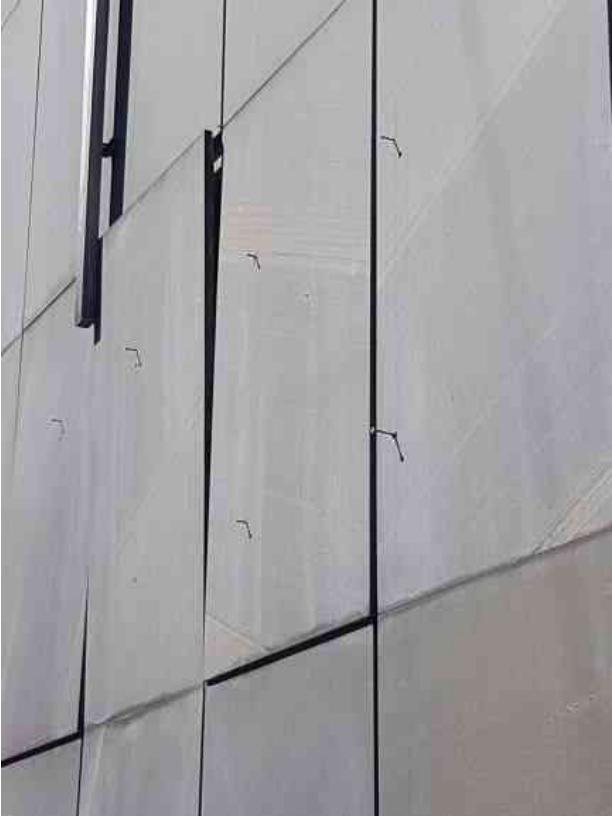
Slate panel held in place only by cross feature

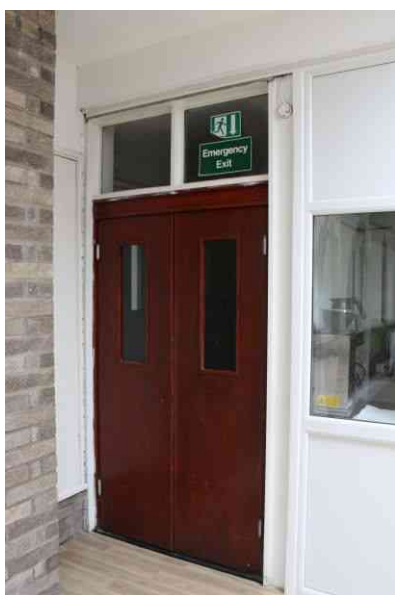
Hazardous dual swing fire door

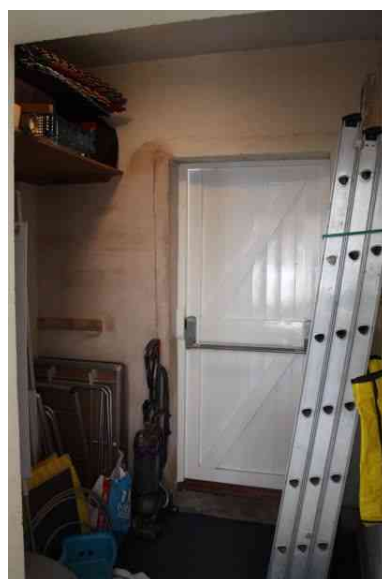
Escape door needs adjustment

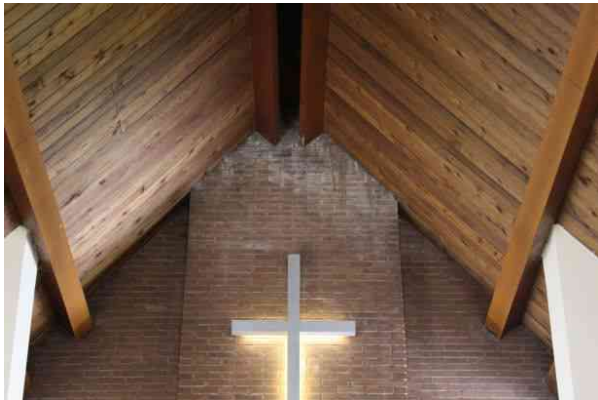
Staining from water leaks at roof/ gable stack

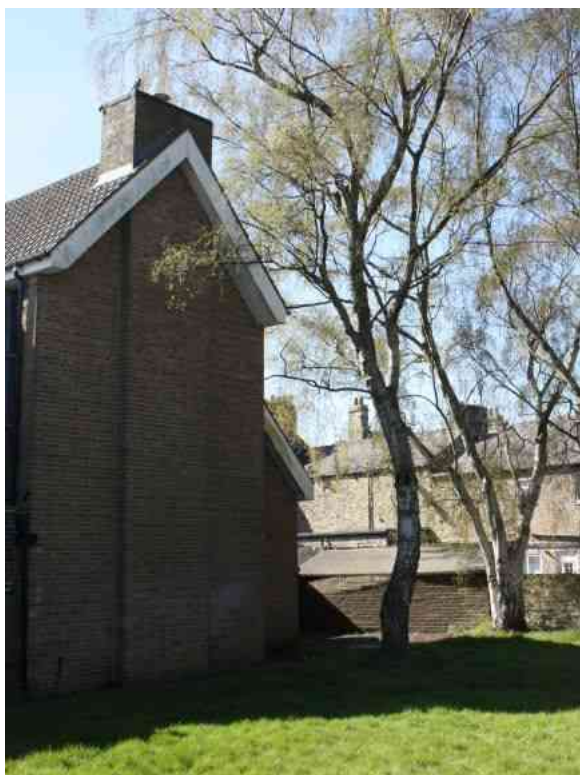
Mature silver birch tree near north gable resulting in stepped cracks to NW wall

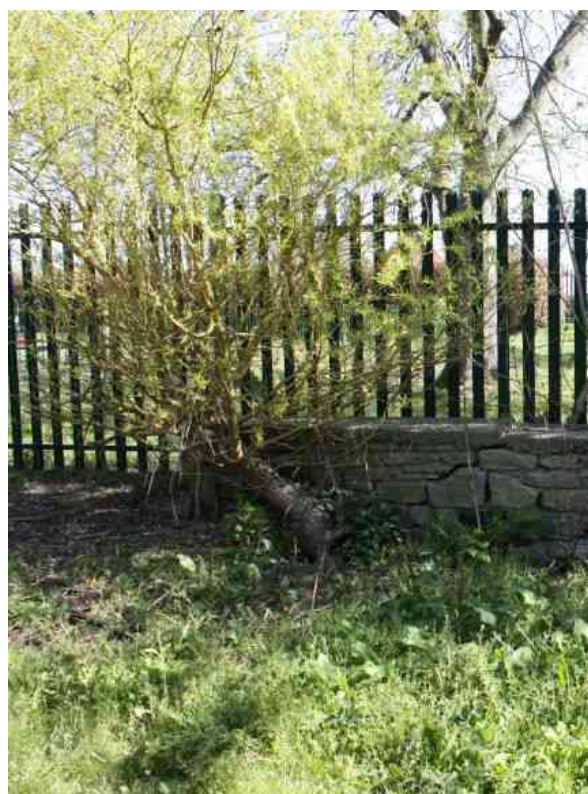
Shrub causing cracking of dwarf wall

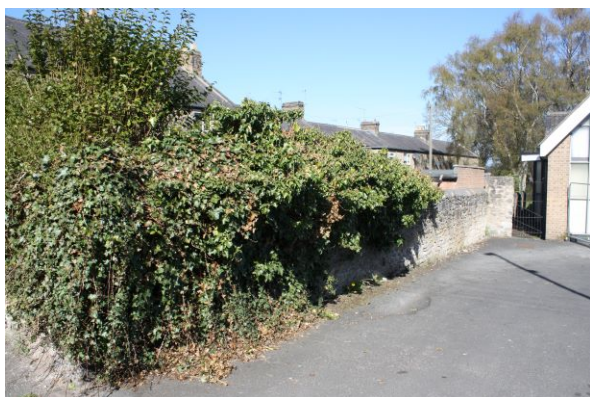
Shrubs in need of pruning

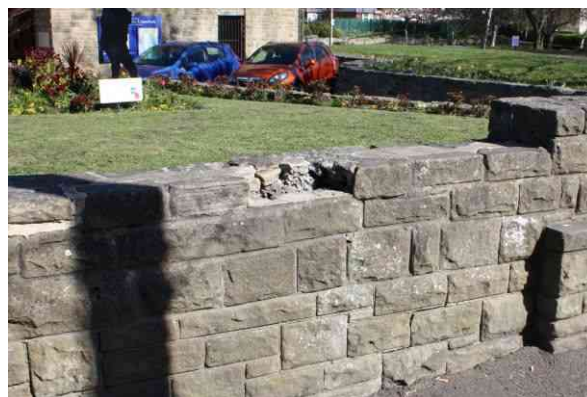
Missing coping to dwarf wall adjacent road
