# ST ANDREW'S CHURCH, DALTON-LE-DALE

ST CUTHBERT'S TERRACE, DALTON-LE-DALE, SEAHAM, CO.  
DURHAM, SR8 8QX

This inspection was carried out on 16th October 2025. The weather was predominately dry and overcast. This was the author's first Quinquennial inspection of the church.

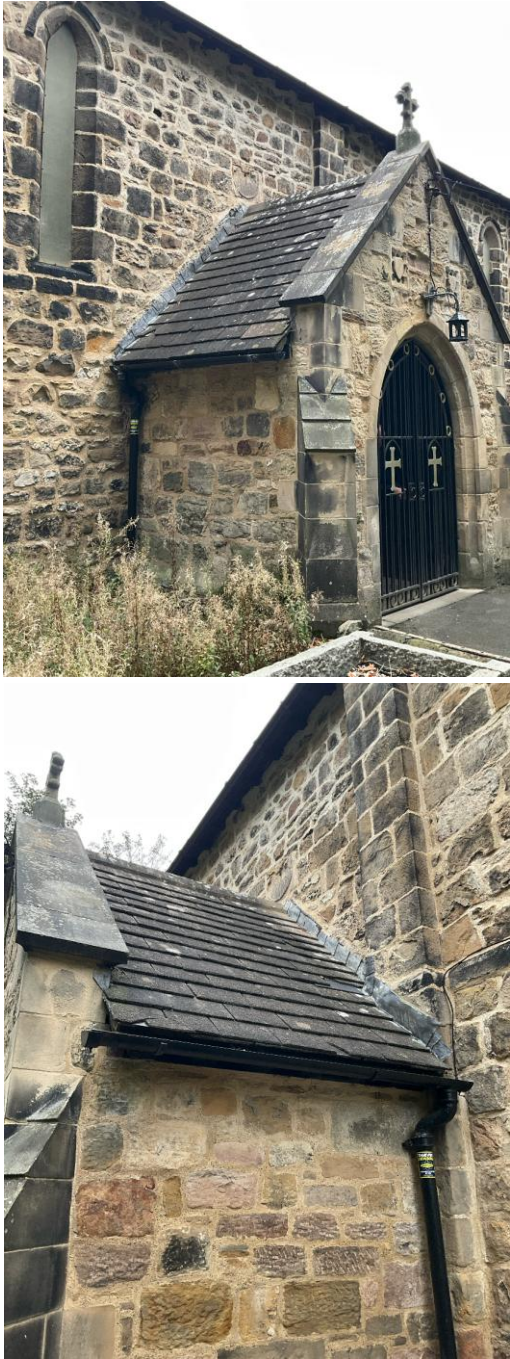
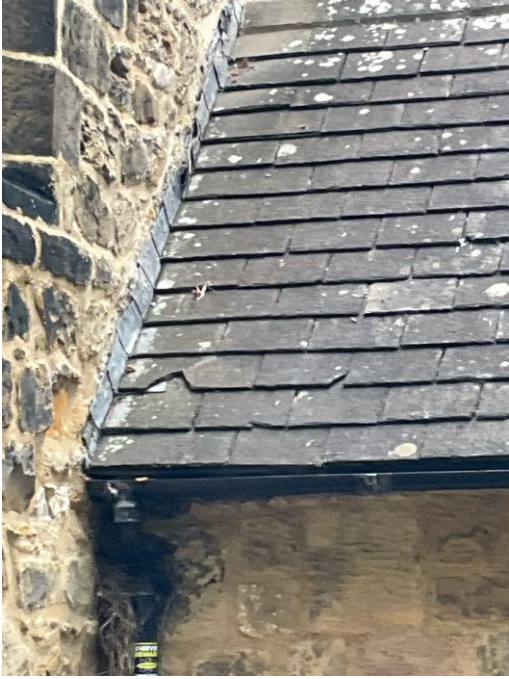
Porch Roof

| | <b>Condition</b> <ul style="list-style-type: none"><li>• A few chipped slates</li><li>• Flashing is beginning to debond on east slope</li></ul> | |

| | <b>Repair Needs</b> <p>Re-fix flashing to avoid water ingress.</p> | B |

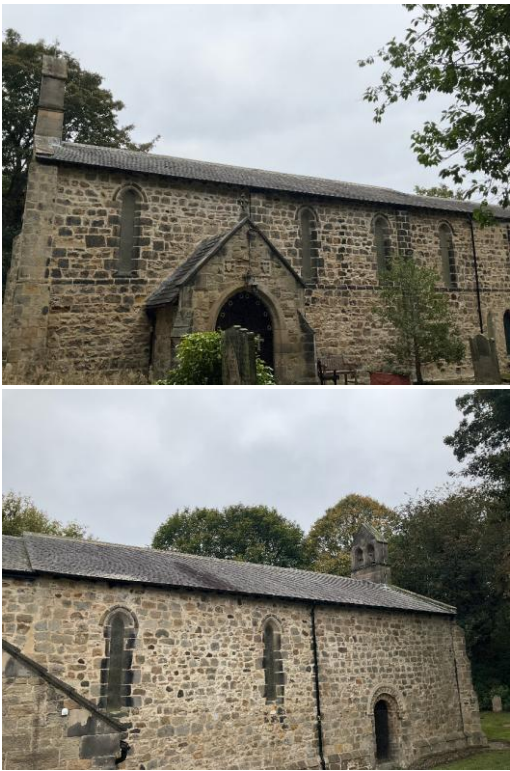
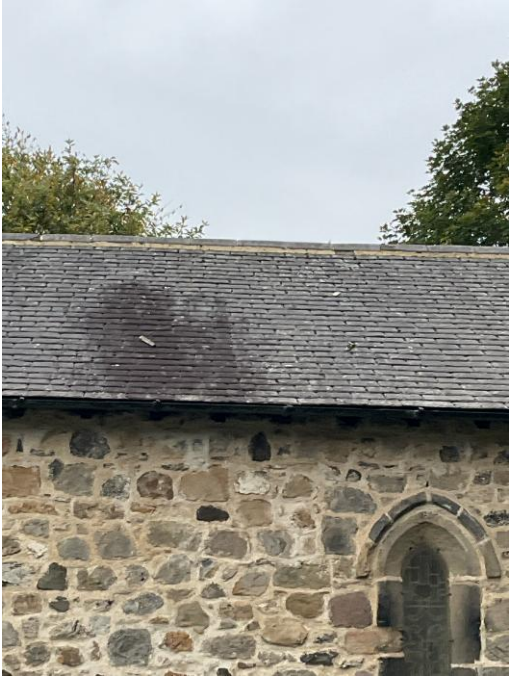
### Nave Roof

| | <b>Condition</b> <ul style="list-style-type: none"><li>• Slate and ridge tiles appear sound and well bedded.</li><li>• Flashing appears sound.</li><li>• Section of ridge tile bedding has come loose and fallen.</li></ul> | |

| | <b>Repair Needs</b><br>Repoint ridge tile | B |

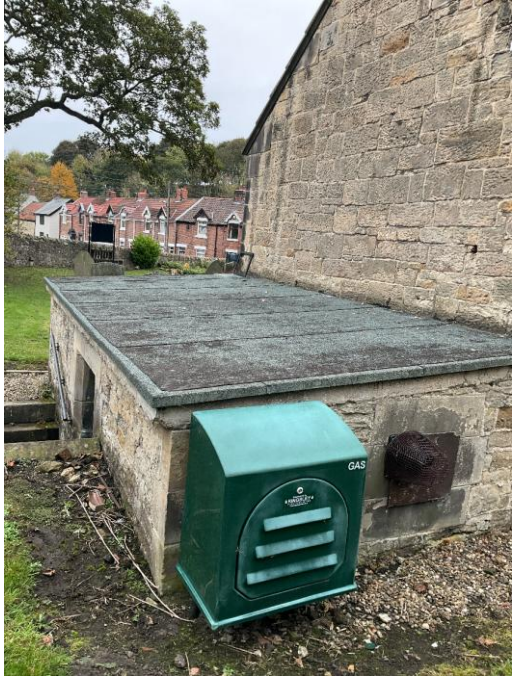
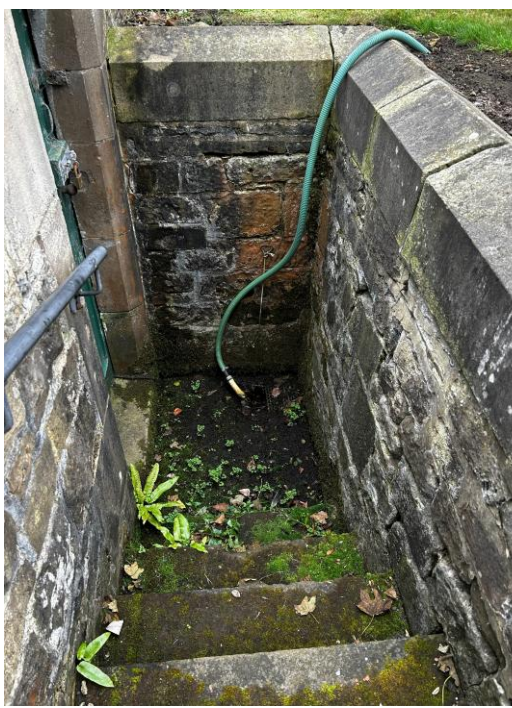
## Boiler Room Roof

| | <p><b>Condition</b></p> <ul style="list-style-type: none"> <li>No flashing present to abutment with vestry wall, doesn't appear to be causing any problems internally, but a visible splash line is evident on vestry wall.</li> <li>The absence of a gutter is resulting in rainwater pooling at the base of the stair and causing moss / vegetation growth.</li> </ul> | |

| | <p><b>Repair Needs</b></p> <ul style="list-style-type: none"> <li>Install flashing at vestry wall abutment to prevent any future water ingress.</li> <li>Install a gutter to the boiler house roof, to avoid the pooling water and prevent water ingress issues.</li> </ul> | <p>B</p> <p>B</p> |

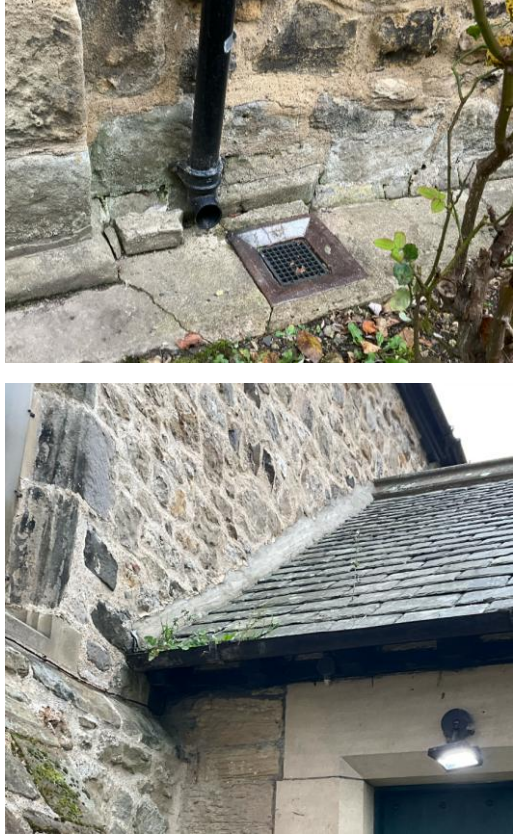
## 10.3. RAINWATER GOODS AND DISPOSAL SYSTEMS

| | <p><b>Condition</b></p> <ul style="list-style-type: none"> <li>• Downpipe not quite aligning with gully next to chancel door.</li> <li>• Some vegetation growth in vestry gutters.</li> <li>• No gutters or downpipes present on boiler house roof.</li> </ul> | |

| | <p><b>Repair Needs</b></p> <p>Clear vegetation growth from vestry gutters to prevent blockage.</p> <p>Consider installing a gutter and a downpipe to the boiler house roof.</p> | <p>M</p> <p>B</p> |

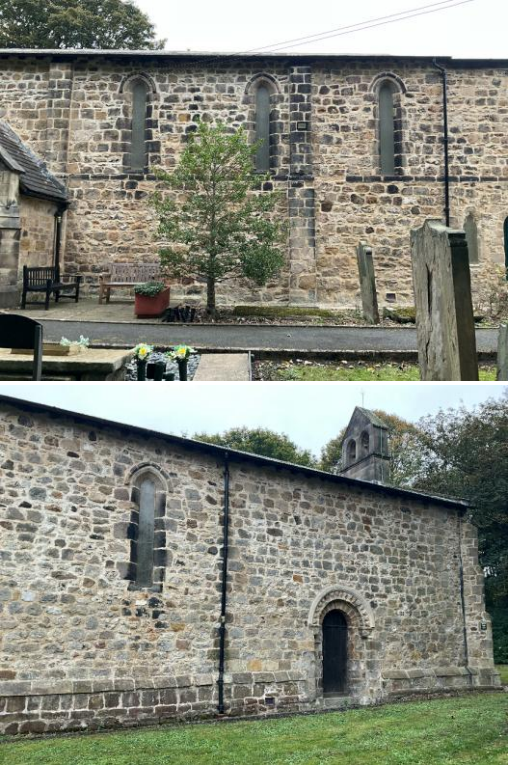
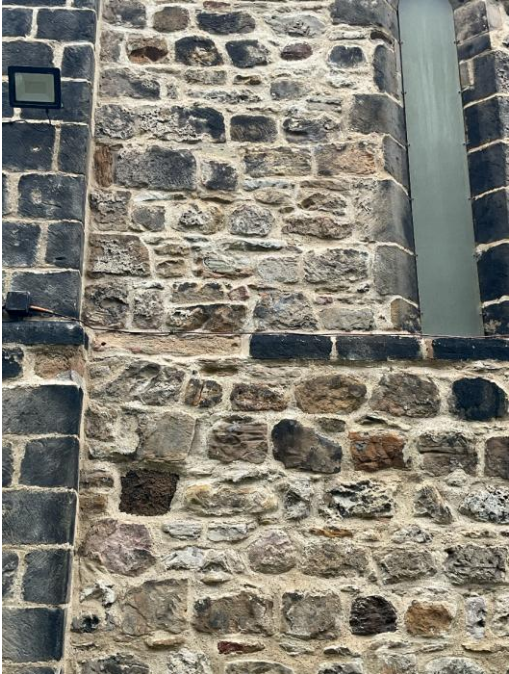
## Nave

| | <b>Condition</b> <ul style="list-style-type: none"><li>• Generally sound</li><li>• Some dark staining to window surrounds, buttresses and string course below windows on south side.</li><li>• A small section of the string course is missing next to the buttress on the south elevation.</li><li>• Some staining to the west gable around window and below.</li></ul> | |

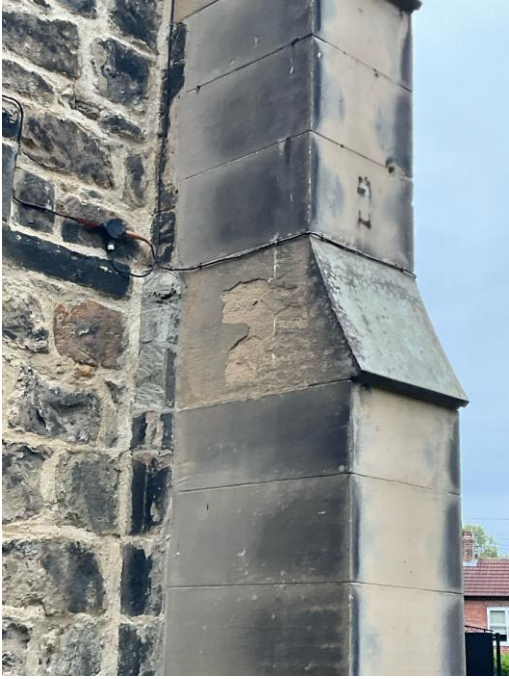
**Chancel**

| | <b>Condition</b> <ul style="list-style-type: none"><li>• Stone and pointing seems generally sound.</li><li>• There is some delamination to buttress stone face.</li><li>• Some dark staining to window surrounds and buttresses.</li><li>• No obvious sign of water penetration causing the internal dampness.</li><li>• Some moss growth on north facing buttress below window.</li><li>• Stone water table appears sound and well bedded.</li></ul> | |

| | <b>Repair Needs</b> <ul style="list-style-type: none"><li>• Monitor moss growth on buttress and brush off if it becomes excessive.</li></ul> | M |

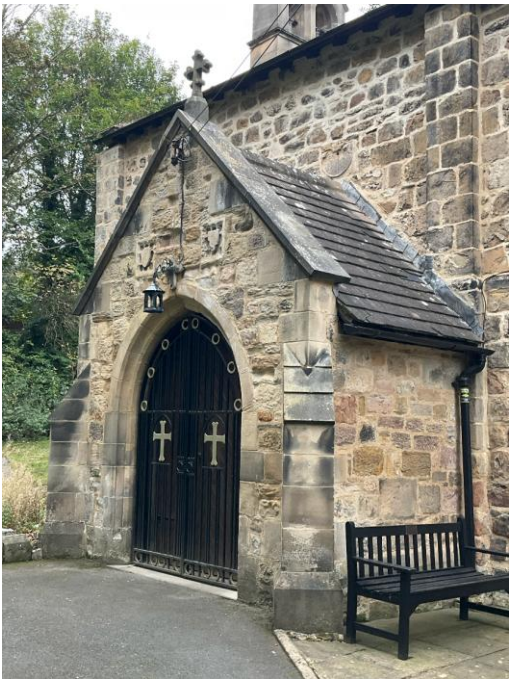
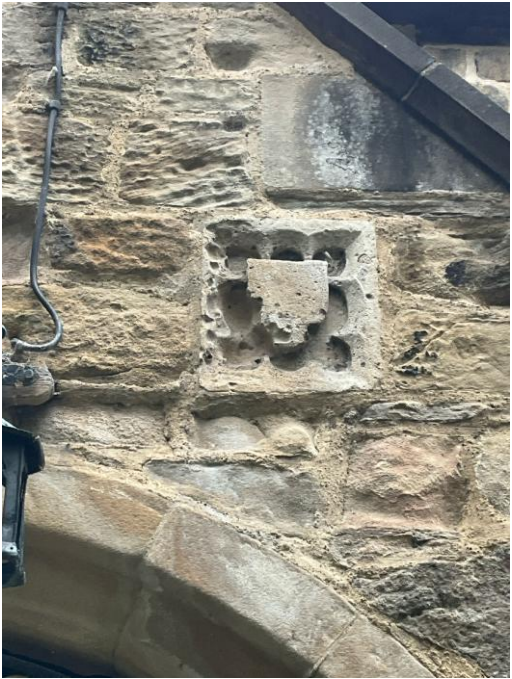
**Porch**

| | <b>Condition</b> <ul style="list-style-type: none"><li>• One shield has eroded more than the other.</li><li>• Stone and pointing appears sound.</li></ul> | |

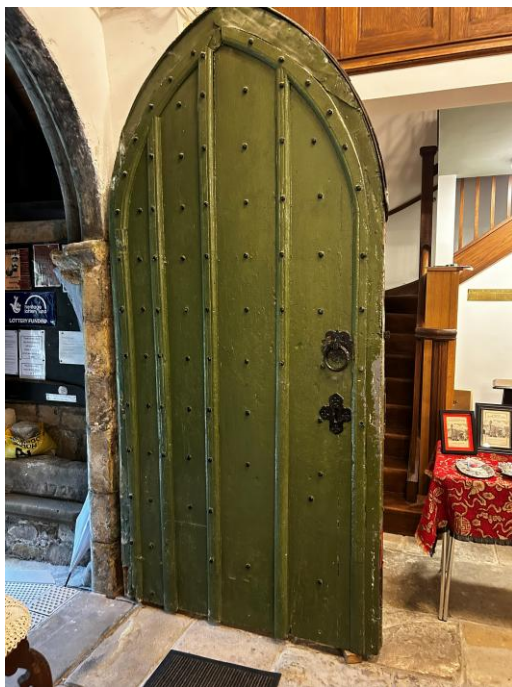
*Internal Porch Door***Repair Needs**

- Chancel lancet door appears sound externally. The door is not accessible internally.
- Internal porch door is draughty as the door doesn't fully sit flush up against the wall. The timber is rotten at the base.
- External porch doors and gates appear sound.
- Vestry door appears sound.

Investigate potential draught proofing and repair of existing door to establish if repair is feasible before considering replacement.

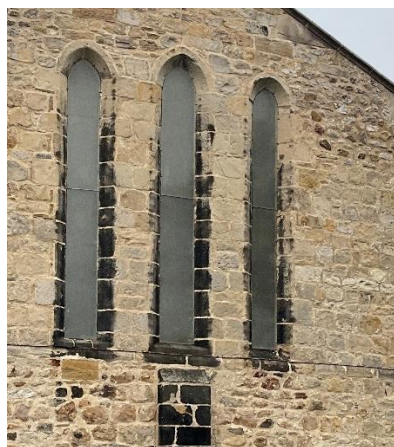
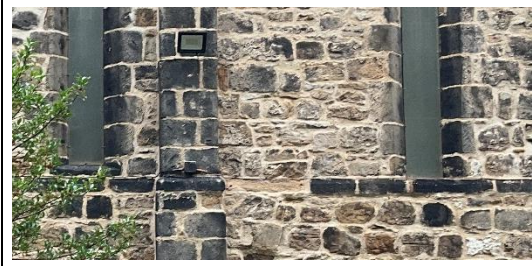
## Windows

- Polycarbonate covers externally are sound, but rather grey and frosted.
- Surrounds are heavily stained.
- The eastern most Nave window on the southern elevation doesn't appear to have a sill stone. This may limit the ability for water to run off which could lead to water ingress.

Install a sill stone to the nave window to ensure water is expelled and doesn't pool.

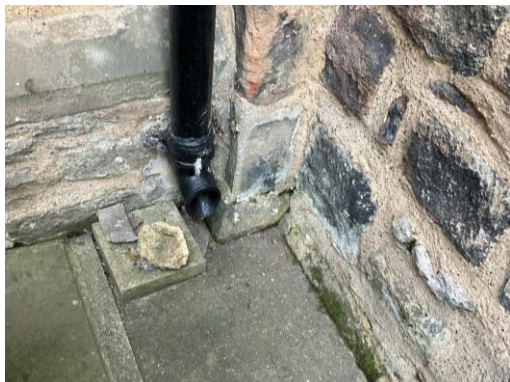
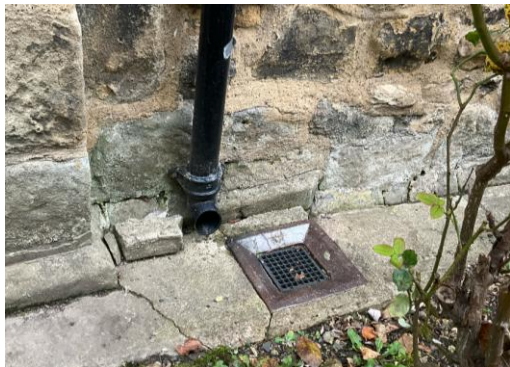
**10.6. BELOW GROUND DRAINAGE**

- Some downpipes don't directly align with gullies.
- There is some dampness around the internal porch area which could be a result of the downpipes discharging onto the concrete to the side of the porch.
- There is a high-water table on the north side which was noted in previous QQI report, possibly attributed to road drainage within the boundary retaining wall. Dampness is present on the walls internally at low level suggesting rising damp.

| | <p><b>Repair Needs</b></p> <ul style="list-style-type: none"><li>• Consider installing new gullies and drainage system around the porch to direct water away from the building.</li><li>• Consider installing a land drain and planting shrubs to mitigate high water table.</li></ul> | <p>D</p> <p>D</p> |

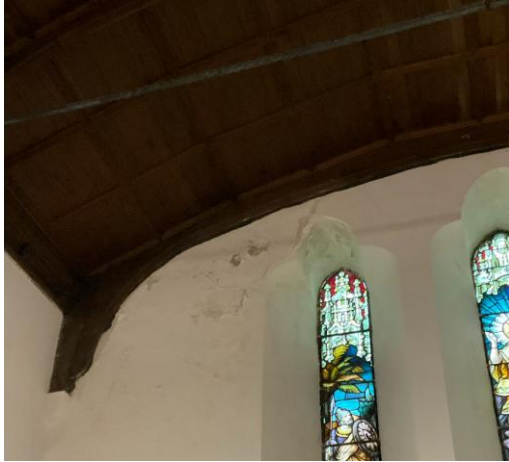
*Peeling at high level on east gable*

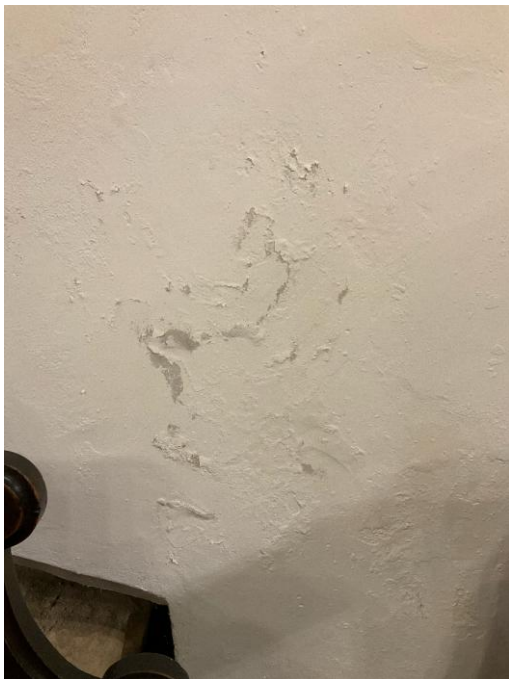
*Efflorescence and peeling on north wall*

- Nave walls have been repainted recently, but efflorescence is beginning to show through and peeling paint on north side. This is possibly linked to a high water table externally noted in last QOI.

| | <b>Repair Needs</b> <ul style="list-style-type: none"><li>• Brush off worst of the efflorescence and monitor the area for reappearance. (Refer to the below ground drainage section for recommendation on resolving moisture.)</li><li>• Monitor staining from high level, particularly after heavy rainfall.</li><li>• Check if there is ventilation in WC.</li><li>• Consider planting shrubs along north boundary and install a land drain to reduce water table.</li></ul> | <div>M</div> <div>M</div> <div>M</div> <div>D</div> |

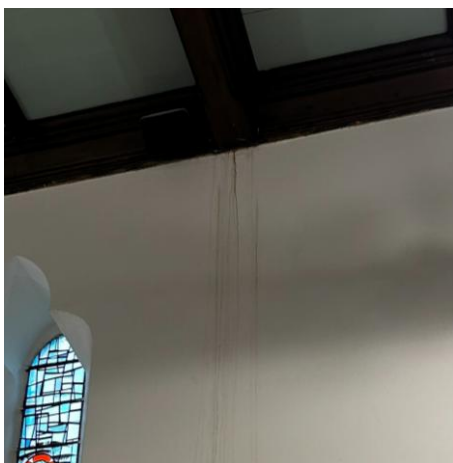
*Staining at high level*

- Some staining on south appears to be water streaks. Following a storm last year. PCC noted no further issues.
- An area of efflorescence and dampness to the west of entrance door beside base of stair at low level. Potentially linked to external downpipe discharging onto the ground rather than a gully.

| Category | Comment | Budget Cost |
|---|---|---|
| | <ul style="list-style-type: none"> <li>• Monitor staining from high level, particularly after heavy rainfall.</li> </ul> | N/A |

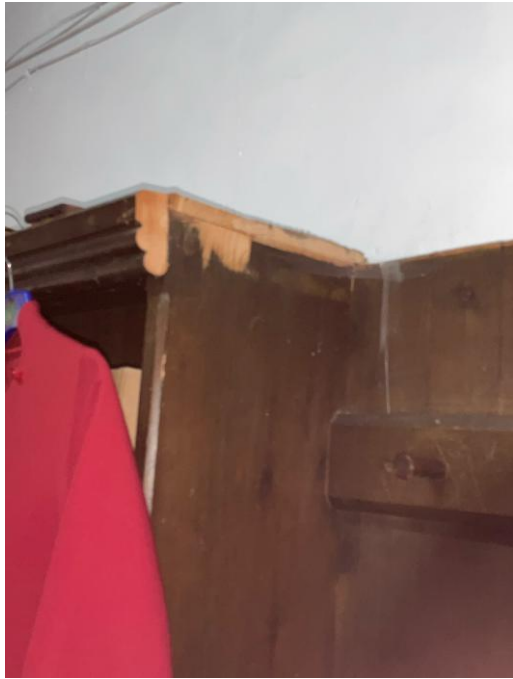
Partitions, Screens and Panelling

| | <b>Condition</b> <ul style="list-style-type: none"> <li>• Screen between nave and chancel appears sound</li> <li>• Served panelling is sound.</li> <li>• A piece of edging is missing at top of vestry panelling, otherwise panelling is sound.</li> <li>• Gallery and stair balustrade and metal rail appear sound.</li> </ul> | |

| | <b>Repair Needs</b> <ul style="list-style-type: none"> <li>• Replace missing edge piece on vestry panelling</li> </ul> | E |

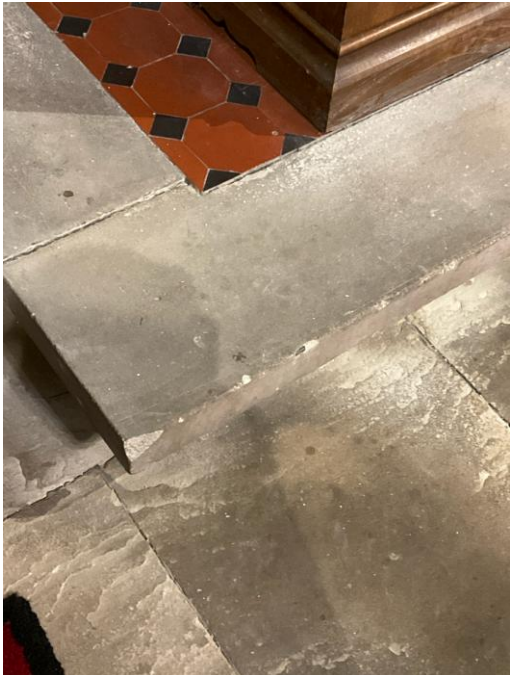
## 11.5 FLOORS AND PLATFORMS

| | <p><b>Condition</b></p> <ul style="list-style-type: none"><li>• Flooring throughout is generally in good condition.</li><li>• Steps have some chips</li><li>• Carpets are good condition.</li></ul> | |

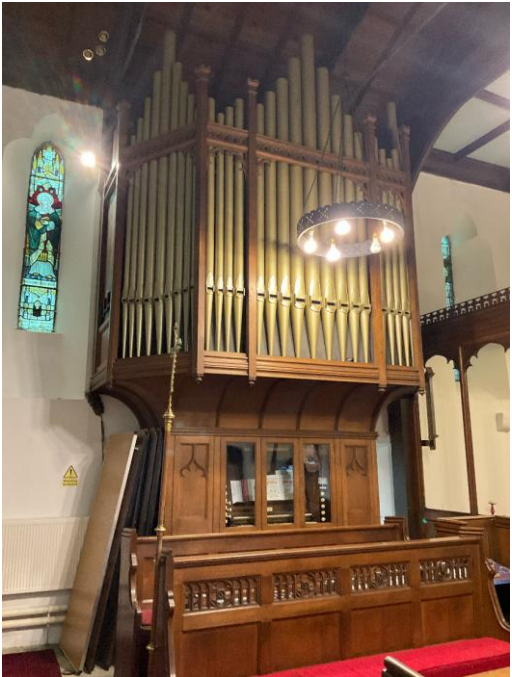
## 11.8 ORGAN

| | <p><b>Description</b></p> <p>Grade II pipe organ, located in the chancel, 1913 by Harrison and Harrison two manual.</p> <p><b>Condition</b></p> <p>There was no record in the logbook of the organ being serviced or tuned.</p> <p><b>Repair Needs</b></p> <p>Arrange organ service / tuning.</p> | <p>M</p> |

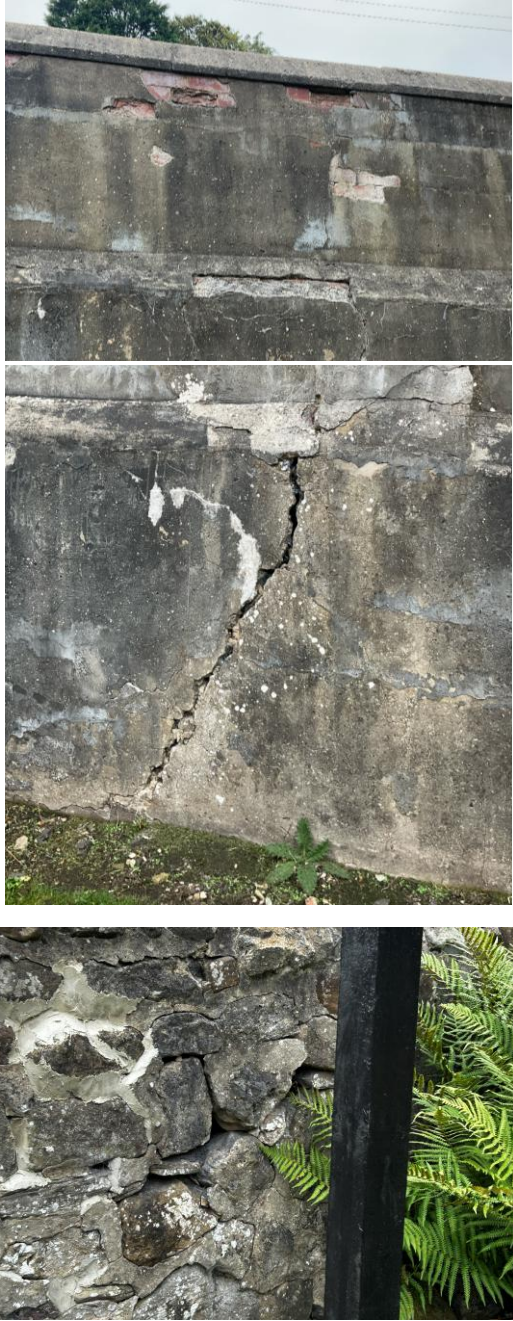
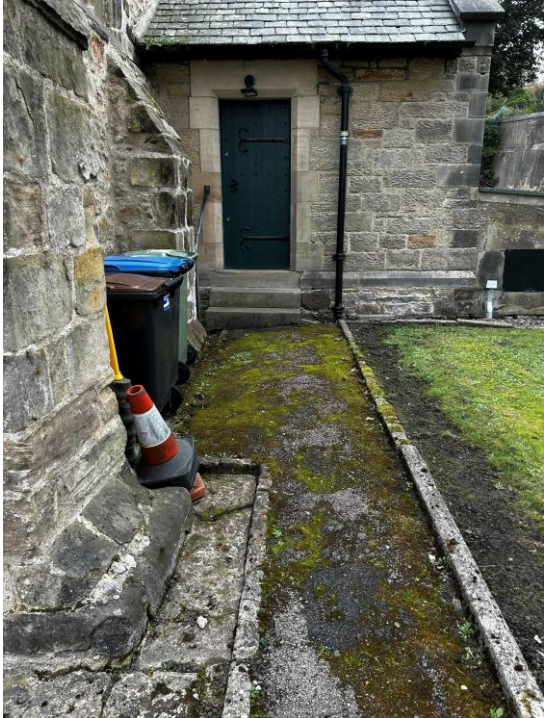
## 12. CHURCHYARD AND ENVIRONS

| | <p><b>Condition</b></p> <ul style="list-style-type: none"> <li>• Small area of pointing missing to curved stone wall at front.</li> <li>• Render to inside face of north walls missing in places, exposing brick behind.</li> <li>• Large crack in part of render to base of north wall.</li> <li>• Railings appear sound.</li> <li>• Some moss growth on front gates.</li> <li>• Moss growth to footpaths, particularly extensive outside vestry door.</li> </ul> | |

| | <p><b>Repair Needs</b></p> <ul style="list-style-type: none"> <li>• Small area of repointing required to curved stone wall at front.</li> <li>• Clean down front gates.</li> <li>• Clean moss growth off footpaths.</li> </ul> | <p>D</p> <p>M</p> <p>M</p> |

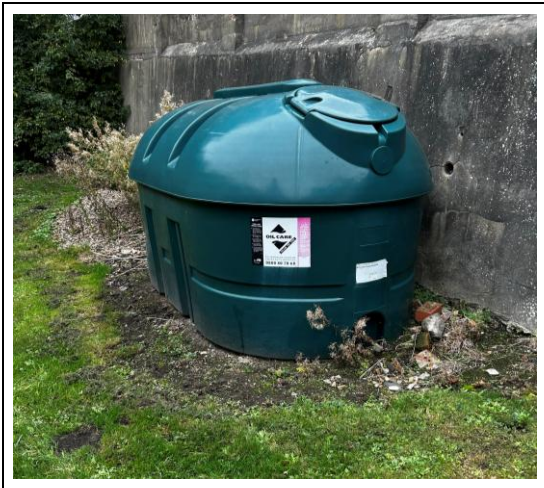
## 13. SERVICES

| | <p><b>Condition</b></p> <ul style="list-style-type: none"> <li>• Redundant oil tank is still present in grounds.</li> <li>• Fire extinguishers have been tested and checked recently.</li> <li>• Lightning conductor has been checked recently.</li> <li>• Gas boiler has been serviced recently and no noted issues.</li> </ul> | |

| | <p><b>Repair Needs</b></p> <p>Remove redundant oil tank</p> | <p>C</p> |
