ST CUTHBERT'S CHURCH

Darlington

Report on Quinquennial Inspection 2019

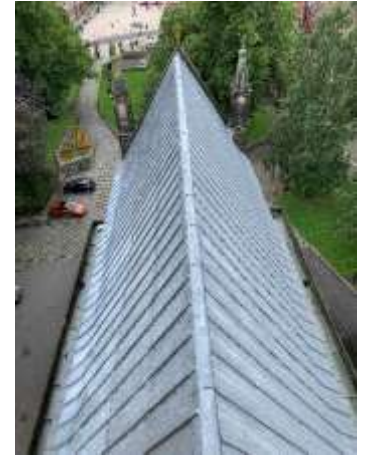
On the north side, there is some evidence of slumping and the clips are likely too tight, however the condition is currently satisfactory. Keep monitoring.

The south side has been renewed since 2018 and is in excellent condition.

2.1.3. **Recommendations:**

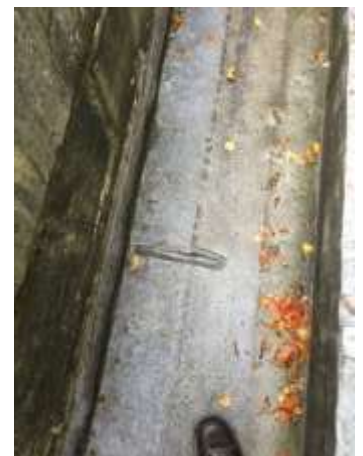
The gutter appears to be clear, but there are certain areas that were blocked in the past and have overflowed, particularly the area towards the east. A recent roof inspection has revealed a number of serious defects which require remedy.

| B | <ul style="list-style-type: none"> • North Aisle roof requires replacement. In the interim, ensure gutters are clear. | Broad Budget Costs |

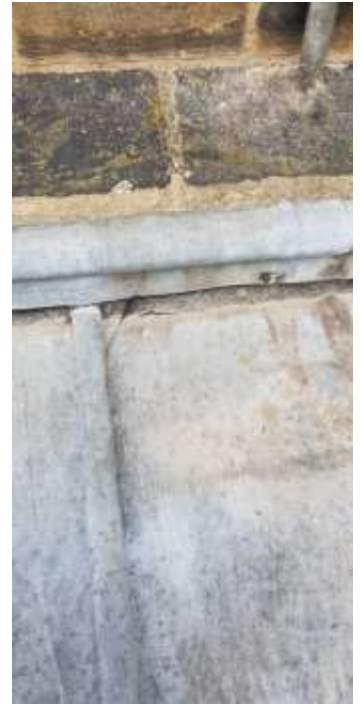
A recent roof inspection has revealed a number of serious defects which require remedy including historic lead splits and failure to the mortar at the flashings.

- B**
- **South Aisle roof requires replacement. In the interim, ensure gutters are clear.**

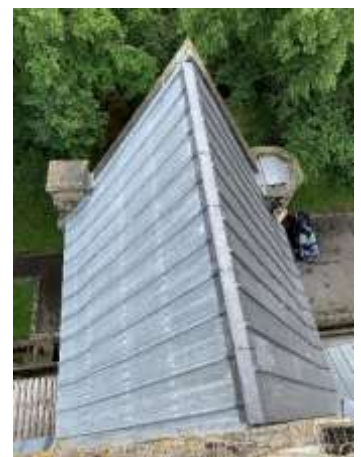
The west side was replaced in 2018. The east has a number of defects.

To the east side, there is a square base. This has a concrete top to it which appears to be in reasonable condition. The stonework requires repointing.

2.4.3.	Recommendations:	Broad Budget Costs
B	<ul style="list-style-type: none"> Replace roof to east slope of South Transept. 	4
B	<ul style="list-style-type: none"> To the South Transept point East Turret. 	1

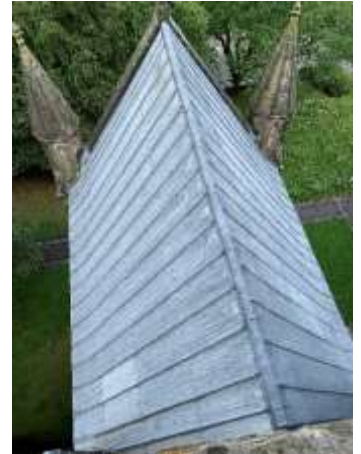
2.5.2. **Condition:**
The cross base has an area of shaled stone; however, it appears to be secure. To the north pinnacle, nearer the base of the pinnacle, there are a few open joints which should be repointed when possible. Some open joints to the pinnacles.

Lead to north deteriorating but not yet requiring renewal.

2.5.3.	Recommendations:	Broad Budget Costs
C	<ul style="list-style-type: none"> Repoint stonework to pinnacles. 	2

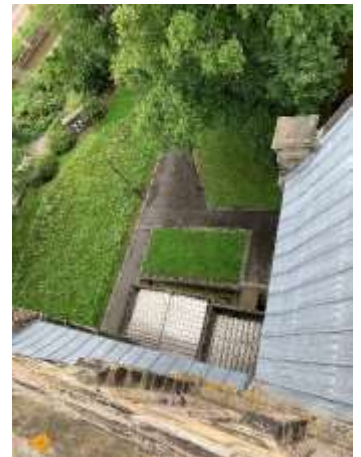
2.6.2. **Condition:**
Generally reasonable condition. The gutters to the Vestries require cleaning out regularly.

2.6.3.	Recommendations:	Broad Budget Costs
M	<ul style="list-style-type: none"> Clear out gutters. 	1

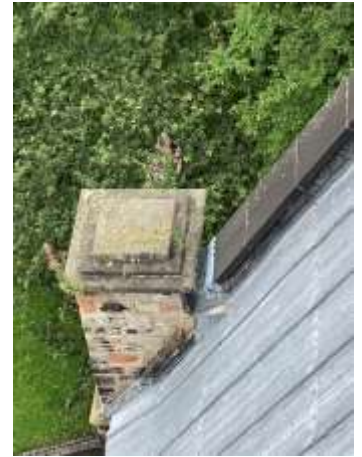
2.7.2. At the apex of the coping at the gable, there is a large mortar joint which is showing signs of failing which should be noted in the future.

The western Turret has a number of plants growing out of it which should be removed. The roof itself appears to be in fair condition with no repairs visible.

2.7.3.	Recommendations:	Broad Budget Costs
A	• Remove vegetation from western turret.	1
A	• Repoint large mortar joint to apex of gable.	1
A	• Repoint turret.	1

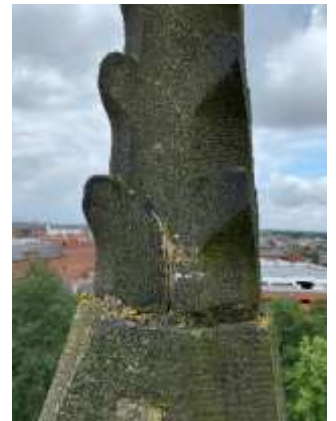
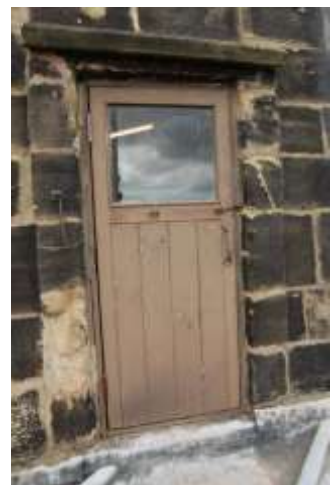
The exterior of the Spire itself, following inspection by steeplejack, appears to be in fair condition with only minor pointing required. The apex stone/weathervane transition, however, is in a poor state and requires repair and redecoration.

The Parapet at the base of the Spire is also in good condition, although very low for inspection purposes, but a mansafe system has now been installed.

2.8.3.	Recommendations:	Broad Budget Costs
C	• Door requires redecoration and minor repair.	1
A	• Clock face requires repair.	3
B	• Repair corroded weather vane and apex stone.	2
B	• Point/repair cracks in pinnacles.	1
B	• Point flashing.	1
B	• Remove all unsafe timber access systems from inside the spire.	2

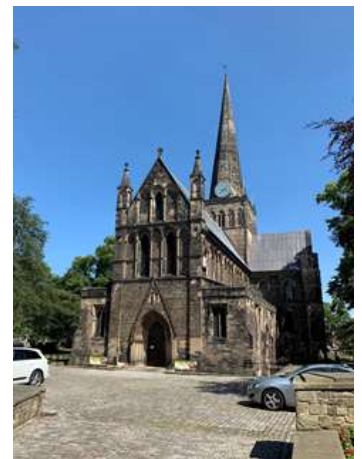
To the west end of the south aisle there are open joints at the coping and directly underneath.

2.9.3.	Recommendations:	Broad Budget Costs
B	<ul style="list-style-type: none"> At the West End -Rake out and repoint open joints over lancets. Monitor for further cracking. 	1
B	<ul style="list-style-type: none"> At the West End -Point around pinnacles, aisle windows. 	1
C	<ul style="list-style-type: none"> Point hood mould of west door and coping stones. 	1
E	<ul style="list-style-type: none"> At the West End -Remove cementitious pointing and repoint using lime based mortar. 	3
B	<ul style="list-style-type: none"> At the West End -Repoint at west end of south aisle. 	1
B	<ul style="list-style-type: none"> At the West End -Remove vegetation from north aisle. 	1

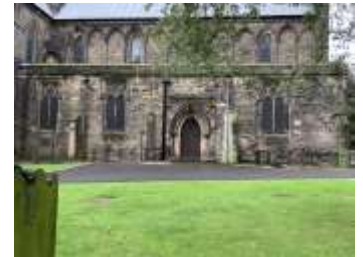
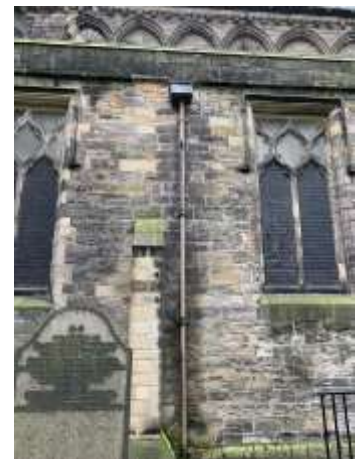
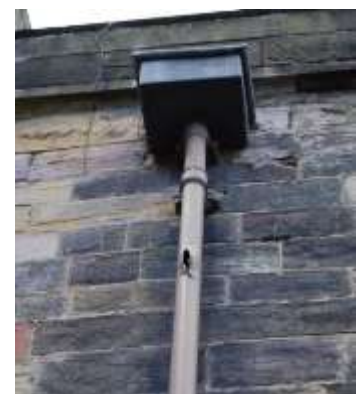
Around the three windows on the North Aisle elevation, there are ferrous fixings in the jambs which should be removed and pointed up. The poly-carbonate protection and the wire-guards are in reasonable condition, but the poly-carbonate looks very poor in the position that it is in and aesthetically distracting.

The black pipe to the east is a dummy and acts as the flue for the new boiler installation below. All the downpipes should be decorated black to match.

2.10.3.	Recommendations:	Broad Budget Costs
A	<ul style="list-style-type: none"> To the North Aisle - Repair down pipes – consider upgrading to next size up. 	2
A	<ul style="list-style-type: none"> At North side - Clean out blockages and maintain free flow. 	1
D	<ul style="list-style-type: none"> Remove ferrous fixings and upgrade window protection to powder coated stainless steel. 	3
B	<ul style="list-style-type: none"> Repair and redecorate north door and ironmongery. 	1
D	<ul style="list-style-type: none"> Decorate all rainwater goods a colour to match adjacent – black. 	2

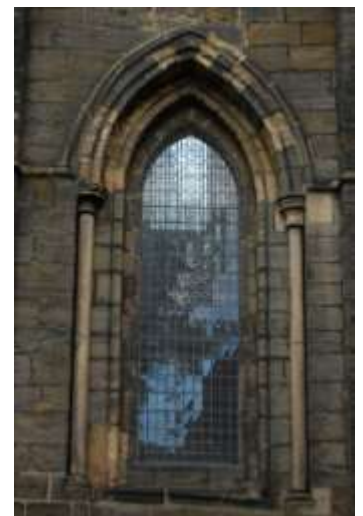
2.11.3. Directly under the eaves at the west end of the Clerestory, there appears to be some decay to the wall plate under the eaves. This is likely to require further repair and certainly closer inspection.

2.11.4.	Recommendations:	Broad Budget Costs
B	<ul style="list-style-type: none"> Inspect wall plate and eaves at west end of north nave roof. 	2
C	<ul style="list-style-type: none"> Inspect stonework around window 54 and repoint open joints. 	2
C	<ul style="list-style-type: none"> Repair columnette to window 53. 	2
C	<ul style="list-style-type: none"> All windows require closer inspection. 	2

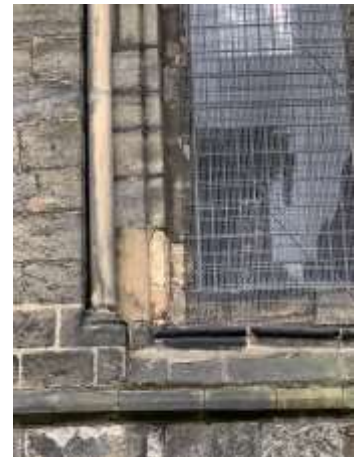
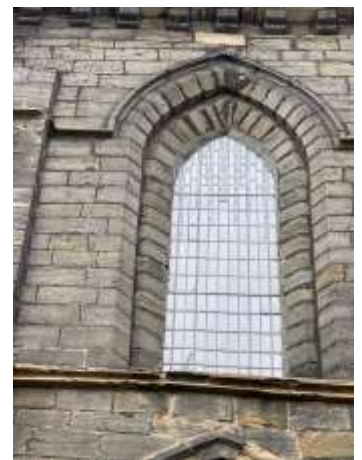
2.12.4. The sill and jamb of window no.4 are deteriorating badly. This will require repair in due course, although it is not currently urgent.

2.12.5. At high level at the top of the corner turret, there is vegetation which requires removal and the holes left repointed. Point open joints.

2.12.9.	Recommendations:	Broad Budget Costs
D	• North Transept - Overhaul window 43 and stone surround.	2
D	• North Transept - Overhaul window 47.	2
D	• North Transept - Remove redundant ferrous fixings around window 7, repair holes.	2
D	• North Transept - Monitor stone deterioration at top of N Transept gable.	1
D	• North Transept - Repair/replace string course stones.	3
A	• North Transept - Remove vegetation from top of west turret and repoint.	2
D	• North Transept - Repair sill and jamb to window 4.	2

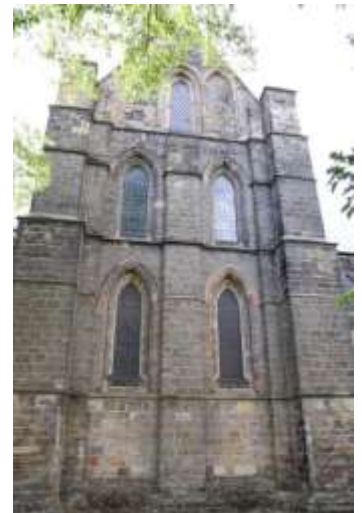
The elevation is generally in a fair condition, except for the top stage where deterioration is more evident. At the upper stages, there have been some mortar repairs utilised in the past and this is beginning to fail. The coatings are beginning to fall away. This should be monitored and the erosion checked in the next quinquennium. There are cracks that have been pointed up in the past over the windows no.5 and no.6 in the lower stage and these do not appear to have moved any further.

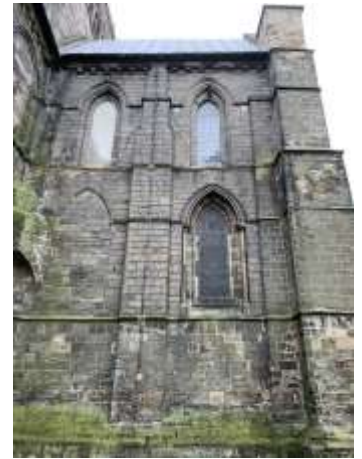
- 2.12.8. Around window no.7 there are some redundant fixings, which ought to be removed and the stone repaired. The Pace window no.47, has a hole in two of the panes. This pace window is also buckled.

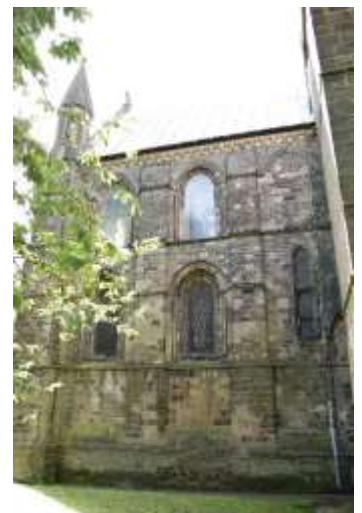
- 2.13.1. **Chancel North Elevation:**
The masonry on this elevation is generally in fair condition except for the jambs around windows no.10 and no.11. The stonework here is somewhat shaled and flaky, exacerbated by ferrous fixings which should be removed, and the stonework repaired. The wire grille protecting the windows has got dead leaves behind it.

- 2.13.2. The upper two windows no.35 and no.34 are protected in a poly-carbonate sheet which looks very distracting. This should be improved if possible.

2.13.3. Recommendations:		Broad Budget Costs
D	<ul style="list-style-type: none"> Upgrade window protection to windows 35, 34 and clean out debris to others. 	2
C	<ul style="list-style-type: none"> Repair stonework to jambs to windows 10,11. 	2

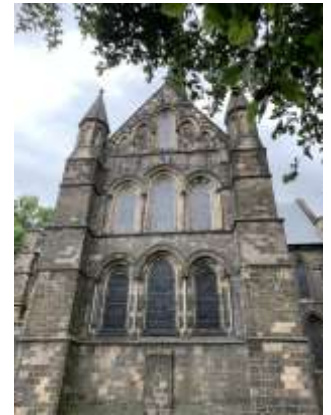
The masonry on the east elevation is generally fair. It was noted that the window no.12a, 12b & 12c have been repaired. Around all of the windows, all appear to be ferrous fixings which ought to be removed and the stonework repaired. Parts of 2no colonettes have been replaced.

Joints are open at the apex and especially at the heads of the blind arcade hood moulds – north side.

2.13.7. Recommendations:		Broad Budget Costs
D	<ul style="list-style-type: none"> Redecorate hopper head and downpipe. 	1
D	<ul style="list-style-type: none"> Remove cementitious mortars and repoint vestry walls. 	2
D	<ul style="list-style-type: none"> Remove ferrous fixings around windows. 	1
D	<ul style="list-style-type: none"> Point high level stonework. 	3

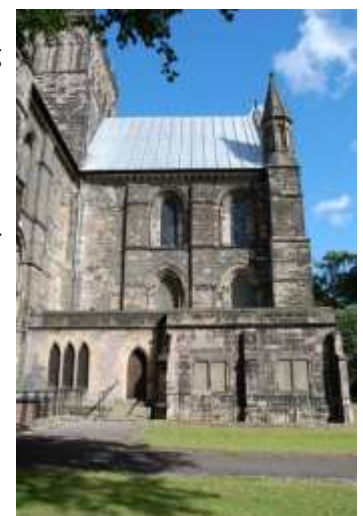
The lead downpipe at the junction with South Transept is leaking (probably blocked). Requires repairs and maintenance.

Some of this elevation is obscured by the Vestries at low level. The stonework is generally in fair condition, with the exception of the window surround to window no.26. Both no.26 and no.25 have poly-carbonate protection and the fixings are screwed poorly into the stonework and are rusting. These should be replaced because damage to the stonework is inevitable. The upper windows have been refurbished in 2017.

2.13.9.	Recommendations:	Broad Budget Costs
C	• Repair stonework around window 26.	1
D	• Upgrade window protection and remove ferrous fixings to windows 25,26.	2
B	• Repair and maintain downpipe at South Transept / Chancel Junction.	2

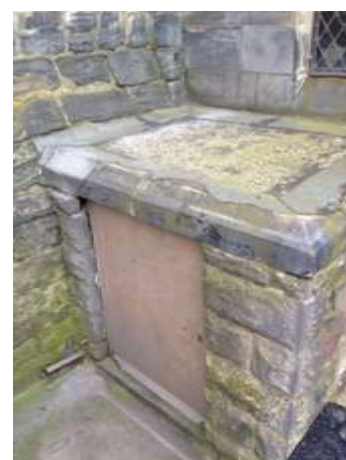
To the base of the Choir Vestry is a stone outshoot which houses the steps down to the Blower Room. The flat roof covering has deteriorated very badly and requires replacement. There is no lintel over the door to the steps and a concrete lintel should be inserted where the timber lintel has decayed. It is noted that the lower chamber, directly below the Choir Vestry is beginning to flood regularly. The drainage around this area should be investigated to determine which way it flows and to make sure that the gullies are clear.

2.14.3.	Recommendation:	Broad Budget Costs
C	• Repair lintol to blower room.	1
C	• Repair reinforced concrete bridge to vestry door.	2
C	• Replace windows to clergy vestry.	2

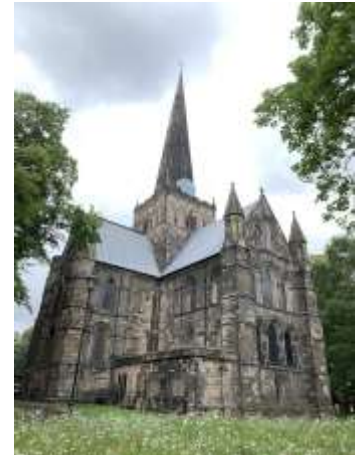
Again, the masonry is in reasonable condition. The secondary moulding to the head of the window no.16 is cracking and may fall away in small pieces. Some pinning and mortar repair may be required within the next 5 years. Window no.36 has a lot of unsightly making-good around the head of the window which should be improved in due course when the window is over-hauled.

There are ferrous fixings around the windows which should be removed. The window no.16 has a wire guard which has lots of debris trapped behind it. It is rusty and requires redecoration or renewal. There appears to be some small amount of water damage to the timbers at the junction between the Chancel and the South Transept at the eaves.

2.15.2.	Recommendations:	Broad Budget Costs
D	<ul style="list-style-type: none"> • Repair window mouldings to window 16. 	2
D	<ul style="list-style-type: none"> • Remove ferrous fixings and rusty wire guards around windows 16, 36. Make good around 36. 	2

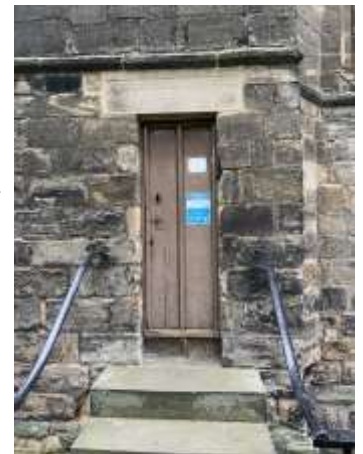
The masonry is generally in a fair condition, with the exception of some open joints on the western turret below the upper sections which has been repointed. Upper levels of masonry are beginning to deteriorate and around the turret there have been mortar repairs which appear to be failing. These are shaling and falling away – especially at strings and hoods.

2.15.4. Small repairs around the sill of window no.18 should also be factored in. There are a number of ferrous fixings around the lower windows which ought to be replaced and the stonework repaired. The door to the Turret requires redecoration.

2.15.5.	Recommendation:	Broad Budget Costs
B	<ul style="list-style-type: none"> • Conservation repairs required to masonry at high level. Especially to the moulded string courses and hood moulds. 	3
D	<ul style="list-style-type: none"> • Repair sill of window 18. 	1
D	<ul style="list-style-type: none"> • Remove ferrous fixings around lower windows to south transept south elevation. 	1
D	<ul style="list-style-type: none"> • Decorate tower door. 	1

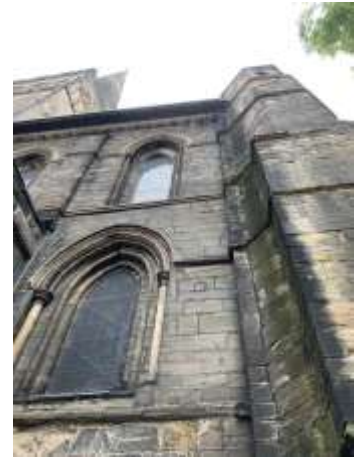
Open joints at plinth (top stage repaired 2018).

Areas around the head of window no.41 are poorly made up in black mortar and could be improved substantially. There are ferrous fixings around window no.19 which should be removed and the stonework repaired.

2.15.7.	Recommendations:	Broad Budget Costs
B	<ul style="list-style-type: none"> • Replace string course moulding stones to turret and towards lower window. 	3
D	<ul style="list-style-type: none"> • Remove ferrous fixings around window 19. 	1
E	<ul style="list-style-type: none"> • Improve mortar repairs above window 41. 	1
D	<ul style="list-style-type: none"> • Point at plinth level. 	1

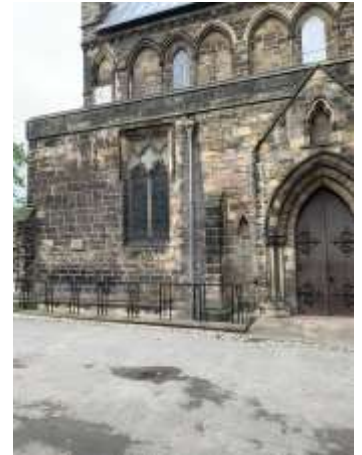
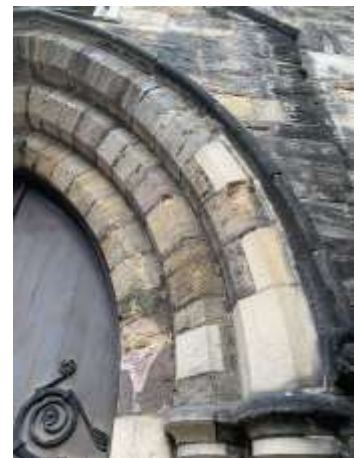
Around windows no.21 and no.20, there are again ferrous fixings which ought to be removed and stonework repaired. Generally, all of the rainwater goods require redecoration and increasing in size, since they are taking all the water from the south nave and aisle at this level.

2.16.2.	Recommendations:	Broad Budget Costs
D	• Repoint to window 22.	1
C	• Repair masonry around door mouldings.	2
C	• Remove salt and repoint cavity.	1
C	• Upgrade down pipes for capacity.	2

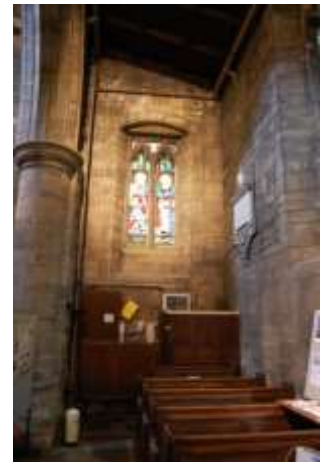
The Cottier window is of significance and would benefit from cleaning and conservation.

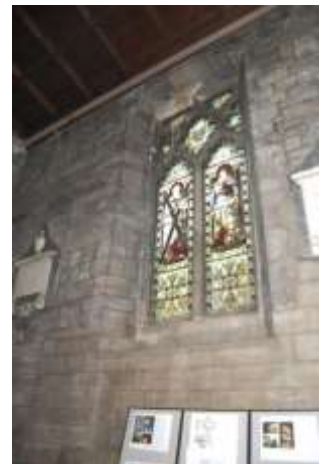
The stone work is generally in reasonable condition, although there is some evidence of salting, particularly close to the North Door. This relates to a blocked down pipe beyond. High level leak to east side of north door dripping onto the pew.

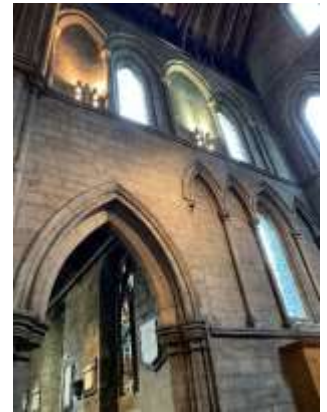
The west elevation masonry is generally in good condition. There is a cracked stone above the arch to the north aisle.

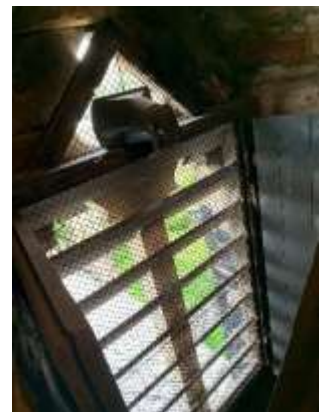
3.8.4. **Condition:**
There is evidence of previous wood-boring insect infestation in a number of the timbers and this is important to keep under review. It is understood that the end of one of the supporting beams above the entrance from the bell ringing chamber below is regularly treated with liquid wood-worm treatment, but this needs to be confirmed.

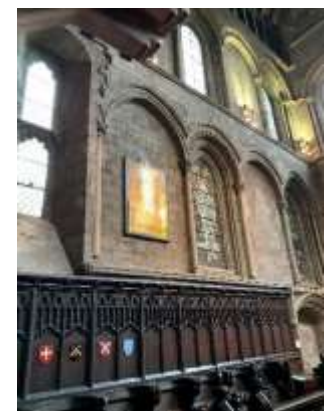
To the east there is the Easter Sepulchre. Within the arch of the niche, cement pointing has been used and this is very unsightly. Consideration should be made to completely remove the cement and repoint with lime pointing.
