ST CUTHBERT'S CHURCH

Darlington

Inspecting Architect Ulrike Knox RIBA AABC

Quinquennial Inspection Report 2024

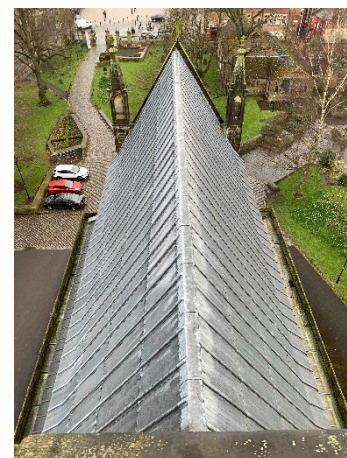
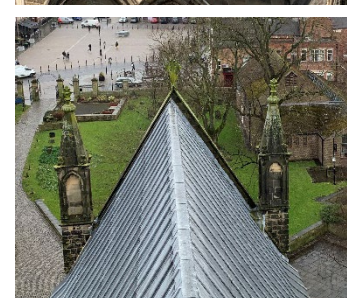
To the north slope, there is some evidence of lead slumping and the clips are likely too tight, however the condition is currently satisfactory and does not appear to have deteriorated since the 2019 inspection.

The south slope lead was renewed in 2019 and is in good condition, although a number of clips to lead sheets have popped up. These are mostly concentrated near to the tower. This may be due to heat being reflected from the stone tower onto the adjacent lead roof resulting in higher temperatures in this location which could be causing the clips to move.

Changes in climate, particularly in temperature and the frequency and intensity of rainfall, may be resulting in an increase in green algae.

2.1.3.		Nave Roof Recommendations:	Broad Budget Costs
	E	Monitor the north slope lead coverings in case cracks occur.	1
	B	Arrange for the lead clips to be fixed down to the south slope. Adjust the tolerance to allow for excess expansion if this is possible. Access to carry this out will likely require a cherry picker or a steeplejack if alternative safe access can be agreed.	2
	E	Monitor the algae to the west end stonework to check if it starts to cause defects or damage to stone.	1

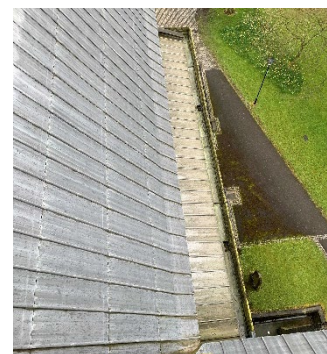
The previous inspection revealed a number of serious defects to the leadwork. The lead coverings and gutters are due to be replaced with new lead this year along with repointing to the stone parapet.

2.2.3.		North Aisle Roof Recommendations:	Broad Budget Costs
	A	North aisle lead roof coverings requires replacement.	5

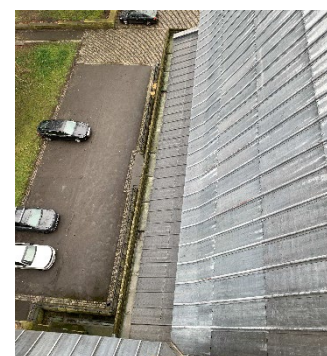
The previous inspection noted some lead splits and cracked mortar at the flashings. It is understood these were addressed, but it was not possible to check.

2.3.3.		South Aisle Roof Recommendations:	Broad Budget Costs
	B	Carry out further investigations by accessing the south aisle roof to check in closer detail for defects.	1

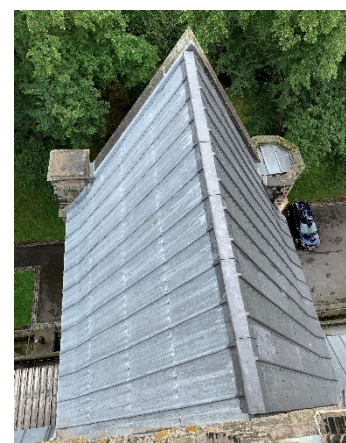
The west slope lead coverings were replaced in 2017. To the east slope, there is evidence of lead slumping, however the condition is currently satisfactory and does not appear to have deteriorated since the 2019 inspection.

Open mortar joints to the stonework to the square turret and cracked mortar fillet to the top. The sky facing surfaces to the octagonal turret parapet has moss and algae. This appears to have increased in extent from the 2019 inspection.

2.4.3.		South Transept Roof Recommendations:	Broad Budget Costs
	E	Monitor the east slope lead coverings in case cracks occur.	1
	B	Repoint the stonework to the square turret.	2
	E	Monitor the algae to octagonal turret stone parapet capping to check if it starts to cause defects or damage to stone.	1

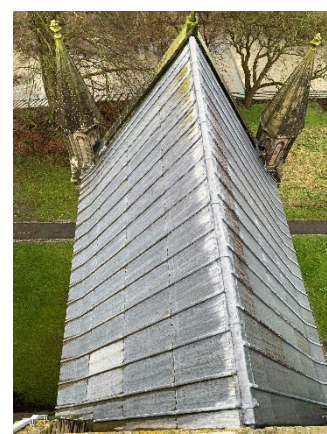
To the north slope, there is evidence of previous panel replacements to two bays. Lead slumping was not noted. The condition is currently satisfactory and does not appear to have deteriorated since the 2019 inspection.

The south slope lead was renewed in 2017 and is in good condition, although areas of rust staining have appeared since the 2019 inspection, mostly to the upper most panels at the ridge. Rust staining is not currently considered detrimental to the lead.

Open mortar joints to the pinnacles were noted, in particular to the base of the north east pinnacle where it meets with the roof and inside face of the gable. *Following the inspection, the churchwarden reported that water was noted on the floor to the north east corner which may be a result of the above defects.*

The cross and several sky facing surfaces to both the pinnacles and the copings are green with algae and moss in several areas. This appears to have increased in extent from the 2019 inspection.

2.5.3.		Chancel Roof Recommendations:	Broad Budget Costs
	A	Investigate around the north east pinnacle at the base for potential water ingress. Carry out repairs to stonework and/or lead. Access to carry this out will likely require a cherry picker or a stepladder if alternative safe access can be agreed.	2
	C	Repoint open joints to stonework to pinnacles.	2
	E	Monitor the algae and moss to the east end stonework to check if it starts to cause defects or damage to stone.	1
	E	Monitor the north slope lead coverings in case cracks occur.	1

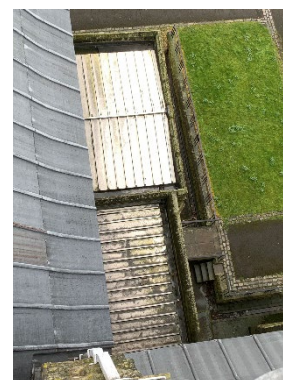
Generally reasonable condition. The Choir Vestry roof has accumulations of debris and leaf mould which should be cleaned off to allow effective discharge of rainwater.

2.6.3.		Vestry Roofs Recommendations:	Broad Budget Costs
	M	Clean the Choir Vestry roof of debris and leaf mould.	1

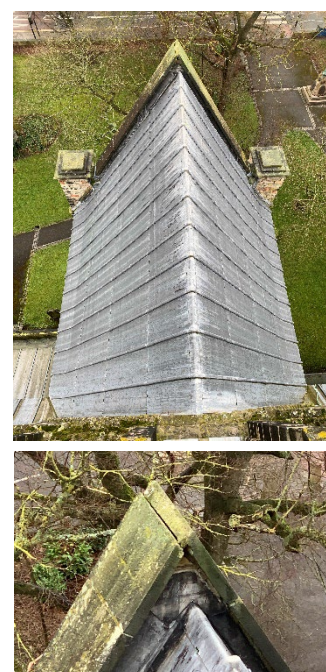
There is evidence of lead slumping to both the east and west roof slopes, however the condition is currently satisfactory and does not appear to have deteriorated since the 2019 inspection.

Following the inspection, the churchwarden reported that water was noted on the floor by the column at the end of the north aisle at the junction with the north transept. It is not clear if potential water ingress is at north transept roof level or at north aisle roof level. Further investigation is required.

There is a large open mortar joint to the coping apex. The west turret has remnants of plants growing out of the top of it. There are open joints to the sky facing stone tabling to both turrets and eroded stone to the east turret to the south east corner.

2.7.3.		North Transept Roof Recommendations:	Broad Budget Costs
	A	Investigate for potential sources of the water ingress around the north west corner of the tower. Access to carry this out will likely require a cherry picker or a steeplejack if alternative safe access can be agreed.	2
	E	Monitor the lead coverings in case cracks occur.	1
	A	Remove vegetation from west turret.	1
	A	Repoint open mortar joint to apex of gable.	1
	A	Repoint open mortar joints to sky facing stonework to both turrets.	1
	E	Monitor stone erosion to east turret.	1

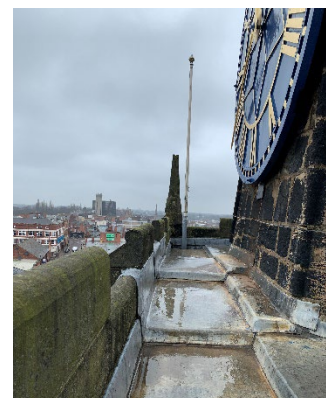
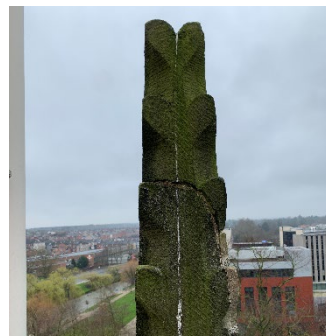
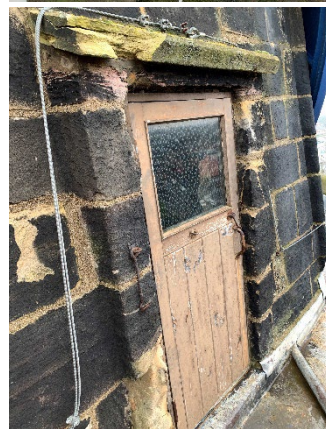
The lead roof covering are in fair condition generally. There are some cracks to cover flashings in several places; to the inside face of the parapet; and to the base of the spire.

The parapet stonework has some open joints and cracked mortar. The pinnacles have cracks requiring repair.

The paint to the door is flaking revealing bare timber. The stone moulding above the door is damaged and a large section has broken off.

2.8.3.		Roof/Parapet to the base of the Spire Recommendations:	Broad Budget Costs
	B	Repair and redecorate the door.	1
	B	Repair the stone moulding above the doors with new indent.	1
	B	Repair cracks in pinnacles, inserting stainless steel dowels.	1
	B	Repoint open joints and cracked mortar to parapet walls.	1
	B	Repair the split lead to the cover flashings.	1

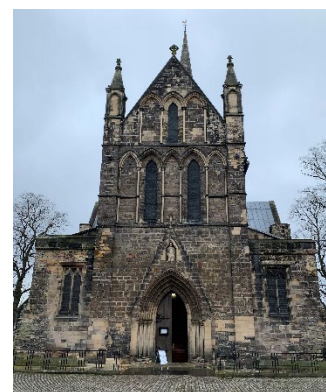
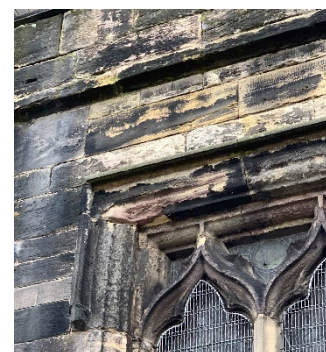
The masonry to the west end is generally in good condition but there are areas with open joints and defective mortar. There is some evidence of opening up of the joints over the central blind arcaded lancets underneath window no.59. This should be repointed and monitored.

The outer hood mould of the doorway has some open joints. Open joints and moss growth to the north and south aisle copings. Open joints and eroded stone to the west end of the south aisle. There is a multi-fractured glass pane to the top panel of the window to the south aisle.

There are areas of unattractive cement pointing which will do eventual long-term damage to the stonework. This should be removed.

2.9.3.		West Elevation Recommendations:	Broad Budget Costs
	B	Rake out and repoint open joints over lancets to blind arcade. Monitor for potential opening up.	1
	C	Point hood mould above west door.	1
	C	Point coping stones.	1
	B	Repoint at west end of south aisle above window upto parapet.	1
	E	Repair/replace fractured glass to window to the south aisle	1
	E	Remove cementitious pointing and repoint in lime based mortar.	3

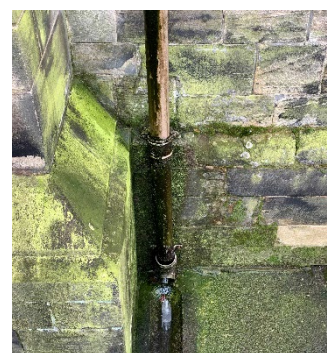
There are ferrous fixings in the stone window jambs to each of the 3no windows. These should be removed and pointed up. The glazing is protected with polycarbonate sheets and wire guards. The polycarbonate is visually distracting.

2.10.3.		North Aisle Elevation Recommendations:	Broad Budget Costs
	A	Repair splits and loose joints to downpipes – consider upgrading to next size up.	2
	A	Clean out blockages to pipes and gullies and maintain free flow.	1
	B	Repoint open joints to parapets and low level stone	2
	B	Repair and redecorate the north door.	2
	D	Decorate all rainwater goods to be consistent colour.	2
	E	Remove ferrous fixings and upgrade window protection to powder coated stainless steel.	2
	E	Monitor the algae to stonework to check if it starts to cause defects or damage to stone.	1

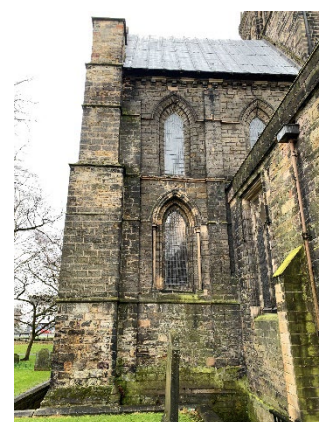
Low level stonework to the plinth has extensive areas of green algae within the dry moat.

2.12.3.		North Transept West Elevation Recommendations:	Broad Budget Costs
	D	Overhaul window 43 and stone surround.	2
	D	Repair sill and jamb to window 4.	2
	E	Monitor the algae to stonework to check if it starts to cause defects or damage to stone.	1

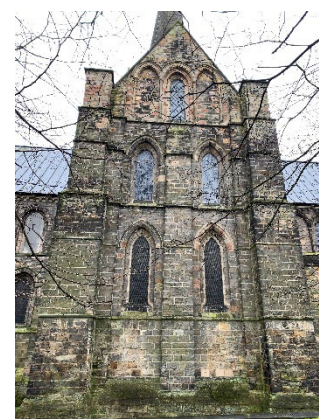
Low level stonework to the plinth has areas of green algae.

2.12.5.		North Transept North Elevation Recommendations:	Broad Budget Costs
	B	Repoint open joints to upper stages of the gable.	2
	D	Monitor stone deterioration at the upper stage of the gable.	1
	E	Monitor the algae to stonework to check if it starts to cause defects or damage to stone.	1

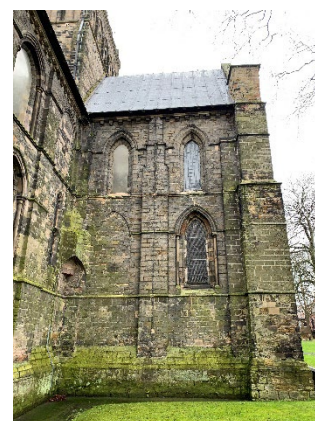
Low level plinth stonework has areas of green algae.

2.12.7.		North Transept East Elevation Recommendations:	Broad Budget Costs
	D	Overhaul windows 7 & 47.	3
	D	Remove redundant ferrous fixings to window 7 stonework and repair the holes.	1
	E	Replace unsightly polycarbonate window covering with black powder coated stainless steel mesh window guard.	1
	E	Monitor the algae to stonework to check if it starts to cause defects or damage to stone.	1

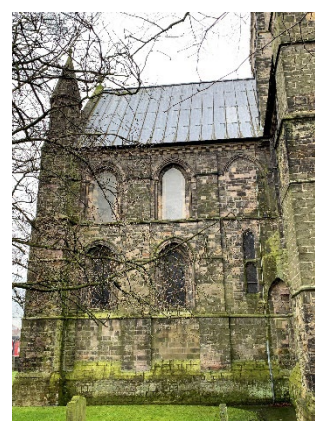
There are several areas of green algae to stonework; to the buttress at the east corner; to the projecting stonework in the corner at the junction with the east elevation of the north transept; window sills and string courses; and to the low level plinth within the dry moat.

2.13.3.		Chancel North Elevation Recommendations:	Broad Budget Costs
	C	Repair stonework to jambs to windows 10 & 11.	2
	E	Replace unsightly polycarbonate window covering with black powder coated stainless steel mesh window guards to windows 34 & 35.	2
	E	Monitor the algae to stonework to check if it starts to cause defects or damage to stone.	1

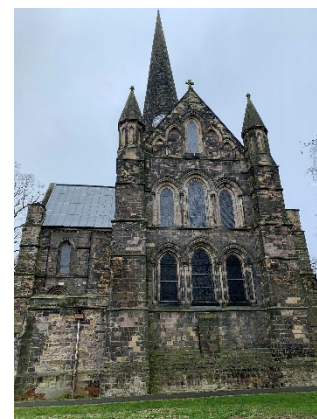
The rainwater down pipe has flaking paint. The area of stonework around the pipe outlet at ground level is damp.

2.13.5.		Chancel East Elevation Recommendations:	Broad Budget Costs
	C	Point high level stonework to gable apex.	3
	C	Redecorate hopper head and downpipe to Vestry east elevation.	1
	C	Remove cementitious mortars and repoint vestry wall.	2
	D	Remove ferrous fixings around windows and make good holes.	1

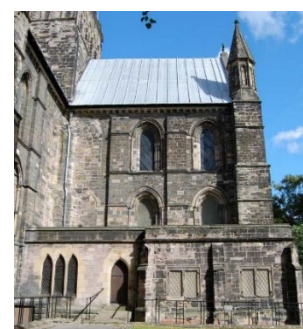
Windows no.25 and no.26 have unsightly polycarbonate coverings with fixings that are poorly screwed into the stonework and are rusting.

2.13.7.		Chancel South Elevation Recommendations:	Broad Budget Costs
	C	Repair stonework around window 26.	1
	E	Replace unsightly polycarbonate window coverings with black powder coated stainless steel mesh window guards to windows 25 & 26.	2

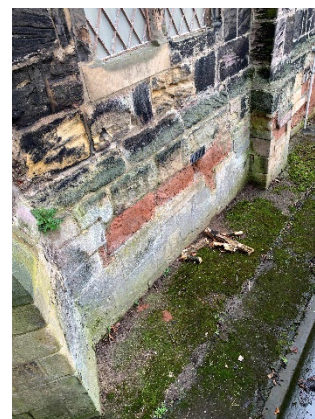
The stonework shaling at plinth level in particular to the red coloured stonework. Stonework is eroding to the buttress at the west and above/below window no.14.

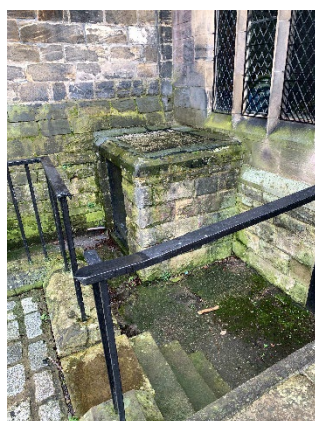
The wall around the downpipe behind the buttress is green with algae but it is not thought this is due to a leaking pipe, but a dark corner that gets little opportunity to receive sunshine and dry out.

2.14.5.		Vestry South Elevation Recommendations:	Broad Budget Costs
	C	Repoint walls and repair stonework to Clergy Vestry wall.	2
	C	Replace the roof to the blower room structure.	1
	C	Repair the bridge to choir vestry door.	2
	E	Monitor the algae to stonework to check if it starts to cause defects or damage to stone.	1

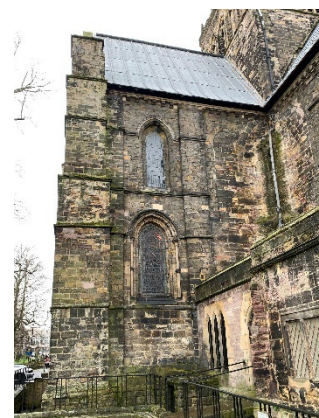
There is a large amount of green algae to the chamfered wall at the junction with the south elevation of the chancel. The lead downpipe may be leaking and discharging water onto the wall.

2.15.3.		South Transept East Elevation Recommendations:	Broad Budget Costs
	A	Investigate if the downpipe is leaking and repair to prevent water discharging onto the stonework.	1
	D	Repair window mouldings to window 16.	2
	D	Remove ferrous fixings around windows 16 & 36. Make good mortar fillets around 36.	2

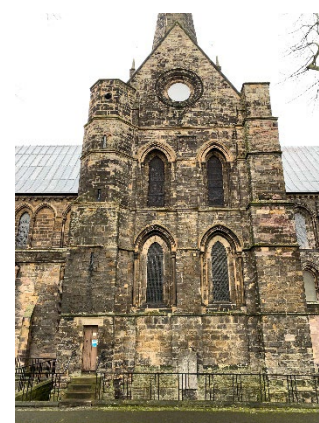
There are also ferrous fixings around the lower windows which should be removed. The door to the Turret has peeling paint revealing bare timber.

2.15.5.		South Transept South Elevation Recommendations:	Broad Budget Costs
	B	Conservation repairs required to masonry at high level, especially to the moulded string courses and hood moulds.	3
	D	Repair sill of window 18.	1
	D	Remove ferrous fixings around lower windows.	1
	D	Decorate the tower door.	1

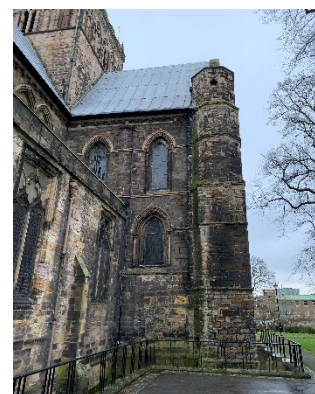
There are areas of poorly executed black mortar around the head of window no.41. There are ferrous fixings around window no.19 which should be removed and the stonework repaired.

2.15.7.		South Transept West Elevation Recommendations:	Broad Budget Costs
	A	Alter the roof detail to prevent water discharging down the wall.	2
	B	Replace string course moulding stones to the turret.	3
	D	Remove ferrous fixings around window 19.	1
	E	Improve mortar repairs above window 41.	1

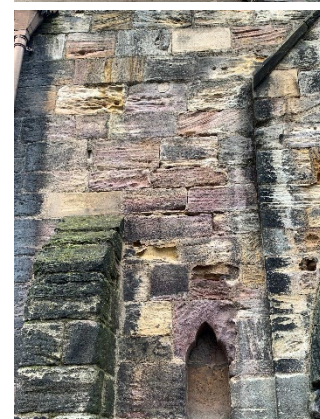
There are two rainwater pipes and hoppers. Pipe joints to the eastern downpipe are leaking.

2.16.3.		South Aisle Elevation Recommendations:	Broad Budget Costs
	D	Repoint to window 22.	1
	C	Repair masonry around door mouldings.	2
	B	Repair and redecorate rainwater goods	1
	C	Upgrade down pipes for capacity.	2
	E	Remove polycarbonate and upgrade window protection to powder coated stainless steel grilles.	2

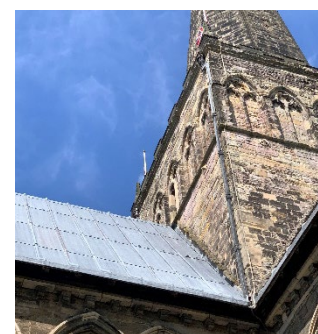
The moulding following the roof pitch line above the lead abutments is eroding with sections of stone missing, meaning that water will not be shed effectively from them. It is not possible to inspect closer to check this detail with the lead roof cover flashings.

2.18.3.		Tower Belfry Elevations Recommendations:	Broad Budgets Costs
	E	Monitor stone erosion to the tower walls.	1
