Diocese of Durham

**DENESIDE ALL SAINTS
SEAHAM**
(94)

QUINQUENNIAL REPORT
on the architect's inspection on

14 June 2017

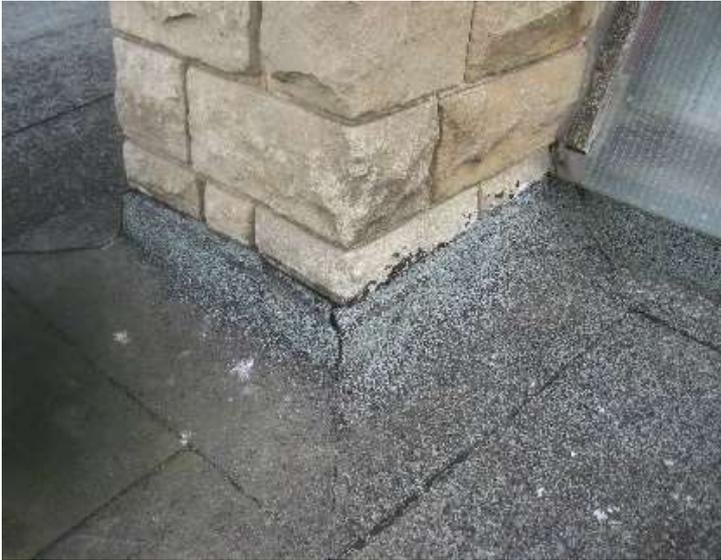
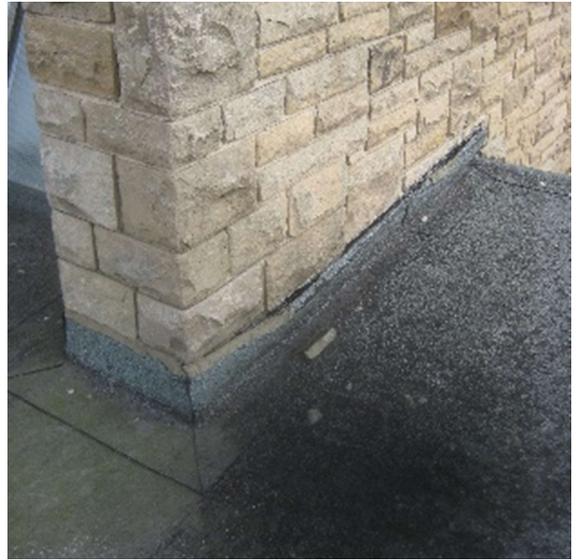
8. The single large monopitch is covered in green mineral felt with kerbs at the rooflights, low upstands at the side verges and an integral gutter at the bottom edge with two outlets.
9. Felt condition is generally good but at the top it is not well turned and pointed into the stone walls flanking the Sanctuary. Parts of the felt upstands are loose from the stone, especially at the S side facing the sun. Inside leaks show as water marks on the stone. New cover flashings or new felt turned at least 25mm into deeper joints and pointed would make the roof watertight.

Remake the felt roof upstands around the stone walls	9
Renew lost fixings around four rooflights	11
Renew felt in the main roof gutte and the timbers under its N end, remove barbed wire and repaint both W pipes	12, 17
Renew the damaged part of the lead cap on the S stone wall	24

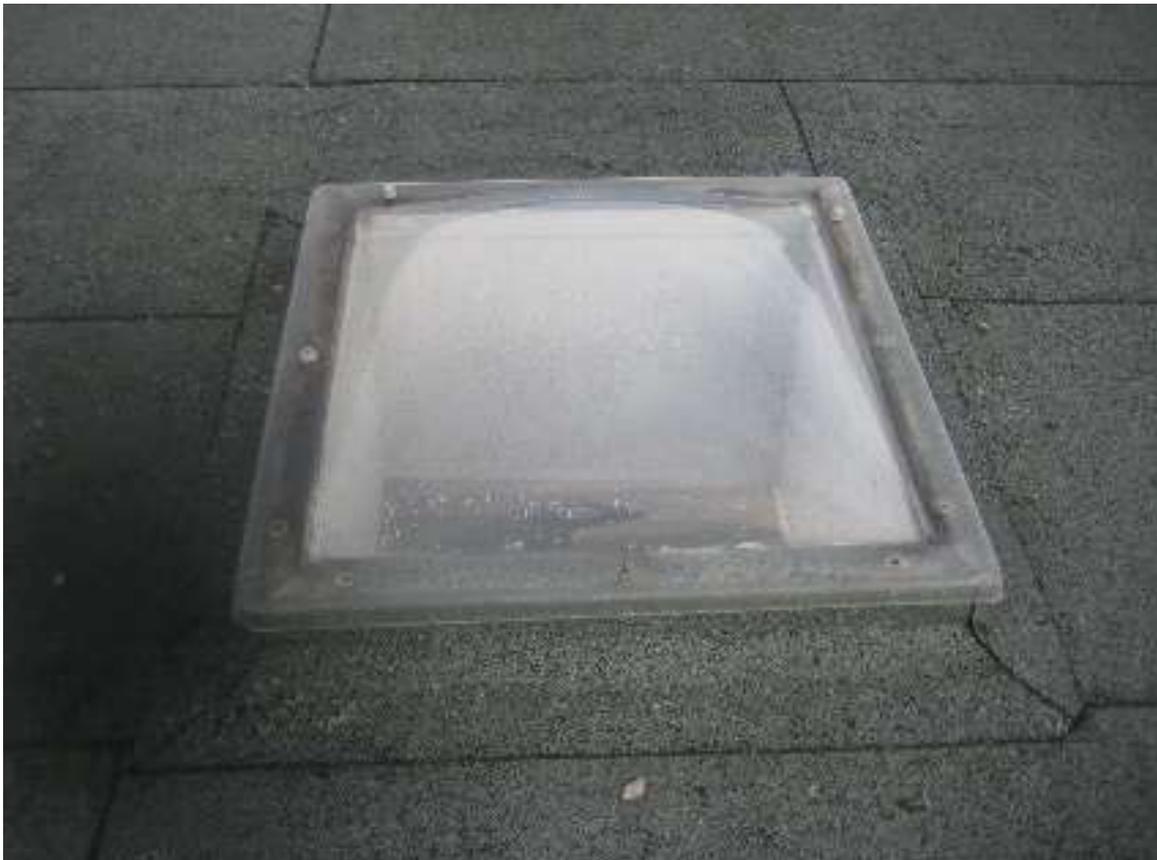
3, 4, 5, 6, 11, 12, 13, 15, 16, 19	old and clouded but sound looking except 16 and 19 have cracked corners 5 and 12 have each lost two fixings 11 has lost caps from fixings 15 has lost four fixings
------------------------------------	--------------------------------------------------------------------------------------------------------------------------------------------------------------------------------

typical rooflight – missing fixings

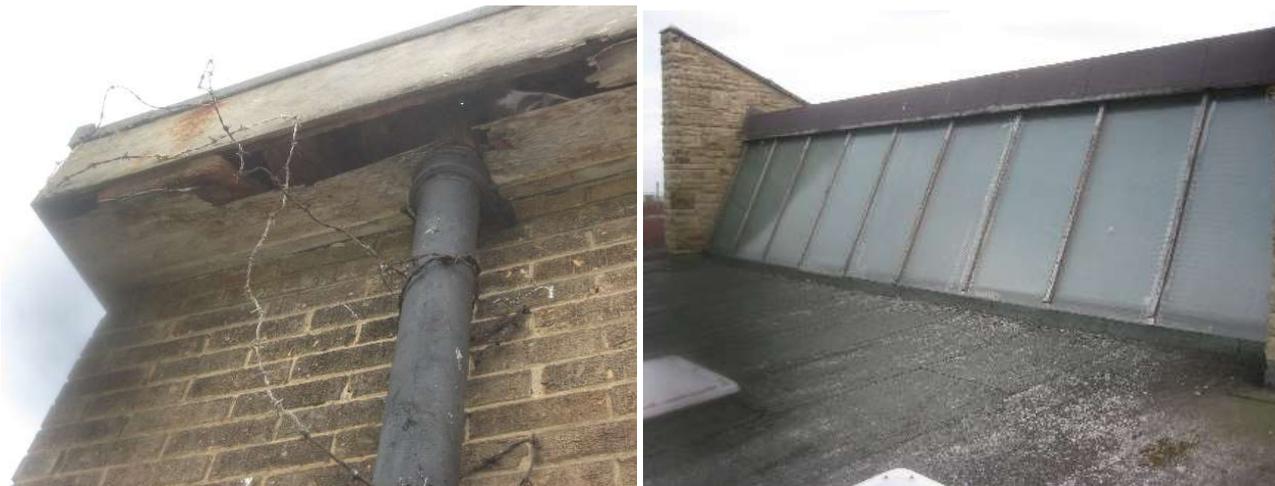
12. The integral felt gutter is mainly fair but there is a hole in the felt by the N pipe. The timber framing must be wet and the board soffit under the gutter has collapsed. A point of daylight can be seen through the felt.

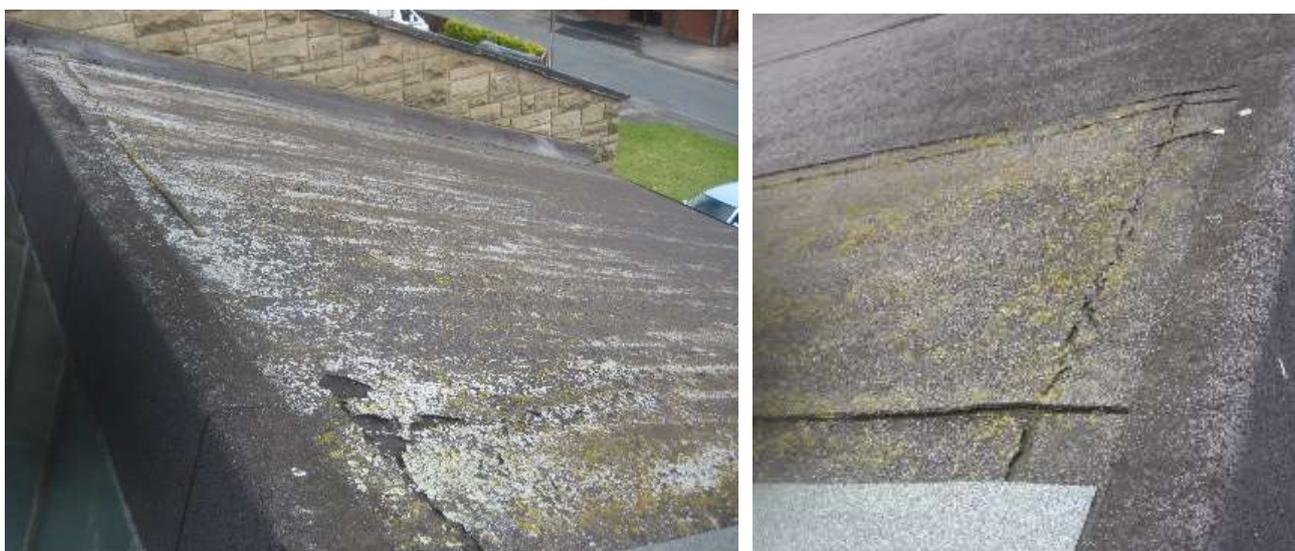
16. The steeper black mineral felt over the Sanctuary seems much older. It is very visible to the approach. It has been patched in different colour where formerly cracked down its centre. The felt each side is holed. No visible leakage yet. At least for appearance it should all be recovered soon.

Strip Sanctuary felt roof and recover with Sarnafil or other high quality membrane and refurbish gutter and pipes	16, 18, 74
Paint the bell bracket	25

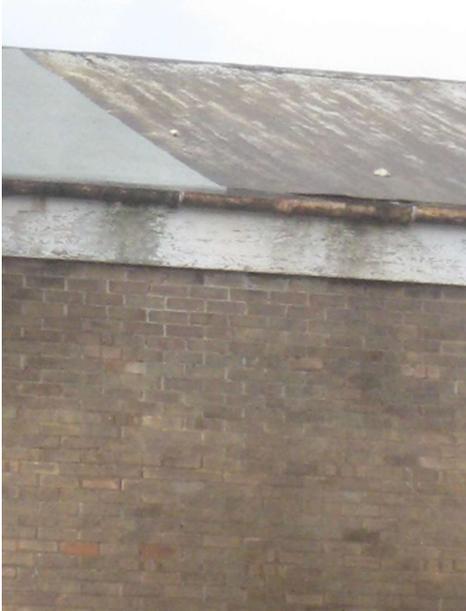
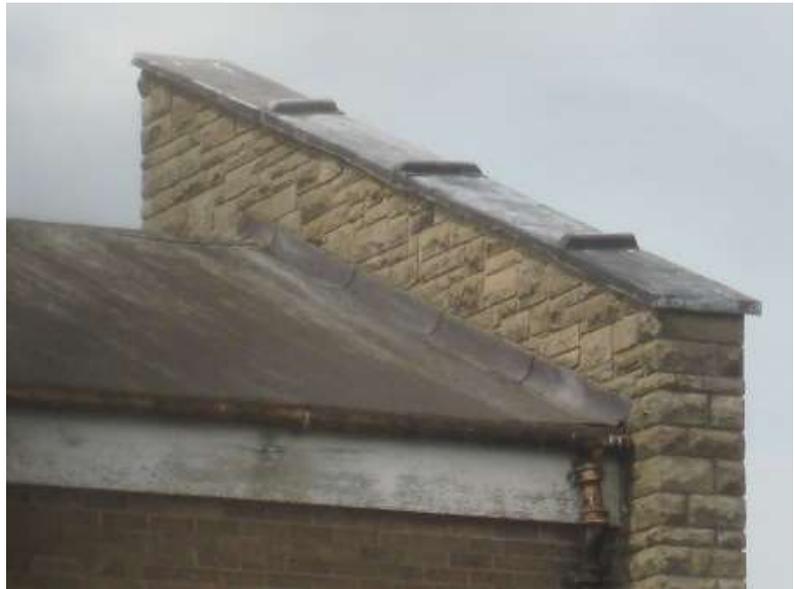
17. At Nave NW and SW sound cast iron pipes drop from the integral felt gutter to gullies which also take the Kitchen and basin wastes. Patchy anti-climb paint, very poor paint with some rust and barbed wire wrapped round the pipes all look poor.
18. The Sanctuary roof has a large half round cast iron gutter with cast iron downpipes at each end, sound except the bottom of the NE pipe is missing. The gutter paint is poor. The S gutter outlet and fascia board appear green with damp. Both gullies seem blocked.

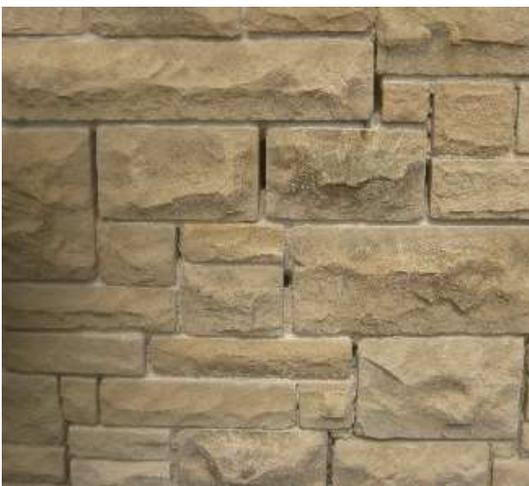
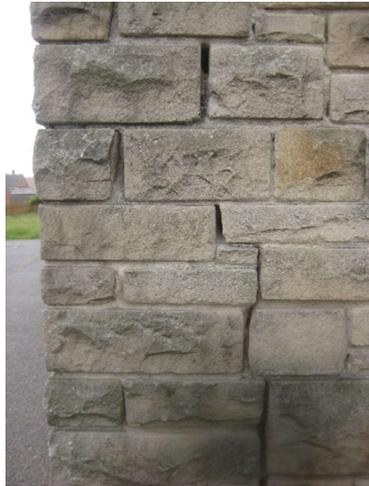
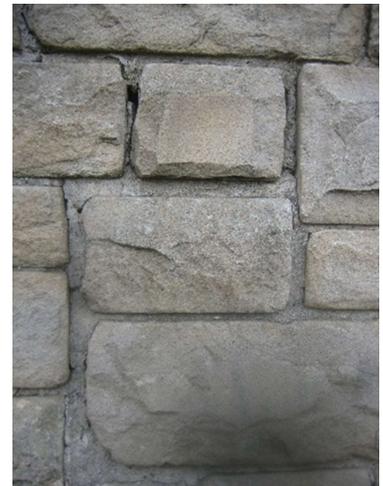
23. The rock faced squared random sandstone walls flanking the Sanctuary are sound but the soft pointing is recessing on all sides, especially at high and low levels, and needs raking and repointing to match.

Stain or oil the cover strips on the Sanctuary glazing	14
Reposition one slipped pane over the Sanctuary and close all stainless steel bottom clips	15
Fill with lime mortar all open joints in the brick and stone work and repoint the stone walls generally	22, 22, 23, 42
Repair and paint the ply fascias or replace them with upvc	26, 74
Replace the failing timber SE escape door	29, 63
Obtain electrical Periodic Test Report in 2018	55 & Addendum

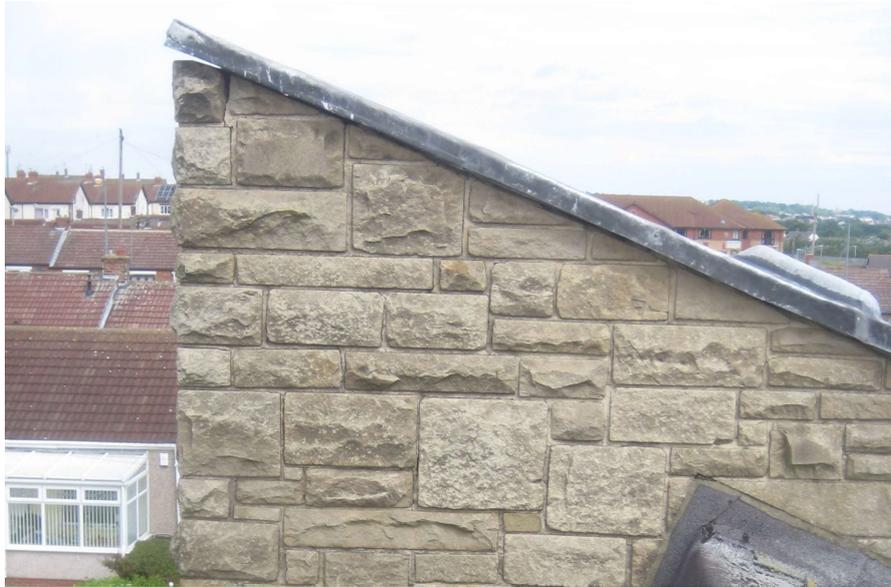
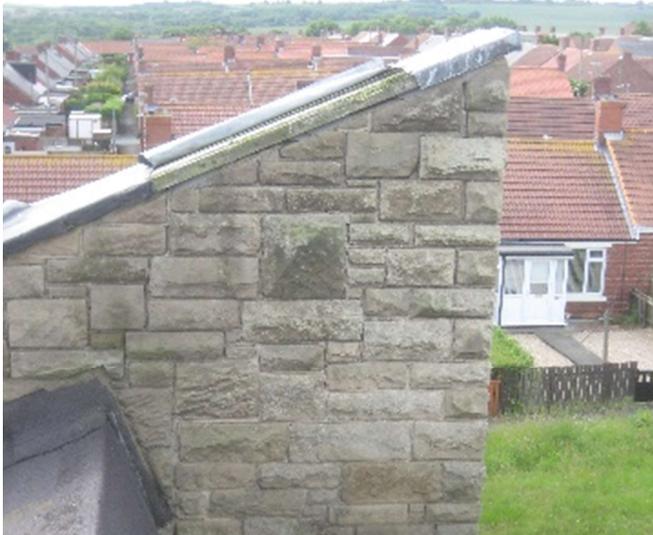
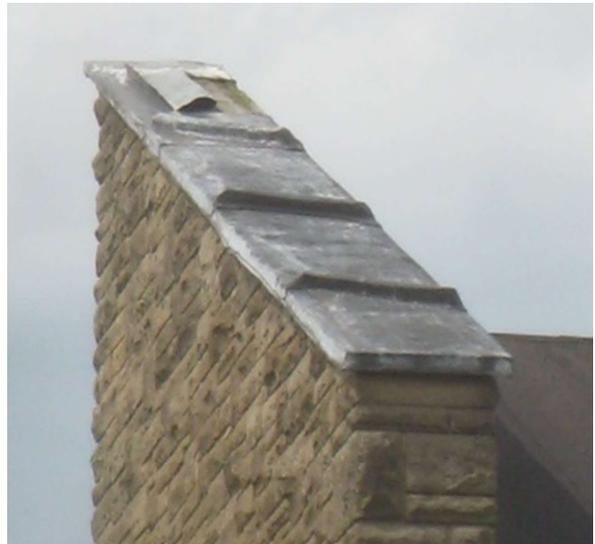
para 24

24. The stone walls are capped with steeply sloping boards covered with zinc or lead on diagonal roll joints. The top of the S cap has been torn and folded back by wind and needs renewal.

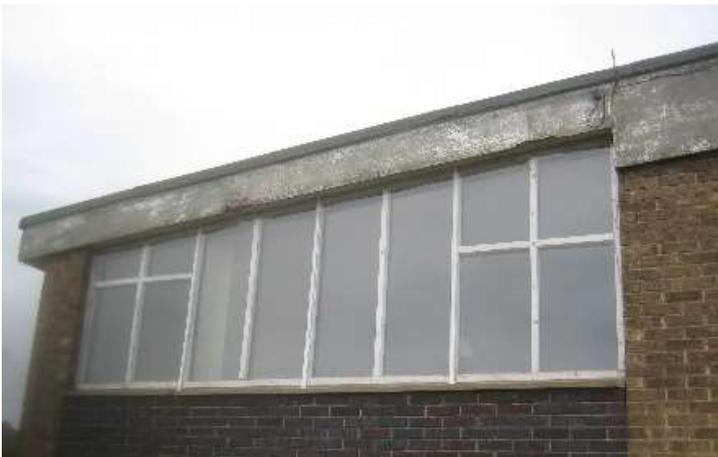
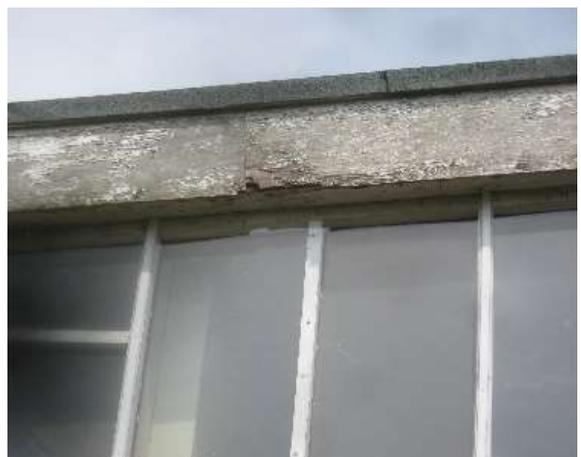
26. Weathered paint at the deep fascias on all sides looks very poor. Most ply seems sound but rot has begun over the S windows. The NW corner badly damaged by gutter leak (para 12).

Maintenance of the ply would be reduced if changed to upvc or stripped and stained rather than painted.

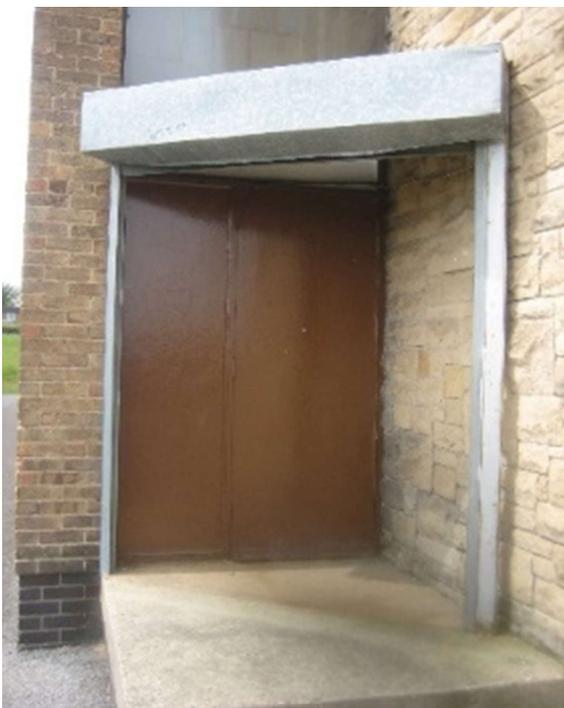
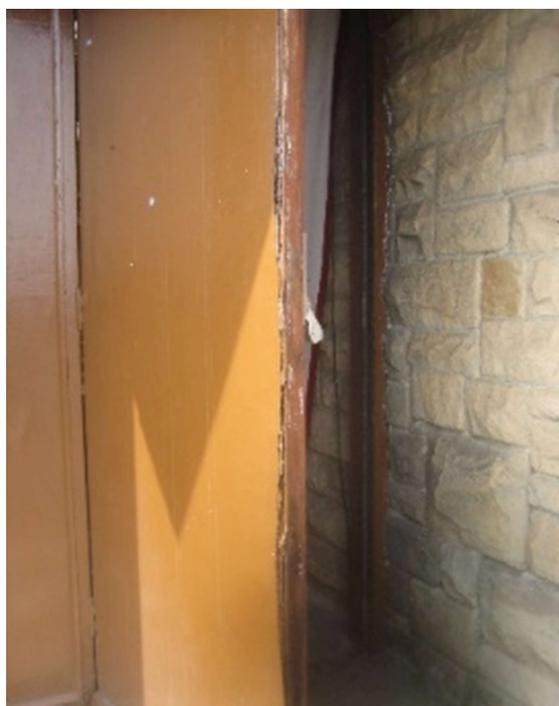
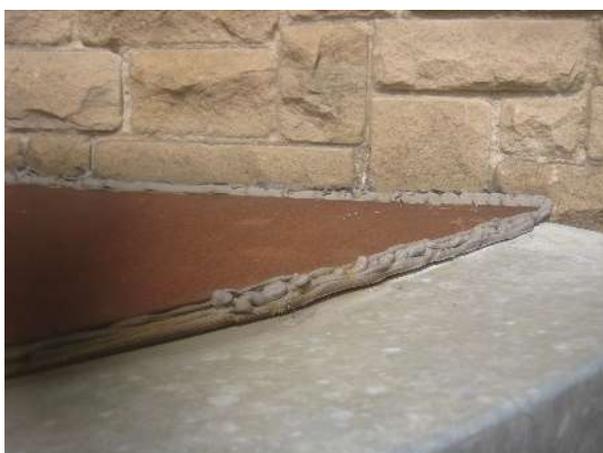
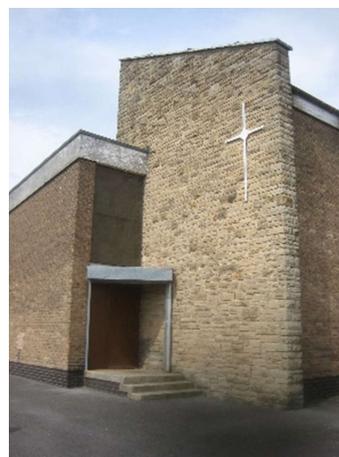
27. Former side screens and fanlight at the W entrance doors have been removed and bricked up. Doors sound stained flush ply with brass ironmongery. The leading door drags on the floor. The galvanised external shutter box begins to rust.
28. Escape doors and side panels at SE and NE are plain painted ply with aluminium panic bars. Painted ply overpanels concealed by motorised galvanised roller shutters, slight rust.
29. The face of the SE door and its weathermould are water damaged and coming loose making it hard to close. The NE door is unpainted inside and has no weathermould.
