QUINQUENNIAL INSPECTION REPORT

CHURCH OF THE ASCENSION

SEASIDE LANE, EASINGTON COLLIERY, COUNTY DURHAM, SR8 3PG

v.2 | APRIL 2022

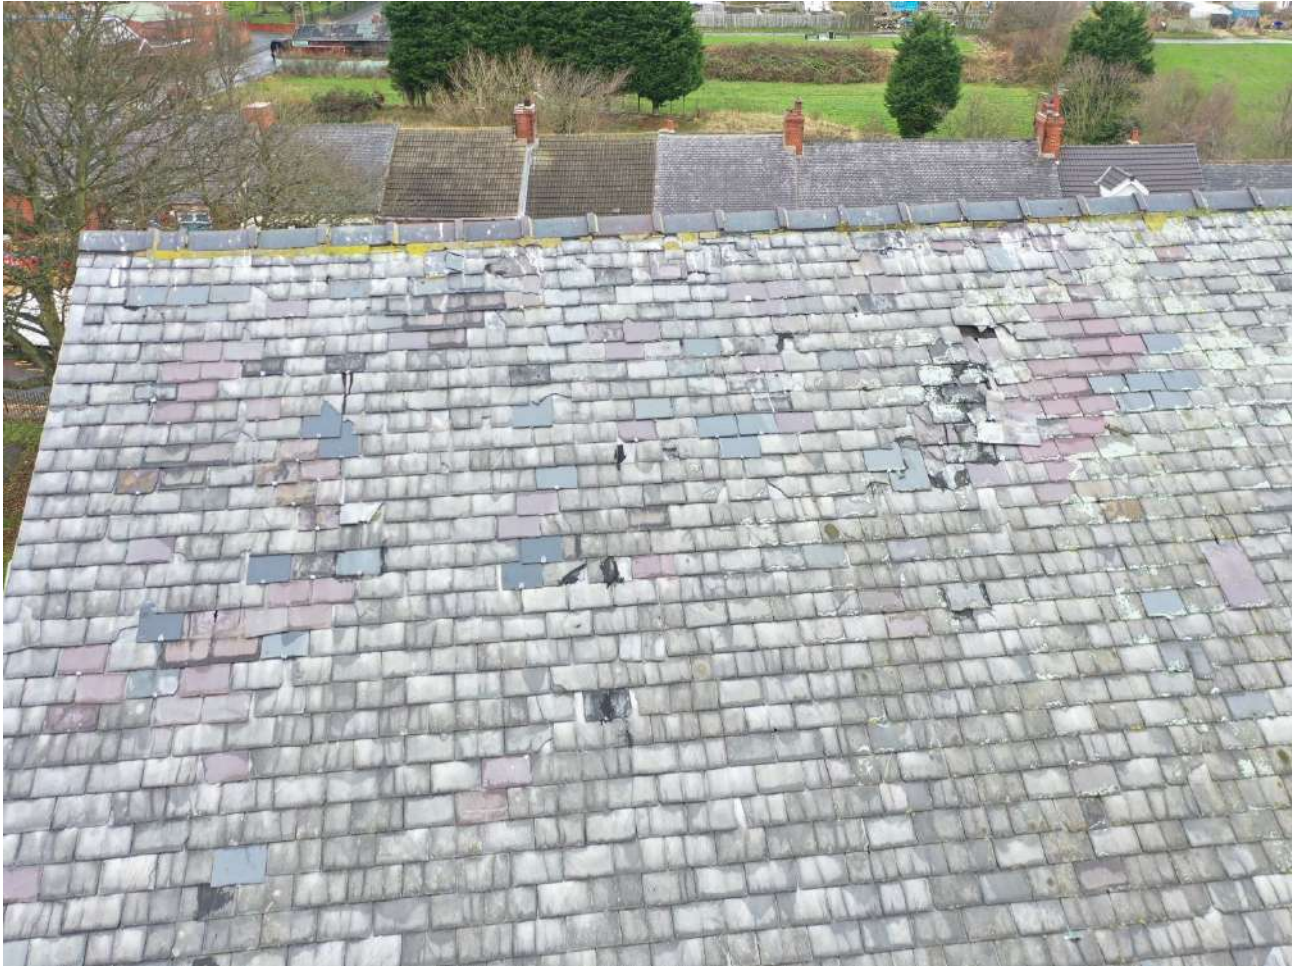
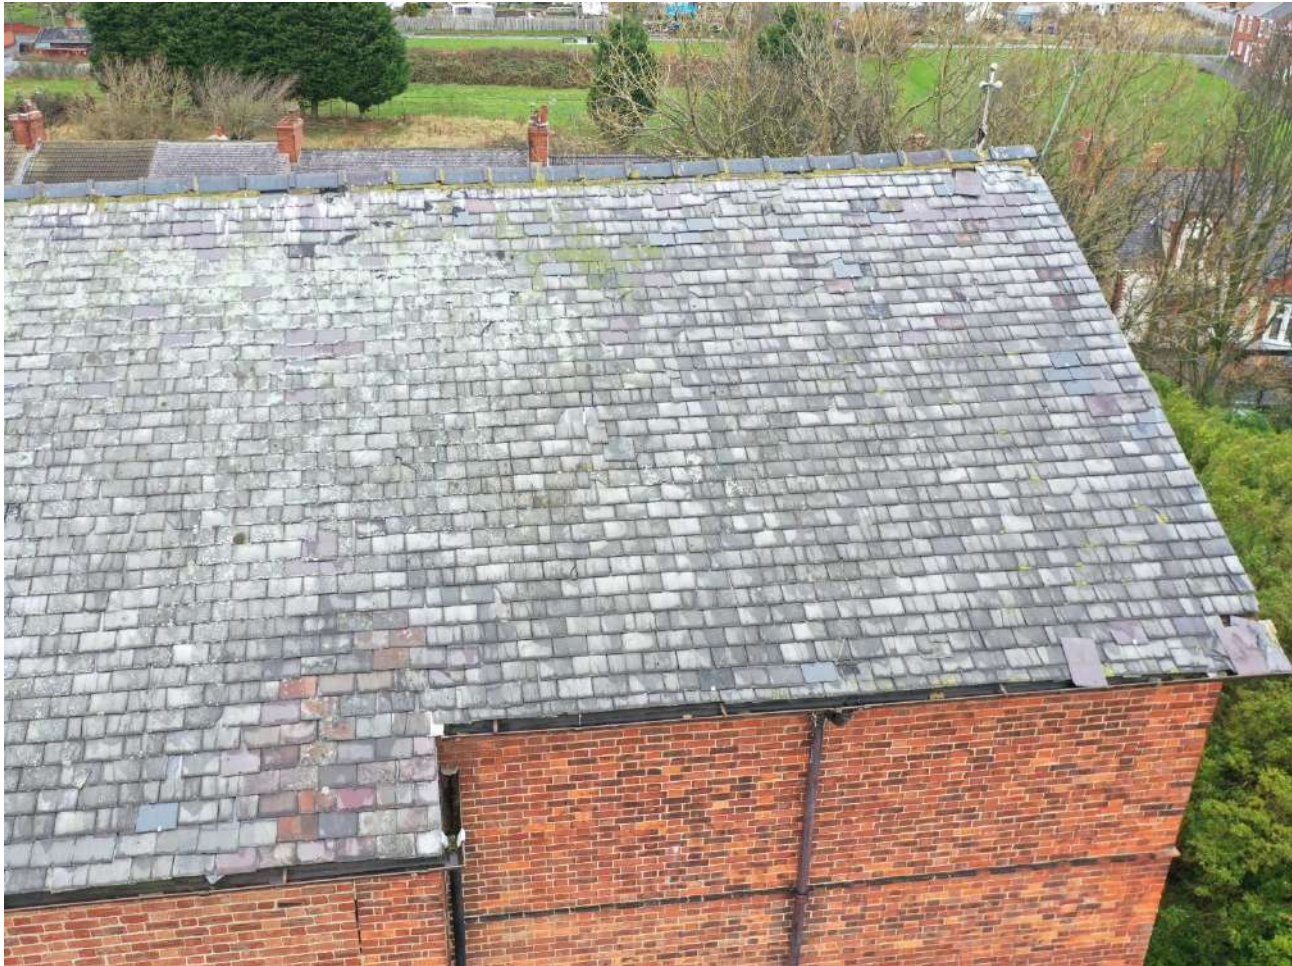
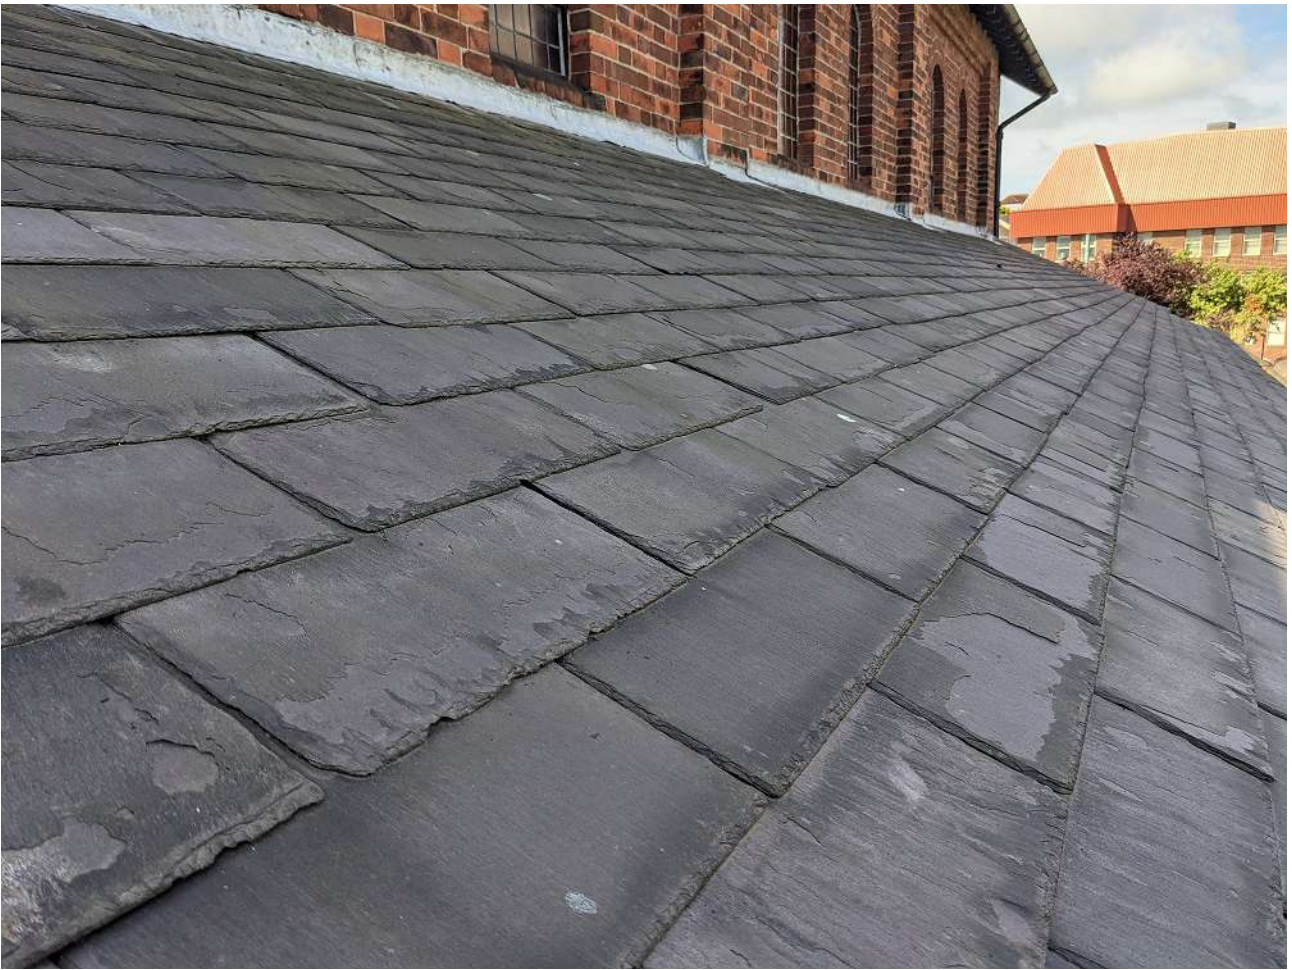
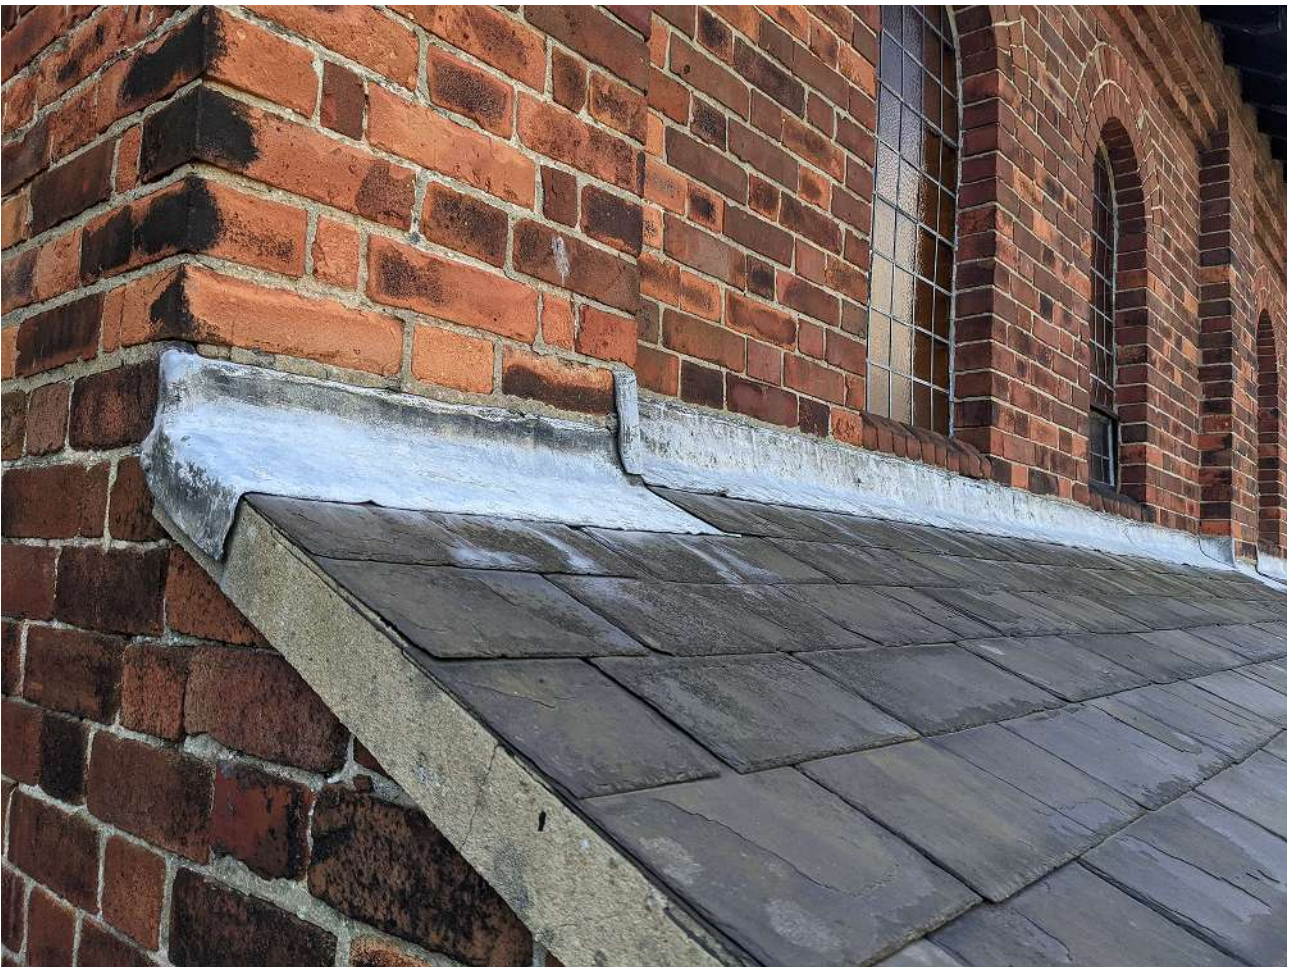
The south side of the main roof is particularly poor where there the slating is very untidy. There are signs of considerable patches of repair noted, mainly concentrating at the west end which is presumed to be of greatest risk of wind uplift. Elsewhere across the south slope there are numerous incidents of slipped, missing and/or cracked slates.

The north side in appearance is in better condition although still prevalent are numerous incidents of slipped, missing and/or cracked slates. It is clear that the existing condition of the roof covering is highly susceptible to storm damage and in a parlous state.

A well-maintained roof covering should last up to 150 years. The roof covering here is understood to be the original roof now approaching 95 years old. The signs of repeated damage indicate a failing in nail fixings which in turn is accelerating damage to the slates that are ageing. Fixings with ordinary steel nails may be susceptible to rust due to the proximity to the sea, vulnerable therefore to corrosion from the salty air. The roof also is in a very exposed position, sat unprotected on a raised position within the church grounds. The PCC may feel that they are already at the point where repeated attempts to patch repair is no longer the best way financially going forward and a full strip and reslating of the roof covering is wise.

R0	It is recommended that a specification and schedule of work is drawn up for full recovering of the nave and chancel Welsh slate roofs.
R1	3.1.2 Carry out roof recovering of the nave and chancel Welsh slate roofs by a competent and experienced roofing contractor.

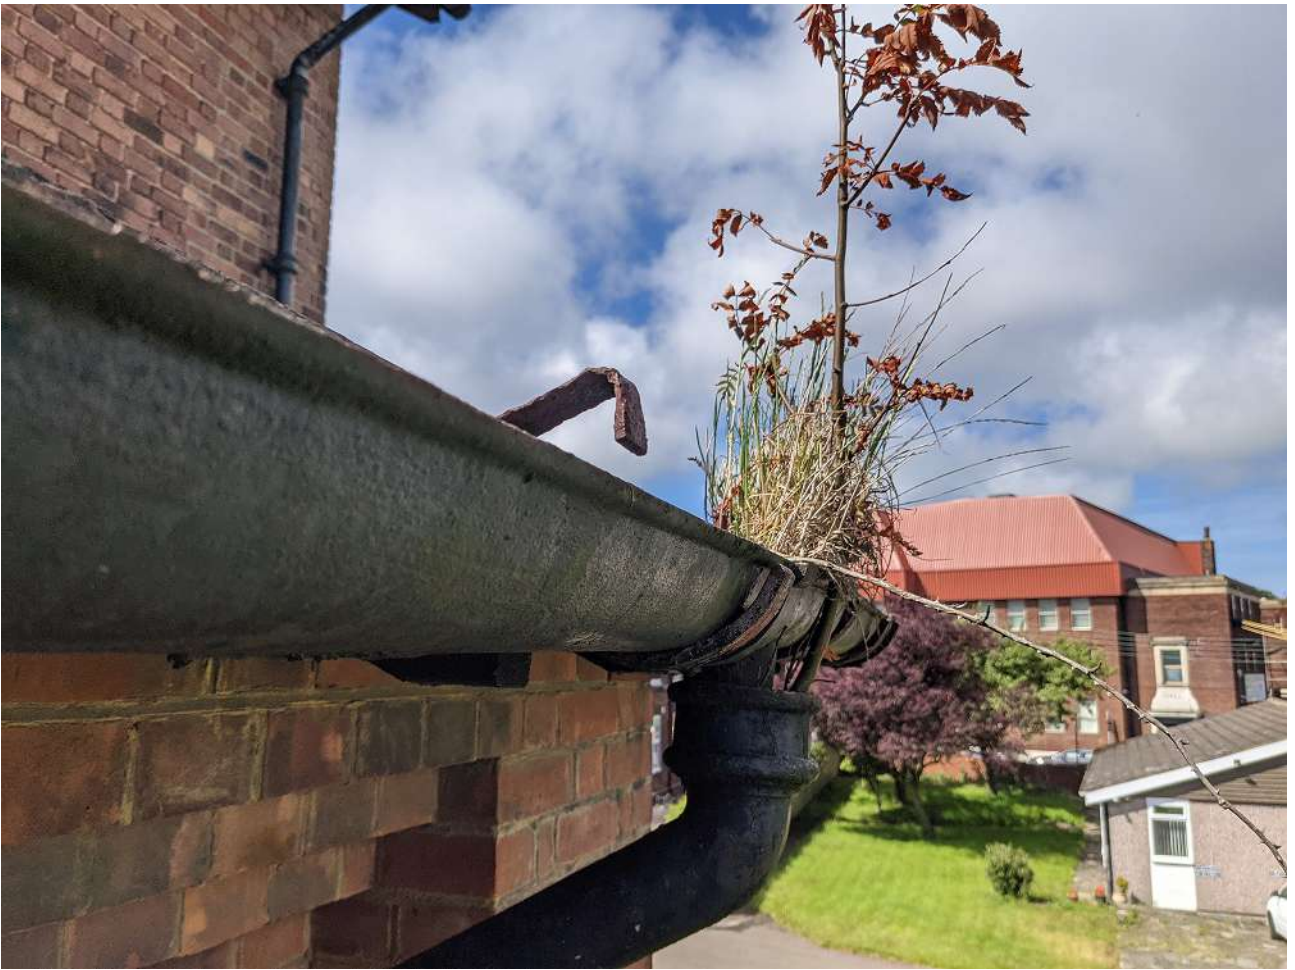
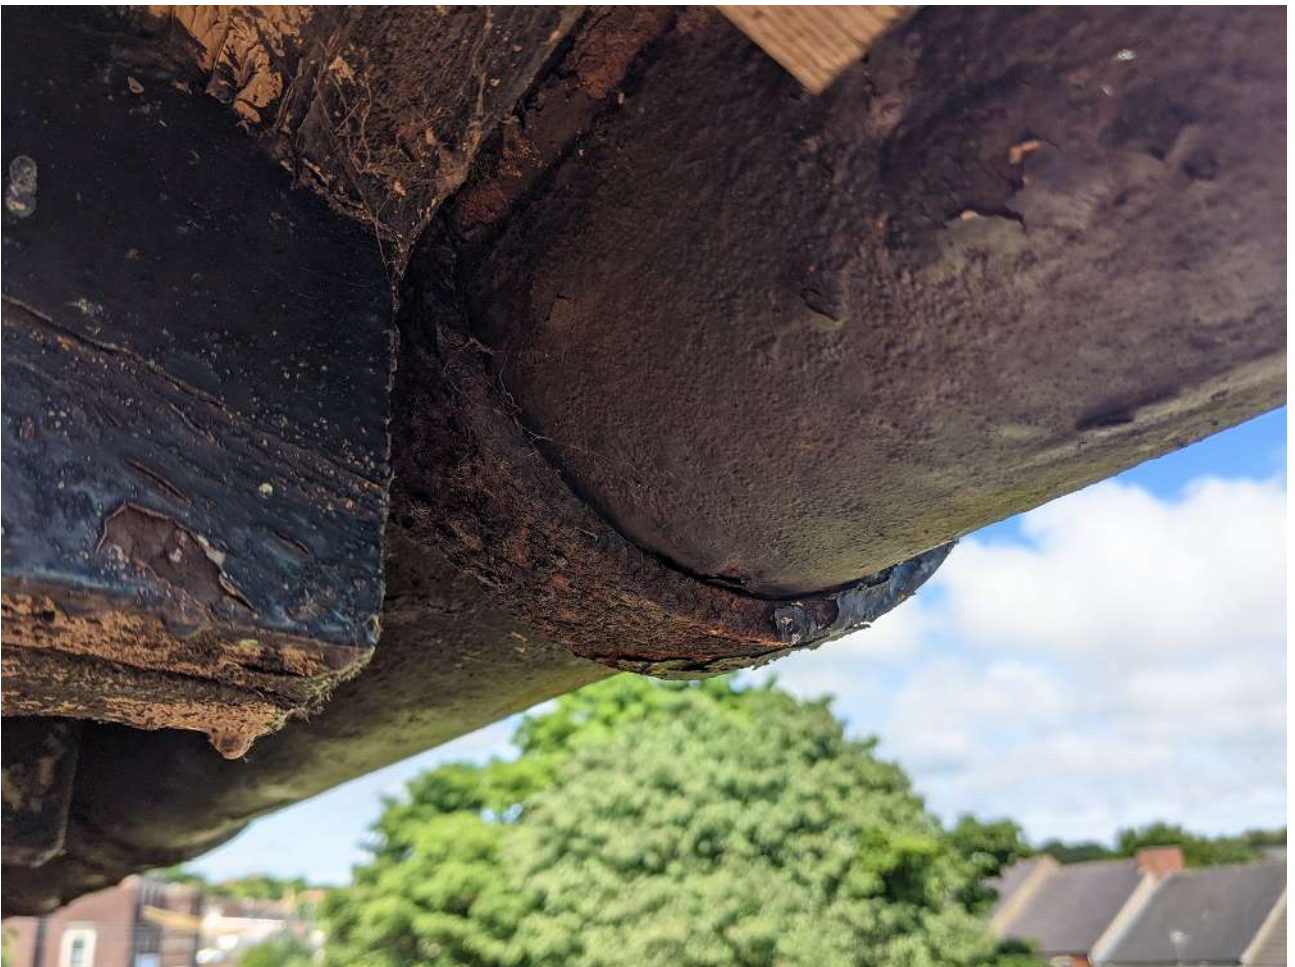
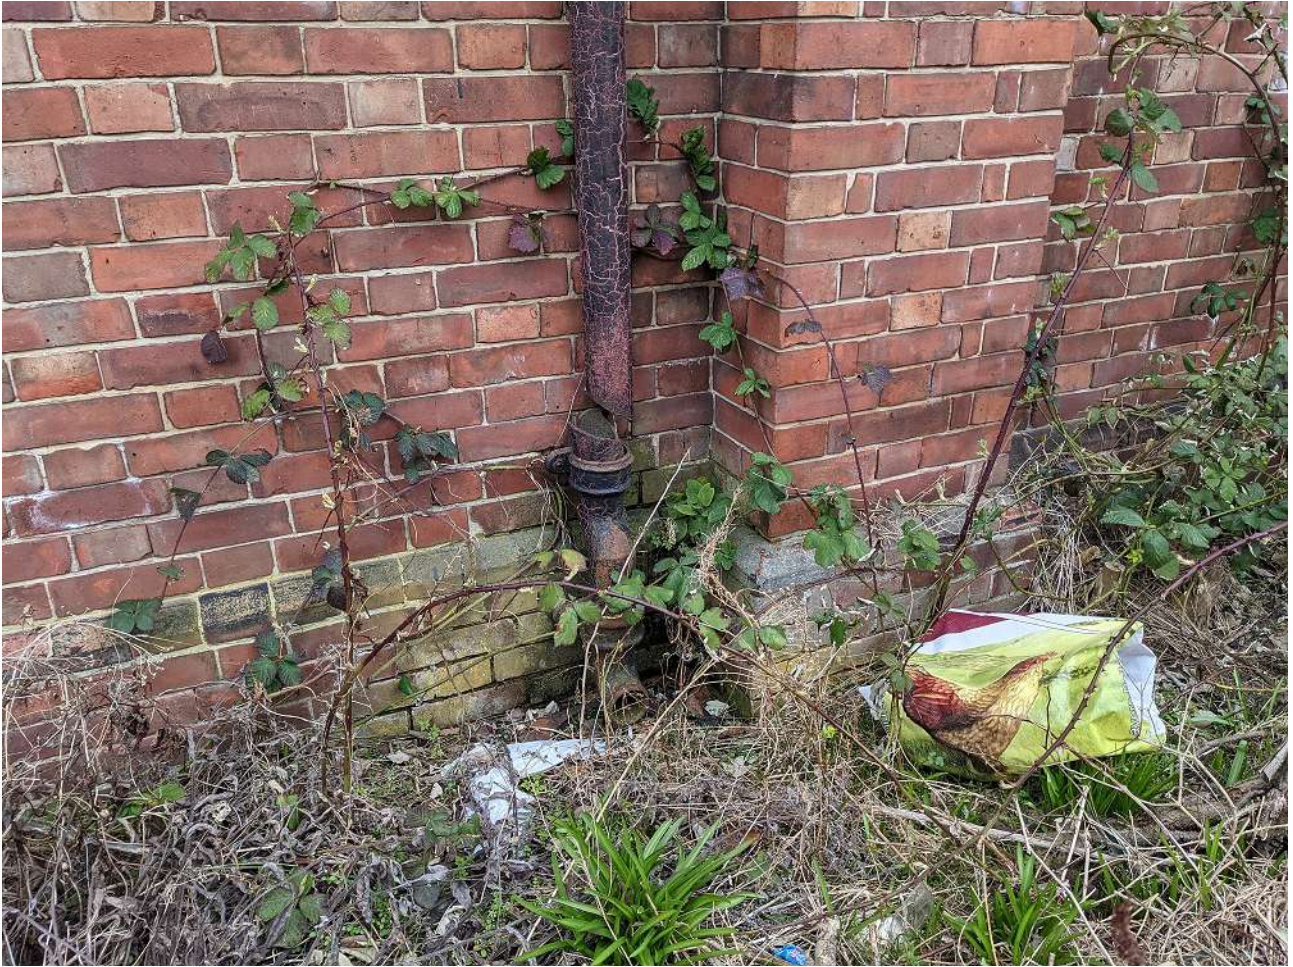
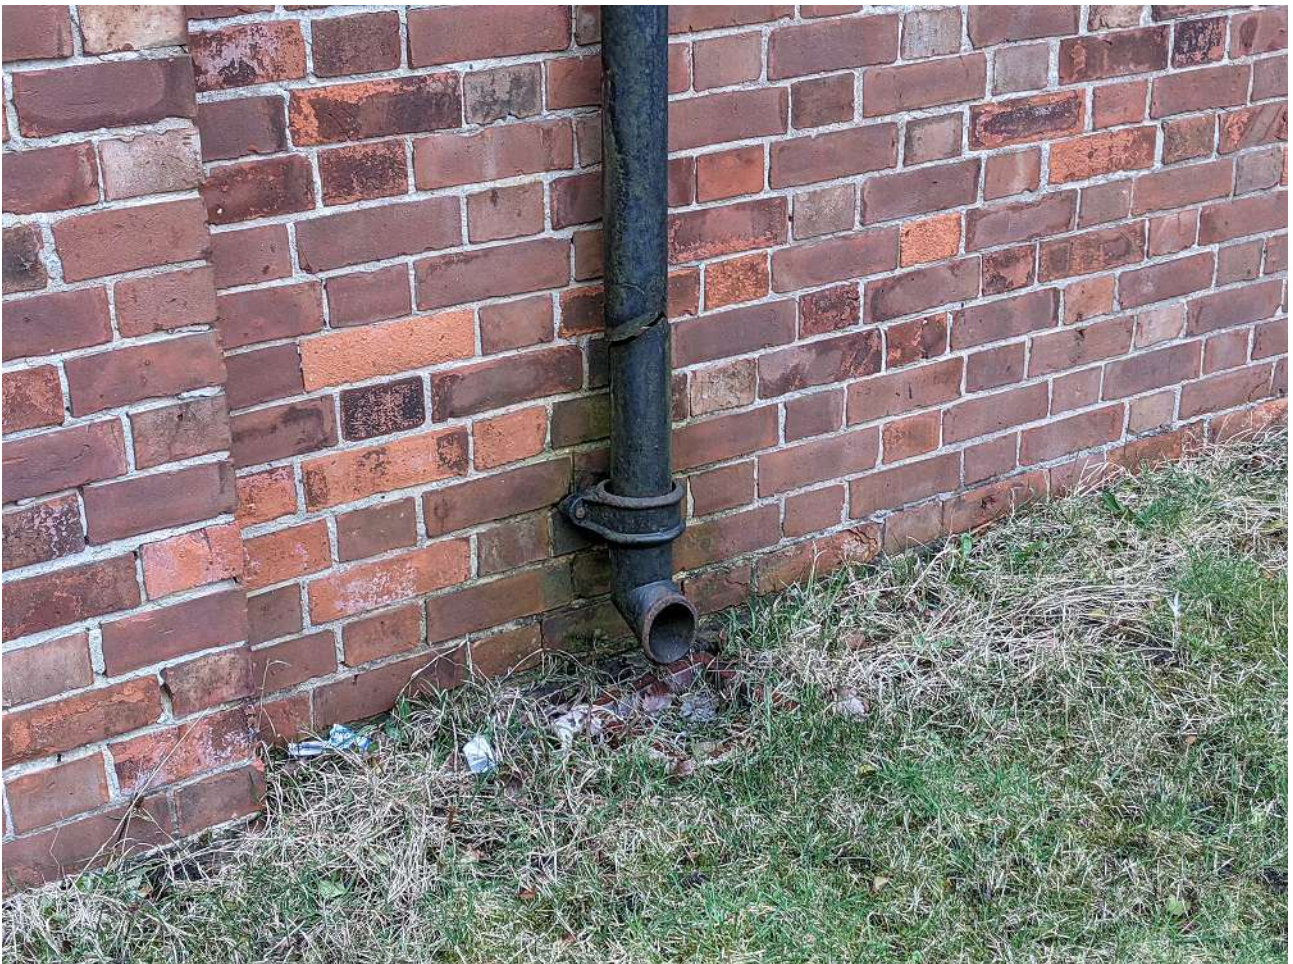
- 4.1.1 Rainwater goods to the nave and chancel are generally rusted throughout, particularly to the rear and in desperate need of refurbishment. There is also damage noted to the chancel northeast downpipe which is broken near to the bottom offsets. Plant growth is evident to the north aisle gutters.

- 4.1.3 Rainwater goods to the north and south aisles are found to be in a similar condition. The downpipes to the south aisle are broken at their base similar to that seen to the chancel northeast.

| R0 | It is recommended that a specification and schedule of work is drawn up for the repair and refurbishment of the nave and chancel rainwater goods. |

| R1 | 4.1.2 Carry out rainwater goods repairs and refurbishment to the nave and chancel by a competent and experienced roofing contractor. |

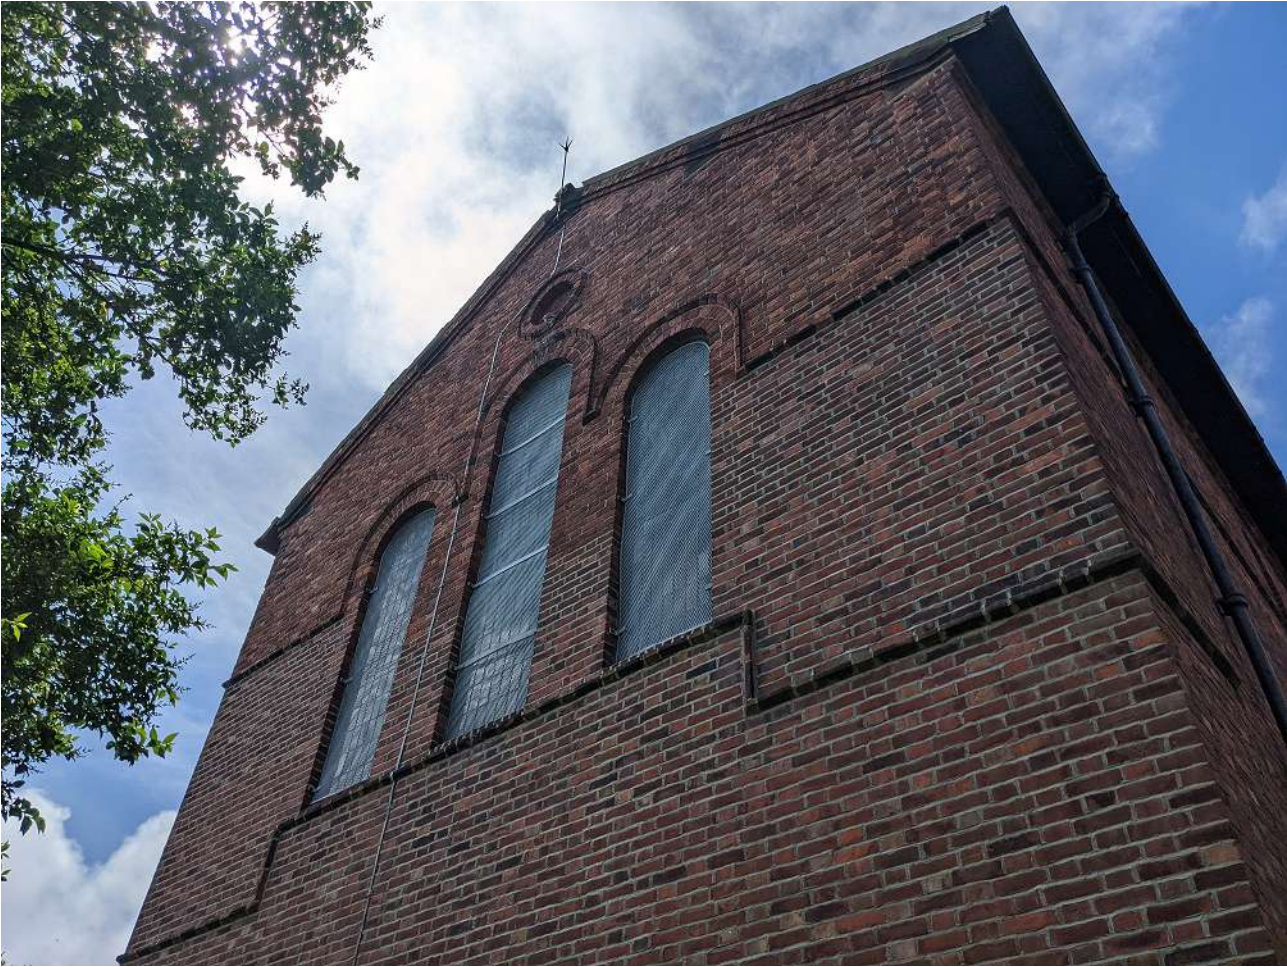
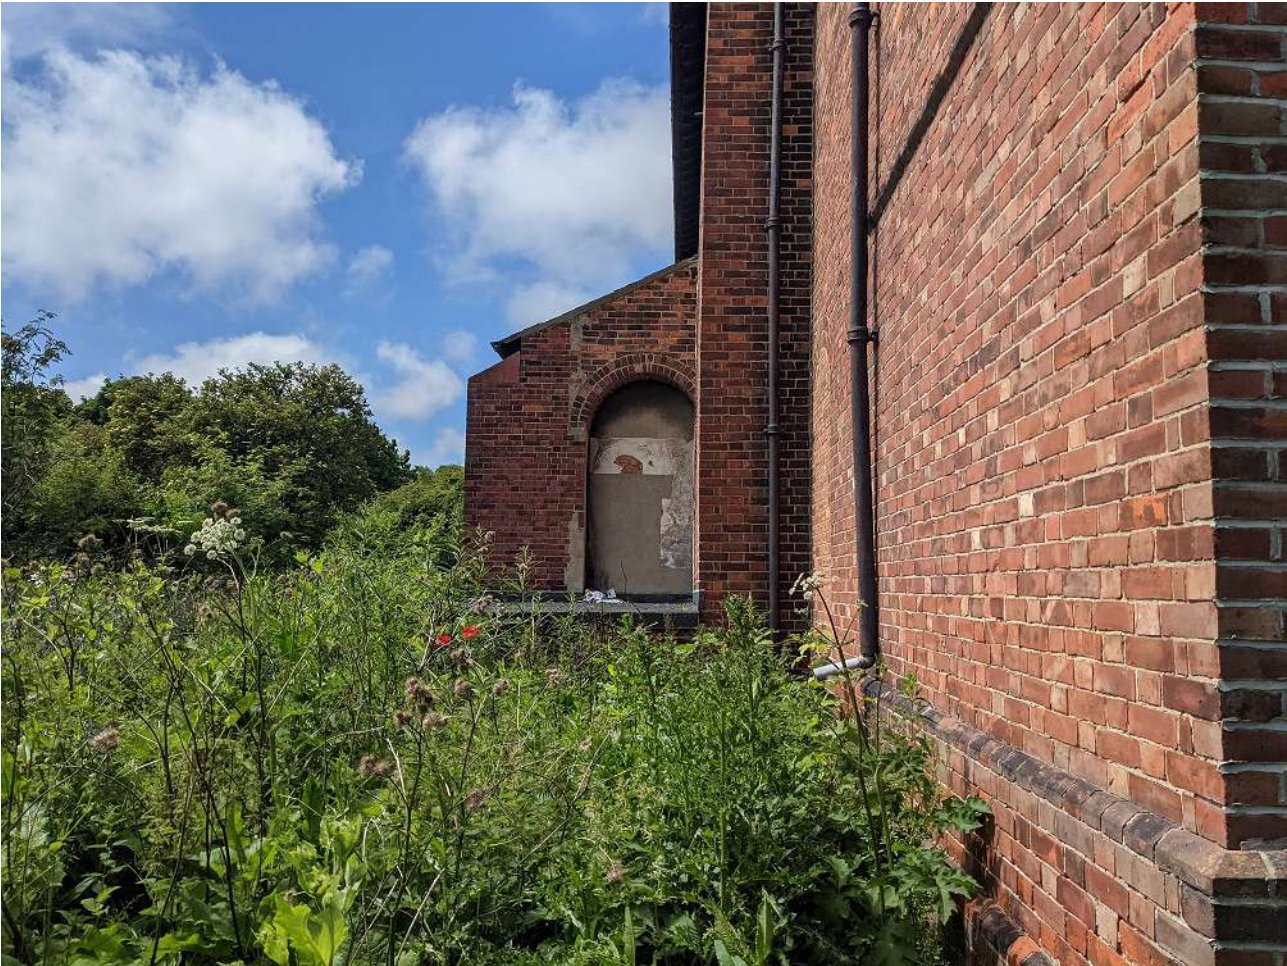
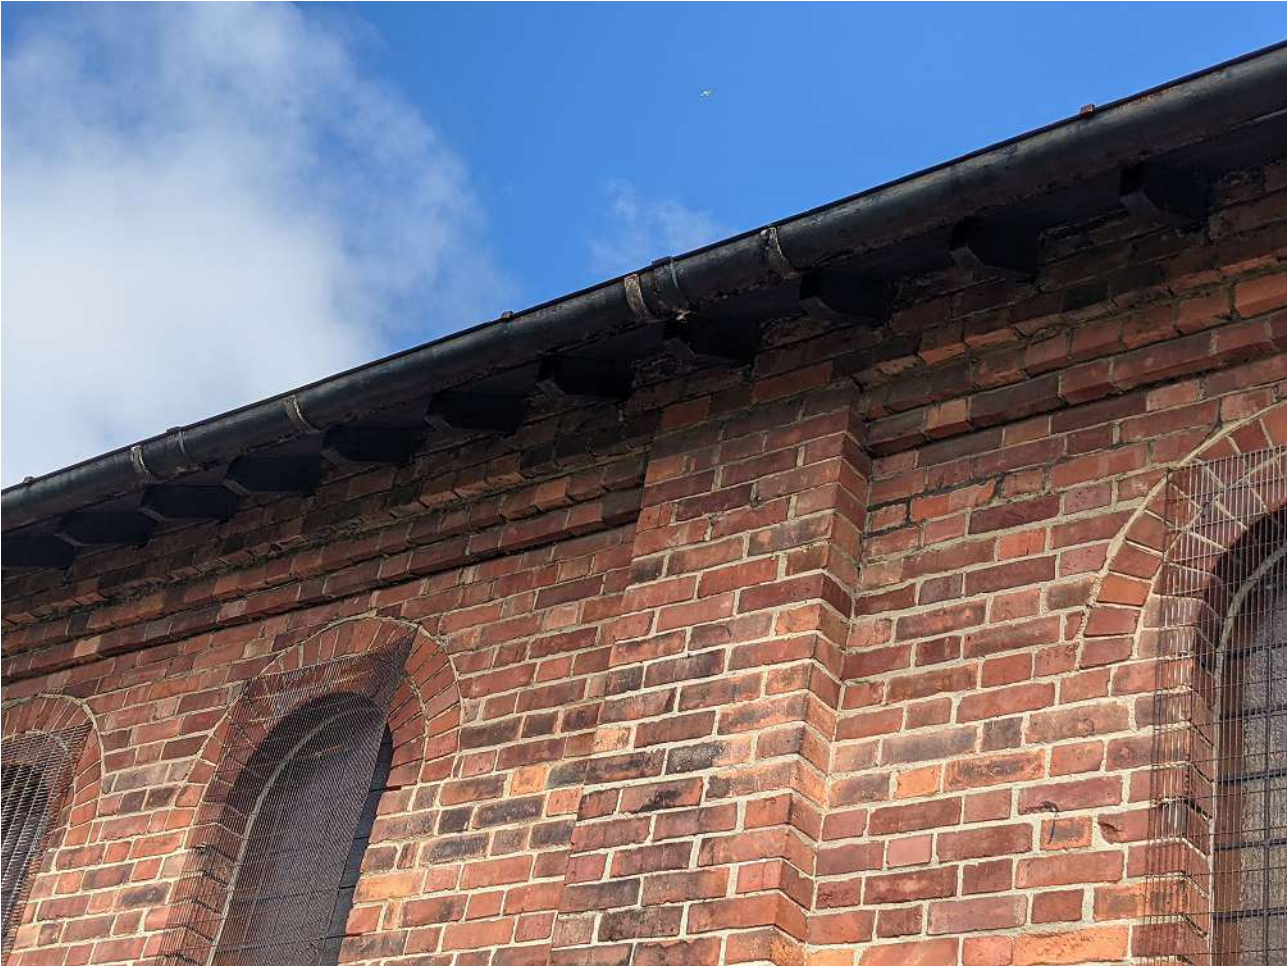
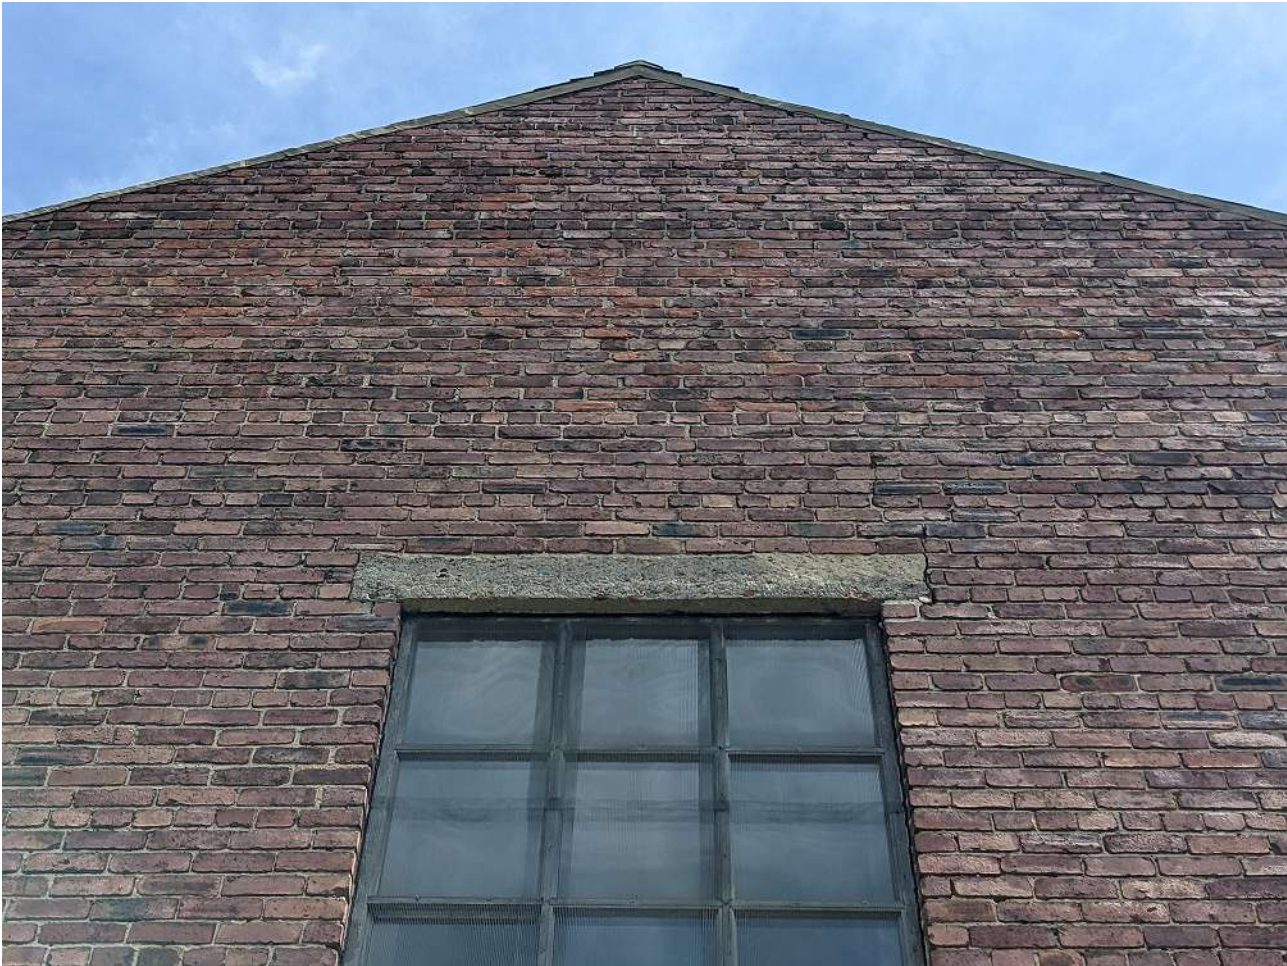
The bottom half of the chancel east gable has been repointed in a heavy cementitious mortar, slightly unattractive in appearance and would have been better carried out in a lime-based mortar. Above, the brickwork is more pronounced as weathering has eroded the face of the pointing and as such is in a worse condition. This is particularly evident to features such as the roundel and corbelled brickwork at the junction with the roof covering.

To the east return of the south aisle an arched opening has a brickwork infill panel which has been rendered over, again part of the 'temporary' works under phase 1 of the church build. The render of which is in a deteriorating condition.

The top half of the nave west gable is exhibiting similar weathering characteristics to the pointing as seen on the chancel east gable. Pronounced brickwork and slowly deteriorating face of the pointing.

R2 It is recommended that a lime:sand mortar repointing schedule of repair work, specification and methodology is drawn up.

R3 7.1.2 Carry out repointing to the defective areas by a competent and experienced masonry contractor.

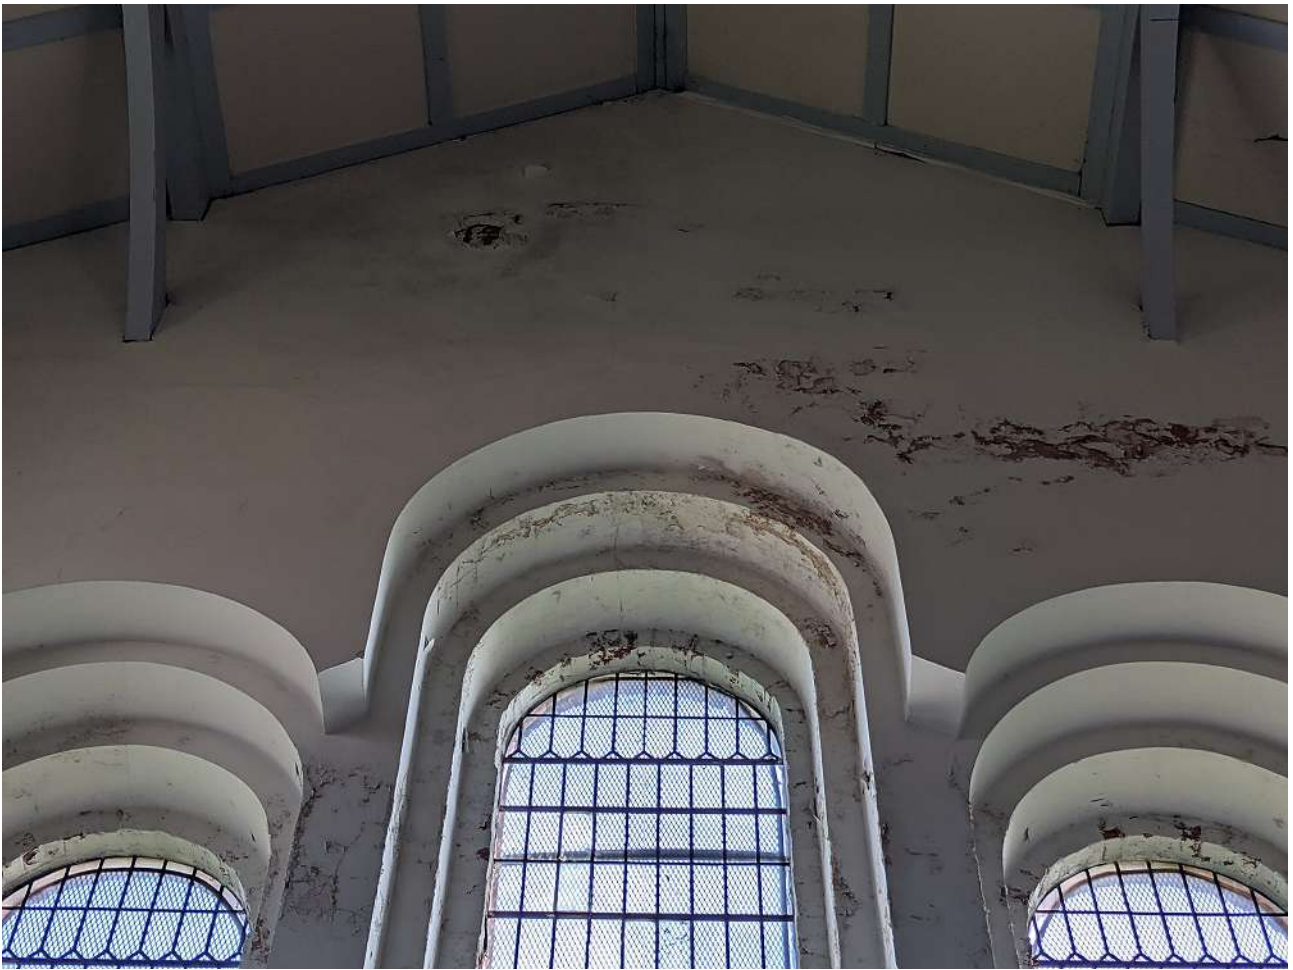
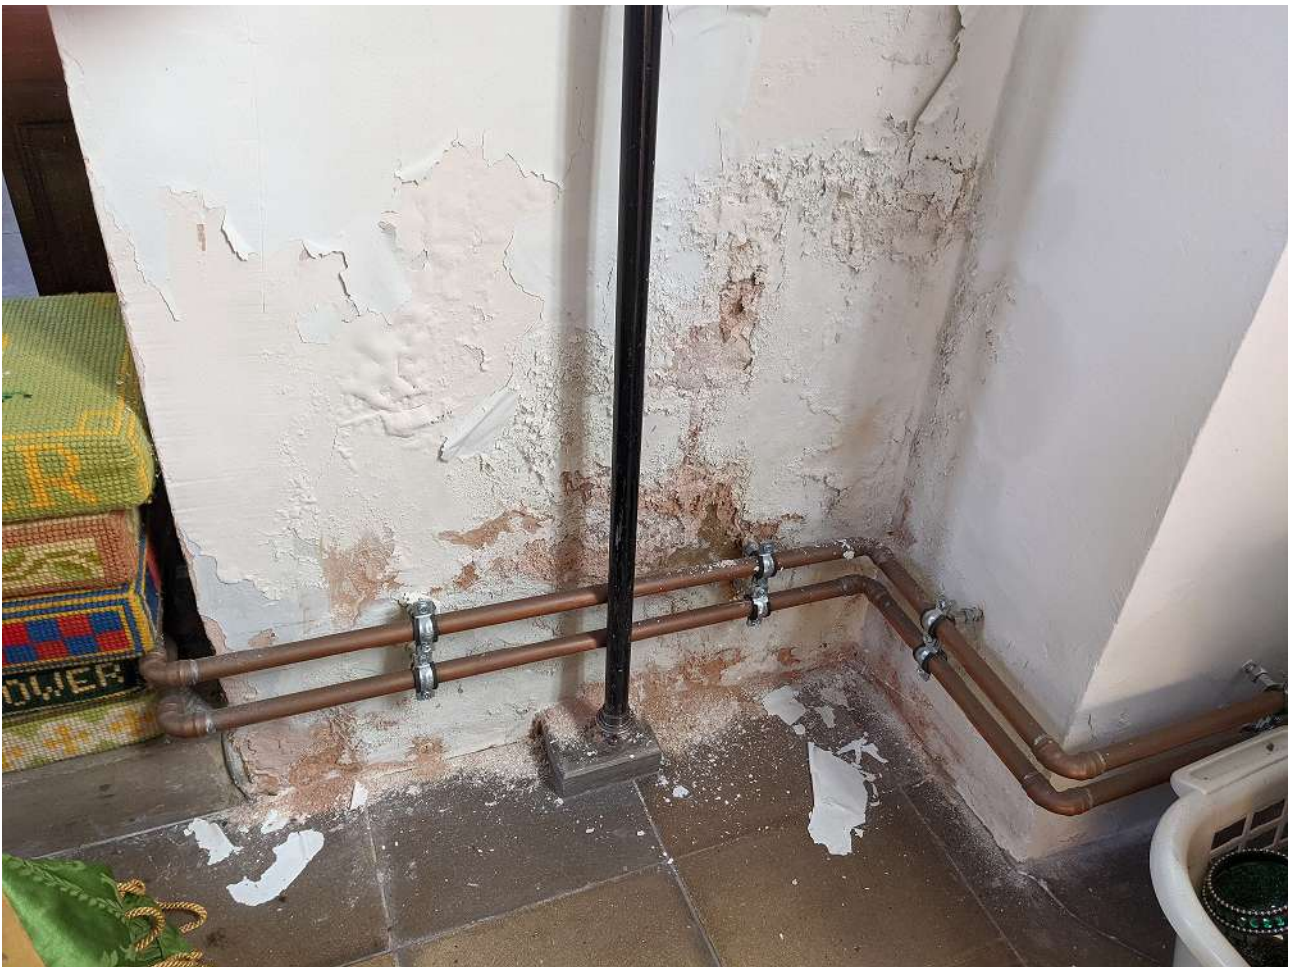
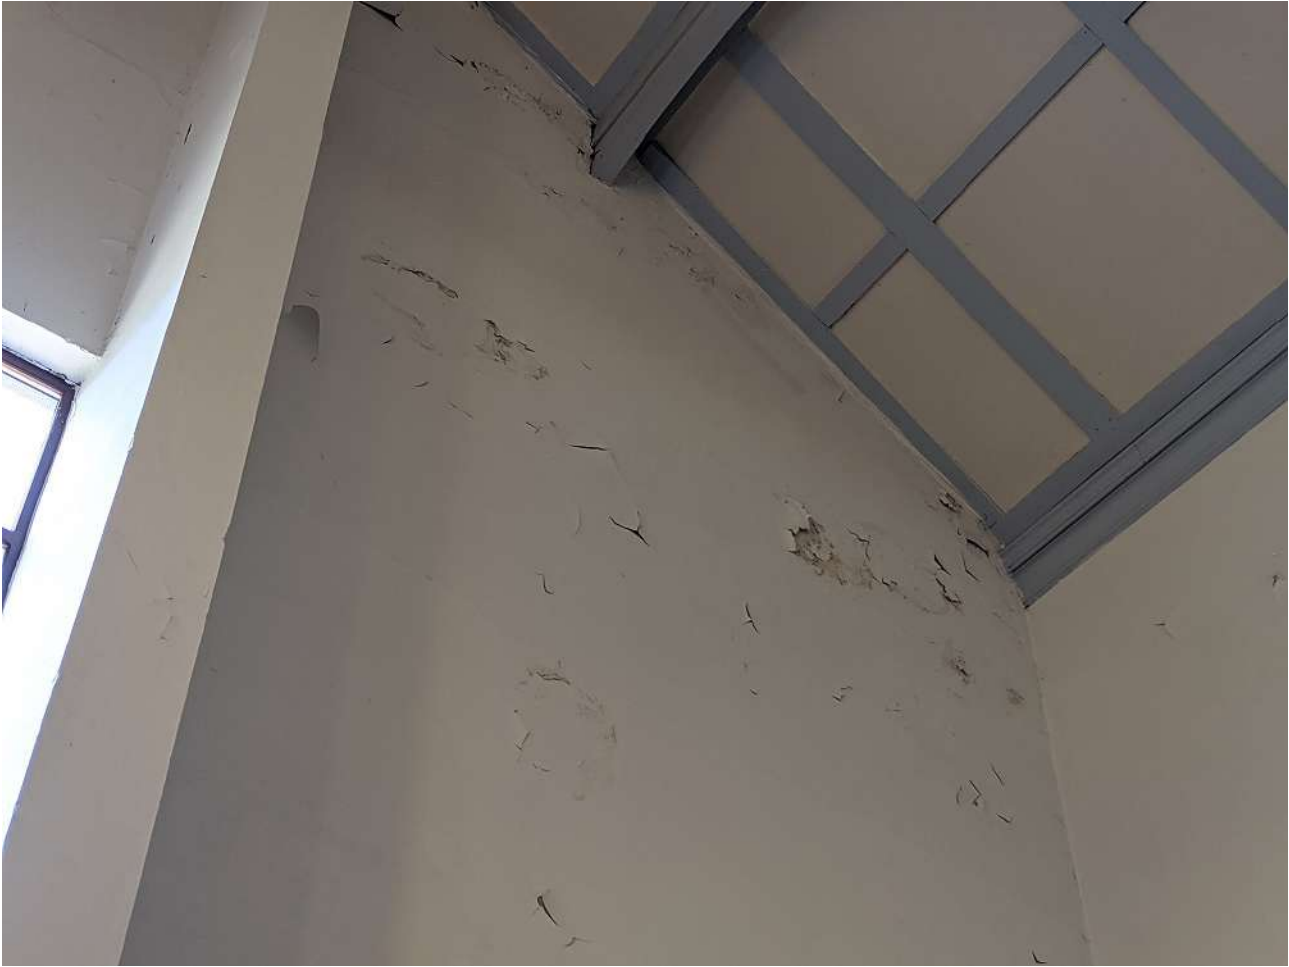
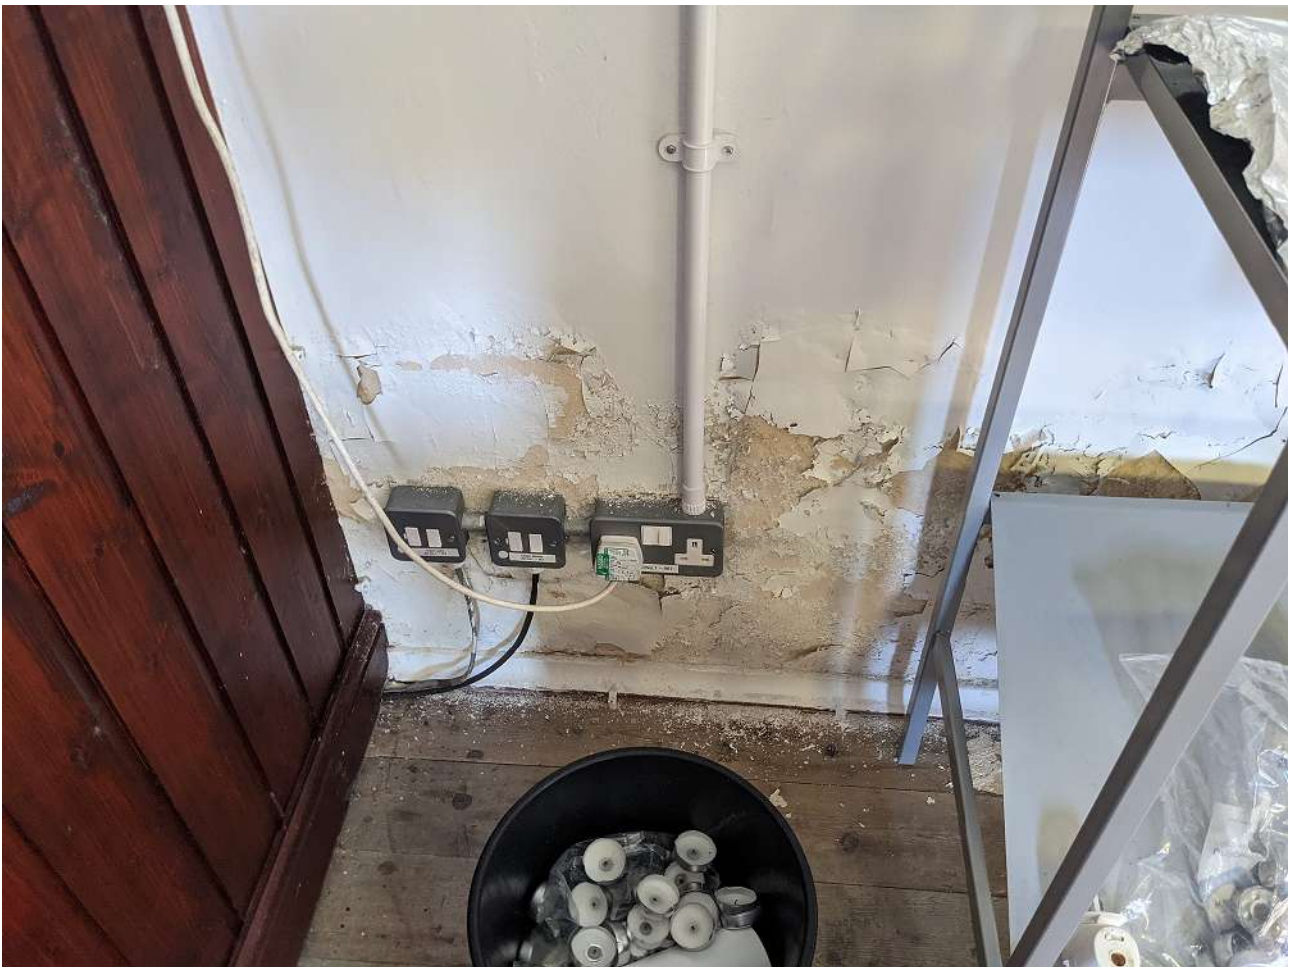
1. Nave west end at high level.

Flaking paintwork at high level to both north and south sides indicative of the 'temporary' nature of the thin brickwork walling, also possible dampness seeping into the wall head from roofing defects above.

17.2.2 It is recommended to carry out redecoration in a breathable clay paint following investigation and correction of any found fabric defects.
