**QUINQUENNIAL INSPECTION REPORT
OF
EASINGTON, ST. MARY**

**DIOCESE OF DURHAM
ARCHDEACONRY OF DURHAM
DEANERY OF EASINGTON**

QUINQUENNIAL INSPECTION AND REPORT

January 2021

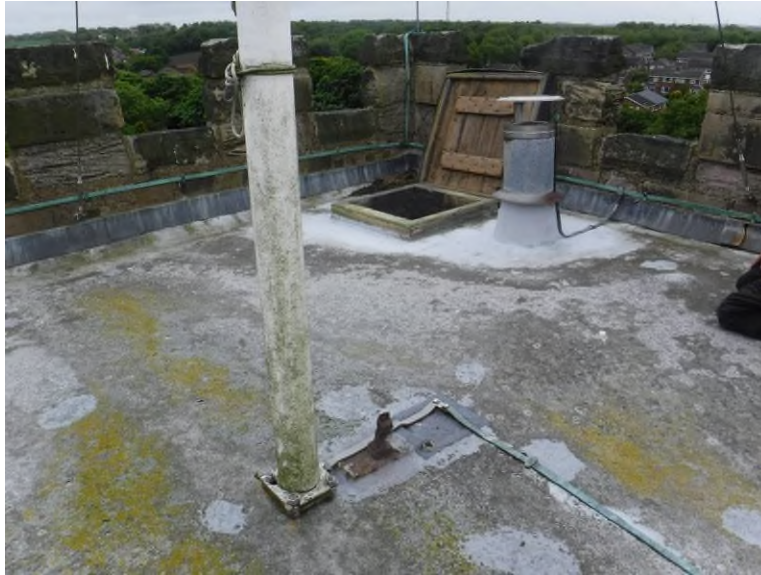
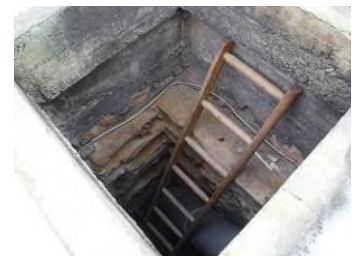
C Tower Roof:

Concrete flat roof with c. 15 year old liquid membrane covering which has holes and tears. It has been patched and may take one last round of patching but full replacement is recommended. One of the flashings are loose on the W side where the flagpole stay is, the flagpole stays look ok as does the glass fibre flagpole, though there is some rust of the bolts showing on the soffit of the roof. The parapets are single stones and look a little bit worn at some of the pointing. The pointing is a heavy grit that is generally alright, and there is just one small area on the E guy rope that is buckling slightly but doesn't need any attention.

The lighting conductor has four air terminals and it is connected to the flagpole but there isn't one all the way up the flagpole. The roof seems to keep itself clean but there is no balloons over the outlet, there are downpipes in two positions on the E side going down on the N and S sides.

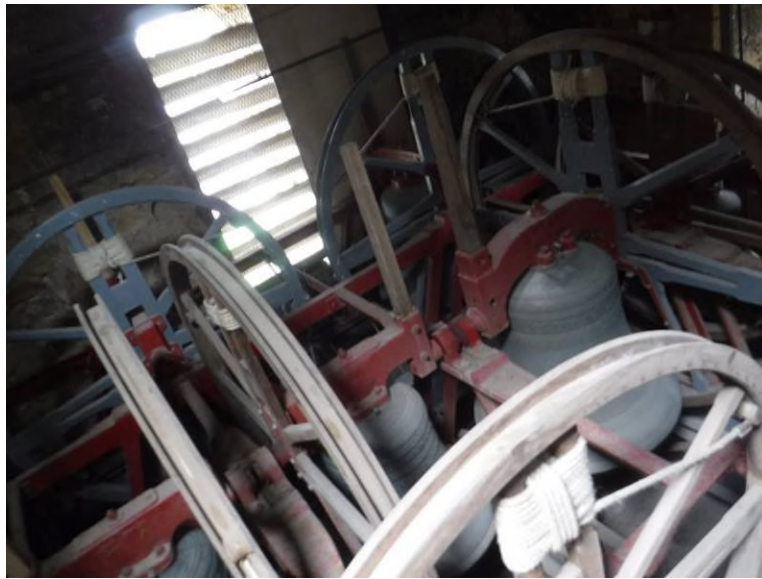
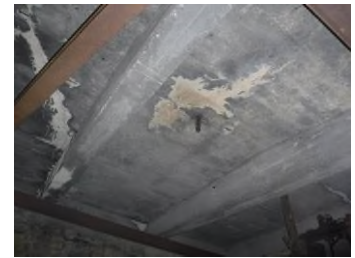
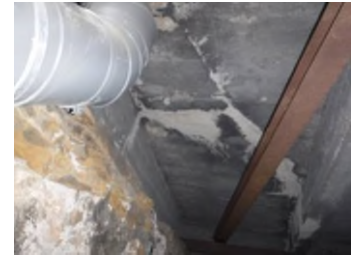
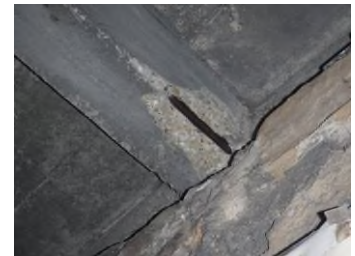
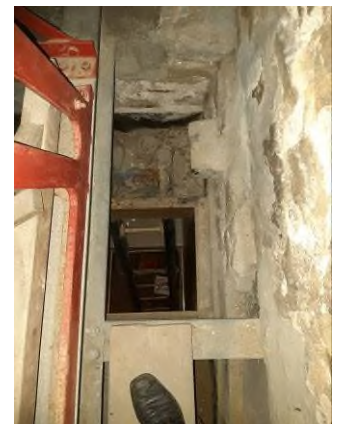
C Belfry:

- **Ceiling** – The tower roof is approximately 8 inch thick concrete, there is some spalling by the hatch and there looks like there is a bit of a crack on the W side where the flue is but it all looks stable. There is a rusting reinforcement bar on the SE beam end. The roof has quite a deep down stand and that is approximately 300-400mm and that sits on top of the stonework. There is some erosion to the stonework at the ladder on the W end but that is generally ok.

- **Walls** – These look ok and can't see any cracking. The louvre openings have blind shutters over them and it looks like there is timber louveres in them. On the N side it looks slightly wonky but probably ok and it's got Expamet covering on. There doesn't seem to be any pigeons in here, the exit off the ringing room ladder is a bit awkward and a few more grab handles would help as also at the top of the belfry timber ladder.
The walkway from this ladder to the next is also poor, as it consists of one plank of wood supported on two steel beams, with gaps on each side. The timber pole ladder from this plank to the roof hatch is in fair condition, but the hatch itself is heavy to lift when standing on the ladder, especially as there are no handrails or similar at this point.

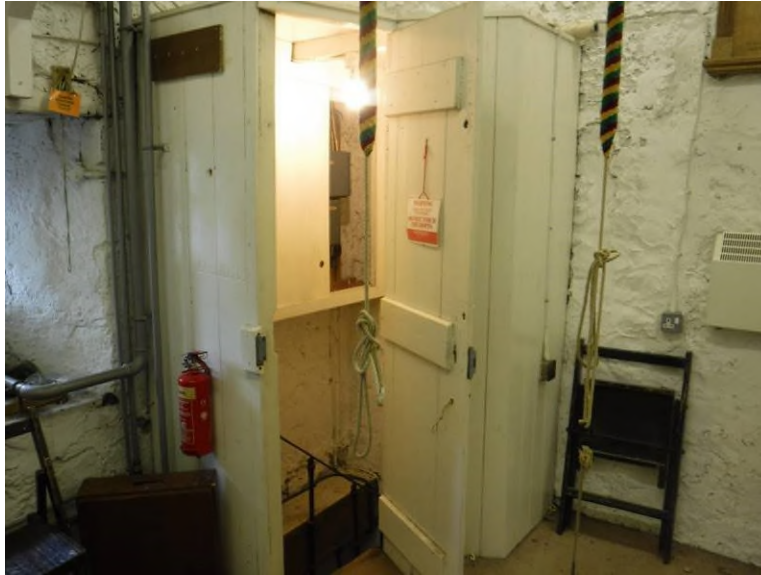
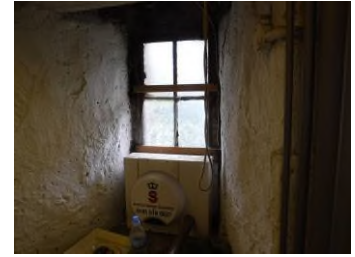
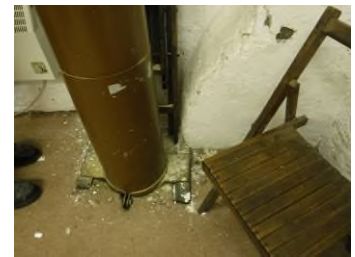
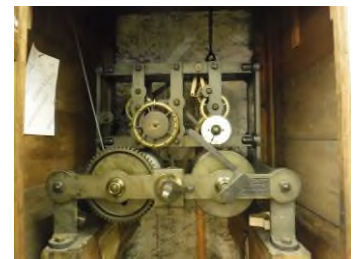
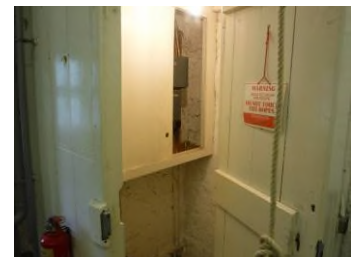
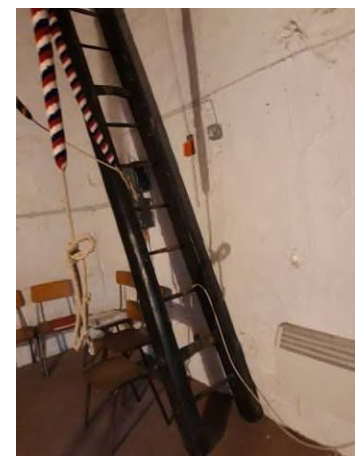
Ringling Room:

- **Ceiling** – The ceiling is over boarded with pine boarding.
- **Walls** – The walls look ok. There is an aluminium flue running up but it also looks like an old brick flue close to it which is showing signs of salting, is that the downpipe route out?
- **Floor** – Timber floor with carpet.
- **General** - The room could do with a bit of a clean-up it is a bit scruffy with paint breaking down. The W window looks a little poor it has been broken in the past and birds will get in here, this houses the security alarm system. The door catches the carpet, the key is kept up here on a string and is a little awkward to open because you are twisting at the top of the stair.

The room contains the clock by W Potts and Sons, Leeds 1895, this has got weights and chimes on it, it looks like the clock is maintained by Smiths of Derby and the last inspection was March 2019. The room has two electric convector heaters and the heating expansion tank is in the room. The ladder to the belfry is frightening (it is long and has little rungs). It should be replaced with an aluminium ladder.

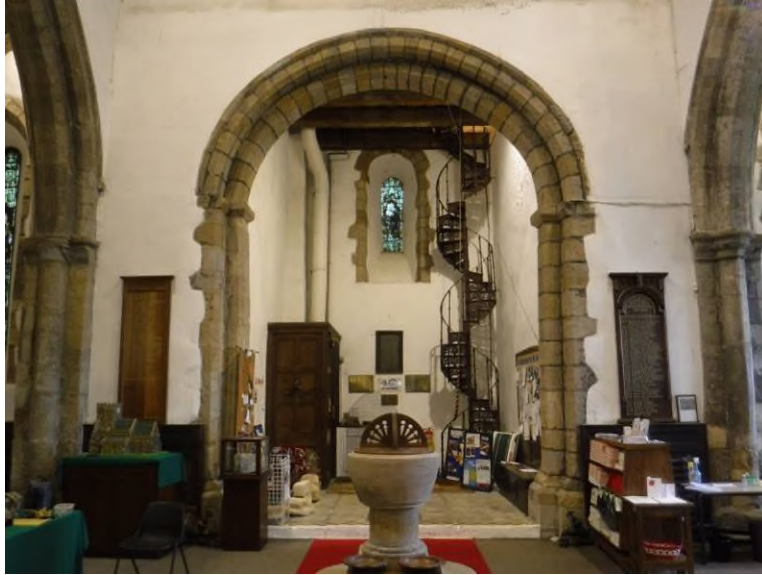
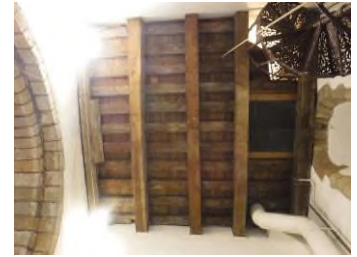
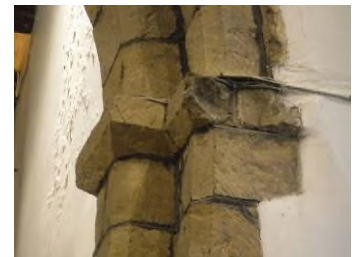
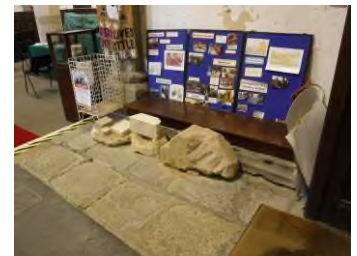
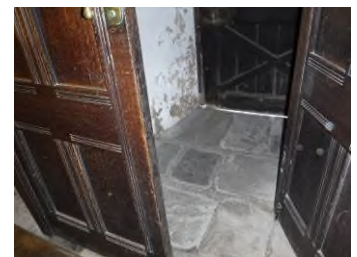
Base of Tower:

- **Ceiling** – Looks ok, there is some large beams holding up the floor they look sound.
- **Walls** – Are lime washed and a bit flaky but ok, no evidence of cracking.
- **Floor** – Is slightly undulating flagstones, it also has a blue ledger inset and coir matting which is a little bit trippy particularly around the entrance area, the doors are ok.
- The floor is supported by light steelwork of different sizes, some of the end bearing isn't very good, and it is also a concern as to whether this has adequate fire protection if the boiler catches fire.
- There is a west window, looks ok but is a bit dusty. A metal spiral staircase up to the ringing chamber, not for the faint hearted but it is sound. Partially descends into the boiler room below.

Recommendation: avoid floor trip hazard, assess floor construction along with thoughts of re planned heating system.

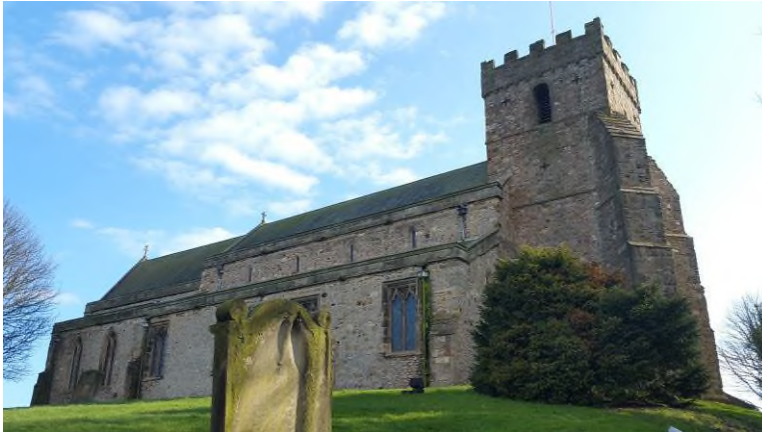
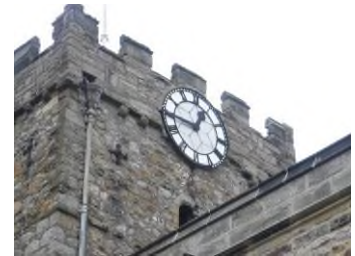
Tower

The masonry is generally good, there is some honeycombing and hollowing out of some stones but they are not particularly concerning. The previous QI report of decay in the soft beds at the SW quoins and SW buttress is still relevant and water may be getting into the core. The NW buttress at the top stage has a small stone missing.

The parapet is ok and there are two sets of iron tie rods running N to S and E to W and these appear ok.

Recommendation: replace areas of missing pointing at buttresses

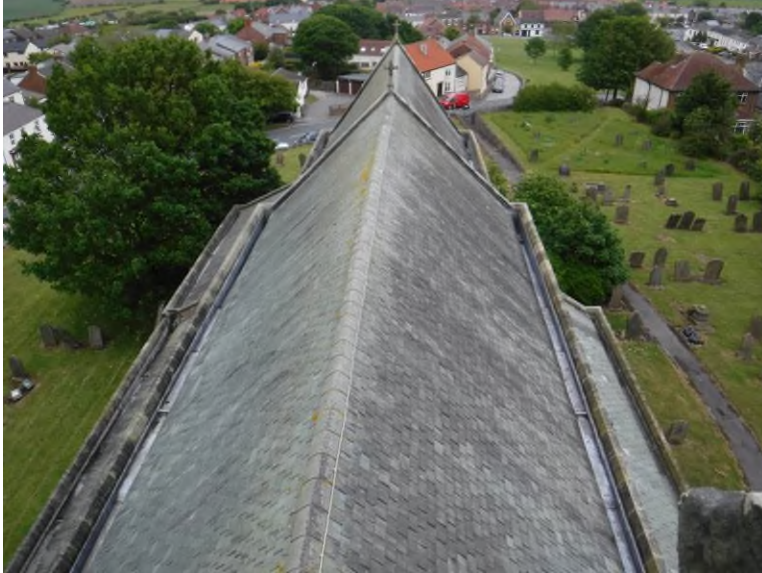
B Roof general:

Specific defects noted are chancel S side slipped slate in the gutter, S side of the nave looks ok as does the S aisle though the replacements look like foreigners rather but it's just a colour mismatch I think.

On the N side chancel can't see anything. On the N side of the nave there is a slipped slate at the W end that has come down from the ridge I think.

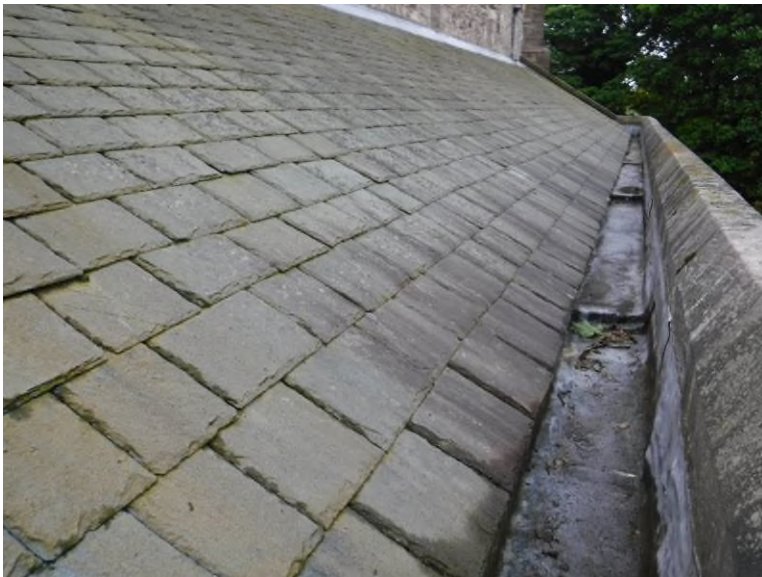
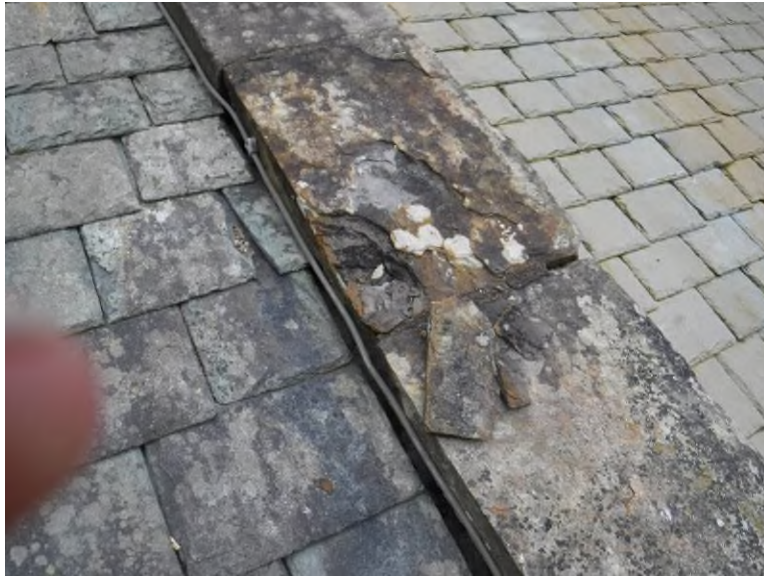
But there is a problem at the junction of the N aisle to vestry.

The water table stone is laminating, the side render at the flashing is cracked and the slate junction flashing is leaking. This is causing damp inside and the loss of plaster.

Recommendation: replaster and decorate vestry/organ high level wall after roof repairs.

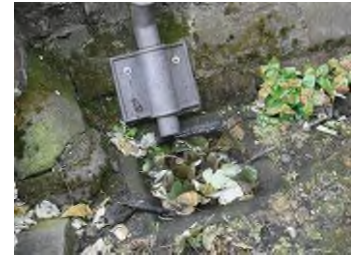
North Chancel :

On the gutter one of the flashings is coming out.

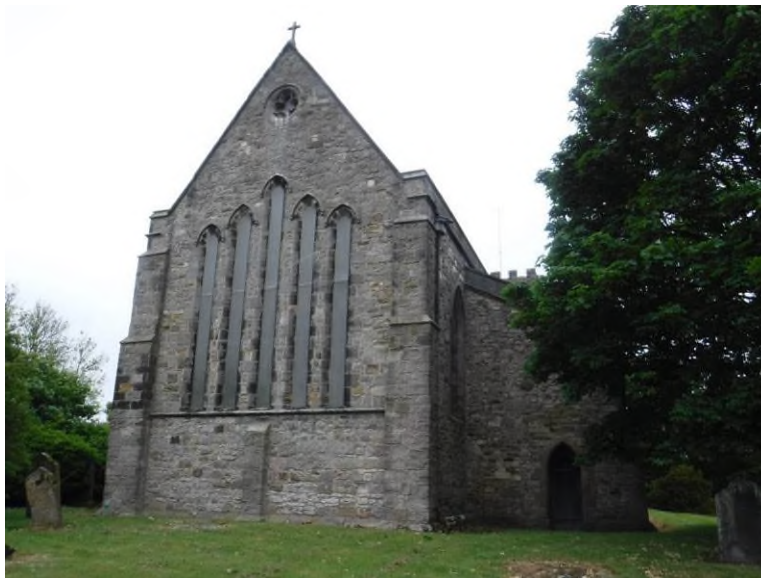
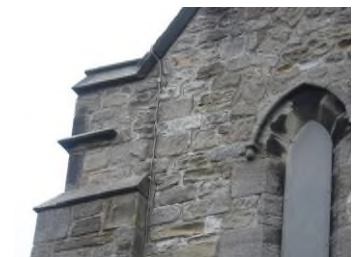
M East Gable of Chancel:

Water table is very steep, open joints at the apex but appear sound. General walling is good as are the buttresses. The quatrefoil light at the apex has bird marking and timber board behind it may have a split.

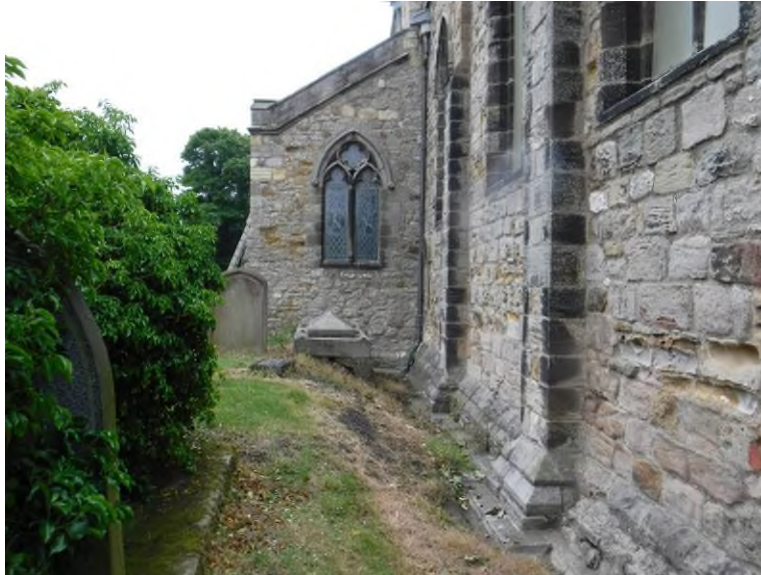
- **South Chancel:**

Slight lamination to one of the parapet stones but no need for action. The general walling is sound though there is some erosion. There is a run of four at the W end that might want some attention sometime in the next ten years or so.

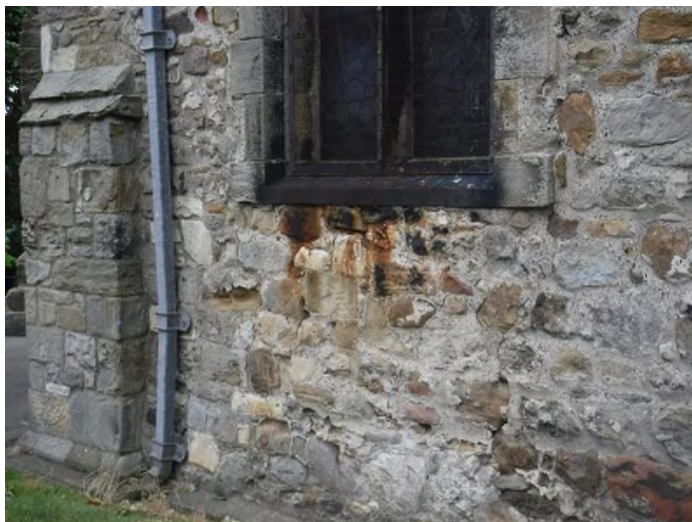
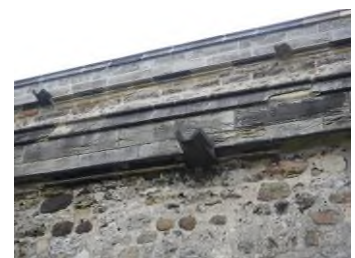
- **South Aisle:**

This has been heavily cement repaired in the past and there are quite significant pockets of erosion to it, some of these were attended to as part of the GPOW works. The parapet is quite laminated in places, there are a couple of apex stones that look as though they might want replacing and some open joints to the pointing, a panel of stonework below the western most window looks in most need. The moulded string under the parapet is decayed in about twenty five percent of the places. This can all stand for 5- 10 years.

Recommendation: none

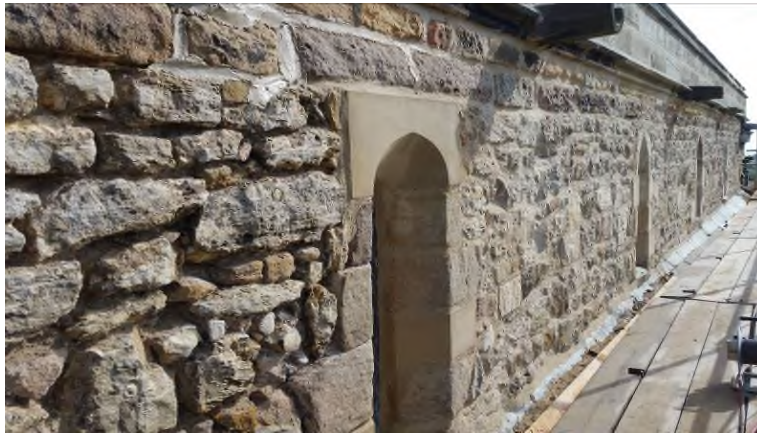
South Clerestory:

This received a complete repoint as part of the 2016 GPOW works including replacement of one of the clerestory arches and some quoin stones and also a rebuild of a part of the walling at the E end as well as pointing to the coping parapet as well and all is now sound.

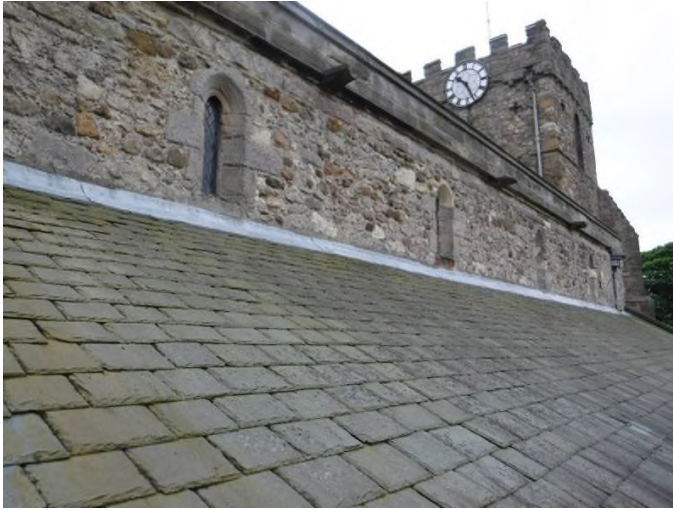
- **North Clerestory:**

Parapet ok about ten percent of the string moulding needs replacement in 5-10 years, some erosion to the middle redundant water spout. Some open joints to the walling, some erosion to the stonework too and partial cement covering.

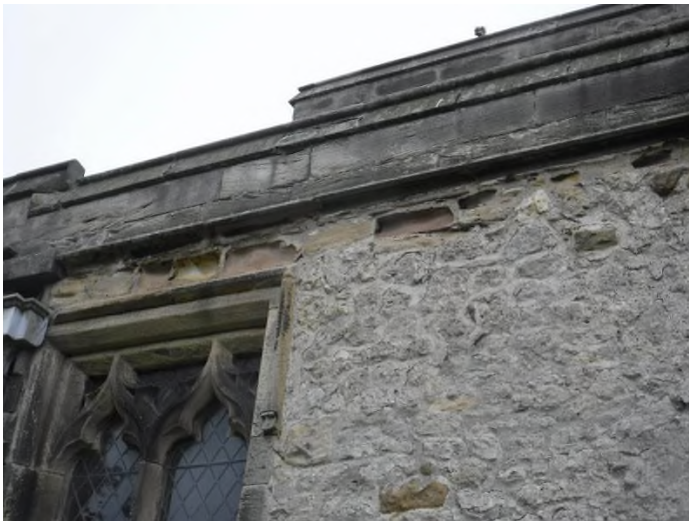
D **North Aisle:**

W end has a massive buttress to the nave that looks ok. There is some slight cracking to it and it also looks a bit wet but I think it is ok. The raking moulding supporting the parapet is quite decayed. The stonework is heavily covered with cement a bit like the S aisle and some eroded stonework possibly a damp corner.

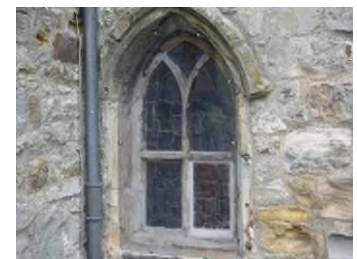
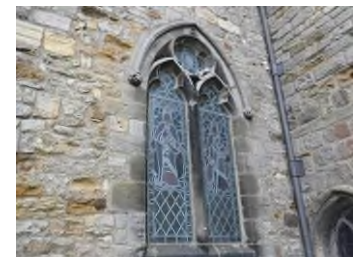
E East End of South Aisle:

E triple light in fair condition, some erosion to the E jamb the stonework on the joints, also some erosion at E mullion at the top. This is over glazed with polycarbonate which is dull now, the pointing is breaking up, open joint in cill.

Three square headed twin lights, some open joints at the square headed hood mould and erosion to the stonework at the W end. Not able to see well as these have metal grids on timber frames, the grids themselves are rusting and staining the stonework and they were recently broken into - they have been cut in the past.

Recommendation: consider renewing protection

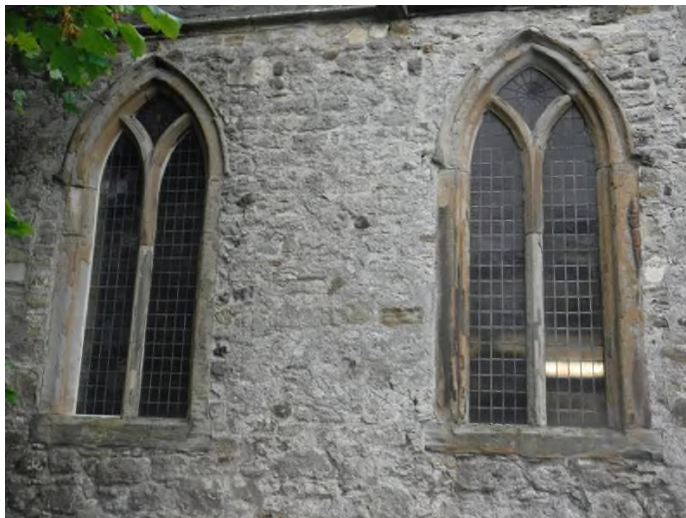
- Organ and Vestry:

Arched twin light with wide tracery and hood mould. Worn but will last for 5- 10 years. The mullions are laminating as well. The cills are reasonably sound. Vestry door is ok, the iron work is rusting a little.

Recommendation: none

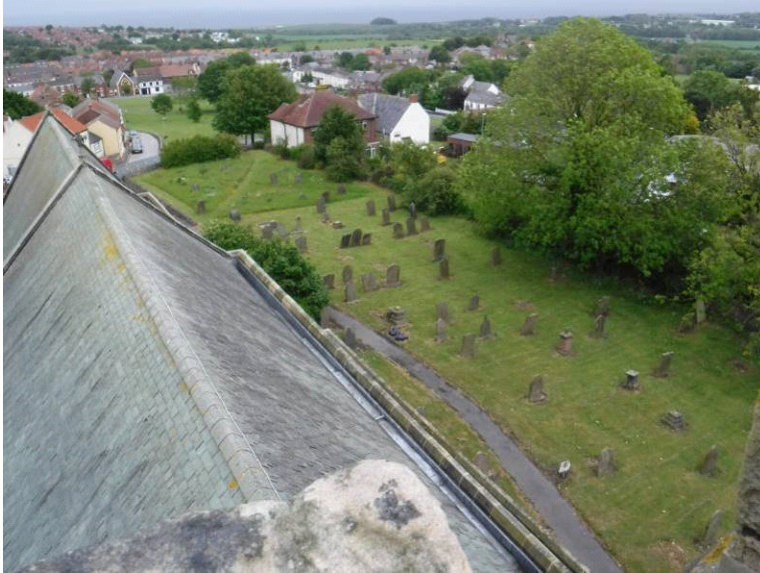
- **South Boundary:**

Boundary on to houses, stone wall, looks like the graveyard has been retained, the wall covered in ivy, not possible to really see. There are two Ash trees on the boundary and in the SW corner a pair of Sycamores. Close to the gateway are more Sycamores.

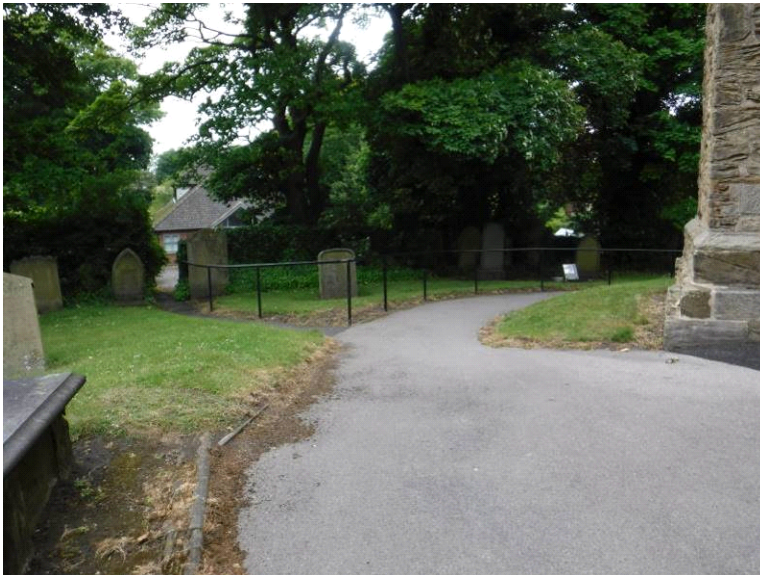
D **West Boundary:**

Onto houses and this has quite a lot of Sycamore on the boundary here, it is quite a strong buttressed wall, looks like it has had a cement face to help it retain better. Probably the Sycamores are bursting the wall a bit, I think the wall is actually built in-between it. Good handrail leading down to good metal gate at the north but the post is loose, slight undulation to the tarmac on the verge down to the highway.

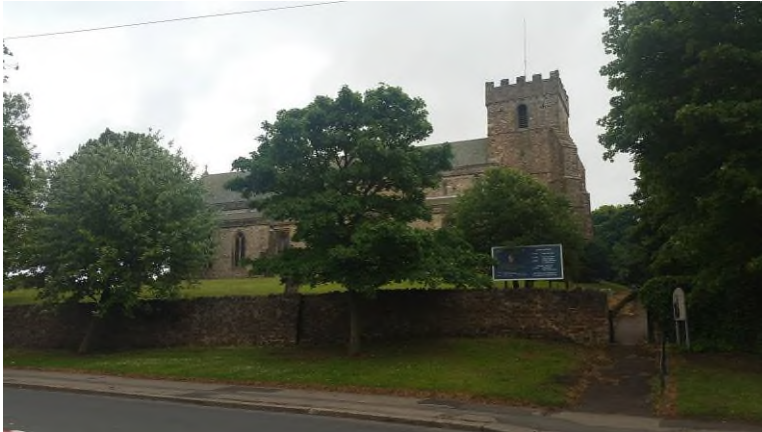
- **North Boundary:**

Fairly substantial battered stone wall retaining the churchyard approximately five feet high. It has been cement repaired.

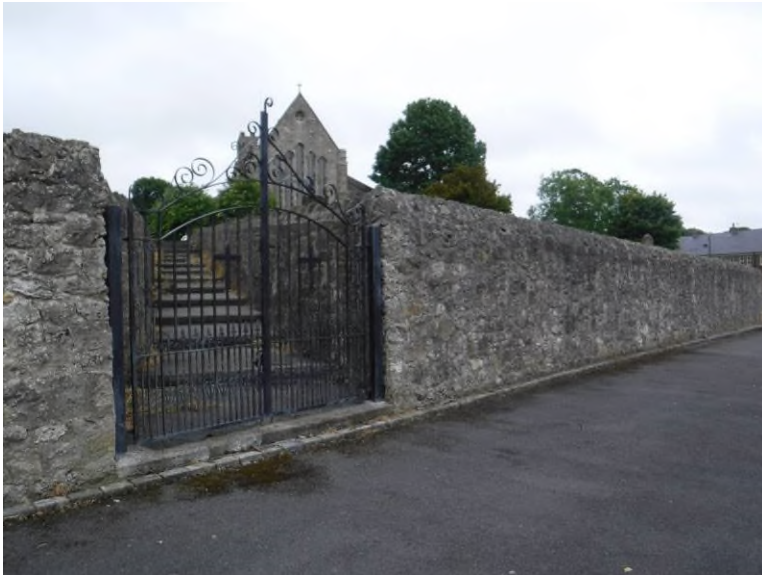
D East Boundary:

The boundary turns round to the E, part of the coping is lost just at the junction, over all it is sound. There are two or three places where the coping has gone. A pair of good iron gates currently locked, so those haven't been tested. There is a seating area dated 1897 up against one part of the wall.

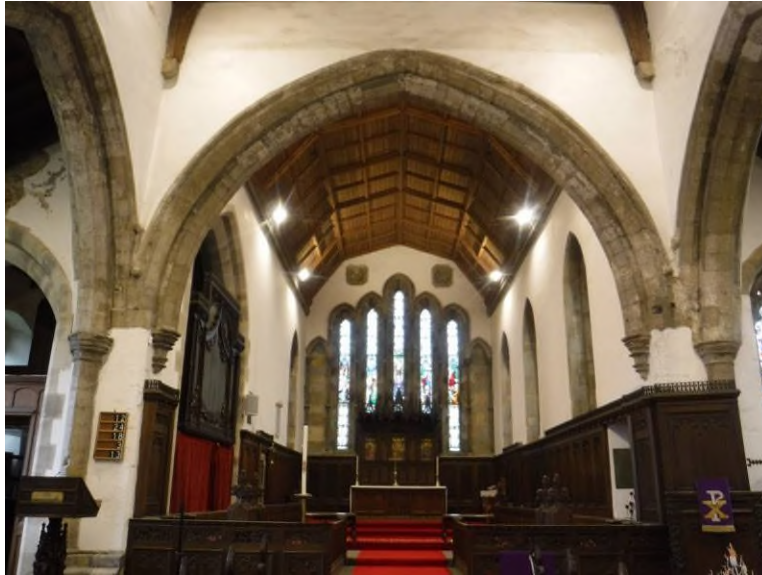
Chancel – boarded plane pine with ribbing, forming rectangular or square panels, small access door in to apex void, slight water staining to it and the only other marking is to the W end- recorded at the last QI.

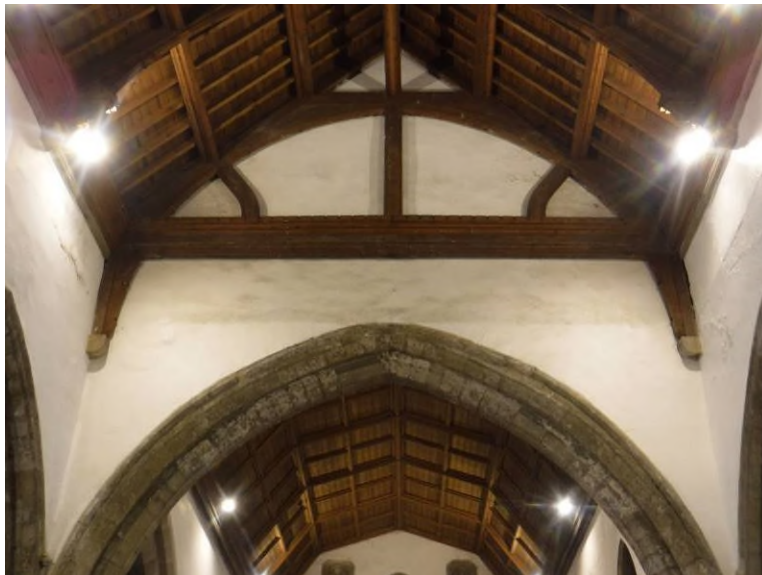
Nave Roof:

Formed by five trusses supporting purlins, rafters and sarking boarding, ends of the arches are anchored to the tops of the clerestory walls. There are braces down to the corbels and you can see the evidence of spread- up to 50mm in places.

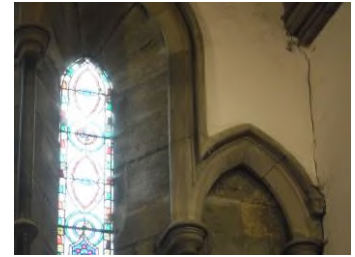
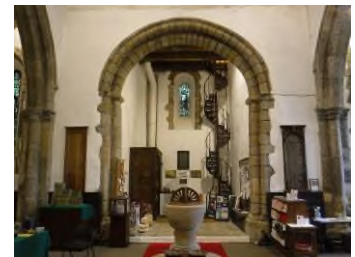
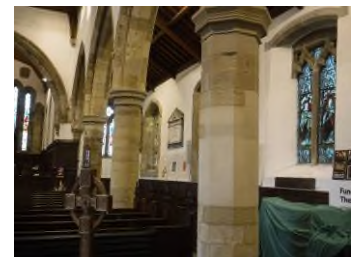
South arcade - has been restored as part of the 2016 GPOW works and a few replacement arch stones. The W most column has had fifty percent of its stones replaced. The capitals were replaced in sandstone rather than magnesium limestone. The E column is the next for repair because as the third course down is beginning to break, the central column was repointed as part of the GPOW works.

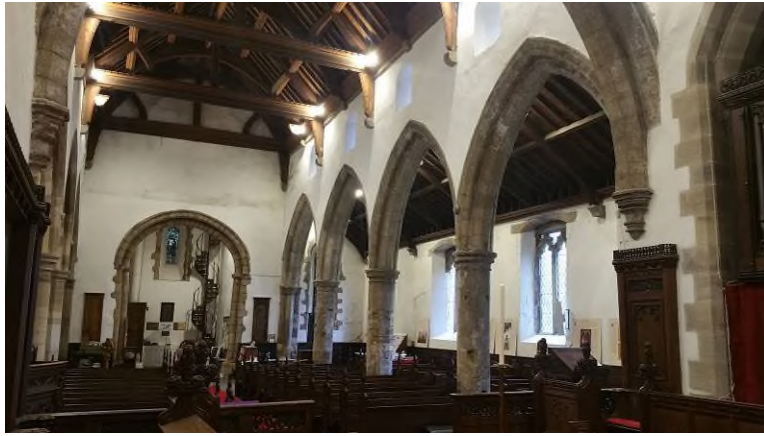
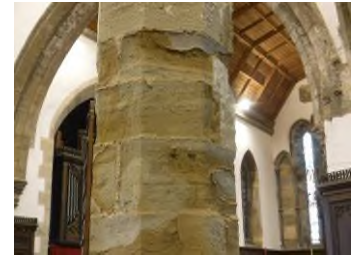
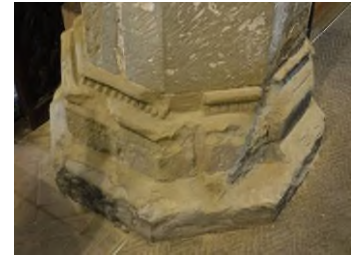
North arcade - Is good with old lime wash showing and some decay of stonework to the W column and mid height in the central column, it is recognised that the columns might have been repaired with cramps (none seen on the S) and that is why the W most is spalling.

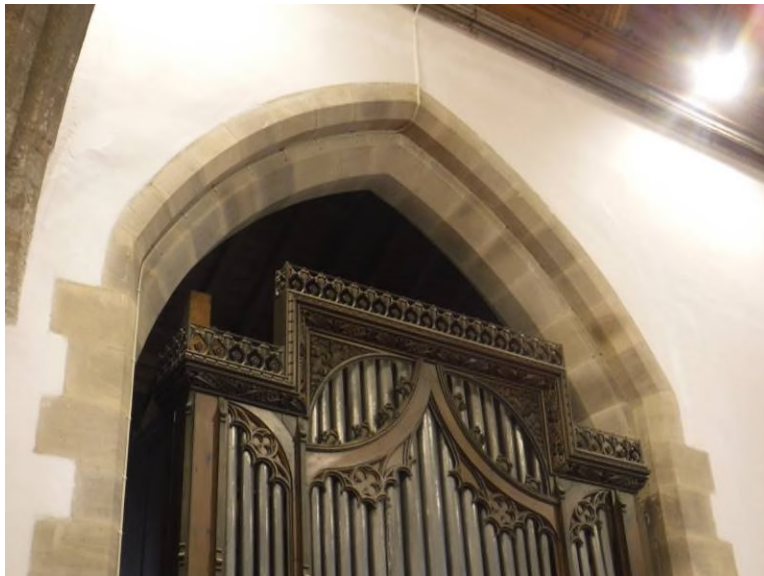
The arch at the organ has open joints at the apex and is significantly damp on the N return wall, no doubt as a consequence to earlier blocked drainage but also as a result of the exposed wall head above, flashing and pointing breaking down (repair recommendation is in roof section).

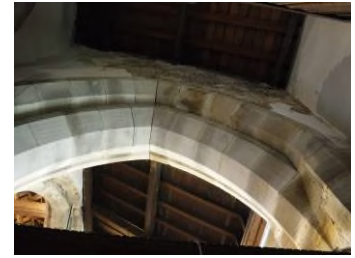
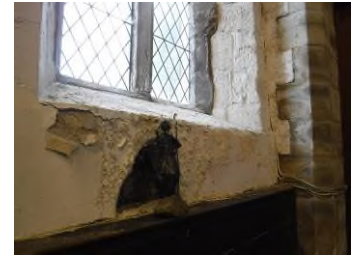
Organ arch – The plaster at the organ archway to the aisle has become detached and was removed on the day of inspection, this is broken down as a consequence of water penetration in the wall head.

Nave – The nave has plaster breaking down on each of the corners above the arcades and this is where there are downpipes, the gable walls are dusty and as there is a lot of dust comes out of the roof space.

It's not yet clear if the walls are sufficiently dry to replaster and decorate. The roof drainage and any open joint to stonework would want resolving first and then a long period of drying out and ventilation so I think this work would fall into 5-10 years.
