## QUINQUENNIAL INSPECTION REPORT

**St. GEORGE'S CHURCH**  
FRONT STREET, EAST BOLDON, NE36 0SW

APRIL 2021

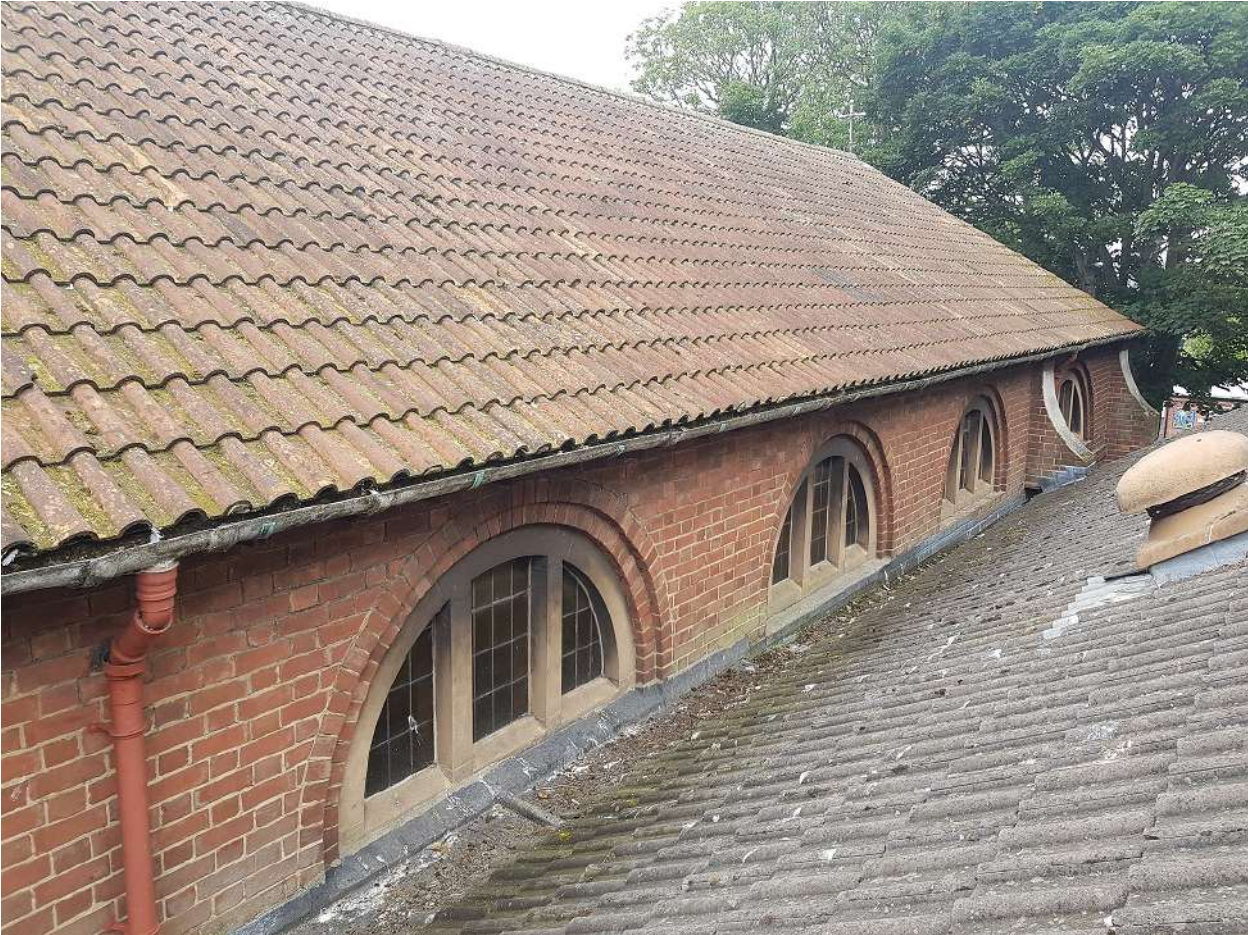
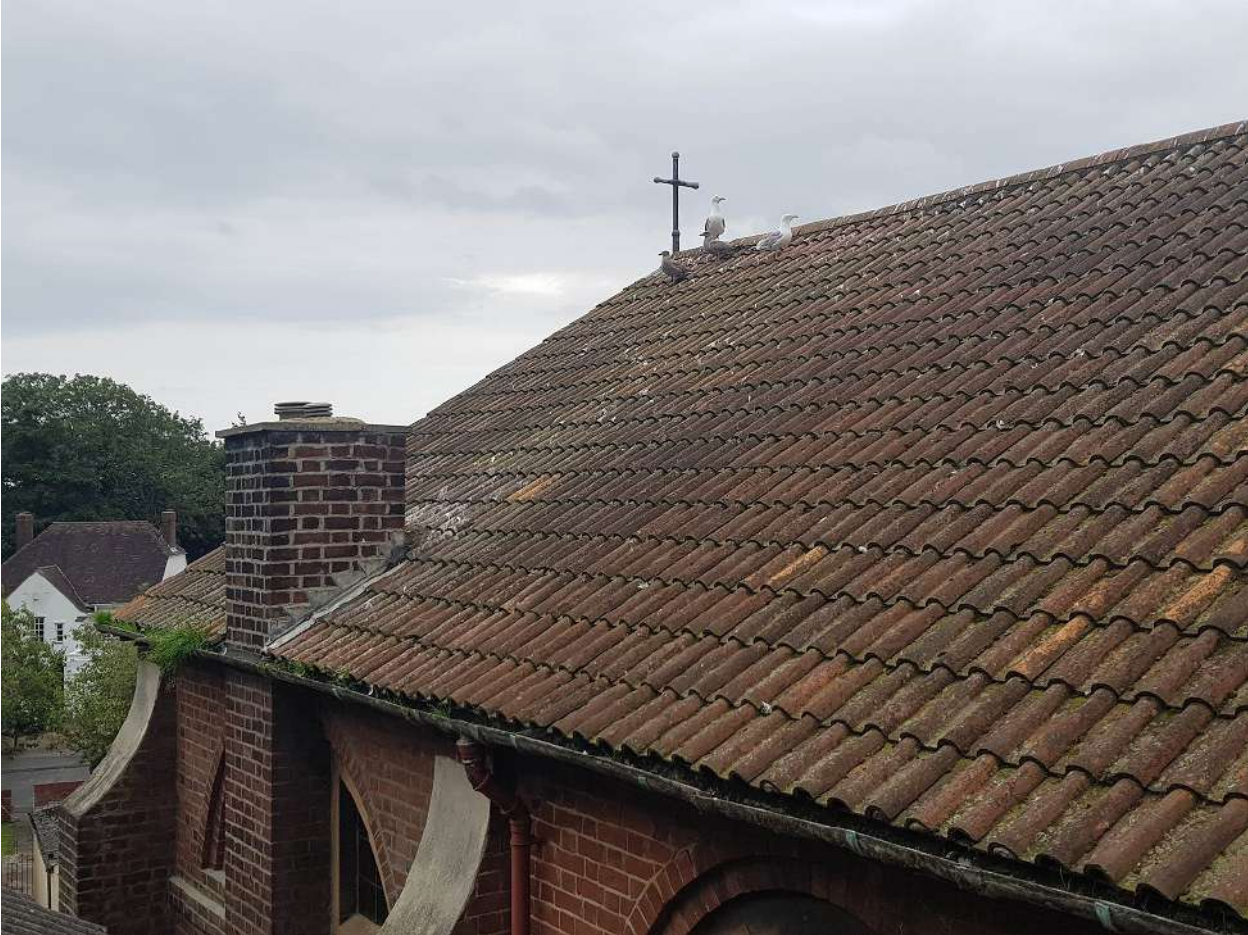
3.1.5 It is possible that a seagull nest exists behind the chimney stack on the north slope, east end.

**R1** Carefully remove once the seagulls have finally flown the nest.

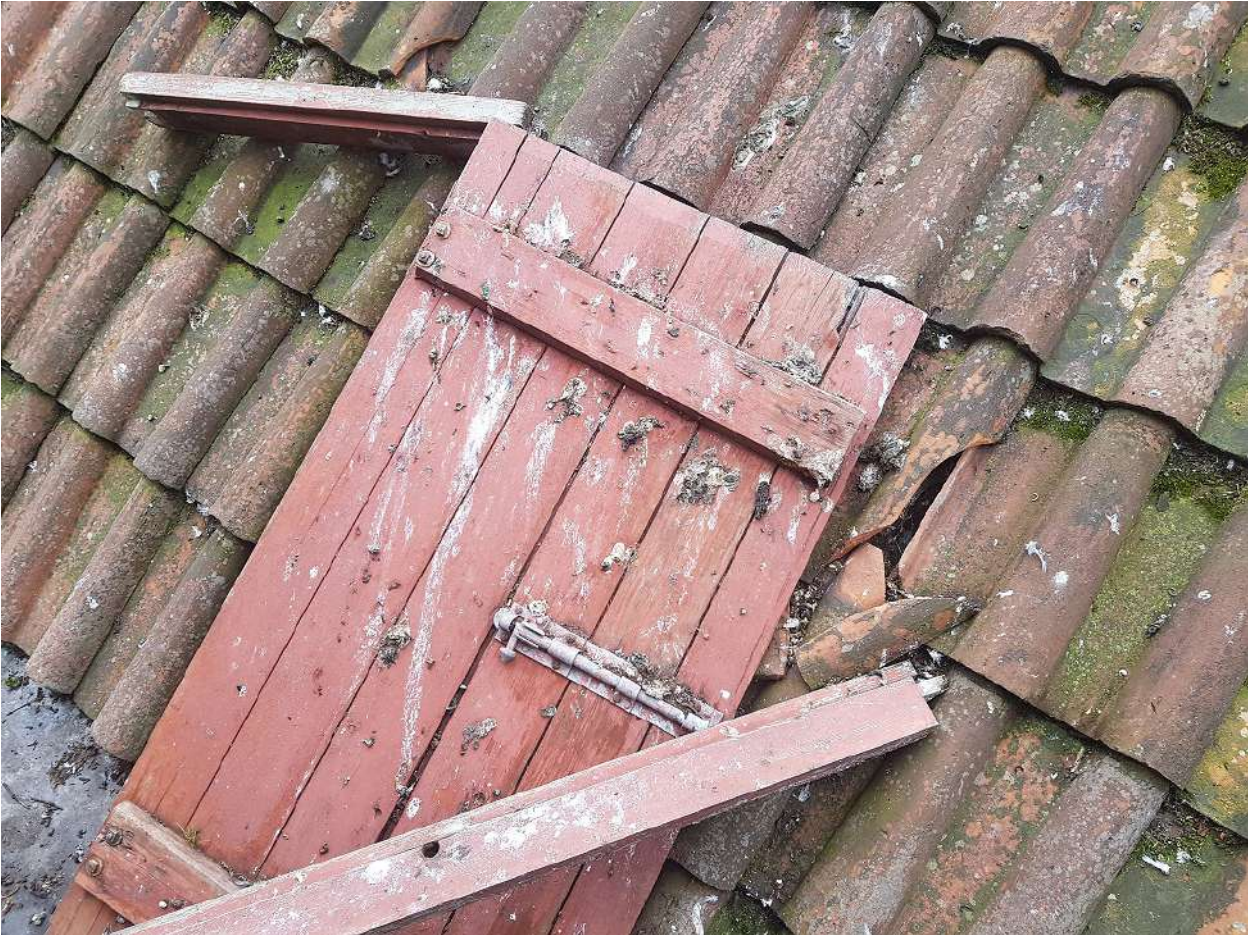
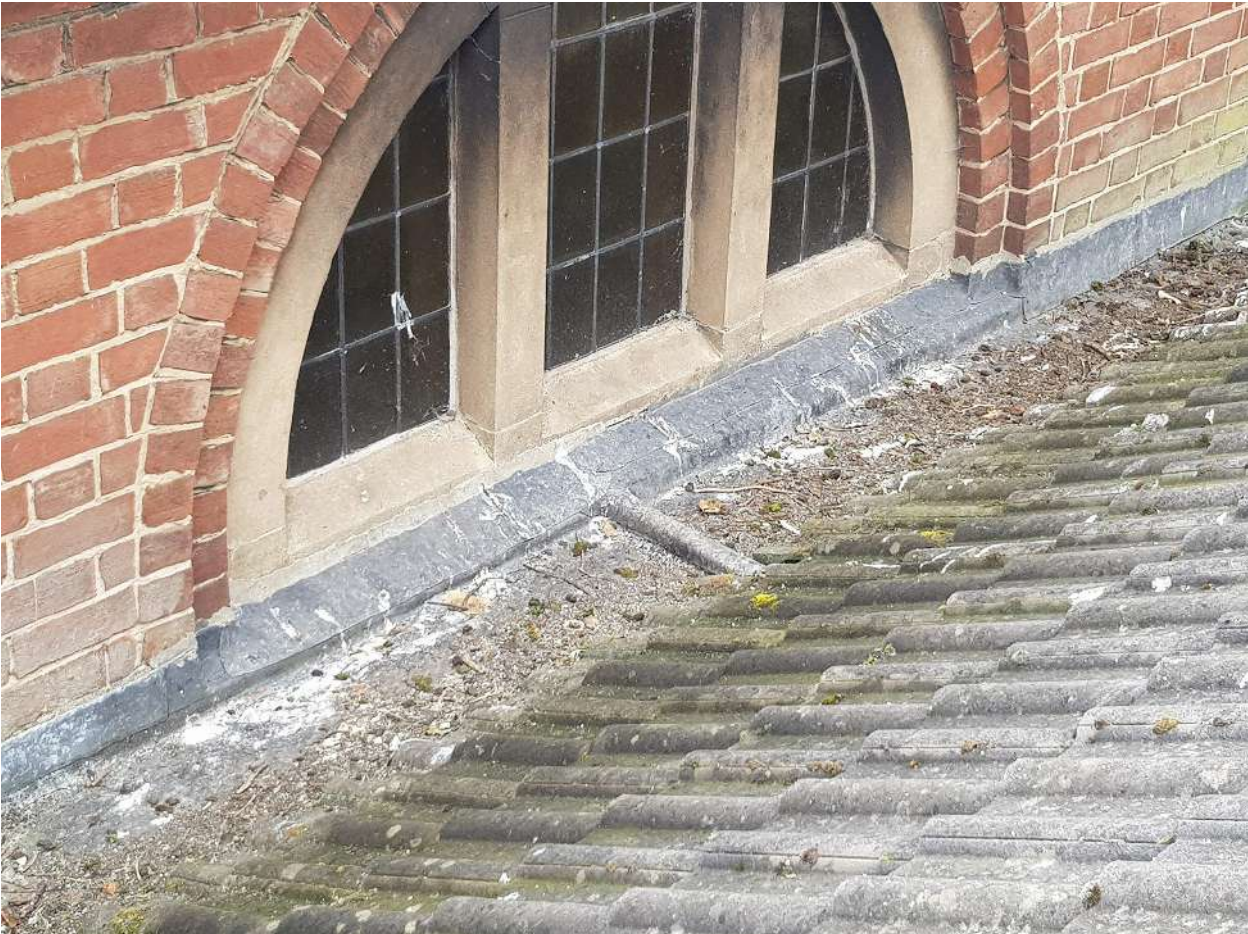
3.4 VESTRY

- 3.4.1 It is understood that the roof covering over the vestry is maintained in a weathertight condition. Several individual pantiles are showing signs of a degree of delamination to the surface finish, indicative of an ageing roof covering. The coursing pattern of the tiles is maintained suggesting that the peg/nail fixings continue to be in an acceptable condition.

<b>M</b>	It is recommended that as a routine item of maintenance the roof coverings are checked and any necessary repairs carried out on a twice-yearly basis.
----------	---

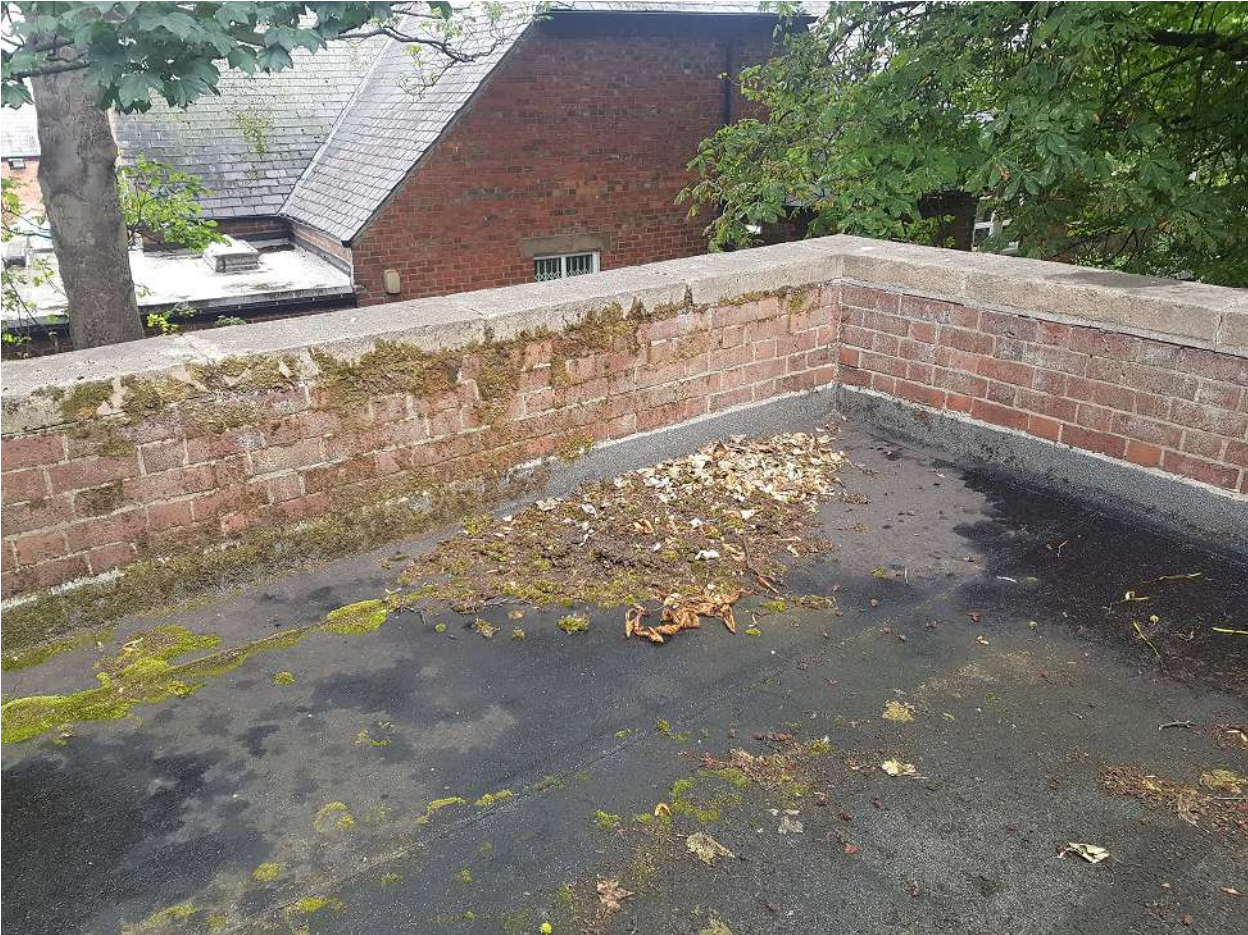
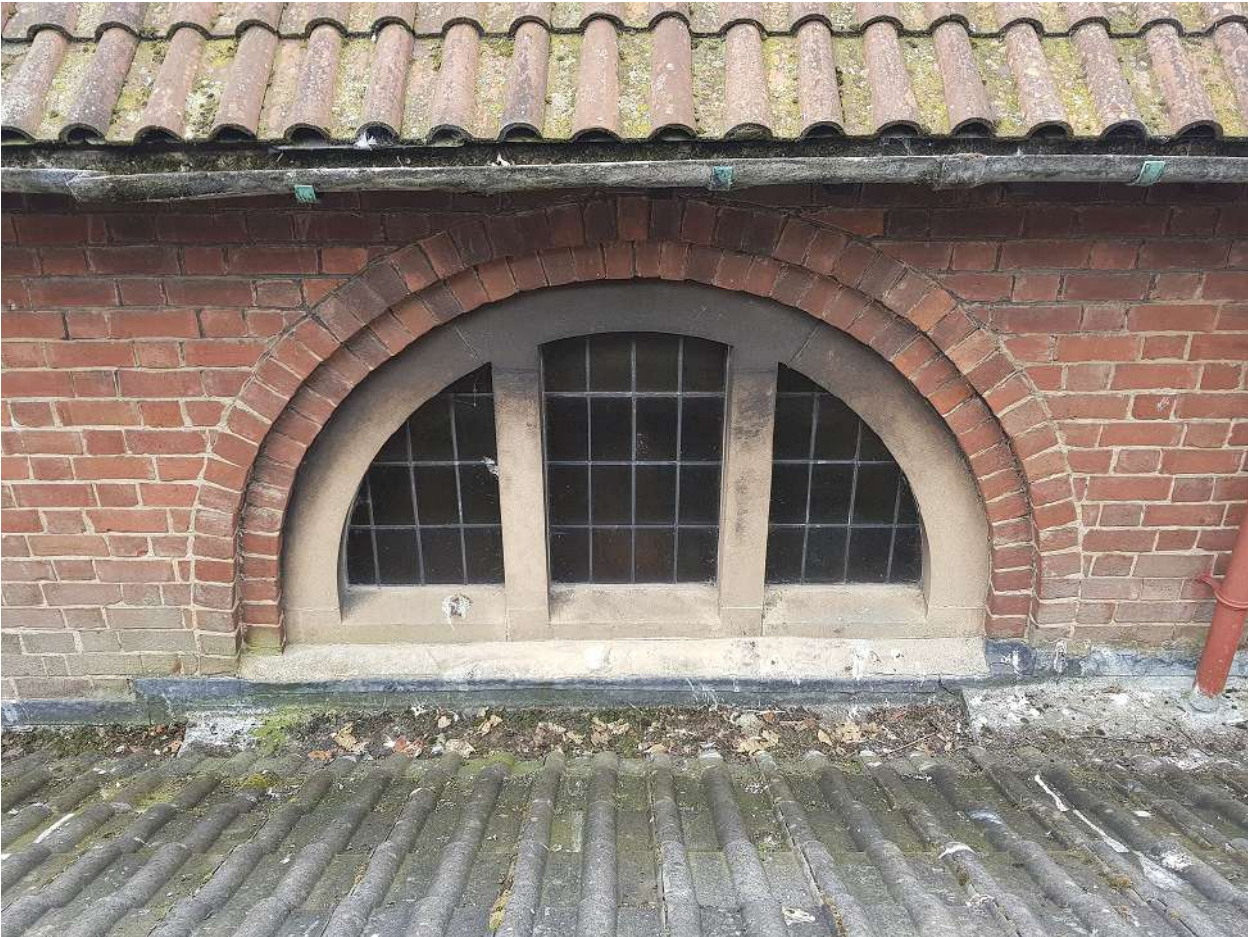
- 4.2.1 The guttering is in similar condition to that of the nave + chancel. The cast iron downpipes are showing some signs of rusting. There is a particularly awkward junction at the transition between gutter and downpipe that consists of narrow and twisted sections of downpipe. This is a weak point for blockages etc. and it would be beneficial to find an alternative solution that reduces the amount of bends to the top section of the downpipe.

The material nature of the gutters is hazardous, particularly so if the fabric of the gutter begins to break down and would be best replaced.

<b>R3</b>	It is recommended therefore that a phased approach to the replacement of all rainwater goods is put in place over the course of the quinquennium.
<b>M</b>	4.2.2 It is highly recommended that all the gutters, downpipes, hoppers and gullies are continually checked and cleared out regularly (at least twice a year).

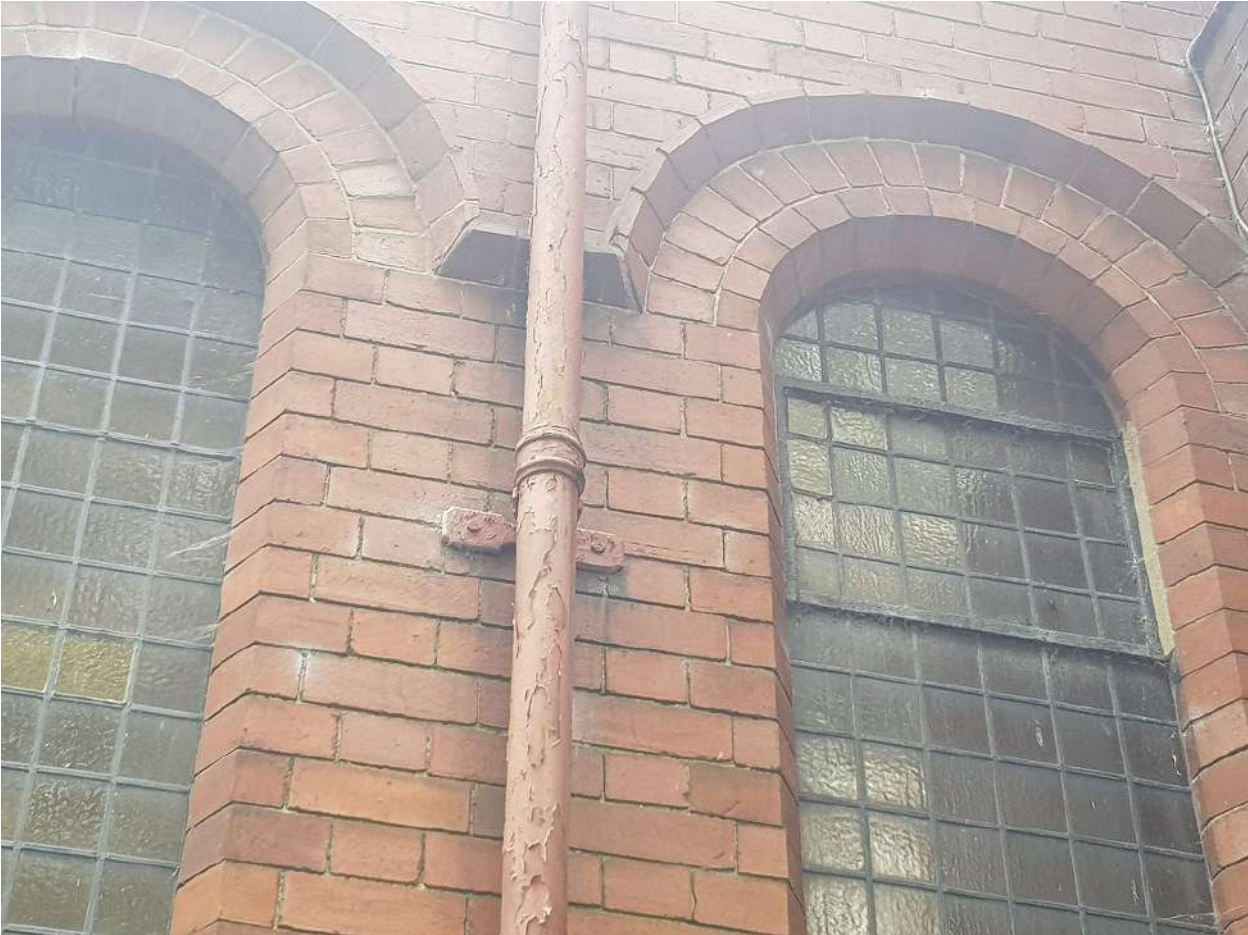
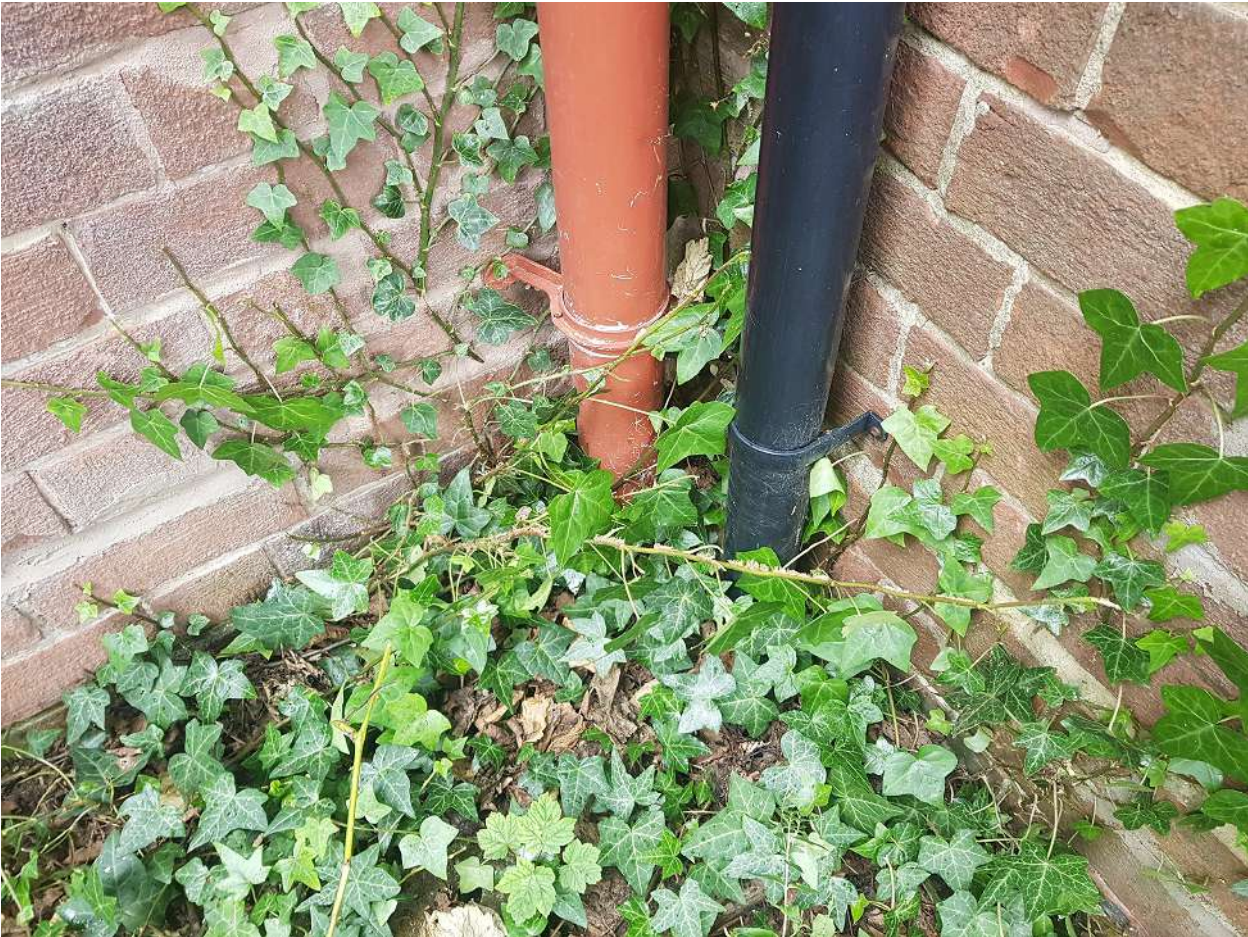
4.5 ENTRANCE PORCH

- 4.5.1 This configuration is greatly restricted particularly at the junction between parapet outlet and hopper head. The diameter of the discharge pipe at this location is thin.

The material nature of the downpipe is hazardous, particularly so if the fabric of the downpipe begins to break down and would be best replaced.

**R3** It is recommended therefore that a phased approach to the replacement of all rainwater goods is put in place over the course of the quinquennium.

**M** 4.5.2 It is highly recommended that all the gutters, downpipes, hoppers and gullies are continually checked and cleared out regularly (at least twice a year).

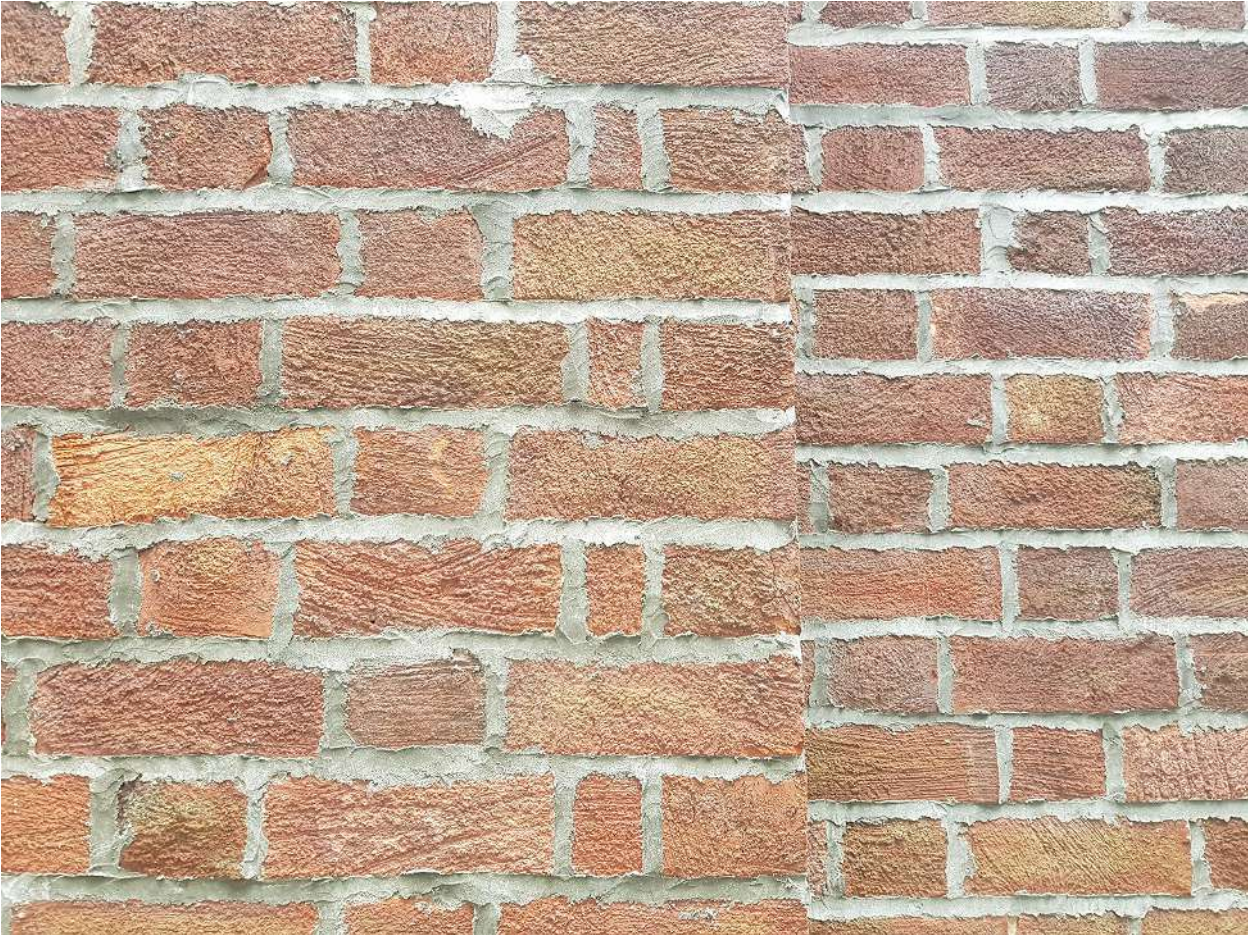
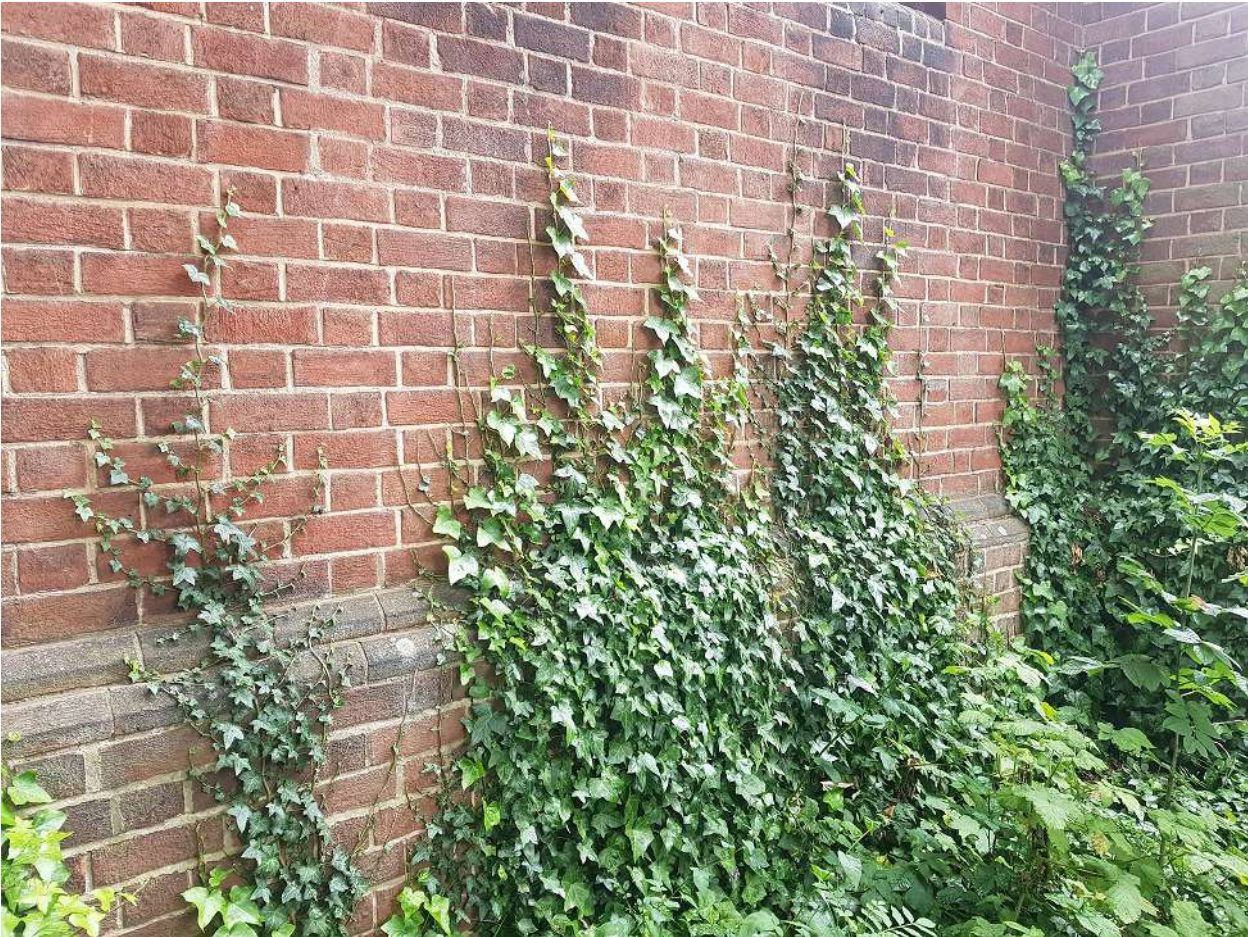
- 7.1.1 The face of the red brickwork to the nave and chancel is textured in appearance, it has had a wire or drag finish. This creates a contrast with the smoother face of the original church build. There is some loss of fragments to the brick face is evident at high level due principally to frost damage. Also, noted that the particular design of the plinth arrangement is weak and encourages standing water on its projections.

Despite the above comments the red textured brickwork generally continues to be found in a sound, good condition.

Repointing of the brickwork, 5-10mm in width is patchy in places particularly at high level on the open faces of the buttresses. There is the occasional open joint due to weathered and/or missing mortar. Render to the curved top face of the buttresses could do with the occasional minor repair. There is evidence of repointing in a cementitious mortar, alongside being inappropriate in material the workmanship of the repointing is poor that gives an unpleasing aesthetic appearance.

To the south elevation there is considerable plant growth, particularly ivy at low level which if left unattended will rapidly grow and cause damage to the walling fabric.

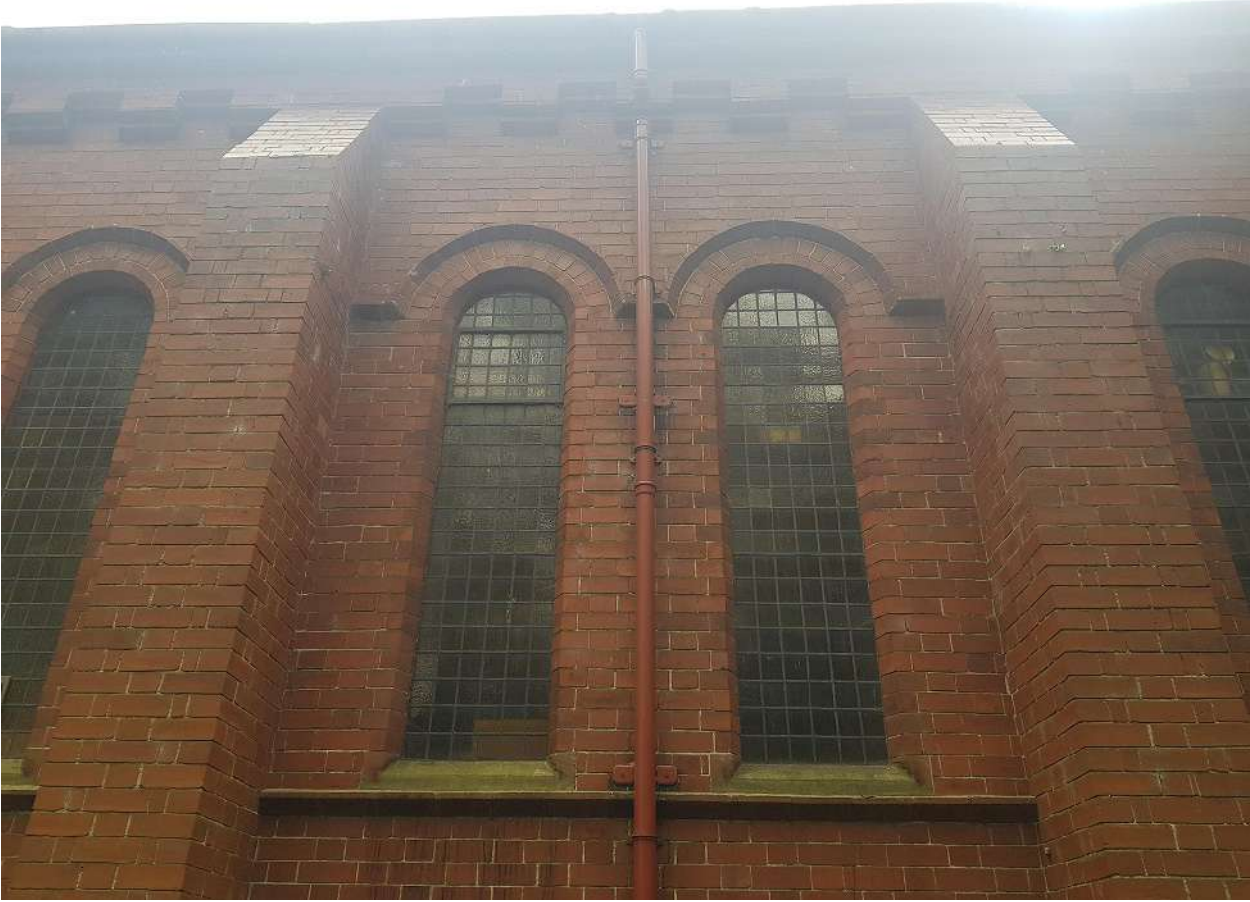
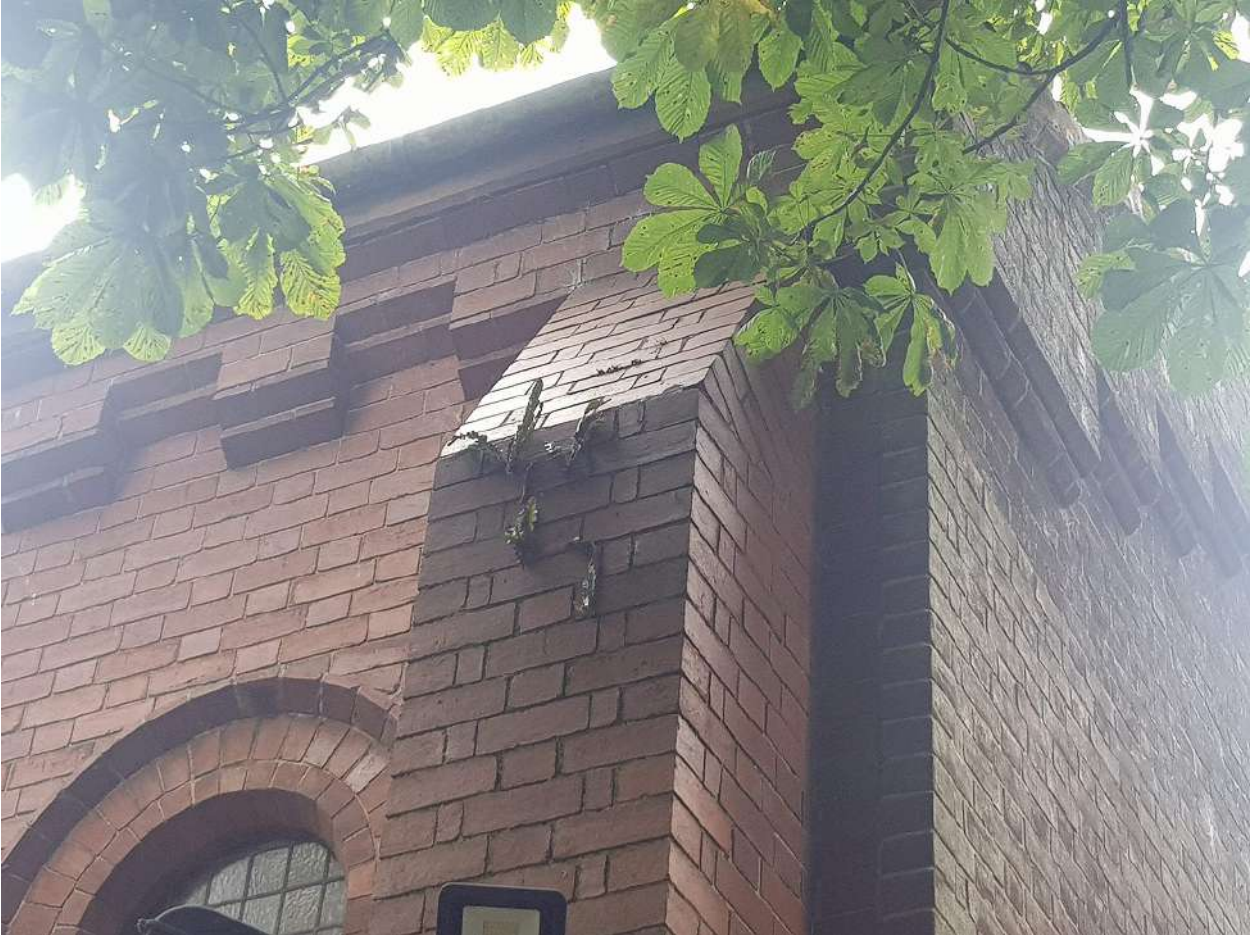
7.2.1 Red facing brickwork all generally in a sound, good condition.

Pointing of the brickwork, <5mm is patchy in places particularly at high level on the open faces of the buttresses and at selected areas of the plinth. There is plant growth growing out of the buttress top to the north elevation.

<b>R1</b>	It is recommended that a lime : sand mortar repointing specification and methodology is drawn up to inform current and future fabric repair needs.
<b>R2</b>	7.2.2 Carry out repointing repairs to red facing brickwork and natural stone window surrounds by a competent and experienced masonry contractor.
<b>M</b>	7.2.3 As a routine item of maintenance carefully remove plant growth away from the low-level walling fabric of the church, check and action twice yearly.

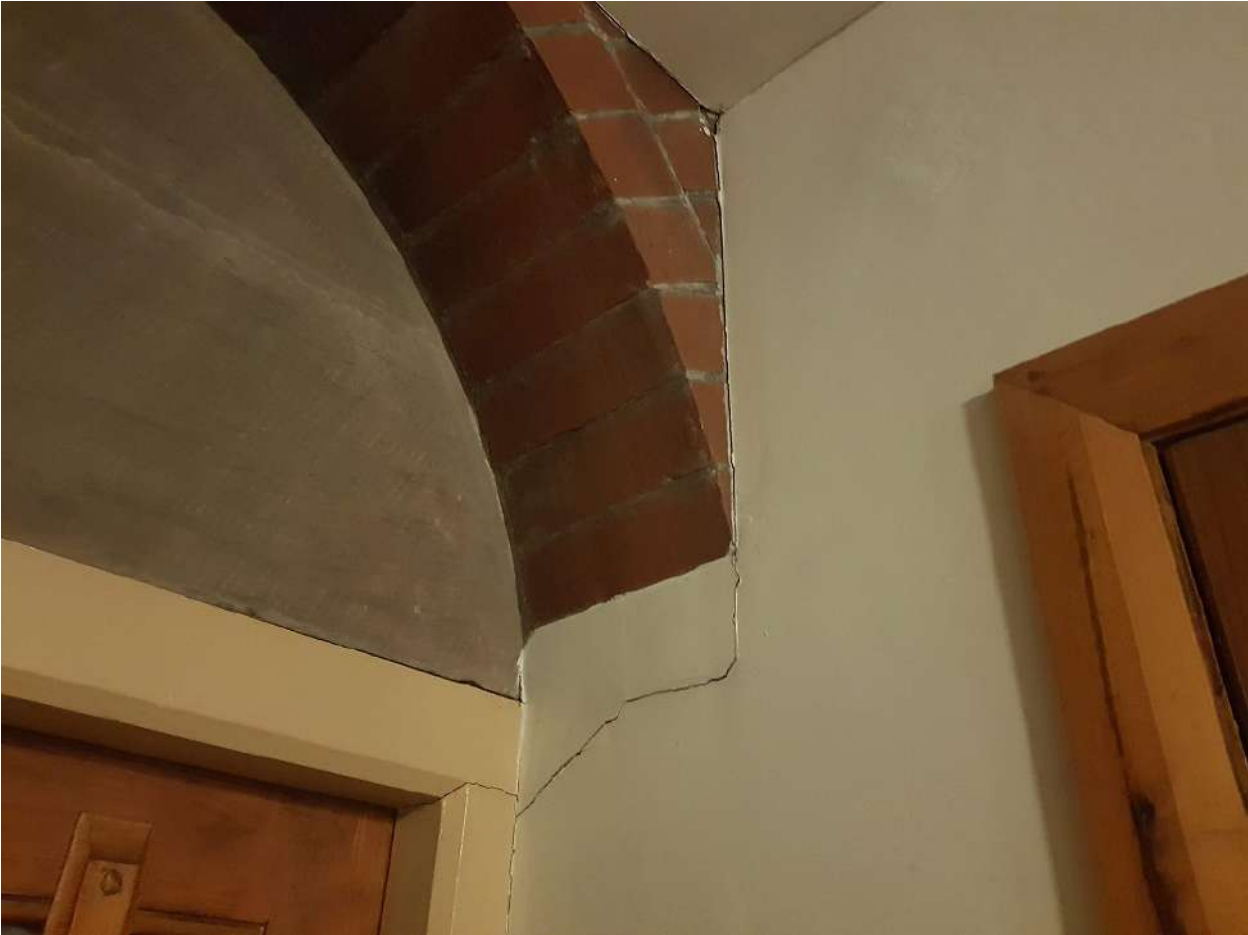
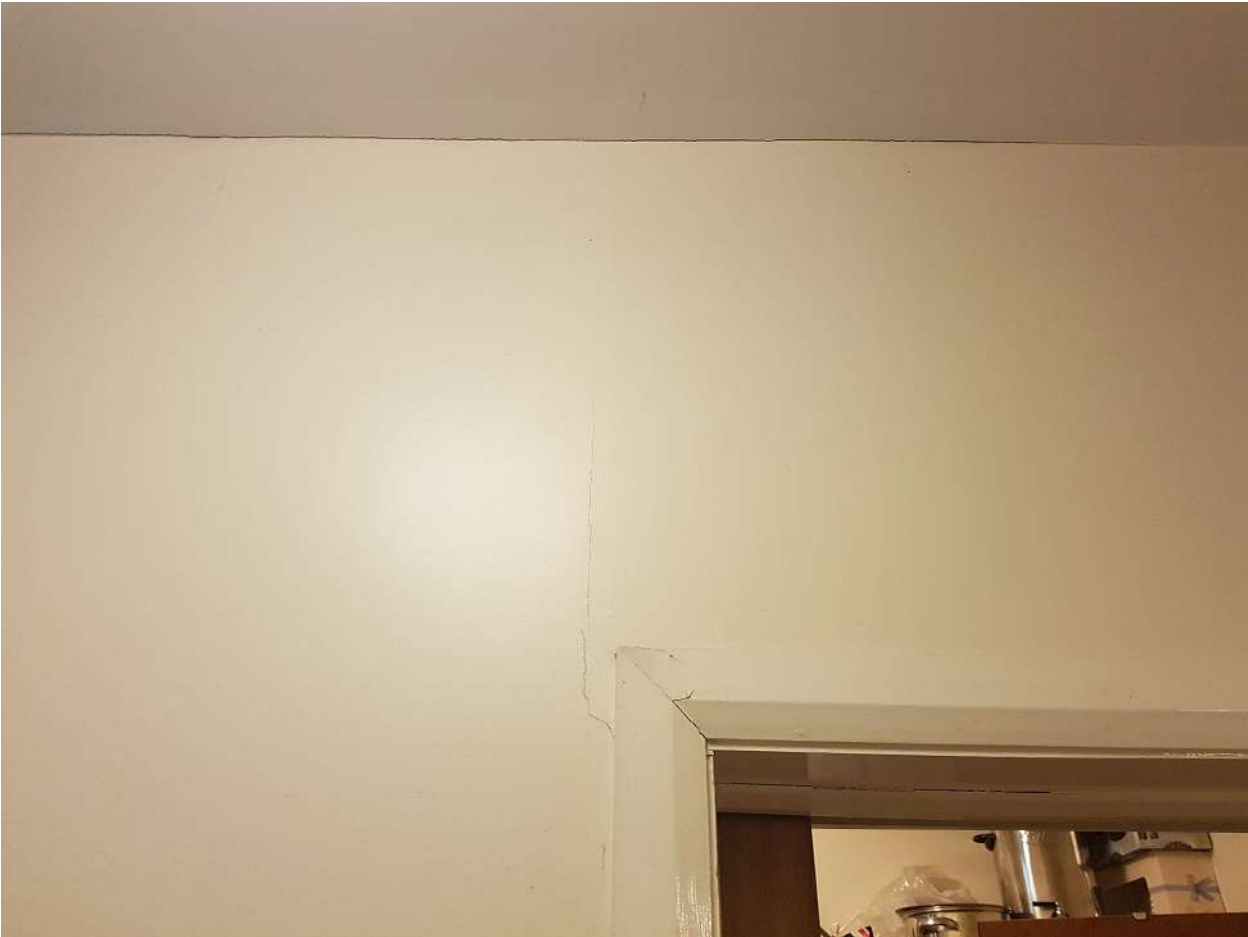
Some hairline cracking exists at the junction of wall and ceiling to the north. This may be due to slight structural distortion and/or movement in connection with the inserted floor above.

**M** As a routine item of maintenance, a visual check of the hairline cracking is recommended twice yearly to ensure that the condition is not worsening.
