**INSPECTION AND REPAIR OF CHURCHES
CARE OF CHURCHES MEASURE 2018
amended by the Church of England (Miscellaneous Provisions) Measure 2020**

**QUINQUENNIAL REPORT on the
THE CHURCH OF ST EBBA
EBCHESTER**

Date of inspection and weather conditions: 7th May 2025. Dry day but slightly overcast becoming brighter as the survey progresses. The survey followed a period of very dry weather.

Date of report: 20th August 2025

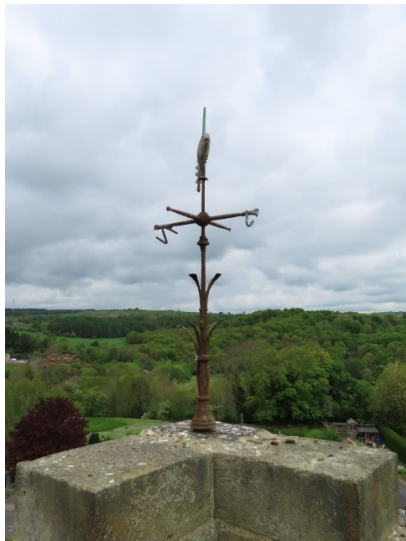
Rusting weathervane

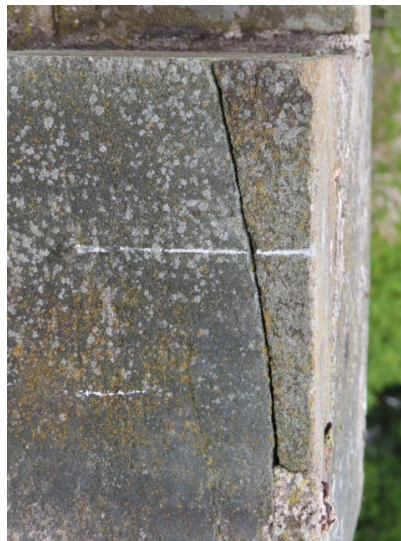
Some high-level pointing has undertaken to the Tower since the last inspection, but a few issues remain including a cracked stone at parapet level which needs repair. The mortar to the edge of the lead panels to the Nave is failing with some section of lost mortar to both the East and West elevations - this needs to be looked at before water ingress becomes an issue. There are a few open joints to the bellcote, but proper inspection was difficult due to tree growth. However, the location of one open joint to the head of one arch would benefit from fairly prompt attention. At lower level vegetation growth at the base of the walls needs to be removed and any resultant open joints pointed – given the location this will be a constant issue and adding this to a regular programme of maintenance would be prudent, a task that could potentially be undertaken by volunteers.

Crack to parapet stonework

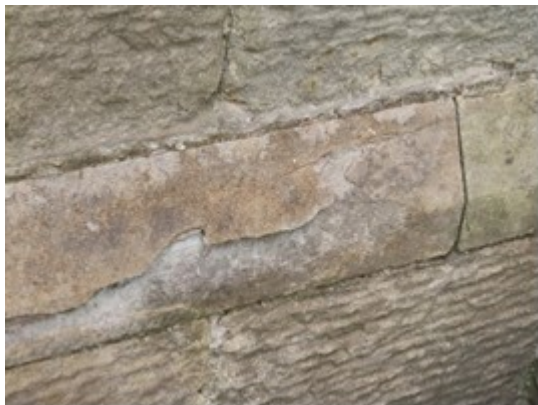
Deterioration of tower plinth stonework (North)

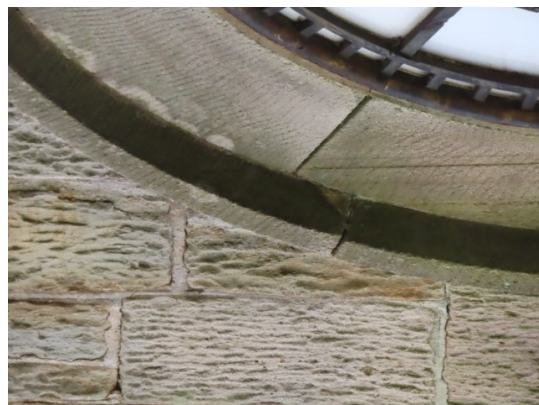
Crack to North wall of the tower

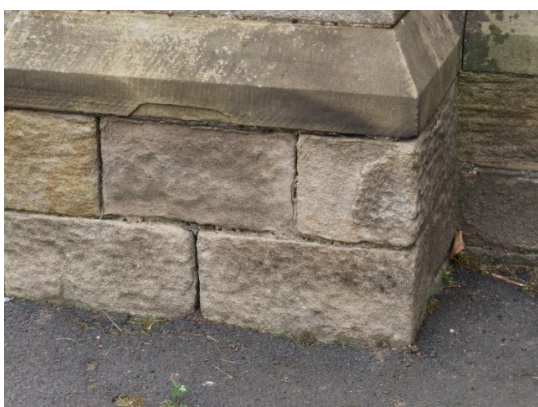
Open joints to the lower section of the tower

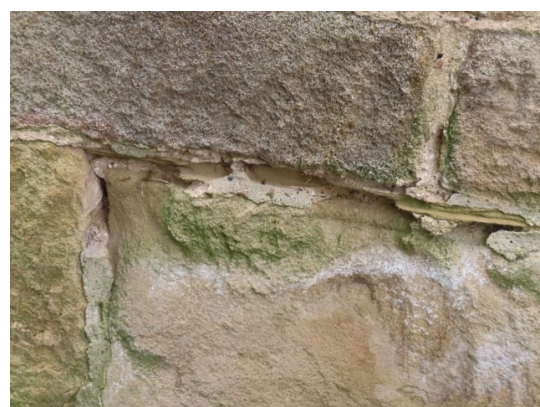
Failing mortar stonework to the Chancel

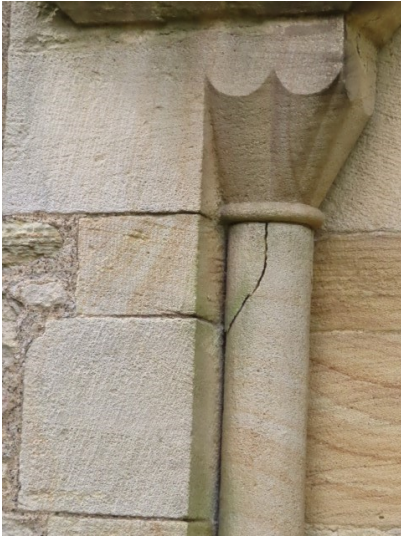
Cracked Pilaster to Chancel

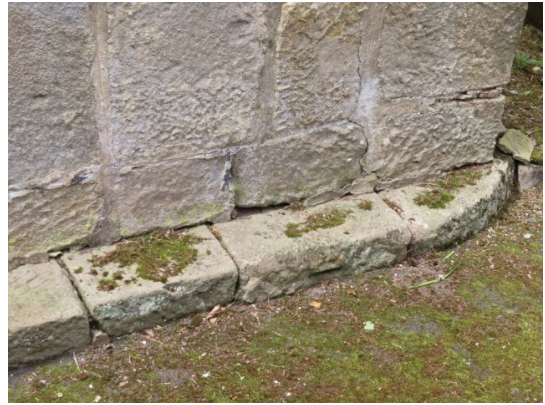
Open joints to the base of the Chancel wall

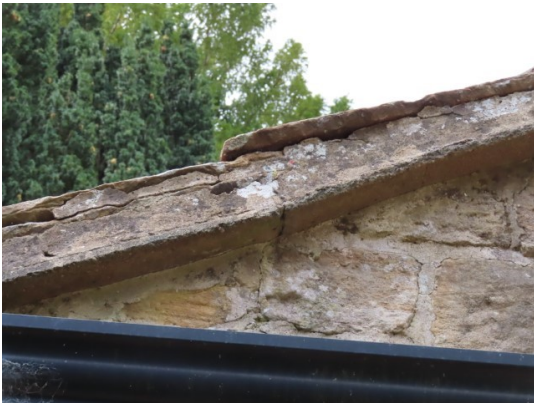
Cracking and loss of pointing to Verge

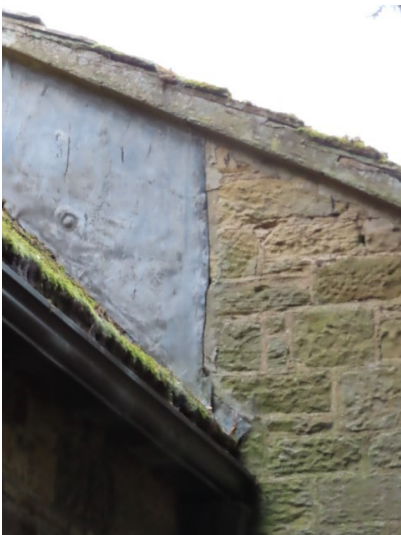
Mortar to edge of lead panels is failing in places

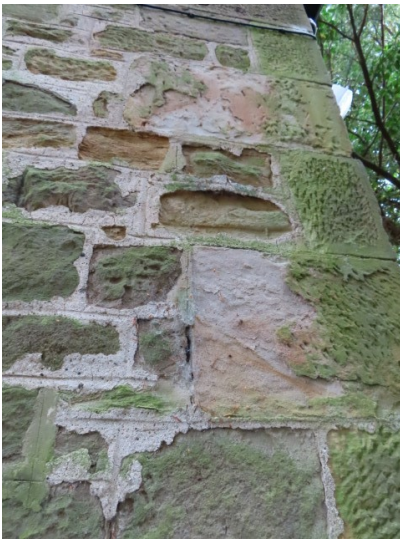
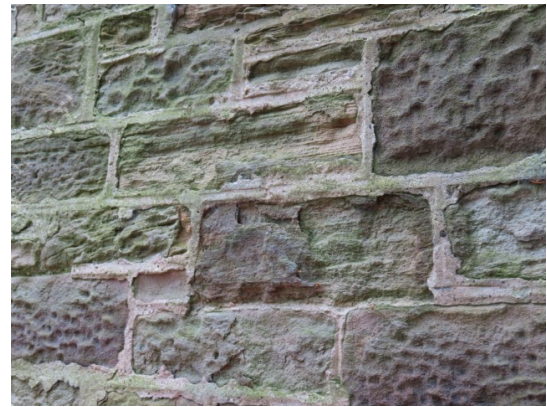
11. West Elevation of Nave	Semi coursed squared sandstone	The adjacent trees are very close to the wall and need to be cut back fairly urgently. The presence of overhanging branches makes it hard to inspect this elevation. Algal growth is visible, but it is not clear whether this is also due to the shaded nature of the wall, or run off from water tables etc.	Discuss and agree a programme of tree maintenance to the trees to the West side of the building with Durham CC to avoid damage being inflicted to the building.	1
		Some cracking of the mortar to the verge is visible and needs repointing.	Inspect from higher level and repoint open joints to bellcote	2
		Mortar is buttered over the stonework and there is some loss and failure of pointing with some sections coming loose, along with open joints and some weathering of individual stones at higher level, one or two of which may need repair in the future. Cracking is present to the sill of one of the windows into the wall below.	Carry out repointing works generally to repoint open joints and areas of failed mortar and cracking using lime mortar. It would be sensible to consider wider repointing of this elevation due to the general condition of the pointing and likely ongoing failure over time.	4

Weathered stone and failing mortar to the West elevation of the Nave (above and below)

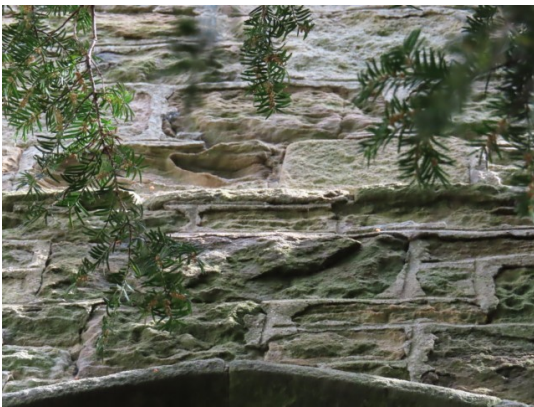
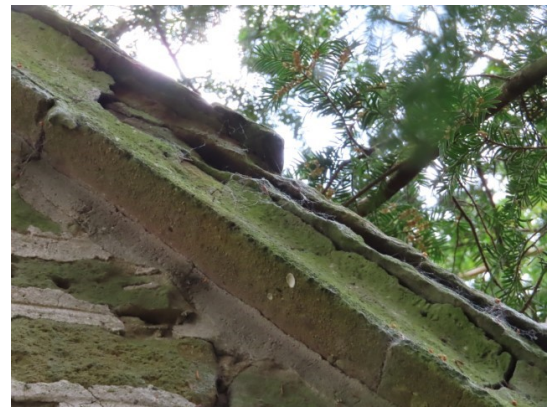
Deteriorating mortar to Western verge

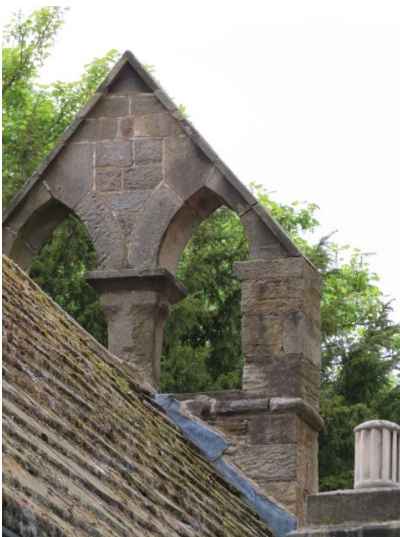
As noted previously, the bellcote is difficult to survey from ground level. It appears generally sound, but does need closer inspection when roofing works are undertaken to check exact condition as there appear to be some hungry joints. Viewed from the East there appears to be a number of open and hungry joints including to the top of one of the arches.

Open joints to Bellcote

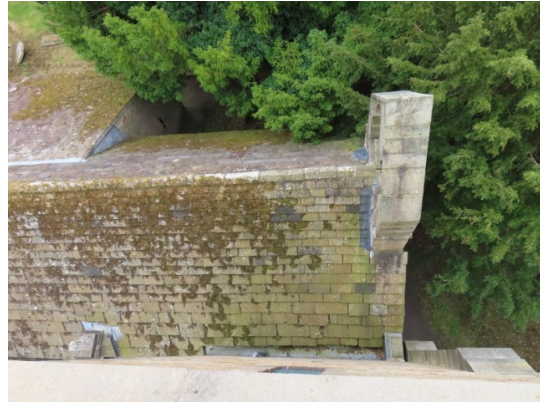
Close proximity of the trees to the Western end of the Church touching the walls/roof in places

Clear debris from tower gutters	1 then M
			Discuss and agree a programme for tree works to the yews to the South West side of the building with Durham CC to avoid damage being inflicted to the building/roofs. This should include ivy removal.	1
			Carry out repairs to all slated roofs including refixing slipped slates and replacing damaged slates.	1
			Check security of the fixing of the Nave cross and carry out any remedial work required	1
			Repoint/rebed ridge tiles where mortar is missing or failing. Remove excess moss growth where this has covered ridges to allow better inspection.	2
			Remove vegetation growth from North Chancel roof slope	2
			Inspect gutter between Nave and Tower and Nave Chimney flashings and carry out any remedial works required.	3

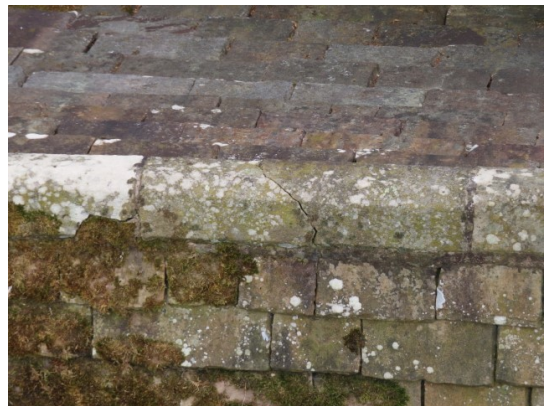
Cracked Nave ridge tile

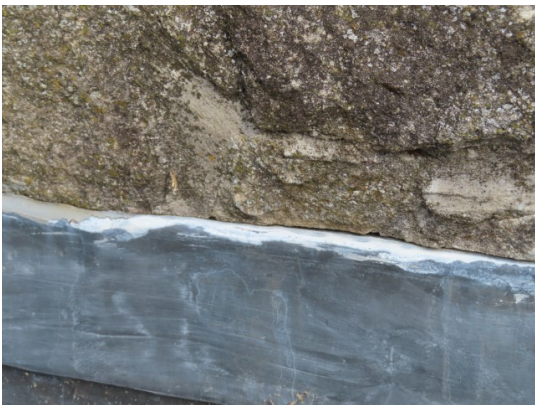
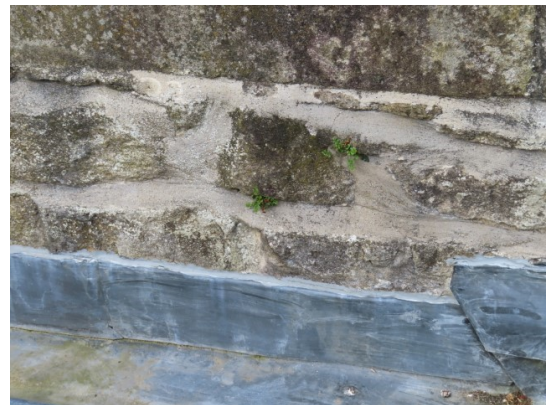
Failed and missing mastic above new Tower roof flashings with vegetation growth to the parapet (top right)

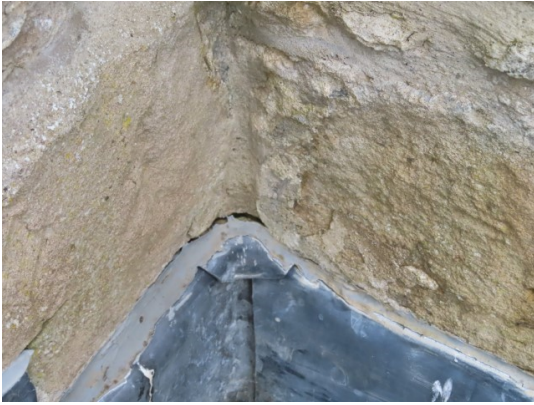
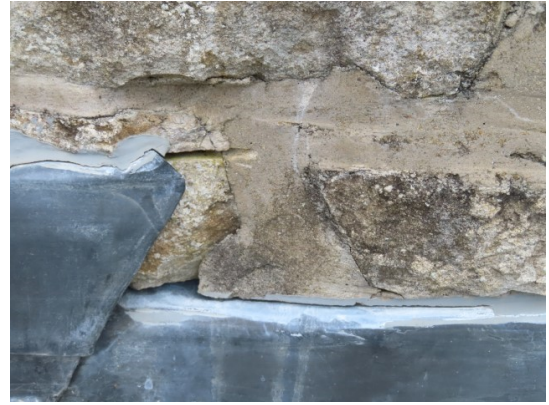
Failed and missing mastic above new Tower roof flashings

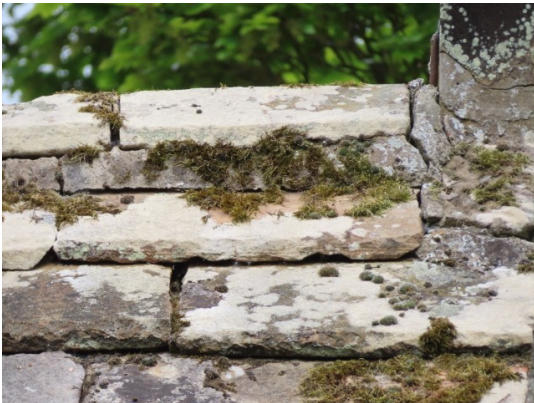
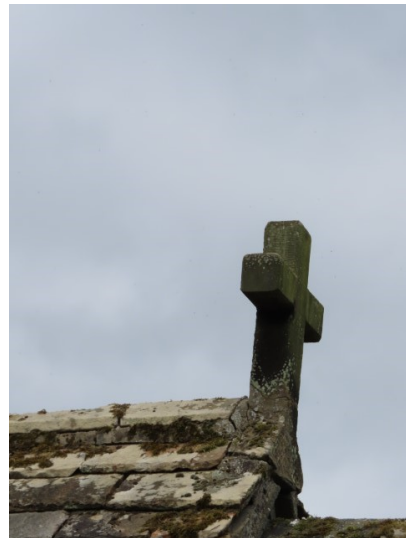
Cracked mortar around Nave cross which appears to be poorly secured

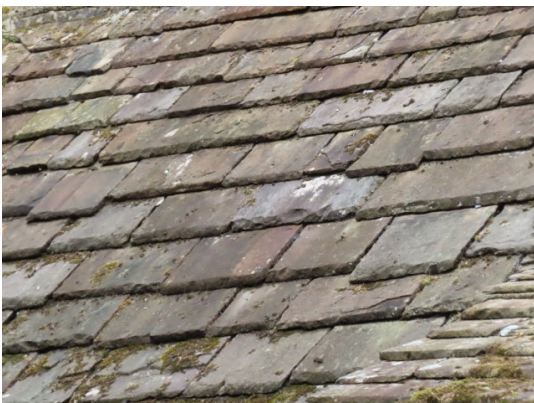
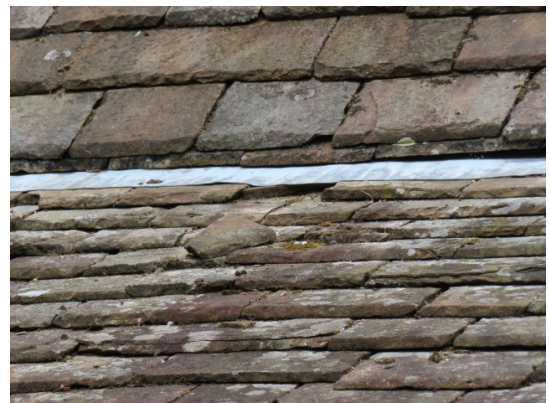
Slipped and damaged slates to the Southern roof slopes

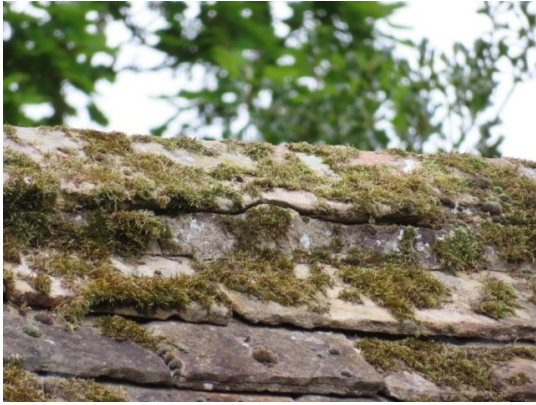
Moss growth and cracked mortar to bedding of ridge

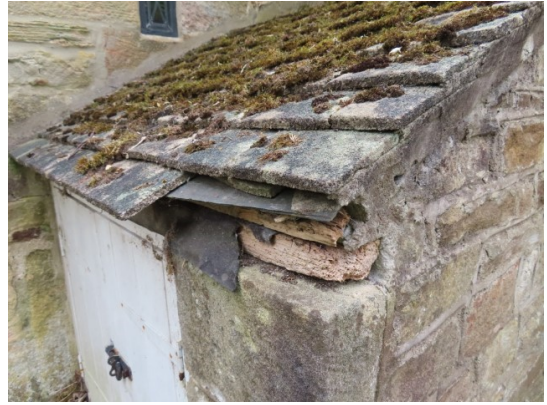
Damaged section of roof to boiler room lean to

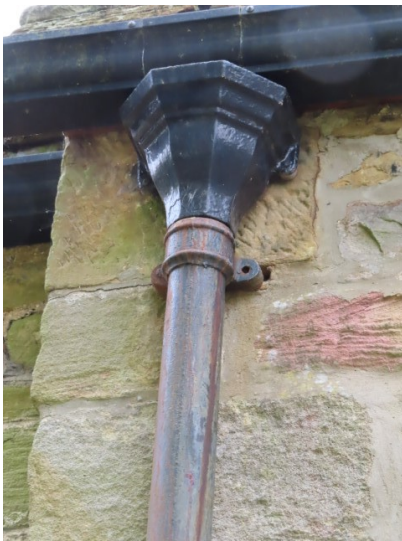
Rusting downpipe

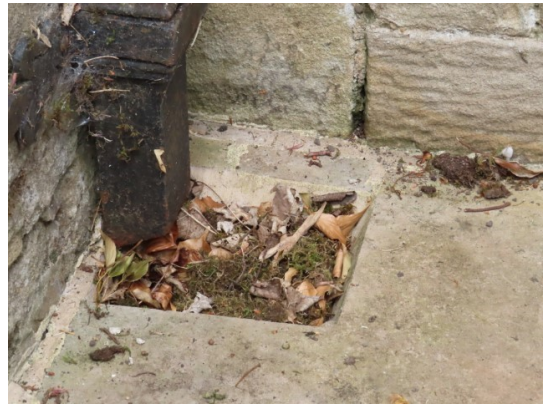
Debris filling Southern gully

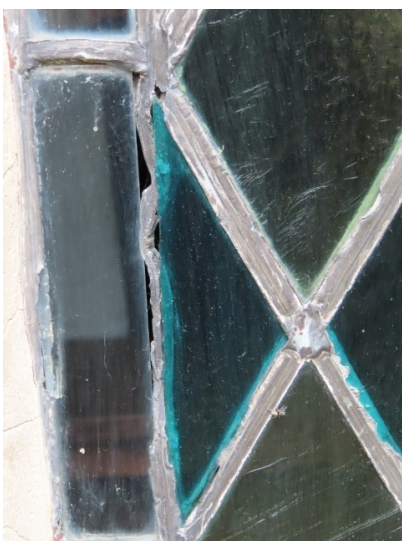
Damage to South Choir Vestry windows

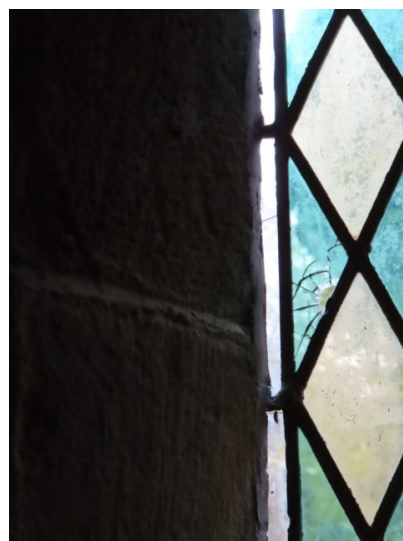
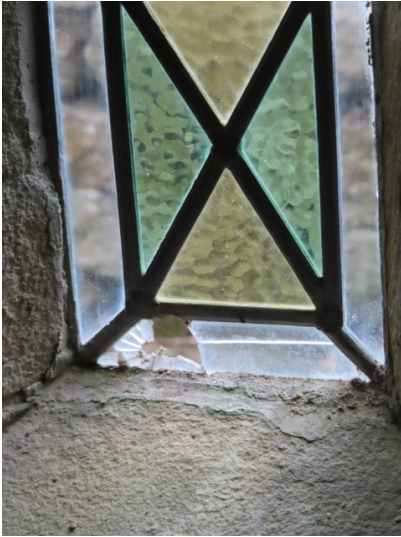
Damage to South Choir Vestry window

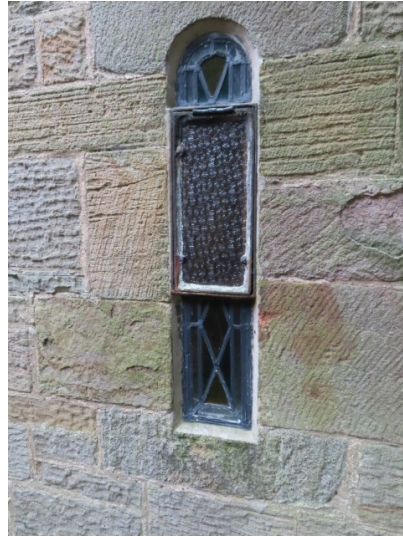
Rusting vent to East Vestry window

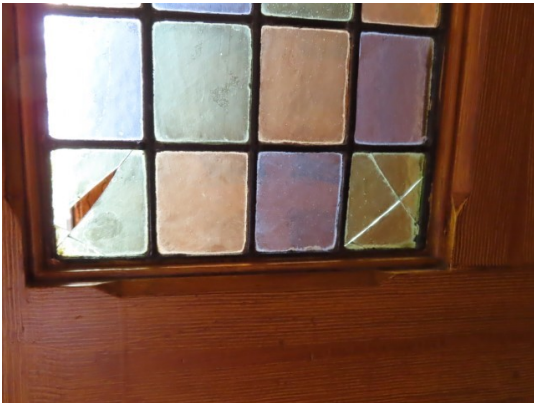
The inner tower doors were mentioned in the last report and sharp edges of failed glass remain. Although most people would avoid touching broken glazing, the location is a concern for children or visitors unfamiliar with the church.

Cracked and missing glass to main internal doors of tower

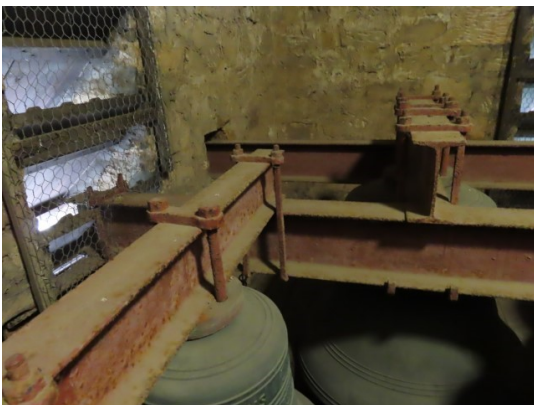
Rusting headstock and beams supporting the bells

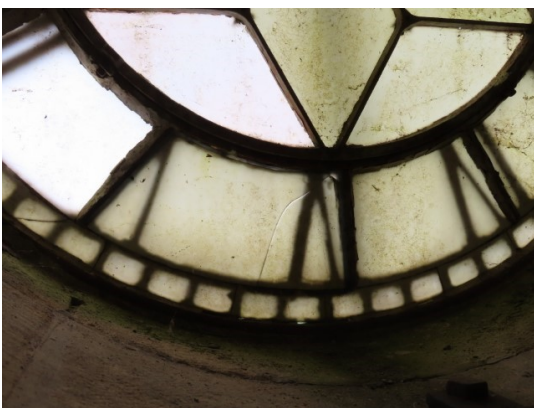
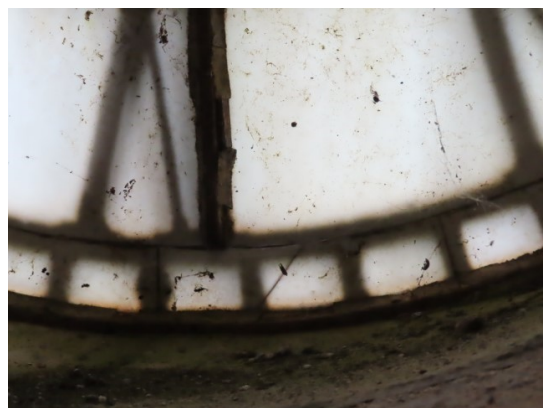
Cracked glazing and daylight visible to clock faces

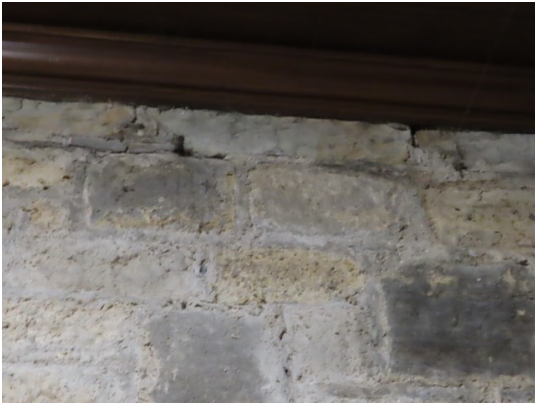
Stonework to Vestry

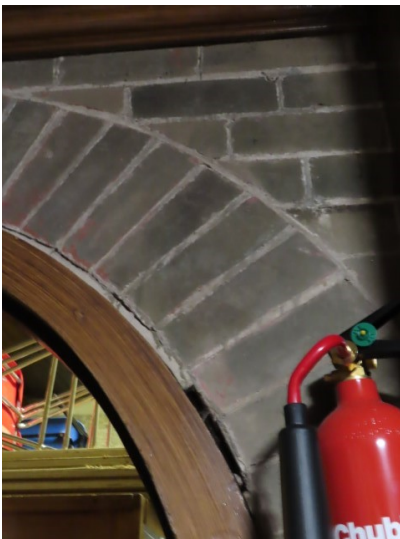
Cracking of mortar around door to organ chamber

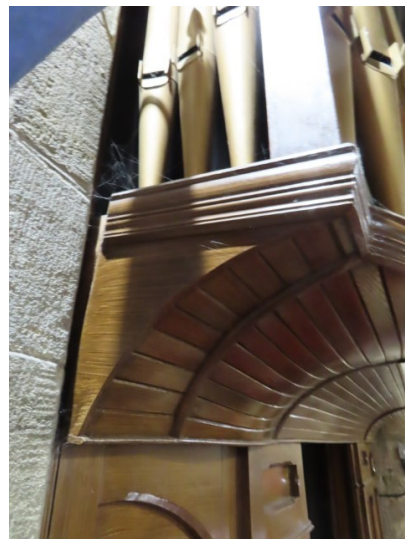
Organ frontal pulling away from the wall

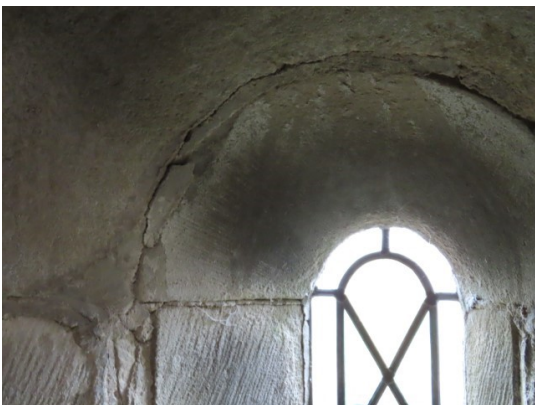
Cracking around nave window

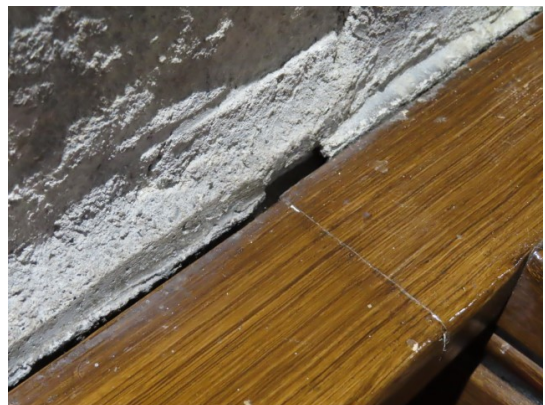
Fill behind pew edging is failing

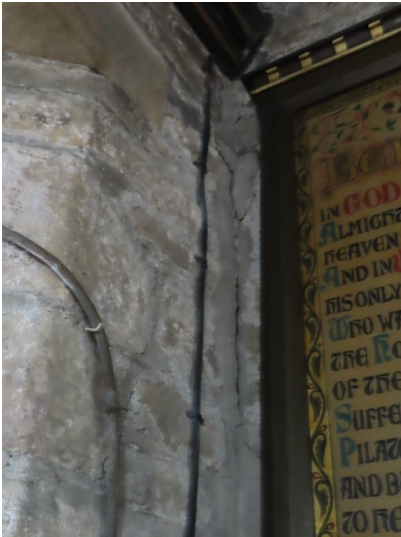
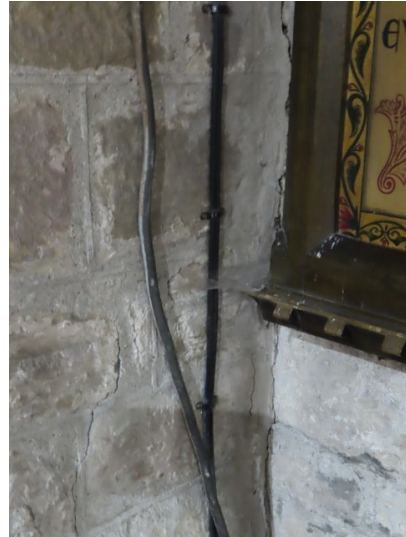
Cracking to NW corner of the Chancel

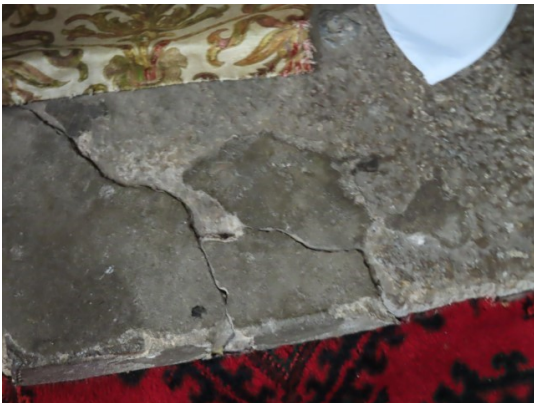
Failure to edge of altar dais

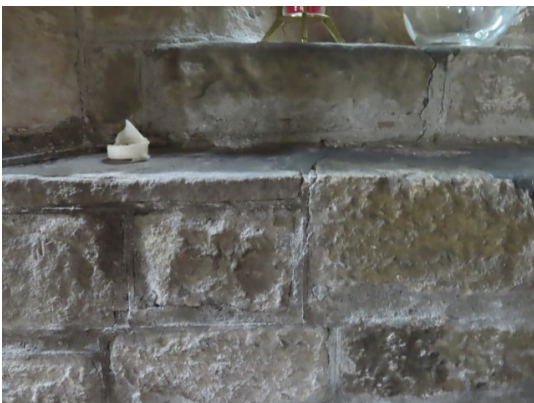
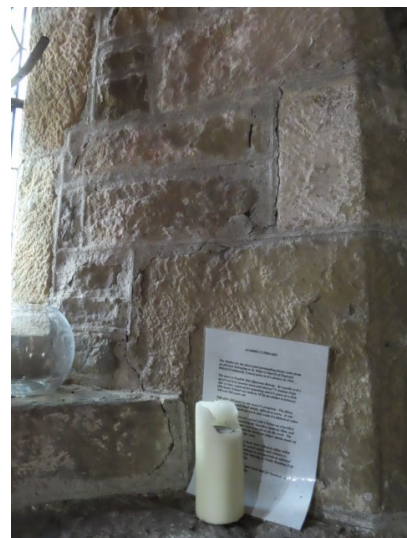
Cracking and hard mortar repairs to various Chancel Windows

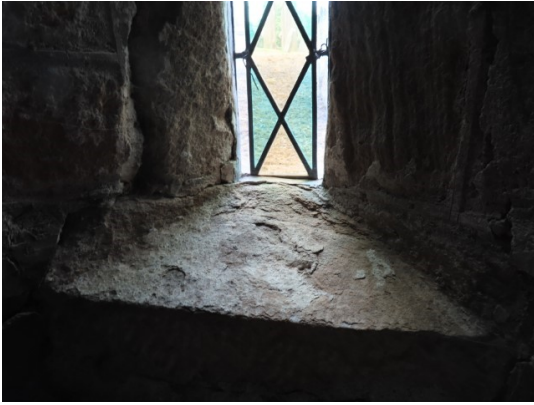
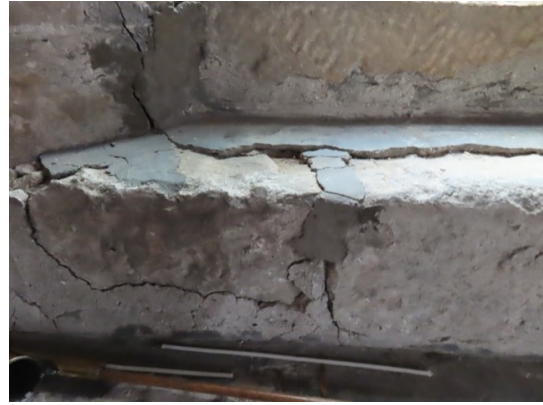
Cracking and hard mortar repairs to various Chancel Windows (above and below left)

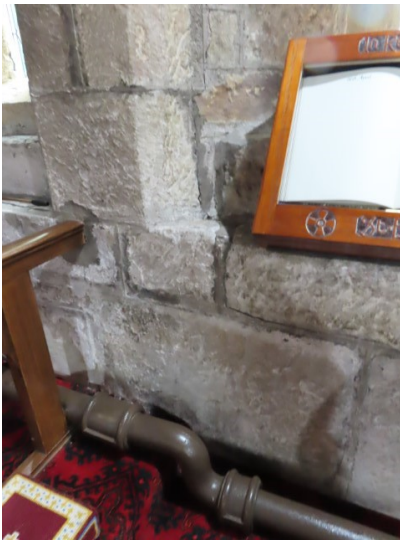
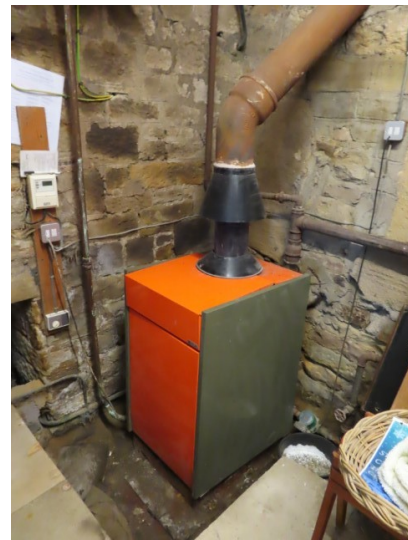
Rusty flue to boiler

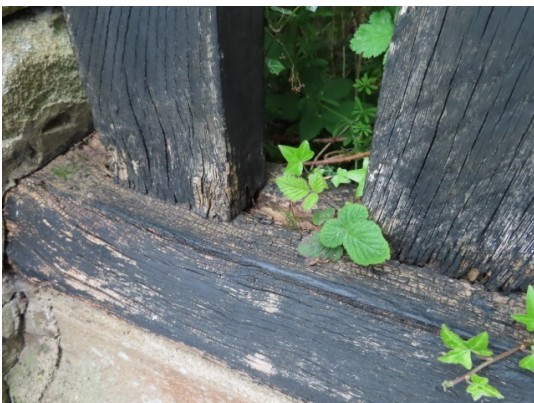
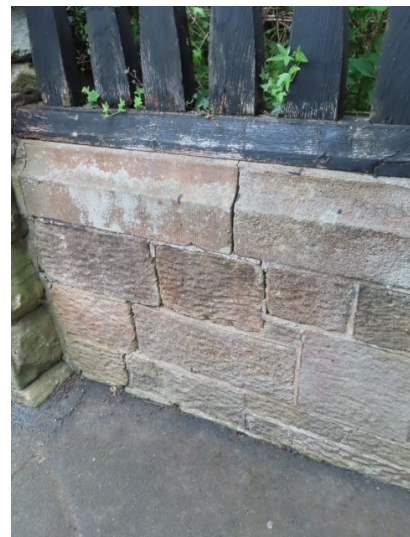
Rotten timber to Lych gate and cracking to stone plinth

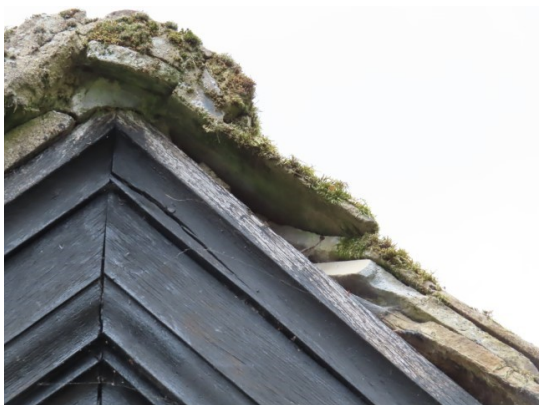
Failing mortar to Lych gate verge

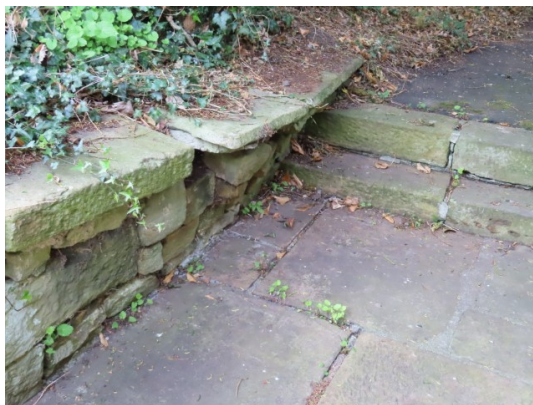
Bowing wall to the South of the Church

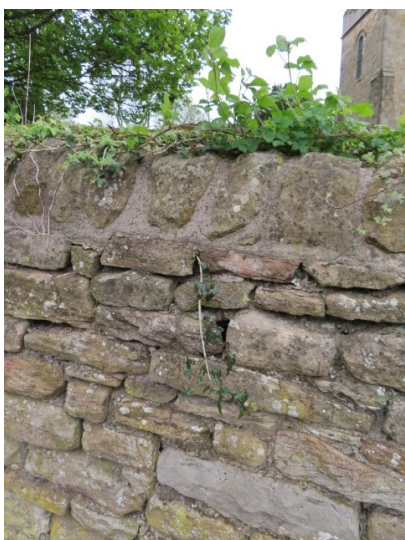
Ivy growth, loss of pointing and bowing around trees to boundary walls

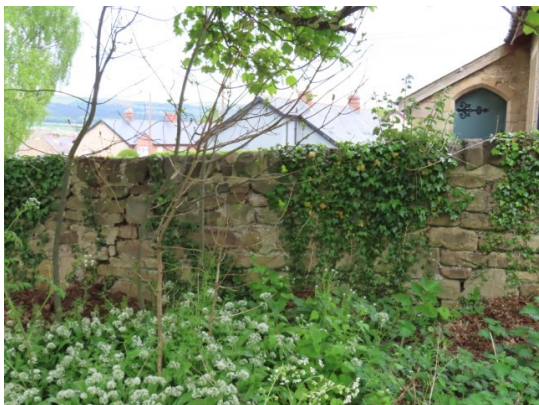
Ivy growth and cracking to the boundary wall

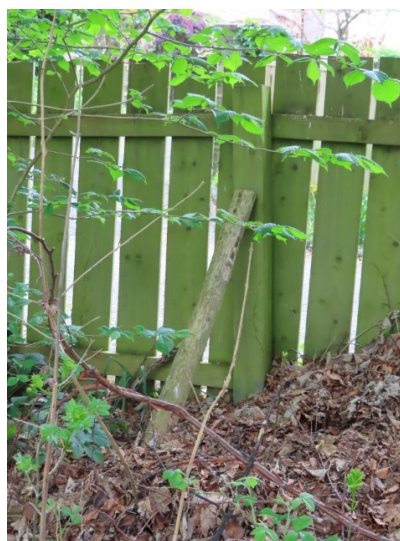
Propped fence post to Eastern side of the churchyard

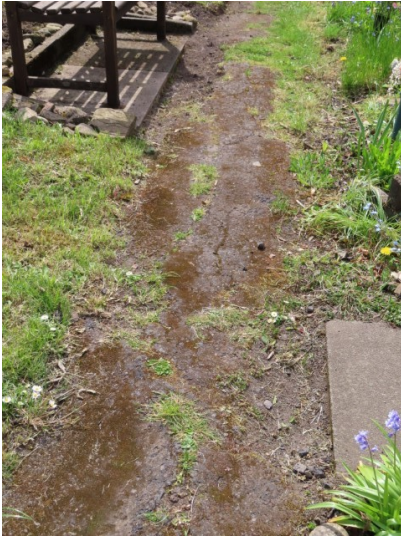
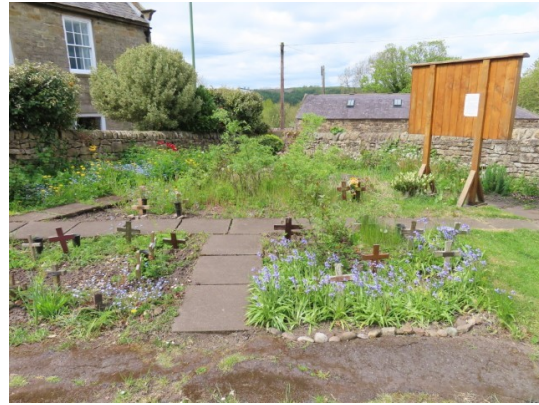
Cracked and raised path to main Garden of Remembrance bench. The Garden is generally rather overgrown

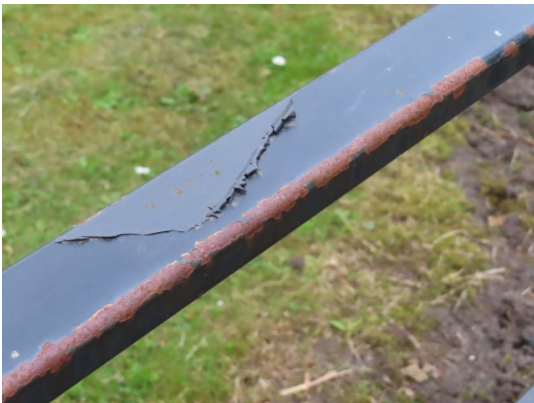
Failing paint to railing to main path

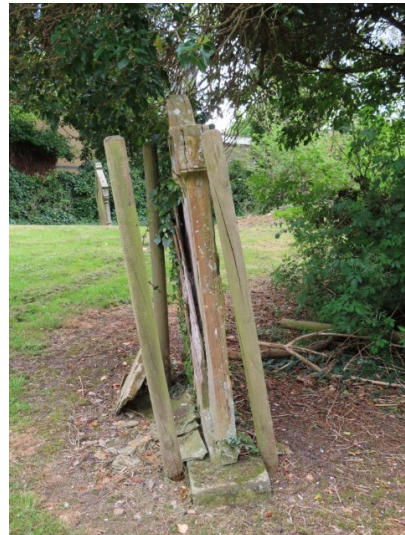
Temporary props to graves need attention
