## Escomb Saxon Church, Escomb

### QUINQUENNIAL INSPECTION REPORT 2022

#### Crosby Granger Architects Ltd

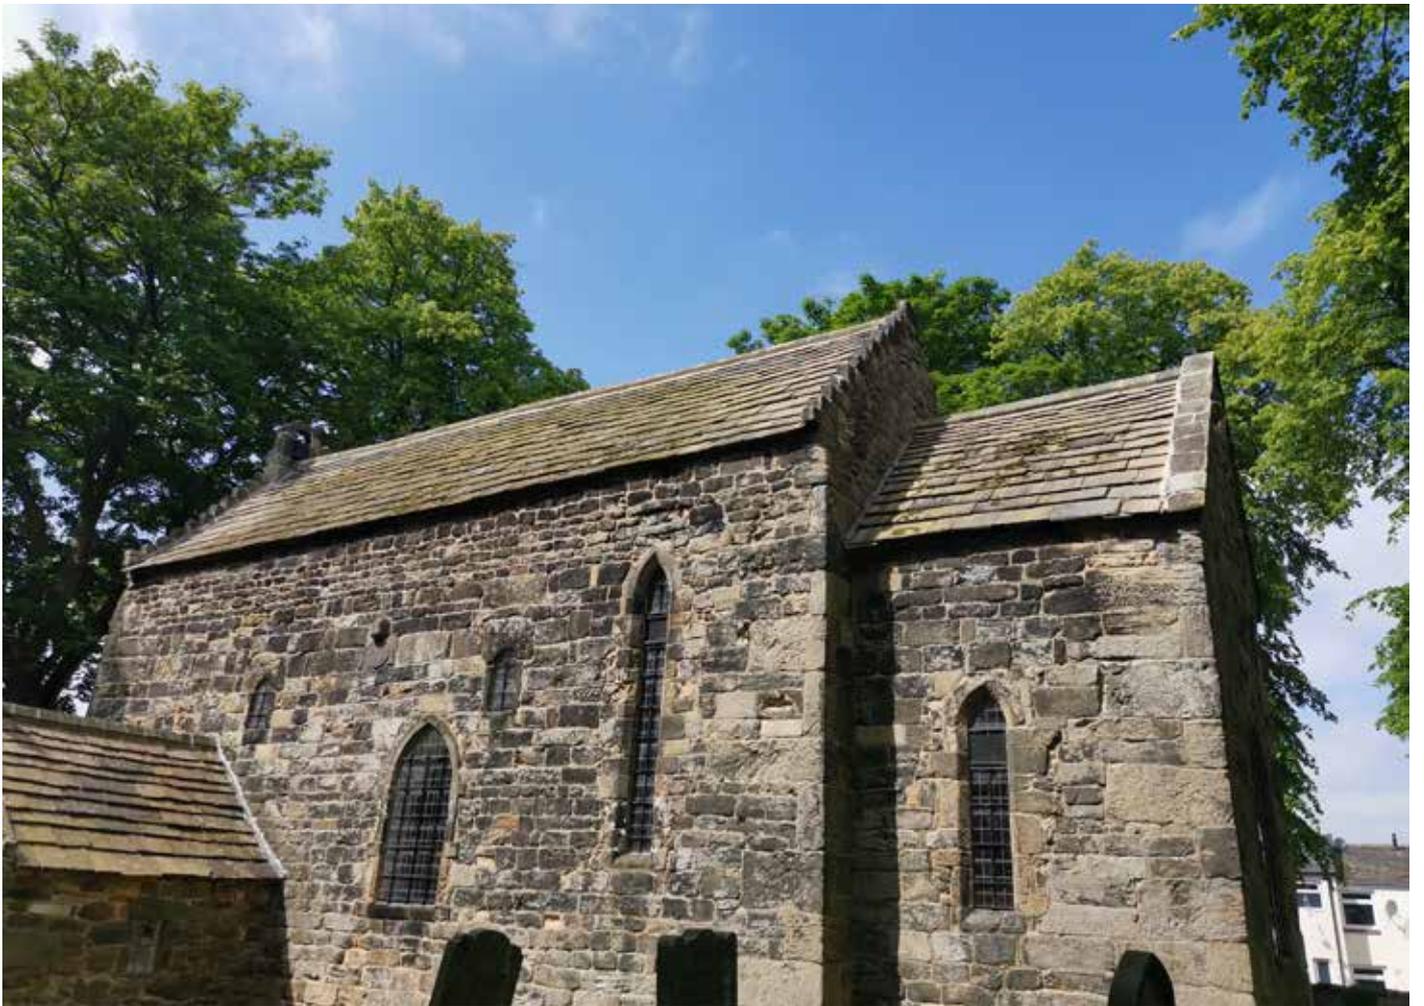
South roof slopes to Nave, Chancel, and Porch, all with heavy sandstone (flag) slates

- 3.01.01 South nave, several chipped slates and two slates sitting lower than the tails of the course indicating possible slippage or larger slates being used as replacements.

- 3.01.02 South chancel roof, again with a number of broken slates, one in particular at fifth course below ridge where almost half the visible slates have broken off, others in the corners as elsewhere.

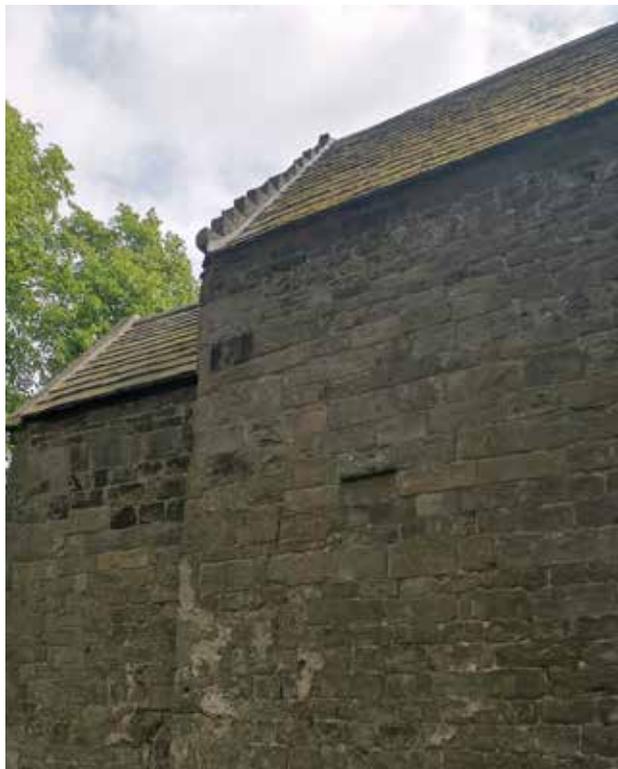
North slopes to Chancel and Nave

3.01.04 North chancel pitch in fair condition. No broken slates visible although there are two slipped or dislodged slates that may require re-securing. A handful of replacement slates secured by wire.

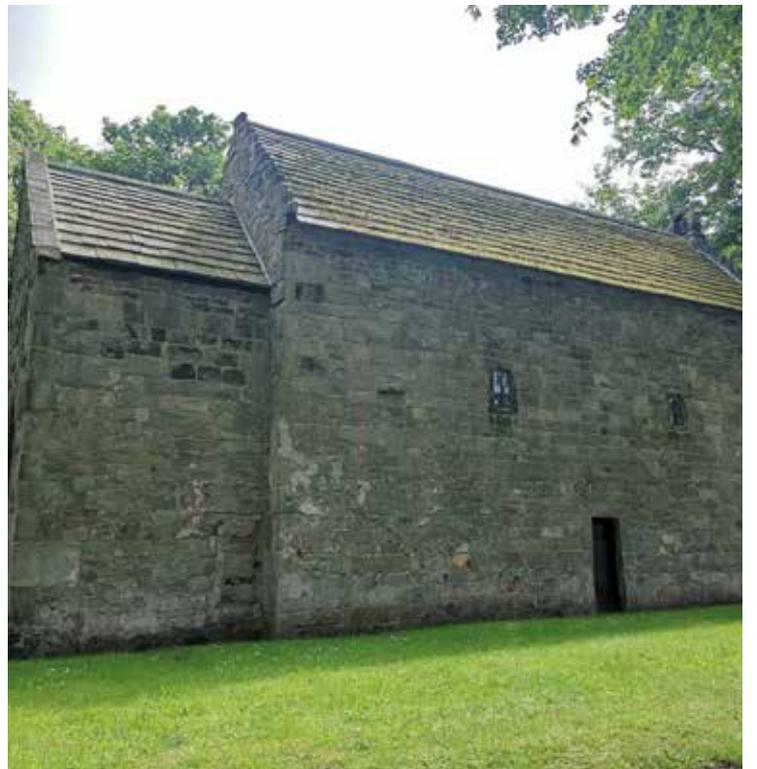
North slopes to Chancel and Nave

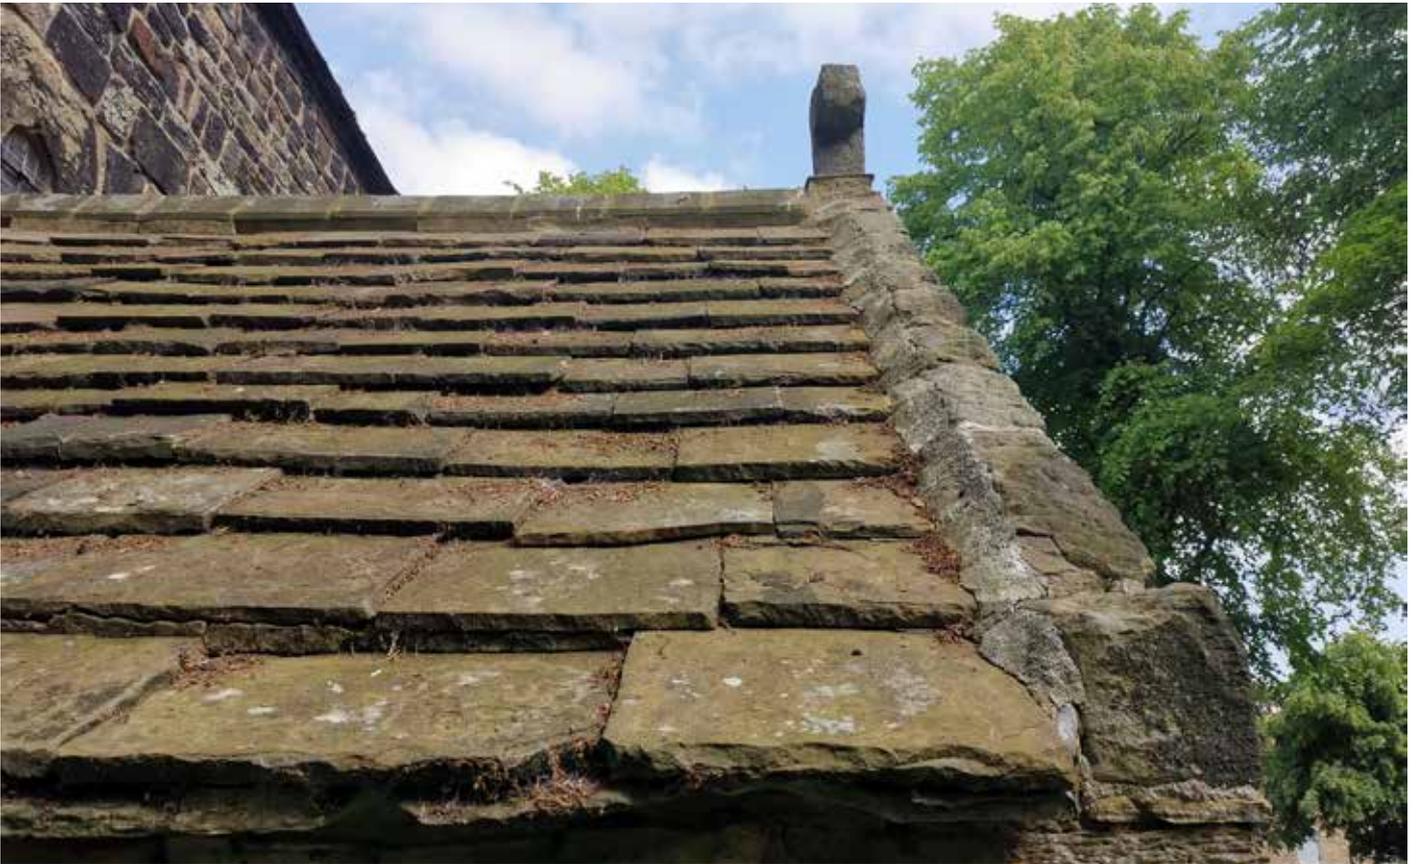
Porch west slope: numerous chipped slates, mortar flashing cracking away from gable

3.01.07 Porch roof, west pitch. Corner broken to a slate third course down, right hand side against the gable, and also half a slate missing to the first course below the ridge in the centre. Several replacement slates held by wire.

3.01.06 Recommendation: Re-roof the Porch, both slopes, repairing the sarking board as necessary, fixing new battens, re-laying existing stone slates supplemented by new replacements to match as necessary. **D**

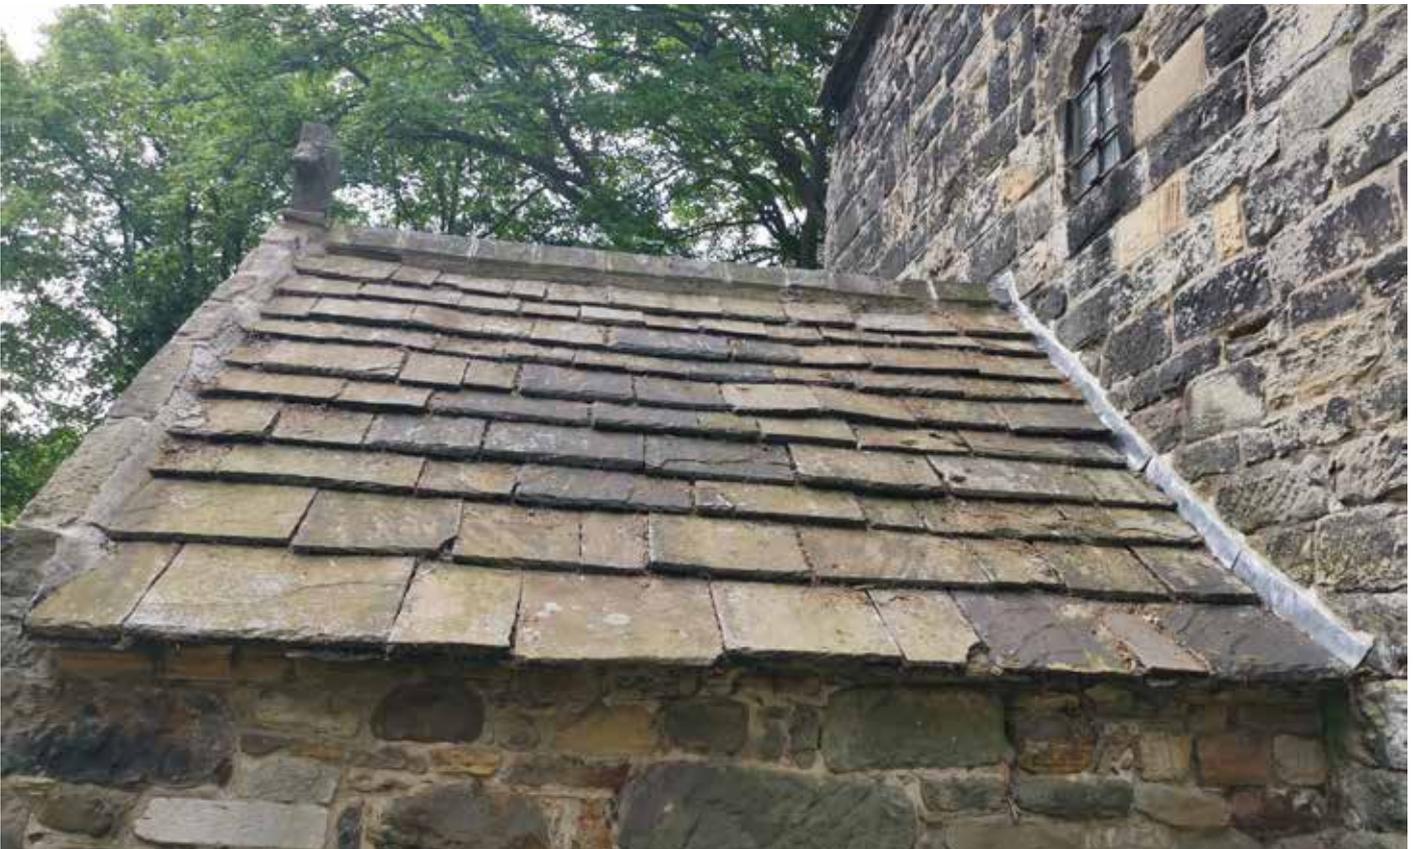
Porch east slope: several damaged slates, mortar flashing cracking away from gable. New flashing in good condition

3.01.05 Porch roof, east pitch. Several chipped slates, two substantially with the top left slate below the ridge corner has broken off and a split slate, third course down, to the right hand side below a tingle has broken at the tail of the course above, splitting the stone in half. Both still in position, sat on the roof with their own self-weight. Several wire replacements. The third course up from the bottom in the centre corner has also broken off.

Patch repairs have been carried out in the last few years to the porch roof, though more broken slates have occurred since then, splits also noted.

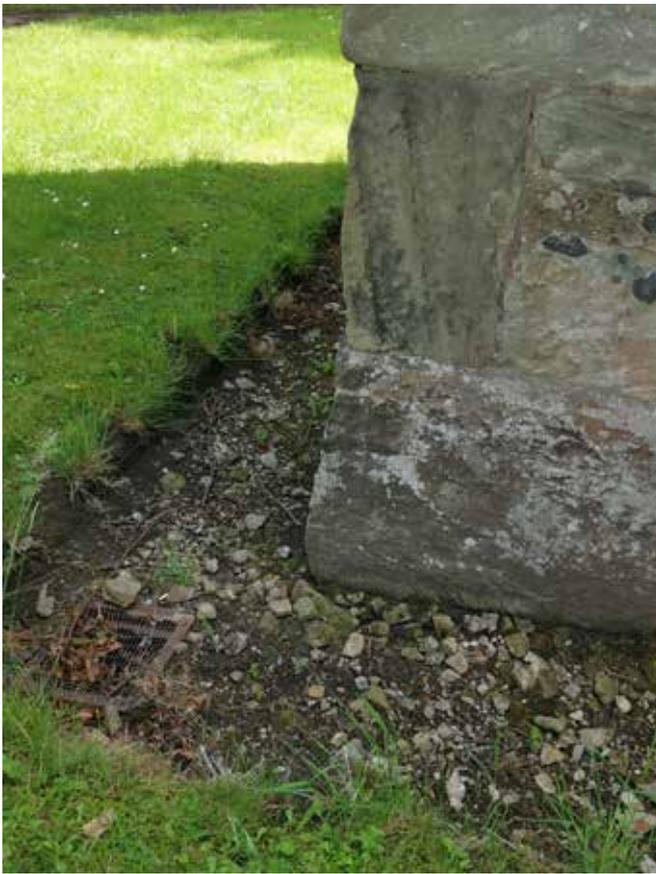
Conditions at the base of the walls are improving now that concrete channels have been removed.

Previous concrete channels around the base of the walls have now been removed allowing the ground around the perimeter of the building to dry out. This has hugely helped improve the damp issues internally and it has been noted by the PCC that walls are much drier.

3.02.03 Recommendation: The small ditch left by the removal of the concrete channels would benefit from grassing over to ensure easy maintenance. To achieve this it would be beneficial to gradually slope the adjacent grassed churchyard into the trench to allow lawnmowers to run into the ditch at the foundation level. C

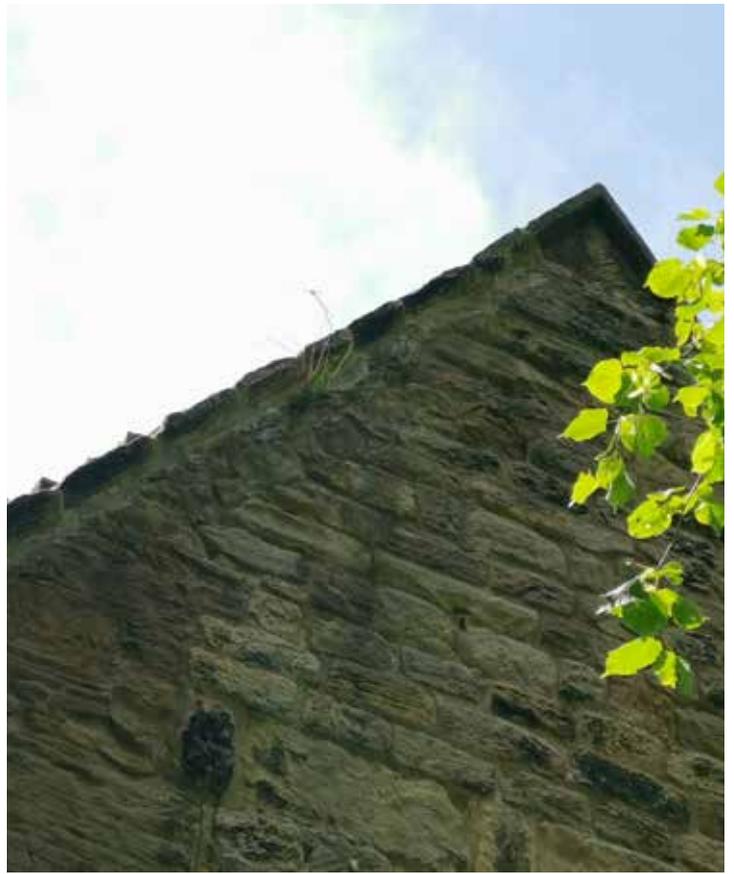
East gable: vegetation should be removed and open joints pointed

- 3.04.03 The crow-stepped gable to the east is less satisfactory, with less height meaning in some instances the lead is not dressed into a chase and is just folded over the top, noted on the north pitch, and the bedding joints of the crow-stepped stones themselves are open, indicating a slight movement, particularly noted again on the north pitch.

- 3.04.04 Recommendation: Rake out and re-point all open joints at high level on gables and to water-tabling.

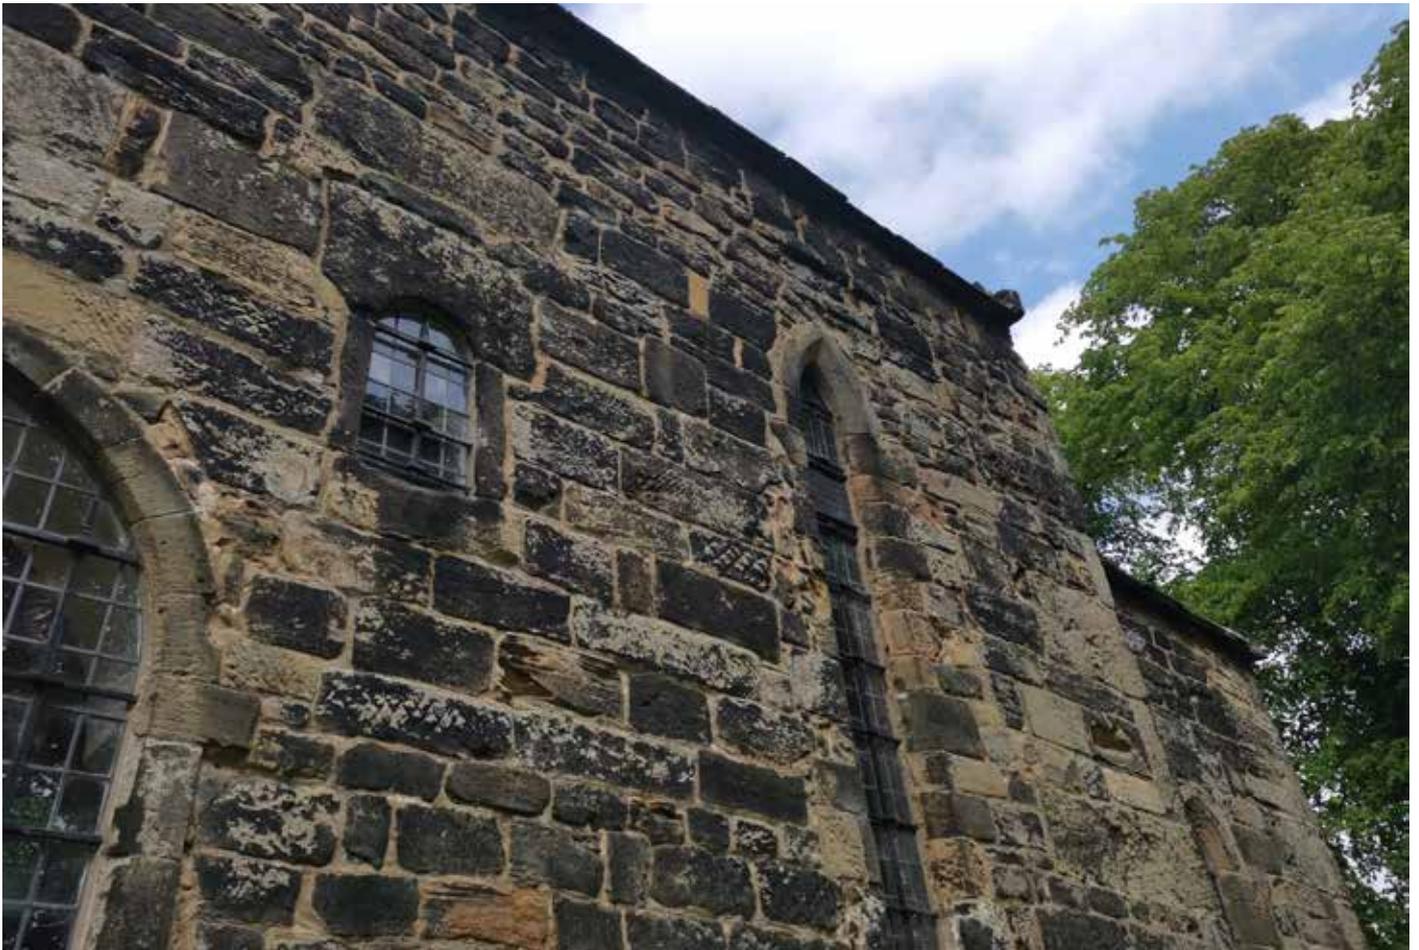
Masonry to the south elevation blackened by historic sulphate deposits, caused by air pollution (coal burning)

- 3.05.02 To the south elevation the masonry to the nave and chancel has blackened by sulphur deposits on the surface and the stonework is showing signs of deterioration, particularly odd vulnerable stones, perhaps poor quality stones or incorrect bedding. Deterioration is isolated, though where present is severe.

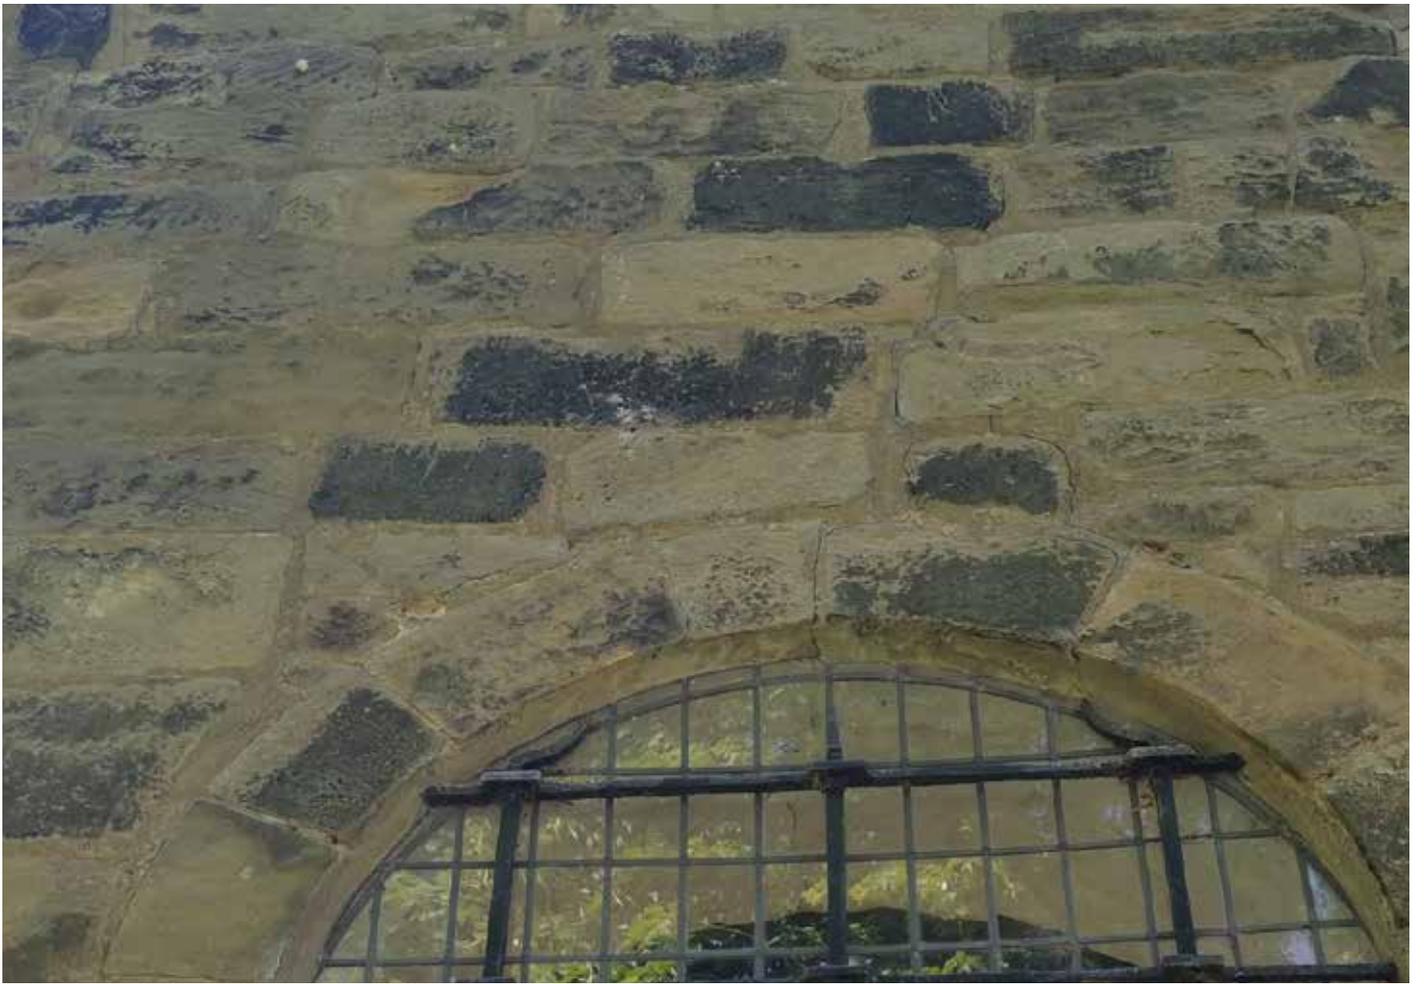
Cracks over head of East window and dropped voussoir (to right of centre)

- Crack over principal east window in east gable of chancel through window head.
- Crack to lower section of southern jamb main east window, running down to ground.

3.05.05 Recommendation: In the short-term all failed mortar pointing, cracks and open joints across all elevations should be raked out and filled locally with soft lime mortar. **A**

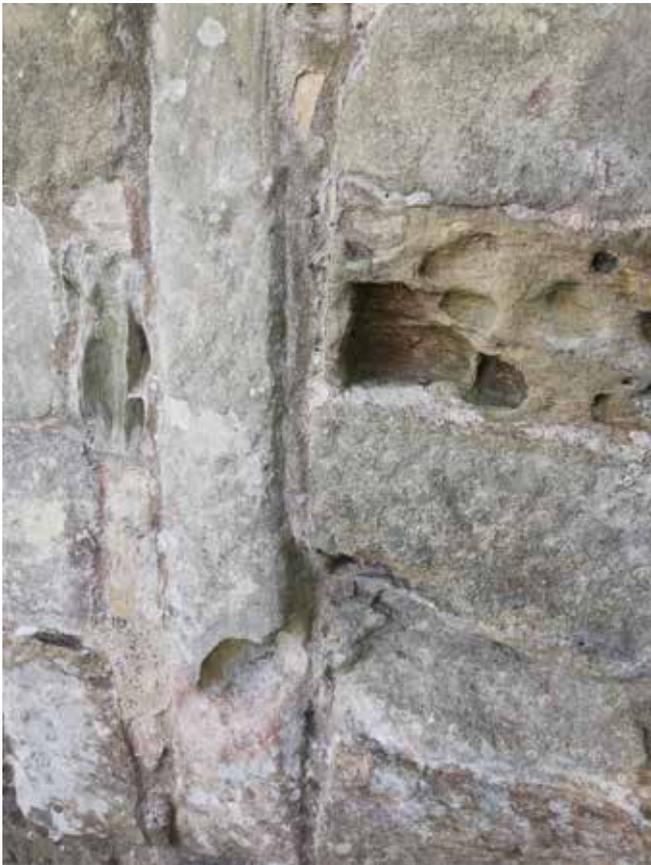
Pockets of erosion to the soft sandstone, isolated but widespread

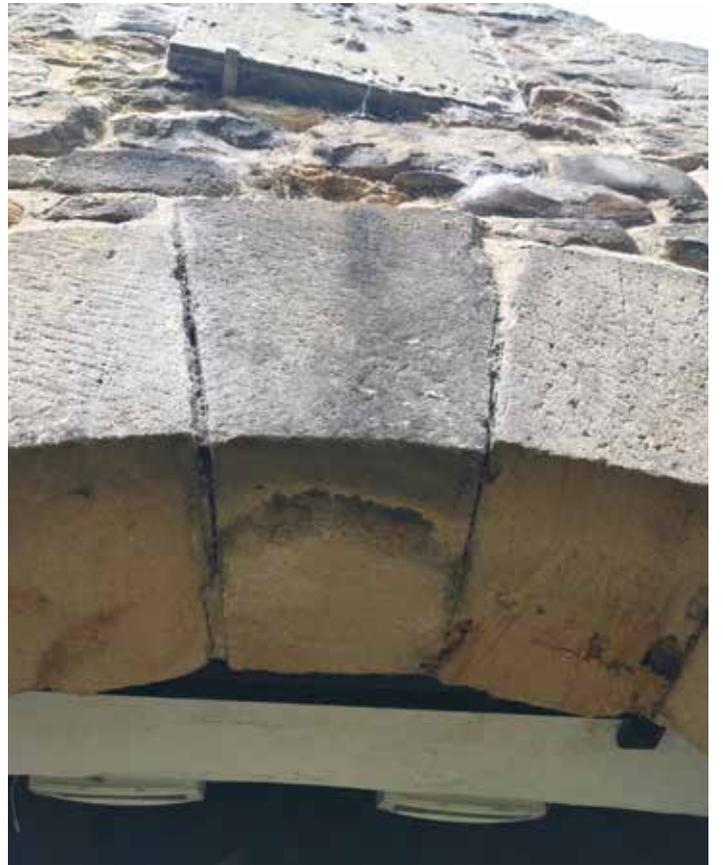
Slight drop to voussoir of Porch doorway

- South gable of porch, hairline cracking through joints vertically to both east and west corners and slight drop to key stone of arch doorway.

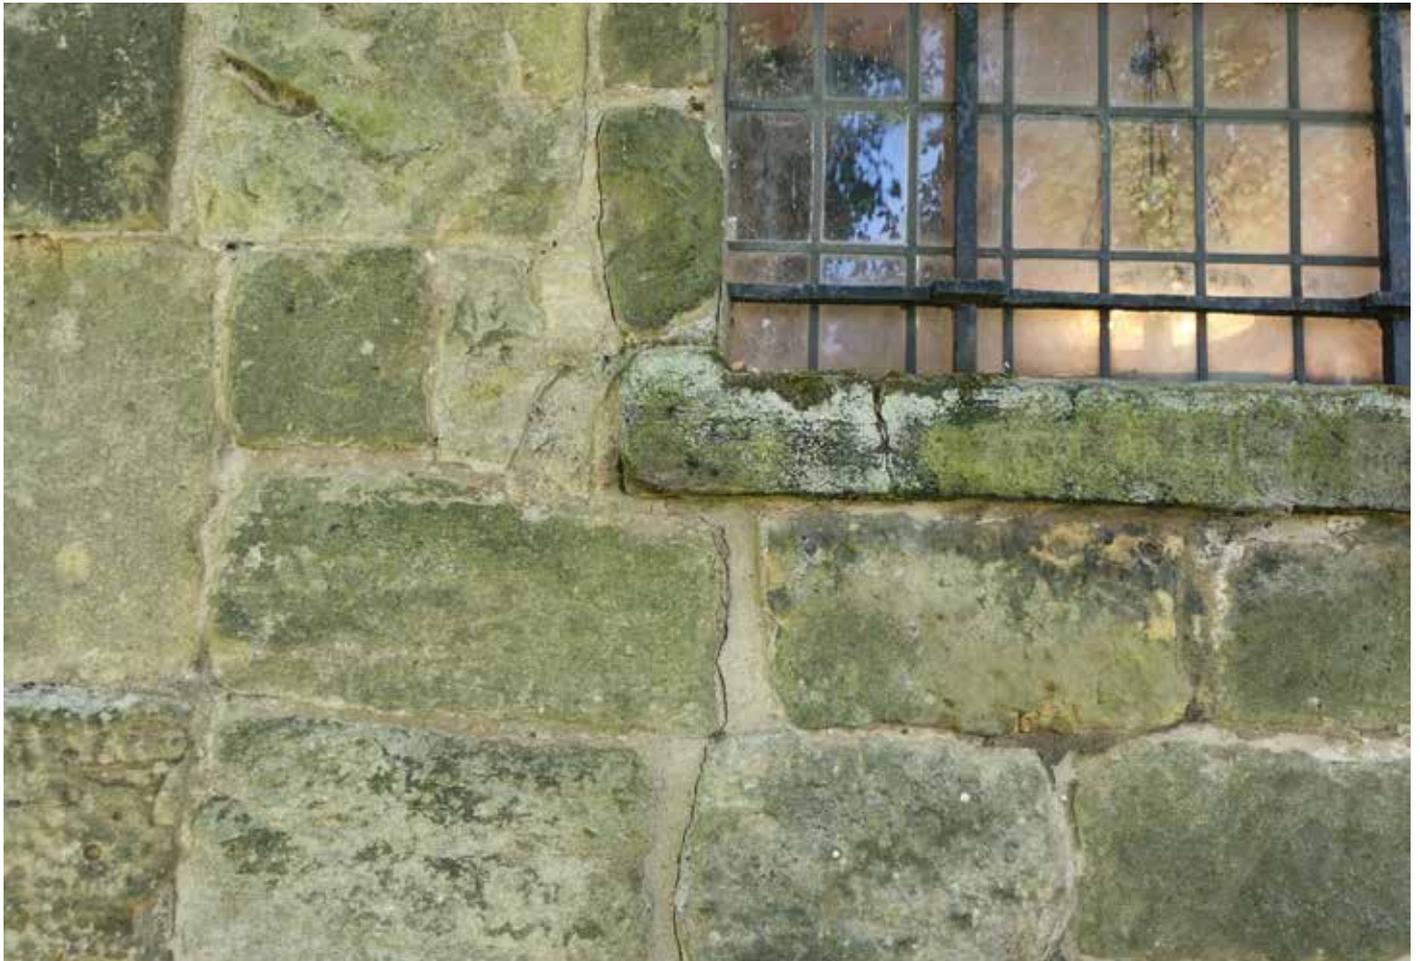
Cracking to East window

- 3.07.01 E: Two historic cracks in the sill. Lack of central keystone at head of the window results in central joint at the apex of the arch, right hand upper voussoir dislodged causing dropping of masonry above. Minor cracking to bottom left side of jamb.  
External ferramenta showing signs of rusting, would benefit from rubbing back and repainting. No signs of cracking within the masonry at present.

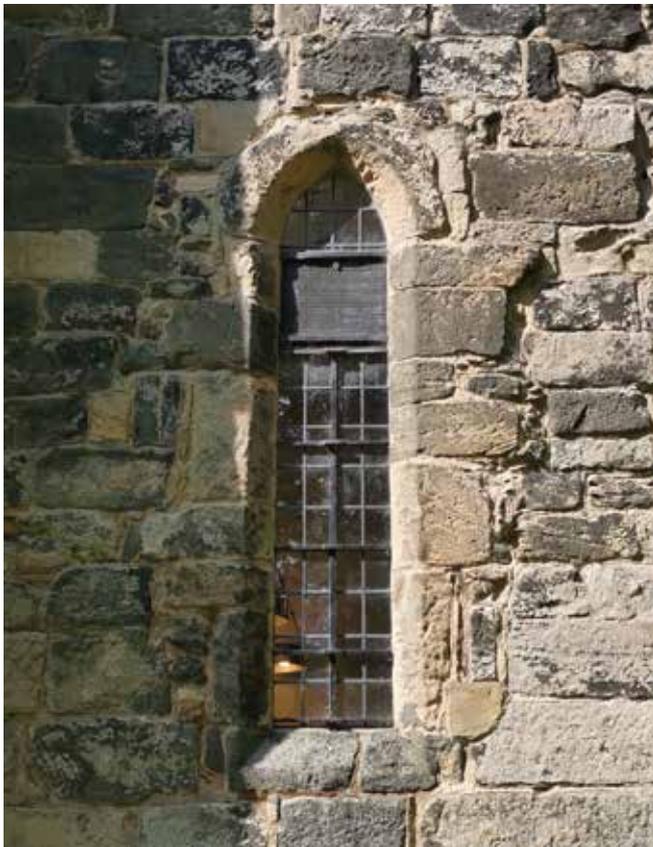
sI: note erosion of surrounding masonry

- 3.07.02 sl: Chancel lancet, large open joint through sill and to right hand seating of jamb, both historic. Crack through head of pointed lancet, also historic. External ferramenta showing signs of rusting, would benefit from redecoration.  
Externally fitted ventilation mesh over opening hopper, secured with timber battens painted black in acceptable condition.  
All masonry to window surround slightly protruding forward from main face of walling, historic.

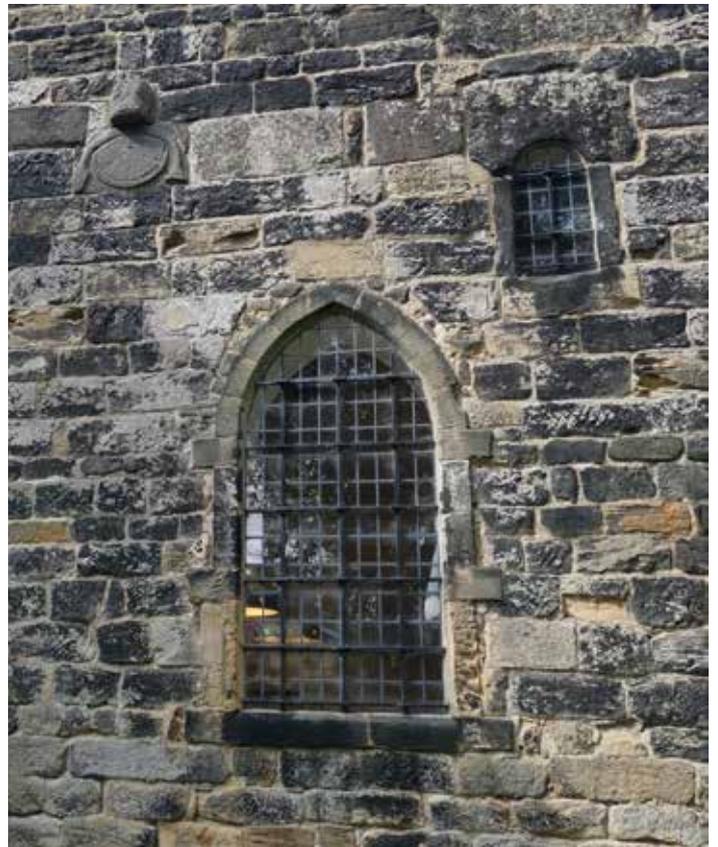
sIV (lower) and sIII (above)

- 3.07.04 sIII: Original Saxon window with monolithic lintel and arched head opening. Slight damage to stone at lintel bearing to left hand side. Ferramenta showing signs of rusting, would benefit from redecoration.

- 3.07.05 sIV: Large pointed arched headed window, all in good condition except to the bottom jamb stones, both heavily weathered, left hand partially replaced. Historic crack through sill. Lower jamb stones likely reused from smaller window.  
Ferramenta showing signs of rusting, would benefit from refurbishment. No signs of ferramenta damaging masonry.

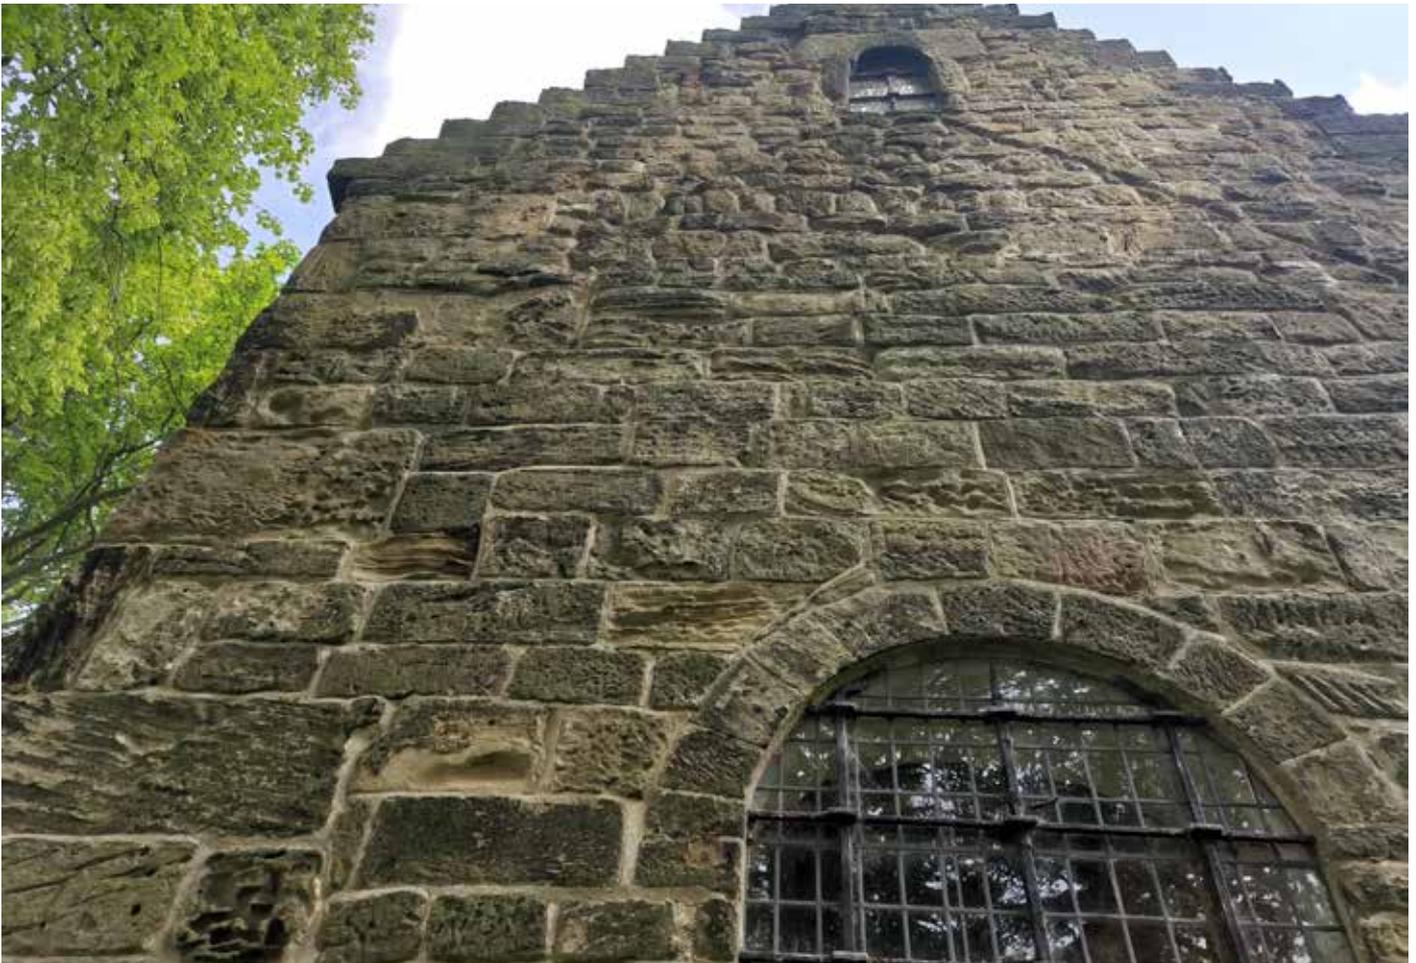
West window (w) and high level west window (W) above.

- 3.07.09 w. Main west window. Historic crack through sill. Minor hairline crack through joint left hand side of central keystone to the round headed opening. Jamb stones run in with regular masonry coursing, reveal pointed in cementitious mortar.  
Ferramenta showing more severe signs of deterioration, requires rub back and redecoration.

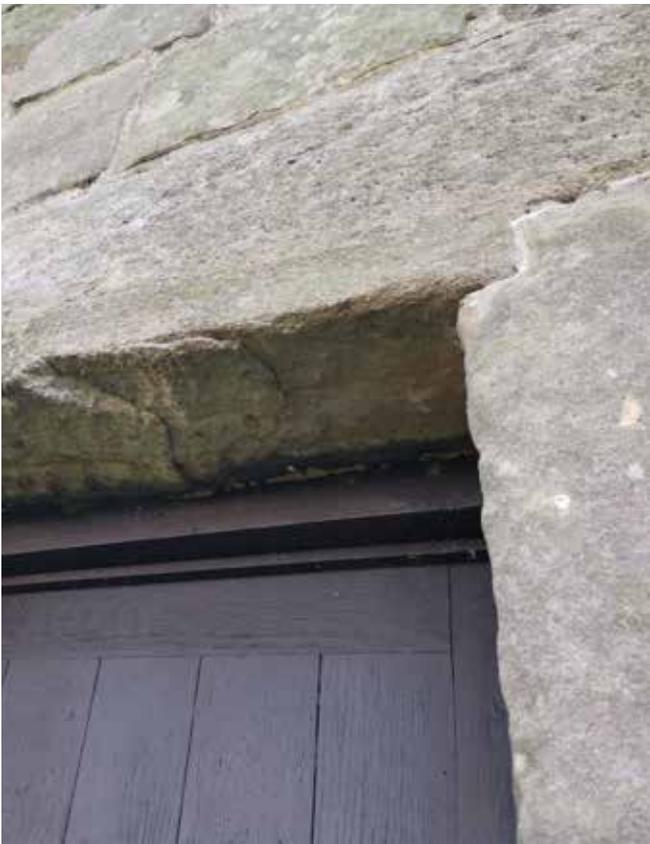
3.06.02 Timber door to north nave. Dark stained timber with strap iron hinges. Previously repaired at base to both door leaf and both jambs. Resin to back of repair at left hand jamb visible and potentially causing further deterioration to original timber above and behind.

North Nave door, showing unusual joggled lintel

3.07.16 DN2. North nave door. Appears to be original with long and short jamb stones and joggled lintel to head. Deterioration to inner face of reveal, would benefit from mortar repair, most notable on western reveal. Face deterioration to bottom left hand jamb. Delamination of lintel to the underside. All deteriorated masonry would benefit from careful conservation.  
Concrete to threshold step over original stonework will be causing deterioration to masonry below.

- 3.06.03 Recommendation: North door appears dried out, possibly from the staining. Would benefit from a full rub back and refurbishment. Rake out sprayfoam filler to frame and point up with lime mortar fillet.

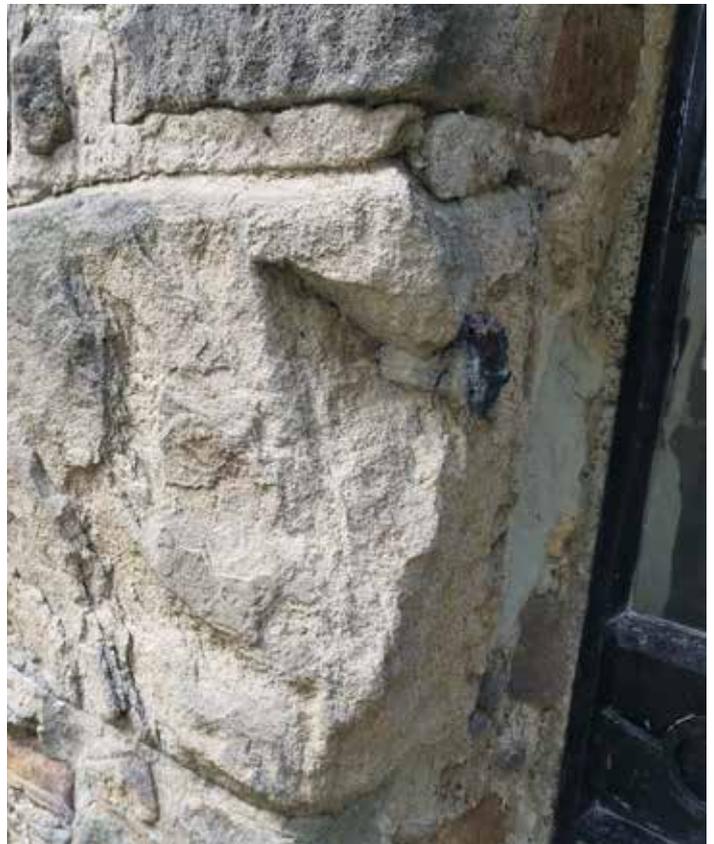
Damaged masonry to jamb of south Porch, due to rusting iron stub (3.07.13)

5)	3.07.13	To all windows - conservation specialist to assess windows, repoint against leading with lime mortar, de-rust & re-paint ferrements. Mason to rake out and fill all cracks around windows with lime mortar.	£3000

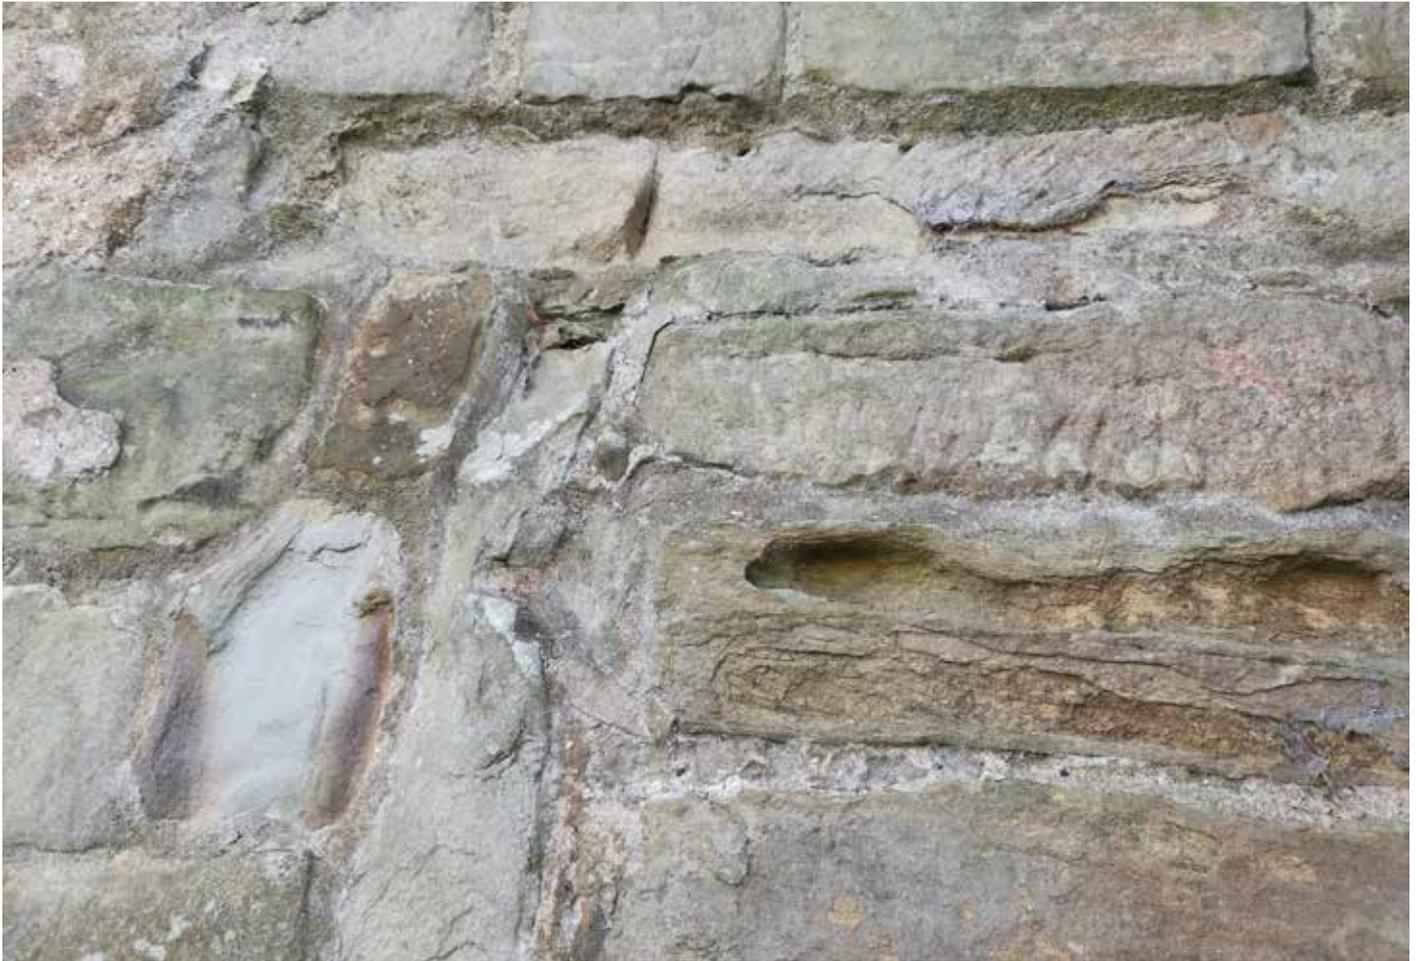
Blocked north doorway to Chancel: deterioration of masonry, in part due to hard cement pointing

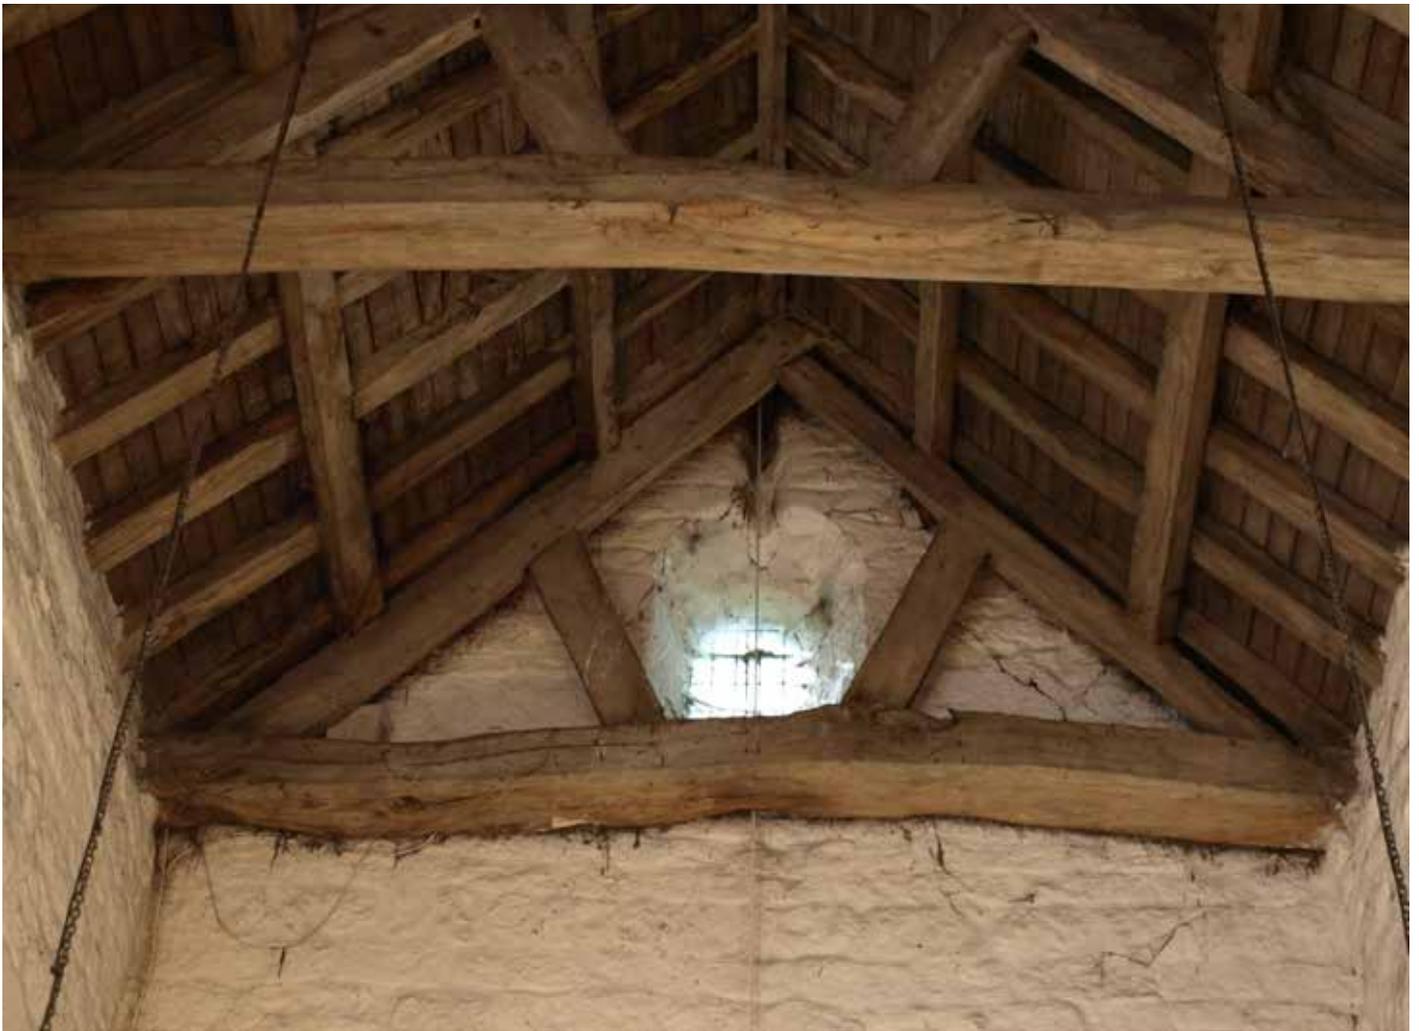
The Nave rood structure all appears to be in good condition

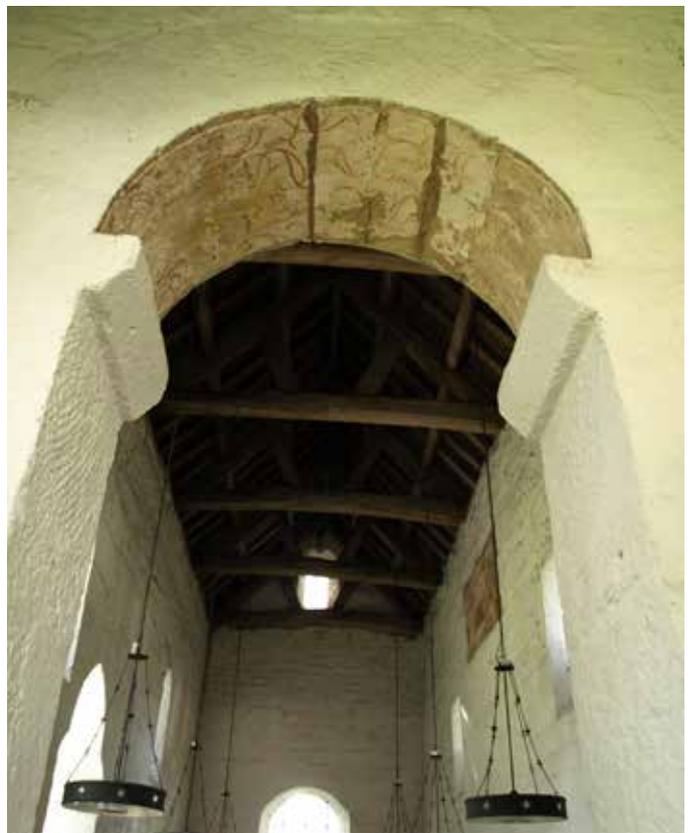
The Chancel arch, reputedly Roman, with ancient painted decoration to the intrados

4.05.01 The Chancel arch is reputedly Roman in origin. It appears stable.

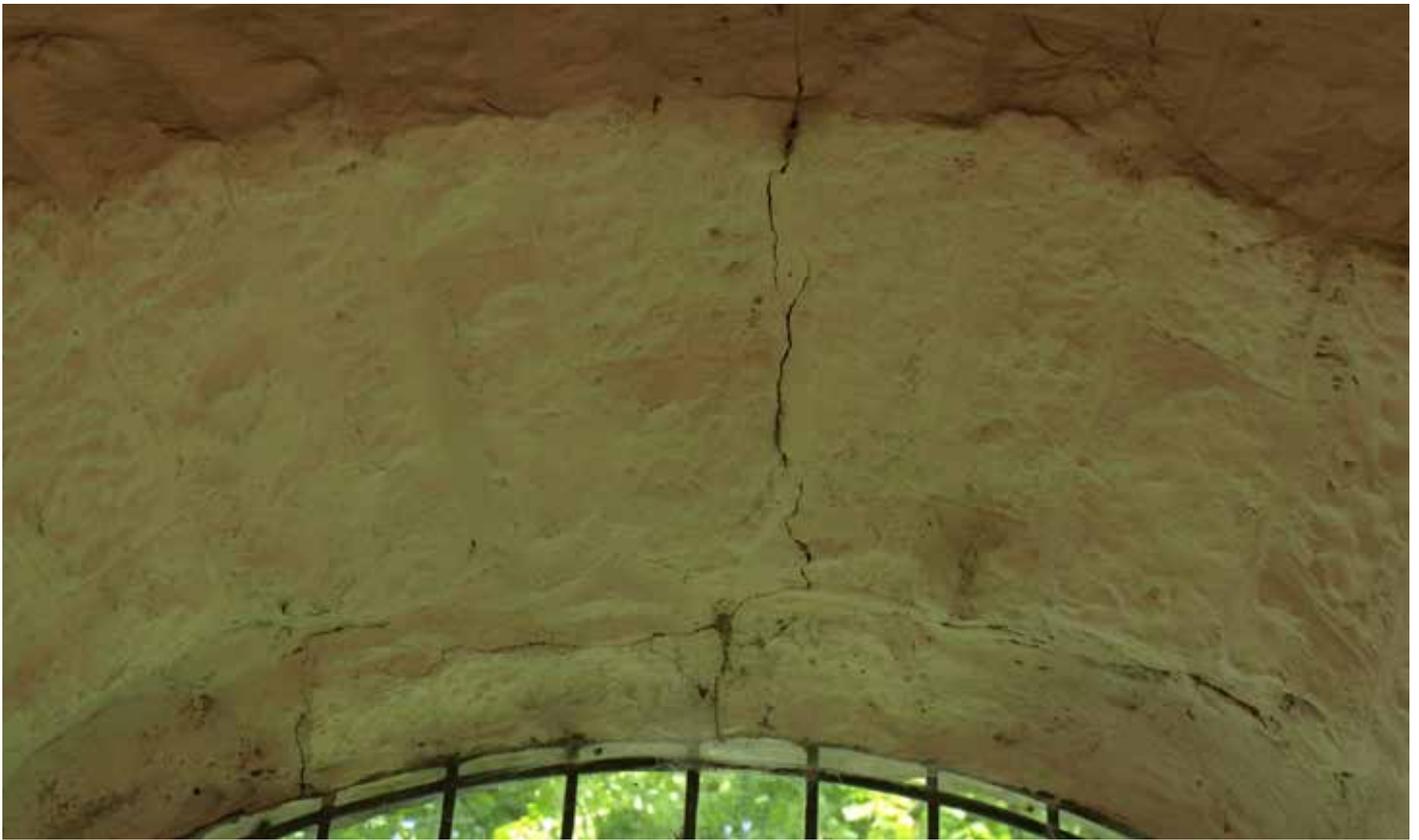
Cracking to head of East window

- 4.05.02 Minor cracks noted at crown of the East window through the full thickness of the wall, below the East window cill, 1-2mm wide. There is damage to the limewash at low level to both sides of the Chancel arch, notable worse to the north side. The limewash has been lost due to moisture in the masonry drying out to the interior of the church. At the time of inspection the masonry appeared to be largely dry.

4)	4.05.04	It is recommended that internal cracks are filled with lime putty so that progression can be monitored over time.	£800
<b>PRIORITY B</b>			
<b>Work recommended to be carried out during the next 12 months</b>

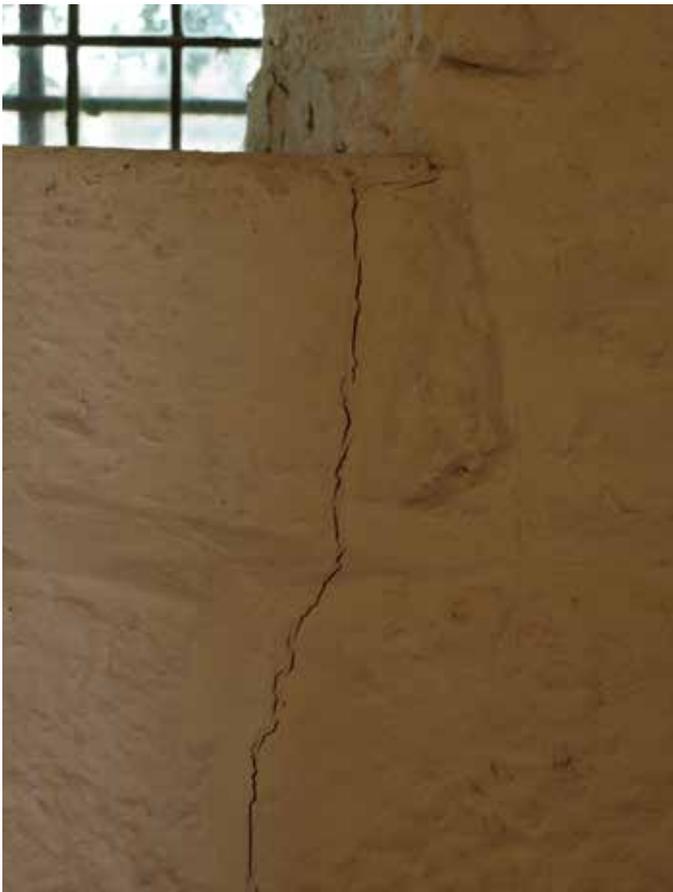
Cracking to the RHS of the East window - through full thickness of wall. Monitor
