## Escomb Saxon Church, Escomb

### QUINQUENNIAL INSPECTION REPORT 2022

#### Crosby Granger Architects Ltd

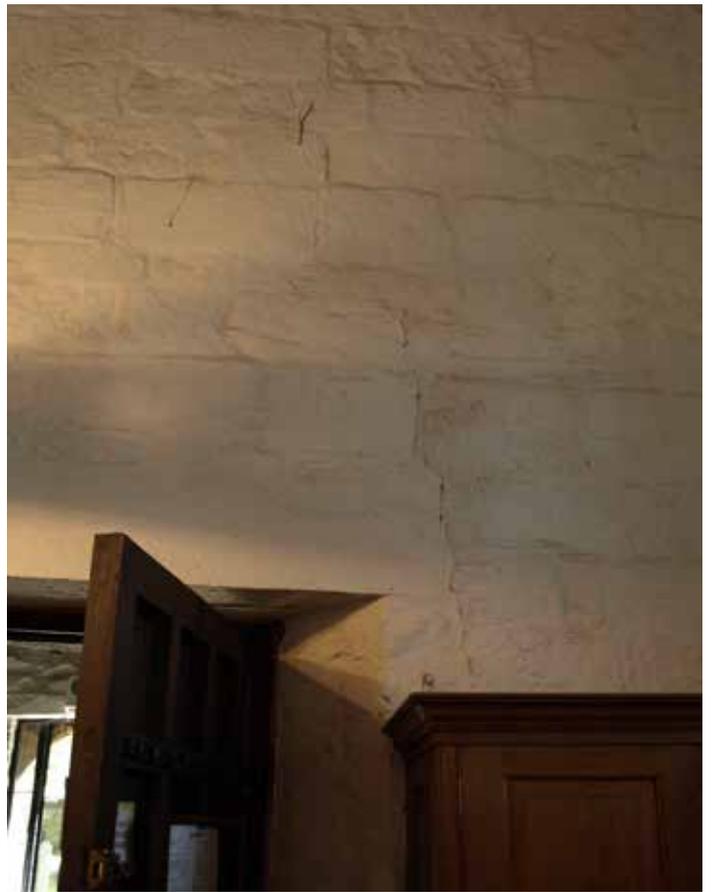
Cracking above lintel to Nave main door

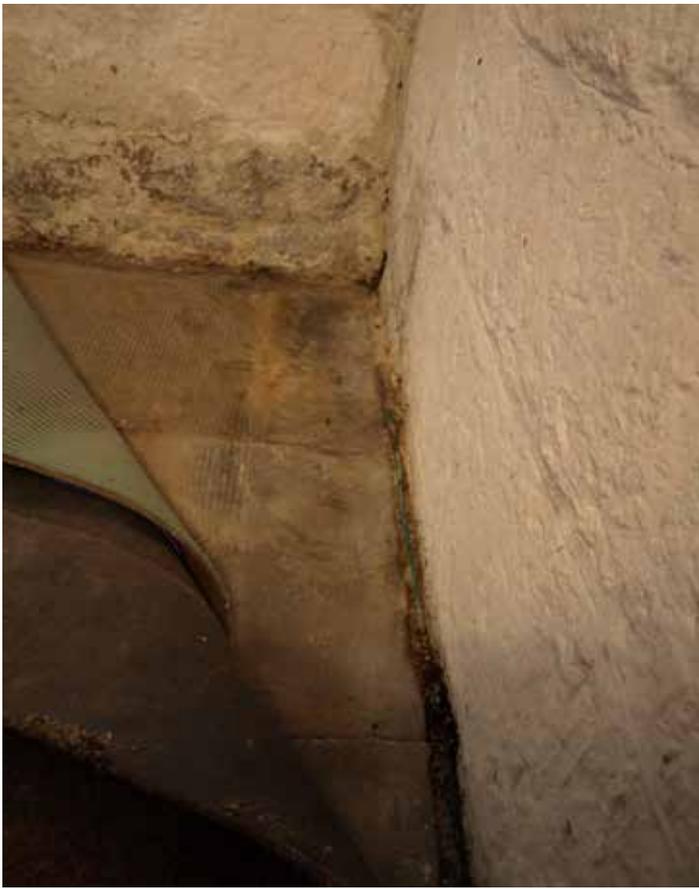
Damp under the Nave carpet, south side

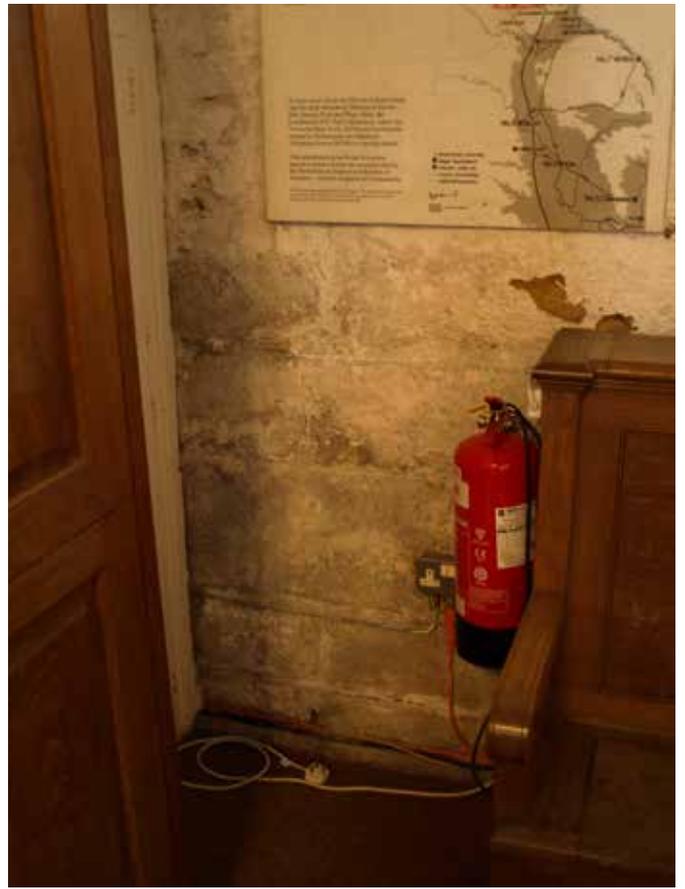
Loss of limewash at low level due to drying of the damp walls. Conditions appear to be improving throughout the church

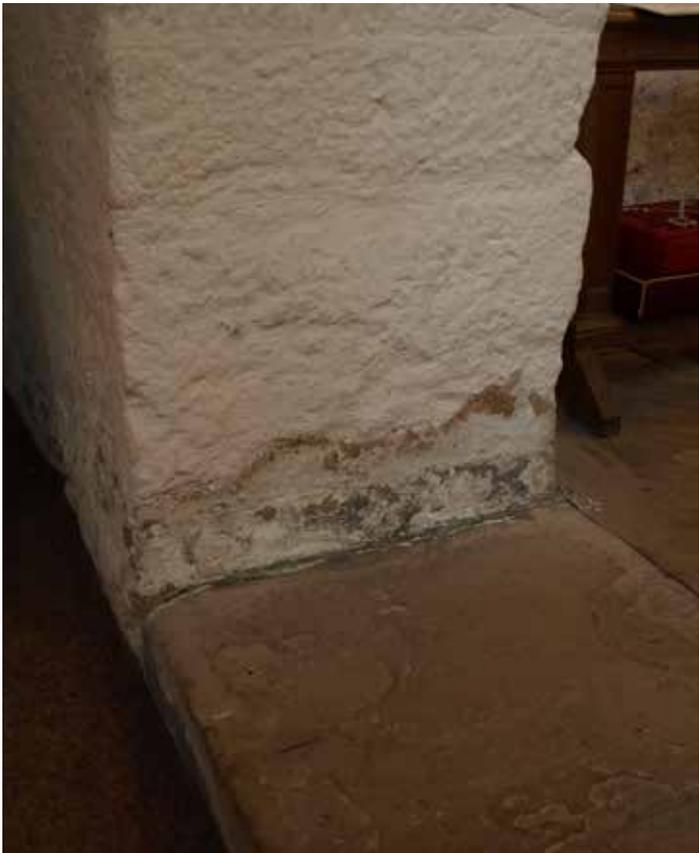
Loss of limewash at the Chancel arch - dry at time of inspection

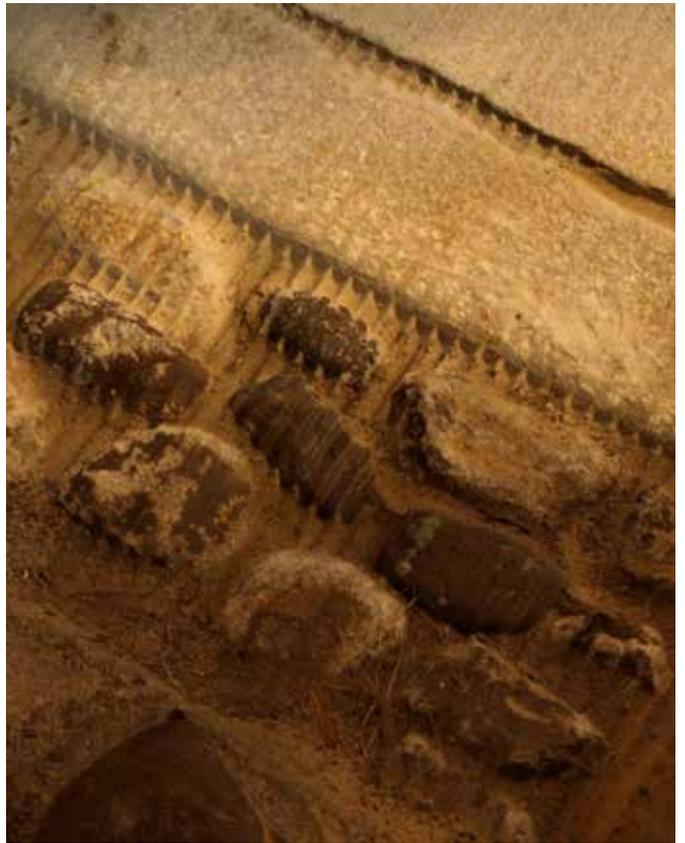
Stonework below the carpet is decaying to sand. The impermeable carpet should be removed.

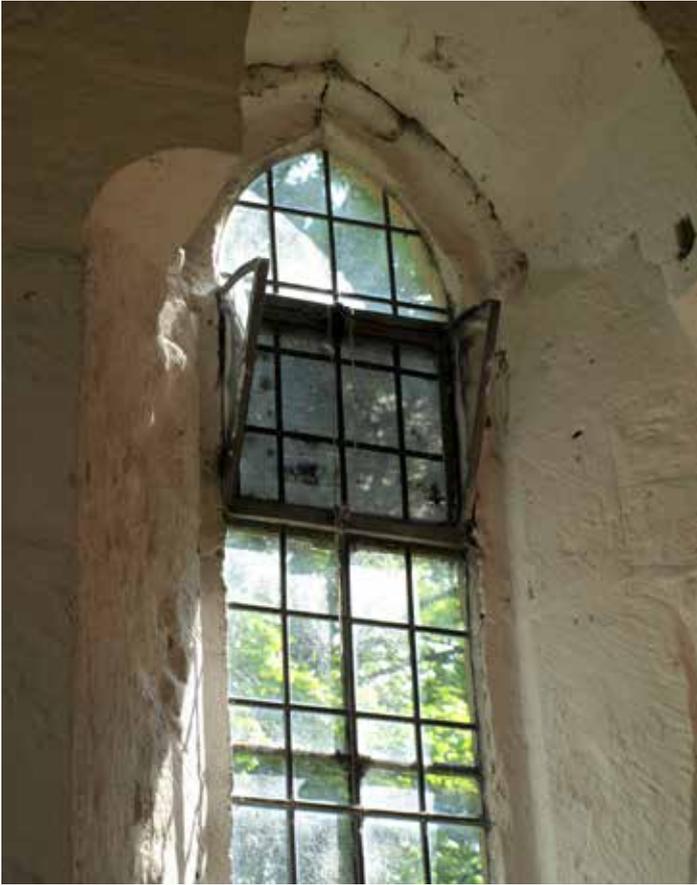
sII: Hopper should be made operational for useful ventilation

4.09.13 Recommendation: The opening vents should have their cords replaced and be made operational, and used when weather conditions are favourable. There is a general lack of ventilation in the church, and open windows would help the internal environment. **C**

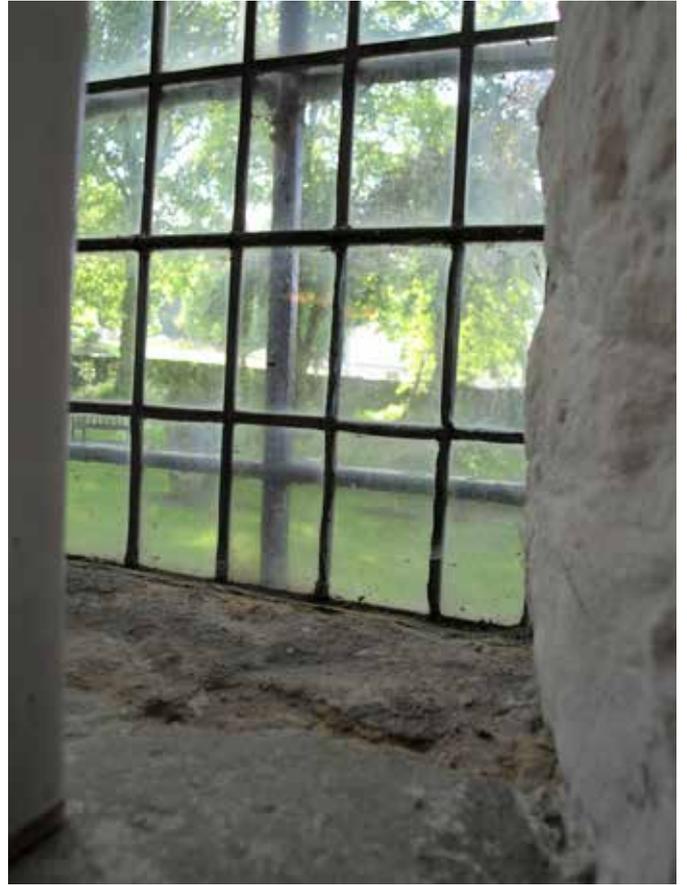
External ferrements to all windows would benefit from de-rusting and re-painting

5)	3.07.13	To all windows - conservation specialist to assess windows, repoint against leading with lime mortar, de-rust & re-paint ferrements. Mason to rake out and fill all cracks around windows with lime mortar.	£3000

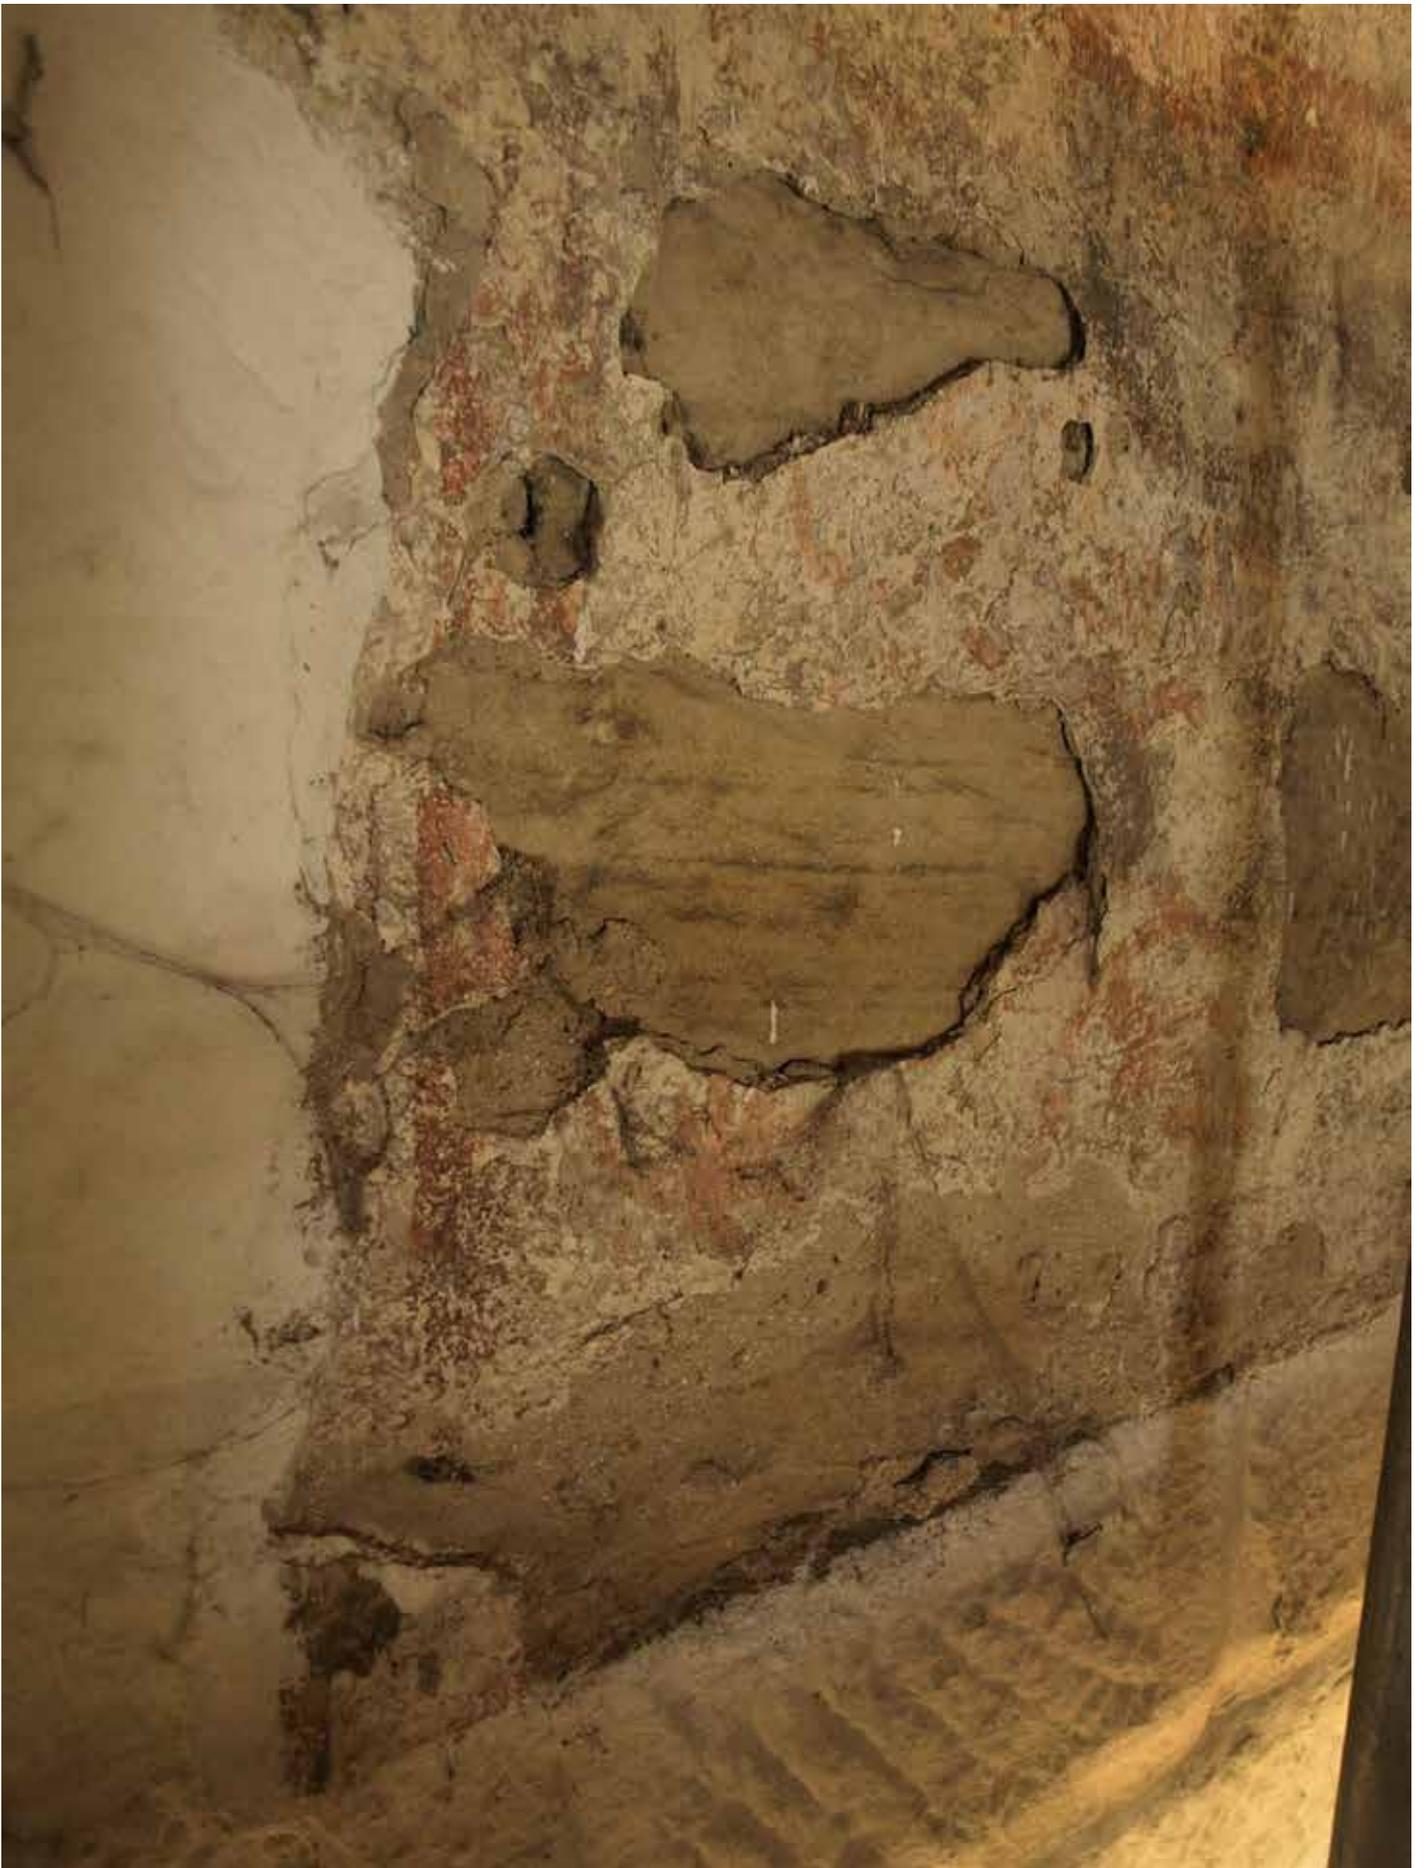
The remaining areas of the early wall painting to the Nave north wall are in need of specialist conservation

6)	4.05.09	Specialist conservator to assess and quote for conservation work to the historic wall paintings	£300
7)	6.05.02	Arboriculturalist to survey trees for condition and safety - every five years	£300

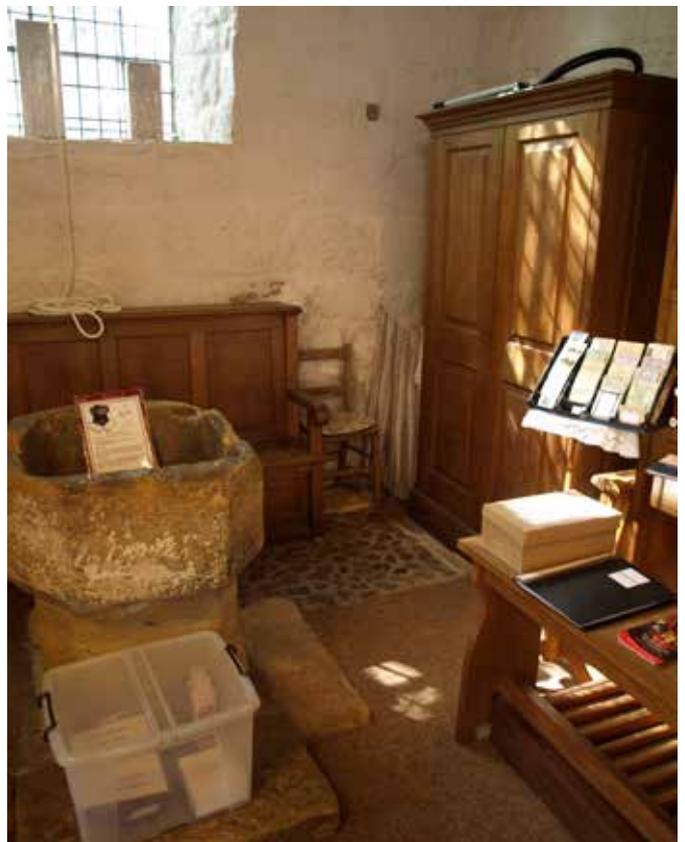
Care should be taken to avoid a build up of clutter in what is a relatively small space

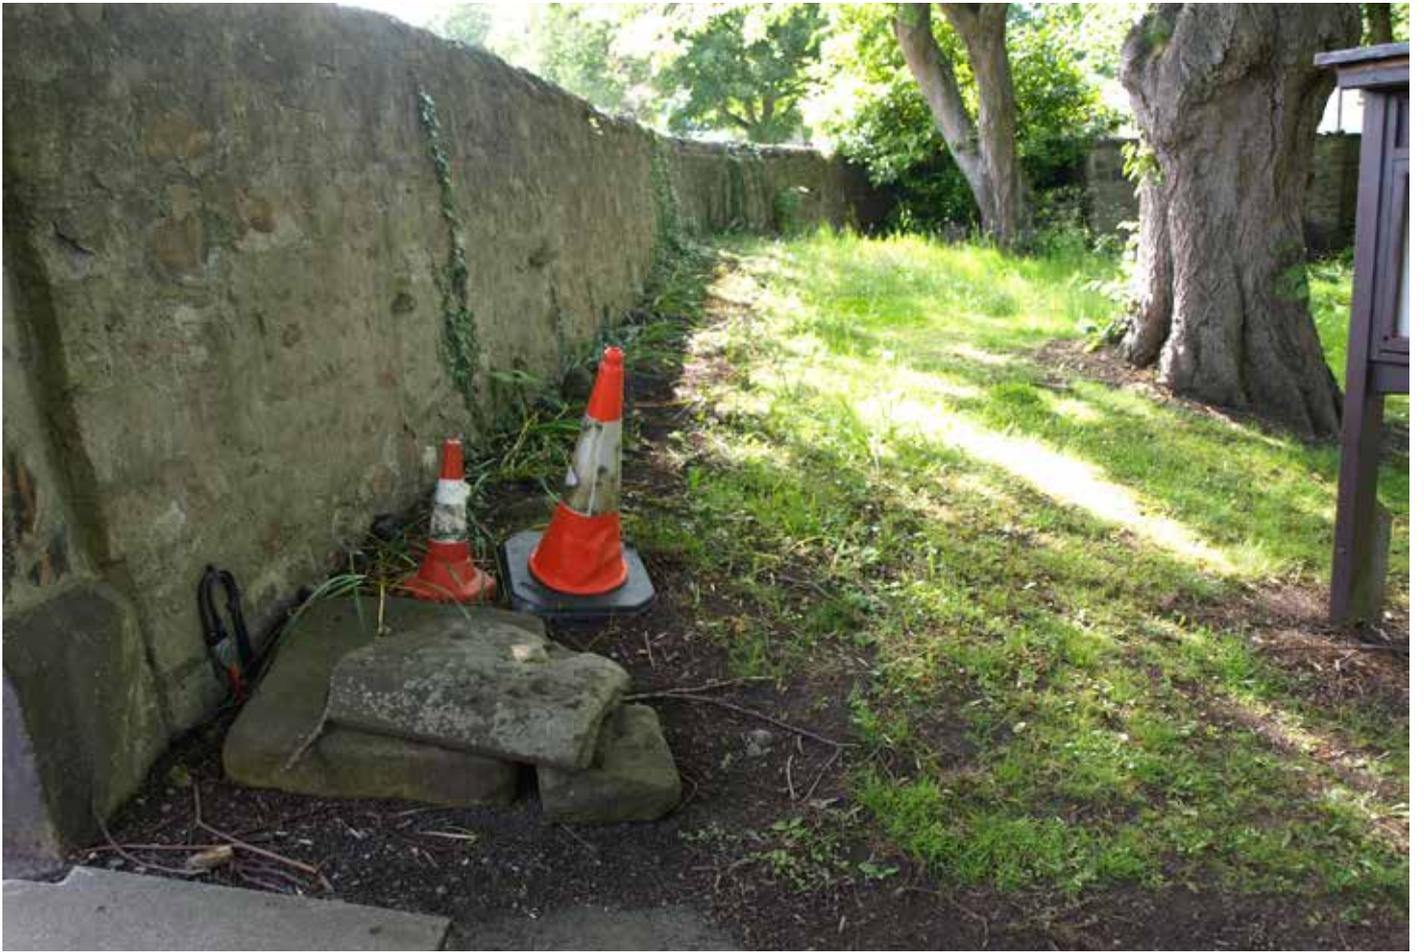
Church yard is generally well maintained, but the area just inside the gate would benefit from tidying

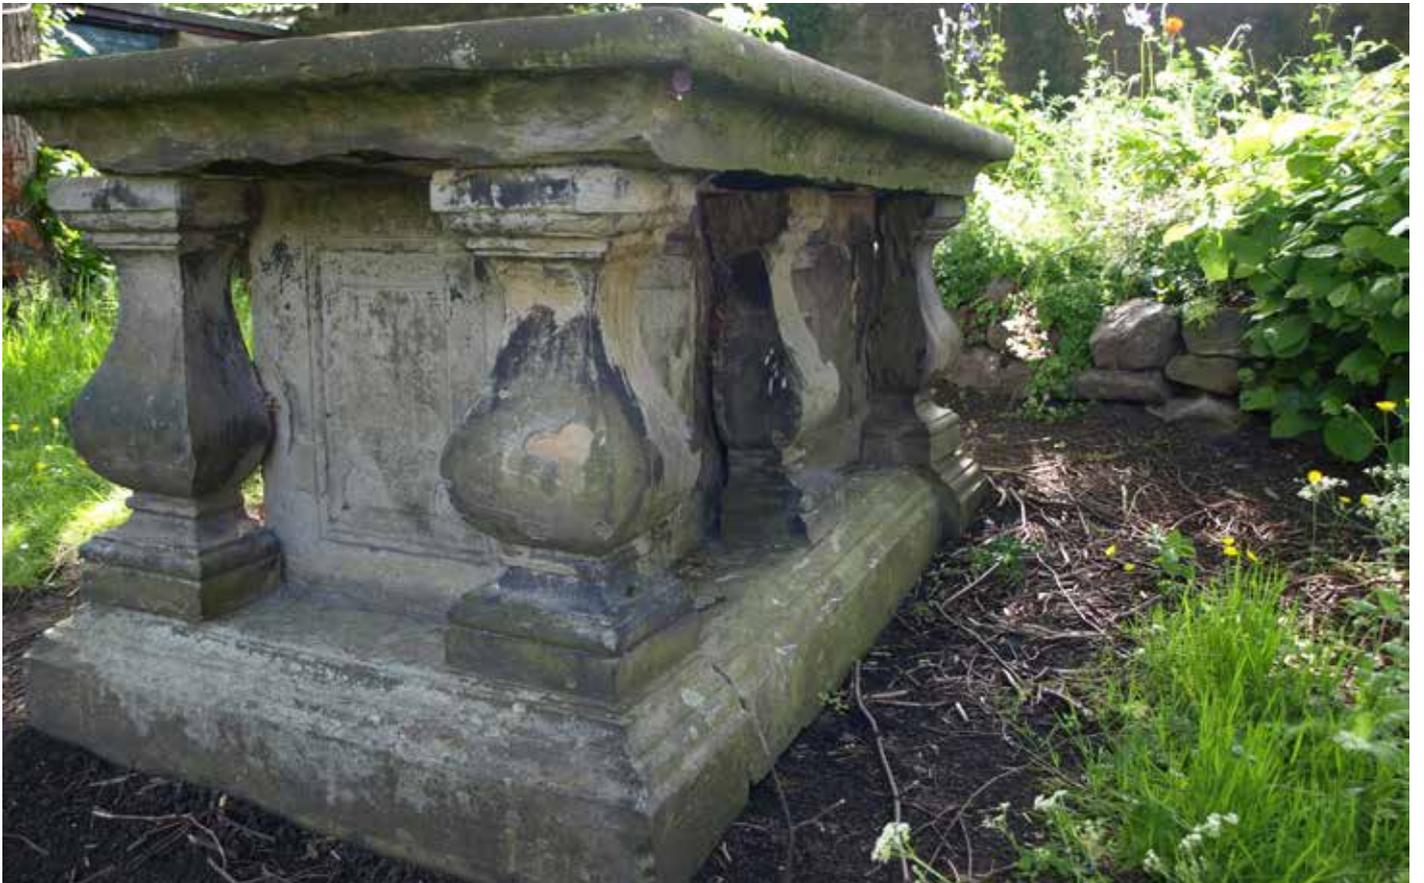
Robson Elliot tomb is in need of repair

4)	6.03.02	A monumental mason should provide a quotation for repair to the damaged tomb	£400

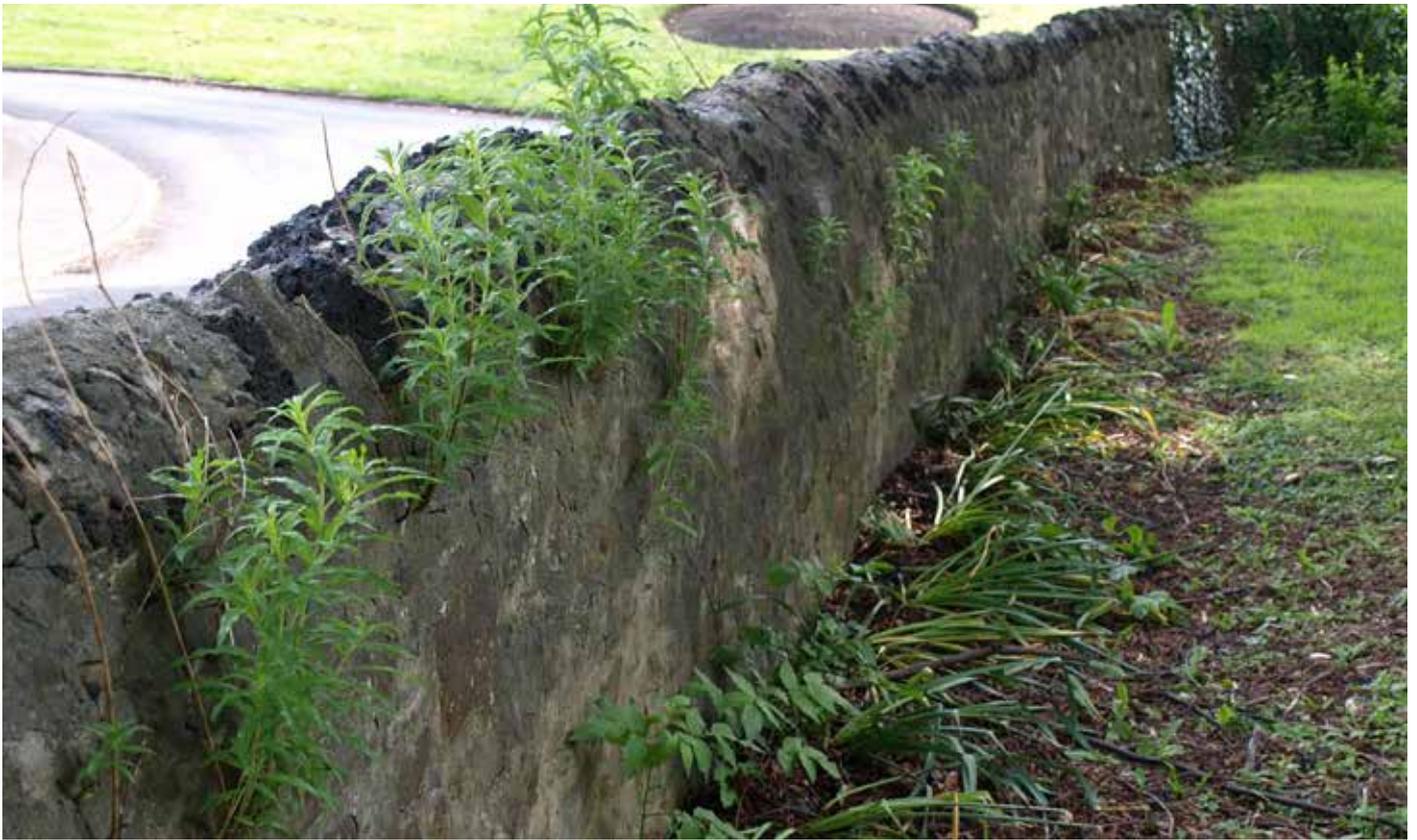
Vegetation should be cleared annually from walls before it can become established

4)	4.09.12	Cracked glass should be repaired by a skilled conservation glazier experienced in the repair of leaded lights.	£1000
5)	6.04.02	Remove all vegetation from boundary walls annually, and point up any open joints with soft lime mortar. In the longer-term re-point sections fully with lime.	DIY
