**Quinquennial Inspection Report
St George's Church, Hatfield, Washington
Deanery of Chester le Street
Archdeaconry of Sunderland
Diocese of Durham**

David Jowett - Architect, BA, DipArch, RIBA
25 Roseworth Avenue
Gosforth
Newcastle upon Tyne
NE3 1NB
Tel: 07788 710 204
email: david@davidjowett-architect.co.uk

30 June 2019

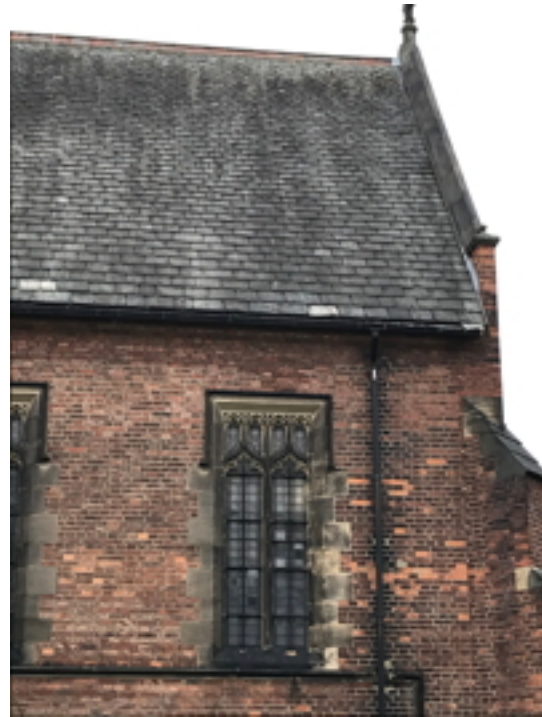
Slipped slate to Porch Roof

Several chipped slates and a few missing and slipped slates to all areas. Not all areas are visible from ground level and should be inspected on a yearly basis by a reputable roofing company. The ridge to Porch appears to be have been overclad with flashband. The ridge tiles are generally uneven.

Replace all loose and missing slates. £750.00.

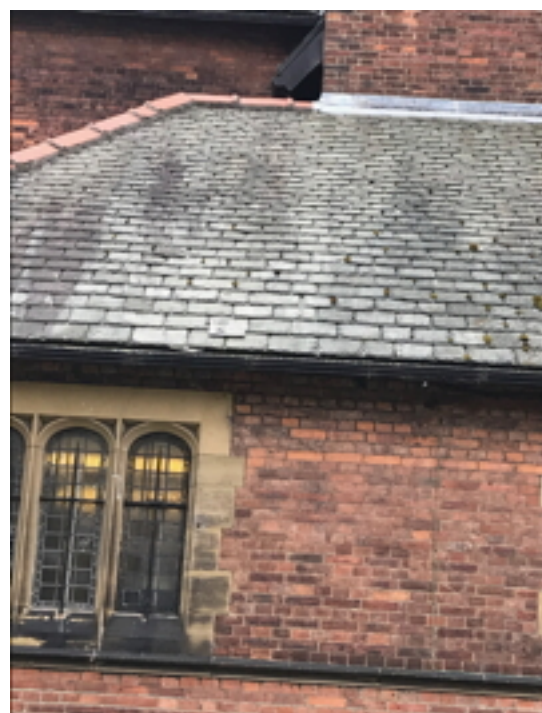
Slipped slate to Vestry Roof

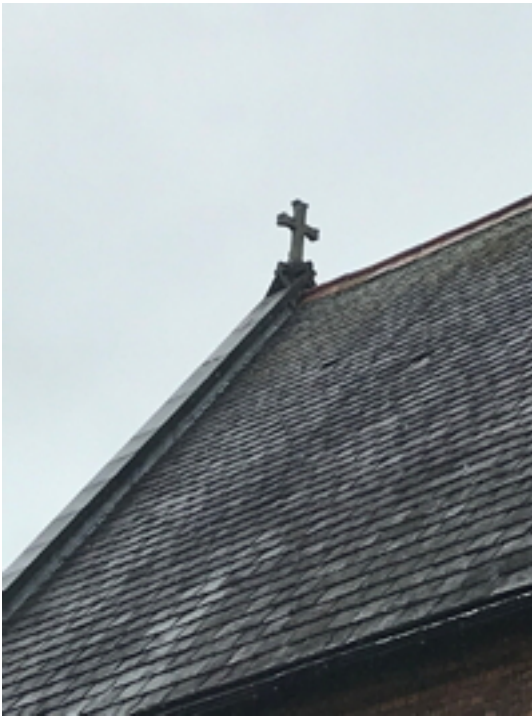
South Elevation West End slipped slates

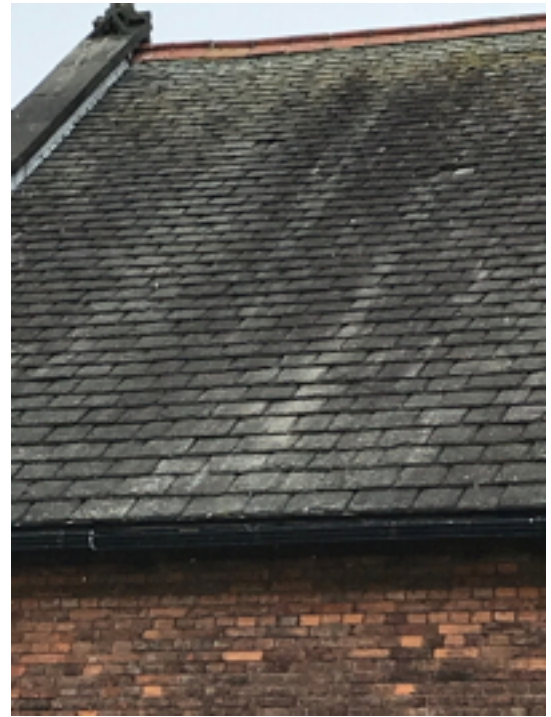
Uneven Ridge Tiles

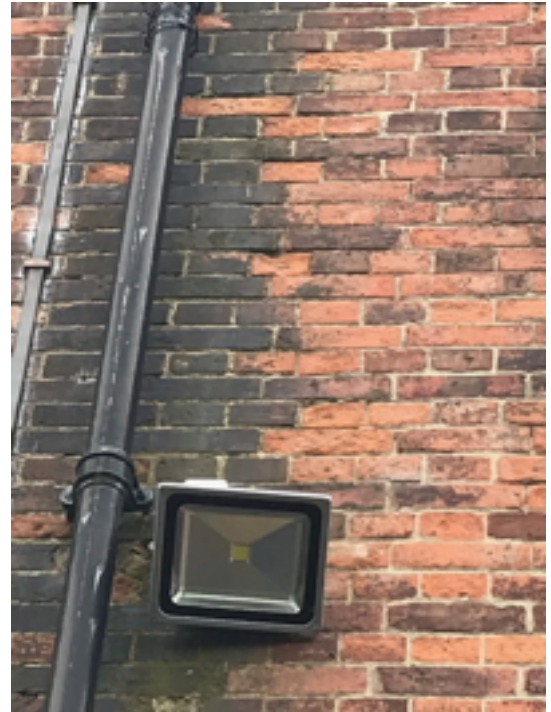
Erosion of brick faces to North Aisle north wall

Some erosion of brick faces is visible. This is largely due to the brick being softer than the mortar, hence water is trapped in the bricks and frost action gradually destroys the brick. This will be an ongoing issue but careful attention to pointing and repairs will slow the deterioration. Similarly to stone string courses some of which have had unsightly mortar repairs and an area of staining indicating a leaking gutter above.

Monitor brickwork and stonework deterioration.

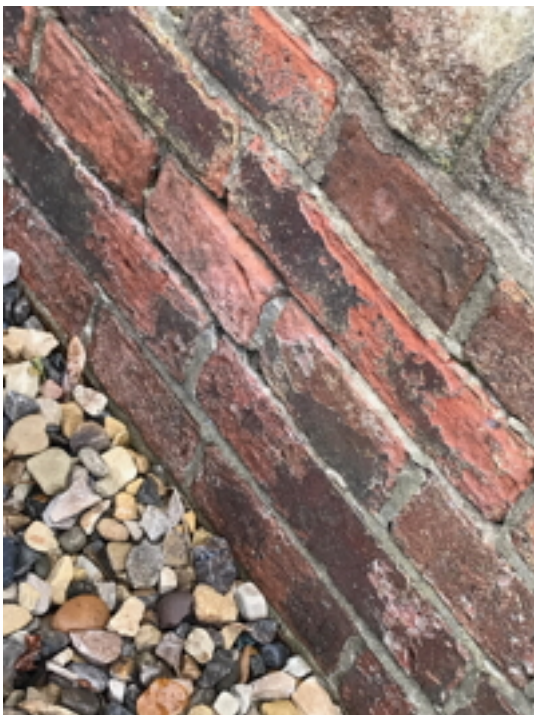
Areas requiring repointing to plinth

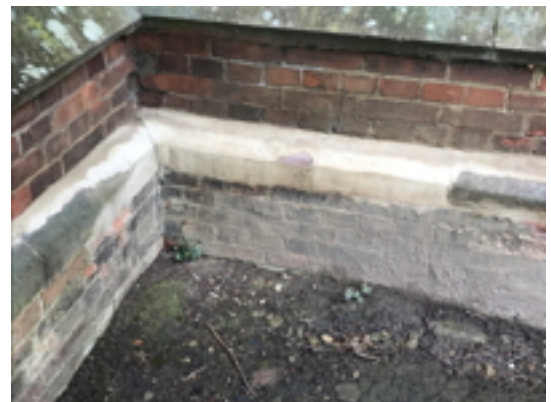
Unsightly plinth repairs

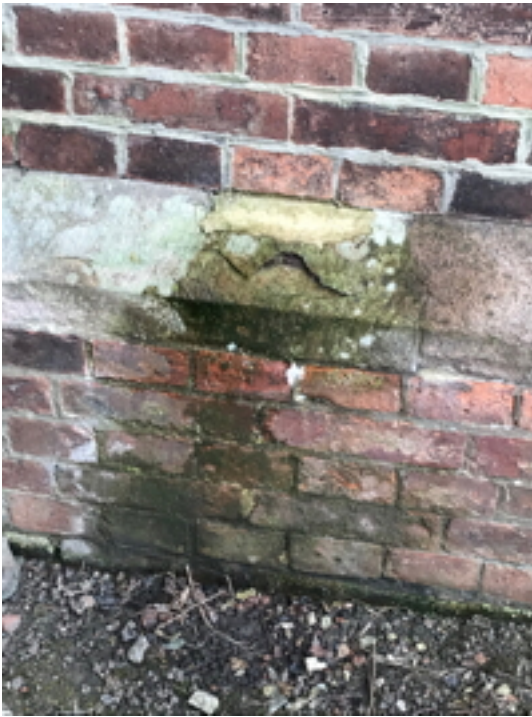
Staining to Plinth

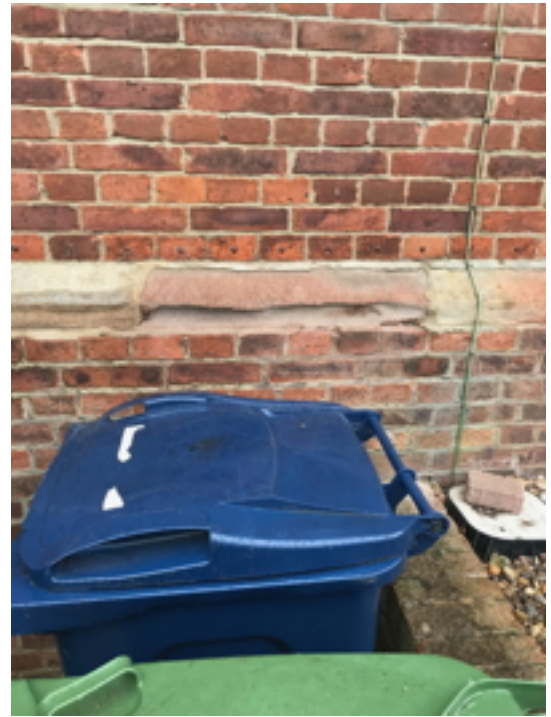
Erosion to Plinth

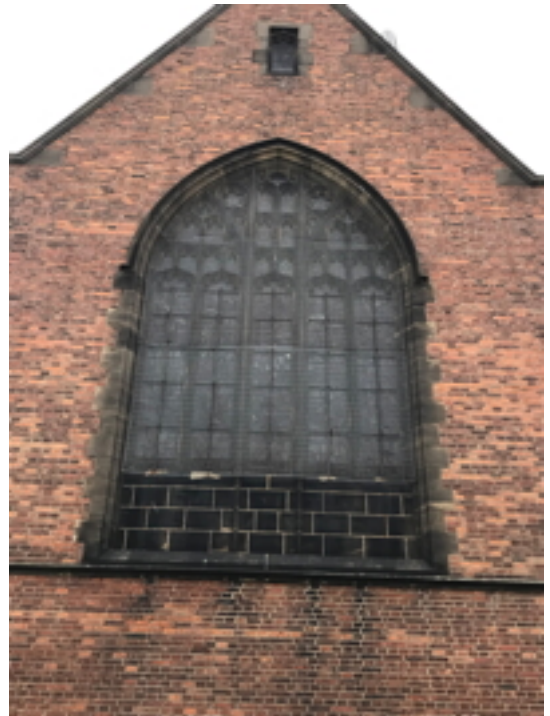
East Elevation Window Grills

Grille to east window is badly fitted and distorted. Both Grilles should preferably be replaced in polycarbonate.

Replace wire mesh grills with polycarbonate. £2000.00

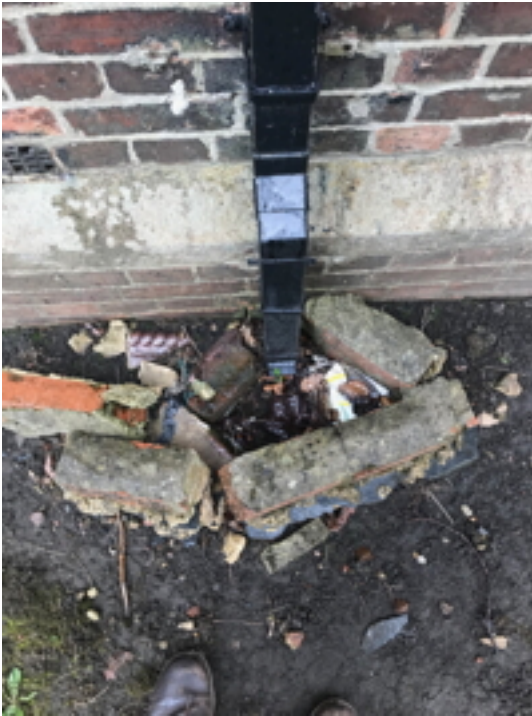
Damaged and Blocked Gully

Gullies are mostly blocked and surrounds are damaged.
Inspection chamber covers are satisfactory

Repair damaged gullies and unblock. £500.00

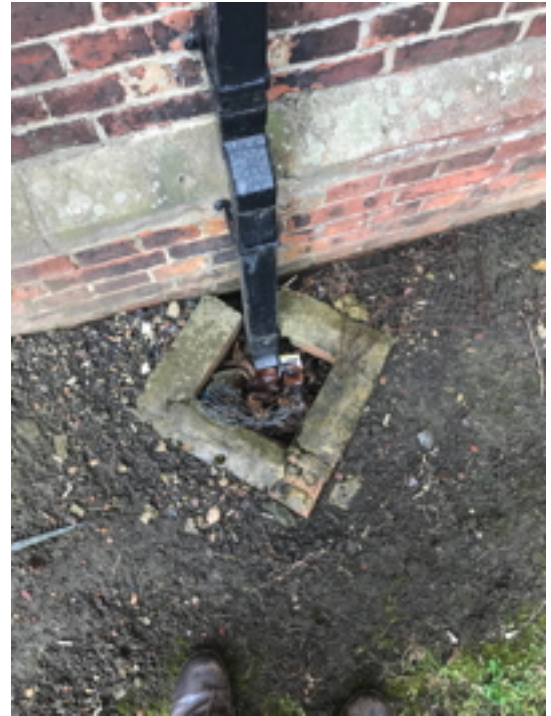
Blocked Gully

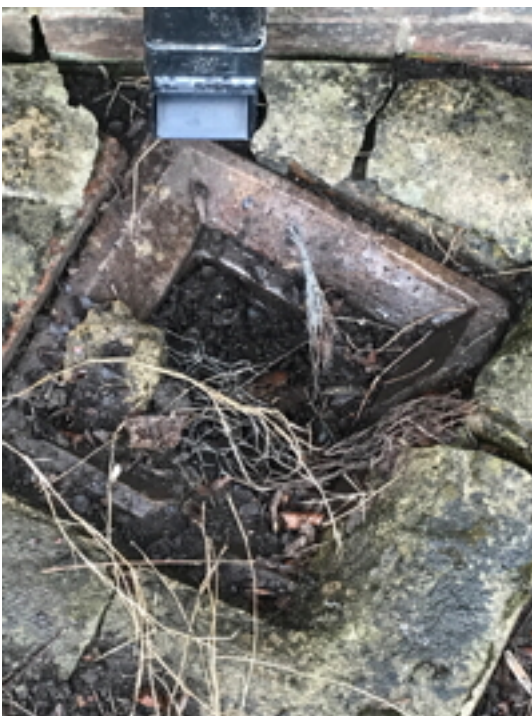
Damaged and Blocked Gully

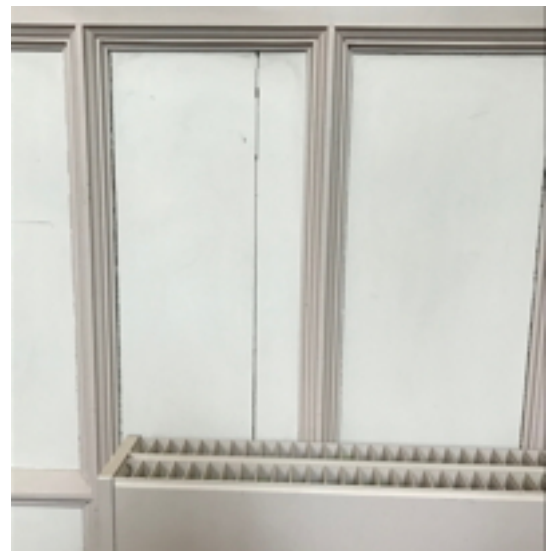
Typical Shrinkage Cracking to Panelling

Doors and screens are all in satisfactory condition. The panelling shows signs of shrinkage cracking as mentioned the last report.

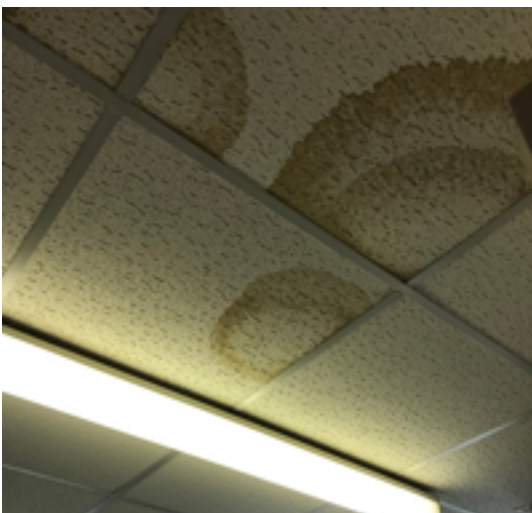
Staining to Vestry Ceiling

There are signs of staining to the ceiling but it was reported to me that the was due to a recent leak that has since been fixed. This is an area below a valley gutter that is always vulnerable. The Vestry is all in satisfactory condition.

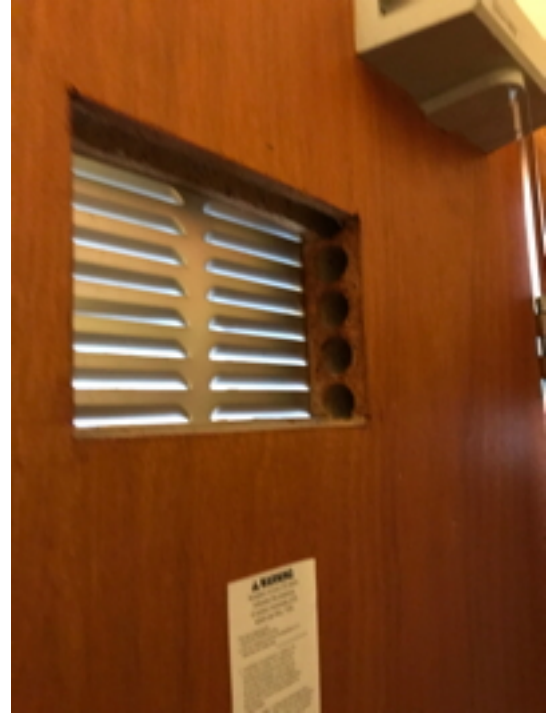
Unsatisfactory Grill to Boiler Room Door

The Office is all generally in satisfactory condition. However the boiler room has a fire door but the air grilles cut into it are not fire resistant, defeating its purpose. They should be replaced with intumescent grilles of half-hour fire resistant standard.

Replace grills to First Floor Boiler Room Door with intumescent grilles of half-hour fire resistant standard. £75.00
