**QUINQUENNIAL INSPECTION REPORT
OF
ST. JAMES AND ST. BEDE, GATESHEAD**

**DIOCESE OF DURHAM
ARCHDEACONRY OF SUNDERLAND
DEANERY OF GATESHEAD**

**QUINQUENNIAL INSPECTION AND REPORT
2019 report on the 2018 Inspection
DATE David Beaumont BA (Hons) Grad Dip, RIBA, AABC**

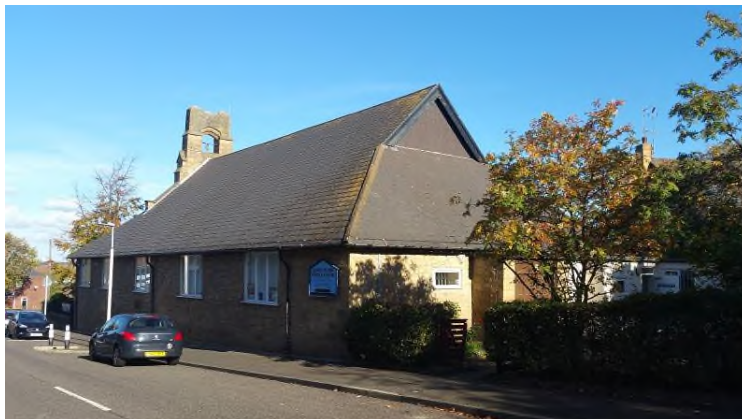
Gablet hipped roof formed of a ridge and four hips and these appear in good condition. The slating is in Eternit type fibre cement and these seem sound though there is moss collecting at the bottom edge of the slates that should be removed.

South - One slate missing and the bargeboard above it requires decoration.

North - Restricted view to the north side but probably ok.

East – This side looks ok. All the flashing are all in place but it looks a bit mossy.

Recommendation: remove moss, replace missing slates, check mineral felt roof condition, redecorate bargeboards

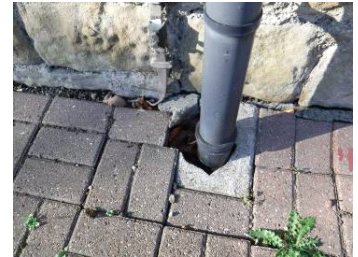
Plastic large format gutters and downpipes throughout the building. Recently cleaned and reporting in good order.

West - There is a bottle stuffed in one of the downpipes trapping the water flow on this elevation.

East – At the Nave the downpipe is loose and it discharges into a rather makeshift gully where the surround is broken, unable to check the one alongside it as it is over grown.

South - Gutter jointing broken. The south side downpipes discharge to the footpath, middle one has a broken bracket at the bottom. At the kitchen, it might be there is a slight drop on the gutter and it seems to be leaking in the corner.

North – bracket is rudimentary and has lost its shoe. It is also discharging high.

The system is split and it discharges only on the east and the west sides. The black plastic is discolouring on some of the downpipes.

Recommendation: make repairs to the guttering, downpipes and gulleys

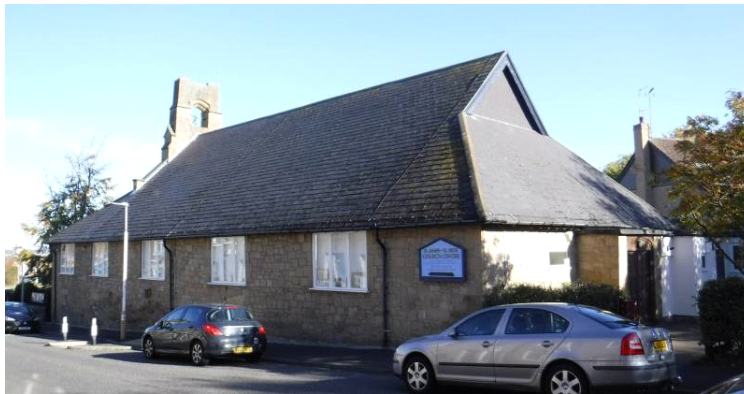
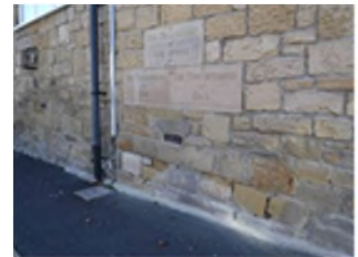
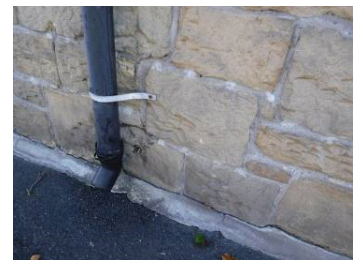
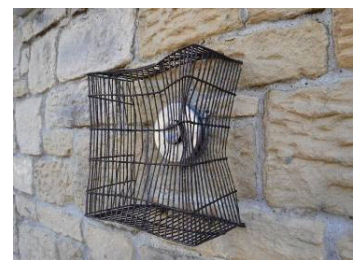
WEST ELEVATION

Stonework is the same as the east though it is a little more worn at the footpath level. There are some open joints mostly in the middle below the memorial signs. There is a fillet of cement against the footpath and damp is clearly coming up, though there is little to be done here other than replace it in lime mortar if funds allow. There are some cement patches that look pretty poor.

A couple of infilled areas are the north end in cement looking heavy handed but acceptable. At the southern end there looks to be some remedial damp proof coursing injected into the mortar joints. There is a damp proof course which starts at the top of the slope, so it is about 1 ½ feet above the top end and the stones are worn beneath that. One of the gas terminals guards is missing and the other is very rusty.

Recommendation: repair gas terminal

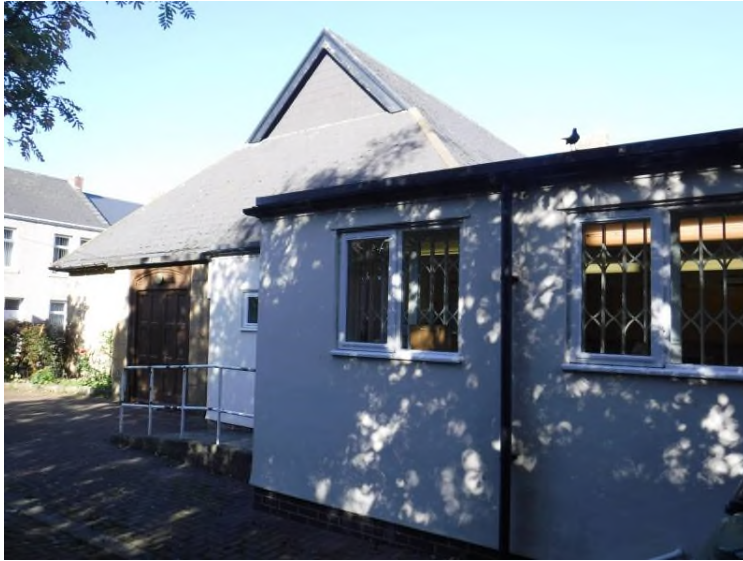
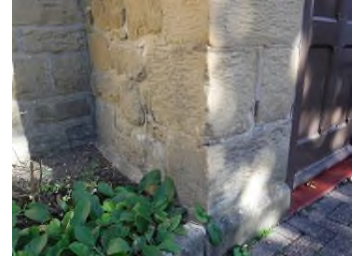
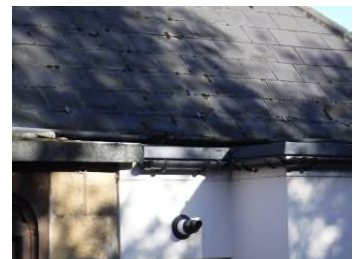
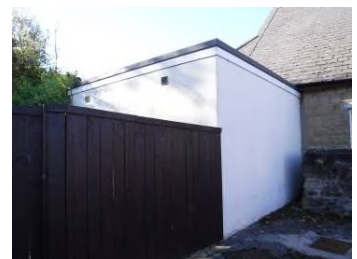
SOUTH ELEVATION

M Mixture of original building plus plastered rendered kitchen block, this has a Sarnafil type roof on, the middle section lobby has an old felt roof with some stone on the top of it.

Masonry here is ok, apart from some open joints to the stonework, heavily cement pointed and there is salt showing on the stonework for the little porch.

Kitchen extension works are all ok. The eastern wall of the kitchen can't be seen due to adjoining property, it will be worthwhile having this checked.

Recommendation: Inspect the kitchen east wall

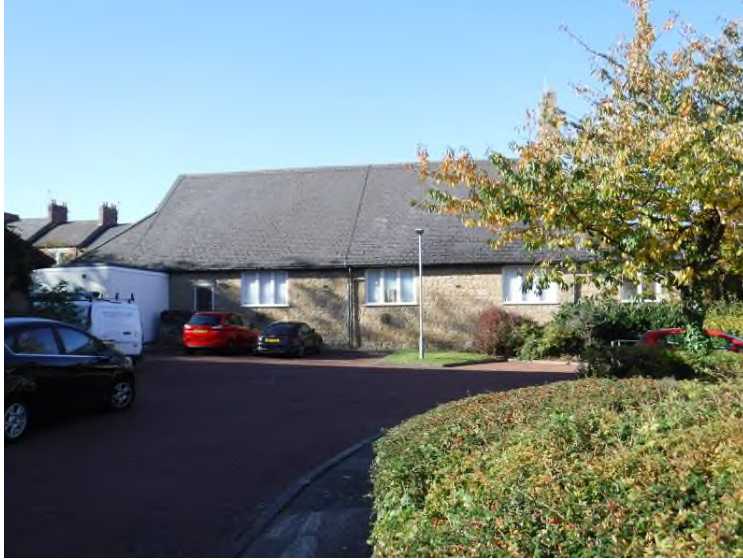
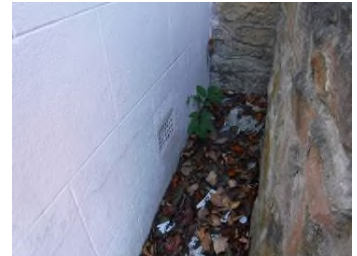
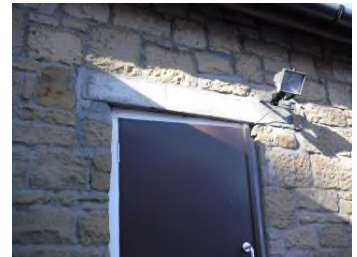
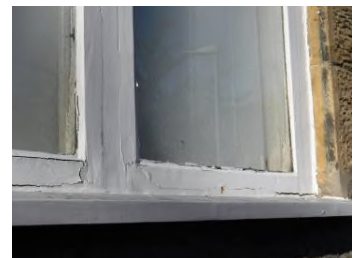
EAST ELEVATION

- C Rendered block extension to the south east corner, looks ok apart from the fascia board which needs decorating. The render has been brought right down to the ground and is staying put, it has been repaired in the past.

The masonry walling of the building is good though it has got a hard mortar but the stonework seems to be in good condition.

Simple panel door for means of escape is in fair condition.

Single glazed windows, un opening and condensation showing on the inside, some slight cracking to the frame and some of the joinery is beginning to fail, particularly near the south end. It would be worth obtaining a quotation for replacement and then decide if viable to repair

Recommendation: redecorate kitchen fascia, repair windows

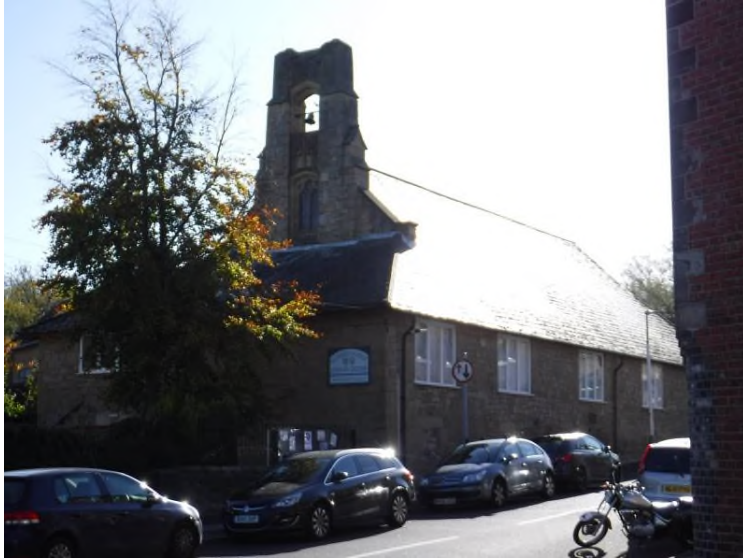
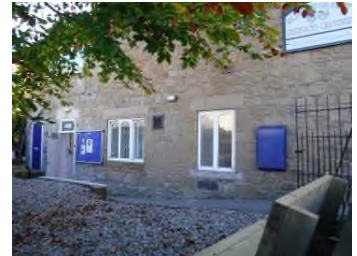
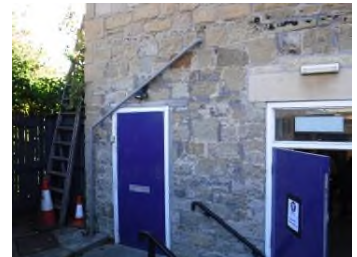
NORTH ELEVATION

- C Upper level is the apex of the Nave below the Bellcote that seems in fair condition. Lower level is the handcrafted operation, walls seem to be in fair condition, there has been some cement pointing. There is a crack to one of the lintels but this looks very old and it doesn't seem to be loading onto the window at all.

Windows are a slight mixture here and there is some loss of decoration on the wearing surfaces.

Security light is loose and the upper level washbasin waste is loose as well.

Recommendation: redecorate windows, refix security light and waste

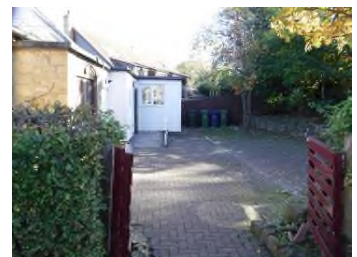
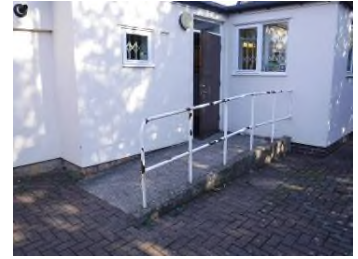
Block paved area, entrance gates are very rickety. Two low brick walls retaining some planting with a small acer tree. Bins are kept here. Modest ramp with rusting handrail, there is a step up on the threshold to the lobby.

Recommendation: redecorate handrail, improve gate fixing

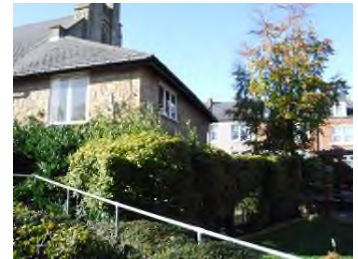
C **North side:** Ramped and stepped area, the ramp provides disabled access down to the ground floor. Drainage grille at the bottom looks silted up and could do with being cleared out. Short brick retaining wall holding back a gravelled area.

Church fencing adjoining, part of which is leaning a bit into the tree, it will be wise to keep this tree in check.

Recommendation: clear out grille, keep tree in check, secure fencing

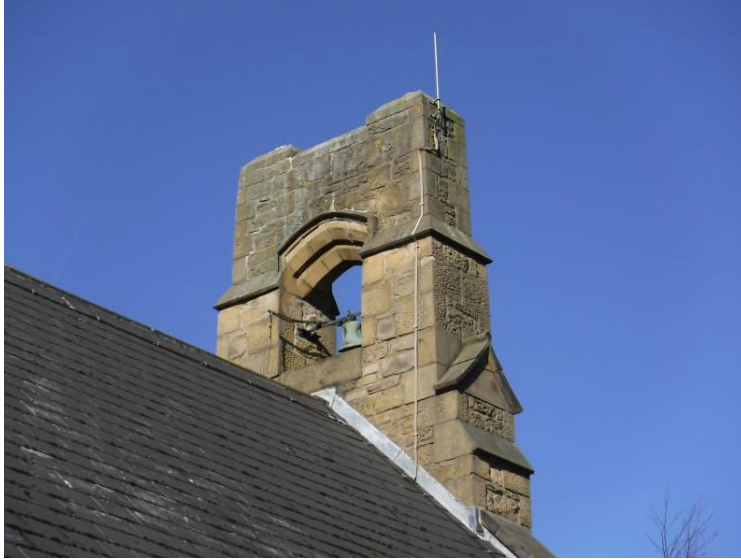
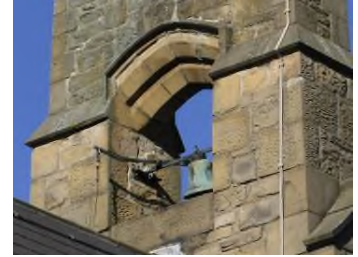
- **Bellcote:**

Stone bellcote in good condition (probable repairs in c. 2010). Formed at the apex of the roof and creating a west window feature. The stonework is in good condition, some remedial pointing that doesn't quite match but no work to be done here. The window below it looks in good condition and the glass is clean, interestingly there is no protection on the glazing.

Recommendation: none

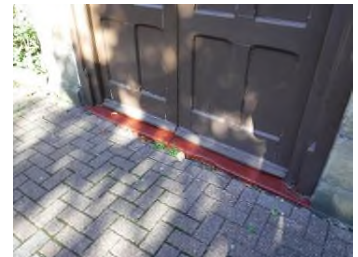
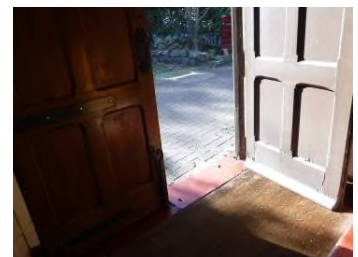
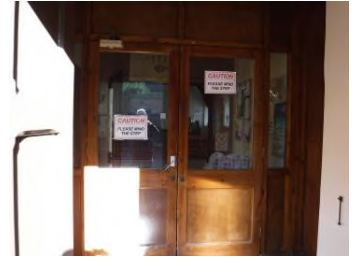
B **Lobby 1:**

- Ceiling – Concrete, shuttered ok.
- Walls – Plastered, showing some damp penetration at low level. There are salts showing on the outside as well but to be expected.
- Floor – Concrete floor with an inset mat well.
- General – Painted, probably pine, panelled doors which have erosion to the bottom rails, the doors have also dropped slightly and are catching where the mould is detaching.

Recommendation: ease doors

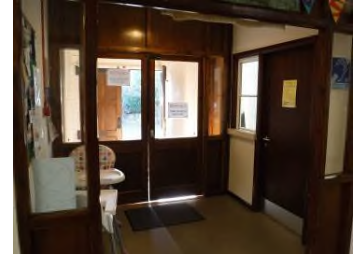
B Lobby 2:

- Ceiling – Plastered.
- Walls – Plastered.
- Floor – Safety vinyl.
- General – Reasonable condition. This contains the fire panel, break glass and sounder. Entrance door doesn't quite fit firmly into the frame.

Recommendation: ease door

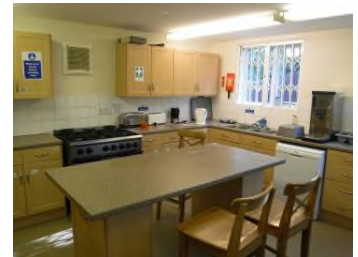
B Kitchen:

- Ceiling – Painted plaster.
- Walls – Painted plaster and ceramic tiling.
- Floor – Safety flooring.
- General – Fitted out with kitchen units and worktops, Central Island, broken wash hand basin. Safety guarded windows look ok. Room in generally fair condition.
- Fire door is slightly warped in the frame but ok, probably pulled in tight with the lock, might need a pull handle to pull the door in tighter when you lock it.
- Contains a 2kg Co2 extinguisher and fire blanket.
- Kitchen extractor fan reporting as needing repair.

Recommendation: repair extract, ease fire door/improve closing, repair wash hand basin

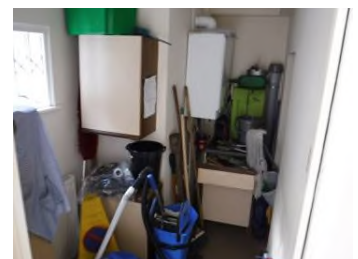
M Cleaner Store:

- Ceiling – As before.
- Walls – As before.
- Floor – As before.
- General – Bit of a jumble of loose items in here. Room contains a 6kg powder extinguisher. Door needs easing into the frame.

Recommendation: provide shelving and tidy up

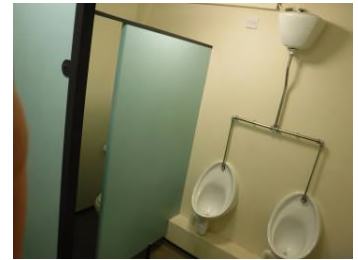
Male WC:

- Ceiling – As before.
- Walls – As before.
- Floor – As before. The flooring is eroded a little at the urinals.
- General – Fitted out with 2 urinals and 1 W.C. the W.C. lid is broken.

Recommendation: repair wc

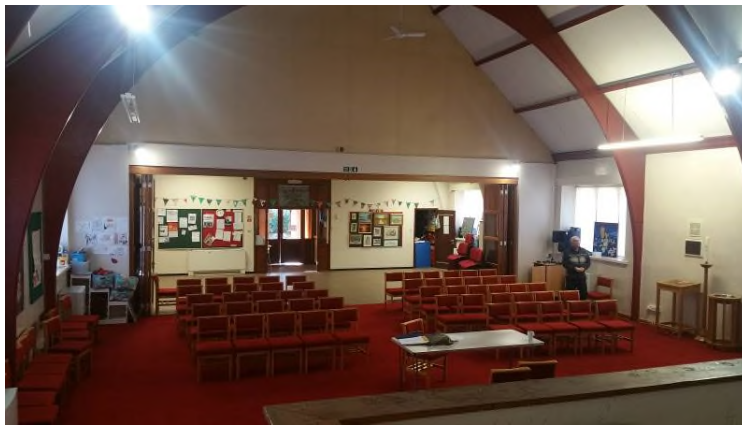
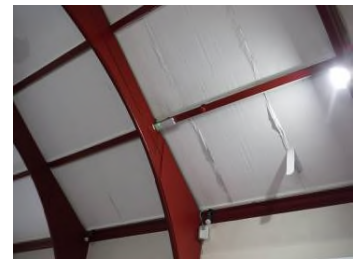
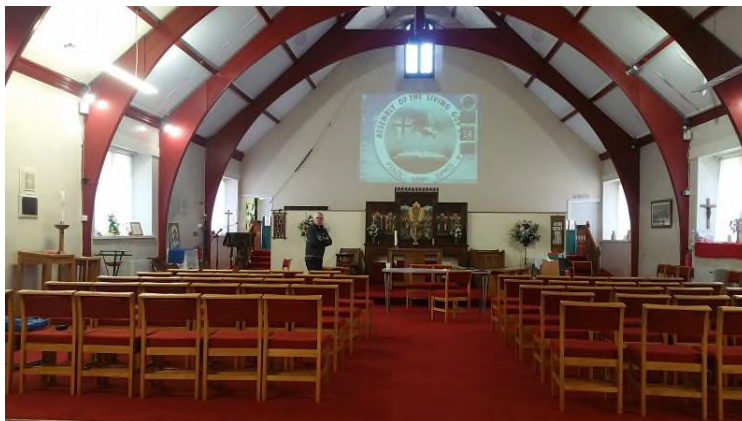
Nave:

- Ceiling – fibre board with taped joints coming away. It is not economic to renew the tape presently.
- Walls – plastered and painted
- Floor – Carpet on suspended floor. Some of the floor boarding is ridging, it is not a trip hazard but it is slightly un-level.
- General – Loose chairs. Some Ecclesiastical fittings from the previous church. Room is divided by large glazed folding screen recently renovated.

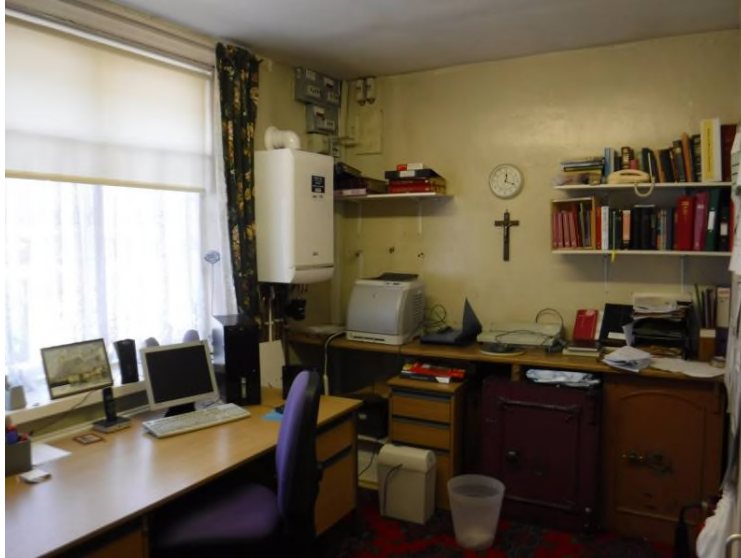
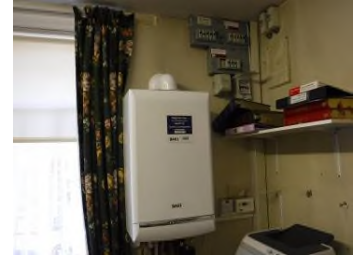
C **Vestry:**

- Ceiling – Painted plasterboard.
- Walls – Old plastered walls that have been decorated over time, quite a build-up of paint on it.
- Floor – Carpeting fair condition on suspended floor, slight undulations but nothing to worry about.
- General – 2kg Co2 extinguisher. Room has 2 safes. Rather rudimentary worktop propped up off them. Platinum boiler with exposed pipework.
- Electrics are slightly rudimentary there is a few extension leads and room has a collection of miscellaneous furniture and could do with a bit more storage. Cupboard to the side with clergy robes is ok but the door keep is missing.

Recommendation: improve storage and electrics

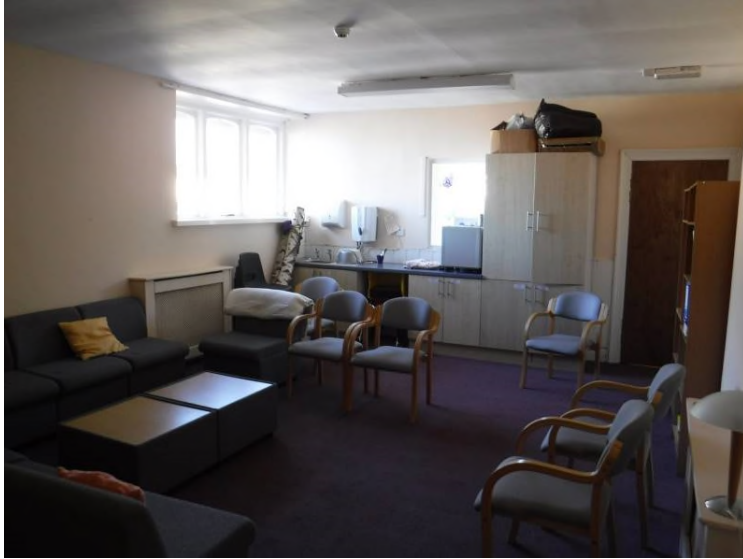
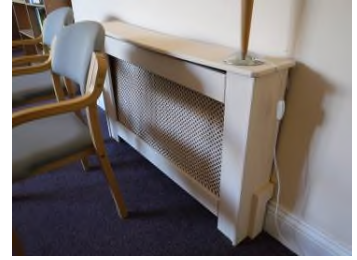
B St. Hild Room:

- Ceiling – Painted plaster, slight cracking at mid-point but ok. Loft access to roof.
- Walls – Plaster is ok. Borrowed light window overlooking the stairs down.
- Floor – Fair condition carpet over suspended floor.
- General – Room contains a fitted servery, sink and a water boiler. Radiator cover is broken.

Recommendation: repair radiator cover

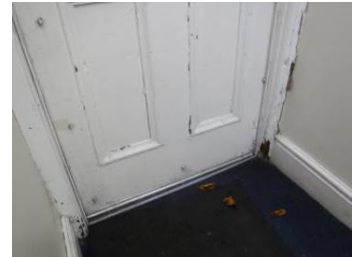
Stairs down – Door from Nave is catching, the dado panelling has got some slight cracking to it. 3ltr foam spray extinguisher. Stair down ok. External door ok. Quite a bit of dust because of the operation in the workshop.

Recommendation: clean up dust and provide draught stripping to door. Ease door,
