**CHURCH OF ALL SAINTS,
GIRSBY, COUNTY DURHAM**

QUINQUENNIAL INSPECTION 2017

DATE OF INSPECTION : 11 October 2017

**Malcolm R Cundick Dip. Arch.(Oxford) RIBA
ADG Architects
6 Pioneer Court
Morton Palms Business Park
DARLINGTON
DL1 4WD**

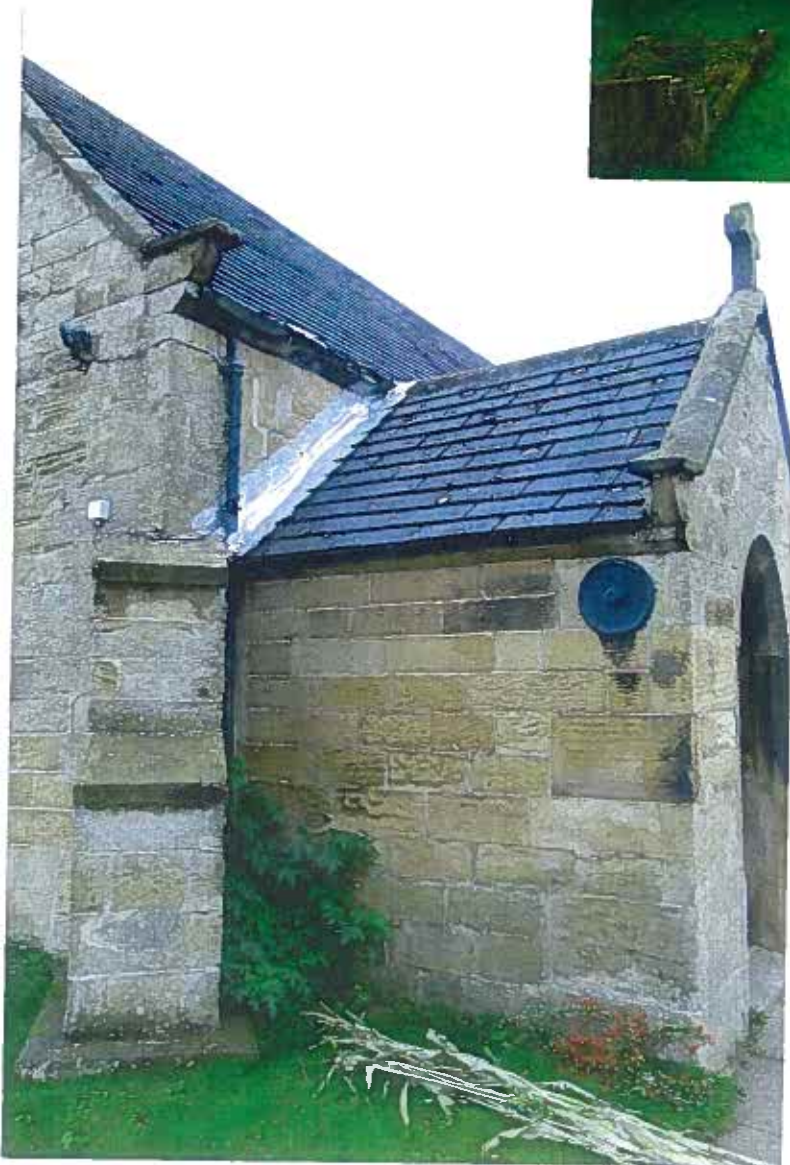
2

- 5.3.1 Flashband abutment of porch roof to main roof/south elevation. Temporary repair quality only, but still appears sound except for some lifting of ends.
- 5.3.2 Settlement of Porch apparently stabilised.
- 5.3.3 Broken cap to right hand tie rod.
- 5.3.4 Absence of gully to porch rainwater pipe.

1. West Gable with bellcote
2. Entrance Porch from South West. Note cap to tie bar and flashband abutment cloaking.
3. South Porch and lean-to.
4. South Porch gable. Note step at threshold

- 8.6 Make good render to lean-to : B (5.2.6) £40.
- 8.7 Review security of and consider replacement of Flashband abutment of Porch roof : B (5.3.1) £220

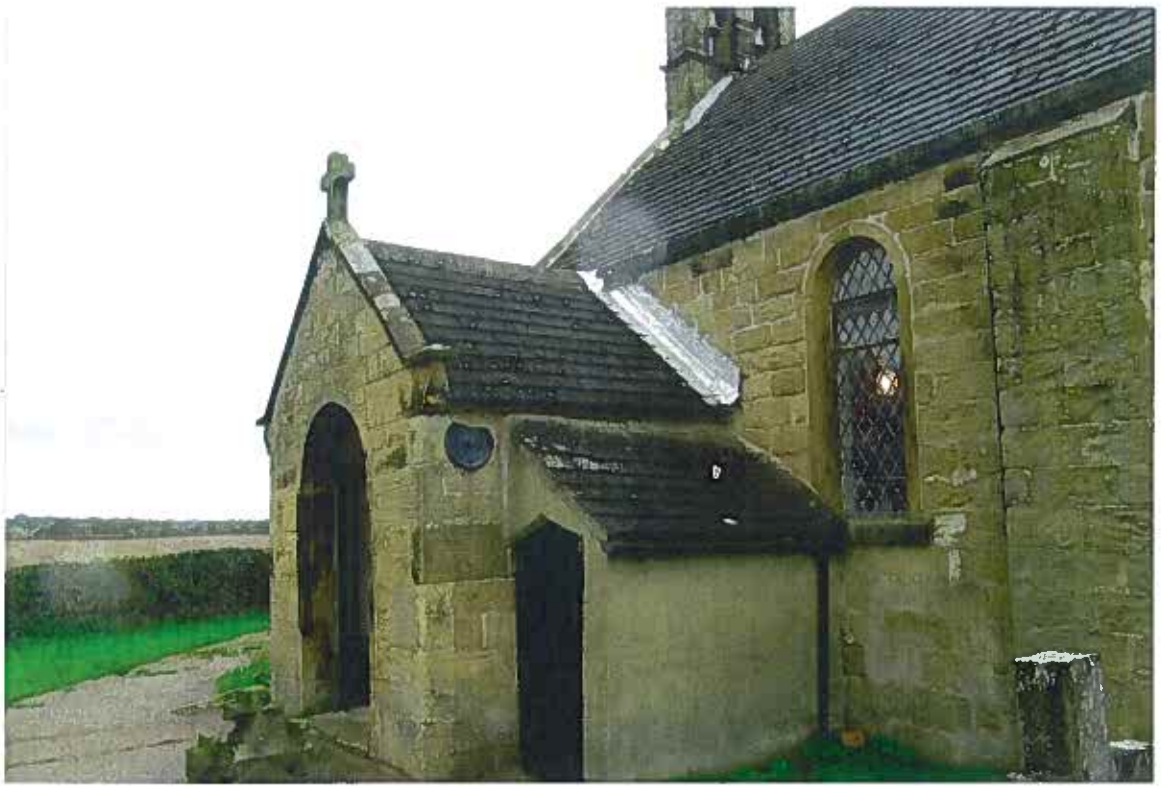
5

5. Porch and lean-to from South East. Note broken cap to tie bar, flashband and settlement angle of the lean-to.
6. South Elevation from South East.
7. East Gable. Note tie bar.

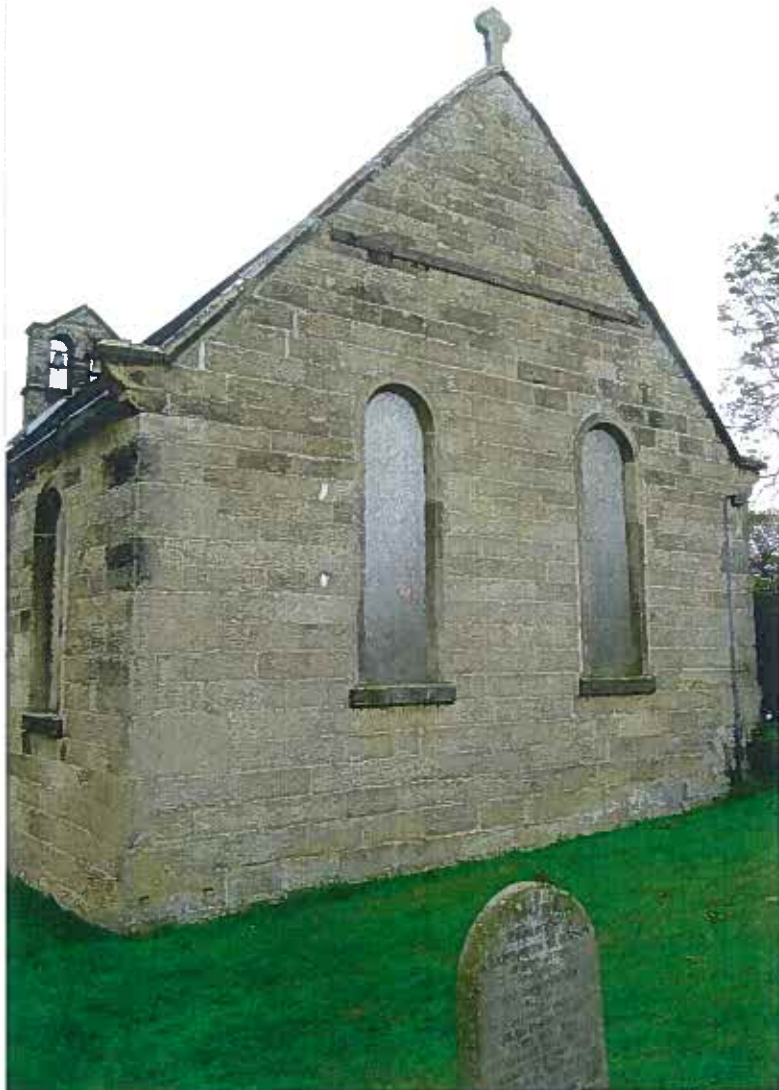
7

- 5.1.1 The high level structural tie bar is in apparently sound condition but, as noted previously, would benefit from decoration to maintain its integrity.
- 5.1.2 Stonework and pointing is generally sound but a stepped diagonal crack through stonework joints is now apparent running from the North-East corner kneeler to the adjacent window frame, where an open joint between the stone frame to the window and abutting stonework is now evident.
- 5.1.3 Polycarbonate sheet protection to windows in sound/secure condition.
- 5.1.4 There remain some minor open joints to the stone arch to left hand window.

- 8.1 Preparation and decoration of external tie bars to East and West gables : B (5.1.1 and 5.4.2) £60.
- 8.2 Installation of tell-tails to movement joints in East gable wall per item 5.1.2 to monitor any further settlement/deterioration.. A. £80

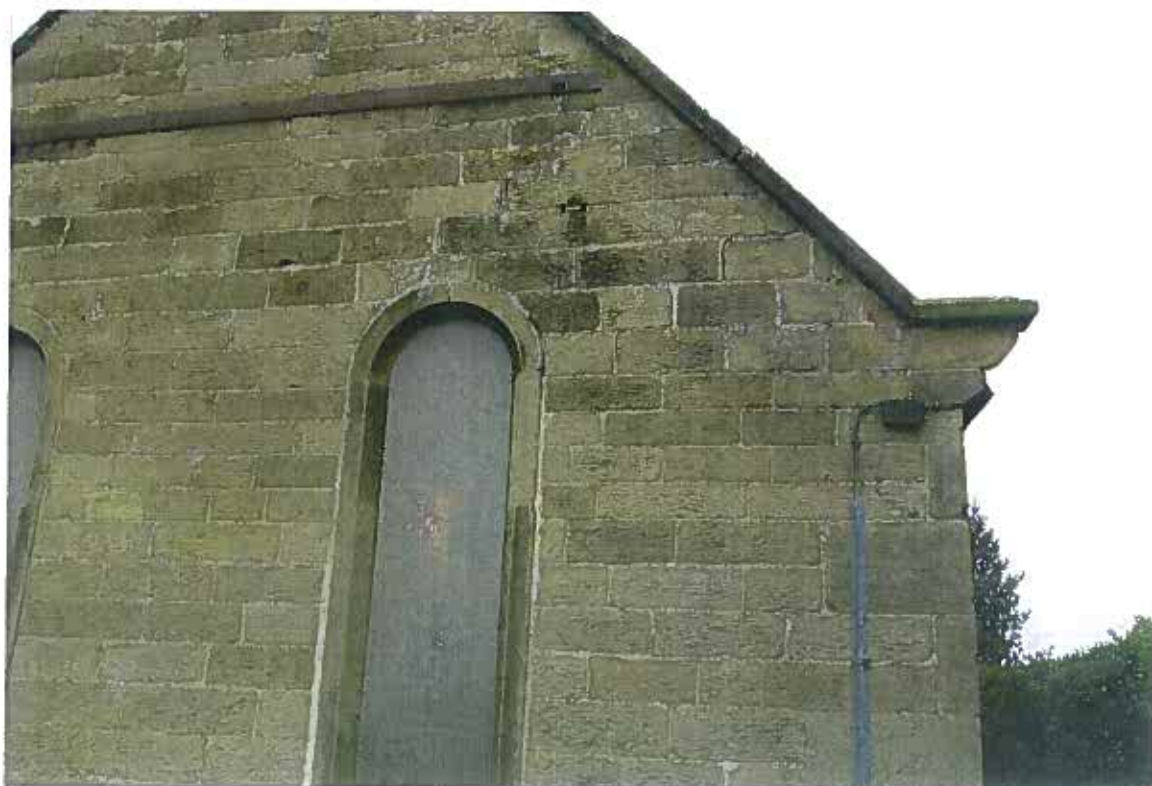
8

8. North corner of East Gable. Note stepped diagonal crack and open joint to stone frame to window.
9. North flank wall from East.
10. North flank wall from South

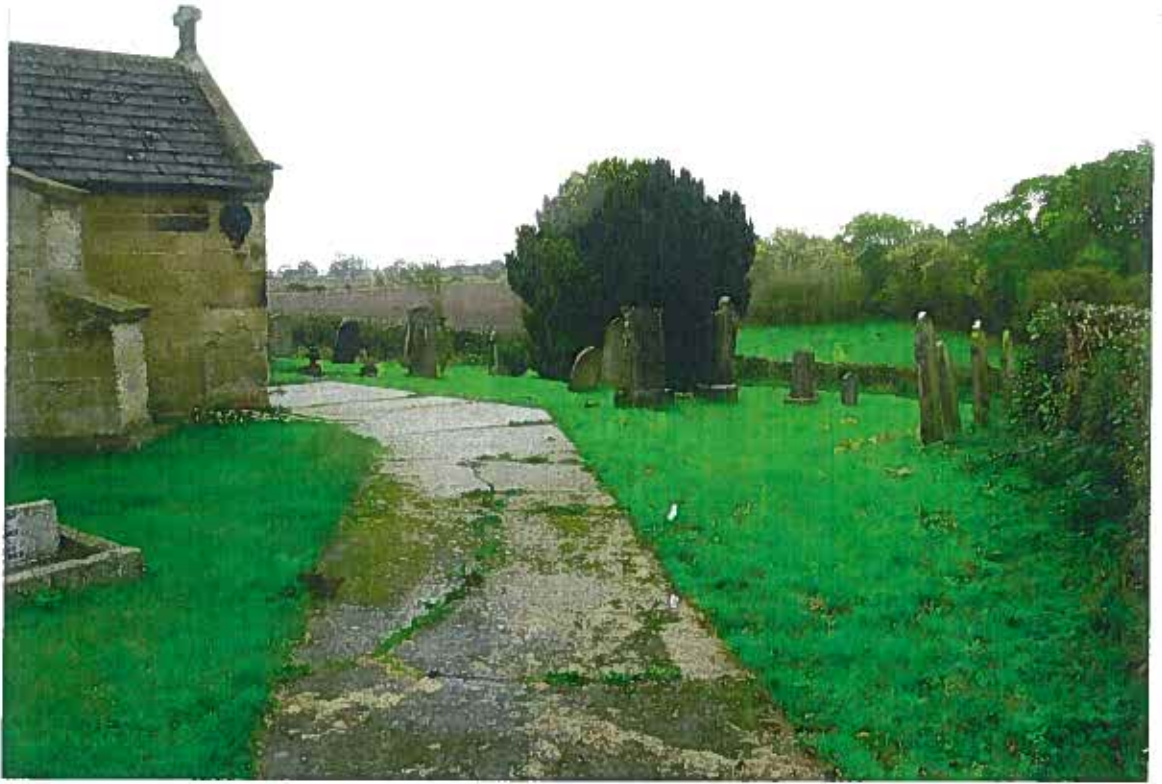
11

11. Approach footpath. Noted distorted and cracked condition of concrete
12. Approach footpath looking back to gate.
13. Consecrated Churchyard. Well maintained with watching brief on gravestone stability.

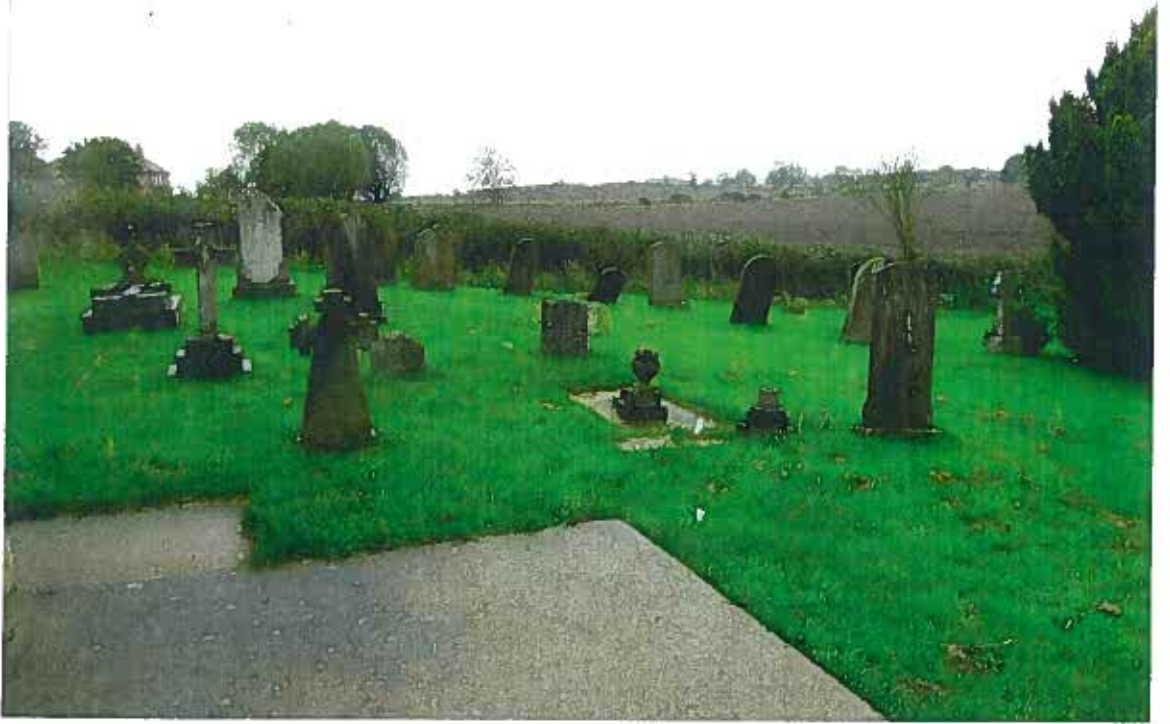
13

- 7.1 The grounds, gravestones, monuments, hedgerow, trees and fencing continue to be responsibly maintained and are in a tidy/fair condition including the continued challenge of the hedge and undergrowth abutment with the North flank wall with related ivy growth. This is being regularly addressed. The stability of gravestones is also to be the subject of ongoing appraisal.
- 7.2 As noted there has been some progress in addressing the condition of the derelict farm buildings to the North with advanced progress on construction of a new dwelling..
- 7.3 The concrete footpath leading from the entrance gate have developed a number of apparent movement cracks which need to be carefully monitored.

- 8.12 Continue repairs and maintenance to grounds, footpaths, gravestones, hedgerow and fencing particular hedge/vegetation/ivy growth abutting North elevation : D (7.1)

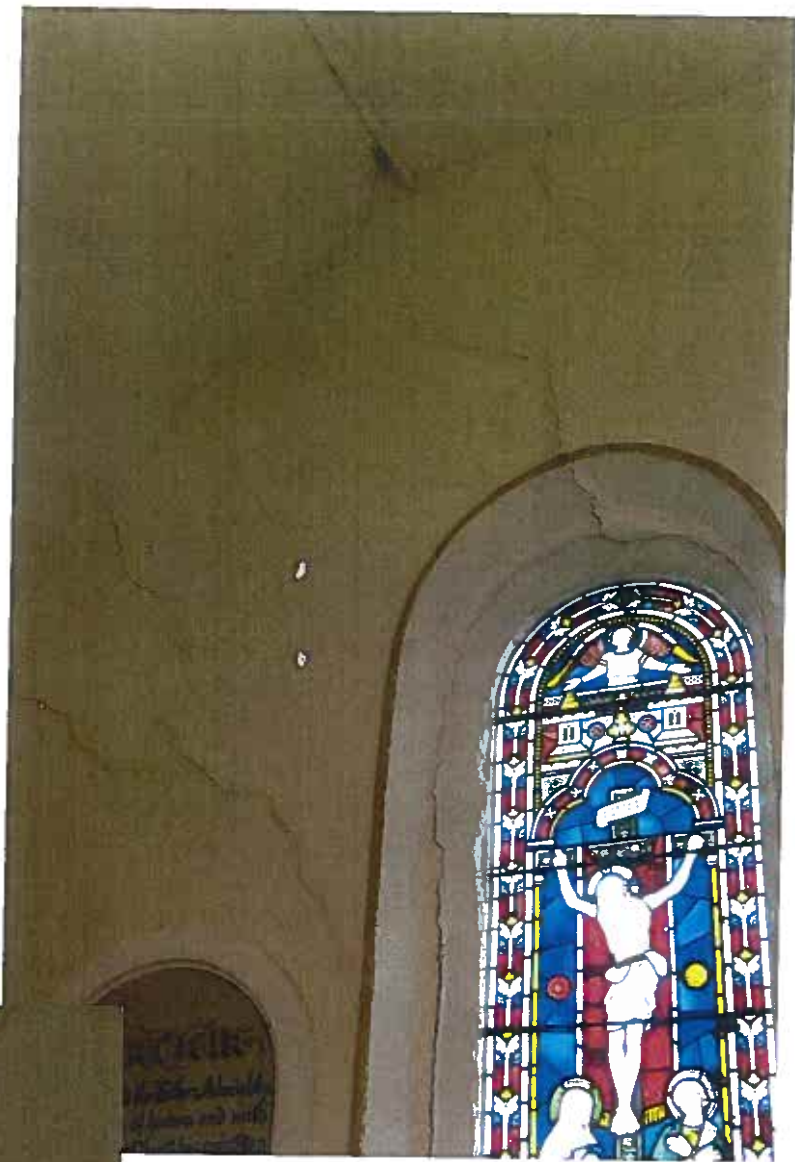
23

- 6.4 Two arched head windows in the East gable incorporate stained glass. Both are in fair condition. There is however evident development of movement cracks in plaster with diagonal cracks to both window heads and other surface crazing.

23. Movement cracks to window head coincident with external movement joint per photograph 8.
24. Diagonal crack to South East corner.
25. Exfoliation of decoration on South elevation.
26. Plaster failure coincident with gutter/peak to Porch
27. Nave looking West
28. Bell ropes and ceiling access hatch.

- 8.10 Scrape of decoration and plaster to East gable wall to expose movement cracks. Infill and redecorate. B (6.4) £800
- 8.11 Scrape off defective decoration and plaster at low level to West gable wall. Make good plaster to render specification and apply anti-fungicidal mist coat. Allow to dry before redecoration. B (6.5) £400

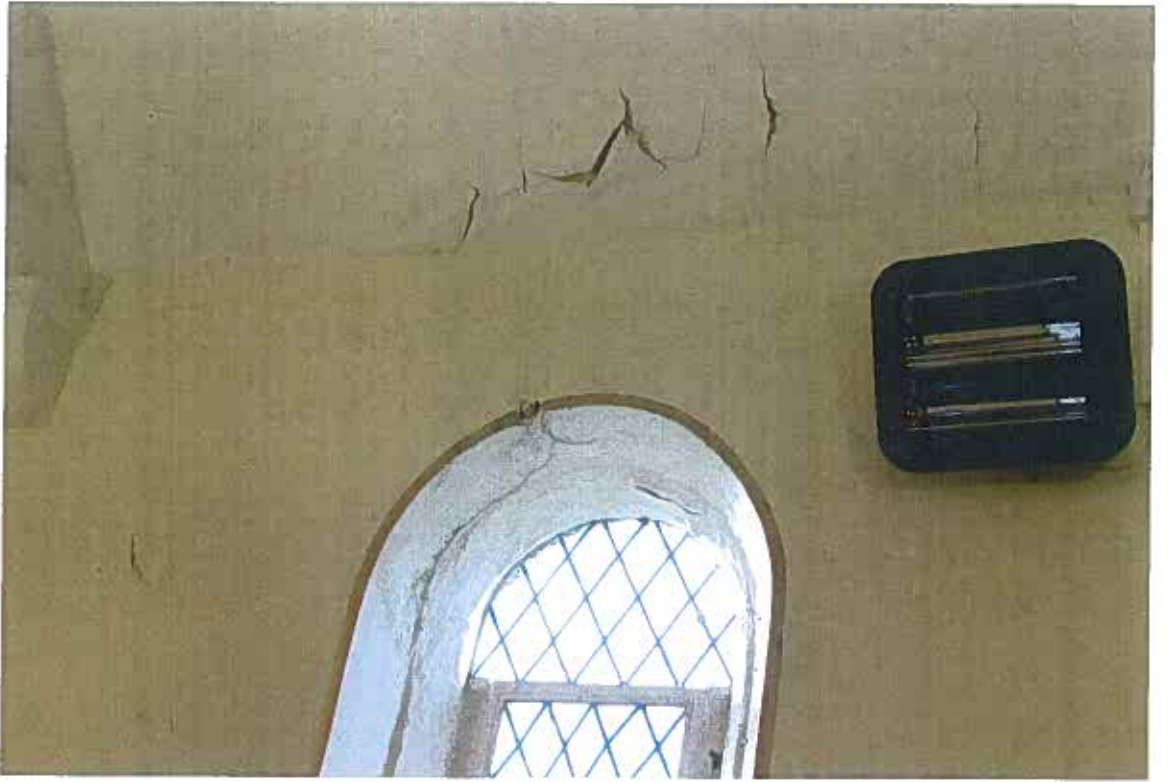
25

- 6.1 The 3 painted main roof trusses and supporting corbels remain in sound condition, enhanced by the post 2002 decoration.
- 6.2 The underdrawn ceiling is in predominantly sound condition and fair decorative order but there is some significant break down/exfoliation of decoration at eaves level on the South elevation in particular with a plaster de-lamination patch coincident with the peak of the Porch roof.

- 8.8 Repair plaster to Porch and redecorate : B (6.15) £100.
- 8.9 Carefully scrape off exfoliated internal decoration at eaves level to South flank wall together with renewal of defective plaster. Treat with anti-fungicidal mist coat and allow to fully dry before remedial decoration. B (6.2) £600
