Quinquennial Inspection Report

Church of St John the Evangelist Greenside, Tyne and Wear

Date of inspection: 13th August 2019; weather conditions – sunny

Date of report: 16th August 2019

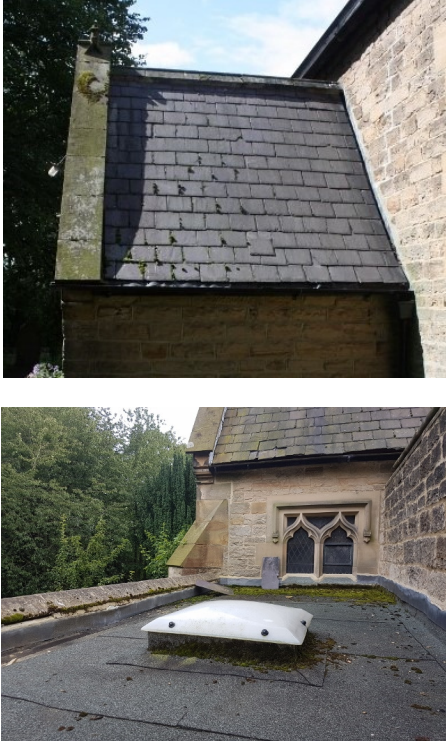
<p>There are number of defects which require attention:-</p> <p><u>Porch:</u> Ridge - open perpend joints East slope – 1No slipped slate; 3 slates with broken corners; 1No broken slate; small moss deposits (see photo) West slope – 2No slipped slates; 1No rotated slate; 1No slate with broken corner.</p> <p><u>Nave:</u> South slope – 2No missing slates; 2No slipped slates; 1No rotated slate. North slope – 2No missing slates</p> <p><u>Chancel:</u> South slope – 1No missing slate; 2No slipped slates North slope - 2No missing slates (near eaves); 1No slate with broken corner; 1No rotated.</p> <p><u>Organ chamber:</u> East slope – 2No missing slates; 2No slipped slates</p> <p><u>Flat roof to Strong Room, Toilet and Kitchen:</u> Mineral felt and roof-light are in fair condition. Some moss. (See photo opposite)</p> <p><u>Flat roof to Vestry and Corridor:</u> Mineral felt and roof-lights are in fair condition. There is some moss and leaves on the flat roof.</p> <p><u>North Aisle:</u> Slating in good condition.</p>

<p>Repair needs</p>	<p>Ridge pointing of the Porch and slating repairs to the roofs detailed above are needed in the short term to prevent water ingress.</p> <p>The moss and leaves to the flat roof areas should be removed.</p> <p>The Porch, Nave and Chancel roofs are suffering from nail fatigue and should be re-slatted in the long term.</p>	<p>B</p> <p>M</p> <p>D</p>

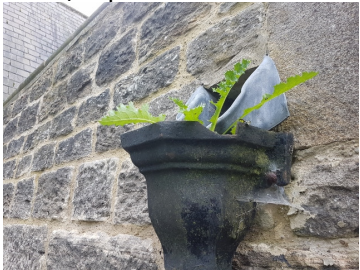
<p>Generally in fair condition. The pipes appear to have been painted with anti-climb paint. It is recommended that this paint is removed and all the rainwater goods are then redecorated and the downpipe joints re-caulked.</p> <p>The hopper on the NE corner of the Vestry block roof is blocked with vegetation. There is some vegetation in the Nave south gutter. The gullies and hoppers should be cleared of vegetation, leaves and silt etc. twice a year.</p>	<p>D</p> <p>M</p>
<p>1.3 Bellcote</p>		
<p>Condition/repair needs</p>	<p>The masonry and pointing appear in fair condition. The copper cockerel weathervane is tarnished and would benefit from cleaning; the metal supports would benefit from redecoration.</p> <p>The bells comprise 3No dishes mounted vertically and chimed from hammers operated from bell ropes at the rear of the Nave. The bells are working but have limited volume.</p>	<p>D</p>

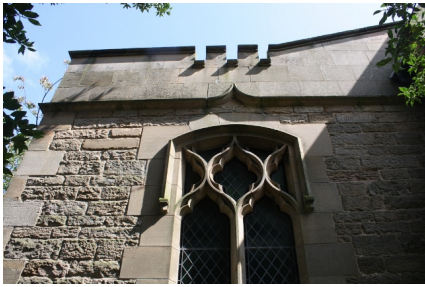
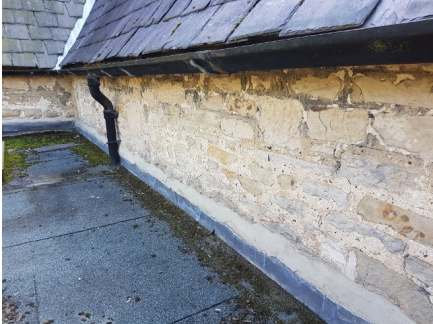
<p><u>Parapets:</u> The bedding is breaking away from the rear of the parapet above the toilet/ kitchen/strong room block. Raking out and repointing is needed.</p> <p>There is a vertical stepped crack emanating from the west parapet of the North Aisle down to the LH of window nVII. This should be raked out and repointed (see photo opposite).</p> <p><u>Upstand walls:</u> Generally the water tabling appears solidly bedded and pointed. However the bedding to the water tabling of the porch is breaking away on the western slope on the gable face. This should be raked out and repointed. The lead flashings all appear to be securely fixed. The pointing to the upstand wall of the Organ Chamber east face is in poor condition and will need repointing within the quinquennium (see photo opposite).</p> <p><u>Crosses:</u> The apex cross to the Nave east gable is in good condition. The apex crosses to the Porch east gable of the Chancel are missing. Consideration should be given to fitting replacements.</p> <p><u>Chimneys:</u> The chimney appears to be solidly pointed.</p>	<p>B</p> <p>B</p> <p>C</p> <p>D</p> <p>E</p>

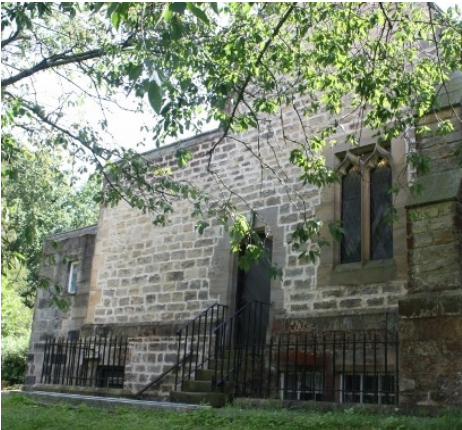
<p>The masonry and pointing are generally in sound condition.</p> <p>The walls have been repointed in places over the years and are of varying degrees of quality. In some places hard Portland cement has been used. This can cause erosion of the stone faces. In other places ribbon pointing has been used. This creates ledges which allow water penetration. The recent pointing on the north side of the Organ Chamber while correctly using lime has been poorly executed with the mortar being partially smeared over the face of the stones giving an unsightly appearance. (See photo opposite). This may have caused permanent damage to the stonework as well as altering the visual character of the masonry. Ideally this new pointing should be carefully removed and the wall re-pointed.</p> <p><u>It is important that any future repointing is carried out to a conservation architect's specification and under his/her direction as incorrect mortars and their application can do irreparable damage to the masonry.</u></p> <p><u>Porch:</u> Crack to LH hood mould over the door - monitor.</p> <p><u>Nave:</u> Loose mortar to the Nave east gable wall near the kneeler on the south side. This should be raked out and repointed.</p> <p><u>North Aisle:</u> Stepped crack from LH quoin of middle window nVI through the plinth to the air vent below. This should be raked out and repointed.</p> <p><u>Note:</u> See section 1.7 for window masonry.</p>	<p>E</p> <p>C</p> <p>C</p>

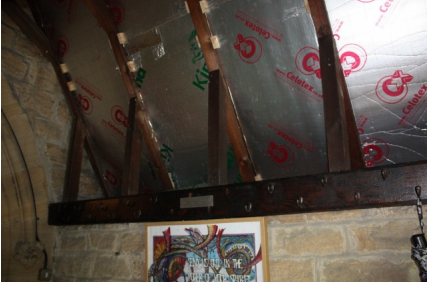
<p><u>Porch:</u> the roof timbers are obscured by insulation bats which have been fitted as an experiment (see photo opposite). However the bats are fitted hard up against the tiling battens with no air space for ventilation and no ceiling to conceal the foil covering. The insulation has been crudely fitted with timber blocks. In the inspector's opinion the insulation will have little impact on the heat losses through the church roofs as a whole and should be removed.</p> <p><u>Nave, North Aisle and Chancel:</u> the exposed timber roof structure appears in sound condition from a purely visual inspection from floor level.</p> <p><u>Organ Chamber:</u> the boarded ceiling appears in fair condition from a visual inspection.</p> <p><u>Basement Meeting Room:</u> the painted boarded ceiling is in fair condition.</p> <p><u>Boiler House:</u> it is recommended that the ceiling be tested for asbestos and any recommendations implemented should asbestos materials be found.</p> <p><u>Vestry, Strong Room, Toilet, Kitchen and adjacent passage:</u> The painted plasterboard ceilings and sloping soffits to the roof light are in fair condition.</p>	<p>B</p> <p>B</p>

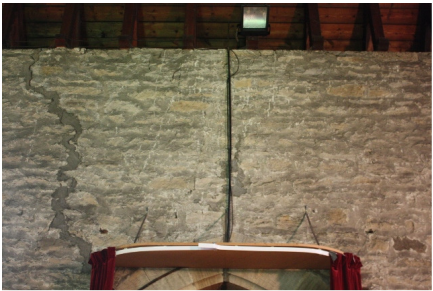
<p><u>Porch</u>: Stonework and pointing in good condition.</p> <p><u>Nave</u>: The stonework has been heavily pointed in the past. Also some past cracks (by Porch door and above Chancel arch) have been crudely filled with hard (and dark) Portland cement rather than lime mortar which look unsightly (see photo opposite).</p> <p>There are some minor cracks to joints as follows:-</p> <ul style="list-style-type: none"> - vertical crack in NW corner - stepped cracks above arcade in western and middle bays - stepped crack running from porch door lintel to wall head; this past crack has opened up again near the wall head - vertical hairline crack above porch door lintel to wall head - diagonal stepped crack from porch lintel to RH window

Repair needs	The hairline and other minor cracks should be carefully raked out and carefully re-pointed in lime mortar under the direction of a conservation architect.	D

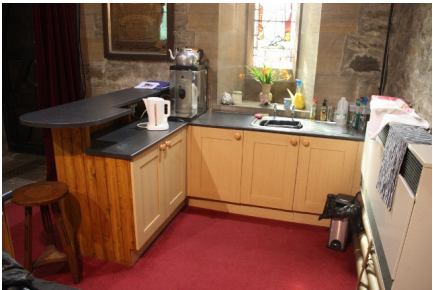
<p>See 2.1, 2.3, 2.4 and 2.5 for comments on ceilings, partitions/doors, floors and wall finishes respectively.</p> <p><u>Vestry</u>: fairly basic space, no fitted cupboard for vestments.</p> <p><u>Kitchen</u>: small and functional but remote from Nave; no cooking facilities; no extract ventilation.</p> <p><u>Servery</u>: (see photo opposite) ideal for serving hot drinks etc. at rear of Nave.</p> <p><u>Toilet</u>: functional but remote from Nave. See section 2.8 regarding facilities for wheelchair users.</p>

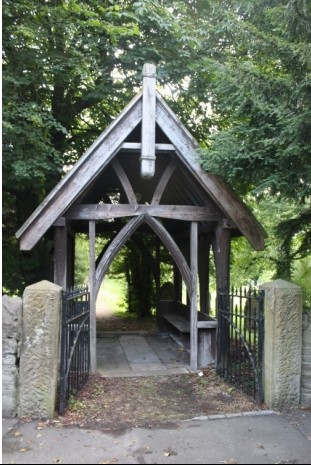
<p><u>South gate:</u> it is recommended that the gates and gate posts are redecorated during the quinquennium.</p> <p><u>East gate:</u> the metal gates by the lych-gate structure are out of alignment and don't close properly. Also the gate is rusting in places. Realignment, removal of rust and redecoration is recommended.</p> <p><u>Lych-gate structure:</u> the felt shingles are covered in moss – this should be removed to reduce weight and prevent damp penetration. The timber structure has some splits which need filling and some rot in the ends of the beams which need treating. The whole of the timber structure is in need of decoration (staining) to prevent water penetration and rot. The particleboard ceiling is also in need of redecoration.</p> <p><u>Railings to Boiler House steps and Organ Chamber door:</u> the railings are showing signs of rust in places. Removal of rust followed by redecoration is needed.</p>	D C C C

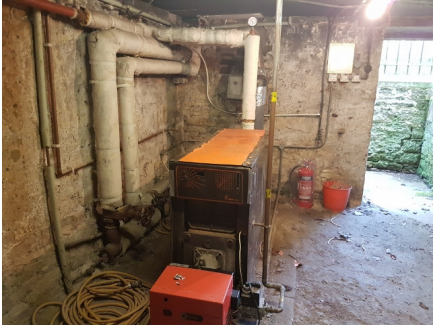
<p>It is understood that it can take several hours for the system to reach adequate temperatures for services. The boiler (see photo opposite) appears to be over 30 years old and is towards the end of its expected service life. Consideration should be given to replacing the boiler with a new more efficient one. This should result in better thermal comfort levels and reduced energy consumption.</p> <p>Pipework is lagged in the Boiler House and Basement Meeting Room.</p> <p>The fan convector heater to the LHS of the Chancel altar appears to be leaking (there are stain marks on the marble floor adjacent). Any leaking pipes should be sealed.</p>	<p>E</p> <p>B</p>

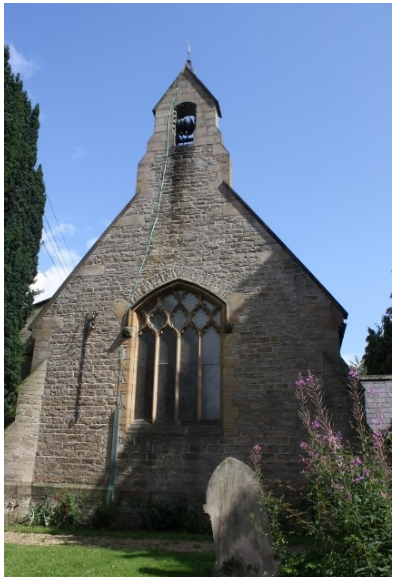
<p>The bellcote has a lightning conductor and copper down tape on the west side of the Nave. This is somewhat obtrusive a location. Ideally the down tape should be re-sited more discreetly (e.g. to the side of a buttress).</p> <p>It is recommended that the conductor is tested every five years by a lightning specialist and any remedial work or upgrading recommended should be carried out. The report should be filed with the Log Book.</p>	<p>E</p> <p>M</p>
