**QUINQUENNIAL REPORT on the  
THE CHURCH OF CHRIST CHURCH  
HAMSTERLEY**

**Diocese: Durham**  
**Archdeaconry: Lindisfarne**  
**Deanery: Lanchester**  
**Job no : 2521 (M674)**

**Inspected by Bryony Roff BSc. BArch. MA, RIBA, AABC**

Date of report: 3<sup>rd</sup> October 2025

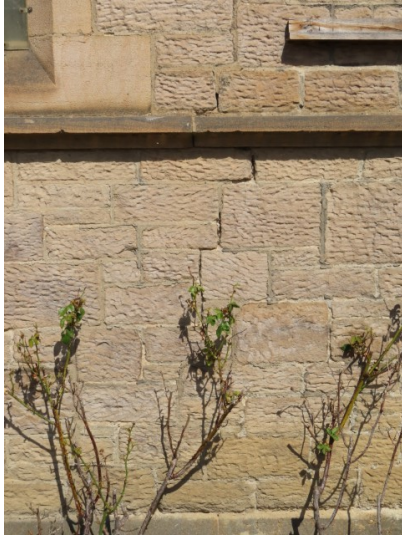
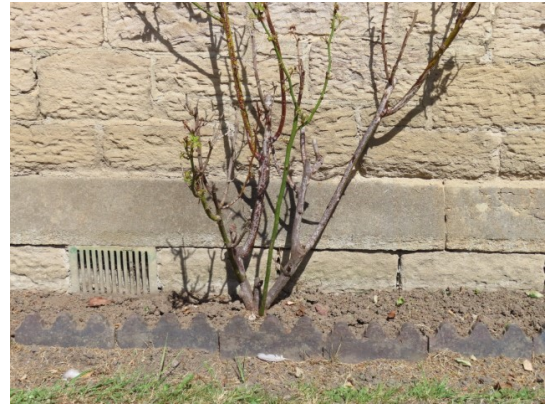
Cracking /open joints to the South Elevation and soil level close to vents

| Location | Description | Condition | Repair needs | Category |
|---|---|---|---|---|
| | | Isolated open joints were noted along this elevation, including near the main door, to the door head and window heads and string, with greater concentration at lower level, where weathering of stonework was also visible. As noted in the previous report, in some case where mortar has fallen the joint left exposed is fairly full of mortar. Some cracking was also noted to the right of the Western window with slight cracking near the second window from the West also. Both these areas would benefit from repointing and visually monitoring. One section of the string course has been repaired in the past with a mortar repair, which is fairly sound, although slightly cracked. | Remove areas of loose and failed pointing and repoint these areas, areas along with areas of open joints and cracks with lime mortar. Visually monitor areas of repointed cracking to assess whether there are ongoing issues with movement. | 3 |

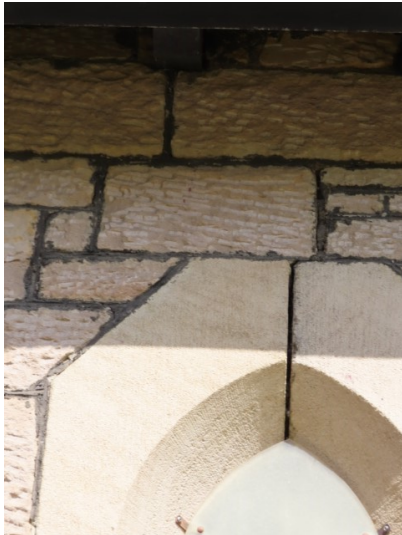
Open joint to Southern window head

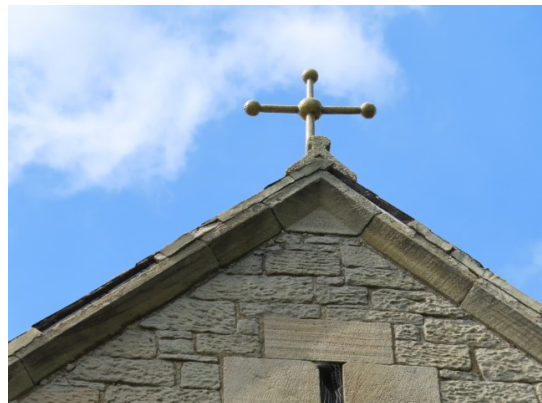
Loss of pointing to Eastern verge

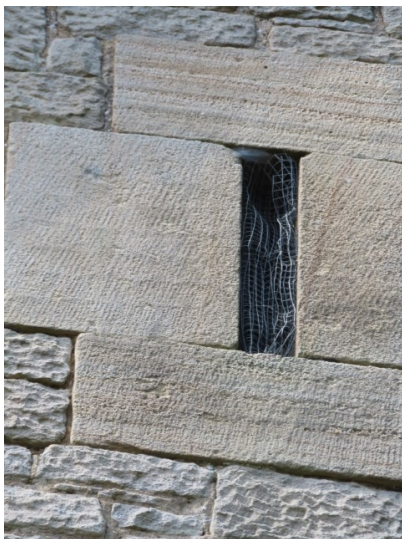
Damaged mesh to eastern slit

| 2. East Elevation | Semi coursed sandstone | <p>The branches of the tree near the East wall are very close to the wall and need to be trimmed back fairly urgently so they don't touch the wall (or indeed interfere with cables).</p> <p>Pointing to the verge is failing and requires repointing. The security of fixing to the cross should be checked at the same time as access is available to carry out verge repointing</p> <p>As noted previously, condition of pointing is similar to that noted on the South Elevation although probably less affected by temperature differences. A number of open joints were visible including to the string course and window surround, with a concentration of issues to stonework noted at high level near the peak/gable. There were also open joints to the projecting stonework of the gable.</p> <p>Very slight cracking is visible to the lower left-hand side of the window running diagonally down into the wall below.</p> <p>Mesh to the slit in the gable appears to be failing</p> | <p>Trim back branches of the tree that are getting close to the East wall</p> <p>Repoint verge and check and rectify any issues with the security of fixing of the cross.</p> <p>Repoint open and hungry joints, areas of failed mortar and cracking using lime mortar.</p> <p>Check and replace mesh to slit opening if required</p> | <p>2</p> <p>2</p> <p>3</p> <p>3</p> |

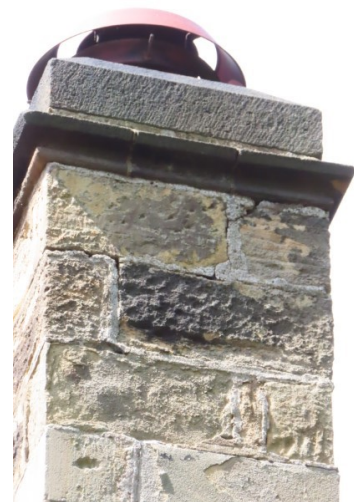
| Roofs including Fleche cont'd | | Cracking and looser sections of mortar were noted to the chimney especially at higher level. In common with other slopes there are a number of slipped and cracked slates. | | |

Cracking/open joints to chimney

| | | Vestry – isolated open joints to the ridge tiles and loss of mortar bedding. Mortar over the flashings to the chimney and abutment with the church walls is starting to fail in some locations. Debris has built up in places to the valley on the upper section of roof and this area should be checked generally due to possible dampness internally in this area. | Repoint any areas of sailed pointing over lead flashings<br><br>Repoint open joints to chimney using lime mortar | 2<br><br>3 |

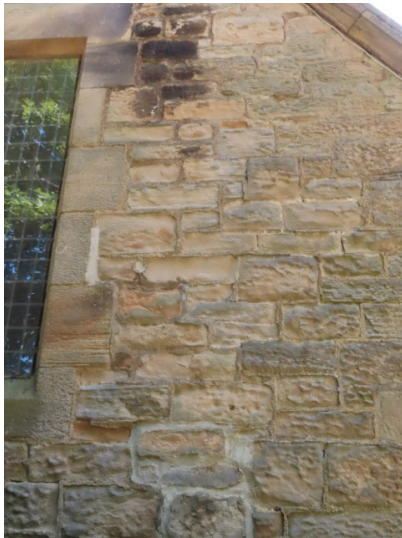
Weathered stone to Vestry

| | | | Repoint walls where required and replace severely damaged stonework using lime mortar | 3 |

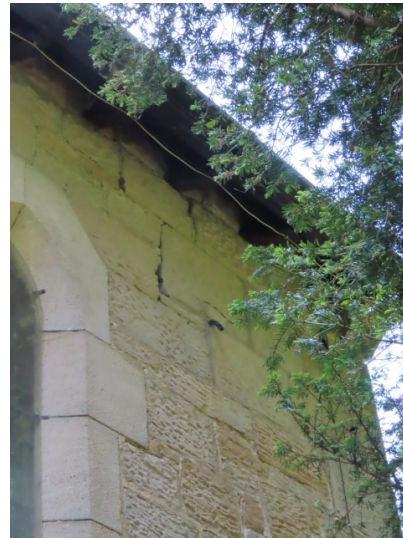
Yew tree branches close of North wall

| 6. North Elevation | Semi coursed sandstone | <p>A number of open joints are visible to the Eastern section of the wall which would benefit from repointing when other similar works are undertaken elsewhere. To the Western section of wall there are different generation of pointing visible, some of which is buttered over the face of the stonework and other areas are dark in colour. There are a number of open joints to this section of wall including at plinth level and to window heads and possible cracking to the Western end of the wall near the central and Western windows. The yew is growing close to the wall and roof near the end of this elevation and should be trimmed.</p> <p>Vents at low level would benefit from repainting.</p> | Trim back branches of the tree that are getting close to the East wall | 2 |

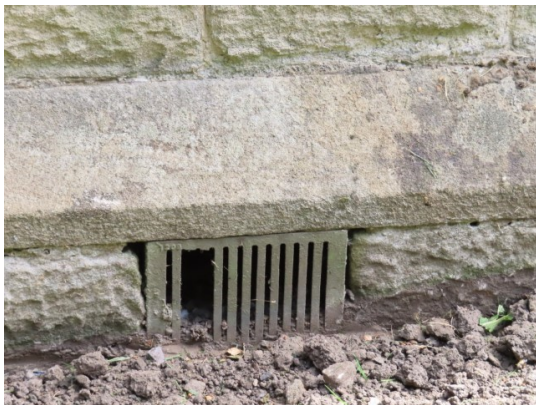
Damaged vent and high soil level

| | | | Replace vent to match existing elsewhere | 4 |

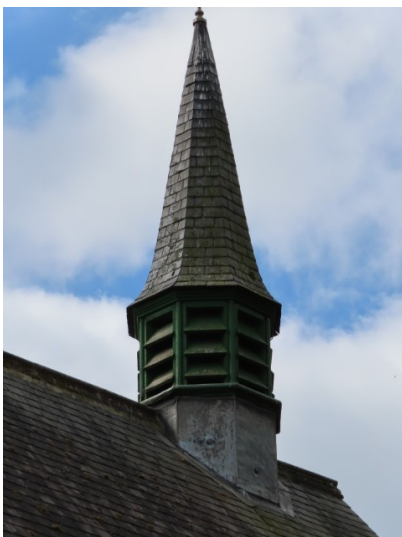
| 8. Roofs including Fleche | Welsh slate roofs with fleche comprising an octagonal timber louvred turret with a slated spire all sitting on a timber base. A lightning conductor runs down the west side of the fleche | Fleche – bird activity was noted during the survey and there appears to be no or inadequate mesh to the louvres. Some nesting material, possible a fairly significant build up is visible that needs to be cleared before the start of the next nesting season, and mesh or other protection added. If there is a bell, it may well soon (if not already) be difficult to operate. While access is made available for this, a closer inspection of the general condition is advised including of the timber, cross and lead. The paint finish has deteriorated exposing bare wood, and while general condition appears to be satisfactory, there are some areas of concern that need closer inspection. | Remove all nesting material before the next nesting season and provide additional protection to the louvres | 1 |

Nesting material and loss of paint finish to the fleche

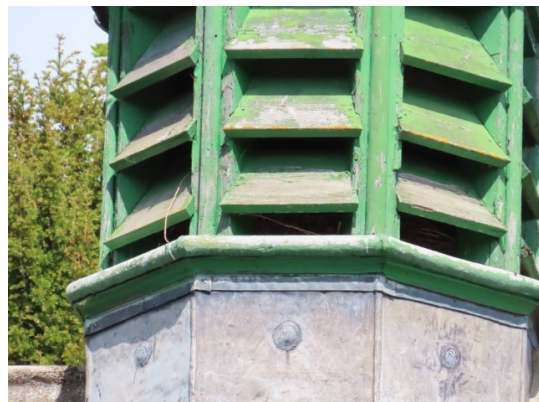
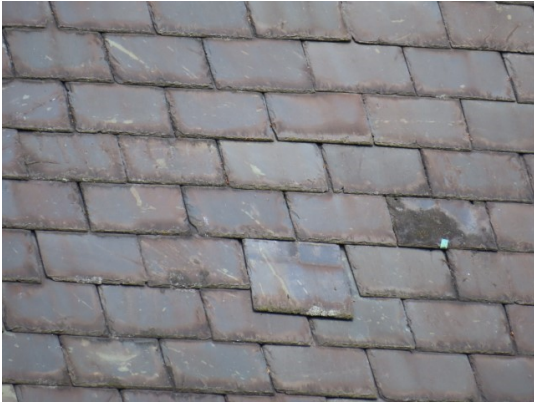
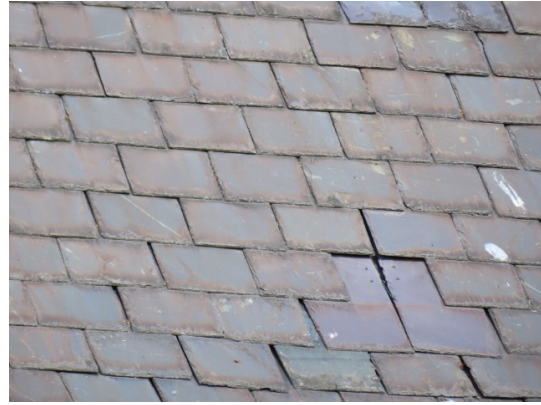
Slipped and missing slates to various roof slopes (above and below)

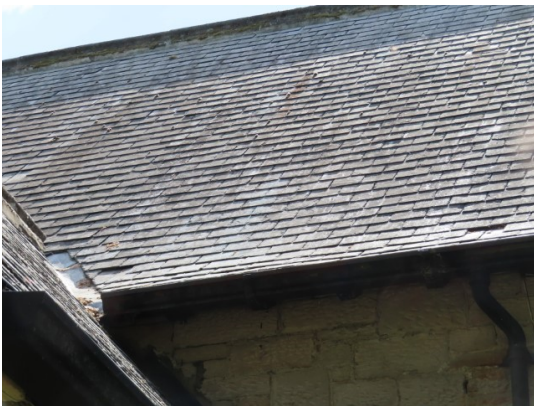
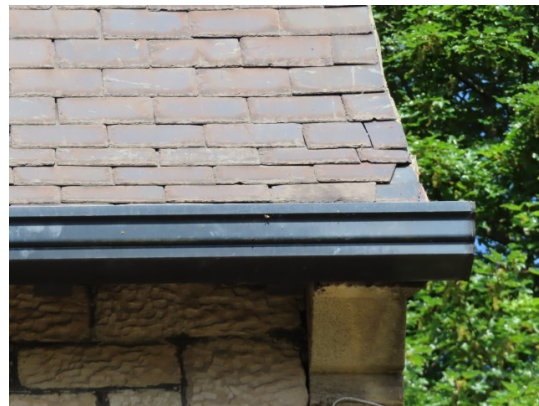
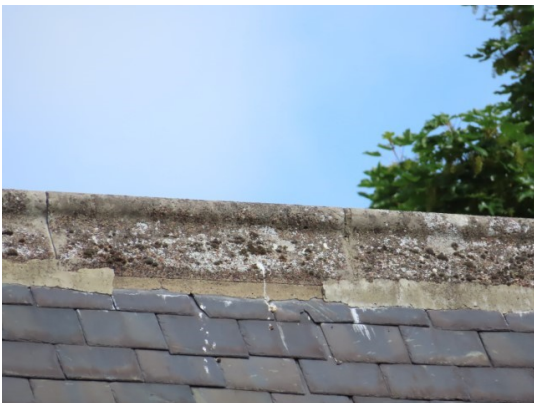
| | | South Slope of the Nave/Chancel – open joints are visible to the ridge with some cracking to the mortar bed. There are a number of slipped or missing slates along this roof slope and some further damaged slates.<br>South Slope of the Nave/Chancel – a number of raised, slipped to damaged slates are visible along this slope, including near the junction with the vestry roof. | Repoint open joints to ridge tiles and replace missing or faulty mortar bedding | 2 |

Failing mortar bedding to Southern Nave roof slope

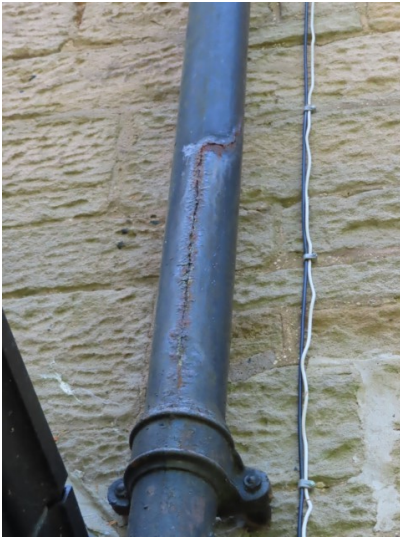
Damaged downpipe to North Elevation

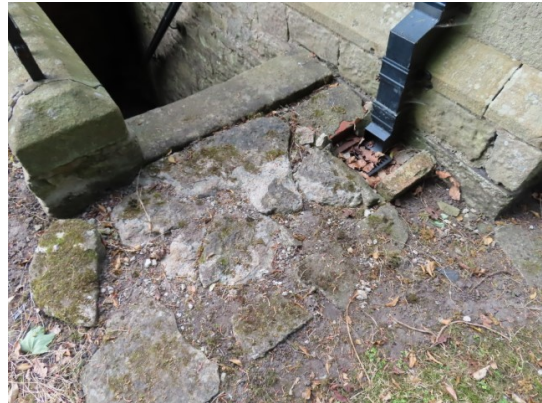
Uneven surface and leaves to Vestry gully

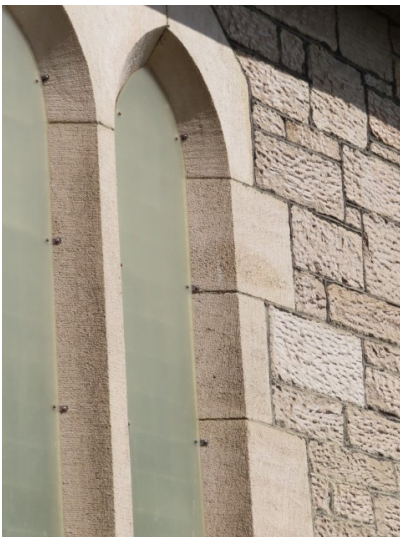
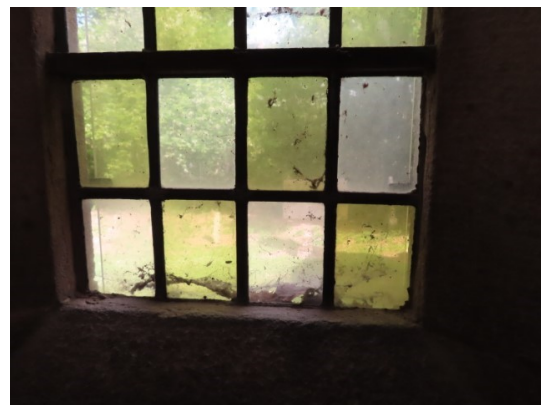
| 10. Windows | | <p>To all windows on both the Southern and Northern elevation there is noticeable build up of dirt, leaves and cobwebs between the glass and external protection which should be cleaned when the opportunity arises. Some of the external protection may need cleaning as well as some panes appears to have got fairly dirty. Advice from a specialist may be needed to understand how best to carry this out. A number of the saddlebars have been painted, but some rust is starting to show through in places.</p> <p>Nave windows North – the central and right hand window have vents that are assumed to be rusted closed. If they could be made operational these would be ideal for providing some ventilation into the main body of the church.</p> <p>Chancel window – North – cracking to one or two panes and possible bowing of glazing.</p> <p>Southern windows to nave – The right hand light of the eastern window to the right of the organ is slightly bowed/distorted. One pane/leading has been lost to the opening light, but this appears to be an old issue, with a similar issue noted to the Chancel window.</p> <p>Vestry window – the vent is rusted and fixed shut and saddlebars are also rusty. Leaf build up is visible between the external protection and window</p> | <p>Clean external protection and the gap between the windows and external protection where debris has built up. Specialist advice may be required before embarking on this task if it is not carried out by a glazing specialist</p> | 3 |

Yellowing protection to window (left) and cobwebs and debris to void between window and outer protection (right and below right)

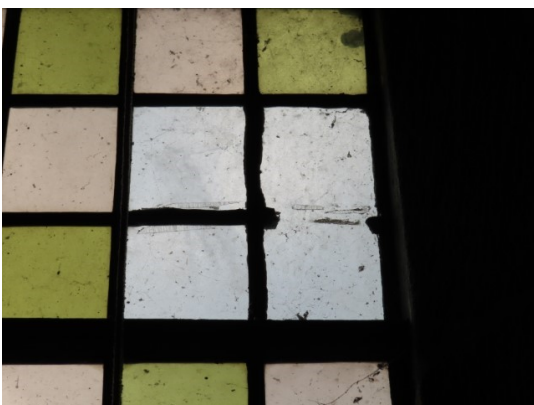
Loss of lead to window

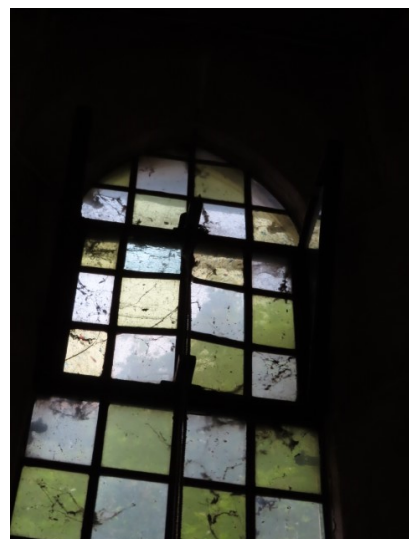
Bowed vent

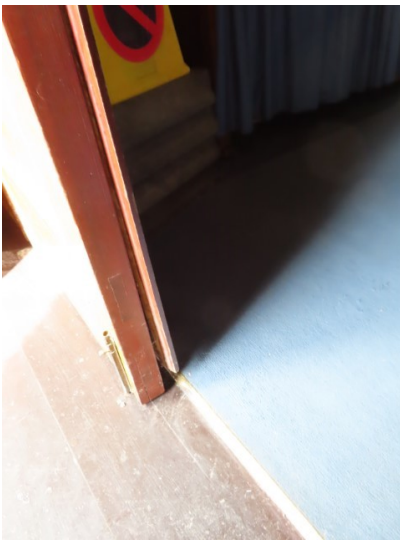
Loose cover strip to internal double doors

| Internal | | | | |
|---|---|---|---|---|
| 1. Internal porch | Timber internal porch. Timber walls on three sides and boarded ceiling. Timber floor with mat well. | <p>When only one leaf of the internal double doors is used/opened, the width of the useable opening is fairly narrow – this is obviously not a defect, but may impact ease of access for some if both doors are not opened as a matter of course. The cover strip to the fixed leaf was coming loose at the bottom, as was the brush seal/draughtproofing along the base of one of the doors, both of which require fixing. Slight gaps are visible between the skirting and boarded walls but generally sound.</p> <p>Some open joints are visible to the head of the stone arch and possible cracking. Finish to the main external door is starting to fail.</p> <p>Paint at higher level is crazing and may need attention when the church is next redecorated.</p> | Carry out repairs to the draft proofing strip and cover strip to the internal doors | 1 |

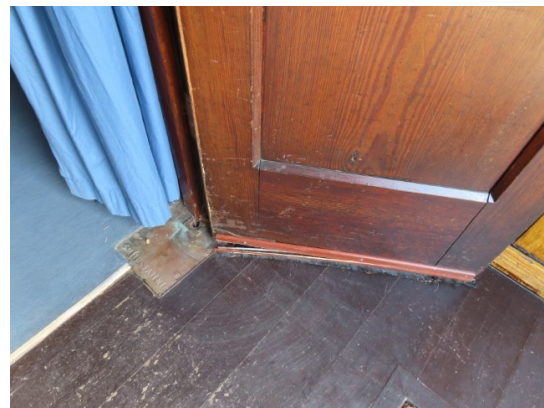
Loose draft proofing strip to the same doors

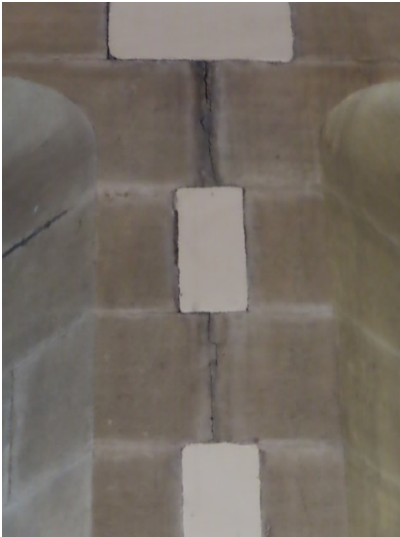
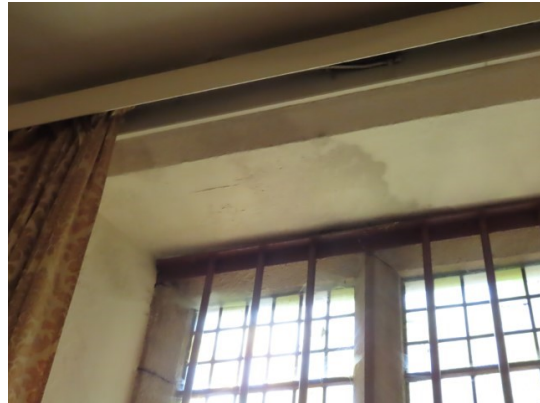
Cracking to stonework to Western window    Damp staining over the vestry window

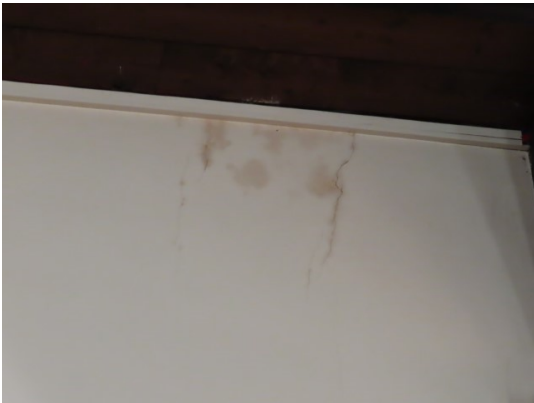
| | | North Wall – evidence of water staining and slight cracking is visible at higher level over the vestry door. There are open joints/hairline cracking visible to both windows mainly at window head level. Slight opening up is visible between the plaster and quoins to the openings and the plaster finish is slightly rough in some locations including towards the Eastern end of the wall, but generally appears sound. | Repoint open joints to the steps and floor using lime mortar | 4 |

Damp staining on North wall by Vestry

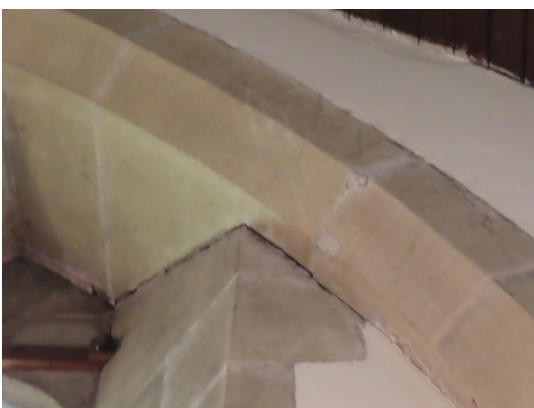
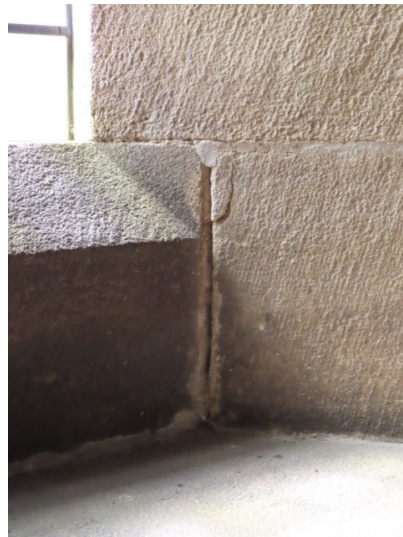
Cracking within window reveal

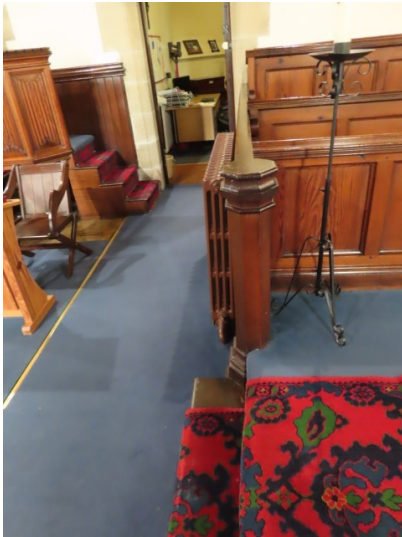
Although the Nave is now fully accessible, the two steps up to the altar remain and it would be worth exploring options to improve access to the Chancel for those with more limited mobility. A ramp might not be practical (or potentially desirable), but a handrail might assist some people.

Steps up to Chancel (no handrail)

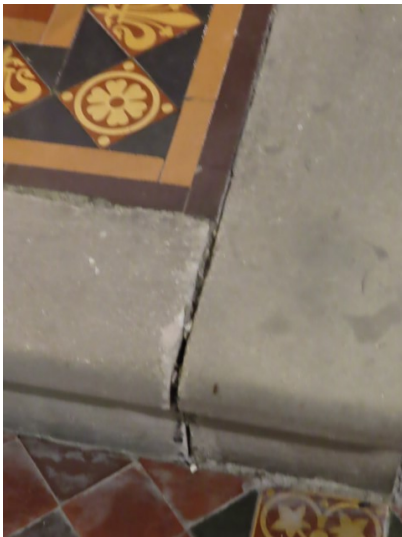
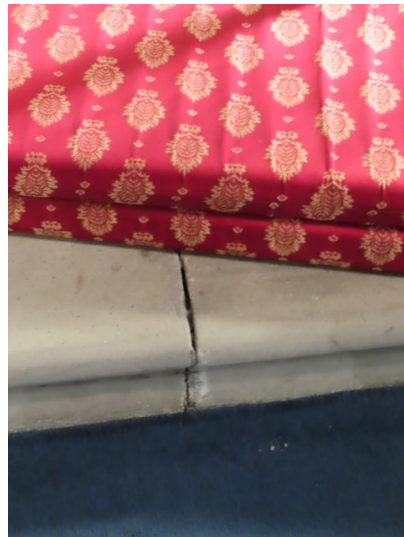
Open joints to altar dais (left) and Chancel step (right)

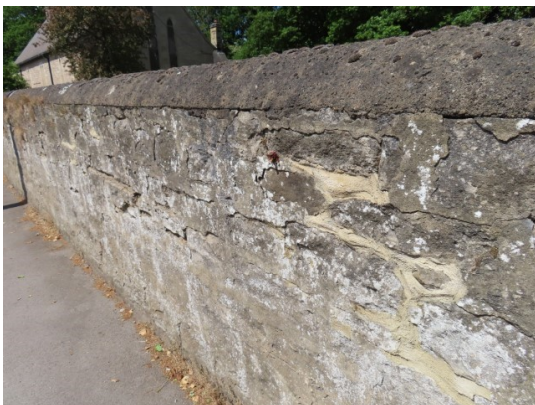
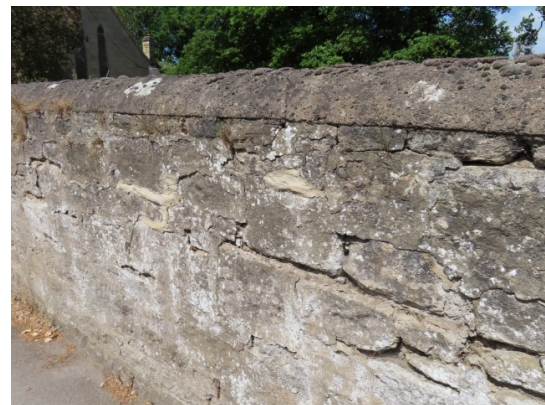
External views of the Southern boundary showing minimal previous repairs

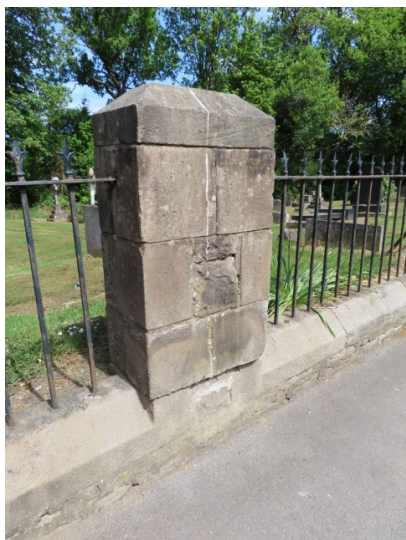
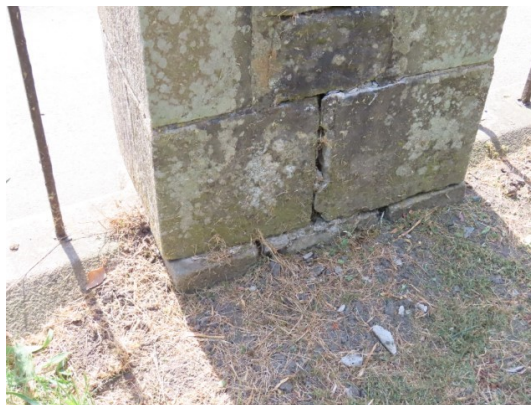
Damaged pier to Eastern side of Southern boundary

| External areas including graveyard | | | | |
|---|---|---|---|---|
| Churchyard | The churchyard is closed and Durham County Council is understood to be responsible for all maintenance. The condition of areas of immediate concern are noted here for the PCC to discuss further with Durham CC | The noticeboard has been replaced since the last inspection and looks very smart. Some rust is showing to the metal at the base. | Carry out repairs to the one damaged pier and impacted railings | 2 |

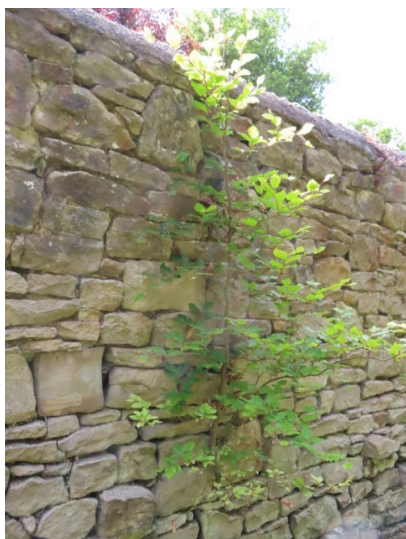
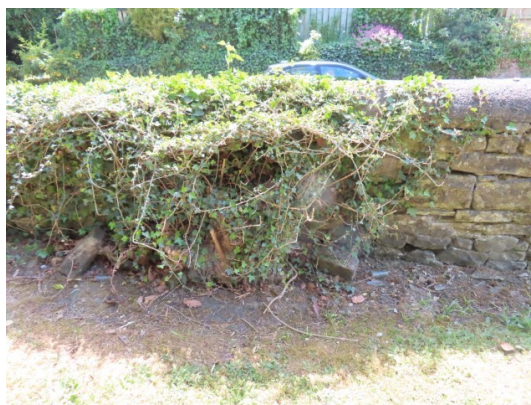
Vegetation growth to internal side of the Southern boundary (above and below)

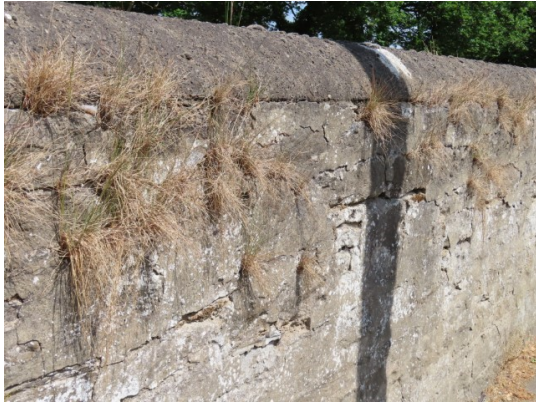
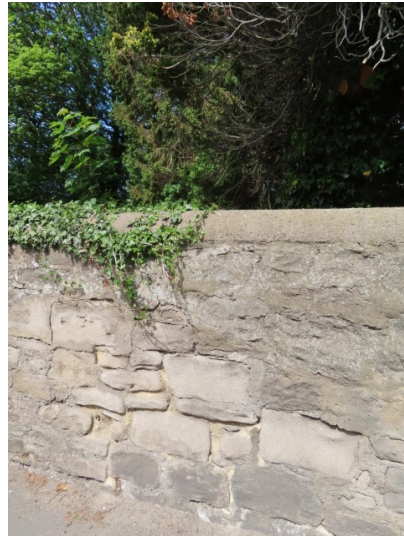
Grass and ivy growth to external face of the Southern boundary
