HARLOW GREEN St NINIAN
(296)

QUINQUENNIAL REPORT
on the architect's inspection on

21 June 2017

IAN NESS
ARCHITECT
26 GROSVENOR PLACE NEWCASTLE upon TYNE NE2 2RE
tel & fax
0191 281 2559

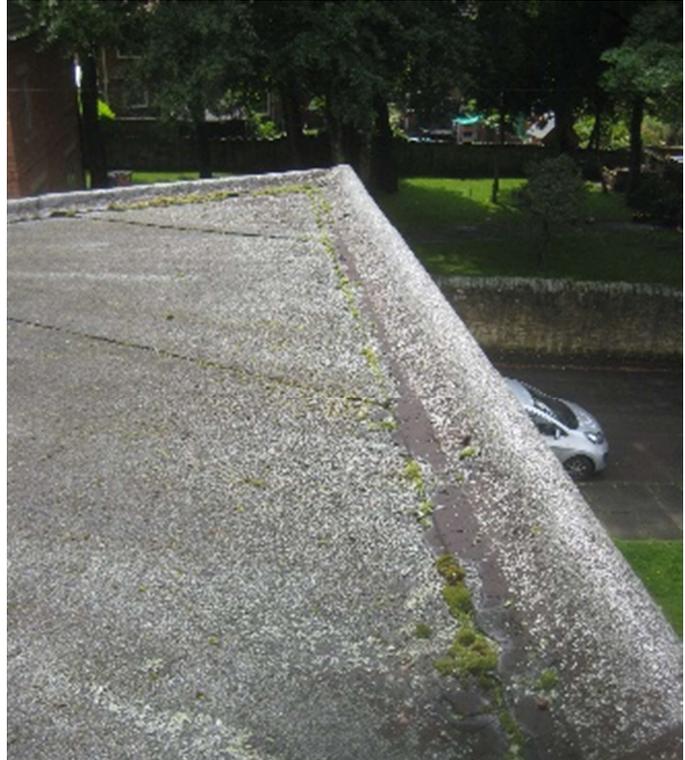
Lantern roof

11. **Lantern** felt aged but appears sound, well laid to good fall to integral gutter and outlet at NE with a wire cage. Moss at some joints may mean they are opening.

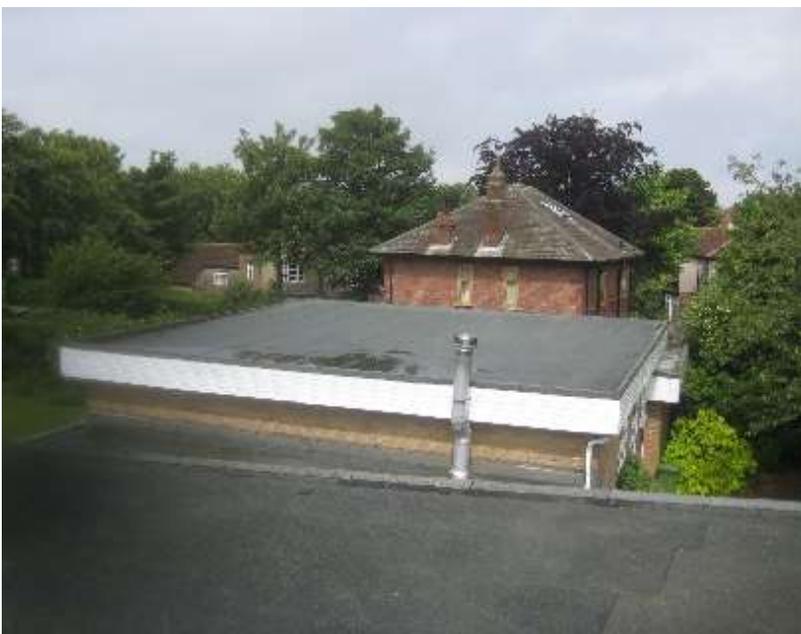
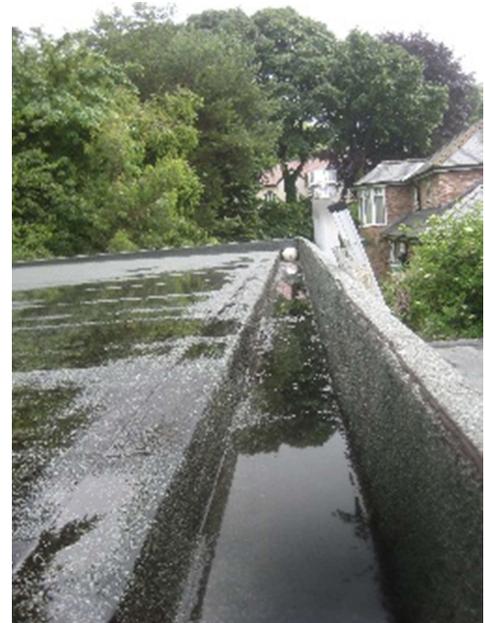
Hall roof

13. The **Hall** roof is structurally flat with slight fall to a deep box gutter and deep external fascia. Well refelted in 2003 and seems sound though slightly ponded. Some silt in the gutter which has very little fall to a single end outlet. Part cleaned at inspection.

Clean roof gutters and outlets every six months	13, 15, 17
Repaint nosings and handrails at external landing and steps	64, 68

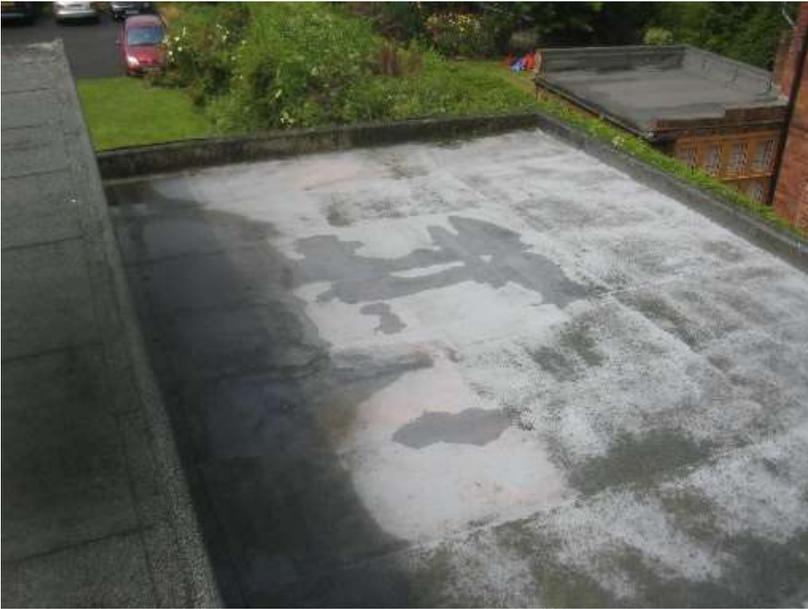
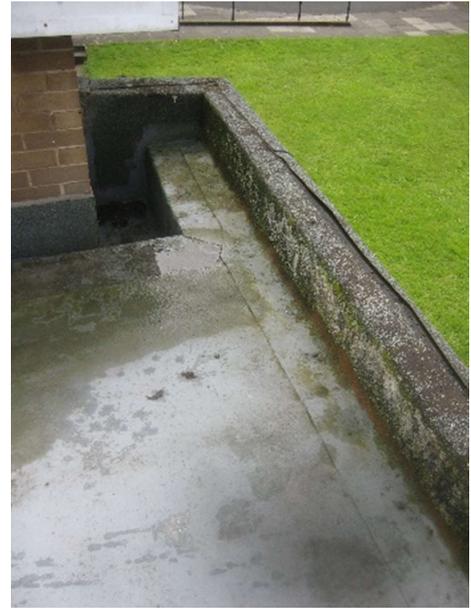
14. The older **Kitchen and Store** roofs have well laid felt neatly patched over the former rooflight and painted over with a sealant which may protect against leaks at its ponded bottom edge. Slight peeling of the felt over the W side fascia.

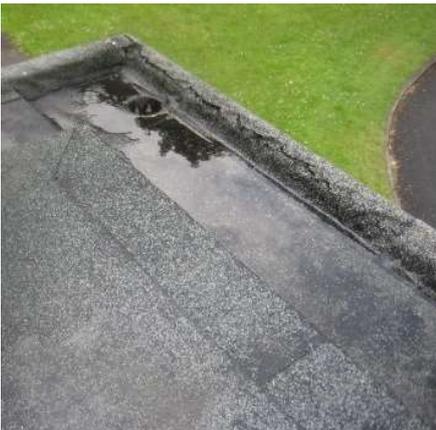
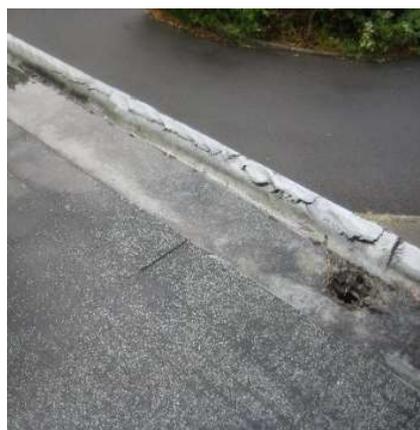
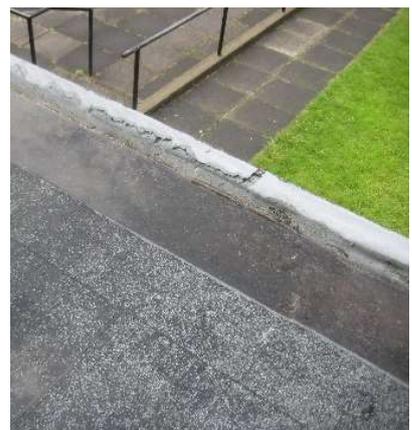
15. Its deep box gutter against the Hall wall has shallow fall and turns a corner to a small single end outlet so gets choked and needs regular clearance. Plants removed at the inspection.

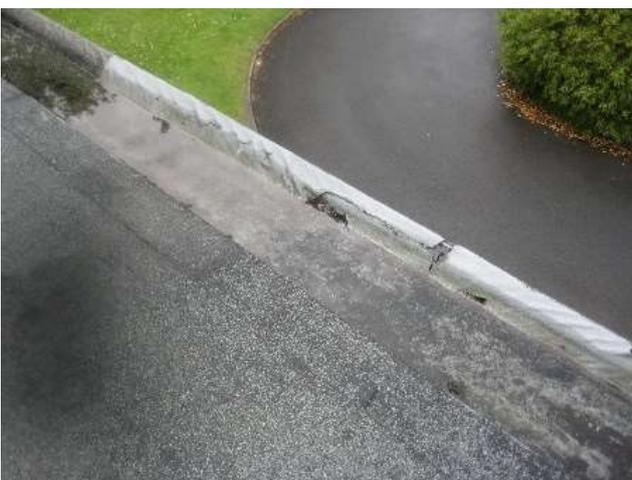
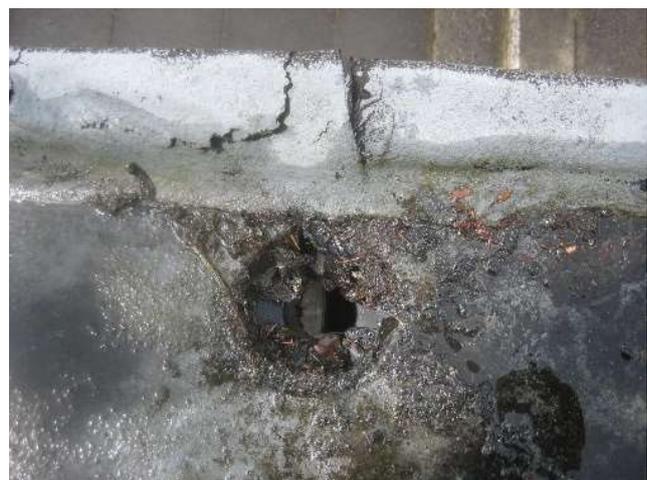
16. The **Vestibule, Vestry, wc and Boiler** link seems sound though increasing splits at parts of the edge upstand at the W gutter, part now with sealant painted over and split again. The time comes for this roof to be refelted. At refelting insulation added over the present felt would reduce fuel cost (except at gutters which need to be stripped to timbers and the outlets reformed).

17. Two bottom outlets each side. One blocked E outlet cleared at inspection.

Refelt the low link roof with added insulation	8, 16
Repaint or replace Hall external doors and frame	26
Lag the heating pipes in Boiler room, meter cupboard and former kitchen	53
Renew downlight fittings and lamps in Church	56
Refurbish sign by road	69
