Diocese of Durham

HARLOW GREEN St NINIAN
(296)

QUINQUENNIAL REPORT
on the architect's inspection on

4 November 2022

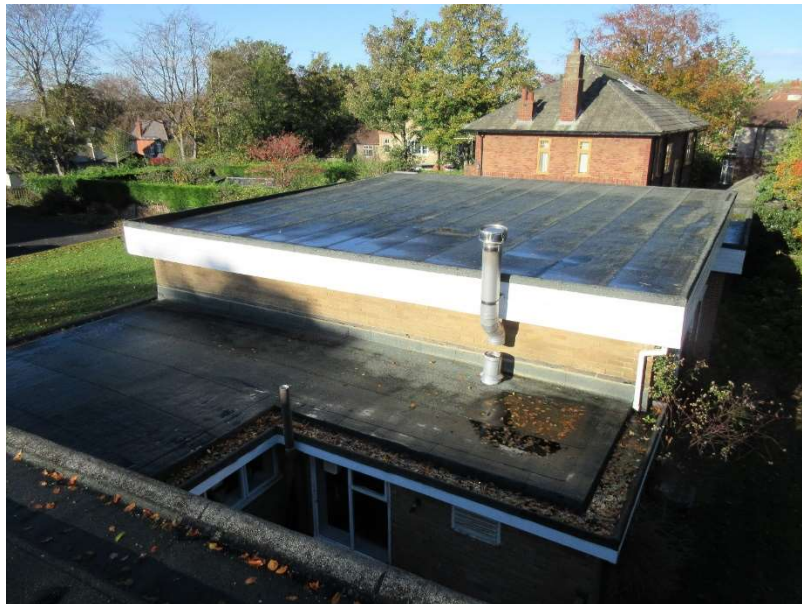
10. **Nave and Lantern** refelted 1990.

Ivy at S wall again close to the roof might begin to damage the felt unless cut back.

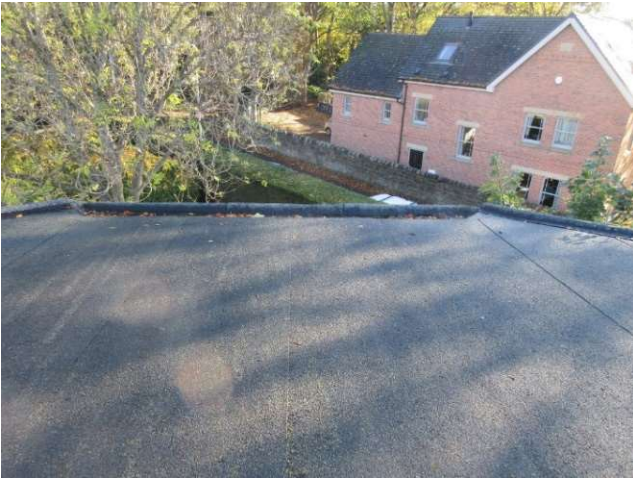
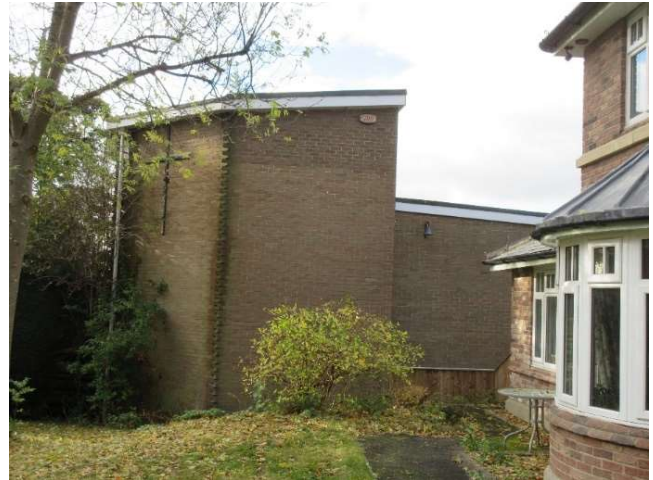
Lantern roof from above and from the Bishop's house showing overflows and bell facing the Bishop's house

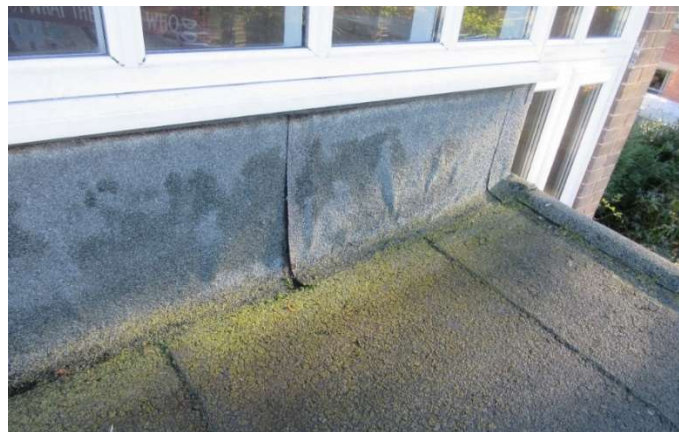
12. **Nave** a square slightly cambered and tilted up on the diagonal from entrance corner to Lantern, where the upstand under the Lantern windows was refelted in the window replacement work. Some joints in that felt are part open but may not leak.

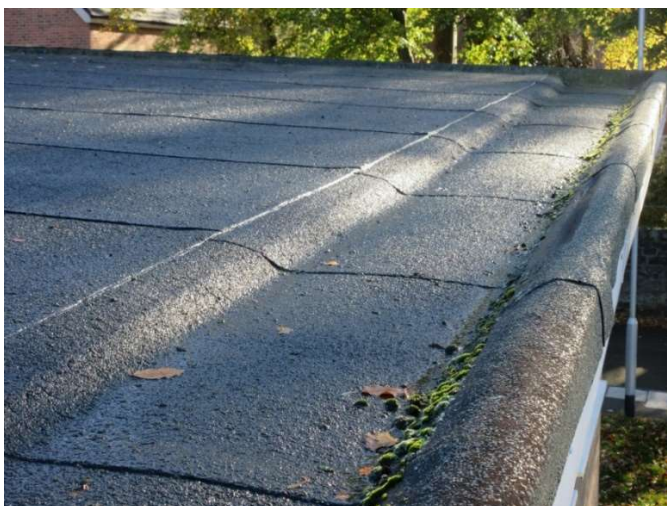
13. Integral gutters on two sides of the Nave concentrate all water at the bottom corner where a single outlet cut through the felt drops by short pipe onto the link roof. There must be strong flow in heavy rain. Parts of the Nave edge upstand and outlet have been patched. Sound overall but part of the S side upstand is loose.

Nave integral gutters

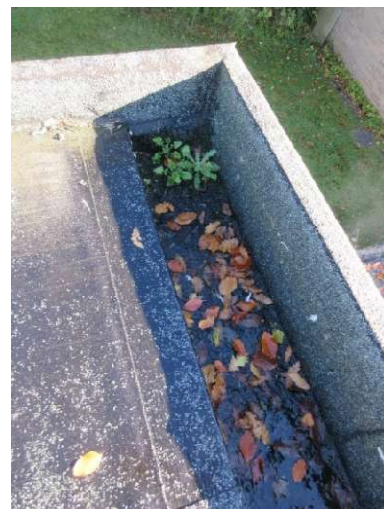
Hall roof – plant in gutter outlet

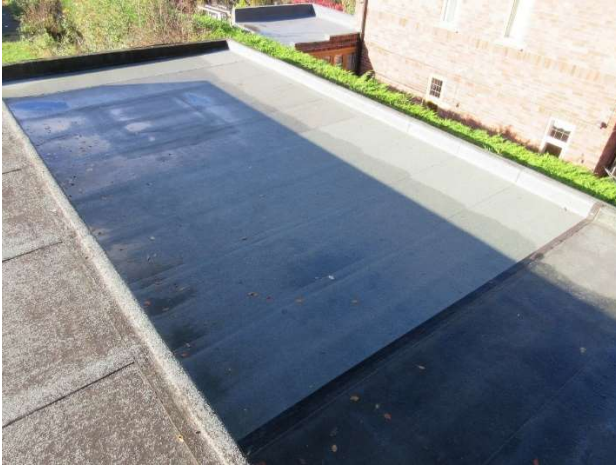
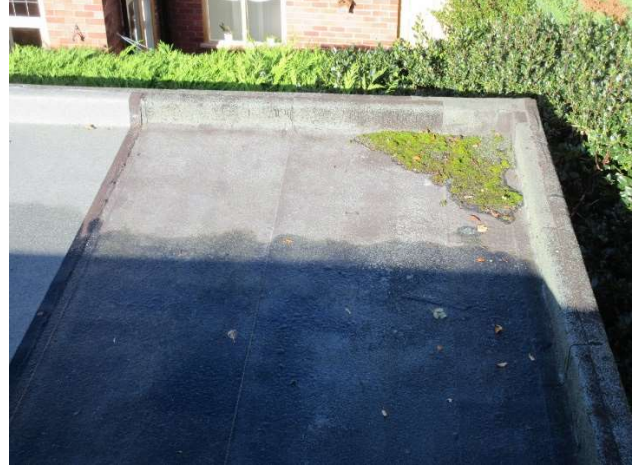
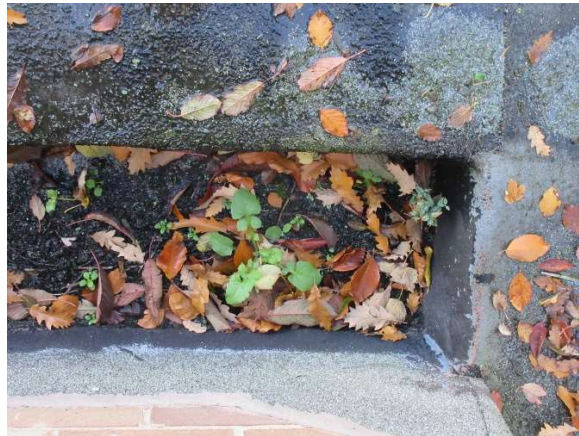
14. The **Hall** roof is structurally flat with slight fall to a deep box gutter and deep external fascia. Well refelted in 2003 and seems sound though slightly ponded. A recent patch at one top corner. Ponded silt in the gutter which has very little fall to a single end outlet.
15. The added **Kitchen and Store** roofs have felt at low pitch. Since the last report about a third at W has been refelted, leaving older felt at E and a slightly ridged previous patch over the former Kitchen rooflight. Still slight peeling of the felt over the W side fascia.

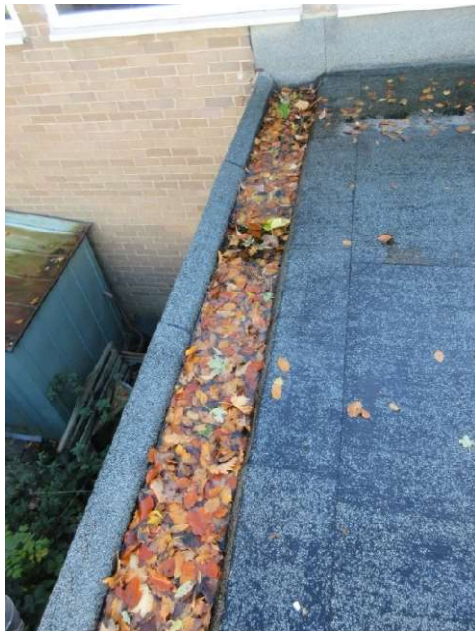
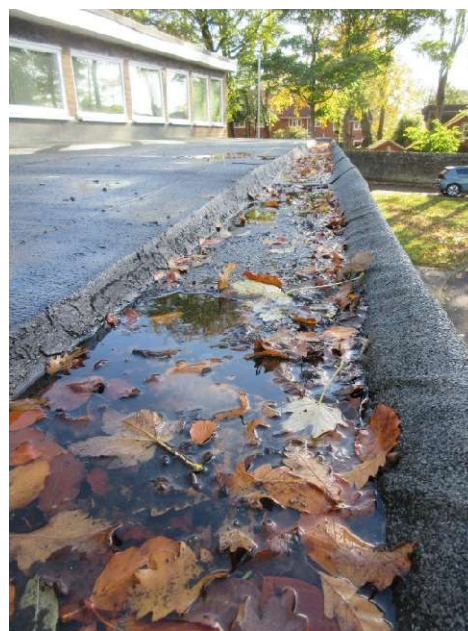
16. Its deep box gutter against the Hall wall is not seen. It has shallow fall and turns a corner to a small single W end outlet so is easily choked by leaves and silt needing regular clearance. Choked again at inspection.
17. The **Vestibule, Vestry, wc and Boiler** link seems sound after patching of the edge upstand at the W gutter. Two bottom outlets each side. All gutters need clearance.

18. Further patching of these generally old roofs is unlikely to be good value for money. As need arises full replacement roof by roof would be recommended, incorporating good insulation to form 'warm roofs'. Either refelting or change to a longer lasting membrane such as Sarnafil on thick insulation added over the present felt (except at overhanging gutters which need to be stripped to timbers and the outlets reformed) would reduce fuel cost and greenhouse gases.

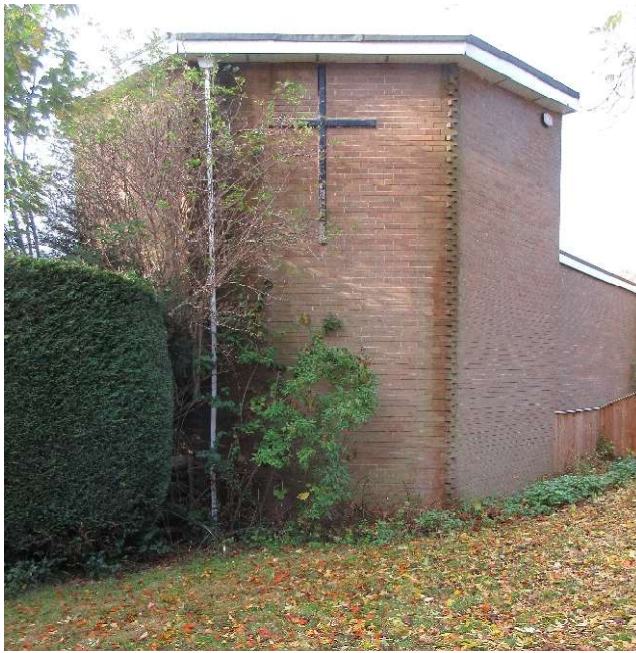
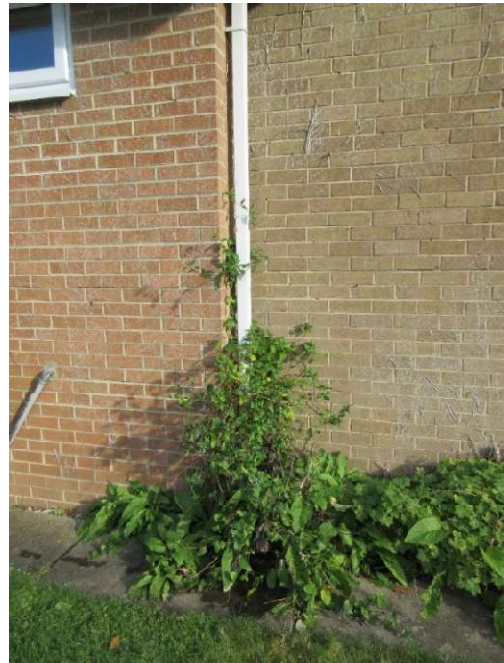
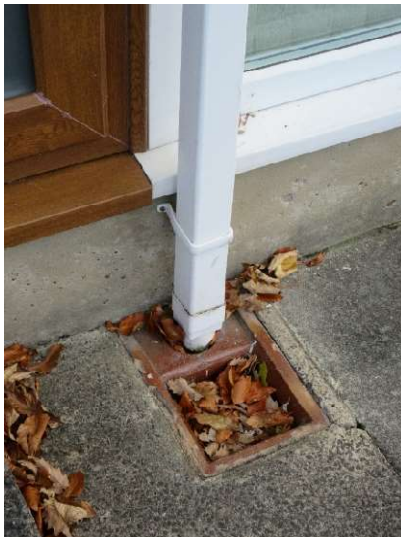
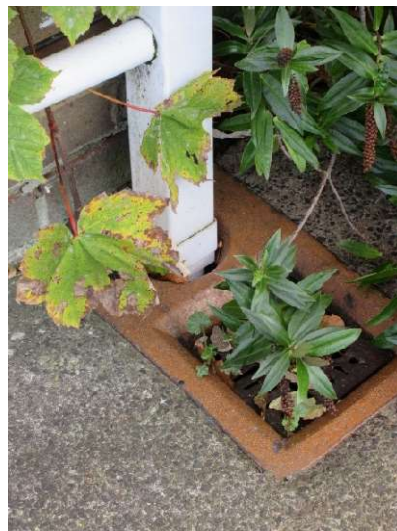
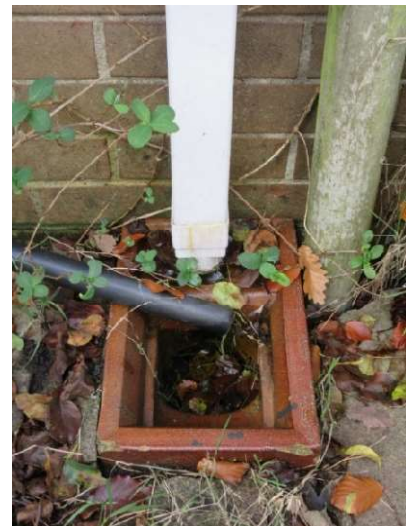
19. The felt gutters drain by white plastic pipes to gullies and drains which seem in good order but most gullies need clearance. The Hall and Lantern gullies are too overgrown to see.
20. The pipe from the Lantern falls in the Bishop's garden. There is water all down the Lantern brickwork suggesting the pipe or gully or both are blocked and overflowing or the pipe has come loose at the top. To investigate and clear or repair and to clean the integral gutter a handyman with long ladder must get access in the Bishop's garden.

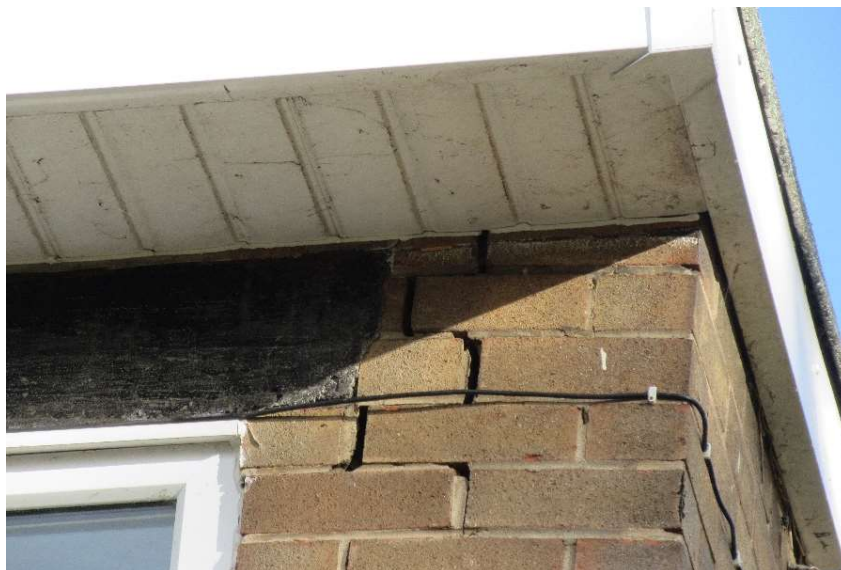
22. At the Nave NE and SW corners minor cracking at the ends of continuous concrete window lintels under the roof suggests original shrinkage without significance. Old tell tales at the NE corner no longer visible due to shrub size. The shrinkage can be seen at SW where it opened several brick joints. No action needed.

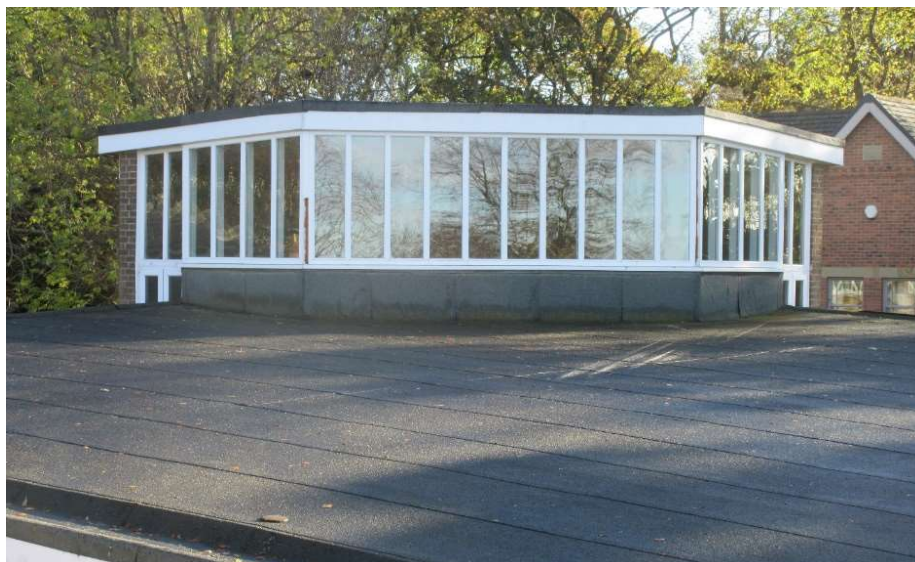
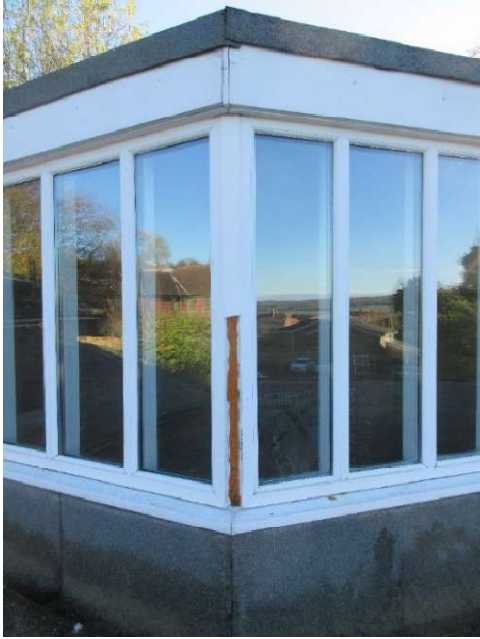
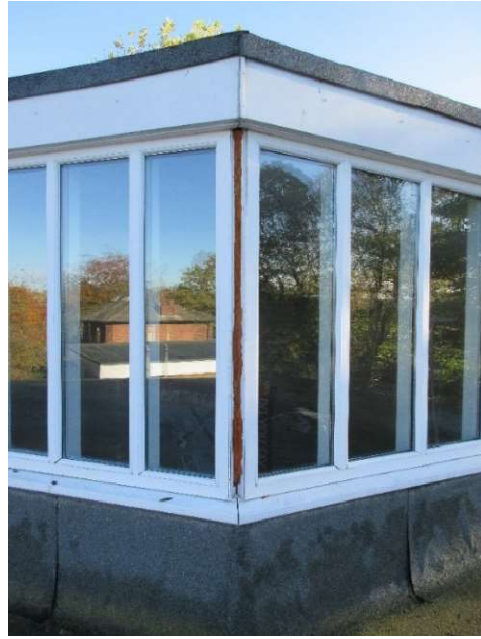
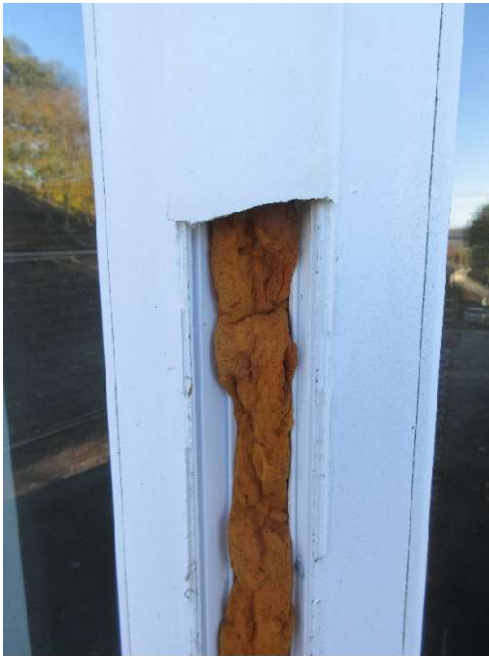
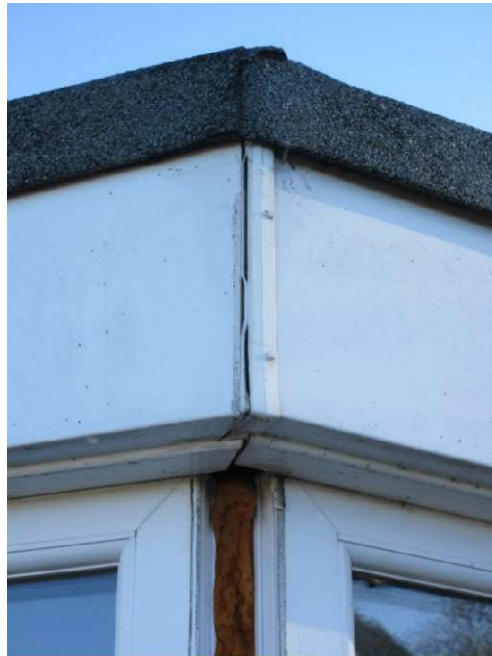
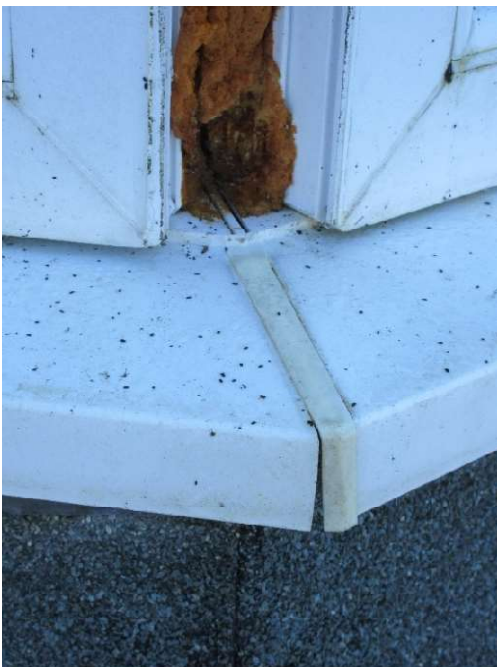
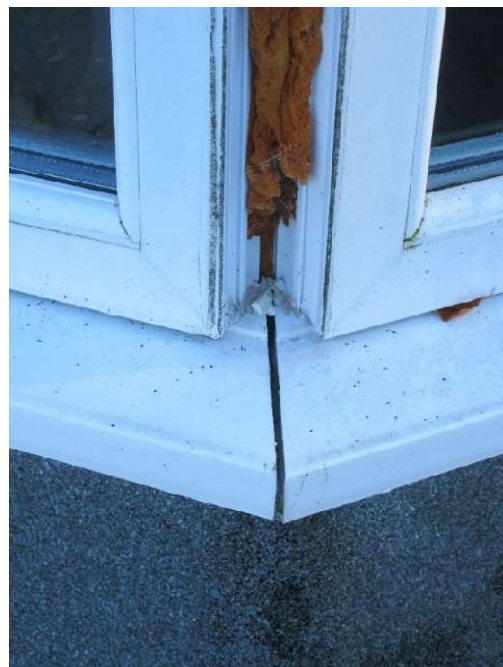
27. Entrance screen and most windows double glazed upvc appearing sound. White plastic fascias with vented soffits at all roofs.
28. The recent double glazed ribbon **Lantern** windows appear sound but the external connections at both 45° corners have failed. Slight shrinkage has pulled open the sealants above and the cover strips between the windows and the cover strips over their cills. Loss of the cover strips between the windows exposes expanded foam which may keep the weather out at present but it is not durable so new cover strips must be fitted. If repeated seasonal expansion and contraction of the long ribbon windows is expected the cover strips must accommodate that movement.

Remake cover strips at corners of the Lantern ribbon window	28
Clean and seal bottom corners of all Lantern glazing beads	29
Repaint the Boiler room louvres	30
Remove redundant and disconnected flue above Boiler room roof (with or without reroofing of whole Link)	56
Restain the fence at the garden recess and the Hall garden doors	75

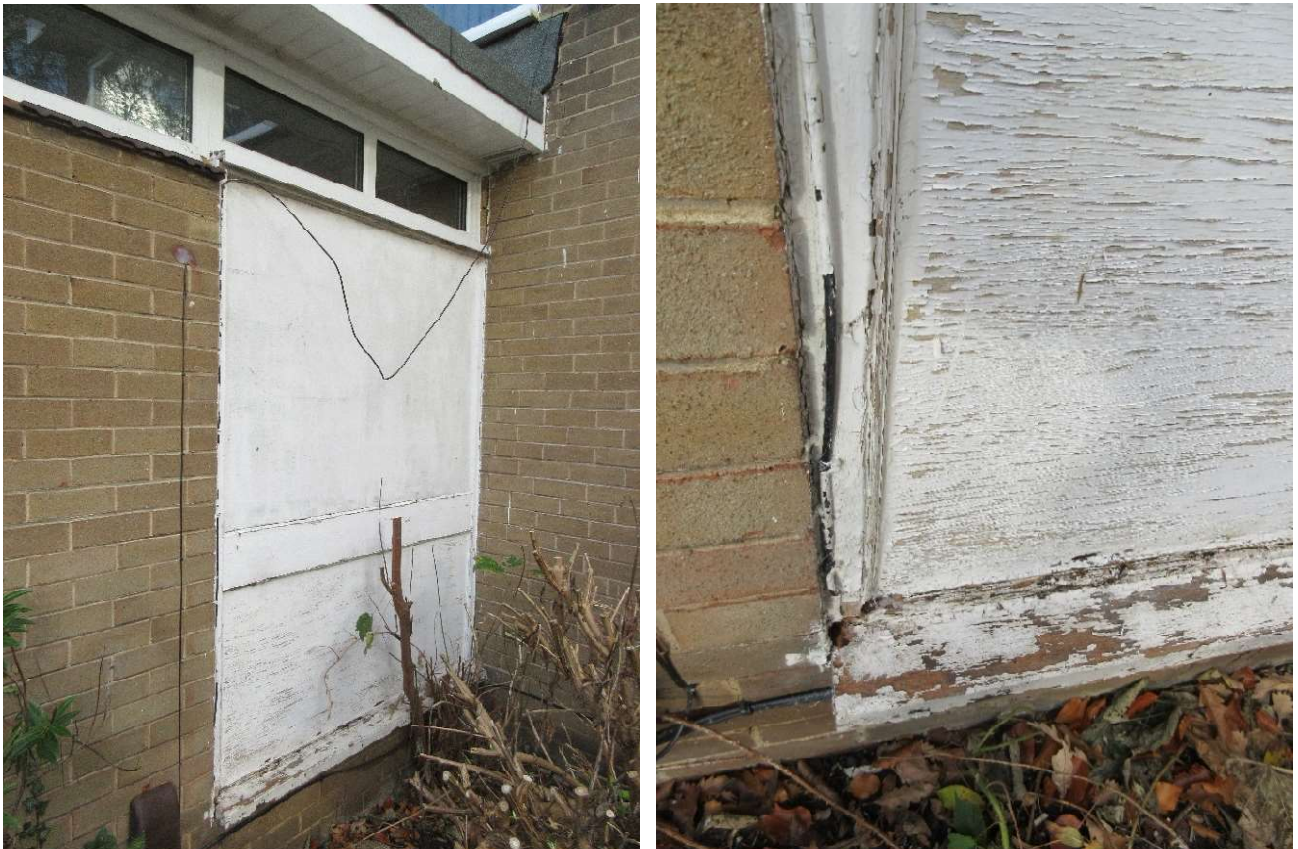
30. The former kitchen and wc windows remain painted timber, single glazed in fair condition.
Paint or stain poor at
- the Hall timber garden doors
- the boiler house louvres and
- especially at a large infill panel at the S end of the Vestry where some decay may need repair before painting. Alternatively the panel may be better replaced in durable material such as upvc.

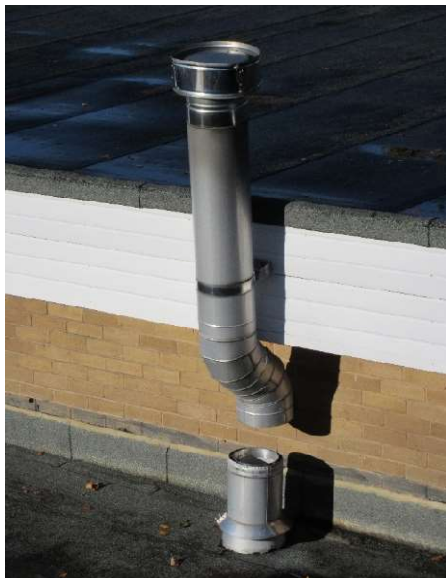
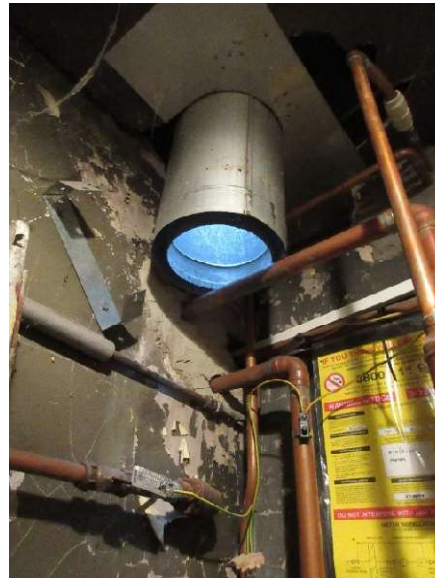
disused flue

outside and inside

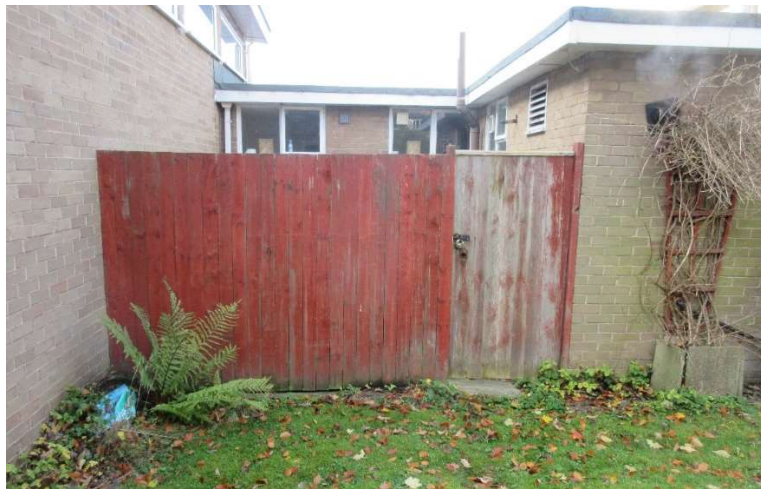
74. The grounds are open to Ivy Lane and enclosed by fences and mature trees in the adjoining gardens. The site is grassed with small planting beds at the building and a small oak. At the enclosed E side a seat and garden has been laid out with tarmac path now blocked by the Bishop's garden fence.
75. The fence enclosing the recess at the wcs is sound but would be better restrained for appearance from the garden.

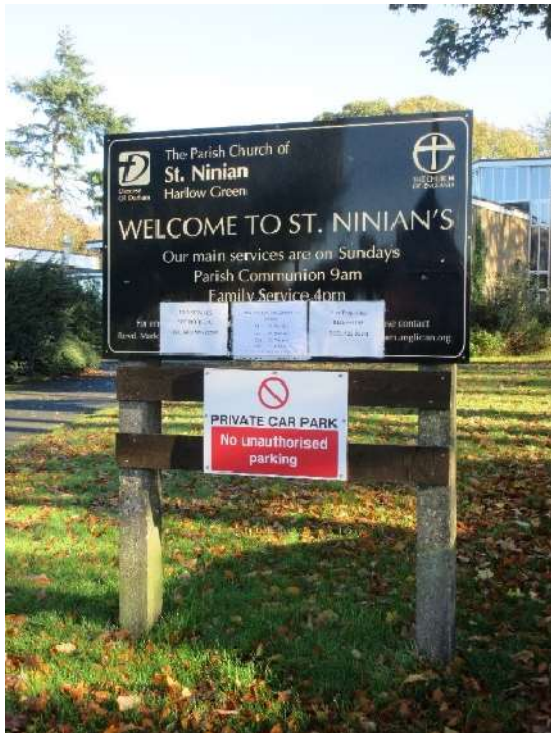
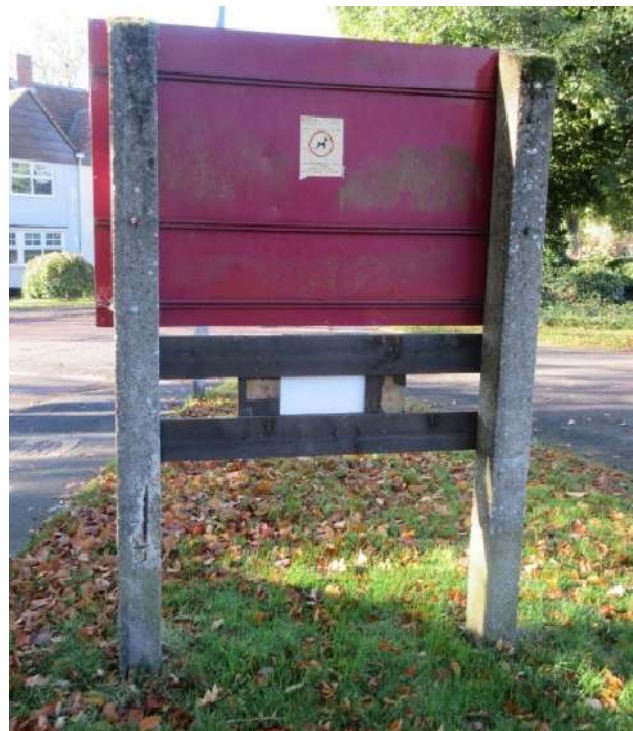
76. A sound flagged path and ramp lead to the door from a large car park which has a single road gully in one corner. Painted galvanised handrails.
77. A good painted aluminium sign.
At concrete posts some spalling exposing steel reinforcement. Special repair mortar could prolong life.

Repair concrete post at sign	77
------------------------------	----
