**QUINQUENNIAL INSPECTION REPORT
OF
HART, ST. MARY MAGDELENE**

**DIOCESE OF DURHAM
ARCHDEACONRY OF DURHAM
DEANERY OF HARTLEPOOL**

QUINQUENNIAL INSPECTION AND REPORT

June 2021

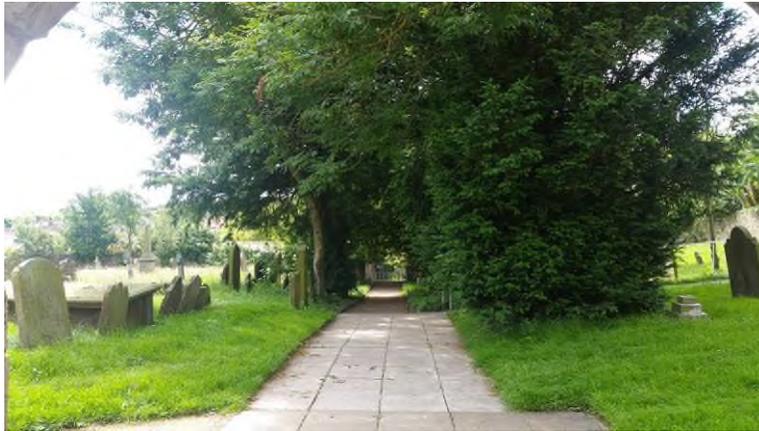
C Trees:

The trees were last inspected in 2013/14. In 2018 work was done to tidy up following a visual inspection. The ash by the bottom of the entrance path to the S W of the site is rather full and is being kept under review. The W tree by the tower is now scraping the parapet and needs cutting back.

Recommendation: cut back W tree

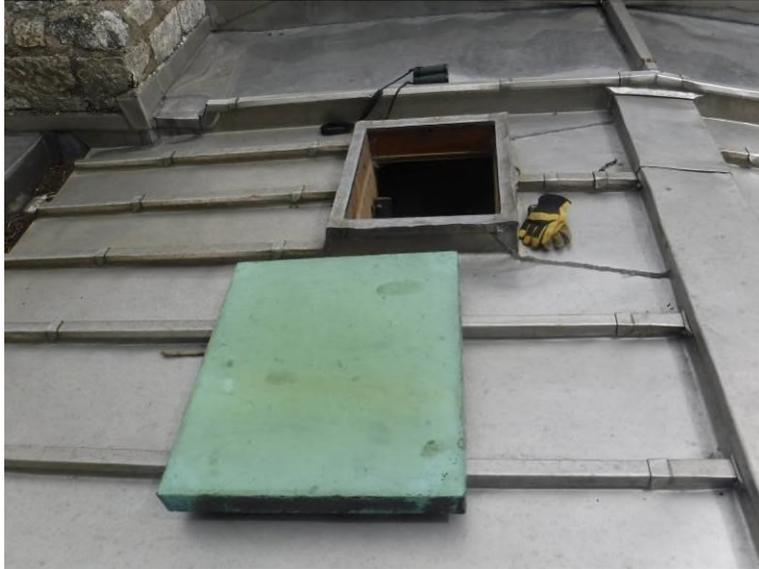
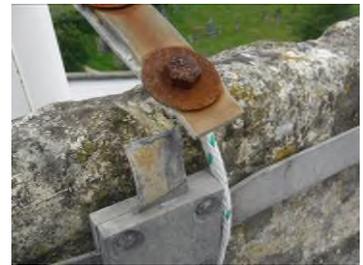
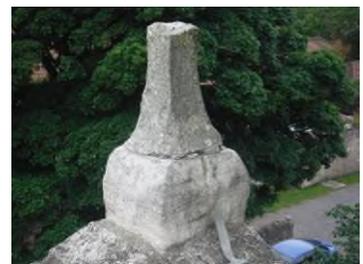
B Tower Roof:

Terne coated stainless steel showing some slight oxidation but satisfactory, the parapet gutters at the high points have got a collection of tree twigs and leaves. The hatch is copper, it catches the trimmed opening edges and is rather hard to use.

There is a couple of areas where the solder dots covering fixings has come away but no repair needed yet.

The flagpole looks a little worn at the fixing point, not wobbling. The lightning conductor is broken there and also the spikes are missing from the two W most pinnacles.

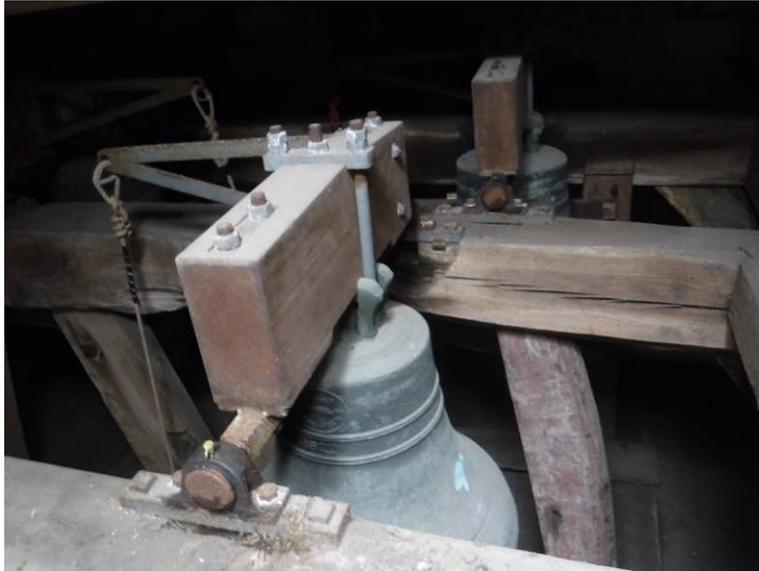
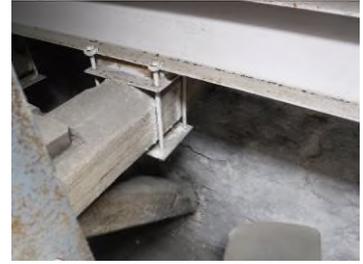
- **Belfry:**

This contains the oak frame with some signs of woodworm which is probably historical now, that is supported off two steel beams that are running E to W, they look secure. The bells themselves look alright.

The tower has a new roof with a principal beam running N and S, it is all in good condition there doesn't seem to be any leaks. The walls are lime washed and appear sound as does the floor. There are two openings with mesh on them and the mesh is a bit rusty and the louvres could probably do with some paint next time there is some scaffolding up.

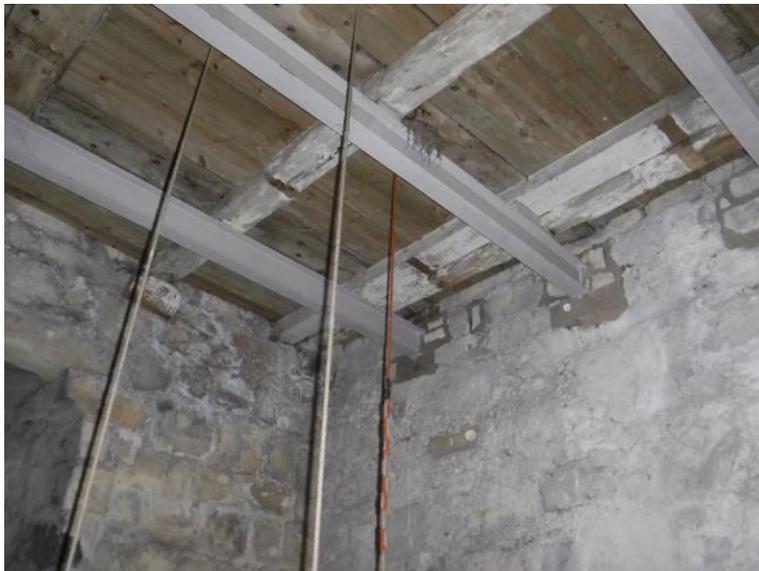
E Deafening Chamber:

The ceiling is supported by modern steel beams and that looks satisfactory. The walls are pointed some with cement, bit of shailing but looks generally sound, the floor has insulation on top

of boarding so it can't be inspected. The roof hatch is a little awkward to pull closed.

Recommendation: improve hatch operation

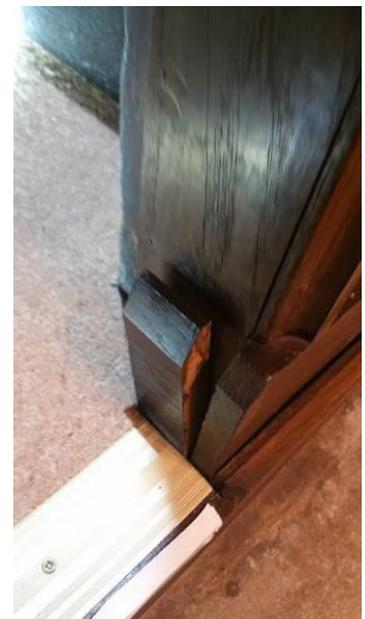
- **East side** – former flagpole holder looks rusty and a bit of shaling on the lancet belfry window.

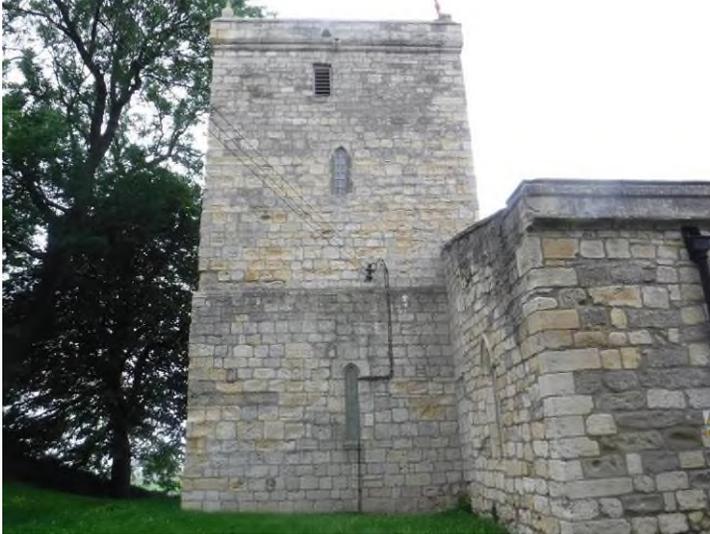
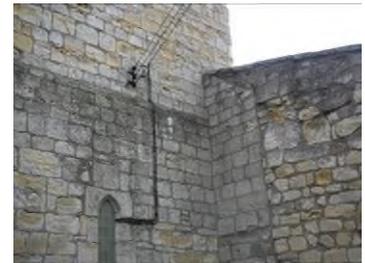
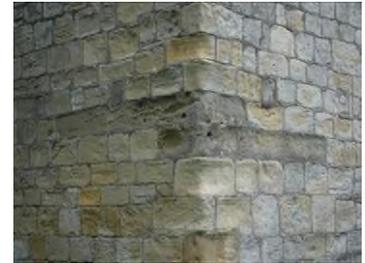
M **South side**

All the walling looks ok, there is some wear just on one stone on the bottom stage on the corner, no apparent movement. The louvre oak frame could do with painting, as could the window frame below it when there is next scaffolding. Beneath that the electrical supply comes in and below that is the ground floor window which has polycarbonate screw fixings that are rusting a bit, there is also a datum point this looks to be where there is an earth cable coming down. The tower is two stages.

Recommendation: decorate louvres and window

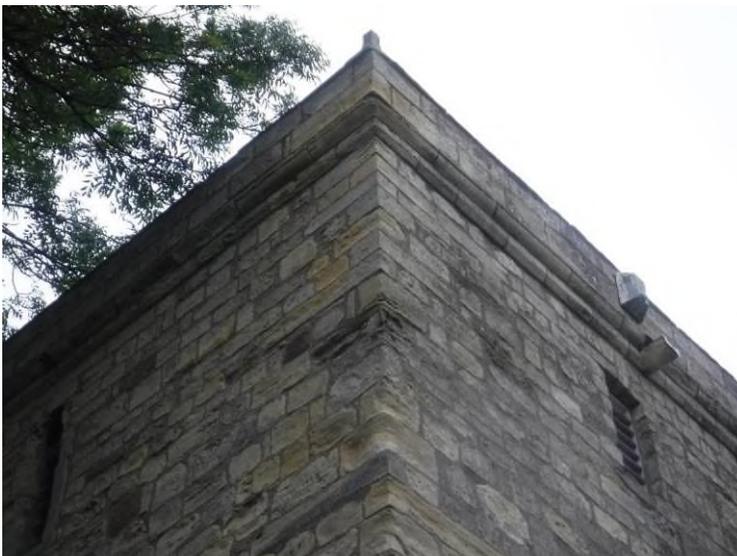
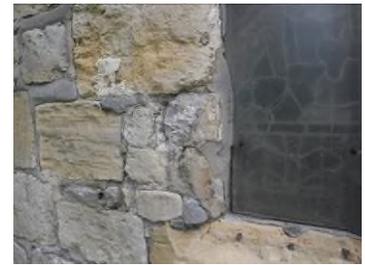
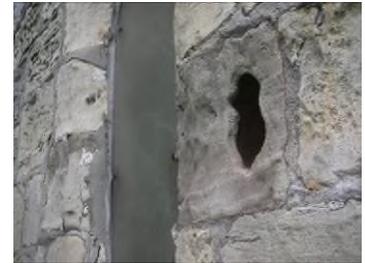
C **West side**

The adjacent Ash tree is brushing against the top of the parapets, the upper stage louvre opening head looks a bit mangled and the wood louvre is undecorated. The upper stage walling looks ok. The lower stage walling has a bit of a crack just below the window through the joints, it has been cement pointed badly and heavily, a different look of pointing on the lower stage of the upper, probably more recent.

One long stone which is honeycombing and below that a smaller which is also dishing out but they are alright. The long stones are ties they wrap round the corner. Below the N one, the wall is cracking a bit, there is a bit of metal below the ordinance survey bronze set out point. Beside the window is a hollowed out reveal stone. Window is over glazed in polycarbonate with rusting screws.

Recommendation: close up hole

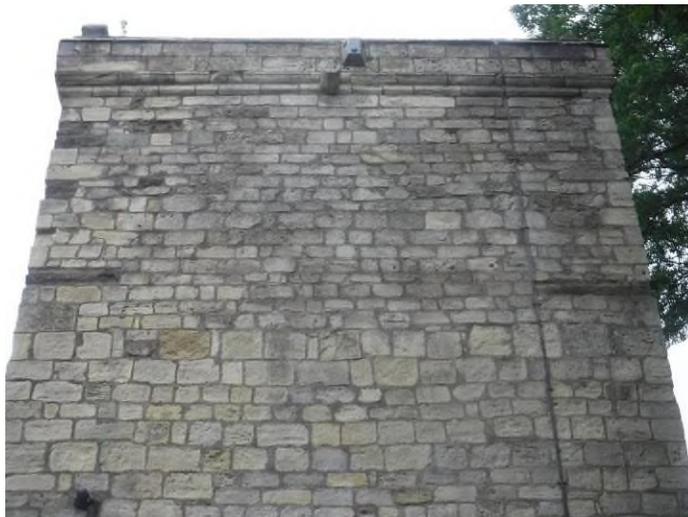
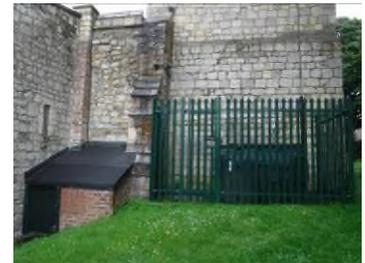
B North side

Here the ties also feature at the point between the bottom and the upper stage and also halfway up the upper stage showing that it is built in one sequence? Some erosion at high level below the over sailing corbel course but ok, pointing looks ok and no obvious cracking. The lightning down tape comes down on this side. At high level is a spitter and above that an alarm sounder I suppose that's what the loose cable is, so does that even work anymore? Some open joints right down at the bottom by the oil tank.

Recommendation: check alarm connection

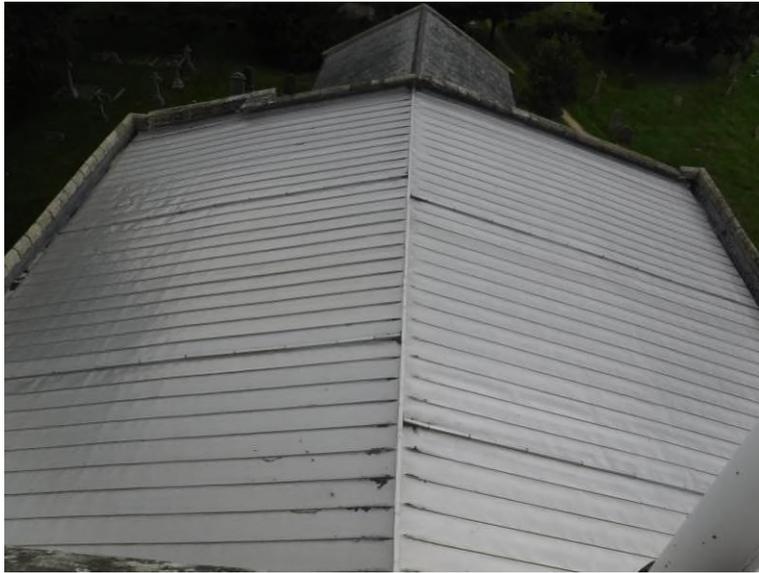
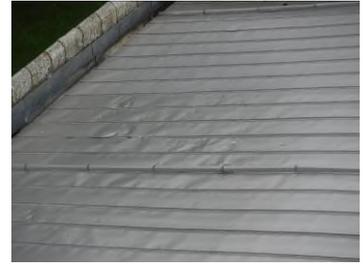
B Nave:

Nave is covered completely along with the outer aisles with a single span stainless steel into parapet gutters, the N side steel towards the E end seems to have some pock marks and perhaps a patch but generally ok. On the S side in the middle along the way there is a high point, either side of that is two gulleys, there has been rainwater inside the building showing at this point. There is some build-up of debris in the parapet gutters, unable to check the flashings against the tower.

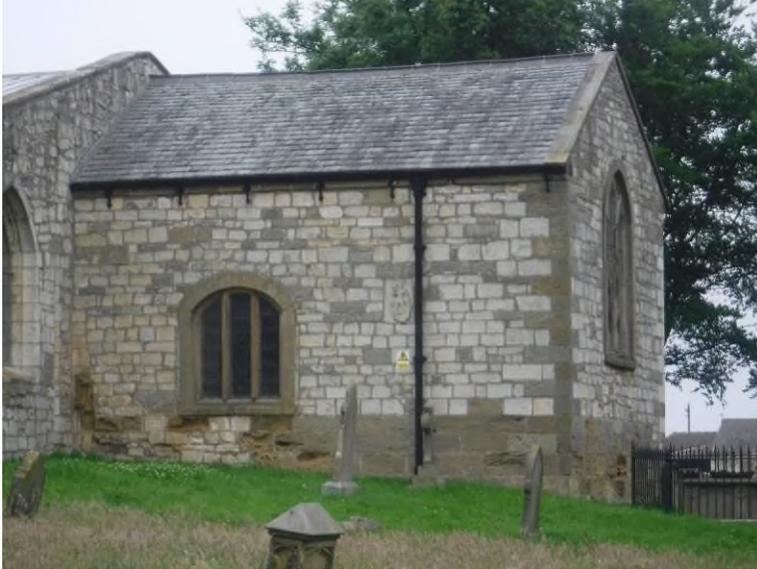
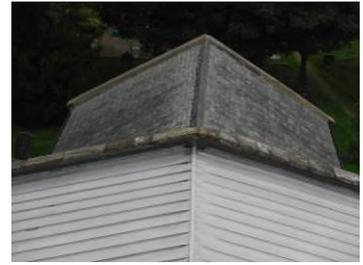
- **Chancel:**

Chancel Westmoreland slating seems to be ok.

Recommendation: none

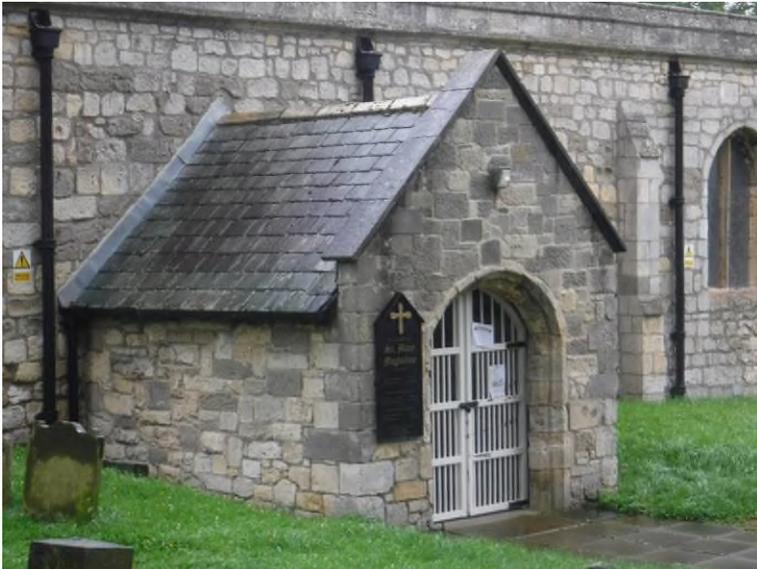
- **South Porch:**

Ridge capping in angled clay is ok with diminishing courses in variable widths Westmoreland and a little chipped in places but sound enough. The abutment flashings are in lead replacement. The S side is a little more worn where a couple of areas where slates could be refixed or new ones patched in but they could go 5 years. The cement pointing to the replacement flashings is coming away a little bit in places but it is generally sound, the water table appears ok.

Recommendation: none

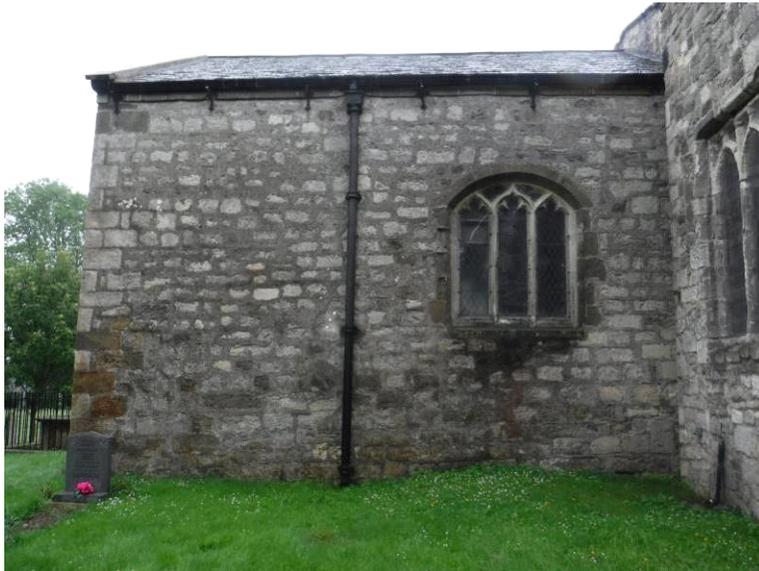
Chancel:

The chancel has a more ornamental ogee cast-iron gutter on rather fancy brackets that look a little bit incongruous. On the N side there is grass in the gutter at the E end downpipe looks ok, in fact the downpipes are four inch and quite oversized.

Same detail on the S side looking a little rusty on the bottom of the gutter.

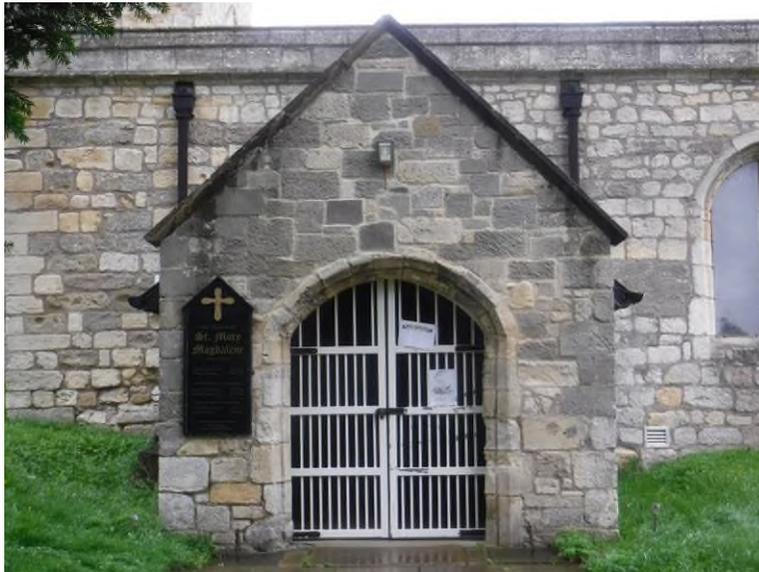
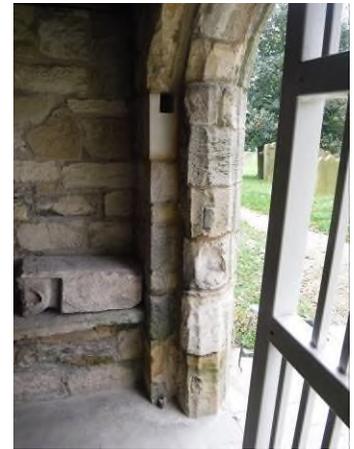
- **South Porch:**

Some loss of pointing at the lower parts of the walls particularly on the W side, rather made up of scraps of material. It had a recent repair of the jamb stones and a bit of repointing on the arch. There is erosion to some of the lower arch stones but that is ok and part of its character. Internally the boarded roof is ok as is the walling, some slight movement on the arch as you go into the nave but that is to be expected. The whole structure is braced back with tie rods that are evident on the nave but not on the porch. The walls feature corbels from earlier stages and some slight erosion to them. Concrete floor.

Recommendation: none

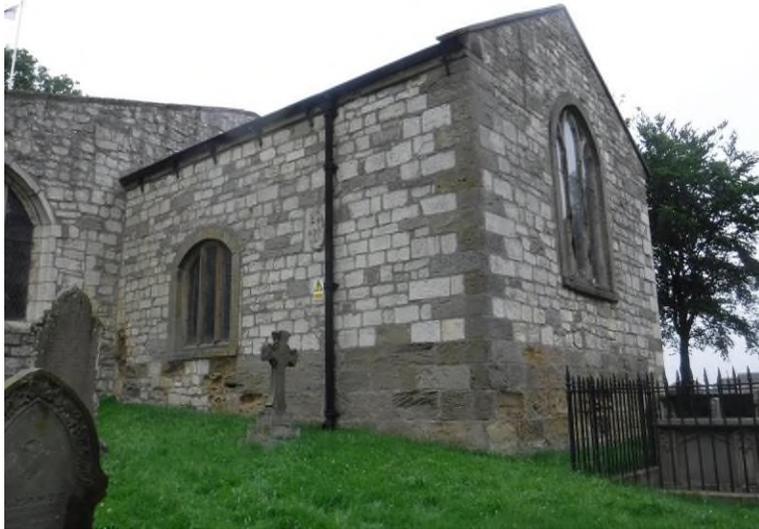
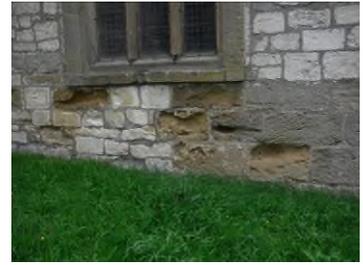
Chancel:

South – eaves corbel looks ok, as does the walling apart from c. nine stones in a softer sandstone, mixed in amongst the lime stone units. They have eroded particularly around the window and the abutment to the nave.

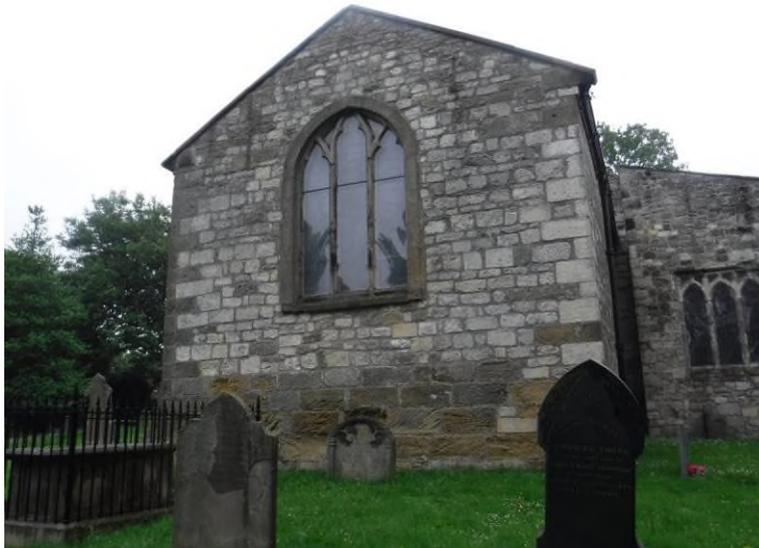
East

Quite a thin looking water table, just slabs though the kneeler looks integral to the slab, it doesn't look its age. The lower part of the walling is the large format sandstone blocks and there is erosion to those, one in particular another below that. Honeycombing in the middle below the window. The general

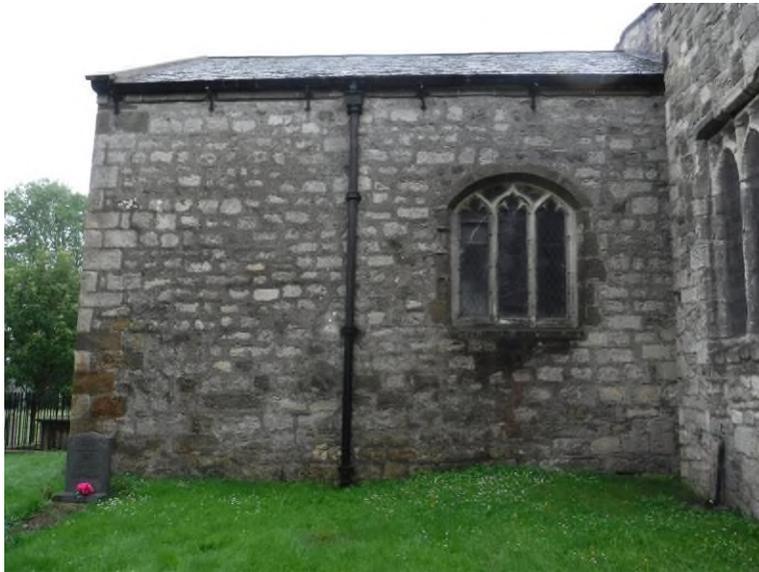
North

Some broken out bits of the over sailing corbel course to fix the brackets or perhaps the bracket fixings have broken it. This wall is differently pointed, it is smeared with cement which has been drawn in course lines so difficult to tell what the underlying wall condition is like. There is a crack up at the kneeler there is also another directly below it at the S E corner, it is mostly following the joints I think but it does look worse than it is because of the cement, there is nothing much to do to it.

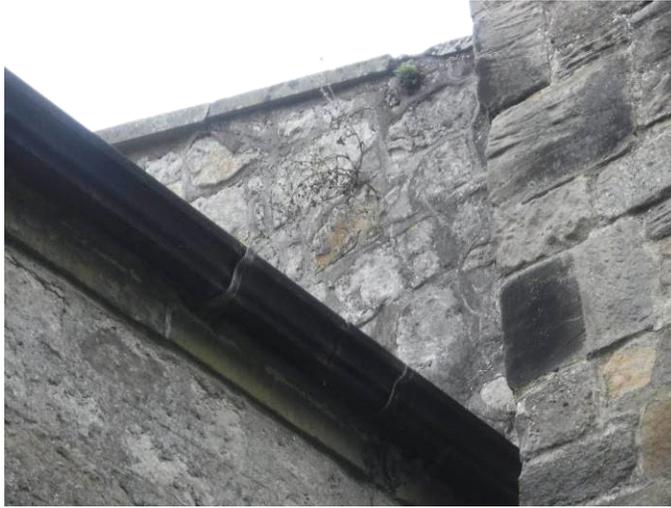
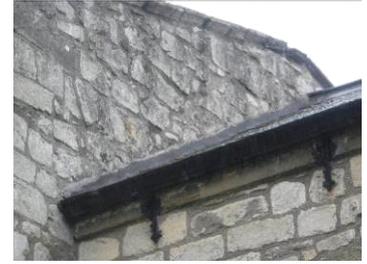
C Nave:

E end water table is cracked in places and looks to be made up of different sizes, there is also some vegetation growing on the N side above the chancel roof and the apex water table looks a little worn as well otherwise it is fine.

Recommendation: remove vegetation form watertable

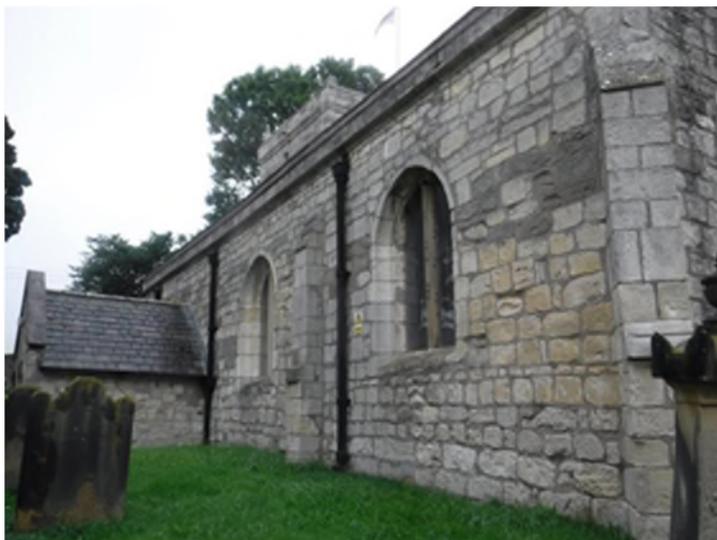
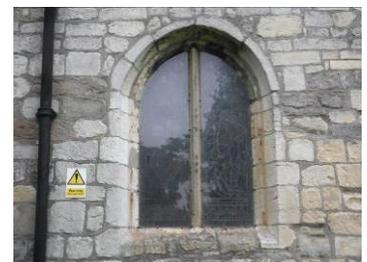
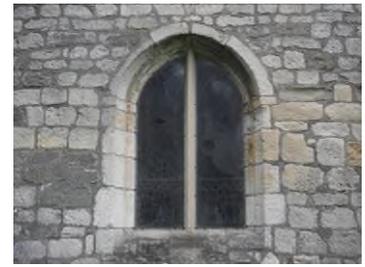
C South side

This is a three bay elevation with three downpipes on it, this has a better parapet which all looks in good condition, the walling as well is good, there is some low level wall ventilators, what is their purpose? There doesn't seem to be any evidence of it on the inside.

Recommendation: point open joints

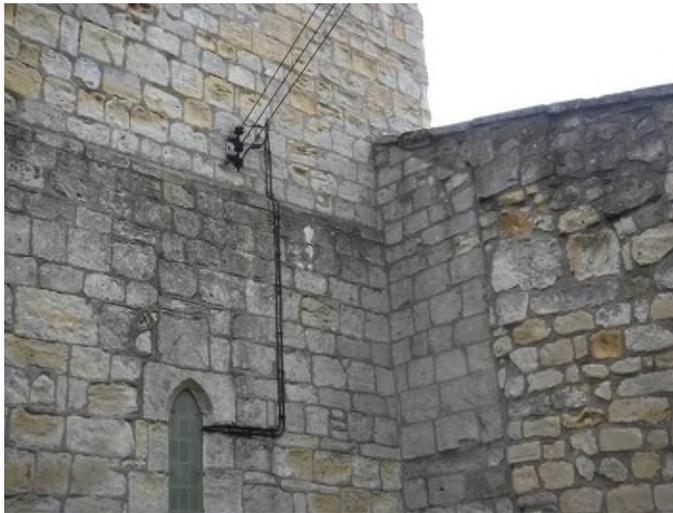
West side

– Same slightly poor quality of the water table and there is some run off as it joins the better parapet on the long elevation. Walling looks ok, some ivy starting to grow. Single lancet window with nutmeg decoration, much eroded and loss of label stop detail. The polycarbonate within is rather obscure now and the glazing support bar behind is rusting on to it.

Recommendation: remove ivy

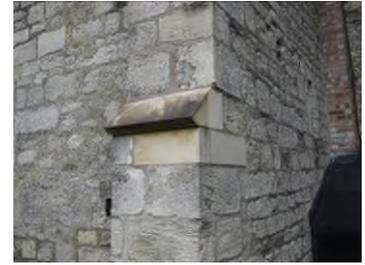
The W wall forms a return with the boiler house, which has a modern brick chimney flue, topped off by a stone top. As the wall returns around to connect to the tower, the walling is of various historic stages, but generally holding together ok, there is some slight redness to the stone perhaps there was a fire here in the past, heavily cement pointed in places above the boiler roof.

The W side is also heavily cemented at higher level and moderately cemented at the lower level. No sign of cracking and the buttress had its middle stage recently repaired, slight touch of movement up at the over sailing string course of the parapet but I think that is negligible.

Recommendation: none

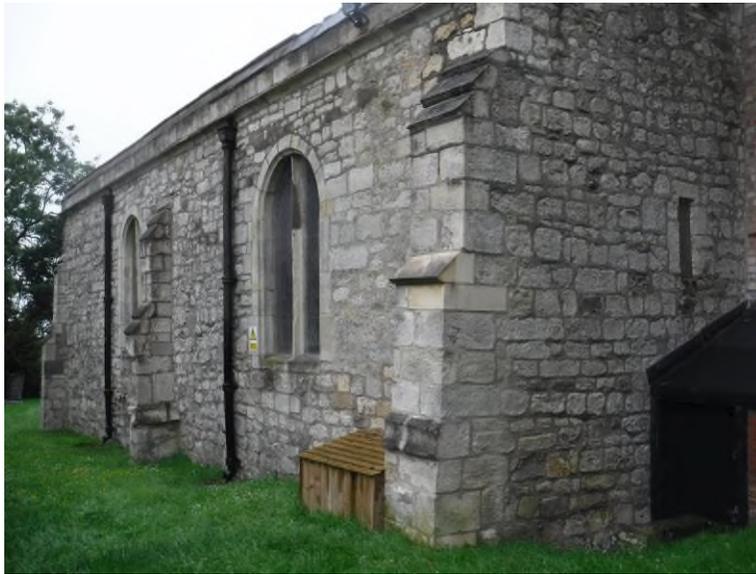
North side

The parapet has lost its roll top moulding. At the W end, there is a security light here and the curved cornice is ok. The walling below it has had a couple of goes of different cement types, the more bulbous type features towards the middle and E end and is just horrible. The wall bellies out and it is interesting to note that the E most buttress is actually built vertical so it must have been attached to that wall after the wall had moved out, whereas the middle buttress seems to have grown outwards with the wall.

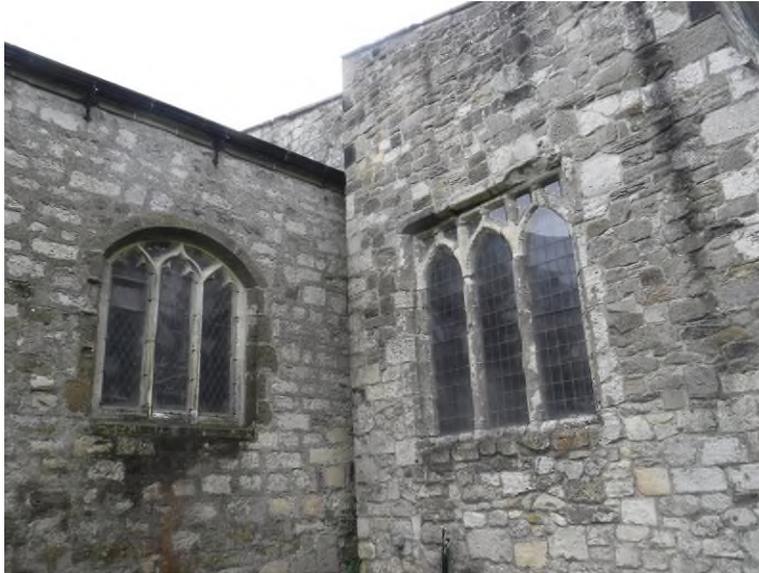
- **East side**

Water marks to gaps in watertable. Stonework ok. Three light leded light with tracery. Has cement facing breaking down. Broken horizontal hood moulding to the N side.

Recommendation: none

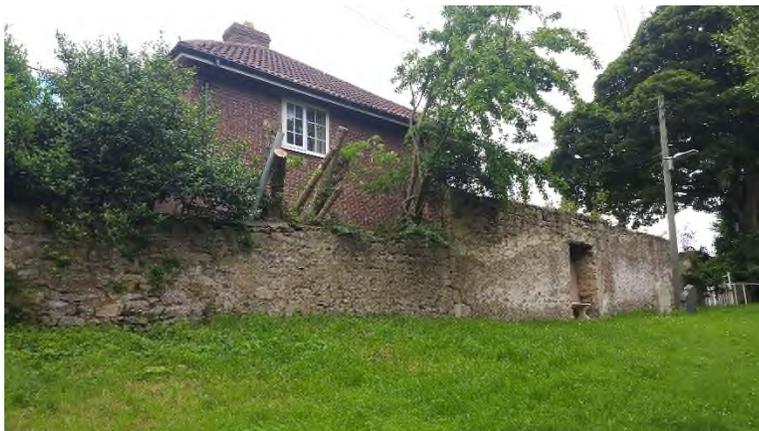
West Side:

Wall head broken up on the garden wall, recently trimmed tree to clear away. A lot of overhead wires here coming through, in fact there is quite a low one here to the adjoining house, it might be redundant but I wonder if someone might make mischief with

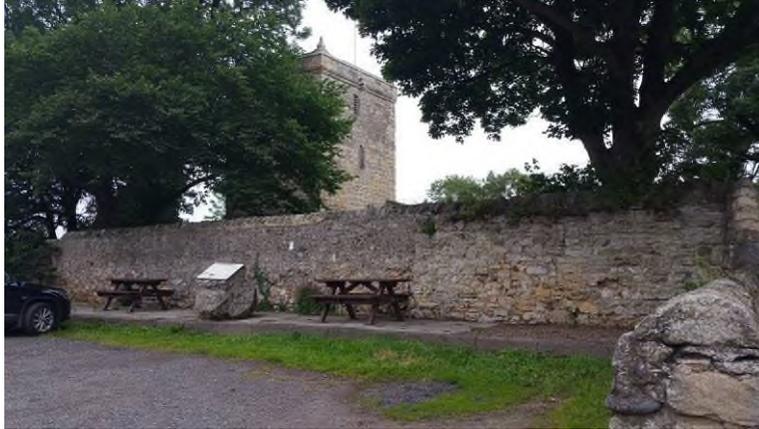
M East Side-

Listed and Scheduled Monument stone wall which has been badly repaired in cement in the recent past by the LA. There are some holes in it that can survive another 5 years. Vegetation growing on the top

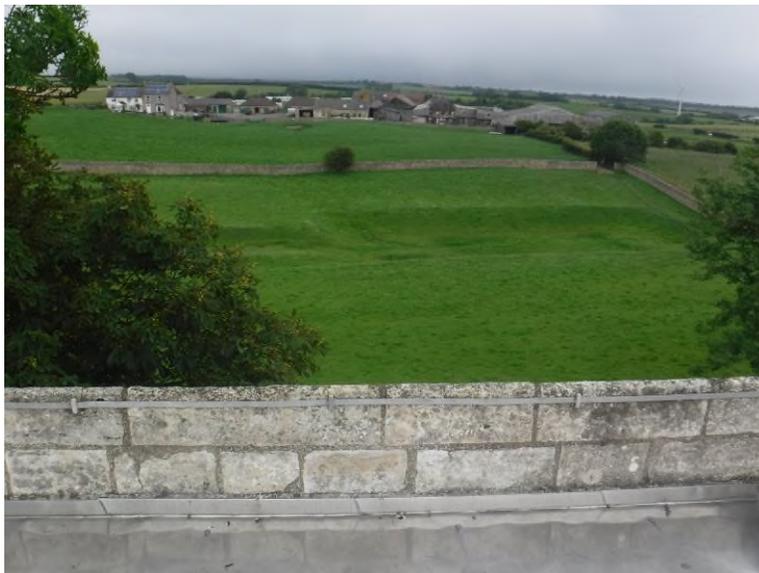
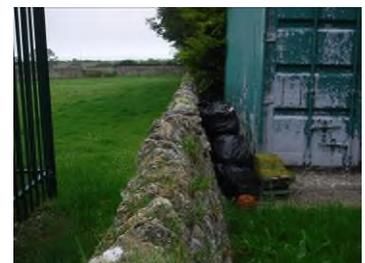
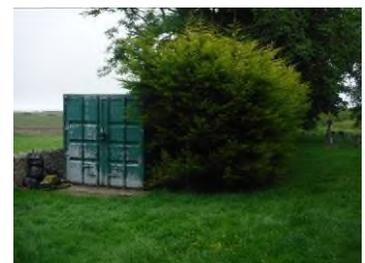
M North Boundary:

This retains the churchyard, at the W end it is leaning out a lot but is stable. It doesn't look to have moved in the ten years we have known the building. Just here is the concrete base and the sea container which is used for pew storage garden items. It is shielded by some conifer trees that need to be kept in check. The

N boundary extends down to the E extension which is unused presently and that is surrounded by field hedges.

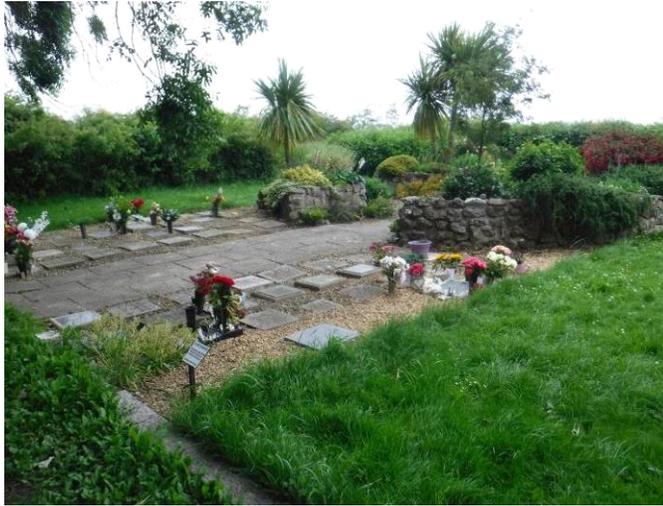
- **East Boundary:**

There is an area for ashes with a formal planting area which is beginning to look a bit full now.

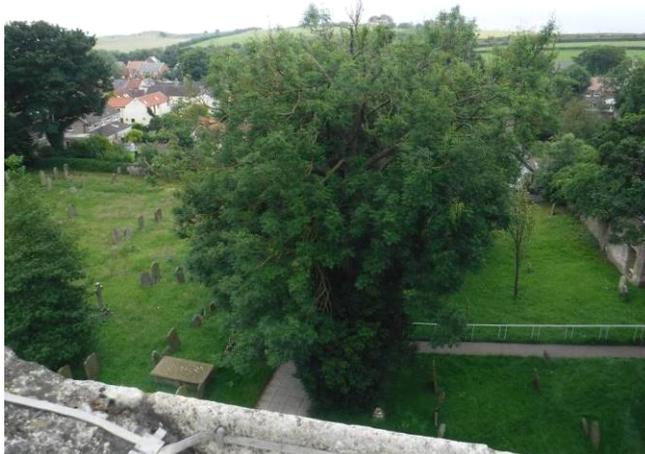
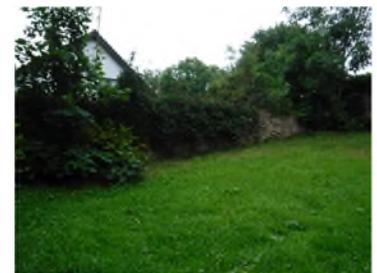
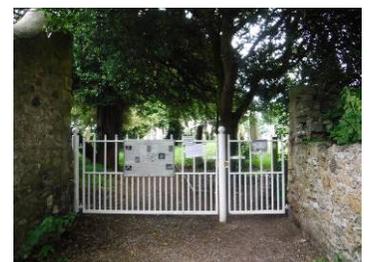
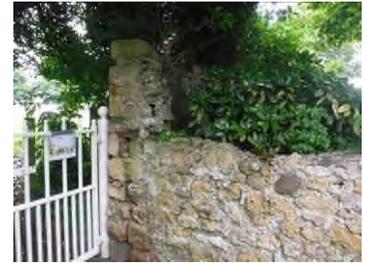
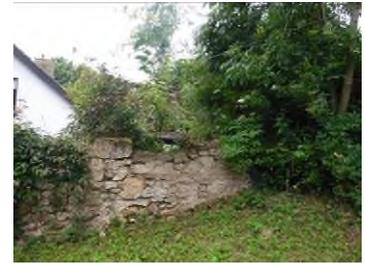
D South Boundary:

This is on to houses with good privet hedging at the E end and there is a stone wall to the more W end, ivy covered in places, there is a few self-seeding sycamores and ashes on this boundary

Recommendation: remove tree saplings and ivy, repair wall

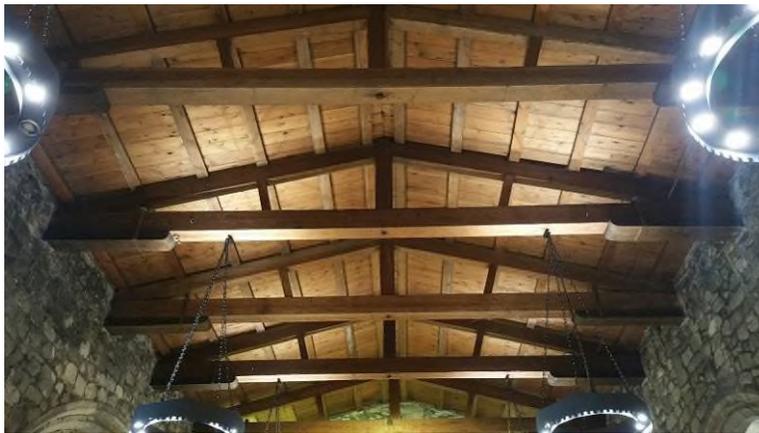
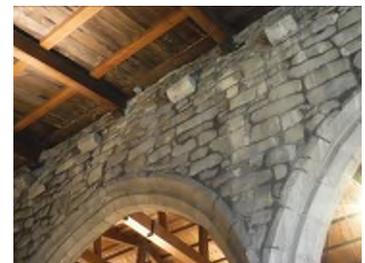
- **Ceilings:**

Nave - Has seven simple trusses supporting purlins and sarking boarding and on top of this will be the stainless steel roof covering, these look modern in the life of the church. There is some pull out showing on the middle northern one and there might have been in the past but there doesn't appear to be a problem presently.

They sit on what looks like oak corbels they are actually linked to the braces that are strapped onto the bottom of the nave principal beam to make them integral, though it is not clear how the tops of the rafters are fixed.

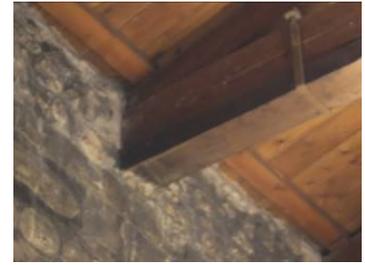
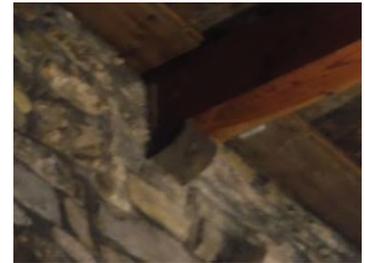
Same sort of detail features at the foot of the rafters and whilst there may be some slight evidence on the S aisle of pull out at the foot, it is negligible, approximately 5mm if that. It is the same design on the N side, though here the clasping member has broken its way through the top cornice which I guess must have been the ledge for the previous roof in the past. Here the pull out seems more obvious on this N side particularly the middle of the wall and that's evident from the outside as well and on the third rafter in from the W end the pull out looks to be approximately 25mm though it doesn't look to have disturbed any of the stonework around it, confusingly. The tops of the wall heads at this point are rather open.

- **Chancel** - Is a completely different affair, there are no trusses here just a ridge and purlins supporting the large rafters with sarking boarding, some water marking perhaps suggesting previous water penetration.

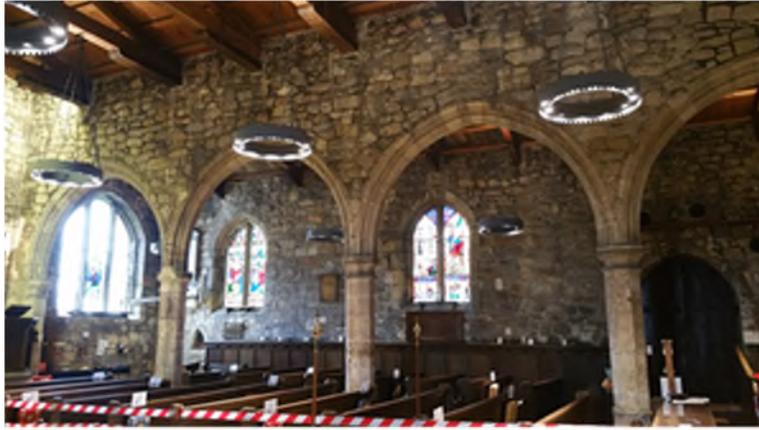
Arcades- South

In good condition, it is leaning and slightly distorted but there is no obvious defect to it and the arcade walling above it is ok. The columns have had some bits taken out of them for old box pew fittings and there is a little bit of cement repairing, but fundamentally they seem to be sound and there seems to be no sign of damp to them either.

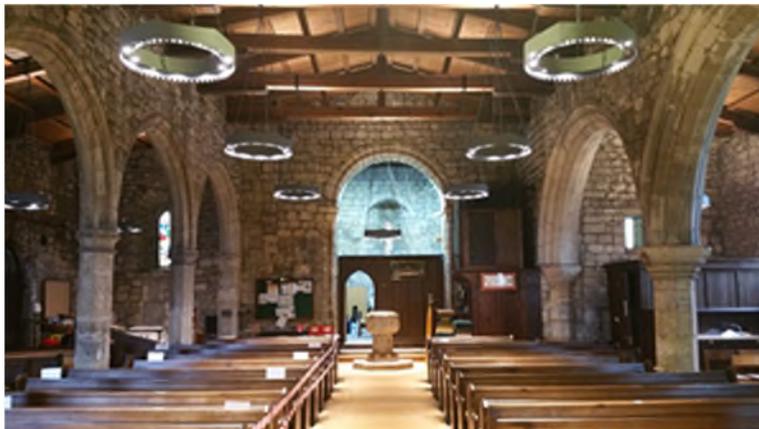
North Arcade

Is formed and supported by one column rather than the three on the S side though it is a little bit shorter and the arch stonework is all good as is the walling above it. The column and the impost column has been cleaned recently as they were significantly covered in algae in the past. There is damp showing a metre or so up on the W most and E impost, I suspect that this has to be as a consequence of all the cement pointing work. The base of the middle column is a bit chopped about and the cement repairs are rather horrible (they match the ones on the font). The E impost is really rather bashed around at the foot but part of the character I suppose.

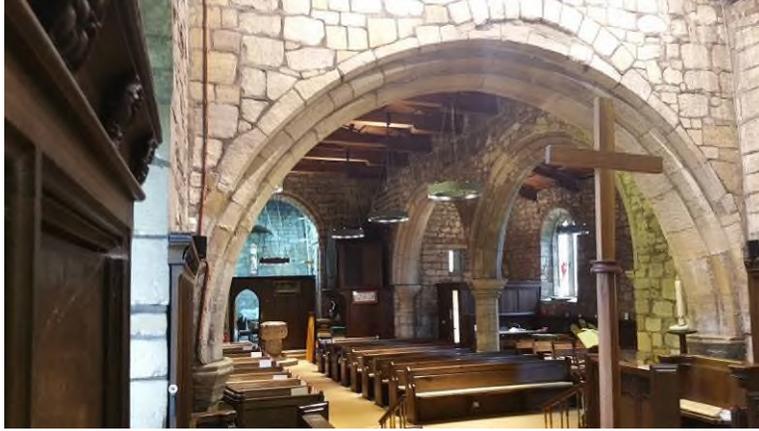
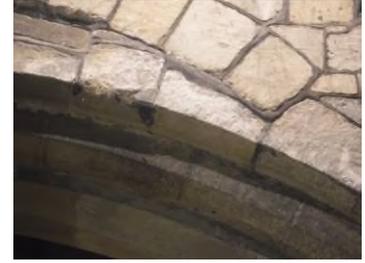
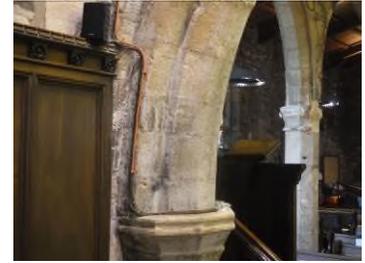
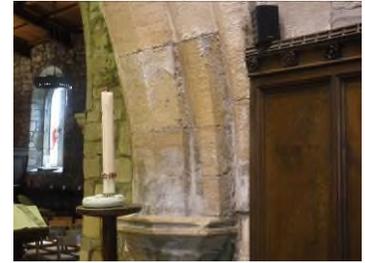
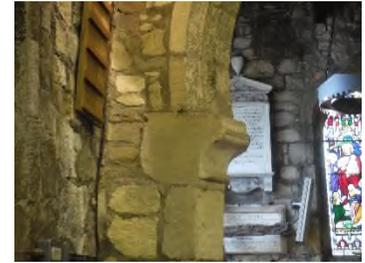
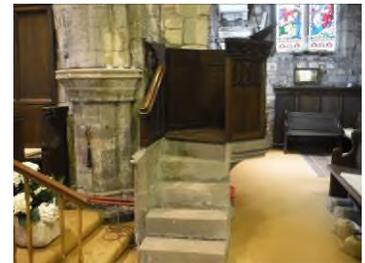
Has had some slight cracking in the past but it is negligible, it has a very low springing point but it is quite commanding. Remnants of a former arch above it with triangular headed window above there is a bit of a crack running up to the window cill but I think that is just exacerbated by brittle cement. The impostes are good to the ground with no damp showing, on the chancel side of the arch just on the N side of the centre, there is some action of shearing happening to one of the outer chamfer stones and I wonder if that is the pressure of the remnant arch above it looking to crack it, there is something going on there, but it is modest nothing really much happening. On the chancel side we can see that at around about two metres high there are salts occurring, and worst on the S side, salts appear to be coming through into the nave side as well.

Recommendation: monitor cracking above chancel arch

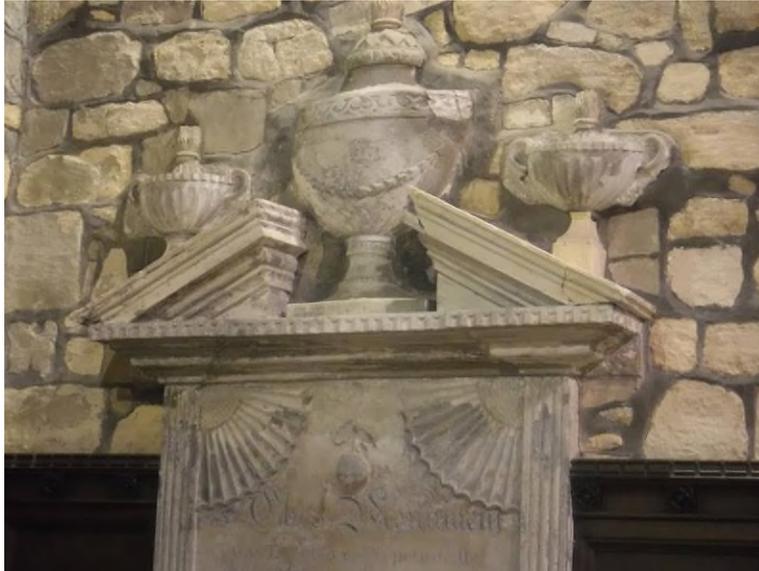
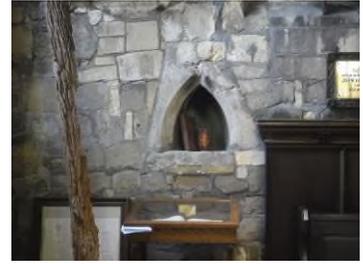
Walls:

Chancel - Walling has bulbous cement pointing on it with water marking at the eaves, particularly on the S side which is said to be historic. There is a timber dado covering the bottom third of the wall. There looks to be a crack on the S wall running through the window arch close to the apex but it doesn't seem to run up the wall, it is on both sides of the centre of the arch, there is a little bit of movement to the right hand side of the window jamb where the cement is coming away a bit but I don't think there is anything troublesome here.

window has a rusty looking markings to it, is that from heat from the radiator or has there been a little fire here in the past? There is efflorescence showing two metres up by the security detector and the impost of the arcade around about 1.5 up where there is a pocket out.

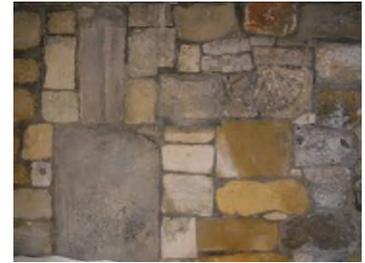
C **North Aisle** - Stonework is in fair condition and seems to be slightly dryer than the S side, the wall has had some various interventions over the time, previous window opening perhaps? The arch to the W window has dropped but that has been picked up before I think and there is little that can be done. It has been pointed back in in its dropped position.
