**HAWTHORN**  
**St MICHAEL & ALL ANGELS**  
(49)

**QUINQUENNIAL REPORT**  
on the architect's inspection on

**29 September 2022**

IAN NESS  
ARCHITECT  
26 GROSVENOR PLACE NEWCASTLE upon TYNE NE2 2RE  
tel & fax  
0191 281 2559  
i.ness@btinternet.com

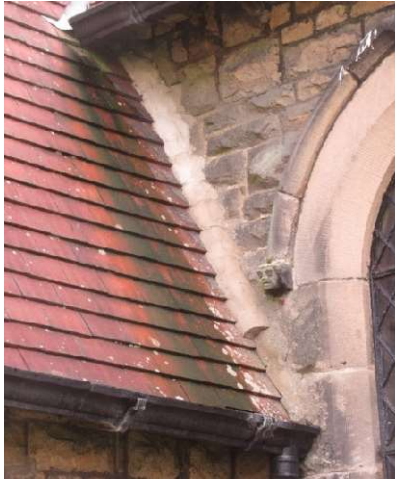
W side of Porch

13. The fillets are mostly sound but at  
SE - a short length at bottom is missing  
S Chancel against Nave - about a metre length near the top and at least one metre at bottom have cracked away from the Nave wall  
E Vestry - one metre length above mid height is missing  
W gable and bellcote both sides – both fillets are all cracked away from the watertables – cracks widest at the top two metres and around the bellcote where parts of the fillets are missing  
W Porch – bottom of added fillet missing  
E Porch – good except short length of added fillet missing  
N Chancel against Nave – good except a length at bottom has broken off and slipped down.

15. When replacing fillets durability can be improved by using combinations of
- smallest cross section (so remove all existing before laying new material)
  - mechanically fixing non ferrous full height anchors such as a stainless steel wire armature or mesh between nails secured between tiles or stones
  - a primer to maximise adhesion to both tiles and watertables.
  - low strength lime mortar (not cement mortar most prone to shrinkage)

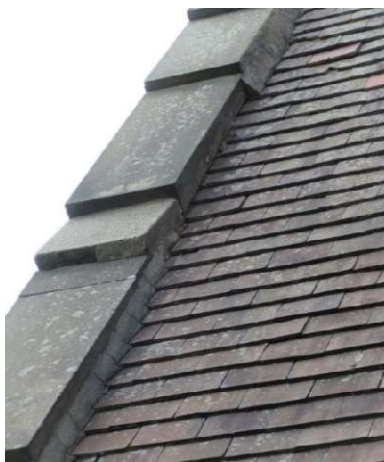
E side of Vestry

10. Tiles good at both sides of steep Chancel and Nave.  
At S Nave some replacement tiles. Minor breakages by the SE valley.
11. Porch and Vestry are unusually steep at about 70°. Porch tiles and valleys sound.  
Most Vestry tiles look older. Perhaps most tiles remain from its building in 1902. Two broken at top of W side and one slipping. At E one broken and four slipping.  
Mortar missing from both sides of the Vestry ridge.

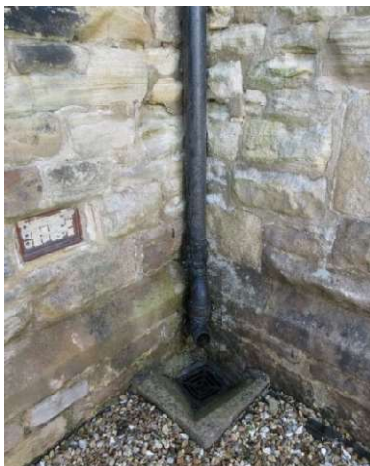
18. Some pipes (N & S Chancel, SE Nave, W Porch) are in corners so very hard to paint rusting backs. No present leak visible except N Chancel whose bottom offset is wet outside after rain suggesting a leak (may also contribute to the Chancel arch damp)

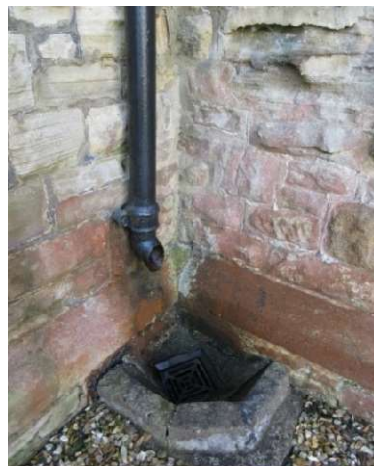
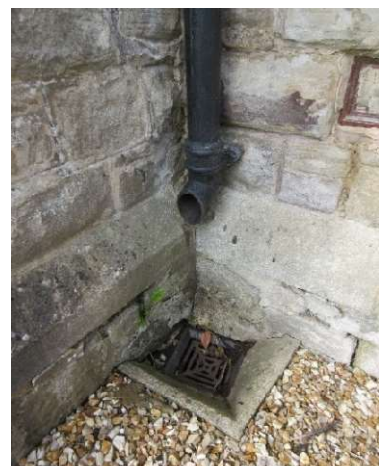
S Chancel – gully slightly dropped

most rainwater shoes are well above gullies and may spill into plinth

19. Both W Nave gutters have open ends draining into the lead valleys and onto the Porch and Vestry tiles which risks leakage through any tile or fillet defect.
20. The S Chancel gully is part dropped, opening mortar joints, and may spill into the foundation.
21. Good cast iron gullies and shallow earthenware drains with three manholes, not opened. System said to drain into the road verge, not to sewer.

Repair Vestry roof tiles	11
Rebed or repoint gully S of Chancel to drain all water	20

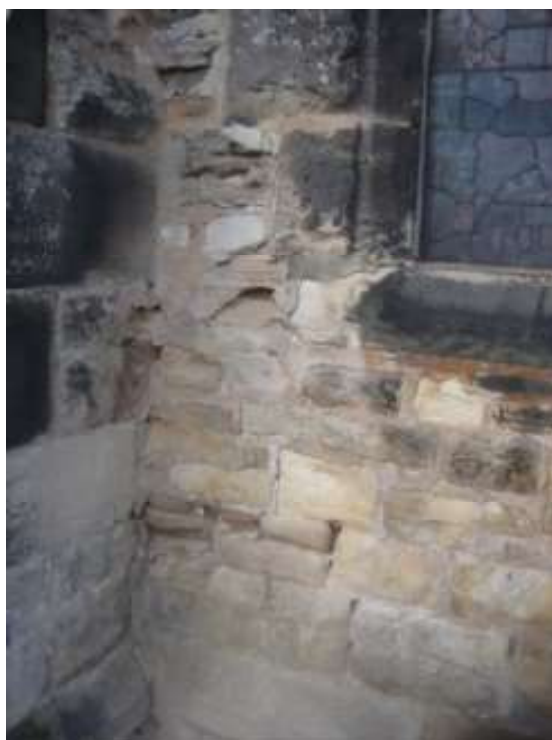
Next to Nave mid SE buttress

26. **E gable of Nave** – decayed stone S side at head height by corner with Chancel.
27. **SE Nave** – wall and mid buttress beginning to decay at and below cill level, worsened by cement mortar.

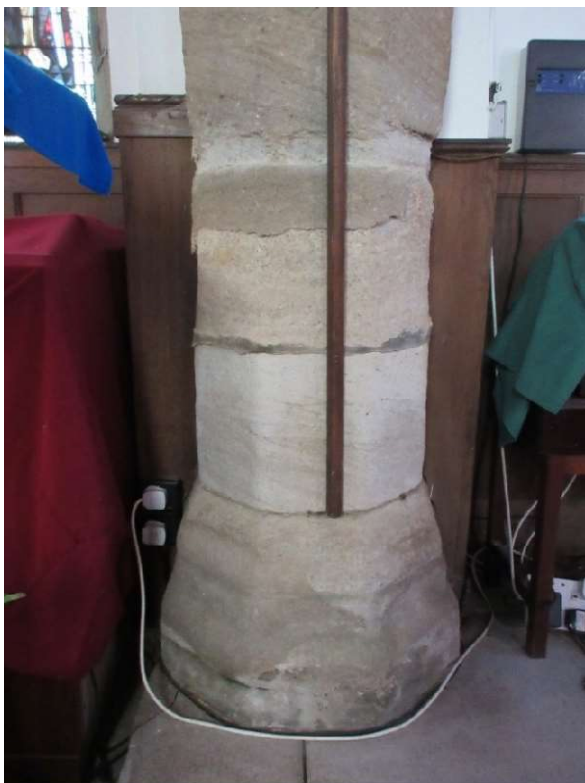
N side Chancel Arch

44. General stone surface decay both sides up to dado level may be due to simple rising damp but also corresponds to rusted pipes, high rainwater shoes and sunken gully outside and perhaps the closure of Chancel subfloor ventilation (paras. 17, 59, 68). Small areas of stone surface very loose, others remain stable.

45. The decay appears to result from damp rising in the arch masonry.  
A simple improvement to reduce damp would be to extend both Chancel rainwater pipes to the gullies.
46. Inserting a damp proof course in the E wall of the Nave would be possible but it may be more practical to reduce the pressure of rising/penetrating damp in the masonry by remaking the cracked Chancel floor as a ventilated suspended floor as original. Extra air bricks desirable.  
Would also solve the Chancel floor damage (para 68).
47. Inside and outside both sides of the inner Porch doors stone decay at level of the dado tops (also high rainwater shoes both sides) may be made worse by the impermeable wall tiling and bedding in the Porch.

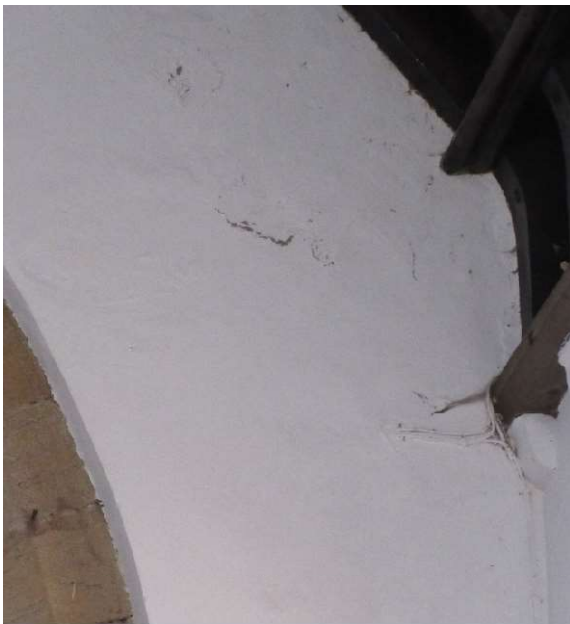
over the pulpit

- Over the S side of the Chancel arch (over pulpit) minor paint damage may show minor leakage from water table above or through the wall from the cracked fillet against the E face of the Nave gable (para. 13, 23)
- Damp damage on Nave W gable upper S side (less pronounced than previously) and in S side of top window reveal may result from the cracked mortar fillets on the tiles or open water table joints and lack of damp proof course or both (para 13, 23)

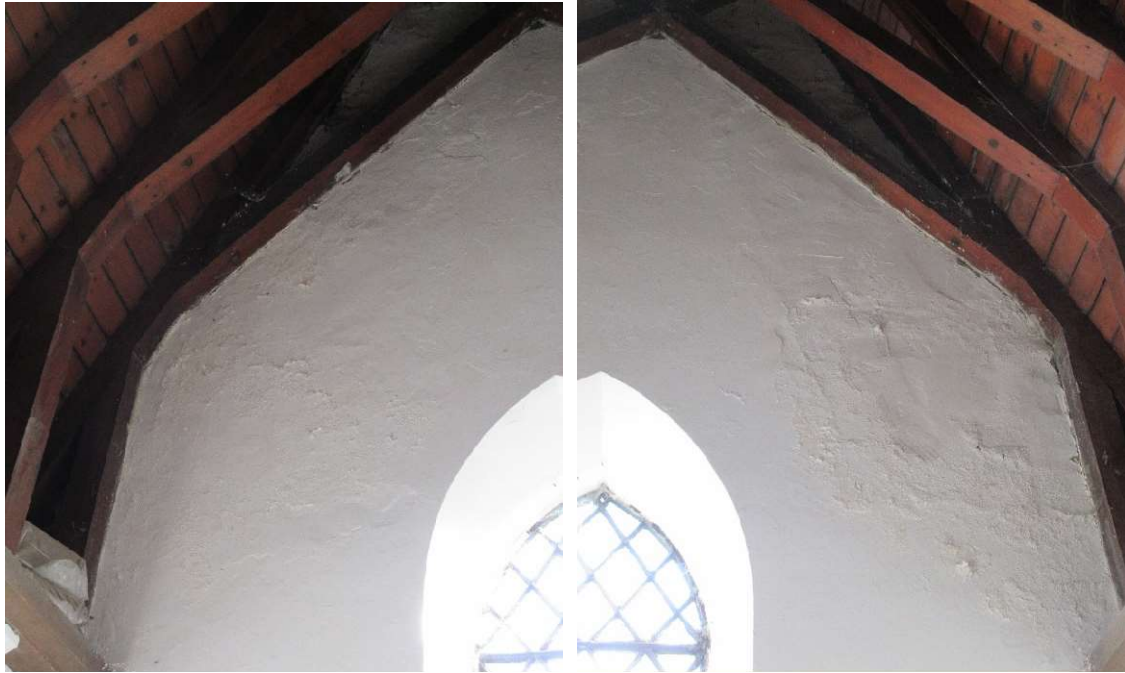
55. In Vestry S gable paint damaged by damp above eave level, worse at W. Might be condensation (a kettle is used) or through the part missing E fillet.
56. Porch fair. Minor damp damage E of the outer door arch.  
Slight damp each side of both window openings may be partly due to the wall tiling trapping moisture.
57. In Porch a patterned dado of brown and buff tiles under a coat peg rail. Thick tiles on a mortar bed. Parts of the borders are lost at both doors and side windows, now part patched with painted plaster. By limiting evaporation of damp the tiles may damage the adjacent plaster and stone.
