Quinquennial Inspection Report

Church of St John

Hebburn

Date of report: 29th August 2019

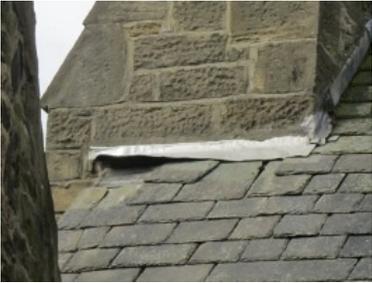
<p>c)</p>

<p>g)</p>	<p>Church roofs: Generally sound but the following defects need attention to prevent water ingress:-</p> <ol style="list-style-type: none"> Nave ridge tiles - open perpend joints need re-pointing; some re-bedding needed Nave, south slope - 2No missing slates by ridge Nave, south slope – 1No missing slate by west gable upstand Nave, north slope – 1No missing slate Nave, north side by Tower stair – verges in need of repointing Chancel ridge – open perpend joints need repointing; some re-bedding needed Chancel, south slope – 2No missing slates by eaves Chancel gable ladder in poor condition - replace Vestry ridge – end tile incorrectly sized - replace Vestry, west slope – 2No missing slates <p>Hall roof: Generally sound but the build-up of moss should be removed.</p> <p>Prayer Room roof: some staining to suspended ceiling tiles indicative of leaks to the roof and adjacent north wall. Roof felt, flashings and parapet copings need checking and sealing as appropriate.</p>

<p>Repair needs</p>	<p>All the above items need attention</p>	<p>B</p>
1.2 Rainwater goods and disposal systems		
<p>Condition</p>	<p><u>Church:</u> Cast iron gutters and downpipes generally in fair condition. Some of the gullies on the north side are blocked.</p> <p><u>Hall:</u> Plastic gutters leaking resulting in damp patches on north wall. Some build-up of silt.</p>	
<p>Repair needs</p>	<p>Replacement of the Hall gutters recommended. Clearing of gutters and gullies every 6 months is recommended.</p>	<p>B M</p>

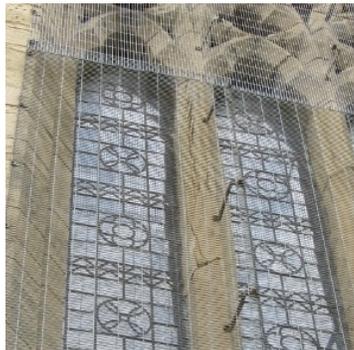
1.6 External walling	<i>Random rubble stonework and dressed stone to windows, and quoins</i>	
Condition	Generally masonry and pointing is in good condition but attention required to following:- <ul style="list-style-type: none"> a) Chancel, east window – some mullion sections are badly delaminating; open joint to cill. b) Transept: window tracery needs repointing c) Nave south: window tracery needs repointing d) Some open joints to buttresses & buttress copings e) Open joints to low level stonework in various locations f) Open joints to string course in various locations g) Prayer Room – ribbon pointing poor; many open joints especially on north wall; open joints at low level on west wall. h) Hall – open vertical joint between stonework and brickwork on NE corner. 	
Repair needs	a) the delaminating mullions require replacement b-f) localised repointing is needed g) raking out and repointing is needed to north wall h) repointing of the open joint is needed	C C C C

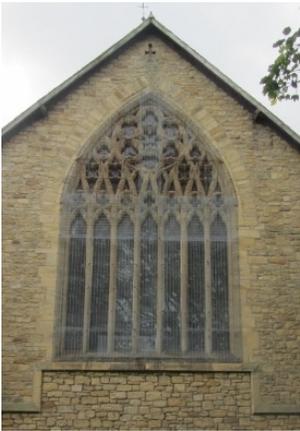
<p>Vestry, Transept, Nave and Chancel: Stained glass, clear glass, leadwork generally all in fair condition apart from one or two cracked panes. The mesh grilles are in sound condition but crudely fixed. Ideally they should be replaced with polycarbonate fitted to the glass profiles.</p> <p>The Chancel east window mesh is a patchwork and has rusting upper members (see photo). This would best be replaced with polycarbonate fitted to the glass profiles. This could be done after the conservation repairs to the mullions.</p> <p>Hall: timber windows single glazed; metal mesh grilles, generally in fair condition.</p> <p>Prayer Room: bronze framed window in good condition.</p>	
Repair needs	<p>Consider replacement of mesh to Chancel east window.</p> <p>Consider replacement of mesh grilles to all other windows (e.g. Nave, Chancel, Vestry and Transept in polycarbonate).</p> <p>Cracked panes in Vestry and above Vestry external door.</p> <p>Cracked pane to 1No Nave north window. These would best be replaced.</p>	<p>D</p> <p>E</p> <p>D</p> <p>D</p>

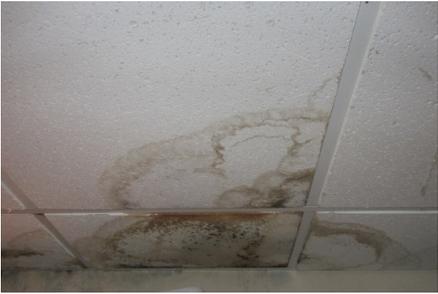
<p>Chancel and Nave: roof structure and boarded ceilings in good condition.</p> <p>Vestry: fibre board ceiling and laths in fair condition.</p> <p>Transept (upper): new suspended ceiling in good condition.</p> <p>Transept (lower): new plastered ceilings in good condition.</p> <p>Toilets and kitchen: plastered ceilings in good condition.</p> <p>Prayer Room: some staining of ceiling tiles due to roof leaks (see photo). See section 1.1 and 1.5 for actions.</p> <p>Hall: some staining of suspended ceilings in store due to roof leaks. See 1.5 for actions.</p>
Repair needs	See 1.1 and 1.5 for repair needs and actions

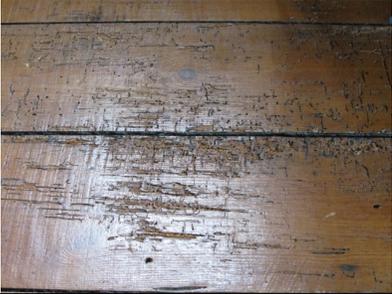
<p>The carpets and vinyl floor finishes are all in fair condition.</p> <p>The new open rise staircase from the Foyer to the upper meeting room is in very good condition along with the glass balustrades.</p> <p>There is evidence of woodworm attack on the pew platforms to the choir stalls and to the stepped timber platform to the altar (see photo).</p>	
Repair needs	Recommendation for specialist to inspect and treat the woodworm.	B

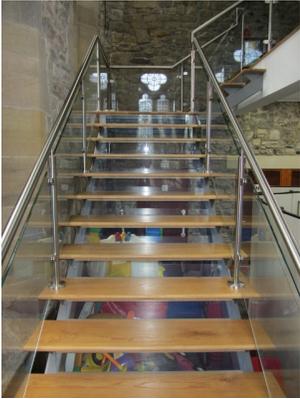
<p><u>Church:</u> Level access is afforded from the drive into the Foyer and Nave. Width of doors and circulation space for wheelchair users is good. Accessible toilet off the Foyer beneficial for wheelchair users.</p> <p>Building Regulations approval to the new mezzanine floor above the Foyer was on the condition that a stair lift would be provided. This should be installed to allow the elderly and infirm to access the upper meeting room. (Photo of stair opposite)</p> <p><u>Hall:</u> Ramped access is provided into the Hall though the ramp is narrow. An accessible toilet is also provided in the Hall.</p>	C

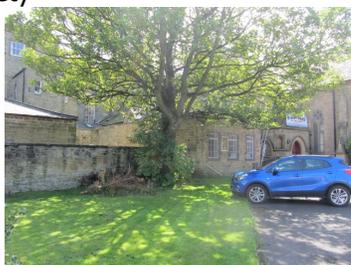
3.5 Trees	The churchyard has a number of mature trees, including sycamore, laburnum, Swedish whitebeam and hornbeam.	
Safety	The sycamore tree located close to the Hall has overhanging branches. (See photo opposite). These should be lopped. A number of trees by the east boundary have had branches lopped by the Council since the last inspection. The sycamore tree opposite the Prayer Room also has overhanging branches. This should be monitored. (See 3.3 re the effect of this sycamore tree on the adjacent wall).	C
Importance	The trees make a contribution to the setting of the church. Apart from the sycamore tree by the Prayer Room, the trees do not have TPO's however they are protected under the Hebburn Hall conservation area.
