Quinquennial Inspection Report

Church of St Oswald

Hebburn

Date of inspection: 18 September 2020

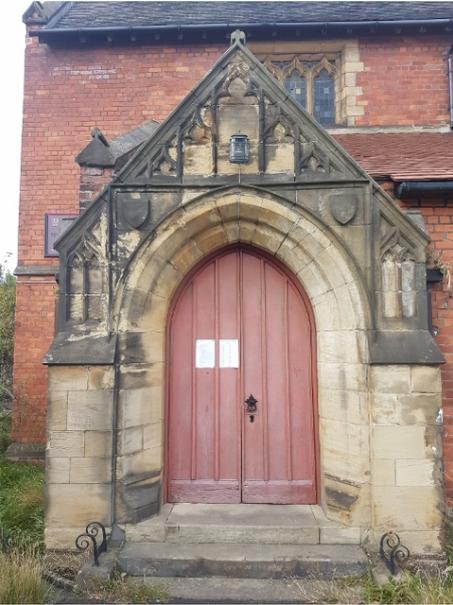
1.5 External walling		
<p>Condition</p>

<p>The external walls are in reasonable condition. However attention is needed to the following areas:-</p> <ul style="list-style-type: none"> - Porch – some open joints to gable stonework; open radial joints to arched lintel stones; open brick joints below. hopper – all require raking out and repointing. - Nave north side – a few spalling bricks to monitor. - North Aisle – some open joints require re-pointing. - Organ Chamber – some open joints above window opening; some decay to stone faces. - Chancel south – some open joints to string course - Chancel east gable - some decay to window jambs; some open joints in window tracery and arch. - Clergy Vestry – east gable wall has open joints above the window. This is allowing water ingress and is causing blistering plaster and paint. 	
Repair needs	Repointing of open joints as noted above. Monitor stone decay and spalling bricks for future action. Repointing east gable wall of Clergy Vestry	D F B

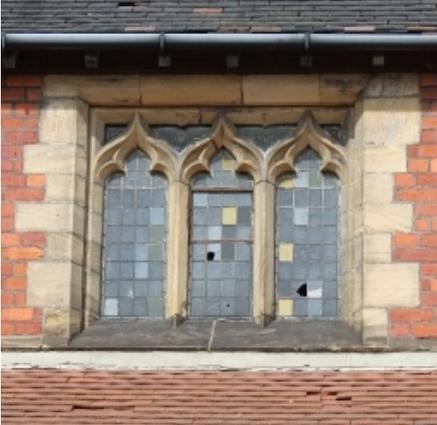
<p>Nave south clerestory window</p>	<p>The window masonry is generally in good condition but attention is needed in the following areas:-</p> <ul style="list-style-type: none"> - Chancel south window stone dressings - open joints - Chancel east window – jambs are eroding along the bedding plane; open joints in tracery and arch. - Nave south clerestory westernmost window – eroded and delaminating mullion. Mullion joints are open. - Nave north clerestory window - mullions joints open - Clergy Vestry – some decay to stone jambs, cill and lintel <p>The glazing and leading is generally in fair condition but there are some broken and cracked panes to some of the Nave south clerestory windows (see photo).</p> <p>The mesh to the Chancel east window is rusty and weathered.</p> <p>The timber window frames to the Choir Vestry are in poor decorative condition.</p>	
<p>Repair needs</p>	<p>Replacement of delaminating /eroded mullion to Nave south clerestory westernmost window</p> <p>Raking out and repointing of open joints as above.</p> <p>Eroded stone window dressings require monitoring</p> <p>Glazing – replacement of broken panes to Nave south clerestory windows.</p> <p>Consider fitting polycarbonate covers to Nave south clerestory windows to protect them from future vandalism.</p> <p>Chancel east gable - Consider replacing the rusty mesh grilles with polycarbonate to protect the stained glass window.</p> <p>Redecoration of Choir Vestry window frames</p>	<p>C</p> <p>C</p> <p>F</p> <p>B</p> <p>E</p> <p>E</p> <p>C</p>

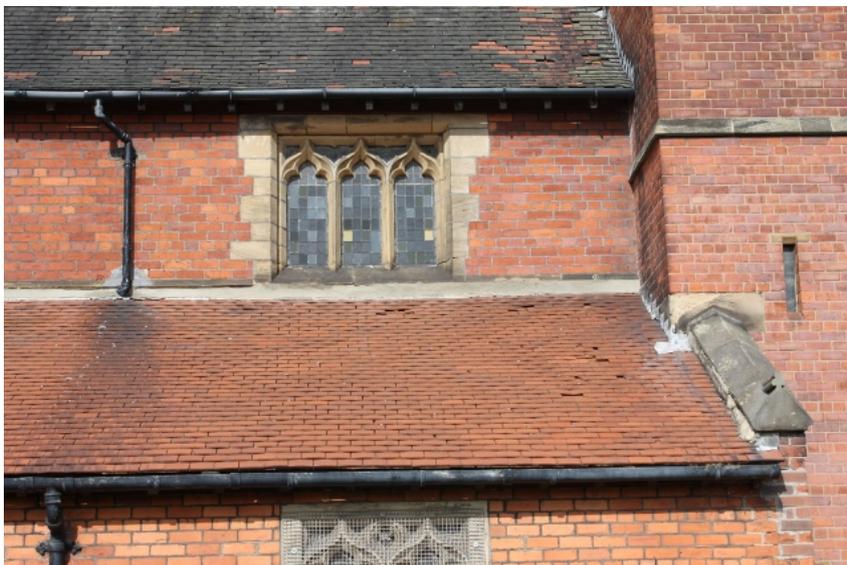
<p>1.1 Roof coverings</p>	<p>Clay tiles to Chancel, Nave, Side Aisle, Organ Chamber, Vestry. Welsh slates to Tower and Choir Vestry.</p>	
<p>Condition</p>	<p>Roofing repairs have been carried out since the last inspection including:-</p> <ul style="list-style-type: none"> - Slating repairs to the Tower spire - Choir Vestry ridge and hips re-bedded - Organ Chamber roof re-tiled and ridge re-bedded - minor repairs to Chancel, Aisle and Vestry roofs - lead valley between vestries coated in liquid membrane <p>However there are a number of roofing defects which need attention. These are as follows:-</p> <p><u>Chancel:</u> Open perpend joints to ridge stones 1No slipped tile to south slope 2No missing tiles on north slope Vegetation growing out of valley gutter to tower</p> <p><u>Nave:</u> 16No missing tiles on south slope 6No missing tiles on north slope</p> <p><u>South Aisle:</u> Has been re-tiled in past but currently over 25No tiles are either missing or broken.</p> <p><u>North Aisle:</u> Some missing tiles. Lead apron flashing to Nave wall abutment has lifted in places.</p> <p><u>Organ Chamber:</u> In fair condition following re-tiling works in 12017</p> <p><u>Clergy Vestry:</u> No access to inspect</p> <p><u>Choir Vestry:</u> Some open joints to ridge and hips. Missing bedding to ridge on west slope. 1No rotated slate and 1No broken slate on west slope. Eaes fascia board has flaking paint.</p>

Missing roof tiles – see para 1.1

Repair needs	Repairs are needed as follows:- <ul style="list-style-type: none"> - re-bedding and re-pointing of hip and ridge tiles to Choir Vestry - re-fixing of all slipped tiles and slates - re-tiling of all missing tiles and slates - flattening the lead apron flashing on the North Aisle roof - redecoration of rafter feet 	B B B B D
--------------	---	-----------------------

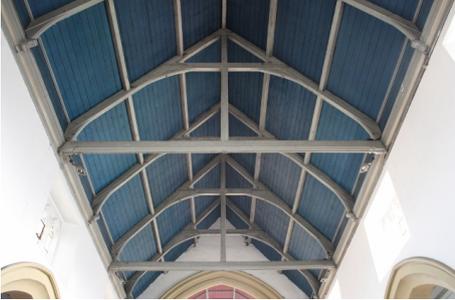
<p>Nave roof structure & ceiling</p>

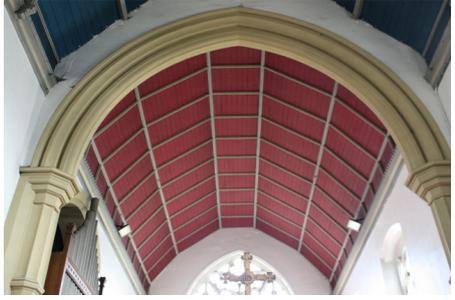
<p>Chancel ceiling</p>	<p><u>Porch</u>: painted boarded ceiling – in fair condition</p> <p><u>Nave</u>: comprises king post trusses, purlins, rafters and boarded ceiling. Some of the decoration to parts of the structure is flaking and there could be some rot beneath. Closer inspection is needed. The boarding and beams would benefit from redecoration when funds are available.</p> <p><u>Side Aisles</u>: comprises trusses, purlins, rafters and boarded ceiling in fair condition though there is evidence of past water leaks.</p> <p><u>Chancel</u>: segmental timber boarded ceiling with profiled beading. The decoration is in fair condition.</p> <p><u>Passage</u>: painted boarded ceiling – in fair condition.</p> <p><u>Choir Vestry</u>: painted boarded ceiling – in fair condition.</p> <p><u>Clergy Vestry</u>: glazed hardboard finish to a curved profile. The decoration is fairly good.</p> <p><i>NB the voids above the ceilings to the Chancel and Choir Vestry were not inspected. The writer cannot state that these areas are free from defect.</i></p>	<p>B</p> <p>E</p>

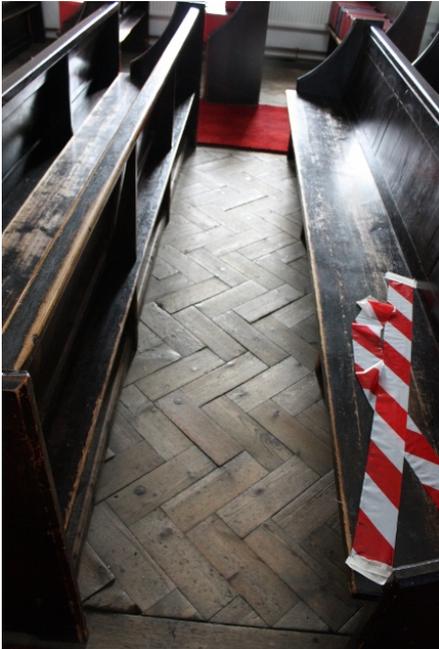
<p>Loose and uneven block flooring</p>	<p><u>Porch:</u> The floor level is uneven. The heating grille which runs through the centre of the floor north south, is on a slight slope and the flooring either side reflects this slope. The concrete is cracked in places indicating the settlement movements which have occurred. The concrete is painted with maroon floor paint. No structural actions are required but filling the cracks and re-decoration would improve the appearance. Alternatively matting could be installed.</p> <p><u>Nave:</u> The floor beneath the carpeting is very uneven at the rear of the Nave adjacent to the heating grille. This poses a tripping hazard. The carpet should be lifted for examination and further advice sought from the architect on how the floor could be levelled.</p> <p><u>Nave, Side Aisles and passage behind organ:</u> Some of the herringbone wood blocks are raised and others un-bonded. Levelling and re-bonding is recommended.</p> <p><u>Clergy Vestry:</u> the rug is in fair condition. The concrete floor is cracked in places. Repair of the cracked section is recommended.</p> <p><u>Choir Vestry:</u> the timber floor is carpeted. The carpet was not lifted and the writer cannot state that the floor beneath is free from defect.</p>	<p>D</p> <p>D</p> <p>D</p> <p>D</p>

D	Levelling of Nave rear aisle floor (2.4)	£1,500 - £2,500
D	Levelling and bonding of wood block floors (2.4)	£1,500
D	Repair to cracked floor of Clergy Vestry (2.4)	£150
D	Repair of depression to Nave north arcade wall/ redecoration (2.5)	£2,500
D	Repointing of copings to west boundary wall (3.3)	£150
D	Replace missing cover to external floodlight (4.2)	£350
D/E	Removal of paint/ re-decoration of Chancel, Nave, Aisles, Passage walls (2.5)	£15,000
D/E	New lighting scheme to Nave energy efficient lamps (4.2)	£5,000
E	Replacement of missing apex crosses to Chancel and Nave east gables (1.4)	£8,000
E	Replacement of eroded apex cross to Nave west gable (1.4)	£4,000
E	Consider fitting polycarbonate covers to Nave south clerestory windows (1.7)	£5,000
E	Redecoration of Nave ceiling (2.1)	£7,500 - £10,000
E	Installation of kitchen and accessible toilet (2.6)	£25,000
E	Provision of handrail at Chancel step near rood screen (2.7)	£400

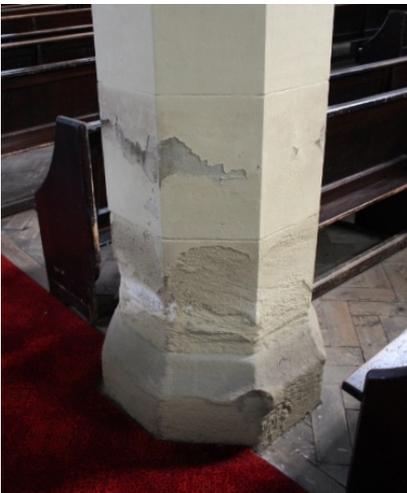
<p>Rising damp and blistering paint to Nave columns</p>	<p><u>Porch:</u> Eggshell paint on plaster.</p> <p><u>Nave:</u> The walls have been painted with eggshell which is badly crazed and preventing moisture vapour migrating through the wall. When the church is next decorated it is recommended that the eggshell paint is removed prior to redecoration in a mineral paint or distemper which is breathable.</p> <p>There is a large depression in the plaster in the north wall above the arcade. The cause of this is not clear but removal of the unsound plaster followed by localised re-plastering and re-painting is recommended.</p> <p>The stone columns and arches to the north and south arcades have been decorated with masonry paint. The paintwork is blistering at the base of the columns due to rising damp. The rising damp is thought to be associated with inadequate surface water drainage on the south side of the building and past flooding in the Boiler House. See section 1.2 for actions on surface water drainage. Removal of the masonry paint to the columns to 1.2m above floor level would allow the masonry to breath and the damp to evaporate.</p> <p><u>Side Aisles:</u> Again the walls have been painted with eggshell which is badly crazed. Removal of the eggshell and redecoration in mineral paint or distemper is recommended.</p>	<p>D/E</p> <p>D</p> <p>D</p> <p>B</p> <p>D/E</p>

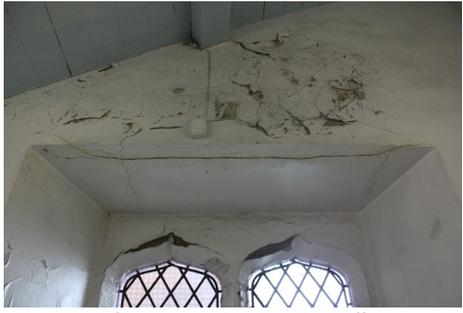
<p>Clergy Vestry east wall</p>	<p>The stone window dressings have also been painted in eggshell which is flaking in places.</p> <p>The paint and plasterwork are blistered at low level on the North Aisle east wall adjacent the passage door and by the Chancel step (see photo opposite). Removal of the blistering material, localised re-plastering and painting is needed.</p> <p><u>Chancel</u>: wall decoration and plaster as Nave and Side Aisles. See previous comments for re-decoration.</p> <p><u>Passage</u>: wall decoration and plaster as Side Aisles. See previous comments for re-decoration.</p> <p><u>Clergy Vestry</u>: as before eggshell finish on plaster. The paintwork is badly blistered on the east wall (see photo opposite). This is thought to be caused by open joints in external masonry. See para 1.5 for actions on repointing. It is recommended that the damp plaster is removed to aid drying out before re-plastering and repainting are attempted.</p> <p><u>Choir Vestry</u>: the wall substrate appears to be glazed hardboard. The paint finish is eggshell which appears to be in good condition.</p>	<p>C</p> <p>D/E</p> <p>D/E</p> <p>C</p>

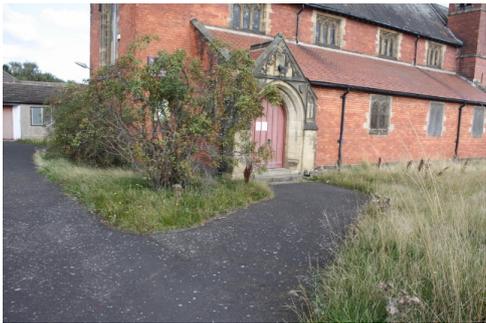
<p>Trees: The elder trees on the north boundary are relatively small. There do not appear to be any problems with tree roots and there are no issues with overhanging branches.</p> <p>Shrubs: The rosehip shrubs adjacent to the west gable of the Nave are overgrown and need pruning (see photo opposite).</p> <p>The brambles on the north east corner of the churchyard adjacent to the Choir Vestry are overgrown and unsightly and would best be removed.</p>	<p>M</p> <p>M</p>

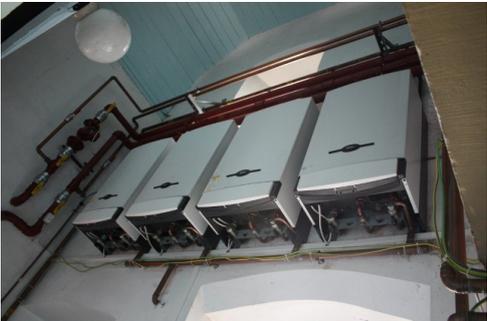
<p>The heating system comprises 4No wall mounted gas fired boilers located opposite the organ chamber (see photo). The boilers serve a combination of convector heaters and radiators via small/medium bore pipework. Electric warm air 'curtains' are located above the entrance lobby door.</p> <p>The system was installed approx. 12 years ago and is serviced annually.</p> <p>The heating system is understood to provide good thermal comfort levels and heat the building relatively quickly.</p>

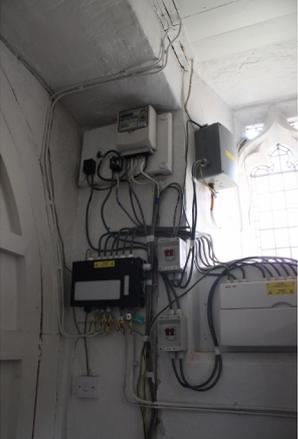
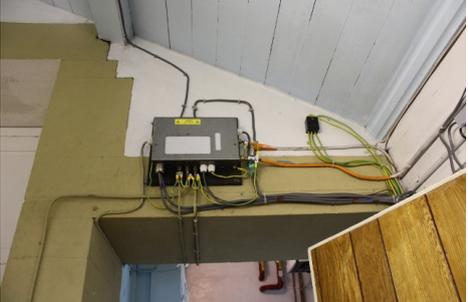
<p>New consumer units and distribution boards</p>	<p><u>Power supply:</u> The electric meter is located in the porch with a sub-meter in the Clergy Vestry and there is considerable surface cabling both in MICC and PVC cable.</p> <p><u>Lighting:</u> The lighting installation comprises the following:- Porch: pendant fitting with circular shade Nave: combination of flood lights and spot lights Side Aisles: pendant fittings with compact fluorescent bulbs Chancel: new LED flood lights Passage: pendant fittings with circular shades Clergy Vestry: suspended fluorescent fitting with diffuser Choir Vestry: suspended fluorescent fittings with diffusers</p> <p>The floodlights in the Nave are mounted at the top of the wall heads making access for re-lamping difficult. Consideration should be given to lowering the fittings. The floodlights are not energy efficient and replacement with modern LED lights is recommended. 2 of the floodlights in the Nave were not working at the time of the inspection.</p> <p><u>External lighting:</u> The floodlight on the Nave west gable has a missing diffuser cover. It is recommended that one is fitted to protect the lamp.</p> <p><u>Mains power:</u> Socket outlets are distributed throughout the church. These were not tested during the inspection.</p> <p>It is recommended that the electrical system is tested every five years and the results kept with the log book.</p>	<p>D/E</p> <p>D</p>
