St MARY HEWORTH

QUINQUENNIAL REPORT

12 July 2022

IAN NESS
ARCHITECT

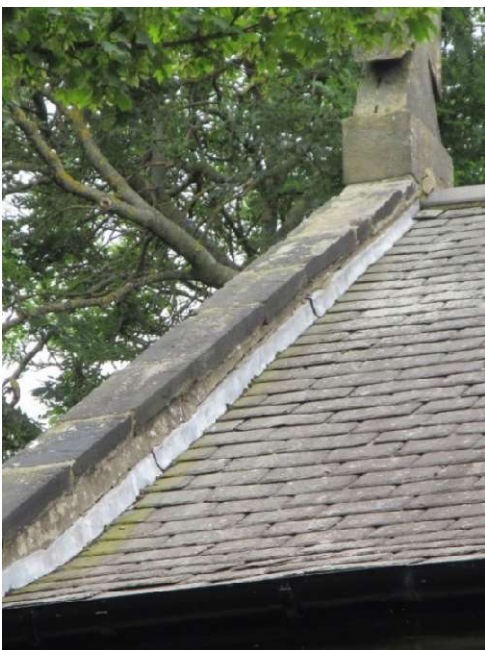
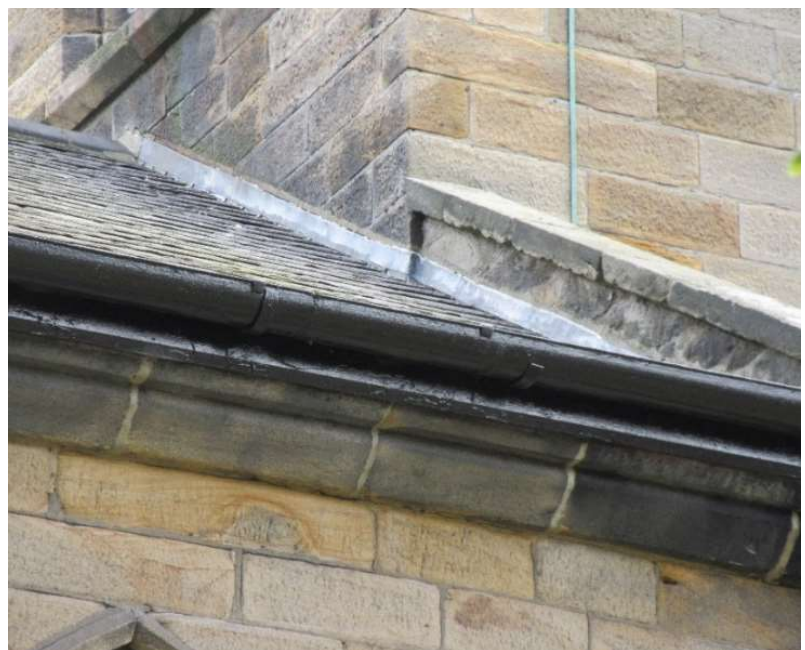
S and W end of Nave

14. The **Nave and Choir** slates are good except at S one is slipped over the Transept.

Repair slipped S Nave slate	14
Break out and recast rainwater dish and ground gutter S of Sanctuary	26, 29
Obtain electrical system test report	88 and Addendum

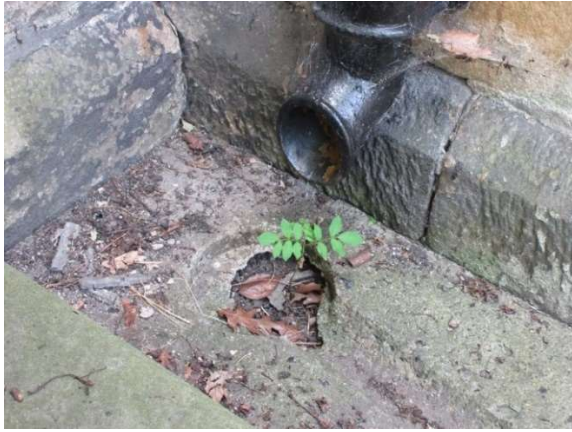
para 26

23. The Tower gutter discharges to an internal plastic hopper and downpipe passing through a louvre onto the Nave roof.
24. All other roofs have large cast iron gutters on modern fascias and 4" round cast iron pipes and shoes discharging into concrete dishes and ground channels, leading onto the surrounding paths and ground. High level hoppers are prone to be blocked by leaves unless regularly cleaned with the gutters.
25. After refurbishment since the last inspection the gutters and pipes are well painted black except a little rust at some pipe backs.
26. The ground channels are mostly clear. At the corner of the S Sanctuary and E Choir the dish broken through, soaking the ground under the wall and now growing a seedling. Reliable concrete repair would be difficult so the dish and ground gutter should be removed and recast as a whole to clear water away from the building.

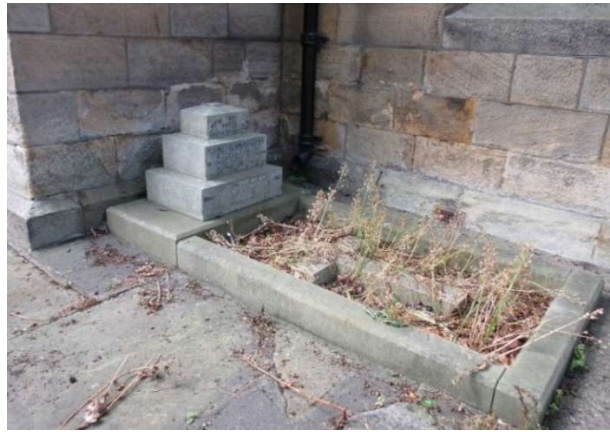
para 29

27. Sandstone ashlar and lime mortar pointing in generally very good condition. Sandblasted clean in 1973. Some loosening of darker repointing over a number of window arches, suggesting past slight movement over the tall openings. So well protected by the eave that they can be left.
28. A few open joints at top of the **E gable** and the E side of the **N gable**.
Minor open joints at the plinth of the N gable and at the **N Sanctuary** plinth.
29. Two courses above the plinth at the internal corner **S of the Sanctuary** are decayed, probably due to rising damp from the broken dish at the ground gutter (para 26). The wall should be kept dry by repair of the gutter.

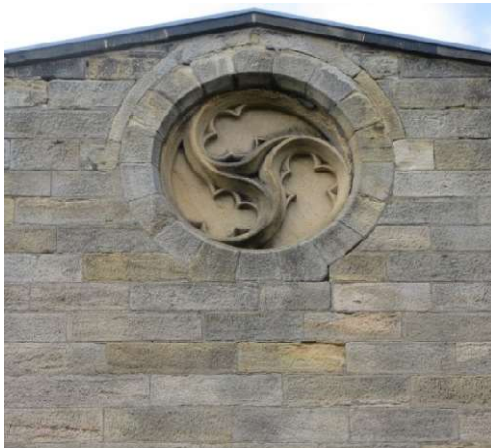
para 30

30. Near the **S Transept** gable peak open joints and some decay in the top of the roundel have not worsened now the coping is covered.
At the gable bottom some stones decay in three courses including behind hard dark pointing which promotes decay in the stones and would be better removed.

Remove remaining hard dark pointing in bottom courses of S gable	30
Increase ceiling insulation on Nave and Sanctuary	52

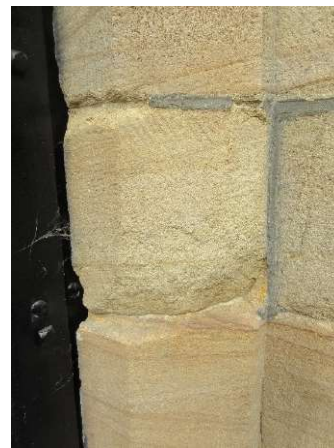
para 45

45. At N Transept door jambs surface decay above step, 5 stones at left, 1 at right.
At S Transept door jambs deeper decay in 6 stones above step and one higher at E jamb.
46. Window and blind openings in good condition except at Nave NE window some cusp decay each side of the mullion.
Part or whole of the outer faces of five window mullions are in renewed sandstone.

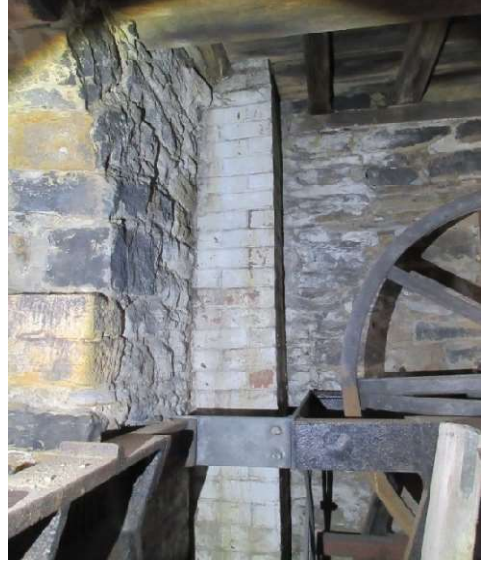
para 36 - Bell stage

35. *The corner pinnacles and merlons are modern. The mid W pinnacle and the mid S pinnacle and its base have old splits but are stable.*
36. Internally damp masonry each side of the brick flue in the SE corner of all stages including damaged painted plaster in the Ringing Chamber and on the Nave W wall suggests a past or present leak. The 2016 photo of the parapet SE corner shows

- the parapet masonry was green, not seen in earlier photos, suggesting the terminal emitted a lot of vapour when working. Unlikely sufficient to dampen the masonry all down the Tower

- parts of the parapet top and inside joints close to the terminal were open
 - the parapet/pinnacle joints, inaccessible behind the terminal, appear open

- mortar flaunching around the asbestos cement flue pot was cracked and may not be well sealed to the parapets
 - the roof gutter end was filled by an active nest. There may now be further build up of nest material, blocking roof drainage.

38. The flue is now redundant. If fully removed above roof level the lead gutter and flashings could be extended into the corner and all inaccessible joints pointed.
39. Lesser damp masonry in the NE corner at Clock stage, under the roof gutter outlet, is little changed.
40. Six bells cast by J. Warner & Sons of London 1880 brought from St Peter's Jarrow were installed 1986 on painted cast iron head stocks and cast iron side frames on galvanised steel grillage, all designed by Eayre and Smith of Derbyshire. Two bells swing N – S, four lighter E – W. Rung occasionally.
41. Four double timber bell louvres all seem sound, covered with chicken wire inside. Bell floor lead covered.

Remove whole flue terminal above roof level, clear nests, extend gutter, add flashings, point parapet	36 – 38, 44, 58, 85
Continue to remove self seeds in graves	106
Repair boundary walls at W	109

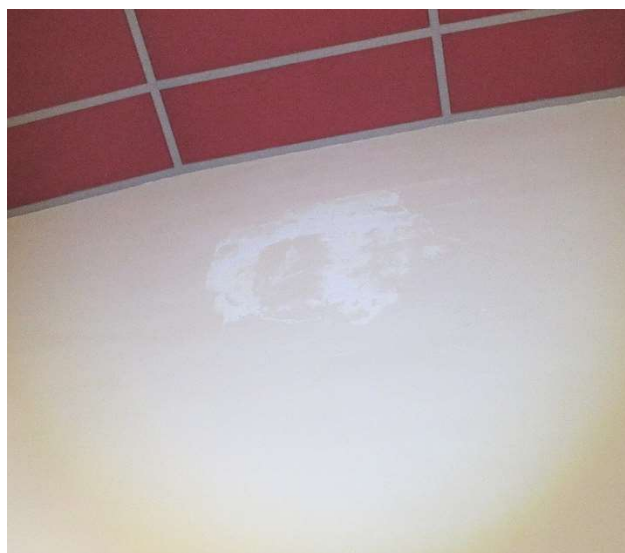
para 37 Nave W wall

37. Further sign of damp masonry in the Tower SE corner is a patch of slight high level plaster and paint damage at the W end of the Nave S of centre, corresponding to high level in the Ringing Chamber SE corner.

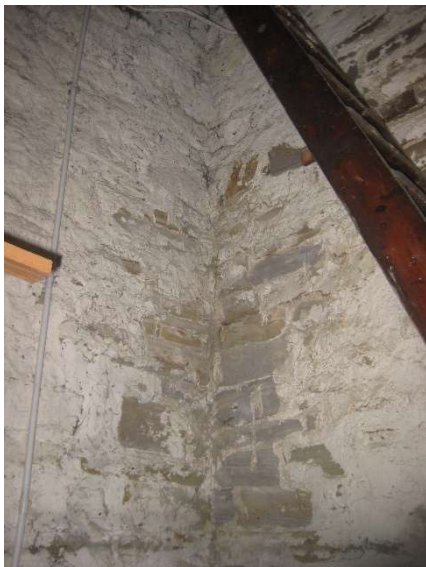
NE corner of Clock Stage

42. At Clock Stage the middle of the E wall plate and one joist end under the bell floor are worm holed. May be associated with earlier damp (stained timber now dry) perhaps from the time of the rot outbreak in the Tower.
43. Clock by Wm Potts of Leeds 1883 in timber case with glass doors, electrified and maintained by Cumbria Clock Co. At three sides painted cast iron dials, gilding mostly lost, with opal glass except S face opal polycarbonate fixed across the inside. Each lit by single spot.
44. Ringing stage has ply ceiling under the modern timber floor of the Clock Stage. Walls painted plaster, sound except a hollow part with a vertical crack near the rounded SW corner. Water damage of plaster and paint at SE corner around the plastered brick flue increased since last inspection. Carpeted. Infrared wall heater.

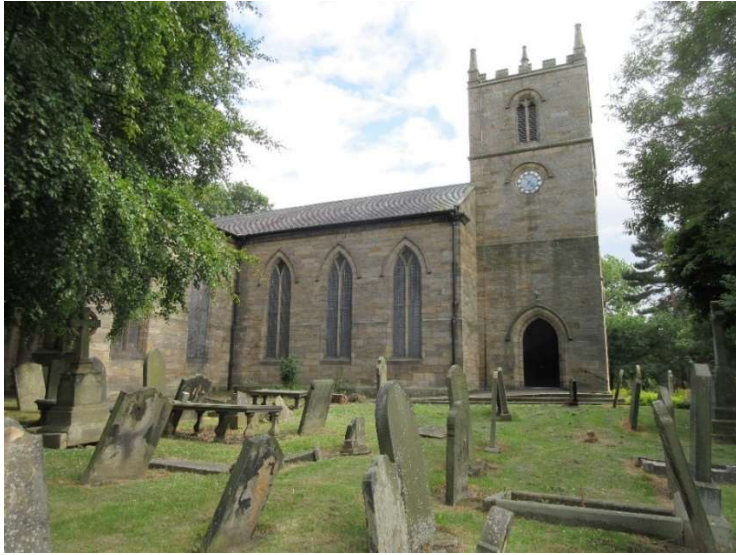
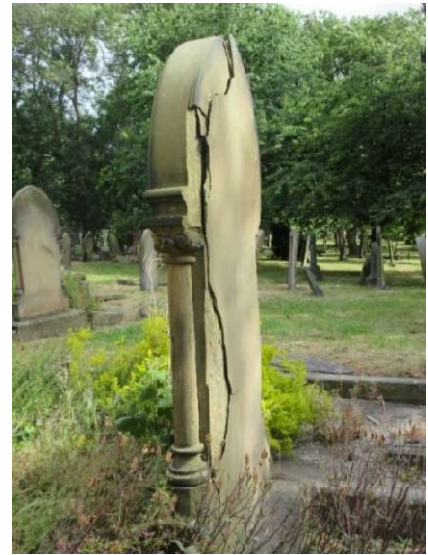
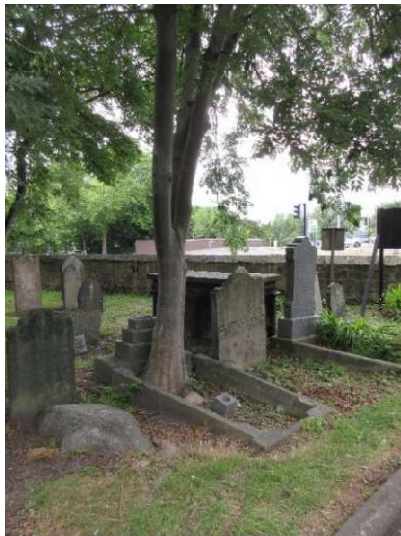
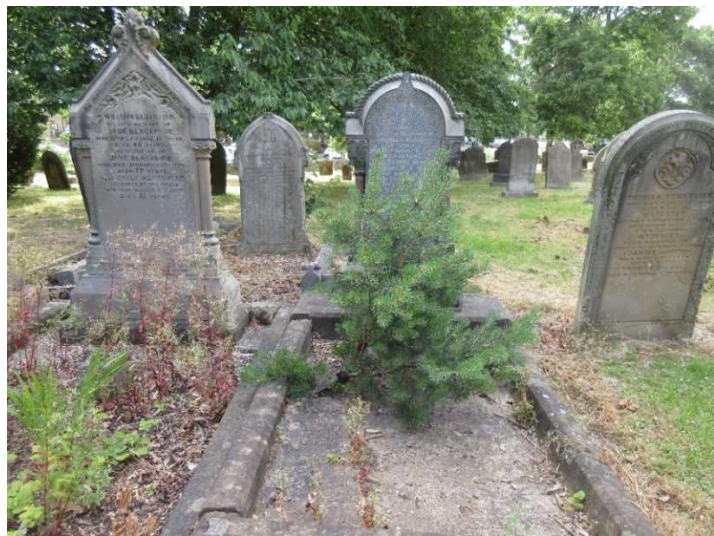
106. An ash tree still grows through a kerbed grave close to the path SW of the Lychgate. Unless removed it will cause more damage in time. Self seed saplings growing out of some graves should continue to be removed before they disrupt the graves further.

trees disrupting graves
