**St PATRICK  
HIGH SPEN**  
(22A)

**QUINQUENNIAL REPORT**  
on the architect's inspection on

**8 May 2018**

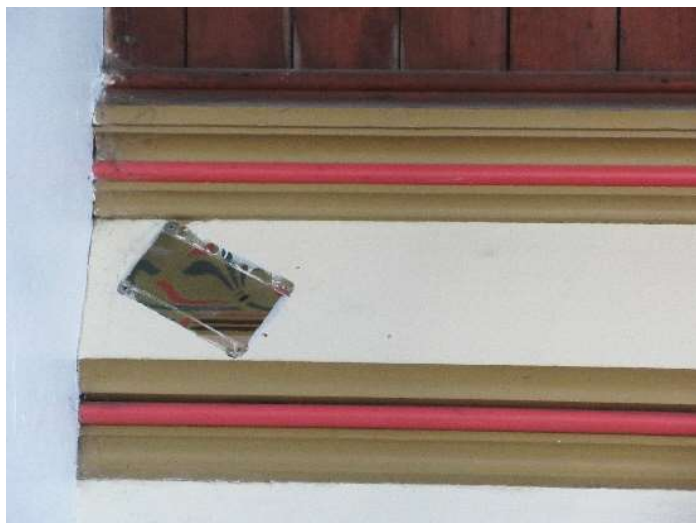
Present frieze colours in chancel with fragment of stencilling

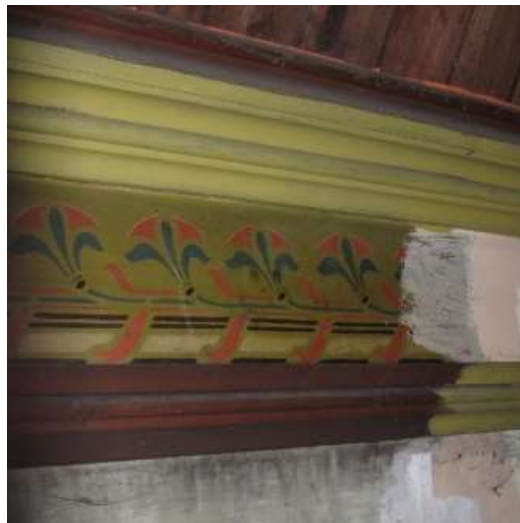
Part of stencilling remaining behind organ

48. Plaster damage remains unchanged at the inaccessible walls behind and left of the organ. It appears the gutter and buttress repairs may have stopped the damage but observation should continue.

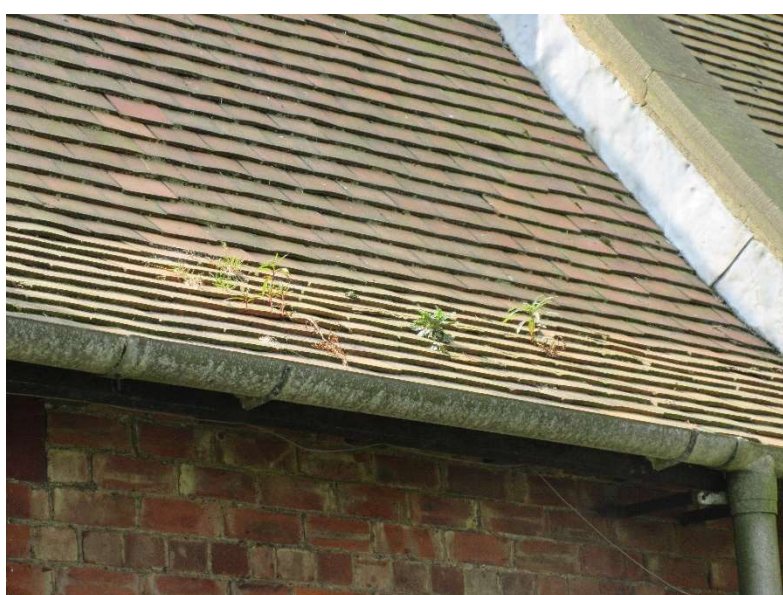
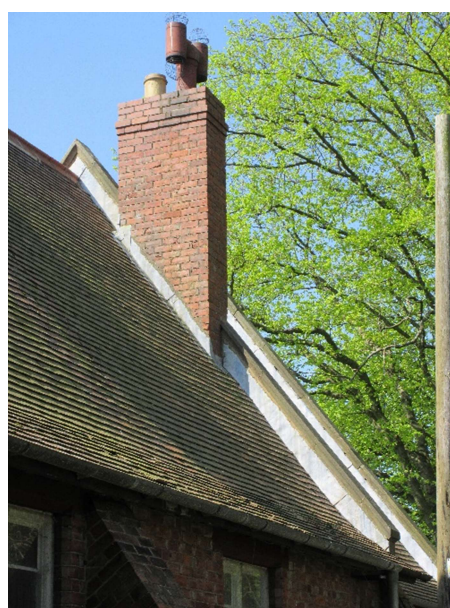
14. On the **main S slope** two tiles at Chancel and three at Nave are broken across and numerous scattered tiles have broken corners or decayed spalled tails especially near the Nave eave.

**N slope** similar with two broken across under the turret. Several broken tiles close to the E gable upstand and two other Chancel tiles broken.
15. The shady **N side** is further shaded by a large sycamore. Moss and small plants grow in some joints, mainly near the W eave. The plants will not grow much more but tend to build up soil between the tiles and may speed decay. Pruning of the tree may be justified to reduce overshadowing.

Point E gable watertables and peak brickwork	12, 31, 32
Replace broken roof tiles	14, 16
Check all E gable plaster, repair and decorate	46
When due obtain periodic electrical installation test report	80 and Addendum
Replace sign board	93

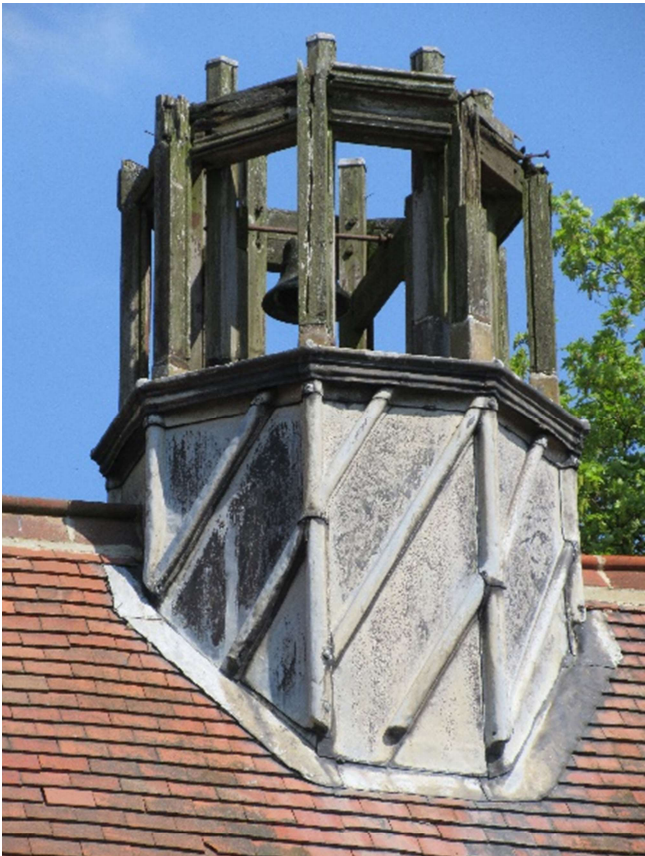
from S

19. The turret roof has been removed, exposing timbers and bolts meant to be sheltered. The bell and its internal rope remain. The bell is rung, to public approval, after the clapper was refitted since the last inspection. The inner posts appear to be lead capped and not obviously decayed though weathered. Decay in the outer ring of posts and the beams between advances from the exposed end grain. At least one of the outer posts shows past splice repair. Some repair timber lost since the last inspection.

21. The bell will fail again and the remains will eventually decay away unless all stump timbers are properly capped or, better, the turret reinstated. A drawing of the complete turret was found in records in the vicarage so accurate reinstatement would be possible. The weathercock stands in the basement.

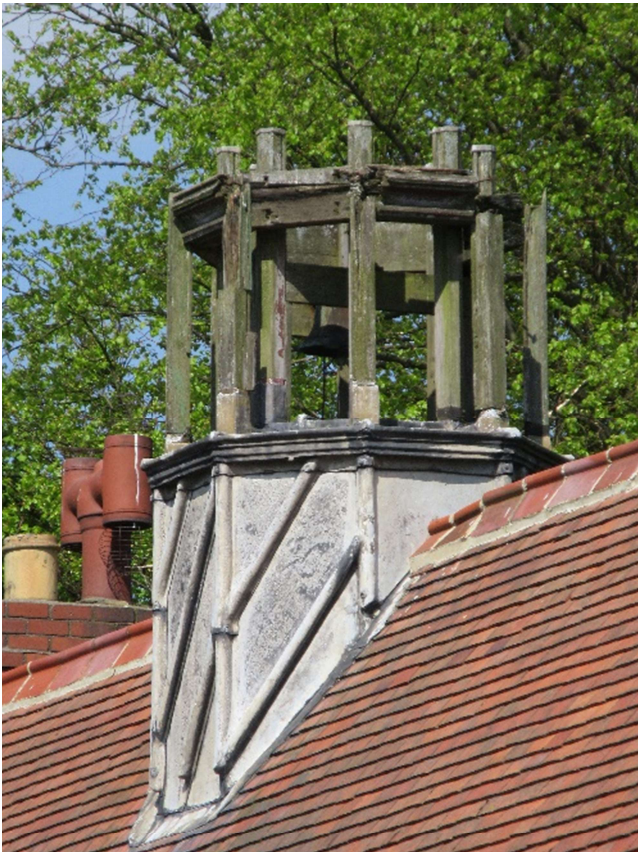
from SE

22. The truncated appearance and decay are unfortunate. If left long term the timbers are unlikely to cause injury when they fall but might damage the roof. If decay reaches lead cap level the roof timbers could begin to be affected.  
The church being unlisted limits the charitable trusts which might support such efforts but enquiry might be made if there is local support.

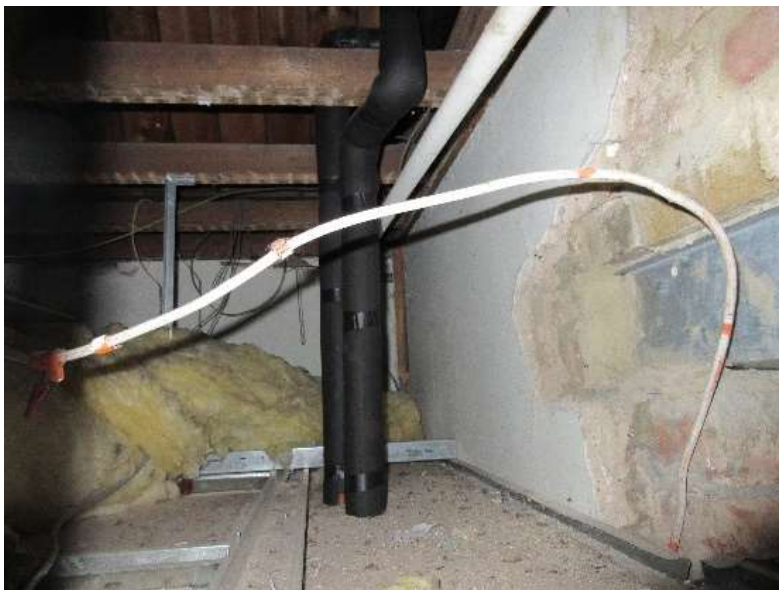
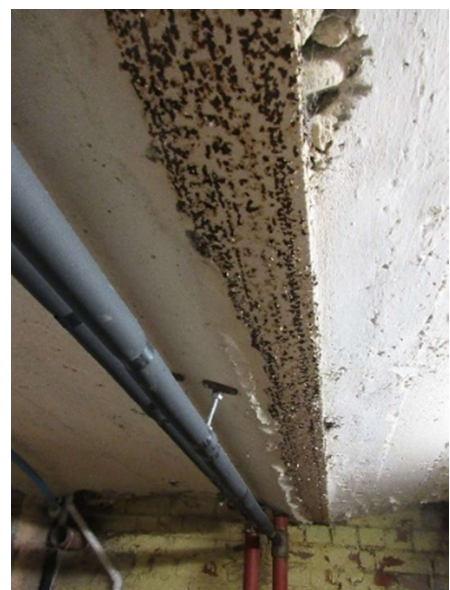
Insulation quilt not relaid over ceiling N of the wc steels at boiler ceiling

- 44. Boiler room ceiling is vaulted in-situ concrete on two steels whose bottom flanges are rusting.

Prepare and paint rusting straps at downpipes	23
Wire brush and paint steels at boiler room ceiling	44

Relay disturbed insulation quilt over part of the W end	43
Reduce soil level in the bed nearest the entry door	49
Consider adding dado boarding in the Porch	49
Clean between the glass and polycarbonate and inside the glass	59, 61, 62
Improve hot pipe lagging in boiler room	78
Re-erect Wilson cross on relevelled base	95

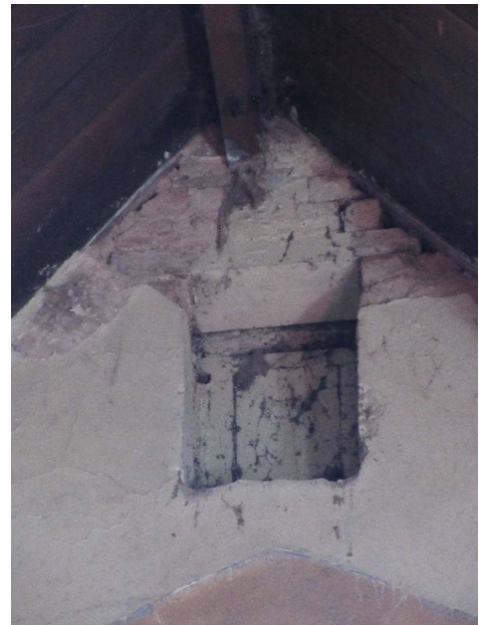
46. Chancel plaster fair. Slightly hollow at the NE corner and mid N side. At high level at the E gable some plaster now missing at the peak (para 31, 32).

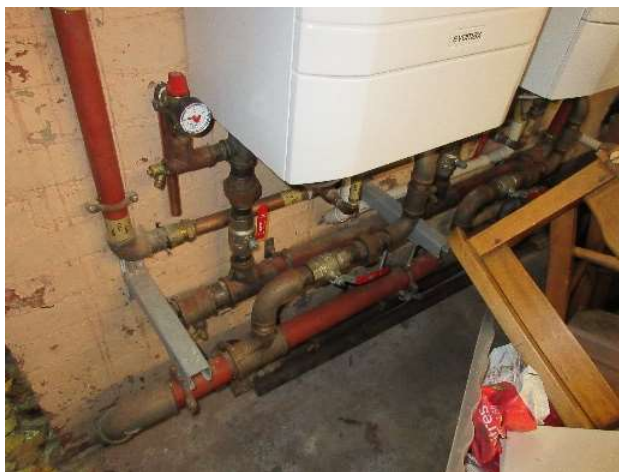
Scope for economy by more lagging at boilers

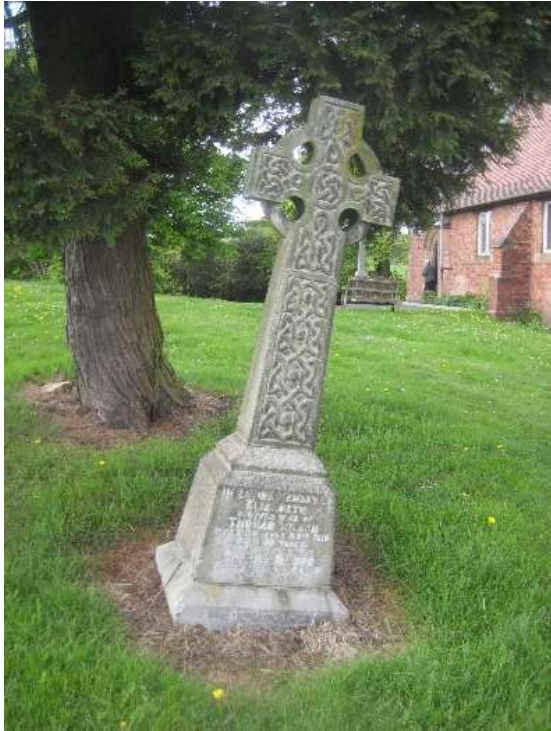
2013

93. Painted timber notice board is now decaying. Might be replaced with new timber on the existing aluminium legs or with a new longer lasting printed metal sign.
94. Large sycamore between the N side of the church and the former vicarage garden, overhanging the church a little. A horse chestnut by the access and tall limes by the war memorial.
95. The few headstones, mainly at E and N are in fair condition.  
 An isolated 'Stewart' stone S of the church entrance will eventually be overturned by a tree growing tight against it.  
 A tall 'Wilson' celtic cross S of the Chancel leaned at the last inspection, perhaps due to the roots of a fir tree close by. Now lying flat. Not known whether it was laid down deliberately. It now impedes grass cutting and is a loss to the quality of the churchyard.
