**JARROW GRANGE
CHRIST CHURCH**
(109)

QUINQUENNIAL REPORT
on the architect's inspection on

11 August and 14 October **2017**

IAN NESS
ARCHITECT

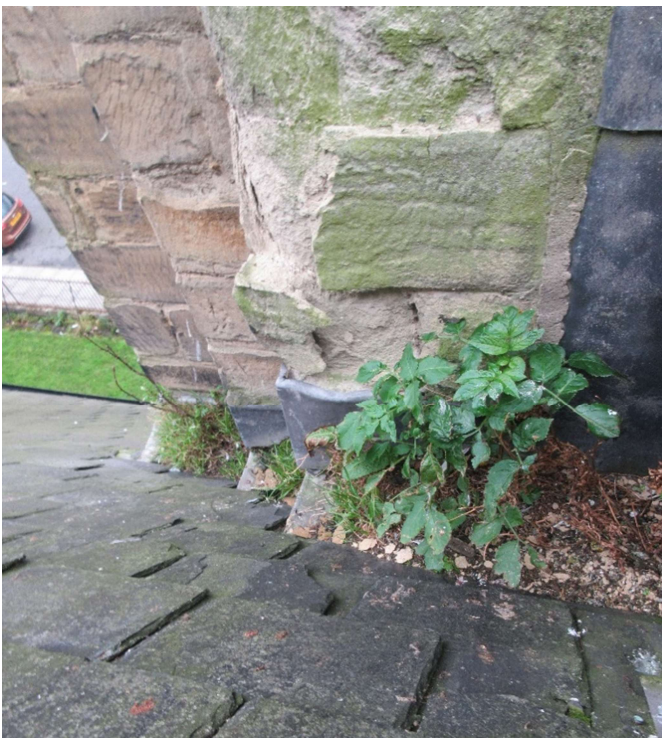
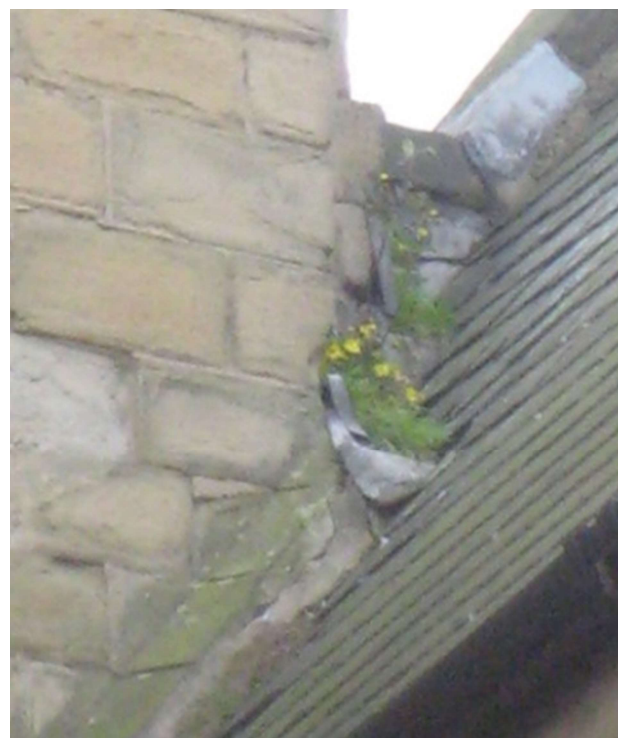
18. **Nave** welsh slate with mortar fillets under the stone watertables. Some lost mortar under the SW watertable.
Lead flashings around the chimney may be coming loose. A small plant grows in the slates next to the chimney.
The slate fair with some clipped repairs. Some broken against NW watertable. One N slate slipping under middle of ridge. Large numbers of N side slates held on an unknown material (resin?) in slate joints below, perhaps one of the recorded storm damage repairs.
19. Where the Tower intersects the Nave roof plants still grow in silt part blocking all the back gutters.

Blocked back gutters between Tower and Nave and deep decay at Tower SW buttress masonry

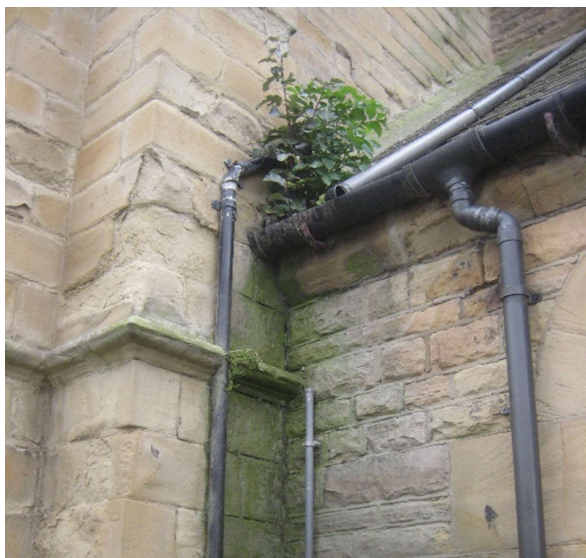
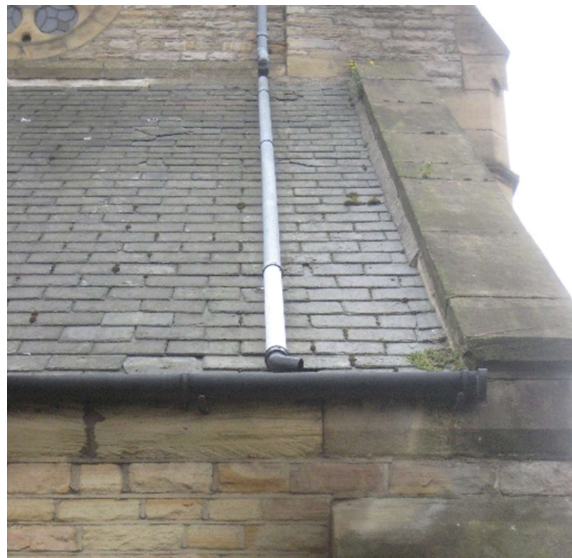
24. A sapling is rooted into the roof itself against the Tower. Past blockage here has caused leaks.
25. **Chancel** slate fair with lead soakers and flashings where it abuts the nave. About half of the mortar infill under the gable S watertables is falling out. N slates fair. One S slate missing, one slipped close to ridge.

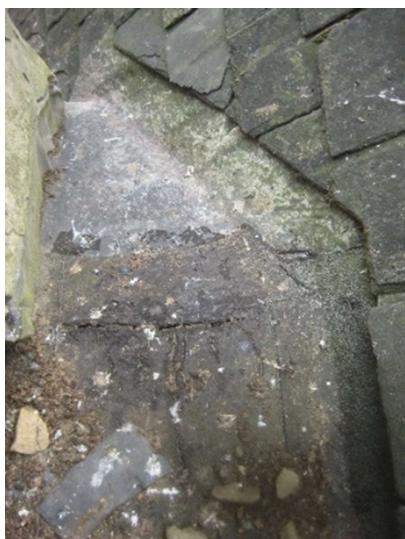
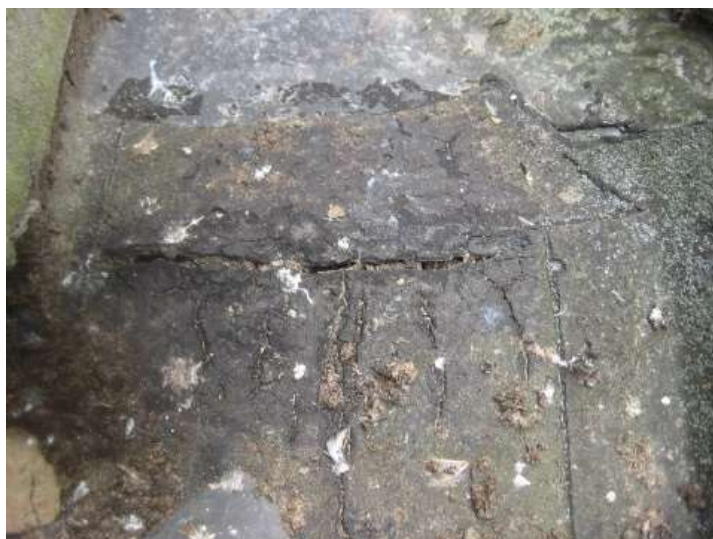
26. Between the N Chancel roof and the Tower a wide abutment gutter, open at one end, discharges over the Chancel slates. The gutter must have been lead lined on boards but is now aged felt on chipboard, cracked across where it discharges. Deep silt (including stone debris from the Tower and plant growth) has just been cleared revealing a fist sized hole through the gutter. A large Flashband patch laid over the hole is not adhered and so has no effect. The accessible timbers under the hole are saturated and there is high risk that the adjacent concealed Chancel truss end will rot causing very expensive repair unless all wet roof timbers are removed and the whole gutter (boards and lining) is renewed in lead to highest standard.

27. Some damage at sloping ceiling plaster suggests water is already in the joists and perhaps down onto the concealed wall head. The organ itself may be at risk.

Repair gutter and underlying timbers between Tower and Chancel	11, 17, 26, 27, 72, 75, 82
Remove sapling from slates at E end of N Aisle	24
Repair two S Chancel slates	25
Repair Aisle gutters and the pipe across the NE Aisle	29, 31
Clear rainwater pipes and gullies both sides of Porch	32, 33, 75, 79
Begin structural engineer's monitoring of movement in the Tower	35 - 39, 42, 46
Change white light and failed lamps	113

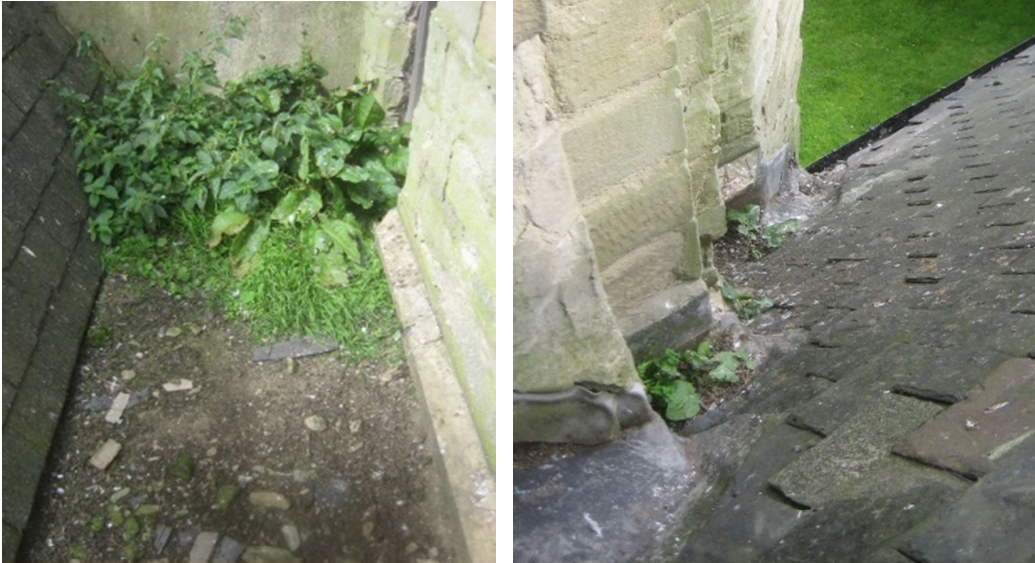
Abutment and Tower SE gutters before clearance October 2017

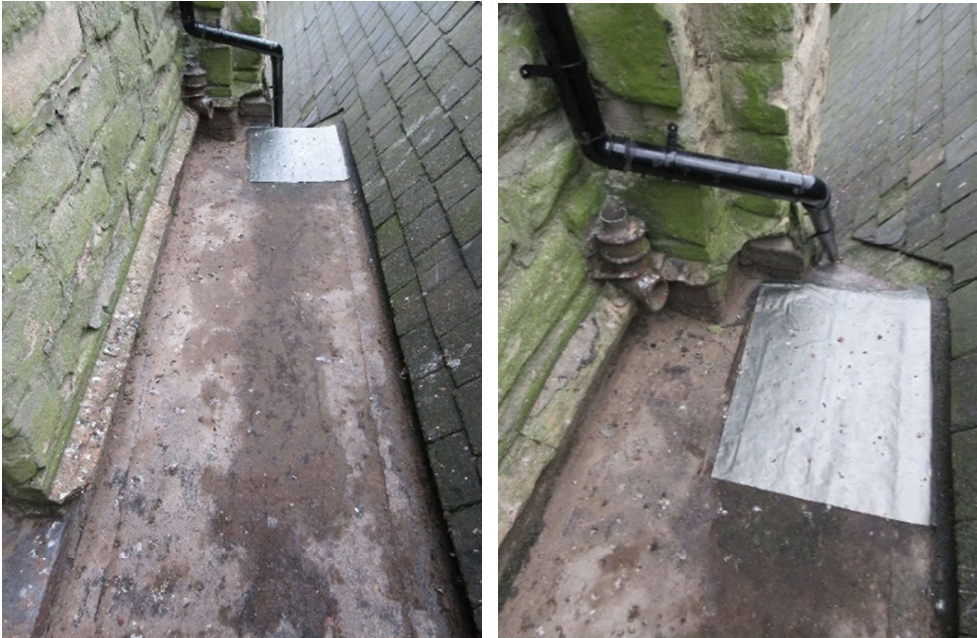
14 October 2017 after clearance

28. The gutter discharges by a series of complicated flashings and back gutters around the Tower SE buttresses, also just cleaned of silted and plants which prevented good drainage into the Chancel eave gutter.

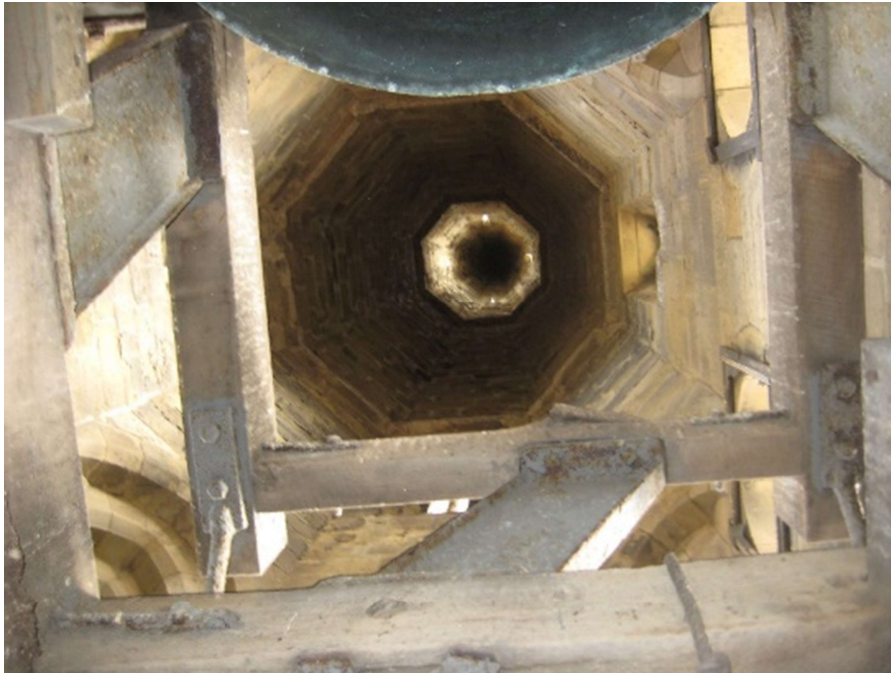
Upwards from Belfry through bell frame into spire

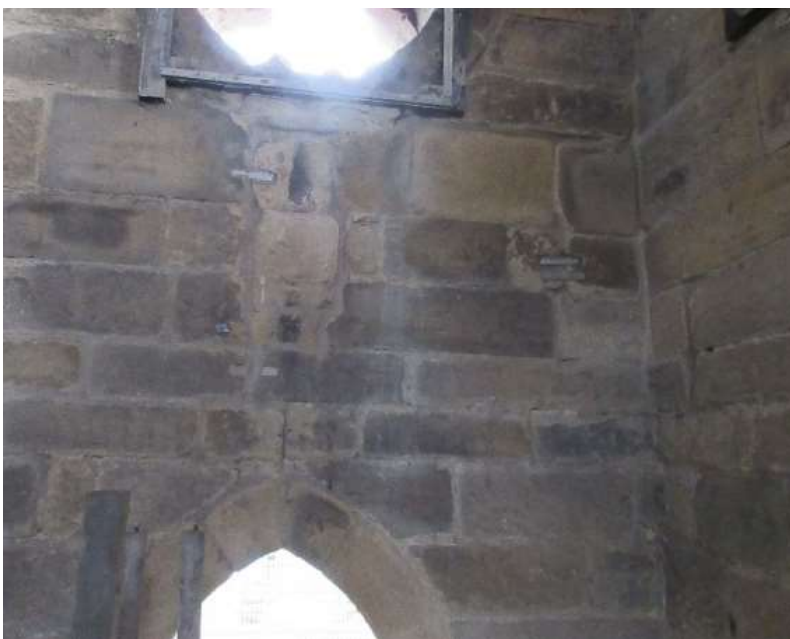
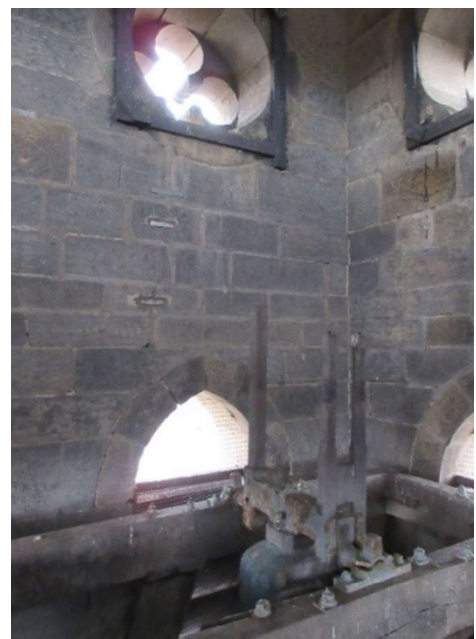
35. In 1992 vertical cracks in the NE and SE corners of the Belfry and between 5 of the 8 pairs of bell louvres and round openings over were repaired by resin filling and one or two heavy stainless steel staples (9 total) across each. Glass telltales across some cracks, which appear intact so movement at Belfry level appears stopped.

1992 stapled cracks between Belfry openings

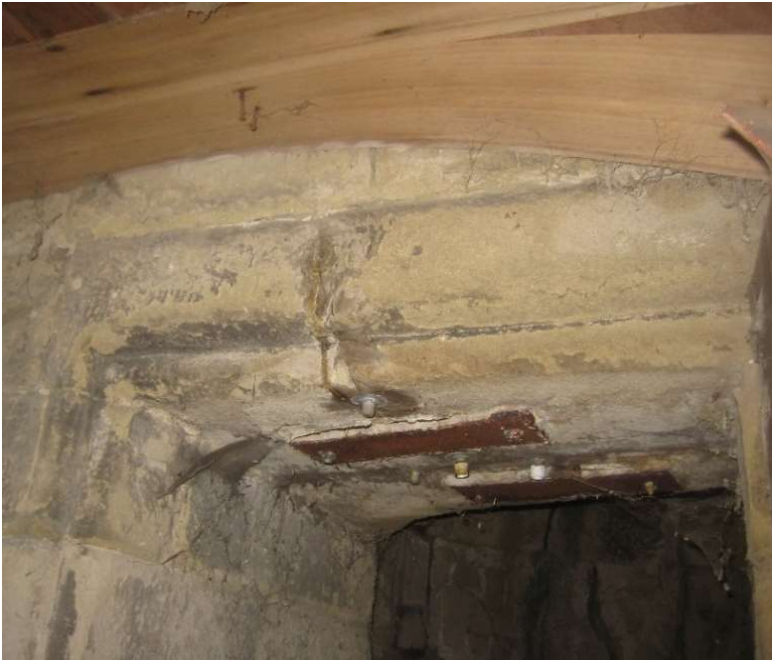
37. Top Chamber sound except a vertical crack through the E door lintel widest about 5mm at top. Resin filling in the vertical crack is cracked. Now also a minor vertical crack on the lintel's stair side. Lintel reinforced in 1992 by two rusting steel plates pinned underneath into resin. The plates are coming away from the lintel. Without accurate telltale comparison with my 2012 photos is not exact but it appears very slight movement over the door continues, complicated by rust behind the mild steel plates which may be forcing them off.

Rusting plates across cracked lintels at top of spiral 2012

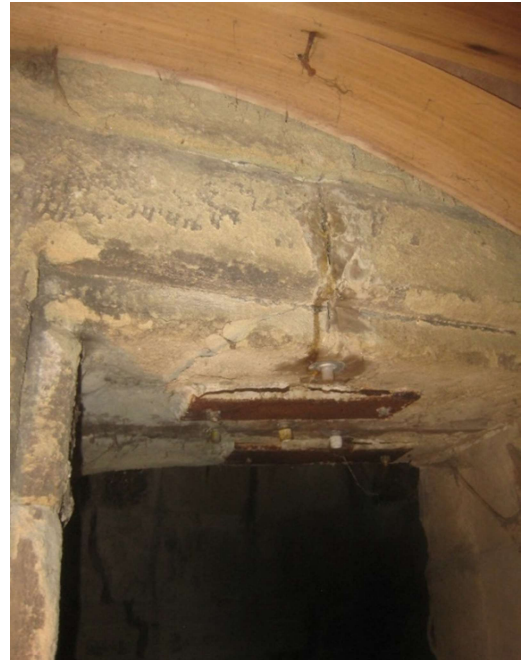
2017 – cracks wider than 2012?

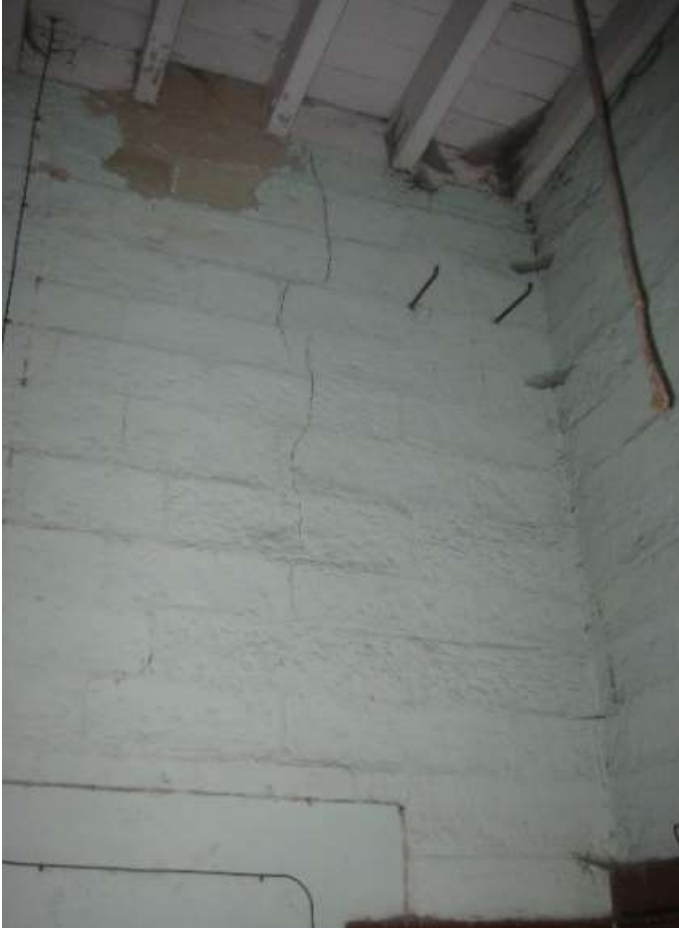
38. The Ringing Chamber below is whitewashed ashlar above a painted dado bottom half. Mainly sound.
At E wall a vertical crack through joints and stones at the top half of the wall backing onto the spiral stair, seems unchanged.
At the W wall two cracked joints in the window arch and joints in each of the four courses above suggest slight spread of the wall.

crack in ringing chamber 2012

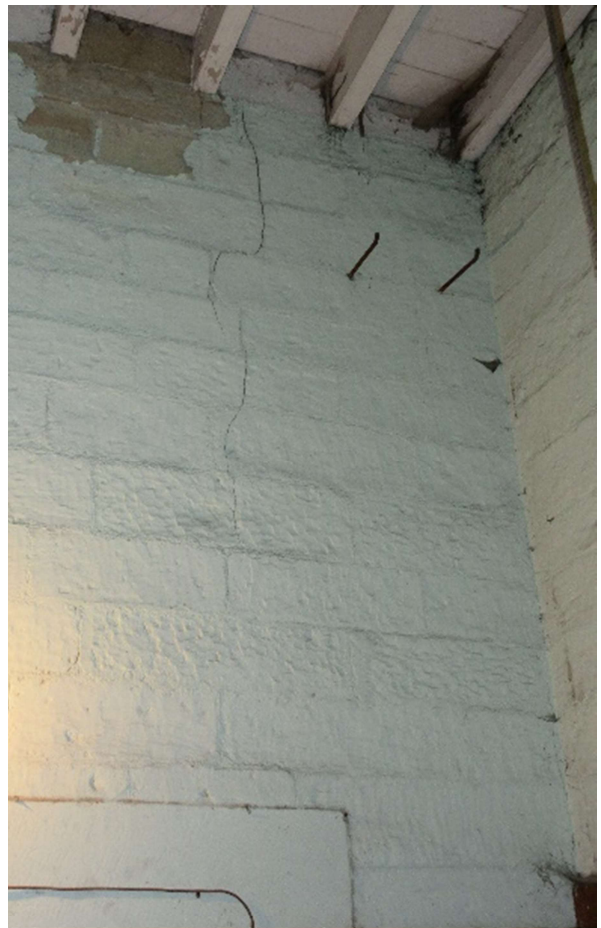
2017 unchanged

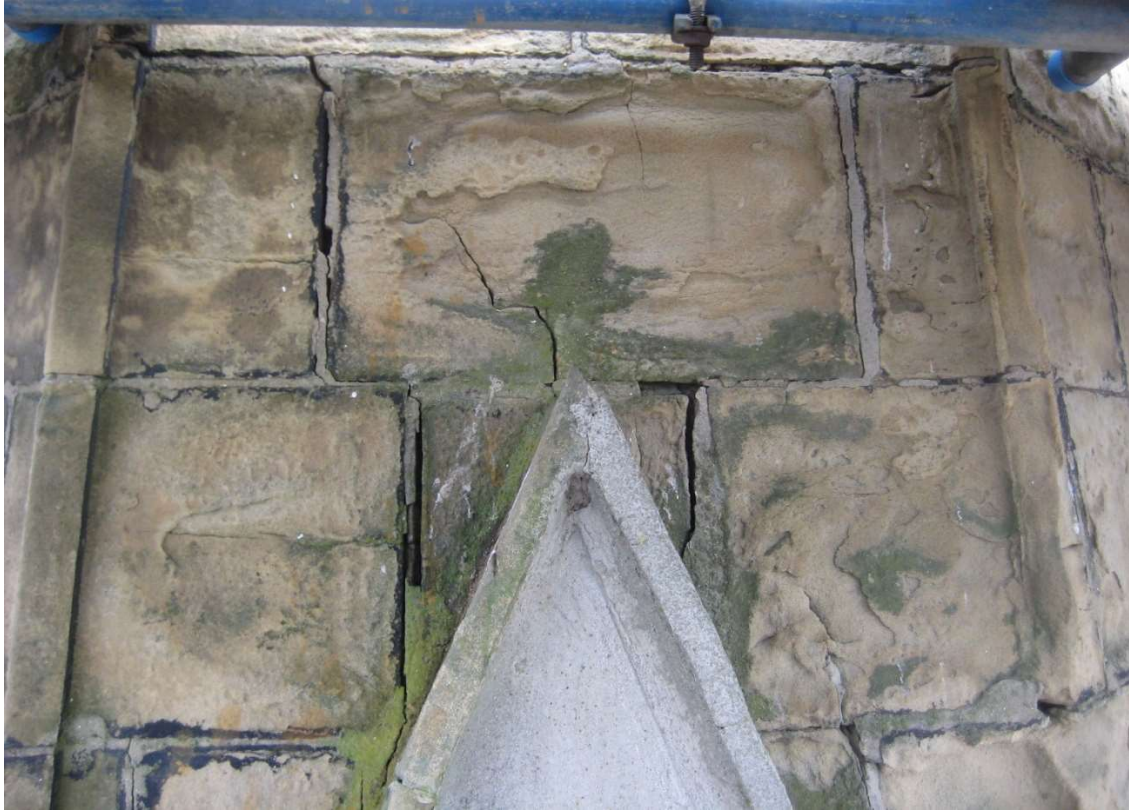
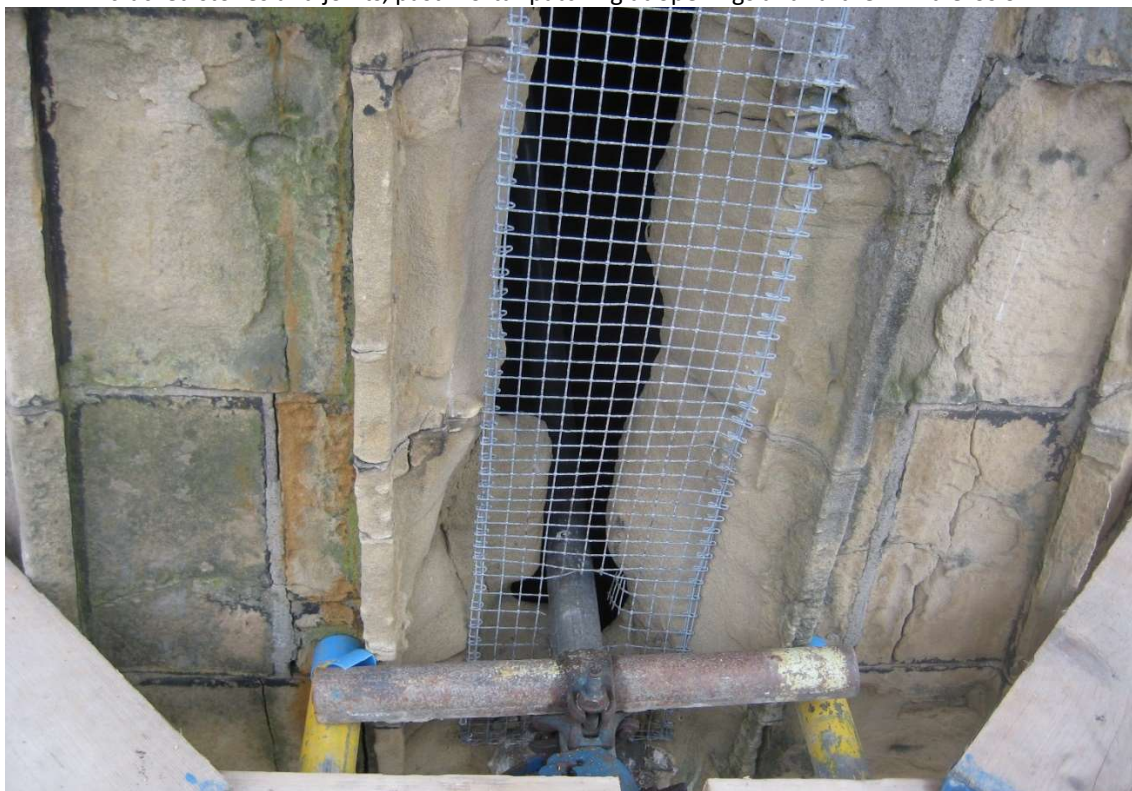
Fair condition overall but a significant number of stones and mortar joints at lower W, SW and S are cracked, exposing openings to erosion by wind and rain.

40. Patches of Spire stones have lost surface and carved detail. Most loss at W and SW where most driven rain. Cement mortar patching around several of the slot openings where decay advances due to wind scour through the openings.

COMMON SPIRE DEFECTS 2011 photos –
cracked stones and joints, past mortar patching at openings and further wind erosion

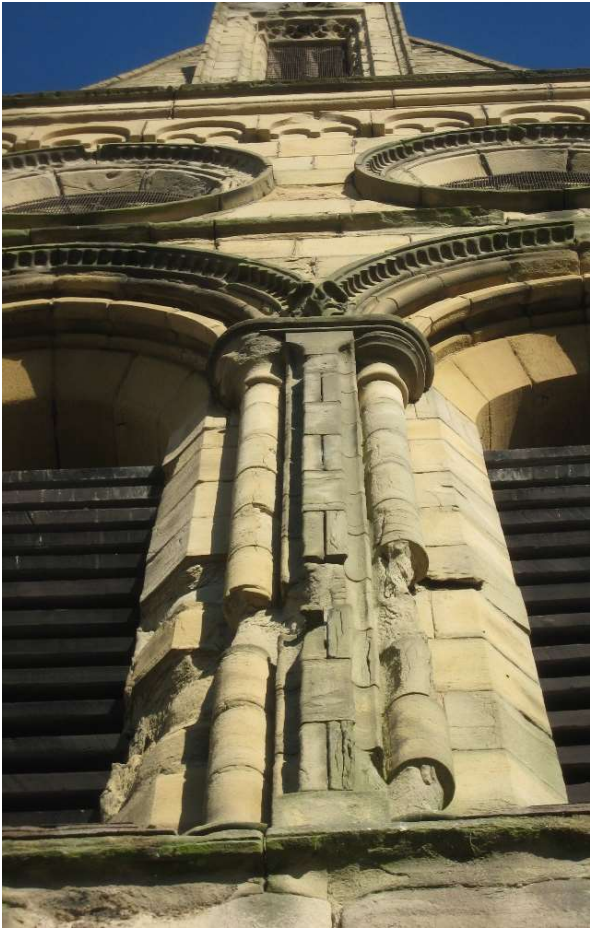
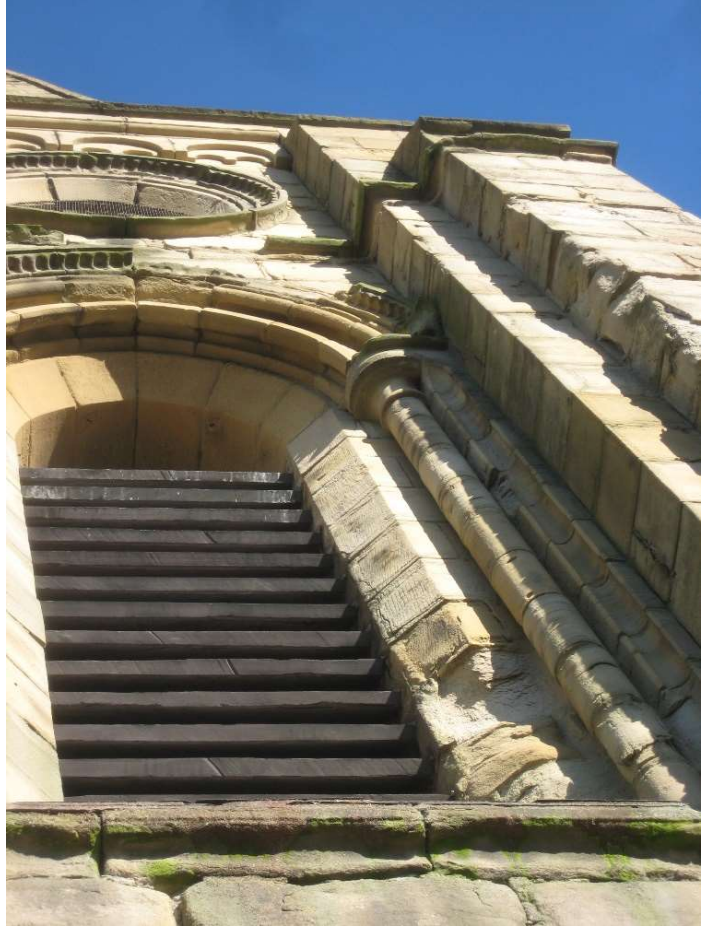
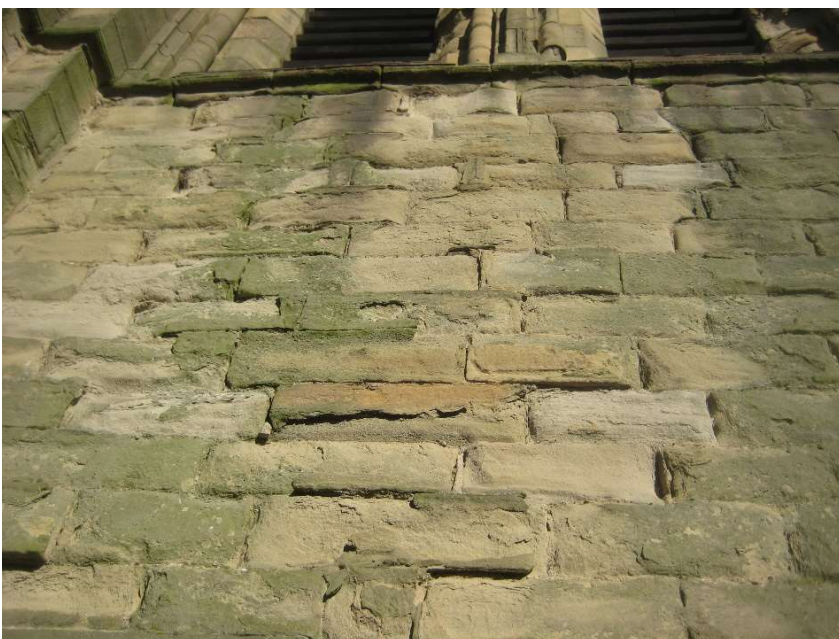
S of Tower

49. **S of Tower** (facing Chancel roof) continues to decay slowly. The protective top string course is about 30% missing. Below the Belfry the walling surface is all weathered away and many joints opened by deep erosion, especially around the door into the abutment gutter. Stone debris adds to the gutter blockage. The SE buttress is most exposed to wind scour so most eroded. Large parts of the reveals, mouldings and shafts in the Belfry openings are now missing.

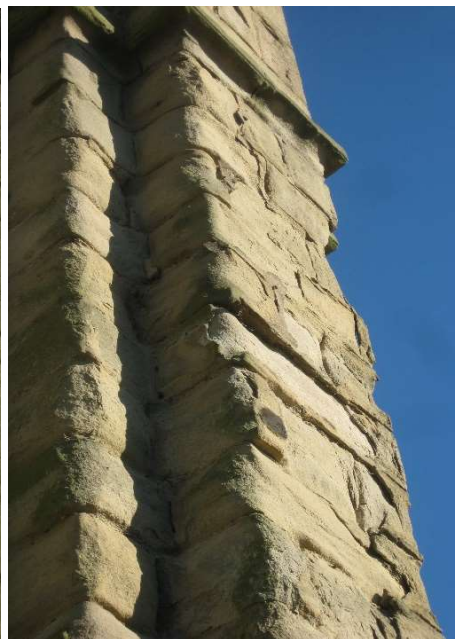
SE buttress

48. Erosion is deepest under the Belfry openings and at the SE buttresses facing the Chancel roof. The rendered repair of the top stage of the spiral stair turret looks sound though not well matched in colour. A tree grows again where silt is trapped between the turret and buttress.

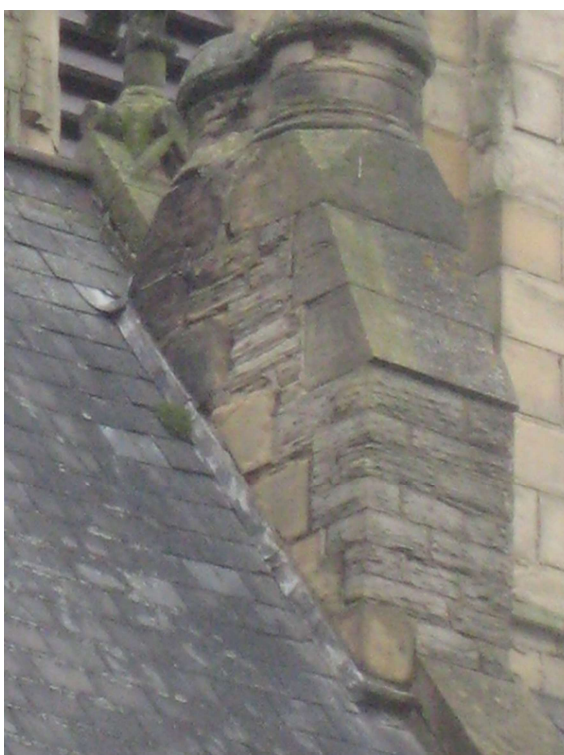
58. The **Nave** E gable S side (above the Chancel roof) and especially the W side of the chimney have many open joints which should be deep raked and repointed in medium strength mortar.

Plant in the slates and open joints at Chimney

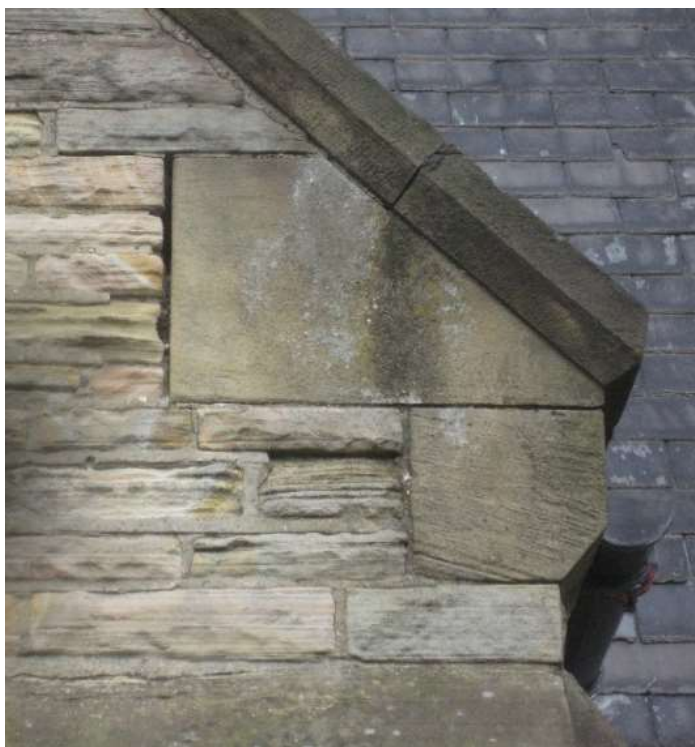
Open joints around the SW kneeler
