**St JOHN the Baptist JARROW**  
(106)

**QUINQUENNIAL REPORT**  
on the architect's inspection on

**2 July 2018**

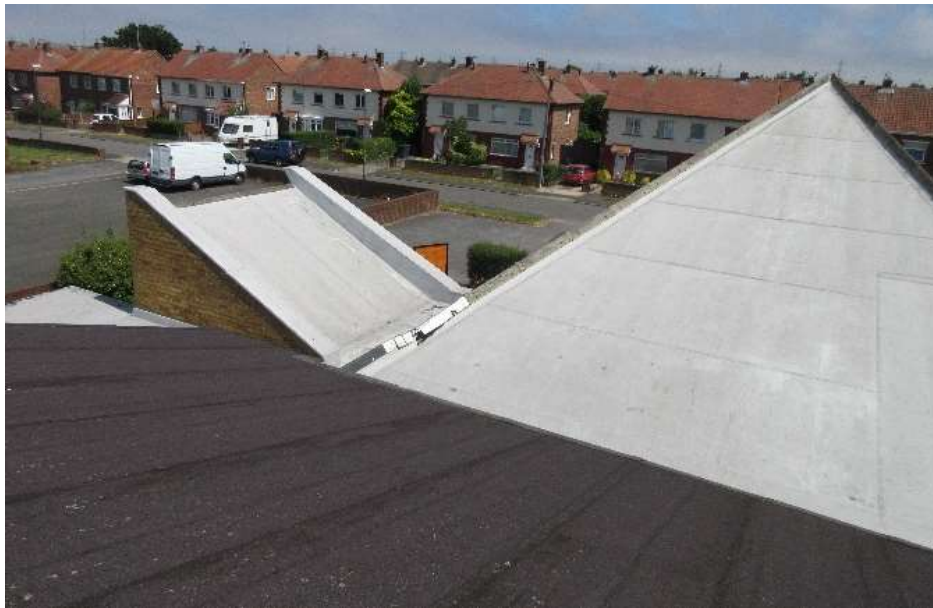
the hidden Sarnafil coverings on the Church hip and Porch from the Hall roof

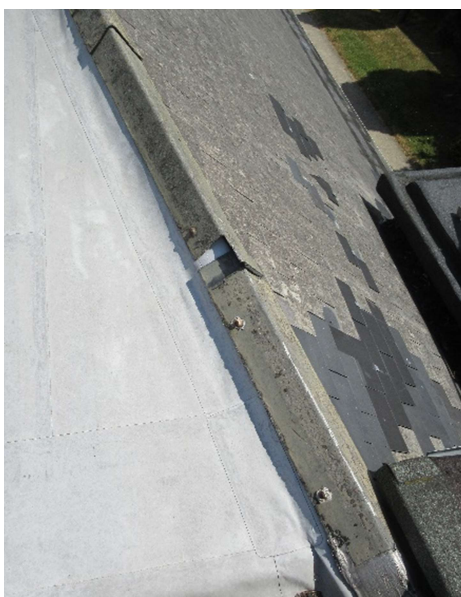
Gutter hidden under flat roof edge (para 16)

16. The S slates have a narrow gutter butted against the SE lobby, under its felt overhang. It appears sound though neglected and again contains debris.
17. Where the N slates meet the side of the Porch a thin substitute cover flashing is stuck to the slate and brick surfaces instead of being turned into joints. Its open top edge has been sealed with mastic, part missing.

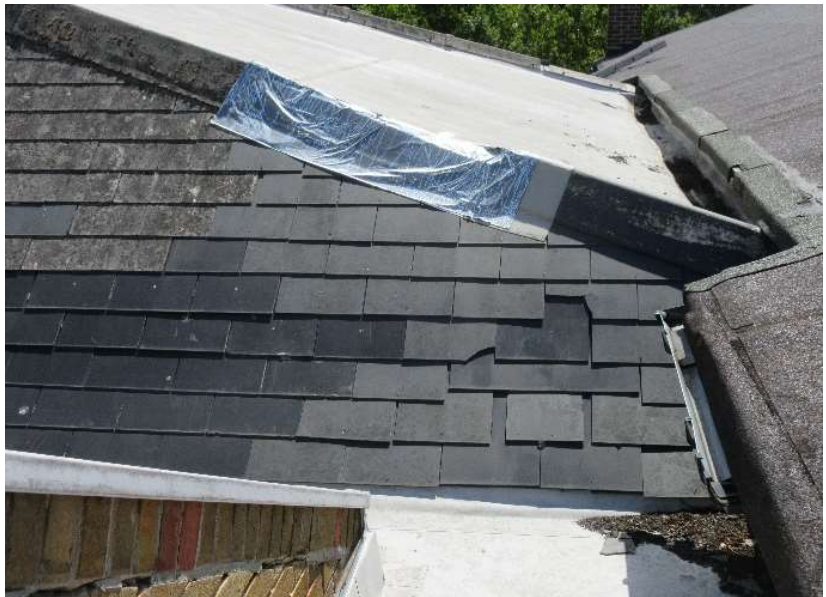
12. From a short E ridge fall two visible side slopes and a shallower hidden hip. Rather crude ridge tiles meant for monopitch roofs cover the hip angles, joined to the ridge with a Sarnafil patch. One hip tile has a broken end. Another broken hip is patched over with flashband, itself repatched and now split.

Internal gutter between Church and Hall  
Broken tiles at both hips, one patched with flashband

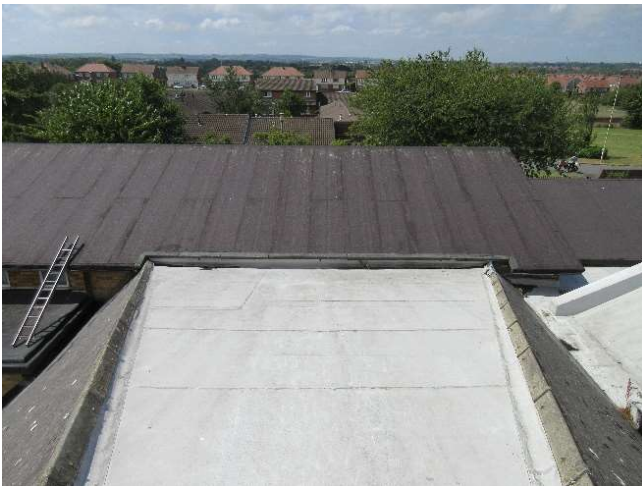
13. The Church's hidden hip and box gutter are covered in Sarnafil pvc membrane over earlier felt. The gutter drains the large hip and part of the Hall through four bottom outlets to two boxed internal pipes. Most of the silt and plants in the gutter were cleared off at the inspection but two blocked pipes could not be cleared without tools. Full clearance and water testing to manhole is recommended.

Internal gutter between Church and Hall

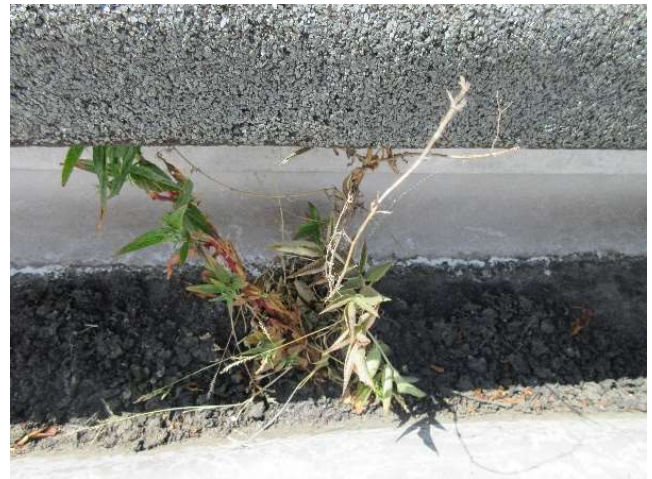
Plant in a gutter outlet before part clearance at the inspection

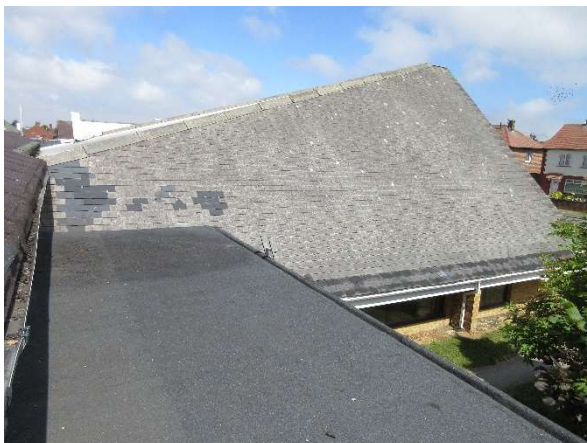
Narrow hidden gutter where the Church S slates butt to the flat roofed SE entry (para 16)

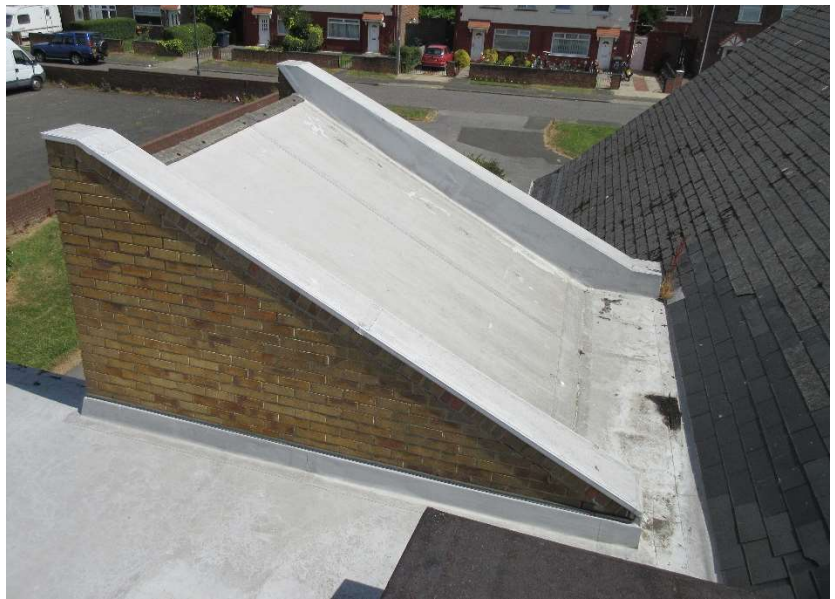
para 18

18. The internal gutter between Porch and Nave makes easy access for climbers. Less silt in the gutter than in the past but enough remained at the narrow E outlet for a plant to be well rooted into the silt and under the slates. Plant, a drinking glass and silt removed at the inspection but some stubborn roots remain either in a Sarnafil joint or under the slates. Clearance at least once a year is essential and removal of some slates to remove remaining roots may be needed.  
The plant was not over the reported leak (other side of Porch) but it could have dammed water causing occasional overflow.

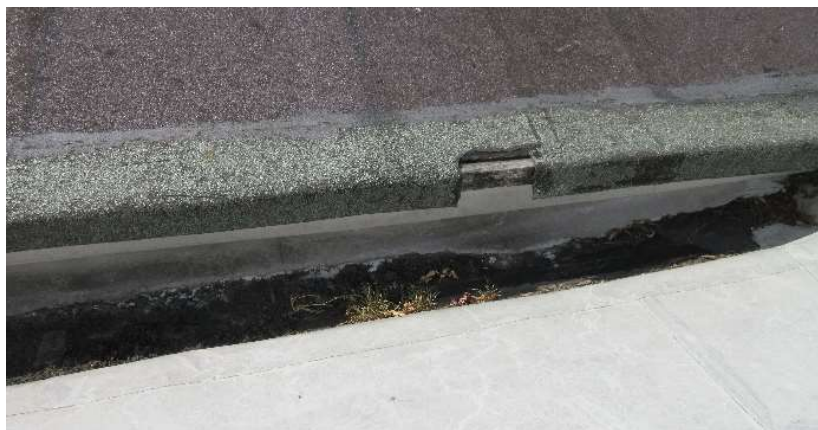
20. The pitched **Hall** roof with wide eave and gable overhangs (originally copper covered) has well laid grey mineral felt on woodwool slabs. The ridge and verges have been patched with new upstands around the chimney and the roof is good overall.  
A remaining defect is a missing short length of eave drip over the Church box gutter exposing the timber edging.

Missing felt at drip and plants in the silted box gutter

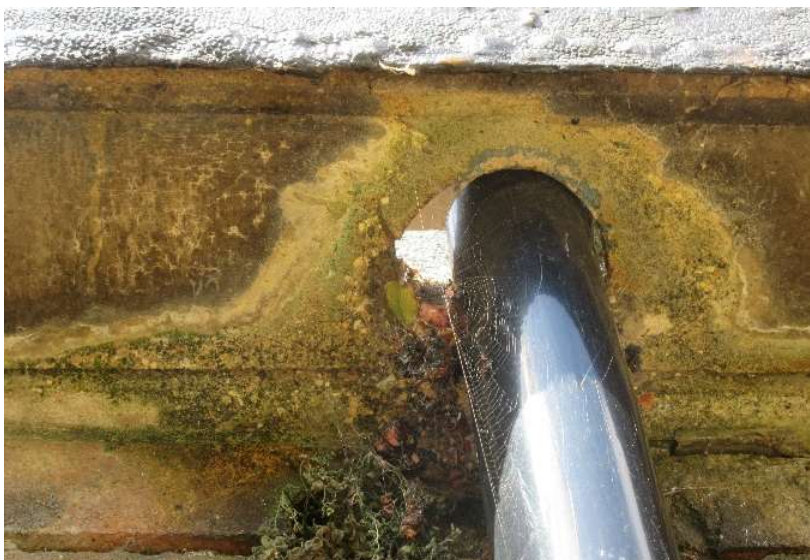
para 28

28. The downpipe in the garden S of the Kitchen has been renewed but not connected to the gutter felt so water must spill down the wall and around the outside of the pipe. The corner brickwork remains soaked. Very poor work.
29. The Kitchen sink waste pipe is missing so more soaking of bricks.

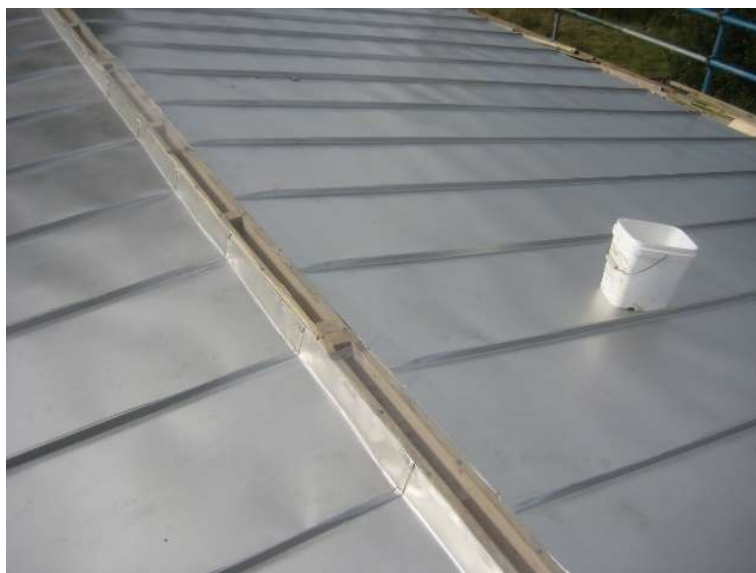
During laying on a shallow pitched roof. Stainless at the steeper roofs at St John would look similar.
