**QUINQUENNIAL INSPECTION REPORT
OF
JARROW, ST. PAUL**

**DIOCESE OF DURHAM
ARCHDEACONRY OF SUNDERLAND
DEANERY OF JARROW**

QUINQUENNIAL INSPECTION AND REPORT

December 2020

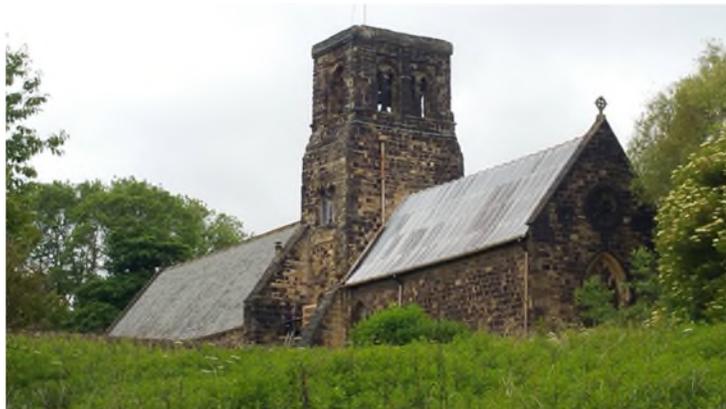
Since the last inspection the fundamental defects still remain and it that there is a little more opening up of the S W corner, midway up the tower, adjacent to the south window. It could be that a limited piece of work could be done here, just repointing and to use the repointing as a crack indicator to judge future movement but that does not remedy the underlying defects. With scaffold up to do just that one begins to think that perhaps the opportunity should be taken for other (once in a generation) works and if so, we would then recommend all the proposed structural repairs and also repointing the tower (and resetting the parapet gutters to fall better).

We reported in 2018 that it was hard to suggest a figure without further technical development but that you should budget for c.£85 - 145,000 ex vat and fees for the full scope of work above. Perhaps just a bit of scaffold and a repoint of the sw crack would be - say, £25,000. Christopher Downs also produced a repair specification following engineer review for the sw corner in June 2011 which received the support of Historic England. Did it ever go out to tender?

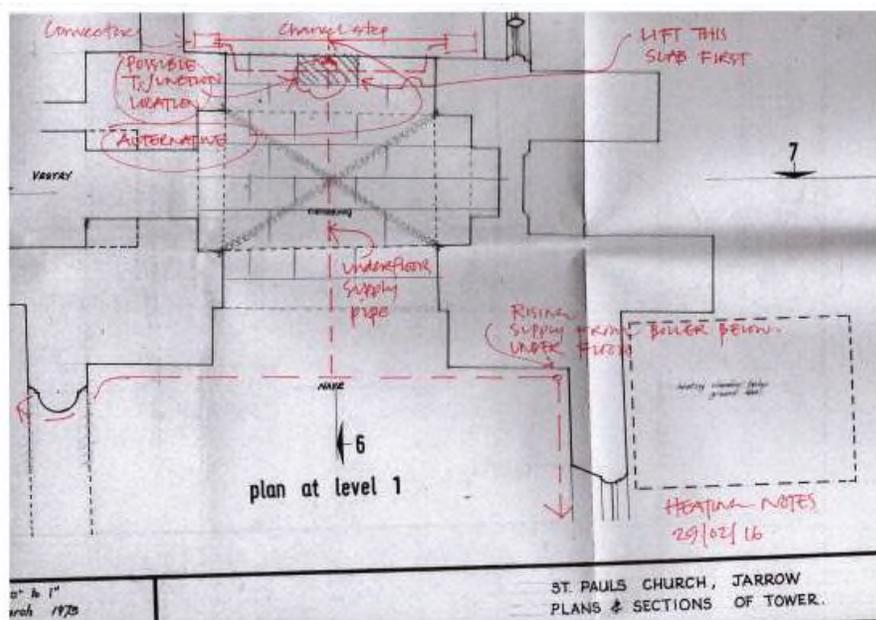
2016 drawing of investigation at crossing

D Heating: Comprises cast iron radiators and surface pipework, additional fan convectors add to the heating to the nave and chancel. The oil fired boiler was replaced in 2016 along with a new oil tank and grille that is outside in its own hut in the se corner. The existing pipe from the tank to the basement boiler room was validated as being ok and not needing change. There was a water leak at the crossing and this was repaired in 2016 there has been trouble before here and looks to be a recurring maintenance issue).

Recommendation: Put test certificate into the log book.

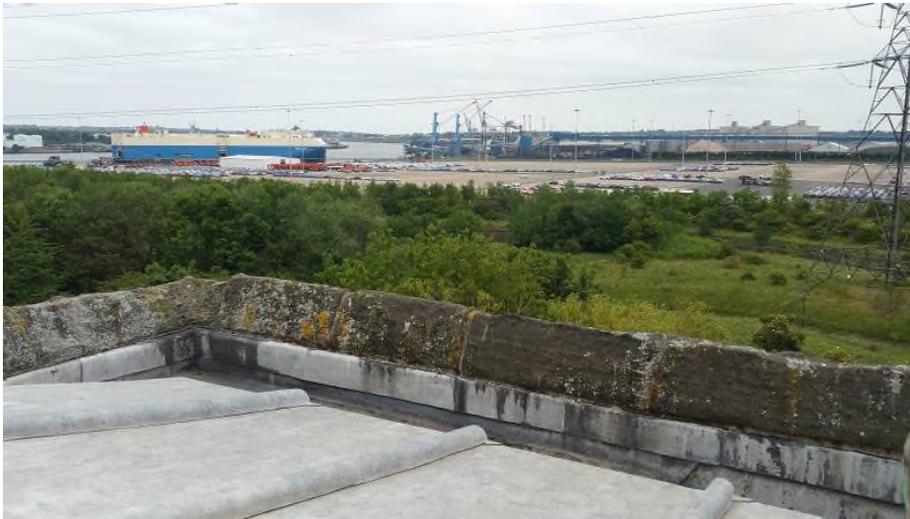
C Tower Roof:

Lead covered with a parapet gutter all the way round, its ponding on the N W side. Outlet on the S E side looks ok but silted up and should be cleaned out.

The lead covering is sound, solid timber battens and lead rolls. There is a ridge fixing nail showing and that could do with a patch over it. The hatch is copper but on rather rusty hinges these need attending to. Glass fibre pole that is rocking and it has a poor copper apron flashing trying to shield the lower lead welded joint and that is cracked and will be leaking. There needs to be a grab handle at the hatch exit.

It has a very low coping, perilously dangerous in fact. The stones look alright but they have been silconed in that past that is beginning to wear away, as reported last time. The flashings are ok but interestingly it looks as if the plastic pointing has shrunk back and so it doesn't need attention now but it's not perfect but it will do for the moment. Really it all needs redoing in lime if there are other repair works to the tower that come in the future.

Recommendation: remove silt from outlets, patch ridge nail, ease hatch hinges, provide grab rail, repair pole flashing and pole fixing down, repoint flashings. Reset fall of gutter when next carrying out significant repair works to the tower.

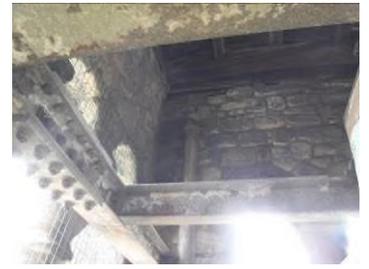
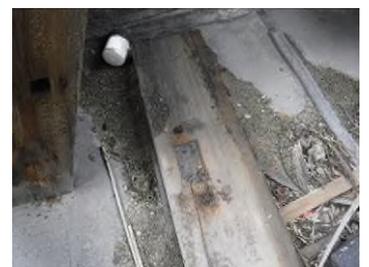
There is a large central floor beam with rusting bolt fixings some of the nuts have gone on it so we need to know what job it is doing on the ceiling below, it is beginning to break-up now and is a bit green in places with some rot on it.

The belfry openings are covered by mesh and that is clearly not effective as there have been birds getting in here, they seem to be broken mostly at the bottom part and they all need fixing back.

Recommendation: sweep up floor, investigate if the floor drains water out, check light works, replace hatch, provide grab rail, ensure bird mesh is effective, prime the bell frame, check bell operation, unblock the downpipe, check stair foot is ok

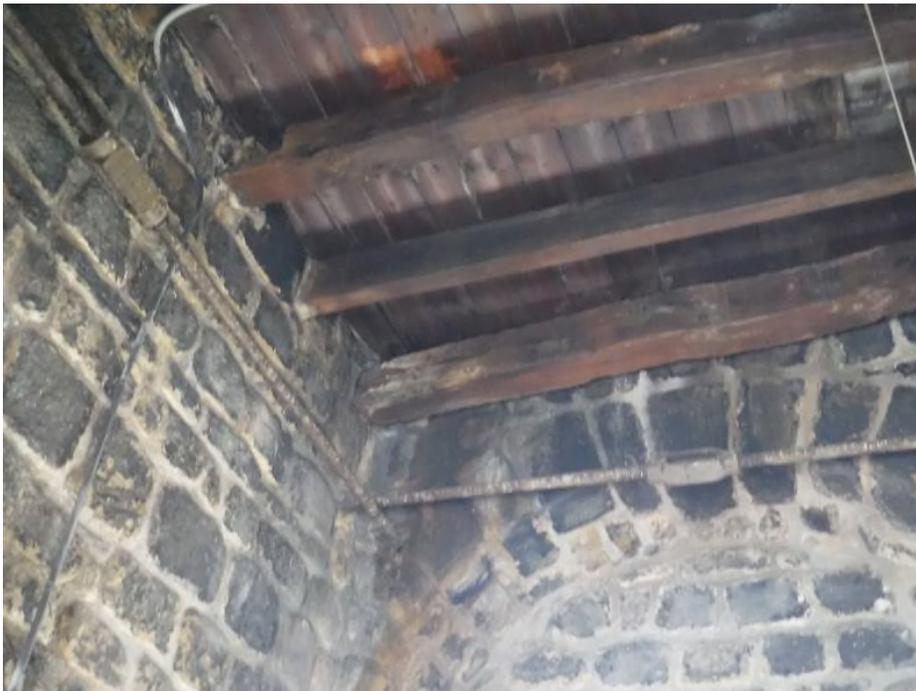
C Deafening Chamber:

- **Ceiling** – There is no explanation for that central beam that is in the floor above. The ceiling is beamed with boarding and the S E corner beam is effected by water, there is also water on the floor directly below it, that is where it is ponding on the lead above, that beam plus the central beam looks as if it has got poor joist bearing.

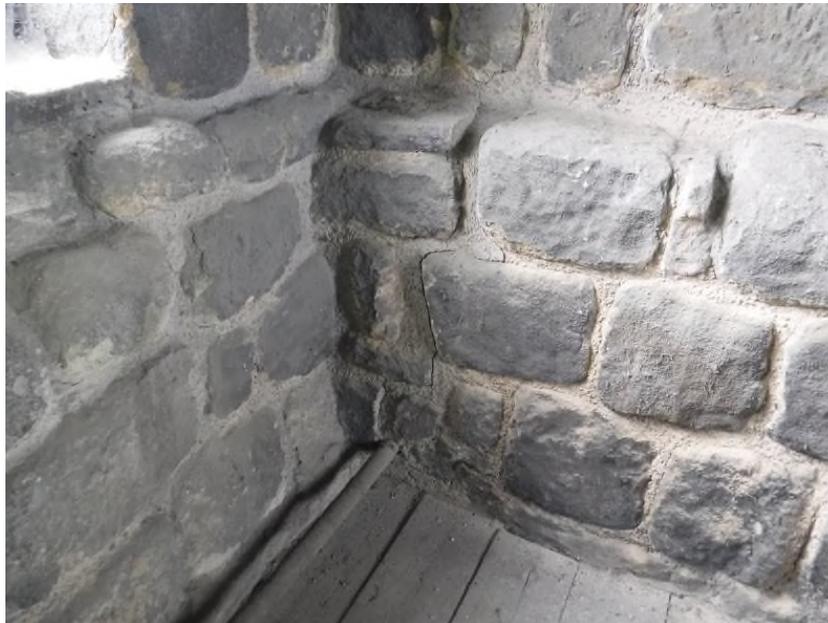
- **General** – In the S W corner just below the window cill we have got a crack running through the joint just above the tie rod this is reflected on the masonry on the outside, there is also a shear crack on the corner of the S W window jamb as it joins on to the cill. Also on the N as well as the S. The S cill seems to be the most affected. It's obvious that this is the weak corner on the tower and that this needs repair. The structural engineer report recommends this as well and makes further recommendations for additional measures. The scope of the repair requires review.

Recommendation: clean down the glass and inspect, review repair options to the cracked corner

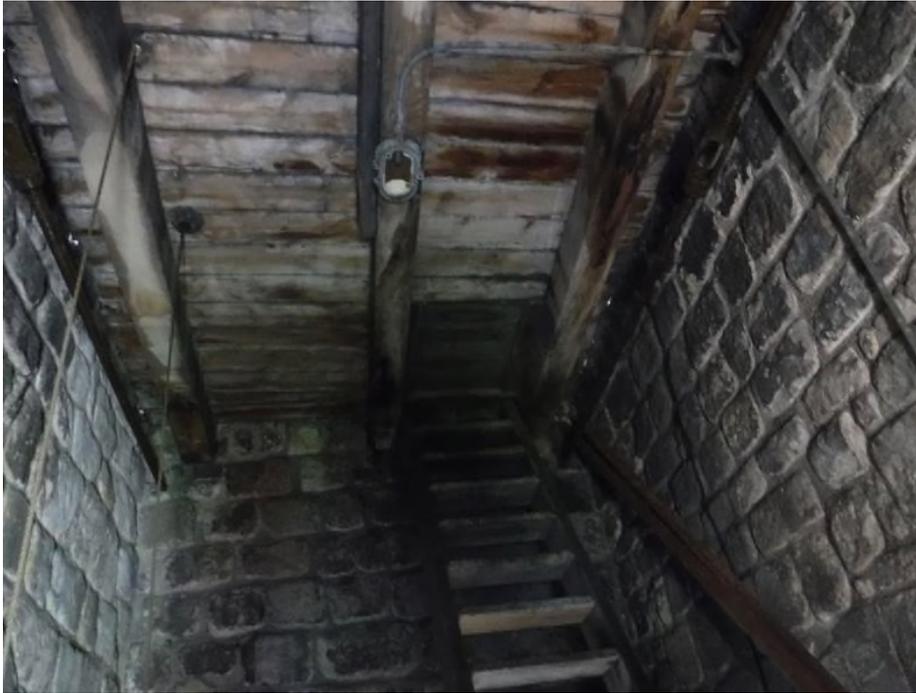
Platform Stage:

- **Ceiling** – The ceiling is beamed and boarded and is structurally sound. It has had water penetration in the past thus reinforcing the fact that the windows in the stage above used to be open. There is a pair of high level tie rods running N to S, these are painted, unlike the ones above it which are not. There is a lower tie rod of a bigger section and different pattern, unpainted on the E side running N to S. So does that suggest that there were two phases of tie rodding?

Recommendation: provide grab handle, review what to do with the bell frame timbers.

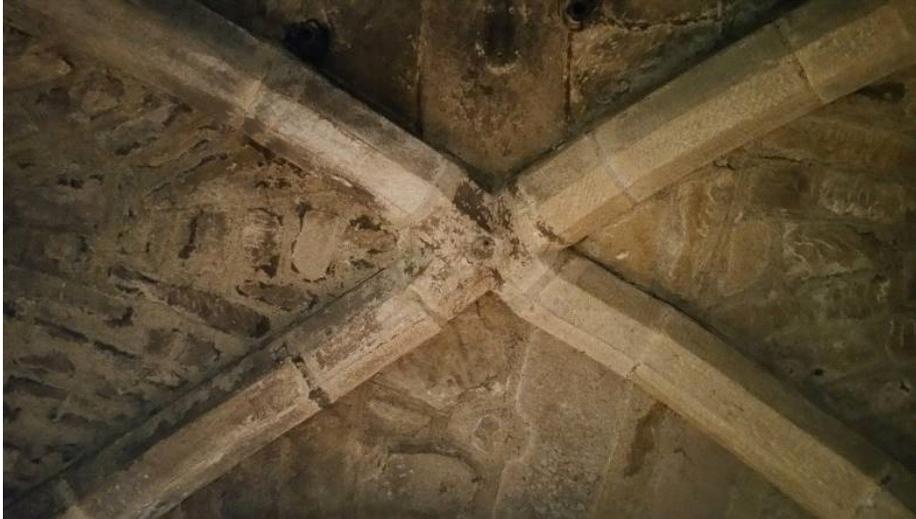
- **Tower Crossing:**

- **Ceiling** – The crossing comprises stone ribs and stone vaulting. The ribs are twisted slightly, probably due to the weight of the walling added over time and historic ground movement.

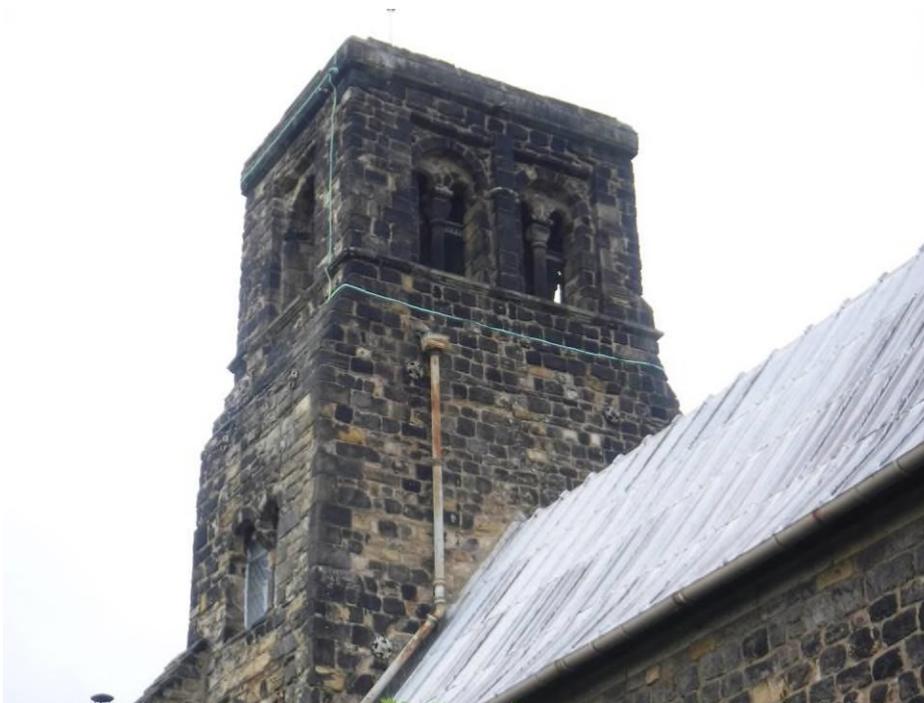
East Elevation – The buttress back is rusting and pushing the stone inwards. There doesn't even seem to be any metal in the stone beds, that is seen on the south and west elevations.

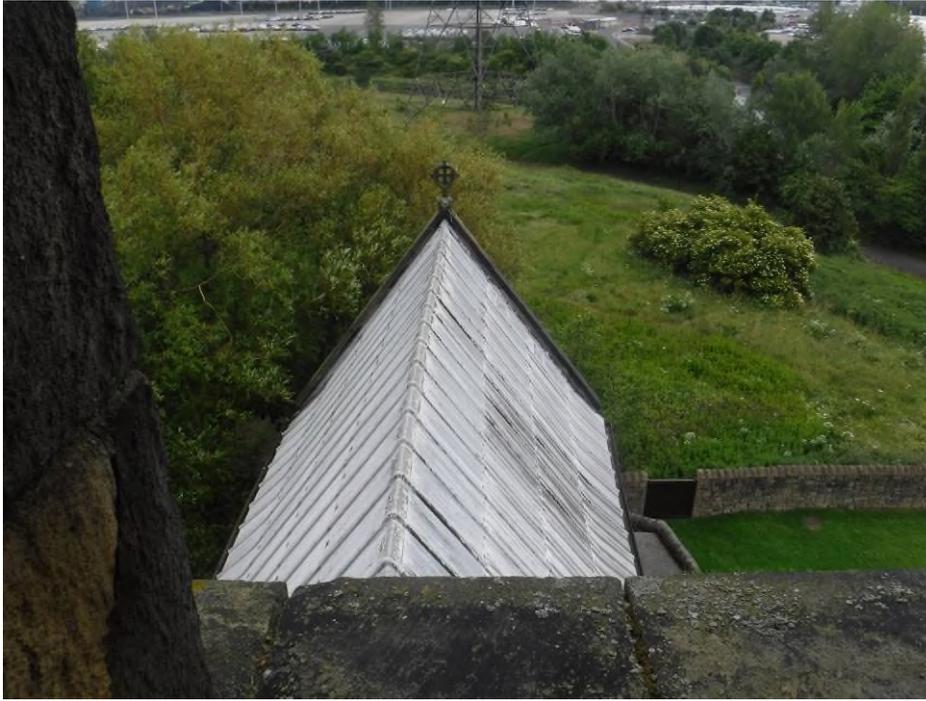
Some patching at the E end in the past, the roof is a bit stained from the copper clips and its age but generally sound. Some horizontal splits identified at last QI but no water penetration obvious inside.

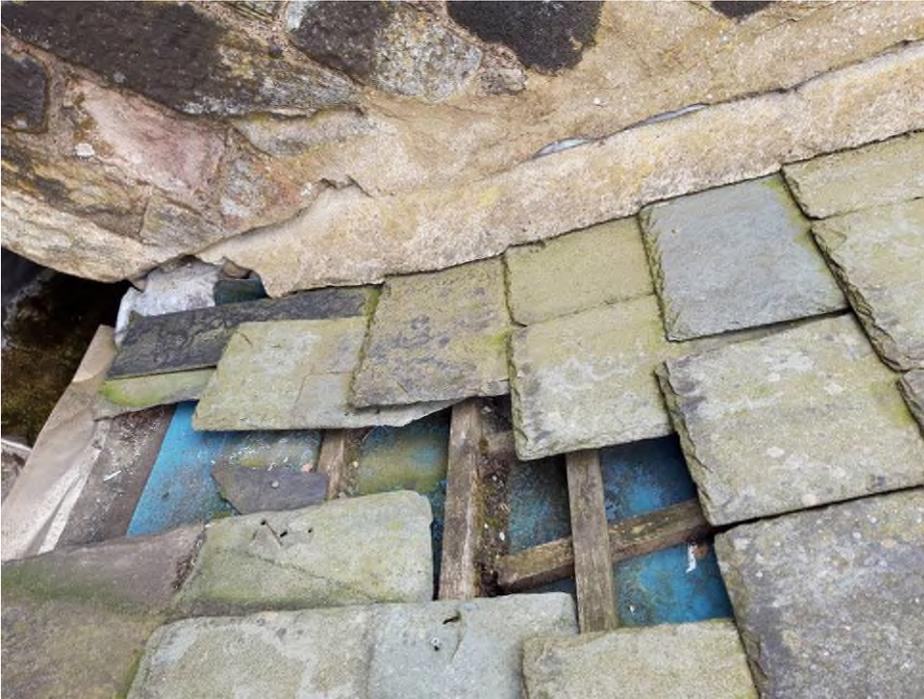
Same as the nave apart from both water tables are cement pointed and are sound. Abutment to the tower at west end slates missing.

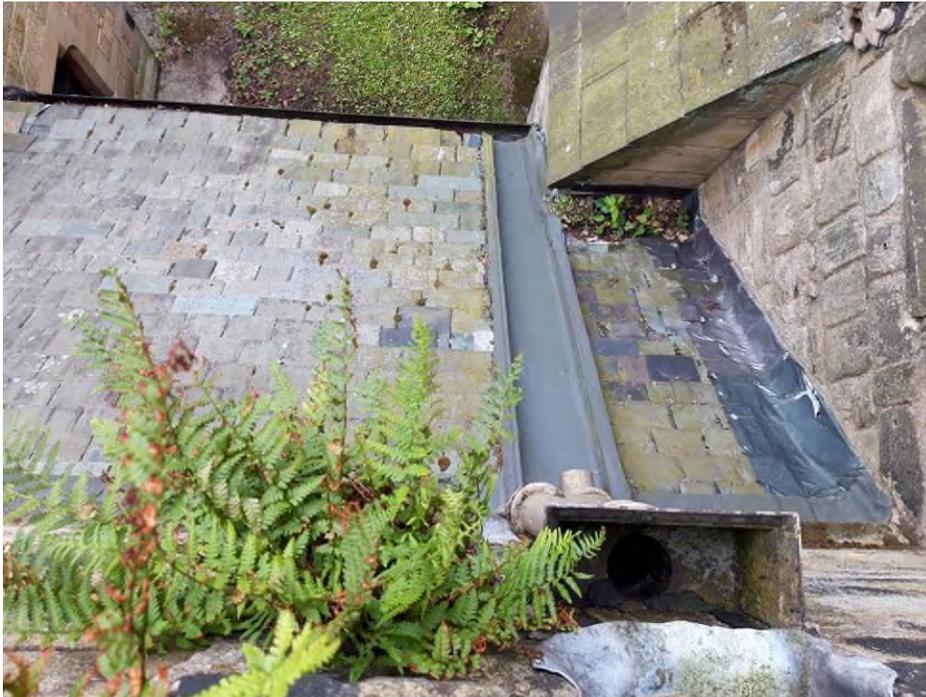
Back gutter clogged and high level planting.

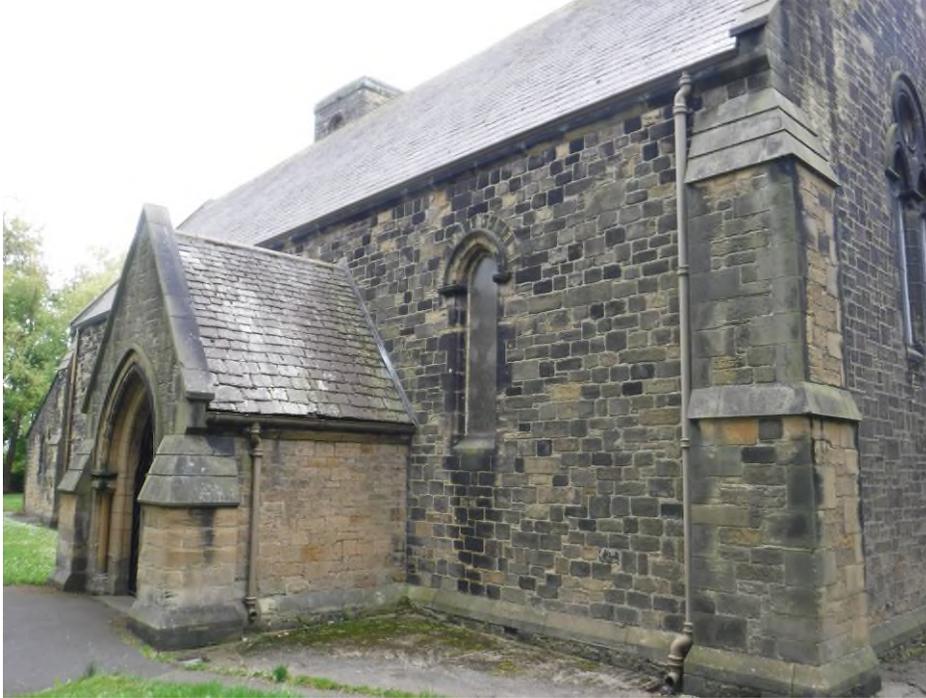
Ridge bedding missing at the abutment to the W nave gable, abutment flashing to the gable is in cement and cracked in places but generally ok, some of the slating cracked as well. It's abutment to the nave wall is in cement and doesn't look very obvious what is there. On the S side there is slate loss and some bad patching in the past.

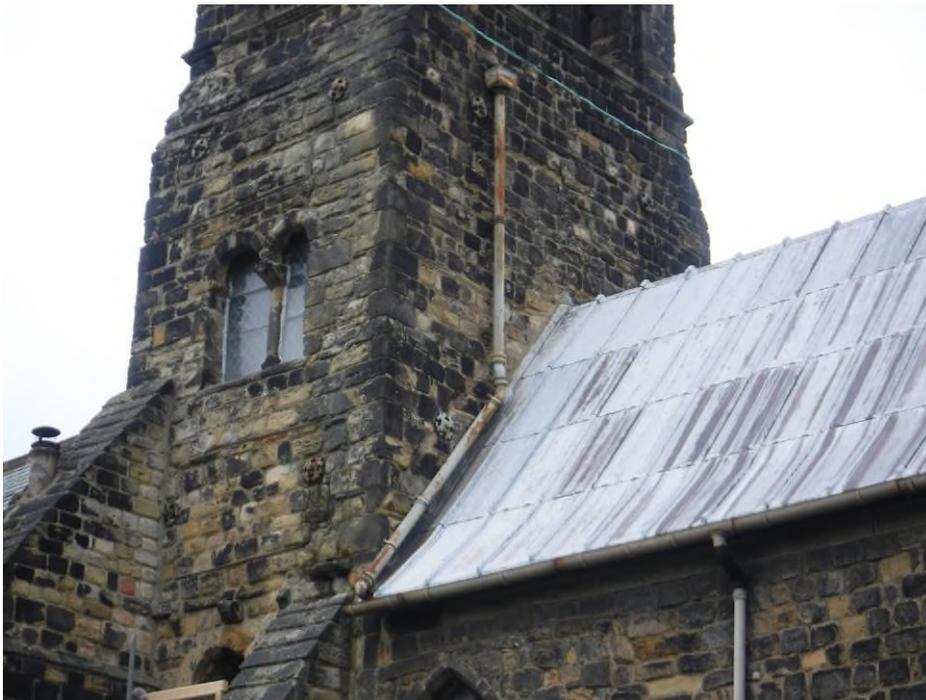
Cracked tower pipe

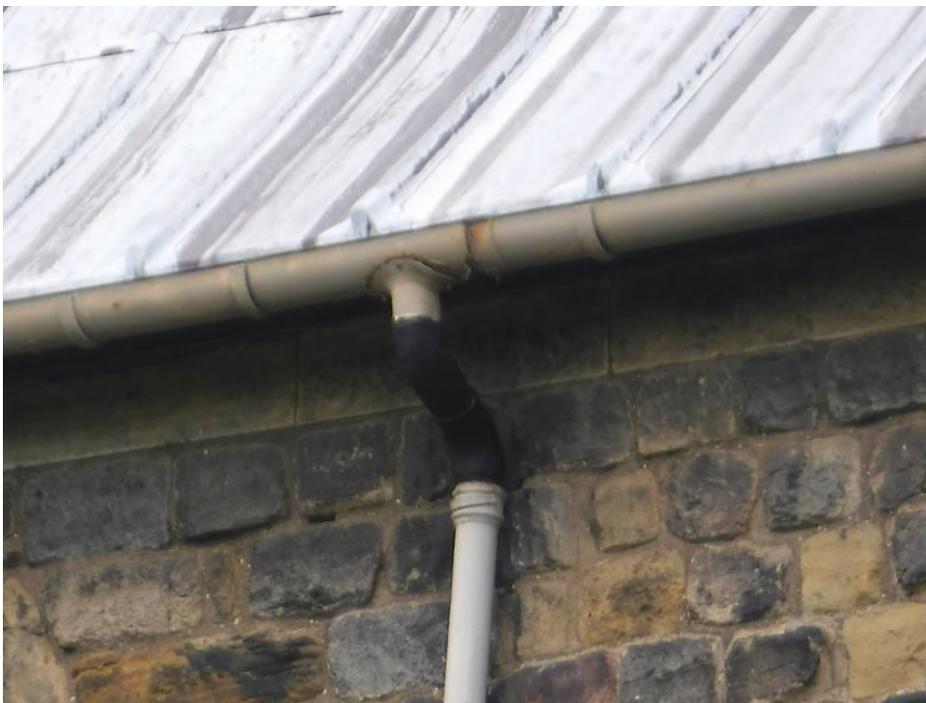
Chancel gutters both sides need replacement and connections to downpipes repaired and refixed. Downpipes are probably ok but should be checked by roofer. Internal tower downpipe at belfry level is blocked.

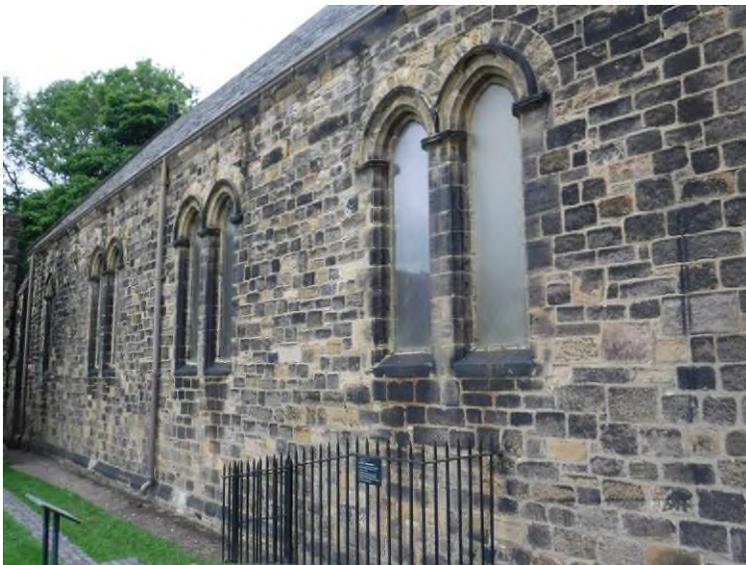
South side – Over sailing cornice to hold up the guttering has open joints, some open joints to part of the stonework, cement pointed in various ages, a couple of the plinth stones have lost their face and the bottom part of the wall the pointing is slightly poor but it will all survive.

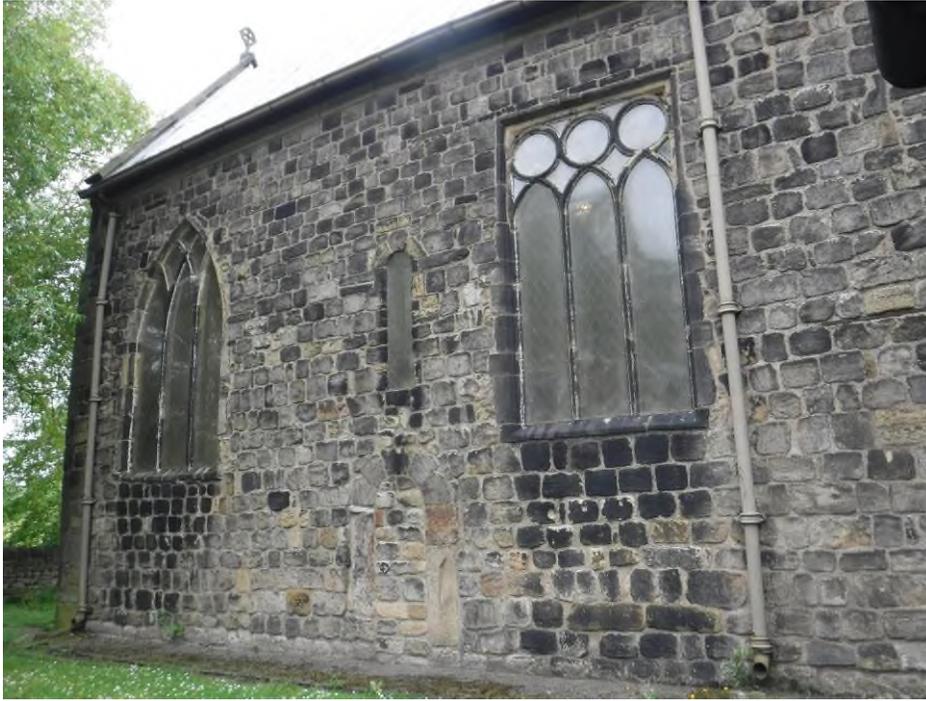
North side – There is a minor crack in the middle of the walling above the single lancet up at high level, there is some cracking inside at low level to the blocked in N door, so I wonder if there is something going on here, the crack doesn't descend down to the ground. However, it's not an issue, just something to keep an eye on.

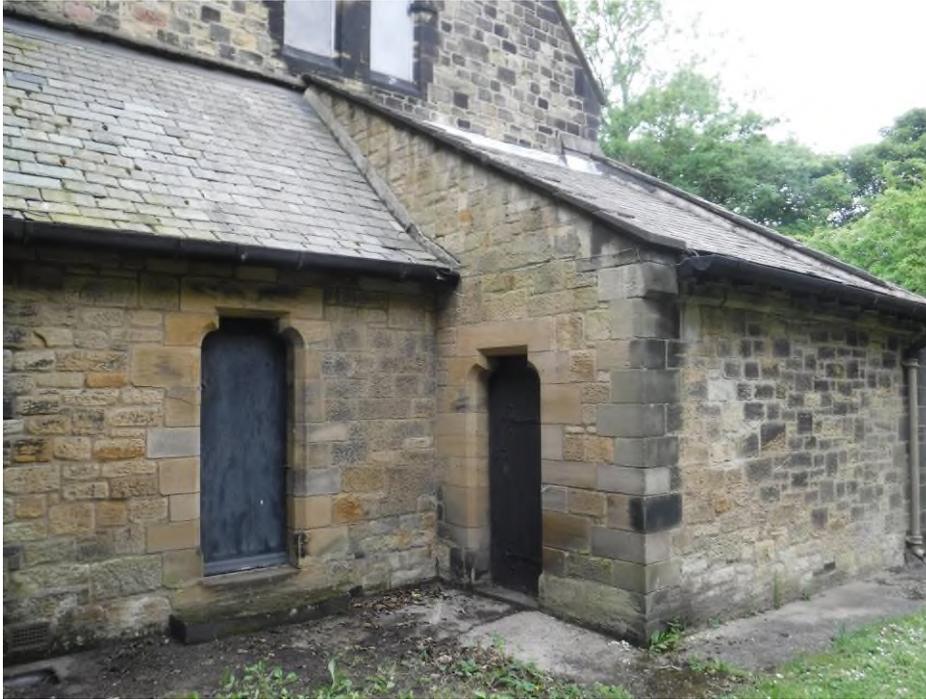
Unused door- decoration pretty poor. Stonework generally ok, there is a snapped stone probably at a hinged location. The projecting vestry door is unused, the handle is missing and painted in-situ rather roughly.

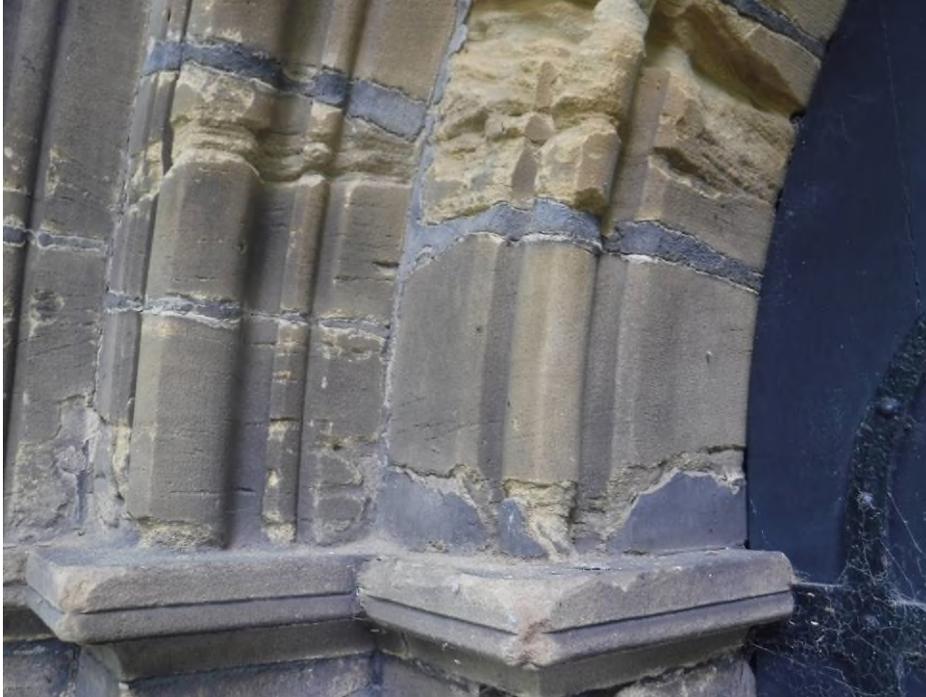
The W doorway has been heavily repaired in cement mortar and this has led to the breakdown of the stonework at the joints, it is such a shame because it has become a mess. It has affected all of the arch and the jamb stonework. More

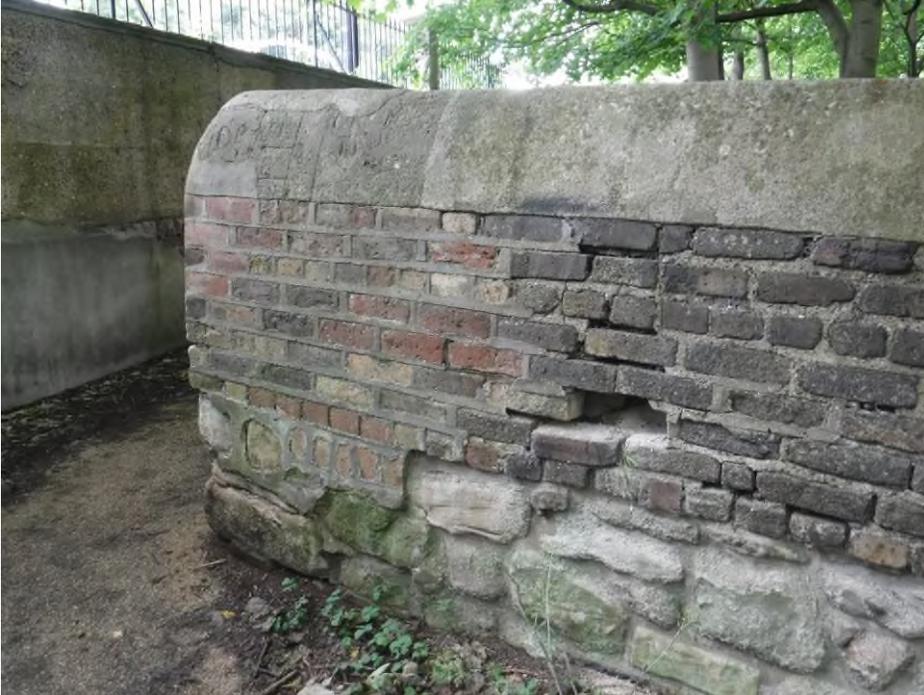
Brick erosion at sw corner

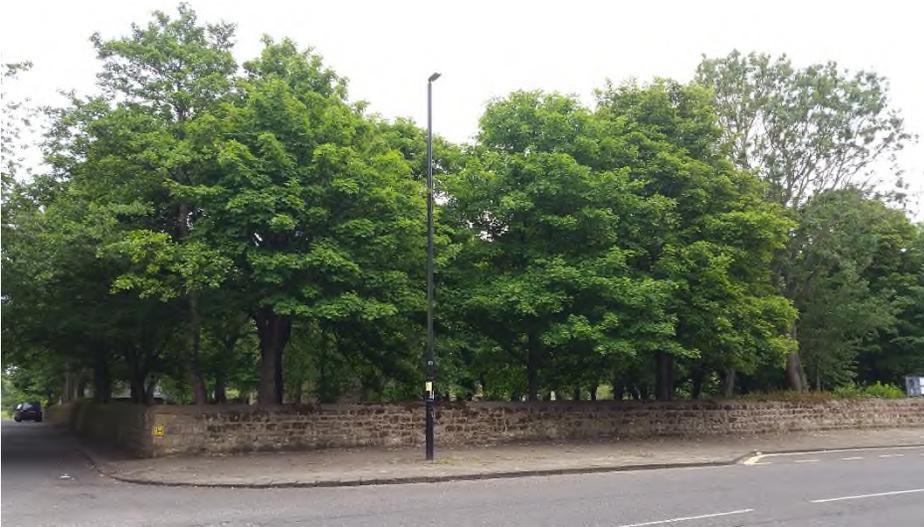
Entrance gates on the N side are good but the piers are cracking because of iron expansion of the hinges and this should be attended to. It is the principal public entrance to the site, and it is important that it doesn't appear run down. The sign board adjacent to it looks a little tired now.

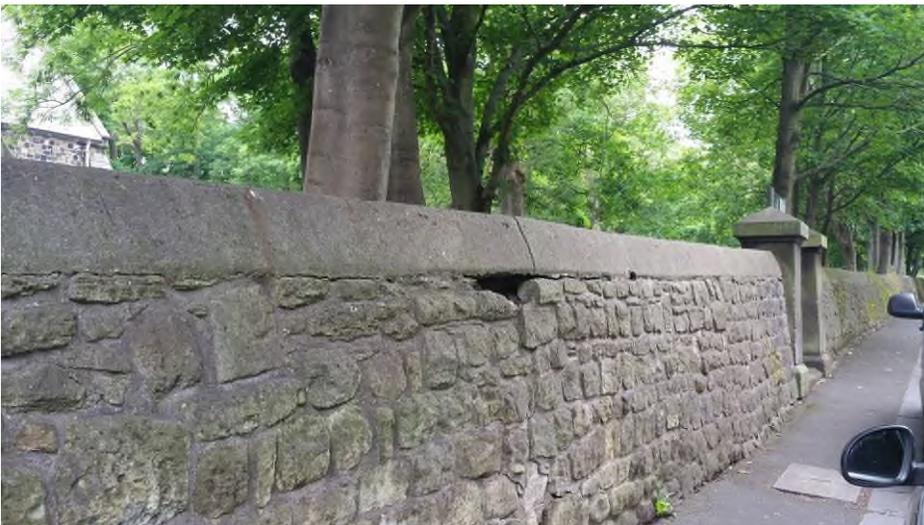
Wall is suffering from three trees close to the boundary which are bursting the walls and this has been advised to the Local Authority who are responsible for repair. Works are planned for 2021. North gate pier top courses have moved and require repair.

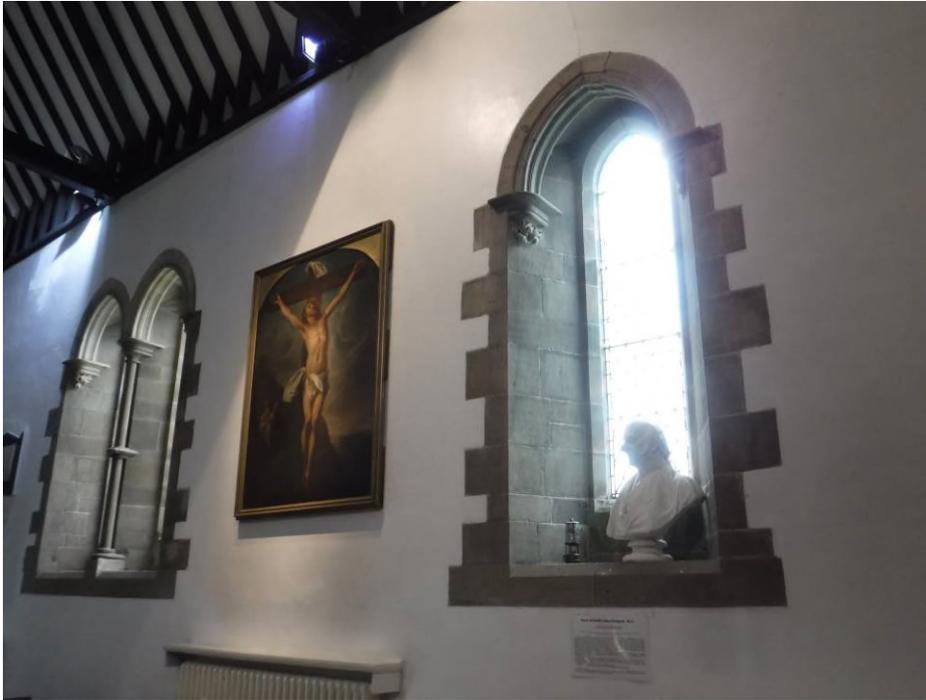
S W corner of nave, just below mid-level, damp or paint coming away. At the S W side of the nave there is a dropped arch at the window. Arcade all looks fine.

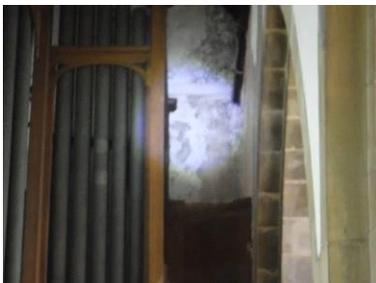
The arcade wall has had water ingress in the past and flaking plaster - from leaking valley gutter at the E end between the nave and aisle. This has since
