QUINQUENNIAL INSPECTION REPORT OF JARROW, ST. PAUL

**DIOCESE OF DURHAM
ARCHDEACONRY OF SUNDERLAND
DEANERY OF JARROW**

QUINQUENNIAL INSPECTION AND REPORT

December 2025

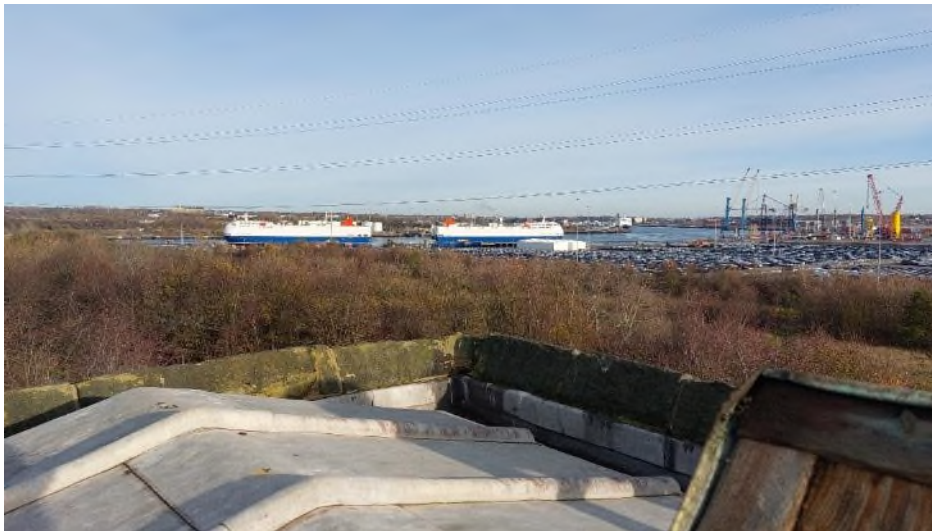
D Tower Roof:

Lead covered with a parapet gutter all the way round, its ponding on the N W side. Outlet on the S E side looks ok but silted up and must be cleaned out.

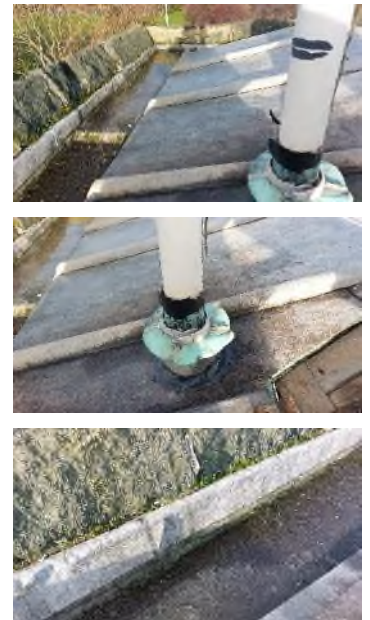
welded joint and that is cracked and will be leaking. There needs to be a grab handle at the hatch exit.

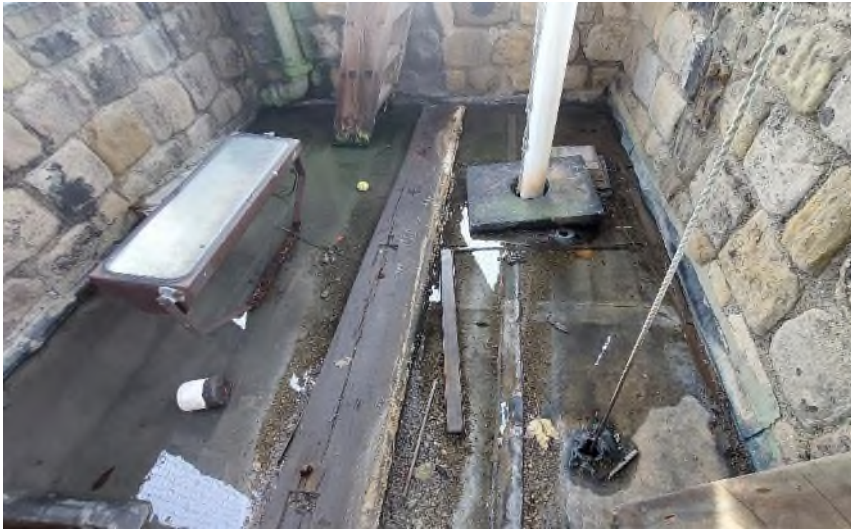
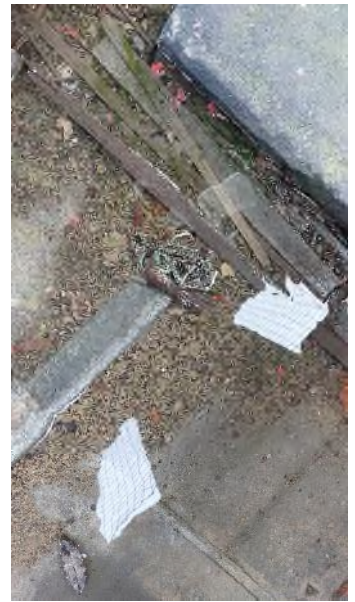
- **Floor** – Lead covered, with low upstand- maybe 50-75mm and full of water, it has an overflow lead pipe under the roof downpipe bend exit. It was blocked at the inspection, and to be cleared. It's very small. The ponding was reported at the last QI and hadn't been addressed. It may now be leaching into the tower walls as it has breached the top of the upstand and overflowed. There may be signs of this penetration at the chancel east wall. There must be a leak in the floor as water goes down to lower levels. Everything here is wet and not good for the tower.

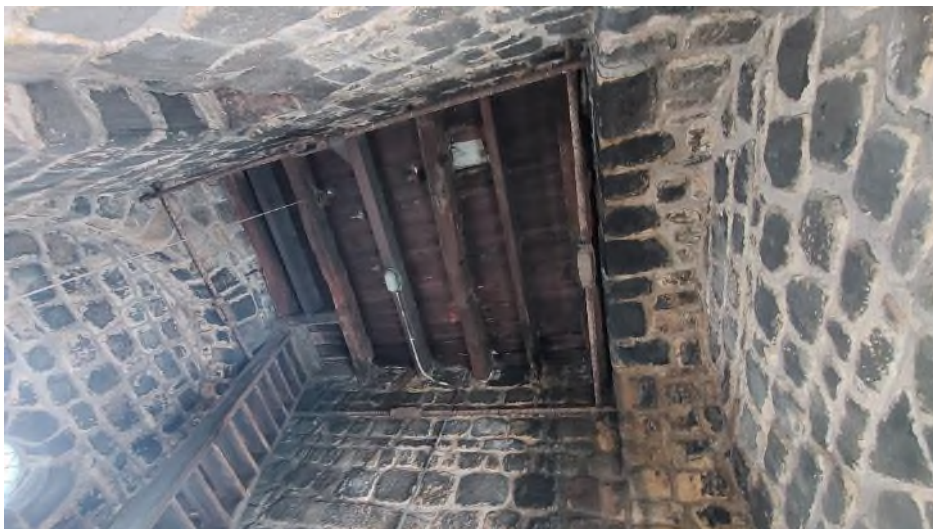
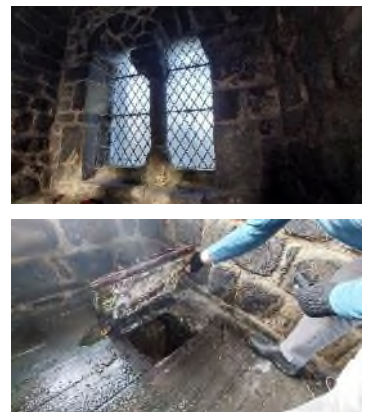
C Deafening Chamber:

- **Ceiling** – There is no explanation for that central beam that is in the floor above (is it for the flagpole support?). The ceiling is beamed with boarding and the S E corner beam is affected by water.
- **Walls** – The wall cracking is unchanged since the last inspection. This room has the two levels of tie rodding in it- up at ceiling and at floor level and it's all as before.

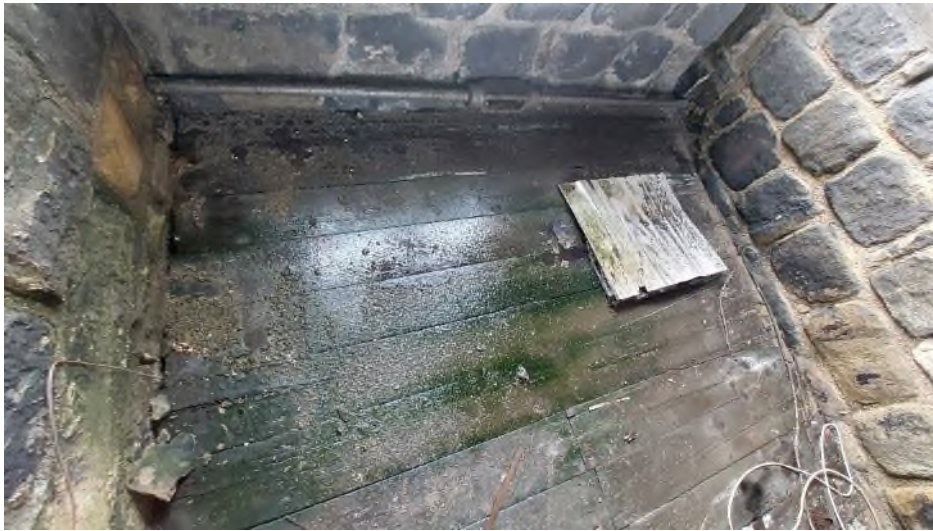
- **Floor** – The floor has a bell hatch with loose floorboards in, there is also a piece of rotten plywood placed over a hatch in the floor which is rotten.
- **Windows** – The windows have diamond leaded glazing. Is this a more modern edition because there is what looks like old bird droppings on the tie bars, so perhaps these were infilled in later years? It has polycarbonate and this is breaking down, the joints are breaking down on the S side they are very cobwebby and they really need a clean down to be inspected further. There is something odd about the position and design of the central baluster in the arch- it isn't in the middle of the wall- it's towards the inside, and the capital outside is cantilevered to catch the arch.

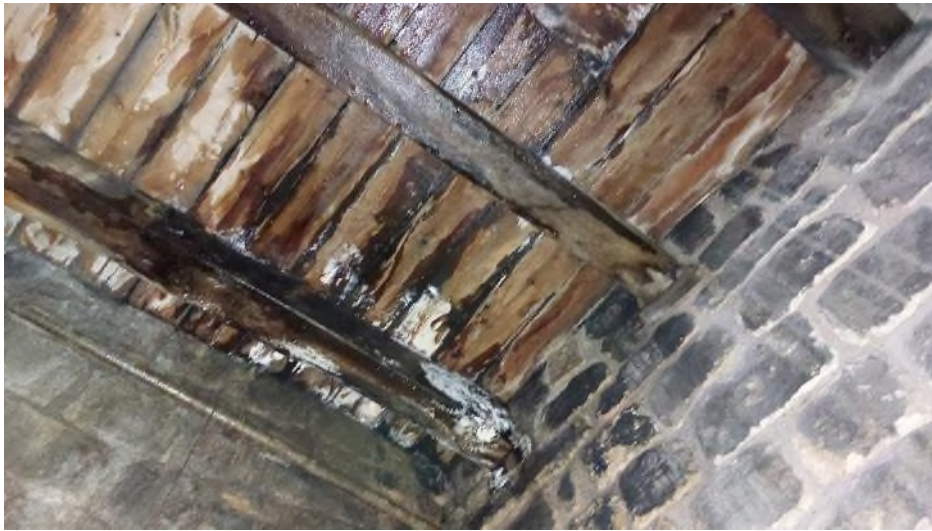
D Platform Stage:

- **Ceiling** – The ceiling is beamed and boarded and has had a lot of water penetration and needs to be checked for rot. This seems to be the worst affected.
- There is a pair of high level tie rods running N to S, these are painted, unlike the ones above it which are not. There is a lower tie rod of a bigger section and different pattern, unpainted on the E side running N to S. So does that suggest that there were two phases of tie rodding?
- **Walls** – The walls are in good condition, arches are all sound.

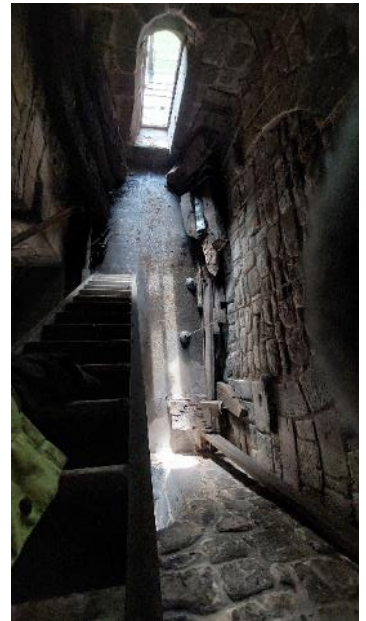
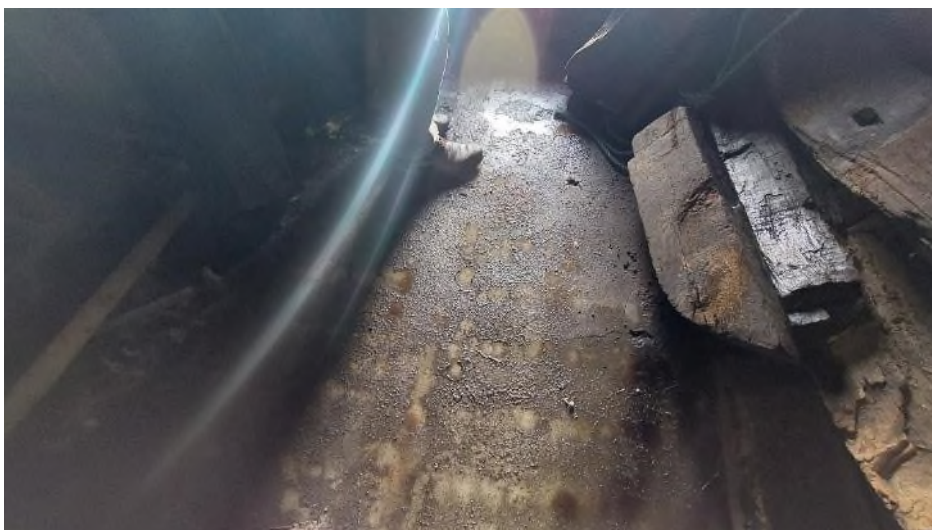
- **Floor** – The floor has quite a slope to it running high at the south and low to the N.
It has a drainage hole on the N side (rodded at the inspection) I wonder therefore if the ceiling is a later introduction and that this actually used to be a shorter tower. The church report that water had come through the floor and showed on the tower crossing ceiling and floor below it.
- **General** – Dirty glazing needs sweeping up.
There is the parts of the redundant timber bell frame here, so what historical worth have they? And when was the steel frame put in?

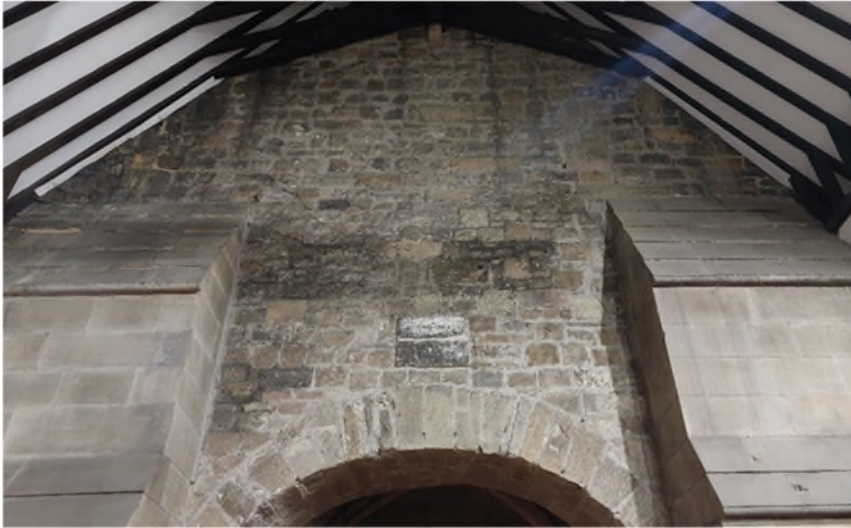
- West Arch looks ok, there is one diagonal crack coming from the S buttress radiating upwards which we know of in the past. Suggesting of a crack in the arch on the nave side but not in the stone only in the joints. Hard pointing doesn't help.
- When weighed up with the observations outside it suggests that the S E corner of the tower has had differential settlement. Or other reasons, as there are competing forces acting on the structure due to tie rods and the massive buttresses may be dragging the tower a little but it's not going anywhere.

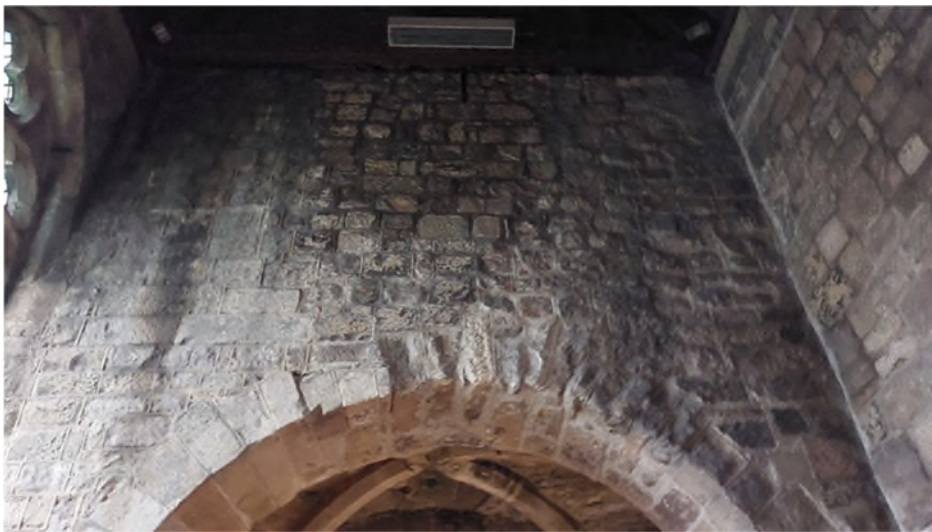
- East has different masonry in the middle- rebuild to the inner or outer edges? Some historic damp marking to the south side and the suggestion of damp in the middle section that may have come from the deafening chamber floor overtopping?
- **Floor – ok**

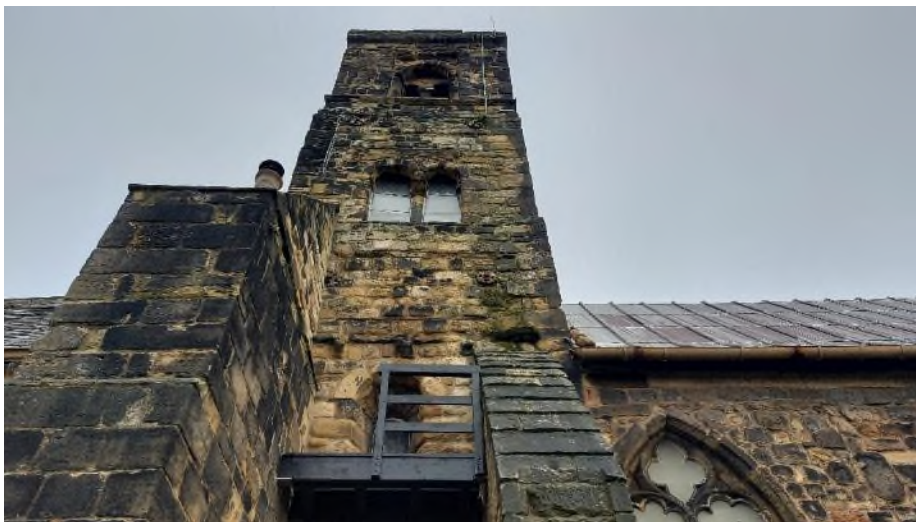
- South Elevation –

The access platform has been repaired and the wall below it can now be seen. It all looks ok. There was a door way in the past The W buttress has a flue coming out of it and seems ok.

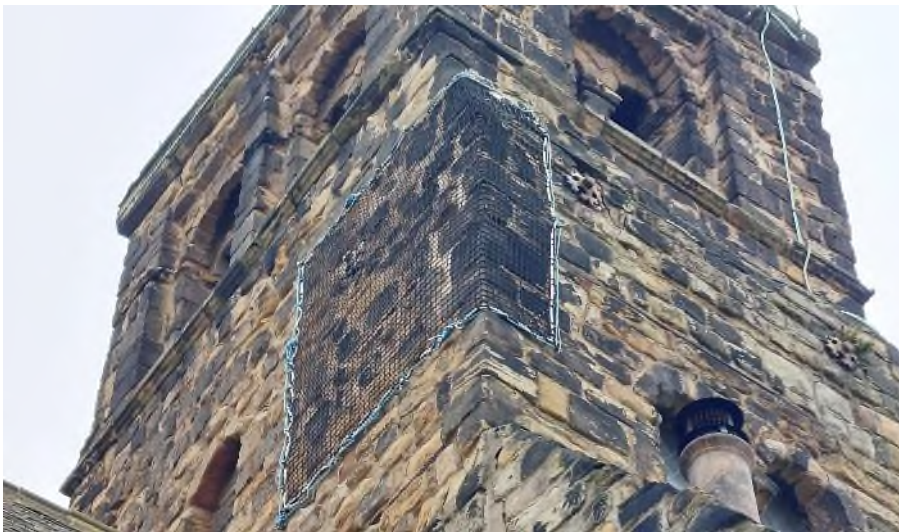
There are also four noticeable bands of bedded metalwork in the stonework that starts from the corbel projection and there are four levels above that, there is also a further crack forming more towards the centre above the apex at the stonework above the top parrass, the belfry stonework and balusters all looks ok above it. It hasn't changed since the last inspection.

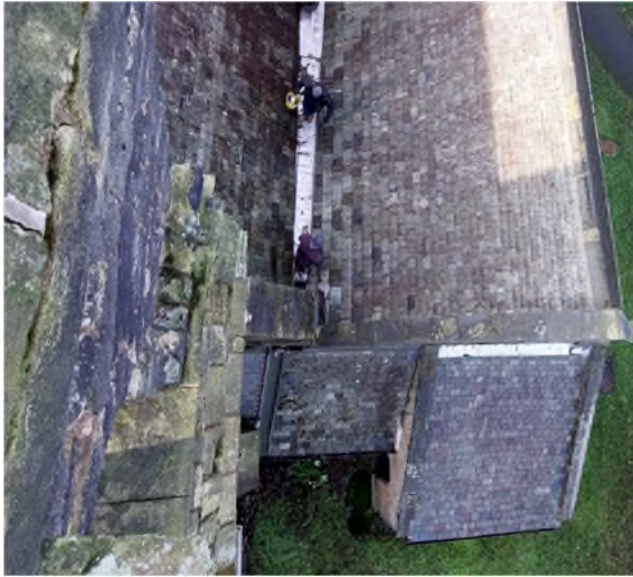
Lead is the preferred material here as it is too fiddly for s/steel but lead theft has caused leaks. It was replaced in lead alternative before the last QI- when we reported a shrub growing there- see side pictures. It was being removed at the inspection, revealing a hole causing a leak to the vestry and organ chamber. And it's likely it has been seeping for many a year. It shows the importance of having an annual roof inspection at the time of gutter and downpipe cleaning.

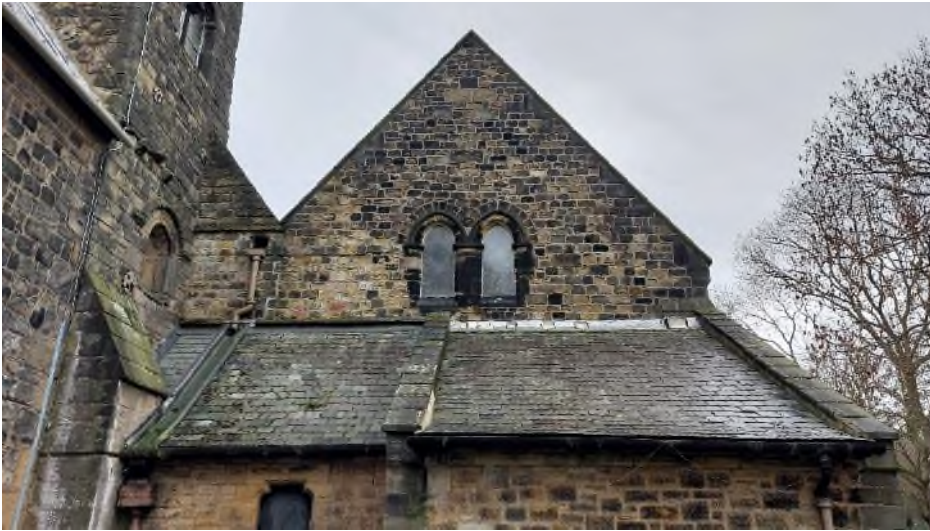
Both of these roofs are patched and not in the best conditions. Their flashings have been lost over time and been replaced by lead alternative which are tearing and looking slightly worn. There are a few slates missing where intruders have tried to get up on to the roofs in the past, some slates slipped as well.

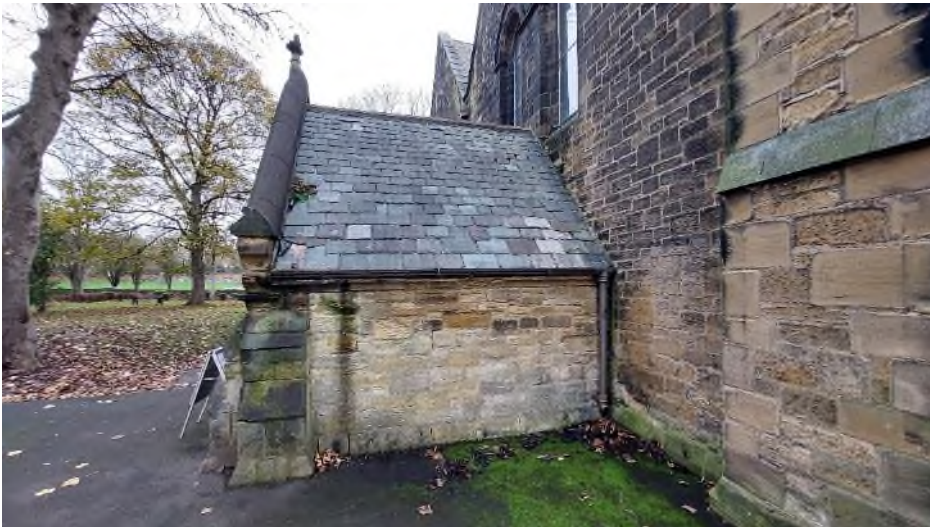
Terracotta ridge tile, bedding ok. The flashing to the N aisle is in lead and ok. The flashing to the N gable is by soaker and this has been covered in cement but it is ok, but on the W face the soakers aren't covered in cement they are in place but someone has tried to pull them away and also tried to pull away the lead against the N aisle. Multiple replacement in non matching slates.

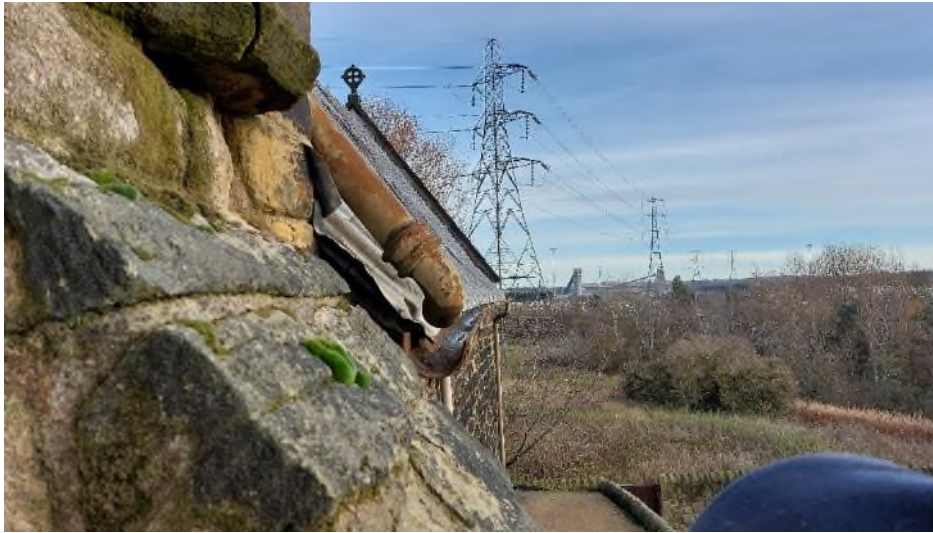
The south looks to need it soon as it leaks at the joints. Downpipes are ok and some were unblocked at the inspection. The gullies are mostly running but the vestry is ponding.

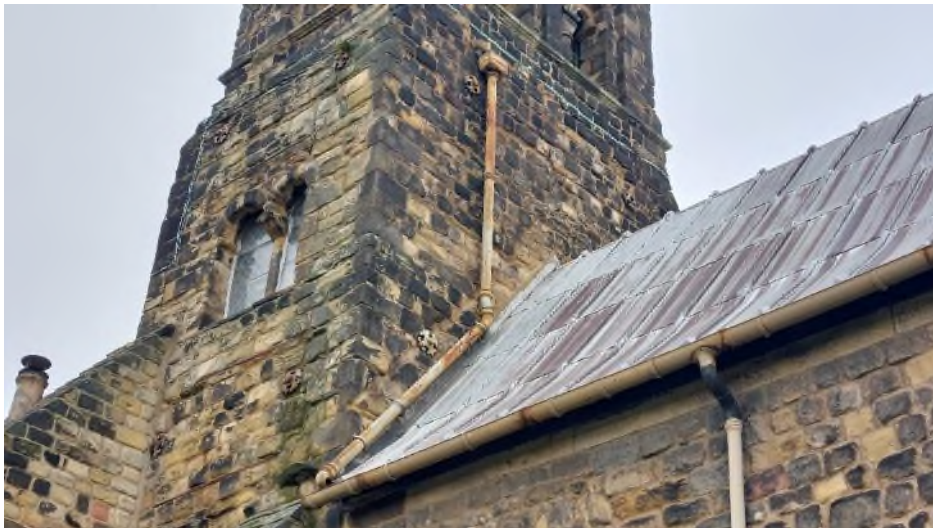
A significant new defect is the soaking of the tower floors by a blocked tower roof downpipe. The water has come down all three floors and the deafening chamber floor is the worst affected with early signs of rot appearing in joists and boarding. Wet into the inner walls is maybe showing within the chancel side of the tower and there has been a leak in the crossing ceiling dripping onto the floor. If the timber floor rots any more its structural efficiency will be reduced, and if standing water seeps into the tower walls there will be degradation of the medieval fabric.

The major problem is the blocked tower downpipe, inside the belfry) which was blocked at the last QI so it's been overflowing for at least 5 years within the tower.

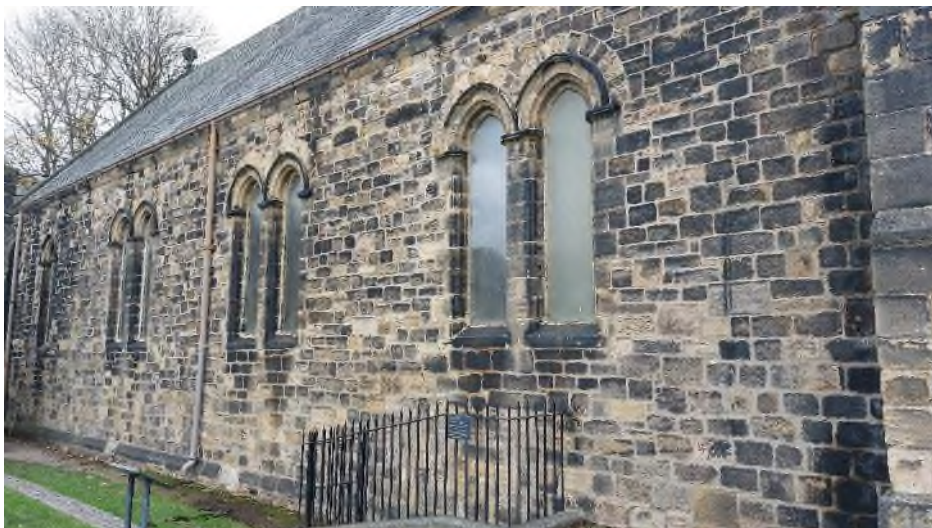
South side – Over sailing cornice to hold up the guttering has minor open joints, some open joints to part of the stonework at the west end that may be causing the plaster peeling inside. Cement pointed in various ages, a couple of the plinth

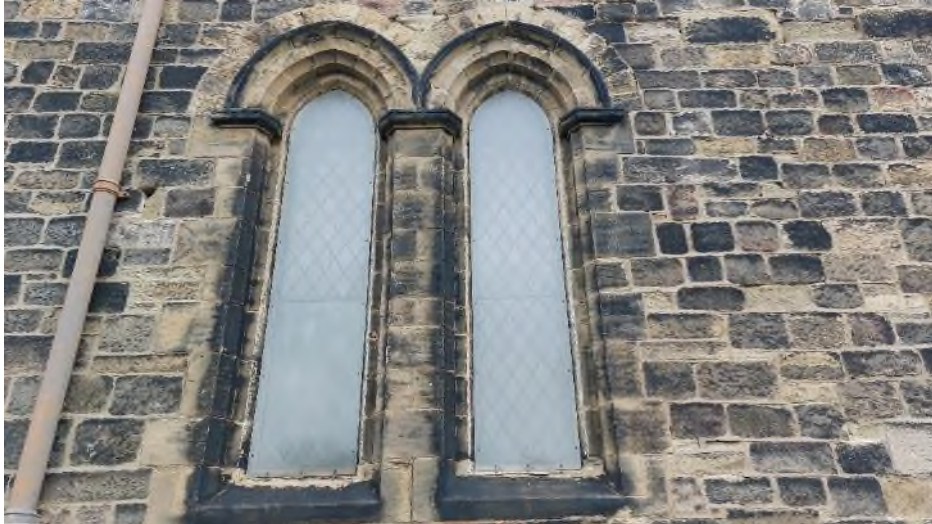
Four windows, three of which are twin lancets the hood moulds have seen some wear and above them the relieving arches pointing is poor in some instances, some water penetration from the hood moulds because of open jointing and there is delamination of the arch stonework. There is a daylight gap seen from inside to the Westernmost window where the arches meet. The cills have been patched in cement and that is breaking up in places. Windows are covered in polycarbonate are a bit dusty and cobwebby but fair. The glass is diaper and some of it is polycarbonate covered of various opacity.

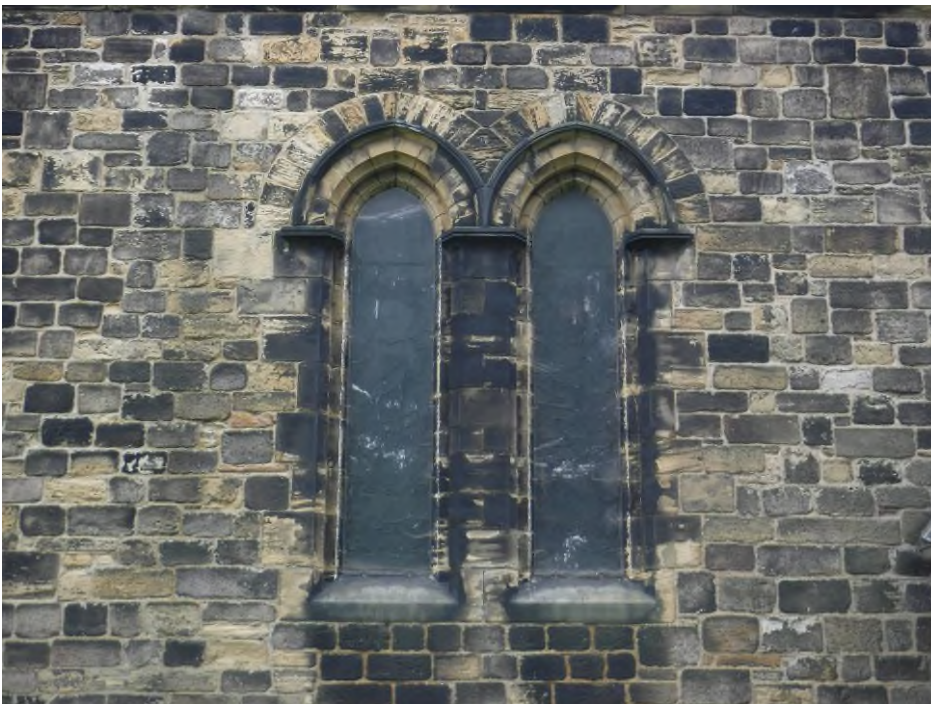
This has more modern over glazing in polycarbonate- more see through. But there are some cobwebs, behind this is pictorial glass. Some wear to the ashlar losing its crust slightly but not really problematic. Arches are in better condition on this side.

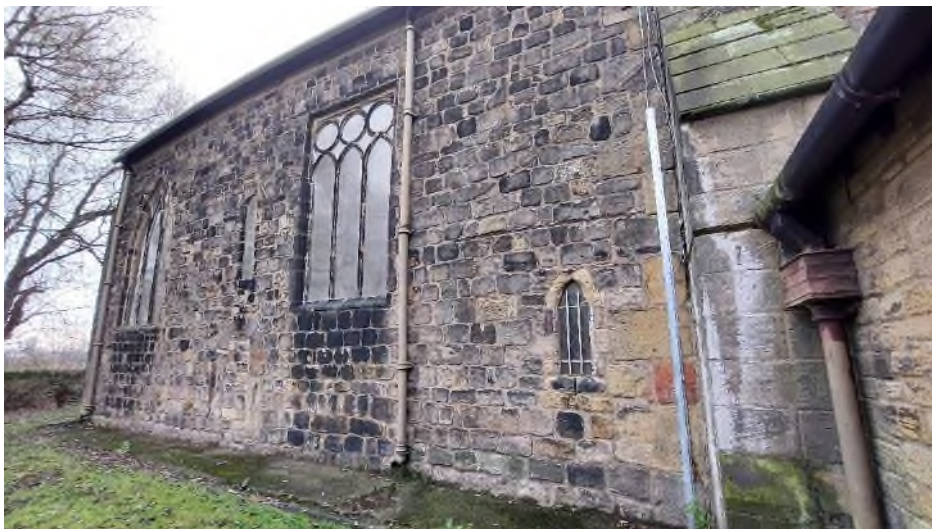
At the chancel N wall, there is a really minor crack (perhaps 1mm), inside and out, midway along the wall above where the door has been blocked in. I don't think that has been picked up before. It is exacerbated by the fact that the chancel has been repointed in cement ribbon pointing and this is brittle and it has snapped. There is no major opening up here, more a minor easing and flexing of the structure which has just snapped the brittle cement. Admittedly there is, on the outside up at high level, directly above the N door and the window above it, a crack at the eaves corbel and might it be that there is some dormant roof spread in the middle of the wall causing that upper level crack? It is now more obvious to see that that the chancel walls sway out to the north in the middle as they are tall and probably thin and ancient.

North side – There is a minor crack in the middle of the walling above the single lancet up at high level, there is some cracking inside at low level to the blocked in N door, it might we wall head spread and that the walls are slender and tall. The crack doesn't descend to the ground. However, it's not an issue, just something to keep an eye on.

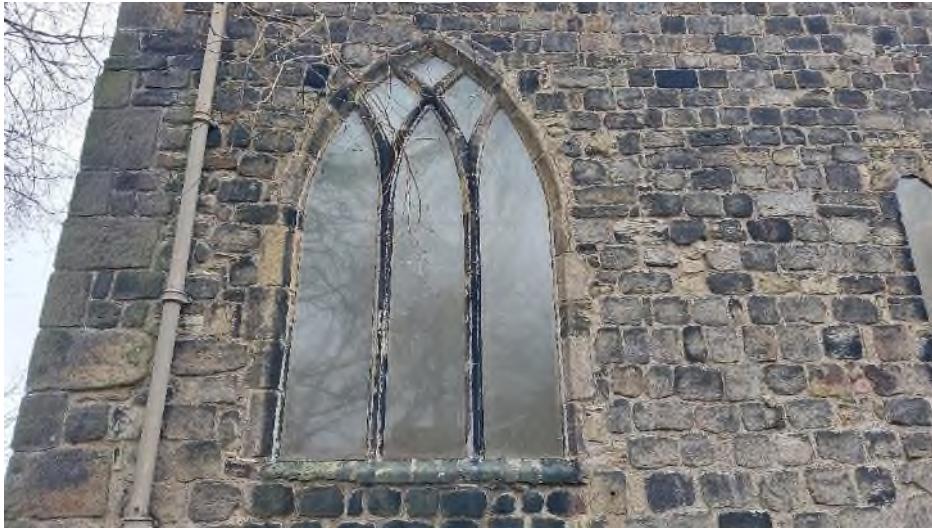
- 1) Wide tracery three light, no hoodmould to this. Slight wear to the upper parts and possibly a crack to the inner crossing transom but seems ok.

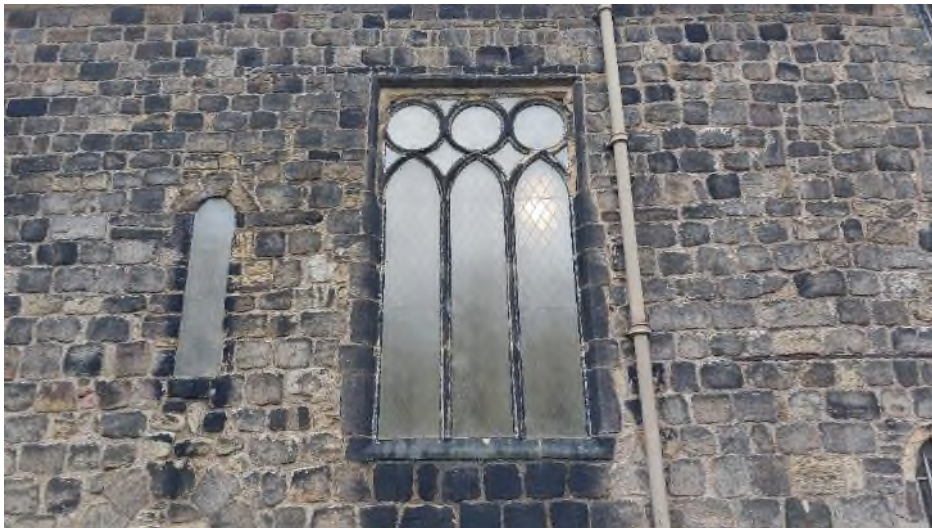
- 2) Narrow, vertical window with pictorial glass has lost a little bit of pointing to the apex. Below that blocked in N doorway is all sound.
- 3) Square shaped three light with circular tops, slight erosion to the frame at the top, seemingly sound, quite slender. These three windows have aged polycarbonate to them.
- 4) Small window with some wear to the arch stone this has a new combination metal guarding and polycarbonate cover. Below that a piece of metal in the wall, above it is a big horizontal piece of iron and you can see how it is jacking to the left hand side, to the right of this window is the down tape, tidied up since the last inspection.

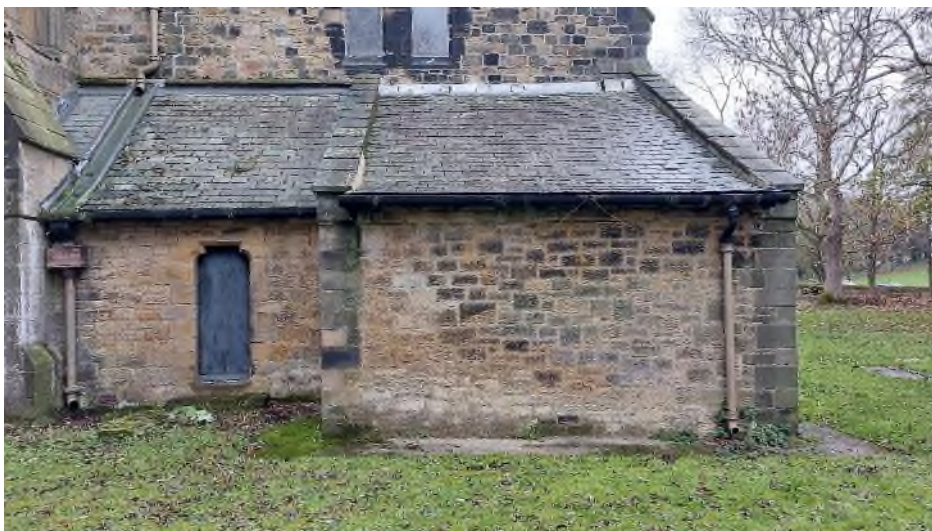
Unused door- decoration is poor. Stonework generally ok. The projecting vestry door is unused, the handle is missing and painted in-situ rather roughly.

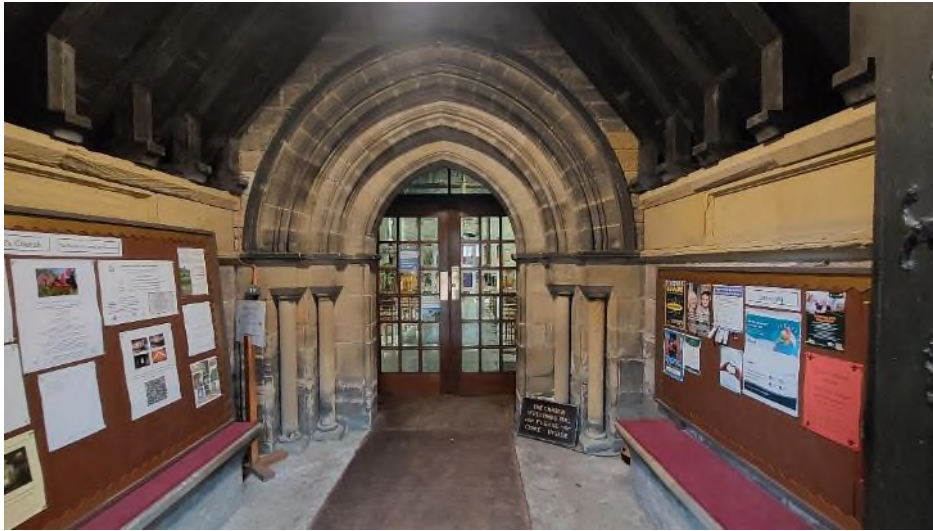
Open timber roof. The walling is all ashlar apart from the W. There is spalling to the stonework on all porch sides apart from the W gable of the nave. Internal gable keystone has dropped- as seen at last two inspections suggesting eaves spread although this is not obvious on the outside. The flooring is concrete with a 3mm crack at the church entrance.

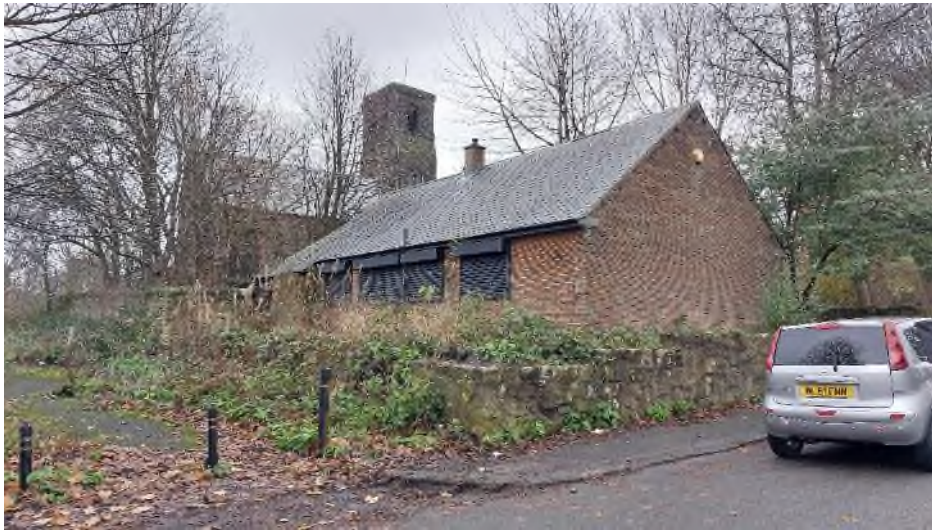
Boundary not easily discernible. Part of it forms the boundary wall of the cottage. Looking rather run down now and will become a antisocial hub if vegetation is allowed to increase.

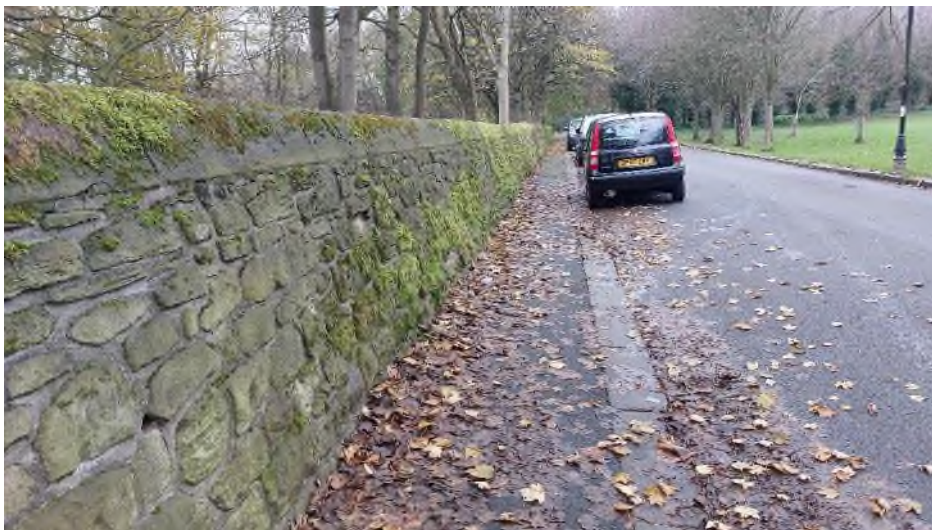
Trees have been removed and the wall repaired. North gate pier cap at W has moved and require repositioning. Signboard in overall good condition but the circle is rusting.

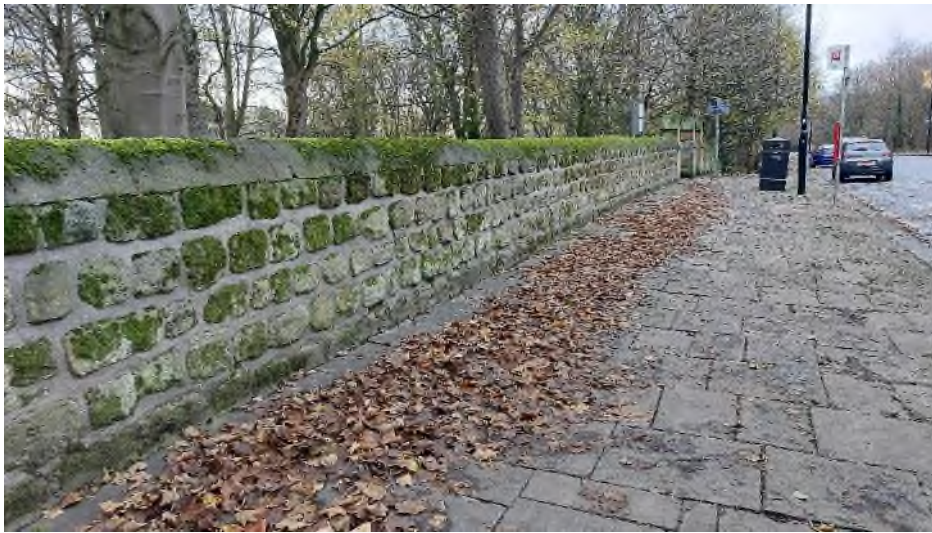
Entrance gates on the W side are away for repair and the stone piers are cracking still because of iron expansion of the old hinges and this should be attended to, as this is the public entrance to the site, and it is important that it doesn't appear run down. The site info board (English Heritage's?) at the west entrance has been vandalised and sets a poor maintenance example and should be repaired promptly). The east boundary is overgrown and forms part of the cottage property and this is run down. BBA have independently reported on the cottage in the past.

Entrance gates on the N side are away for repair but the piers are cracking because of iron expansion of the hinges and this should be attended to. It is the principal public entrance to the site, and it is important that it doesn't appear run down. The Southernmost walling is poor in places.

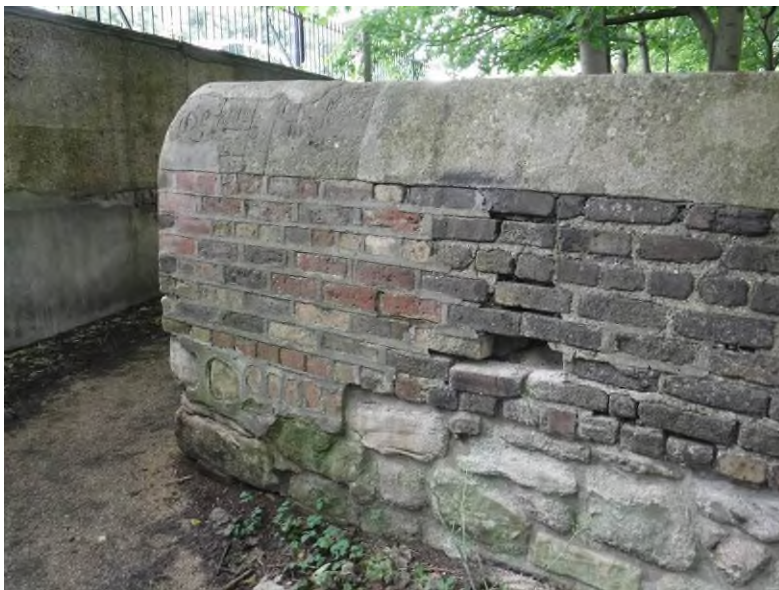
Brick erosion at sw corner. Pic from 2020

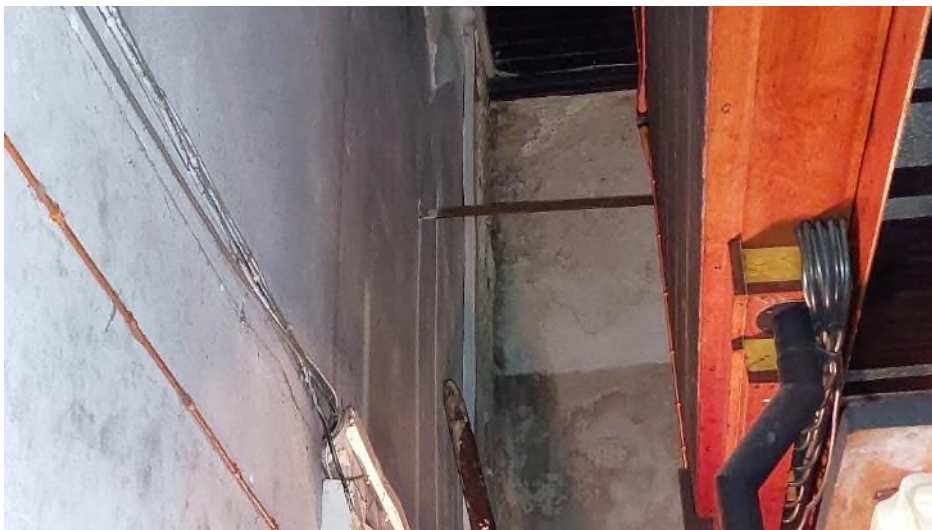
- They share a box gutter and the east end leaking has been a recurring problem.. First through lead theft, then poor work at the outlet, then lack of maintenance to lead alternative resulting in a sapling rooting in the lining- reported at the last QI causing leaks and at this inspection the sapling has been removed showing a 25mm hole in the lining. The consequence of this constant leak is the walling is in poor condition

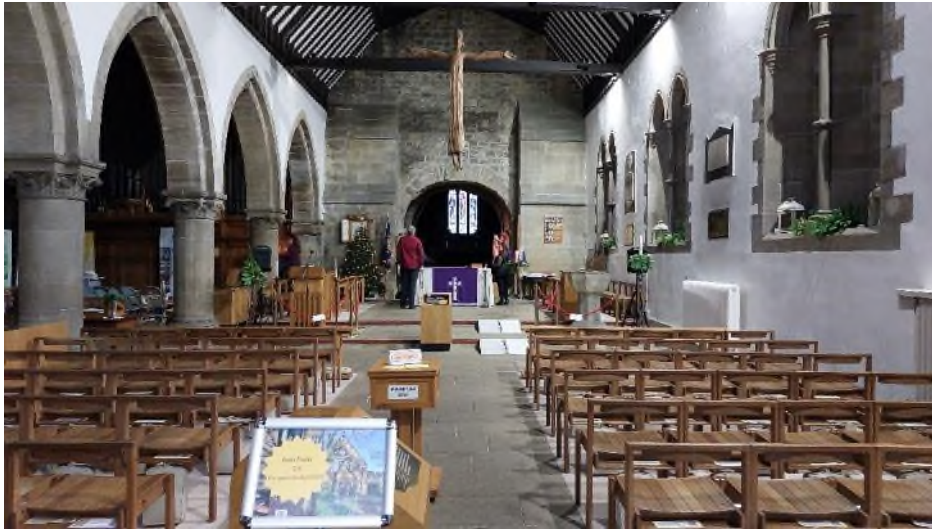
- **Walls** – The walls are painted white. There has been plaster loss in the past but only the skim coat and this has been decorated over. Minor crack over the south side western window (slim daylight gap at the apex of the inner plate tracery). Dropped arch as seen before. All probably as a consequence of differential settlement at the corner.

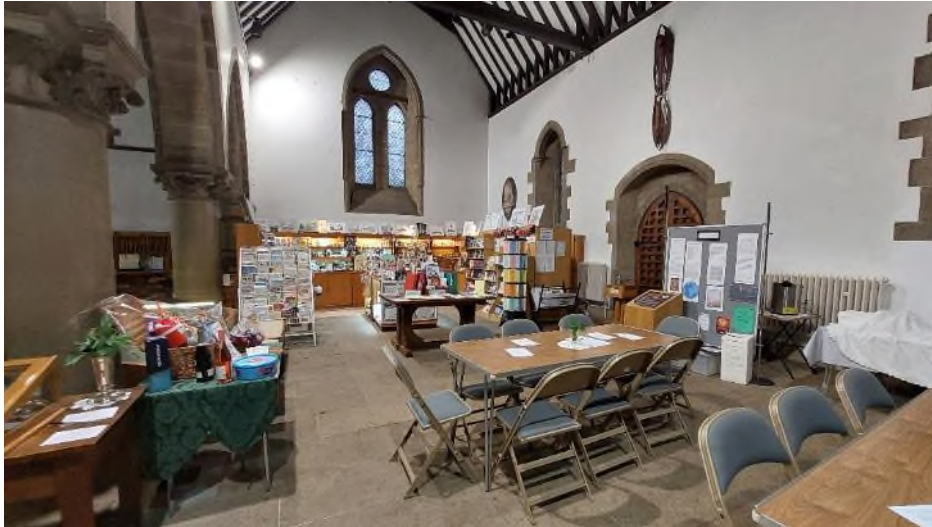
Formed behind the shop at the west end of the aisle. Contains shelving and storage for many items. It is beginning to feel full. Loose slab by rad at north door.

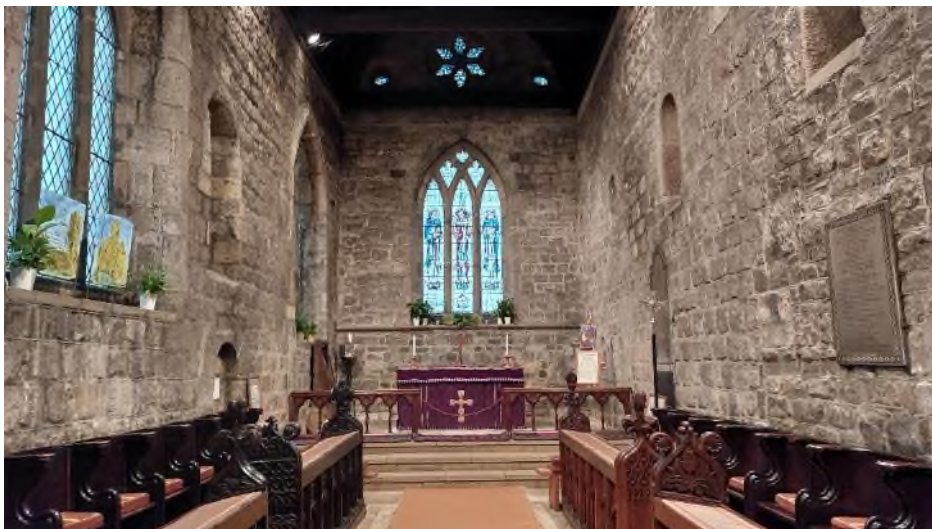
- **Ceiling** – curved rafter roof supported by large principal beam trusses. Water staining to boarding in SE corner (new or missed in the past?)

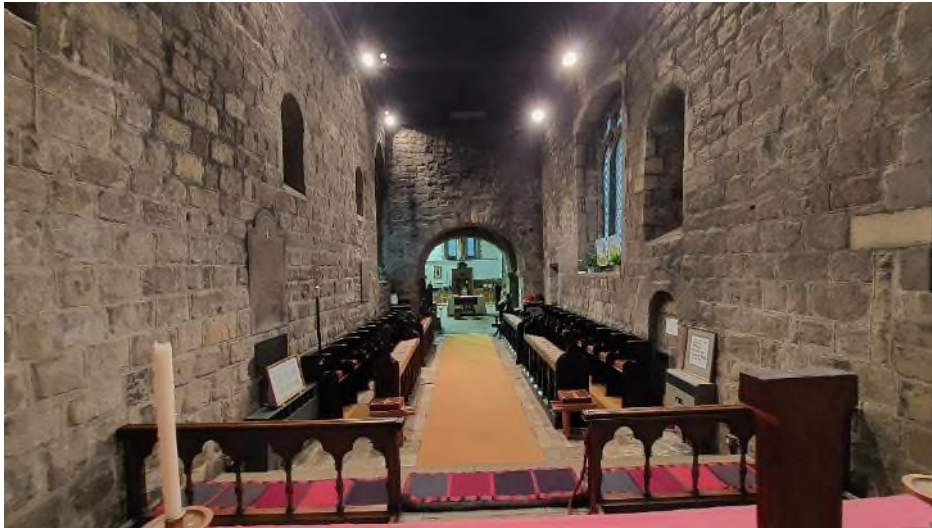
- **Walls** – Exposed stonework that received a repoint in cement pointing with surface ribbon decoration. Little can be done other than keep the external pointing in lime to let the wall breathe as best as possible. The alternative is to remove it, repoint in lime and then limewash it. There are other more pressing issues to contend with.
Crack at the N door commented on in the external section, otherwise everything else is ok.

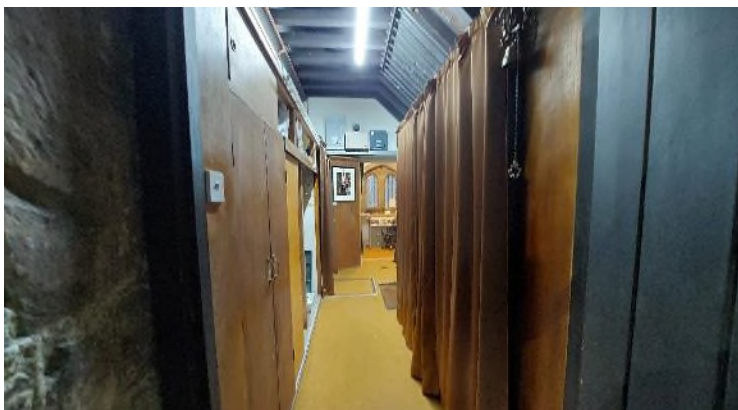
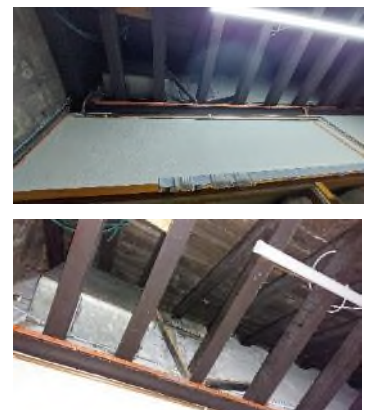
- **Ceiling** – The board panelling at the first aid kit could be redecorated. Some ceiling paint peeling. Roof leak corresponding the E end of box gutter and other side of the wall in the organ chamber.
- **Walls** – painted plaster. Historical water staining. Vestry wall decoration is good
- **Floor** – The floor is squeaking slightly by the doorway.
- **General** – It has multiple cupboards and these are containing garments, pamphlets, booklets etc. They also house the distribution board and electrical cabinets. There is also further electrical works above the entrance into the vestry and within the cupboard to the left-hand side of it.
- Has a sink and hot water heater.

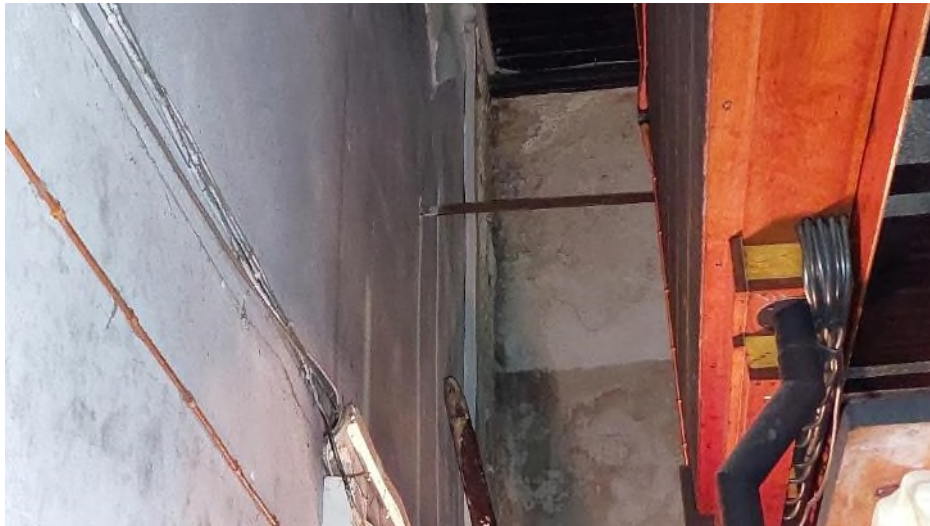
The arcade wall has had water ingress in the past and flaking plaster - from leaking valley gutter at the E end between the nave and aisle. The room is full of organ so it's not really possible to tell what wall and ceiling condition is like.

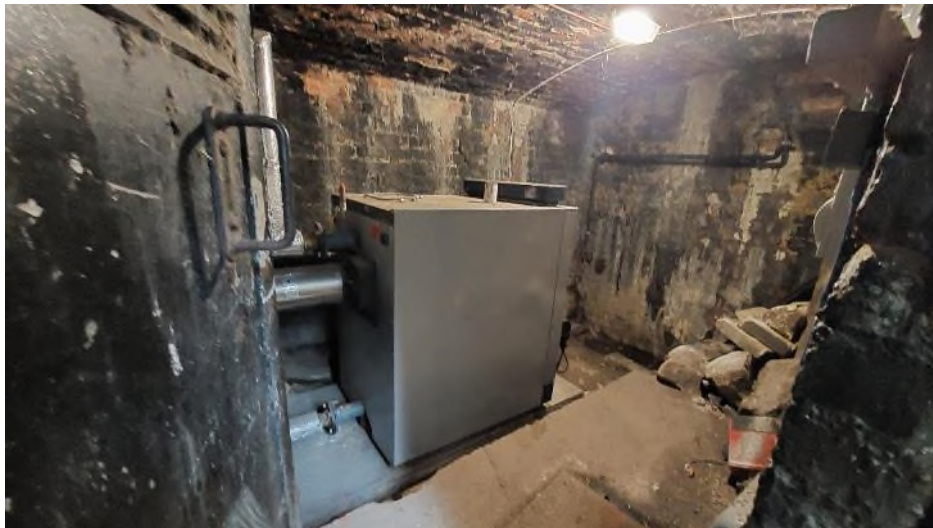
Brick vault ceiling with render coming away and the walls are also brick and somewhat sooty. Floor is on two levels, dry, in concrete and the room contains various bits of stonework and lumber and could do with a clear out. Contains a Harrier GTS boiler new in 2106 utilising the existing oil feed pipe that runs under the Monastery site from the remote oil tank. Metal door in frame jams in the opening, rusted a bit and needs easing. The retaining brickwork walls are ok, steps are a bit slippery, and stonework below is a little bit patchy but is ok.
