**INSPECTION AND REPAIR OF CHURCHES**

**QUINQUENNIAL REPORT on the**

**ALL SAINTS CHURCH  
LANCHESTER**

Date of report: 5<sup>th</sup> March 2021

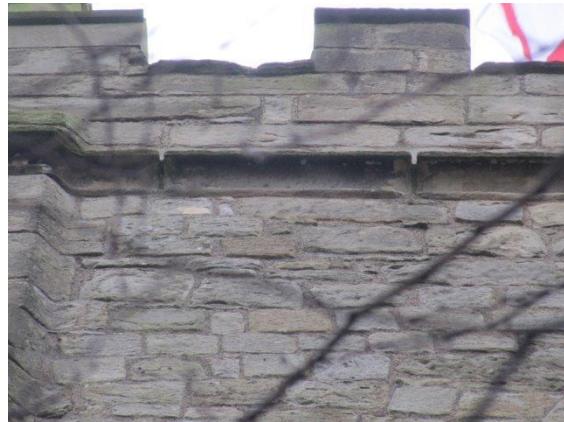
Open joints to tower string course

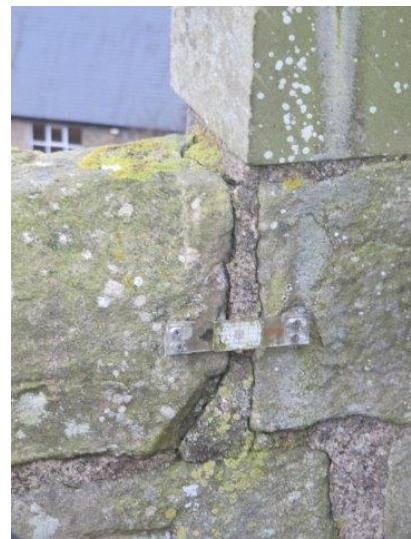
Cracking to tower parapet to be repointed or grouted

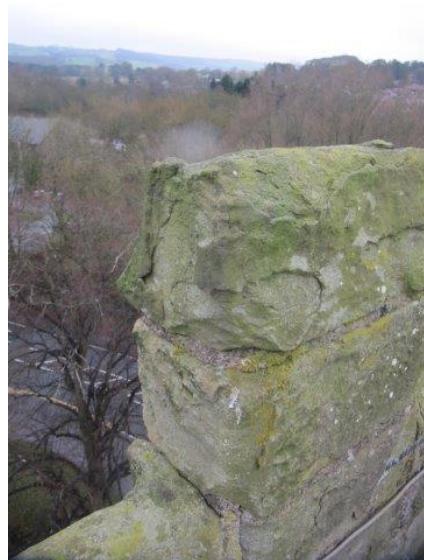
Weathered copings to tower parapet

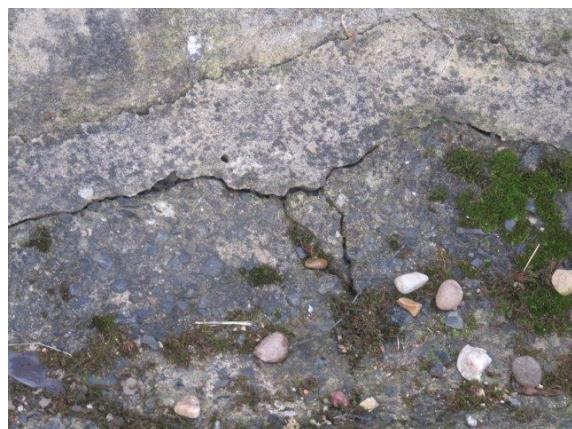
Cracking to concrete skirt at the base of the tower

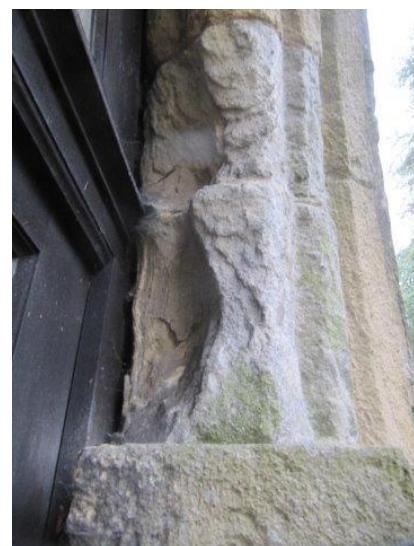
Weathered stonework to main porch

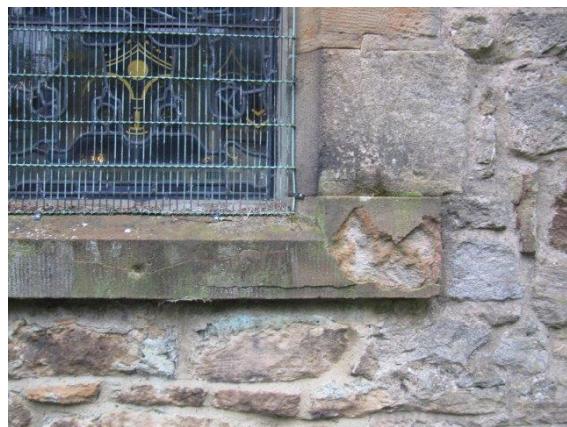
Cill to window 4

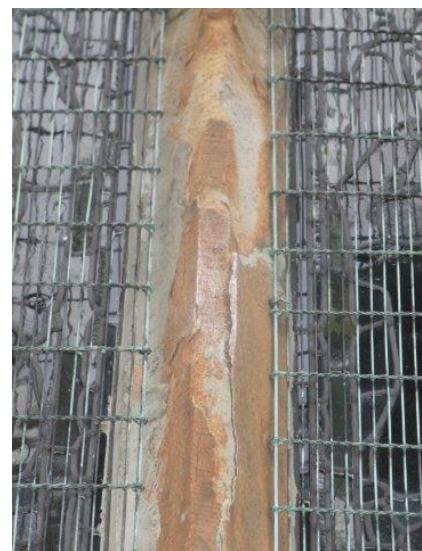
Mullion to window 3

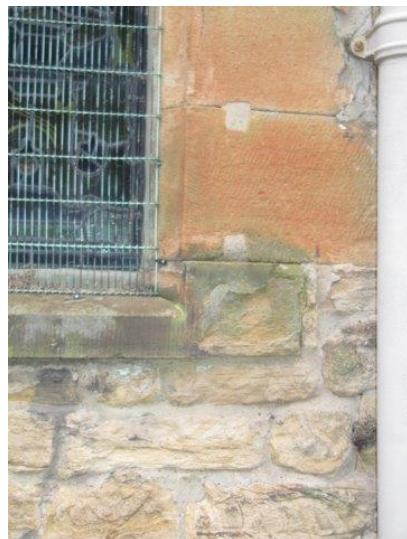
Cill to window 3

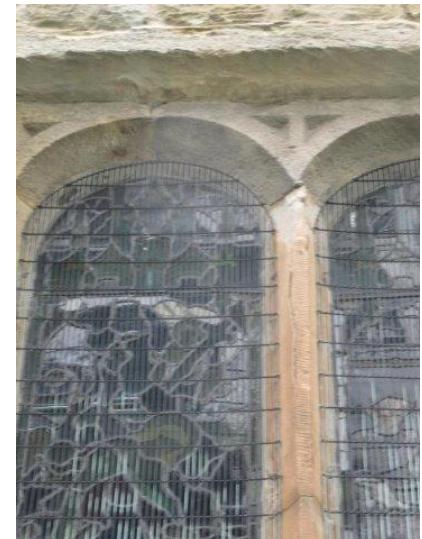
Mullion to window 2

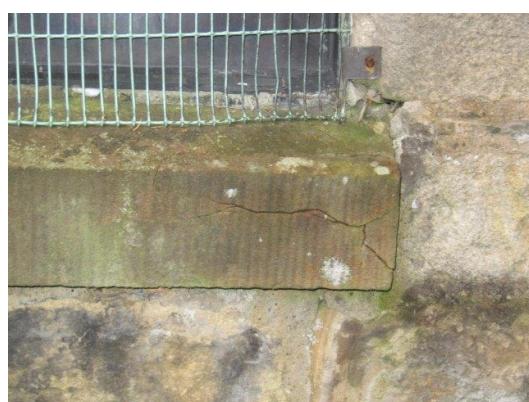
9. East Elevation of South Aisle	Squared sandstone walls with ashlar dressings.	Window 1 – there is loss of material and damage to the mullions of this window. Although for the mullions the damage is not as severe as that on the South Elevation this has been significantly descaled in the past and warrants attention and repair at the same time. There is cracking to the sill with one small section loose and likely to come loose if disturbed.	The stonework to the mullions and sill, needs addressing as the condition is poor, and a programme of repairs scheduled in the first instance to establish the extent of the work required. Repairs to the windows should be included as these will need to be removed to facilitate the work to the stonework	2 for scheduling works, 3 for carrying out works to allow for obtaining funding
----------------------------------	--	---	--	---

Cill and mullion to window 1

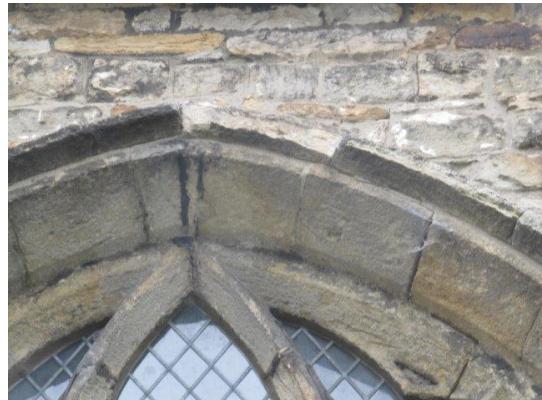
Hood moulding to window 16

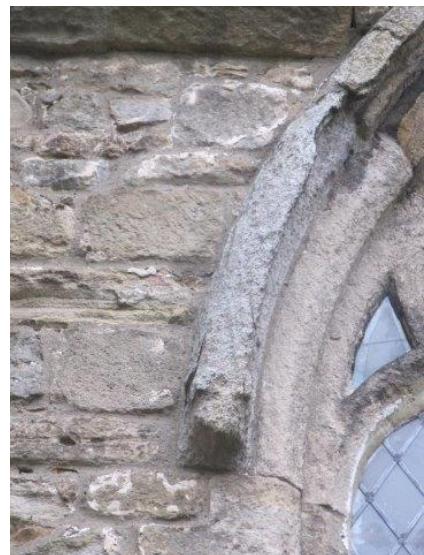
7. South Elevation of Chancel	Squared sandstone walls with ashlar dressings.	<p>Isolated open joints at higher level, with minor open joints to the base of the wall. Contour scaling to the stonework of the Eastern buttress with some material starting to come loose.</p> <p>Window 14 – Open joints to the surround and cill</p> <p>Window 15 – Cill starting to split – this doesn't appear to require immediate repair but should be checked at the next inspection. Weathering to left hand section of hood moulding – this should be periodically monitored and checked carefully at the next inspection. Some weathering to mullions and slight loss of material to tracery</p> <p>Window 16 – loss of stonework to hood moulding and open joints to mullions and surround. Some <del>weathering to mullions</del></p>	<p>Repoint open joints using lime mortar</p> <p>Repair/replace damaged section(s) of hood moulding</p> <p>Descale loose sections of stonework to buttress</p> <p>Monitor hood moulding to window 15</p>	<p>3</p> <p>3</p> <p>3</p> <p>M</p>

Hood moulding to window 15

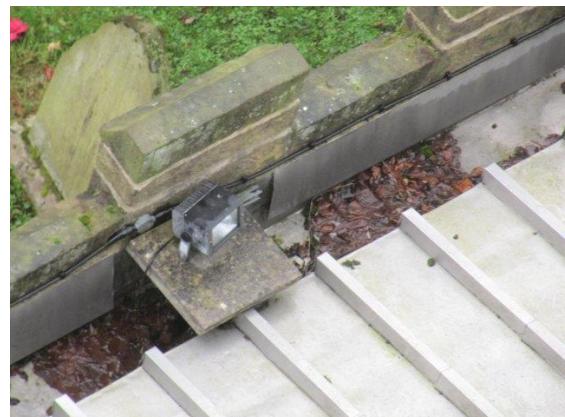
Build up of leaves in Aisle gutter

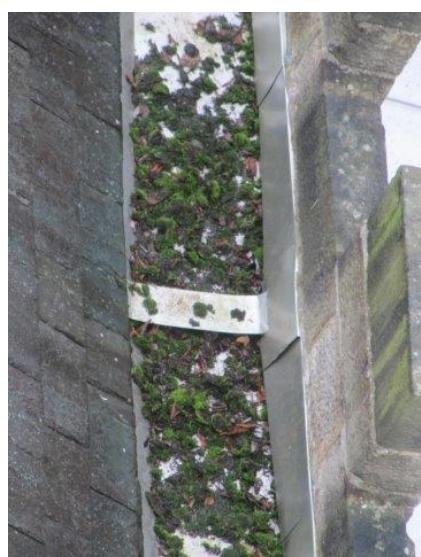
Buildup of debris in aisle gutter

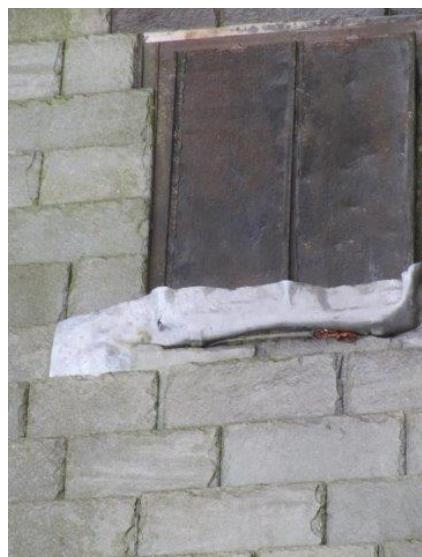
Deformed lead over hatch/old skylight

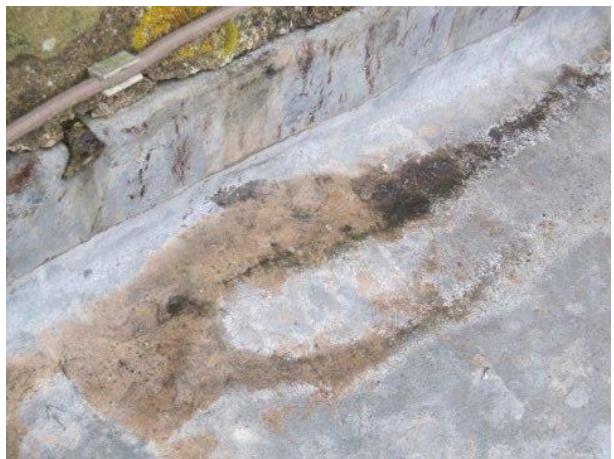
Raised leadwork to tower roof

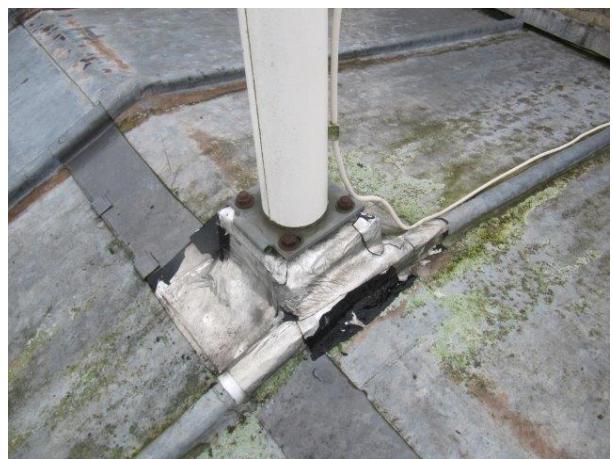
Failing modern flashings to base of flagpole

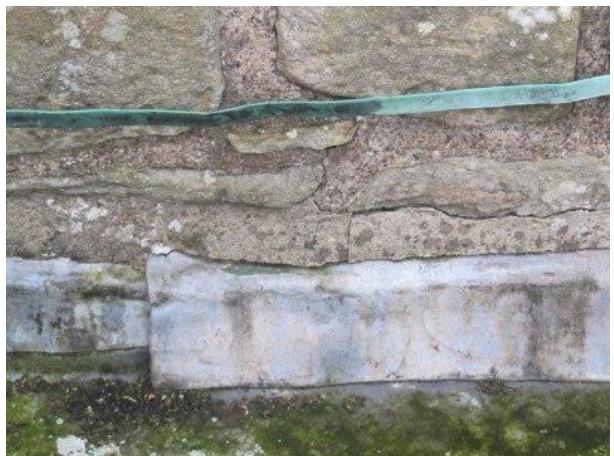
Cracking mortar over flashings to tower roof

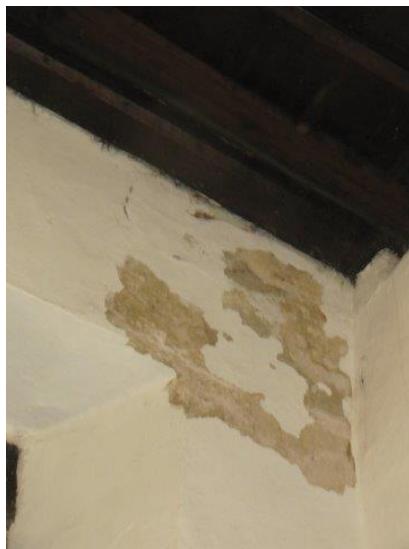
Loss of limewash to West wall of North Aisle

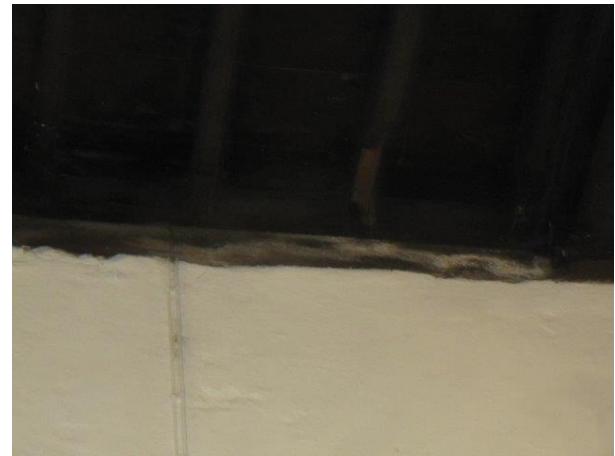
White staining to wall plate in North Aisle

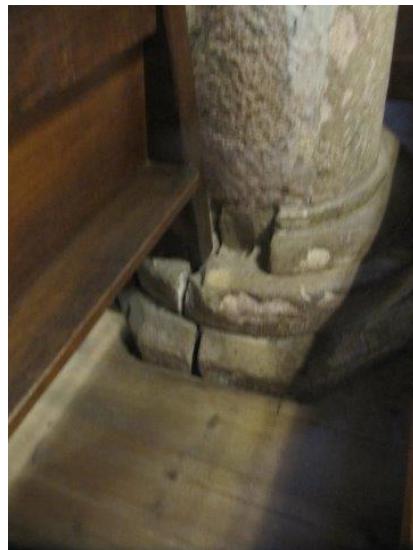
Open joints to column in North Aisle Window

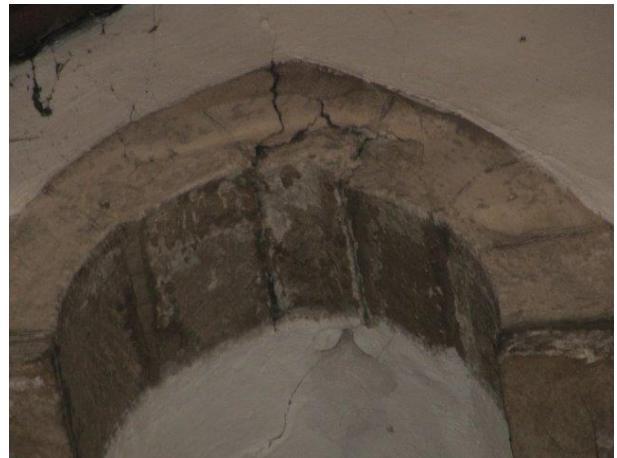
Cracking of arch over left light to East Chancel

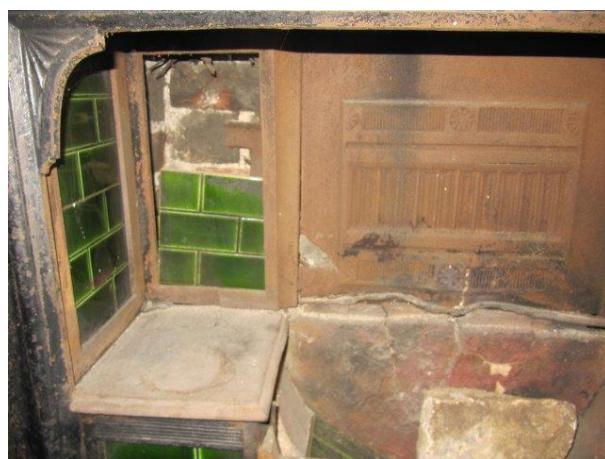
8. Vestry	Plastered walls and ceiling with timber paneling and cupboards. Fireplace to South wall. Carpet.	<p>Open joist to surround of opening to kitchen (blocked). Plaster to left hand reveal on North wall is in need of attention – the plaster sounds hollow when tapped and dust appears from cracks when this occurs. Some areas of paintwork in the same area appear to be poorly adhered and may indicate issues with damp.</p> <p>Loose tiles/slipped tiles to the fireplace are now in part stored in the grate. Cast iron fire back and brick below is cracked and the metalwork of the grate is rusted. Ideally this should be restored, but as a minimum it would be good if damaged elements are kept safely stored in case funds are available for this in the future</p> <p>Open joints to window surround, now internal, on North wall</p>	Ascertain whether there are issues of dampness in the area near the left hand opening on the North wall. Carry out repairs to poorly adhered area of plaster using lime plaster.  Safely store failed sections of fireplace.	2 for investigation, 3 for plastering  2  5  5

Damaged fireplace in vestry

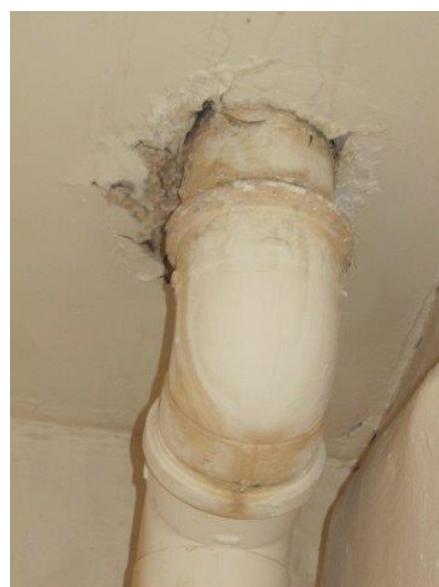
Staining around SVOP in forts floor WC

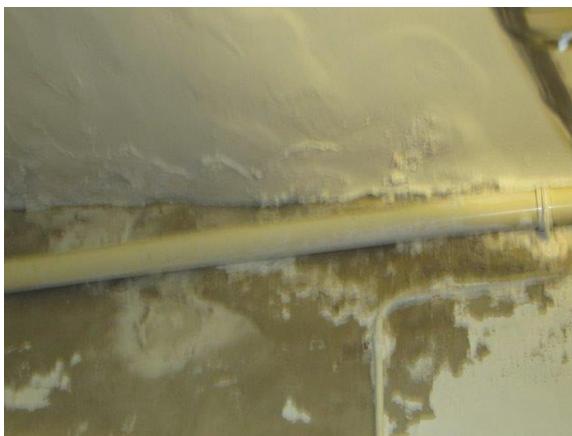
16. Boiler Room	Exposed stone and plastered walls. Exposed Boarding.	<p>Full access impeded by boiler plant and the flue/structure surrounding the flue could not be inspected.</p> <p>Loss of paint finish to North wall and issues of blistering to the wall and ceiling indicates issues with dampness which were noted in the previous report.</p> <p>Open joints to stone walls.</p> <p>The lock out the door is stiff and would benefit from easing.</p>	<p>Ease lock to door</p> <p>Investigate causes of water ingress/dampness and carry out remedial work.</p> <p>Brush off loose material to wall and ceiling</p>	<p>1</p> <p>1</p> <p>2</p>
17 First Floor WC	Plastered walls and ceiling. Vinyl flooring. Tiled splashback.	<p>There is evidence of water damage visible under the roof light, which was noted previously so is assumed to be historic but is difficult to tell. There appears to also be dampness (possibly ongoing) near the SVP. Cracking noted to the NE corner with rough plaster in the difficult to reach areas by the SVP.</p> <p>The door to the WC is very stiff and would benefit from easing.</p>	<p>Ease doors to WC.</p> <p>Investigate causes of water ingress, unless known to definitely be historic issues, and carry out remedial work.</p>	<p>1</p> <p>1</p>

Loss of paintwork to first floor boiler room wall

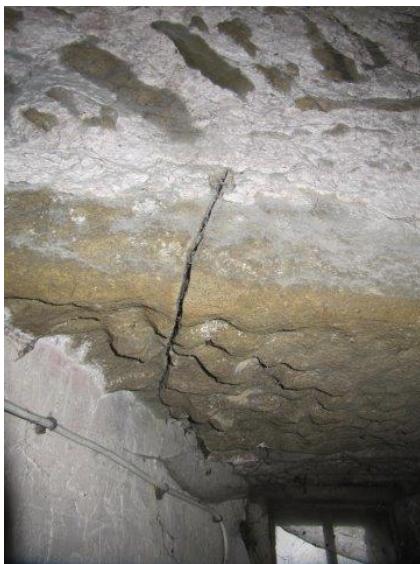
Crack to clock chamber lintel is understood to have been repaired but not repointed

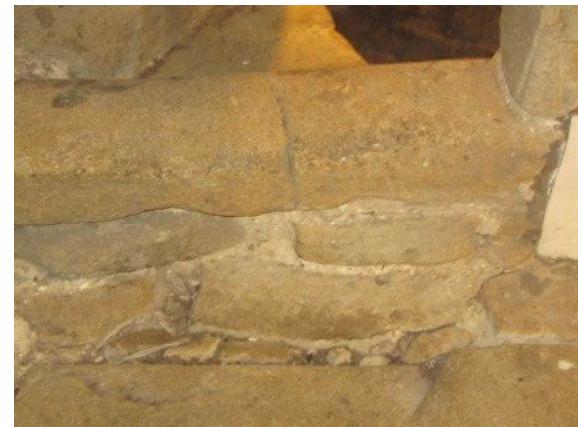
Step into clock chamber is awkward

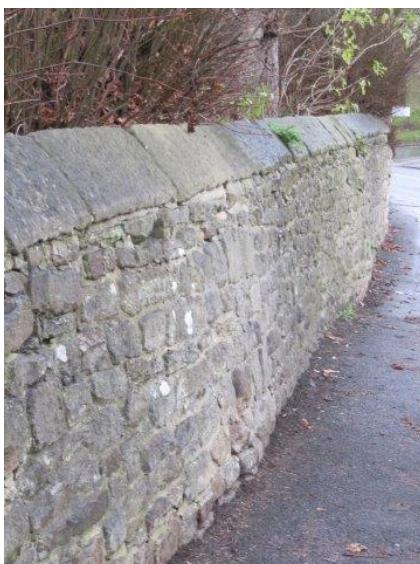
Bowing wall around tree to Southern boundary

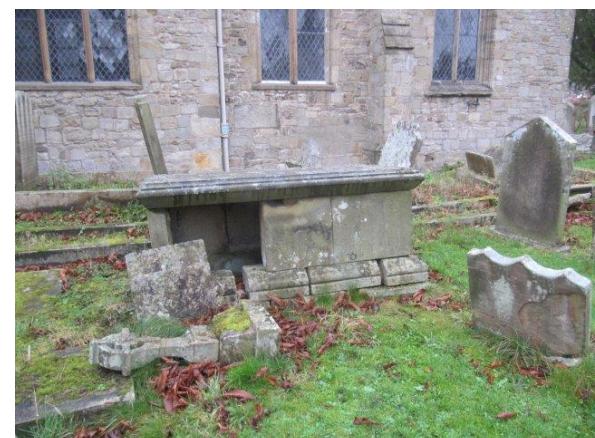
Damaged table tomb

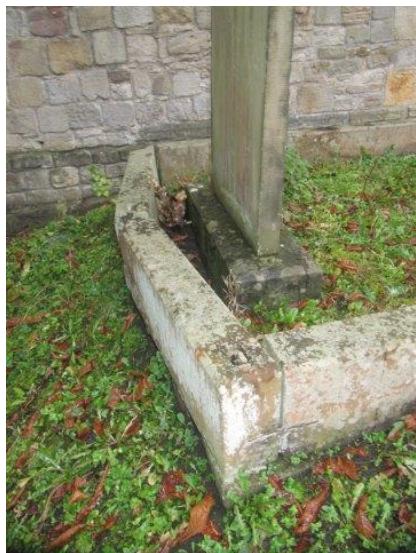
Unstable grave edging to the East of the  
steps/entrance  
South Aisle

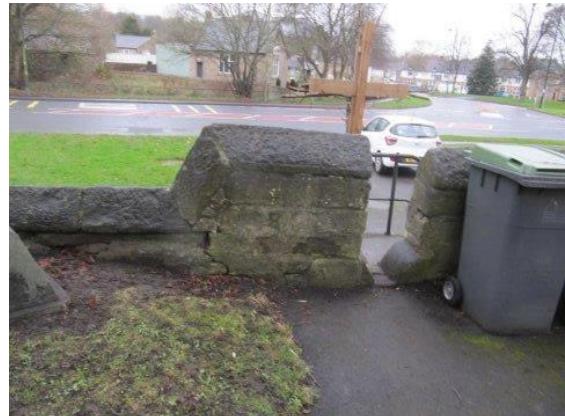
Cracking wall to the South of the main
