QUINQUENNIAL INSPECTION REPORT - APRIL 2021

# ALL SAINTS CHURCH

LOW MOOR ROAD, LANGLEY PARK, CO. DURHAM, DH7 9TZ

JDDK Architects

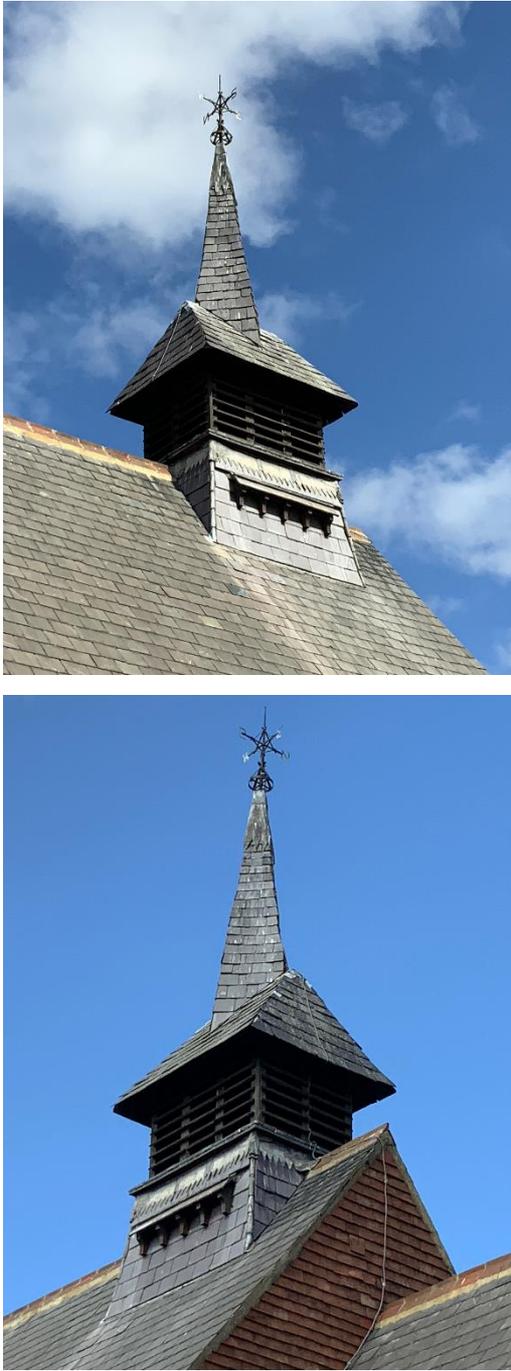
Bel-cote

<p><b>Description</b></p> <ul style="list-style-type: none"> <li>• The bel-cote and its spirelet are dressed in Welsh slate with mitred hips.</li> <li>• Hardwood louvres to the sides are well sheltered by generous overhangs on all sides.</li> <li>• Junctions are protected with lead ridges, flashings, soakers and rolls.</li> <li>• Spirelet is topped with a weather vane and lightning conductor. Conductor cable is clipped to the East side of the bel-cote, and East gable of the Nave.</li> </ul>	
	<p><b>Condition</b></p> <ul style="list-style-type: none"> <li>• The 2004 report indicated that the bell-cote and spirelet were overhauled in 1992 including the replacement of the original shingles with Welsh slate.</li> <li>• As far as can be seen from ground level, the structure is in sound condition</li> <li>• Exposed timber is showing signs of distortion, and would benefit from coating with timber preservative to prolong its lifespan. However, no loose timbers are visible.</li> </ul>

<p><b>Repair Needs</b></p> <ul style="list-style-type: none"> <li>• When roof repair works are next carried out, it is suggested that the contractor inspect the timberwork for any loose elements</li> <li>• Exterior timber work is due for treatment with timber preservative.</li> </ul>	<p><b>M</b></p> <p><b>M</b></p>

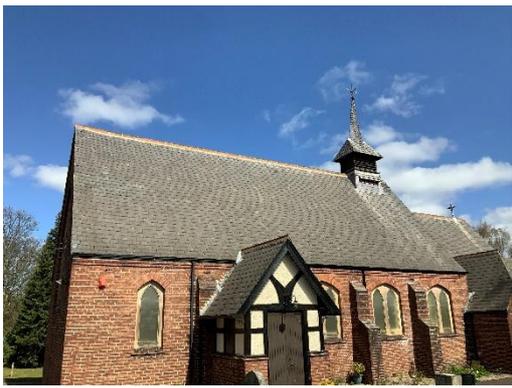
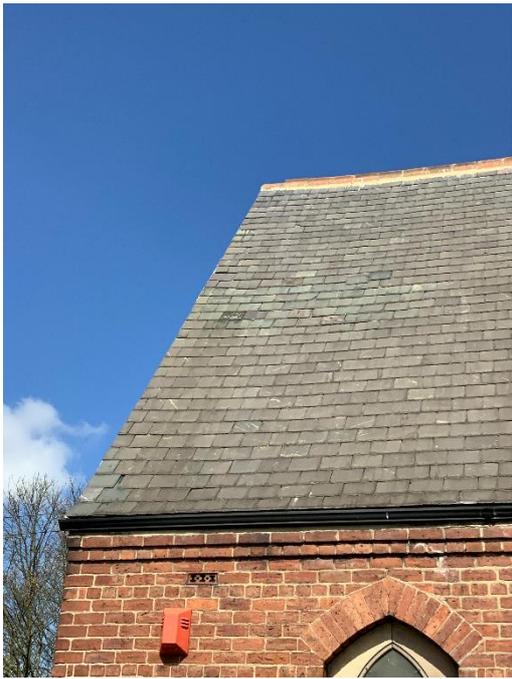
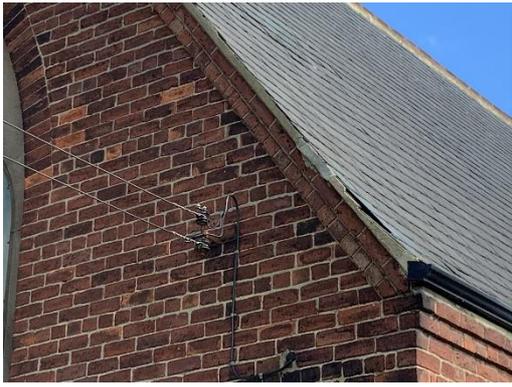
**Southern Pitch of the Nave Roof**

<p><b>Condition</b></p> <ul style="list-style-type: none"> <li>• Generally in good condition. No missing slates, although some have chipped corners.</li> <li>• Mortar pointing between ridge tiles appears is weathering out gradually. Westernmost ridge tile does not match the others.</li> <li>• Pointing to the western verge is complete and appears to be stable.</li> </ul>

<p><b>Repair Needs</b></p> <ul style="list-style-type: none"> <li>• Repoint ridge tiles, and at the same time, check that they are soundly bedded, taking remedial action as required.</li> <li>• Monitor slates and refix any which continue to slip, or are blown off.</li> <li>• Replace westernmost ridge tile with a closer match to the others.</li> </ul>	<p>D</p> <p>M</p> <p>E</p>

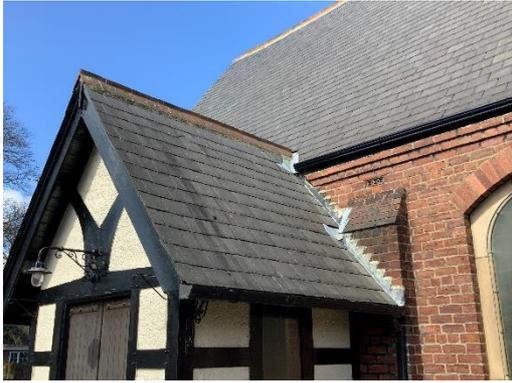
**Porch Roof**

<p><b>Condition</b></p> <ul style="list-style-type: none"> <li>• Generally in good condition. No missing slates, although one or two are slipping and others have chipped corners.</li> <li>• Mortar pointing and bedding to ridge tiles is sound, although beginning to weather out of the joints at the top edge.</li> <li>• Lead flashings are in good condition.</li> </ul>	
	<p><b>Repair Needs</b></p> <ul style="list-style-type: none"> <li>• Monitor slates and refix any which continue to slip, or are blown off.</li> </ul>	M

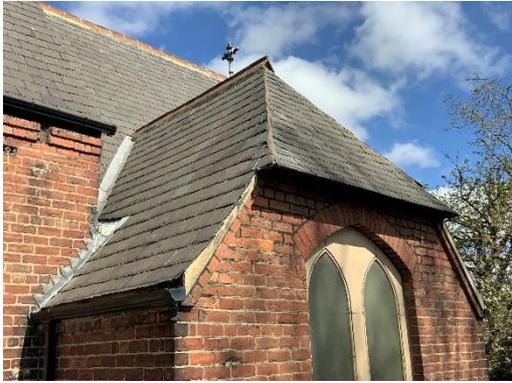
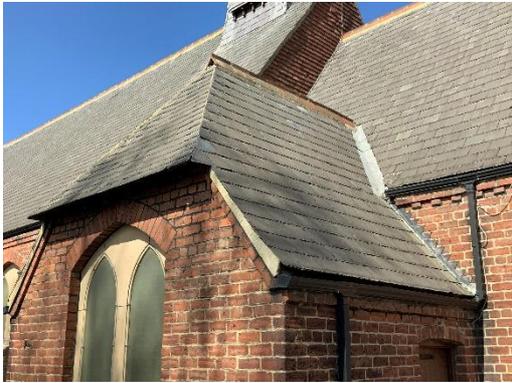
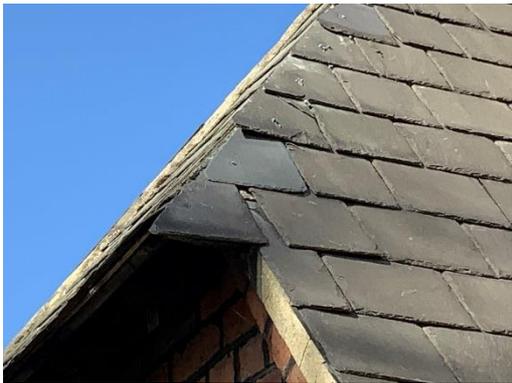
**Roof over the South Vestry**

<p><b>Condition</b></p> <ul style="list-style-type: none"> <li>• Generally in good condition, with slates secure although some have chipped corners. One slate on the East slope has slipped.</li> <li>• A slate has slipped at the lowest part of the East edge of the hip leaving a gap in the roof covering.</li> <li>• Mortar pointing and bedding to ridge tiles is sound, although beginning to weather out of the joints at the top edge.</li> </ul>

<ul style="list-style-type: none"> <li>It is peculiar that no lead roll flashings were originally installed at the hips and the slate to slate junction is a vulnerable construction method and warrants careful monitoring.</li> <li>Minor cracking in pointing to the verge.</li> <li>Lead flashings are in good condition</li> </ul>	
	<p><b>Repair Needs</b></p> <ul style="list-style-type: none"> <li>Monitor slates and refix any which continue to slip, or are blown off.</li> <li>Fix slates at East edge of the hip, or introduce a lead soaker to protect roof structure beneath.</li> </ul>	<p>M</p> <p>C</p>

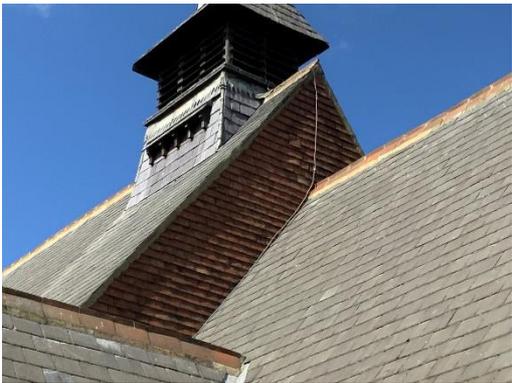
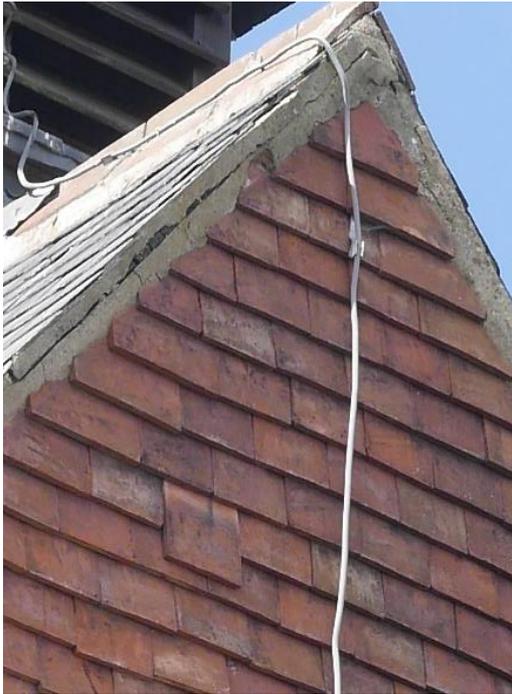
**Tiled East Gable to Nave**

<p><b>Description</b></p> <ul style="list-style-type: none"> <li>Clay tile hanging below mortar verges.</li> <li>Note that only the Southern part of the gable can be seen from ground level due to the North Vestry roof which conceals the Northern part from view.</li> </ul>	
	<p><b>Condition</b></p> <ul style="list-style-type: none"> <li>All tiles appear sound although one or two have broken corners.</li> <li>One tile has slipped noticeably and should be monitored. Any further slippage will warrant a repair.</li> <li>Mortar pointing to the verge continues to crack and the ends of the roof sparking boards are visible. It is time for this to be repaired.</li> </ul>	
	<p><b>Repair Needs</b></p> <ul style="list-style-type: none"> <li>Repoint the mortar verge and fix the tile that has slipped.</li> <li>Continue to monitor other tiles for slippage.</li> </ul>	<p>D</p> <p>M</p>

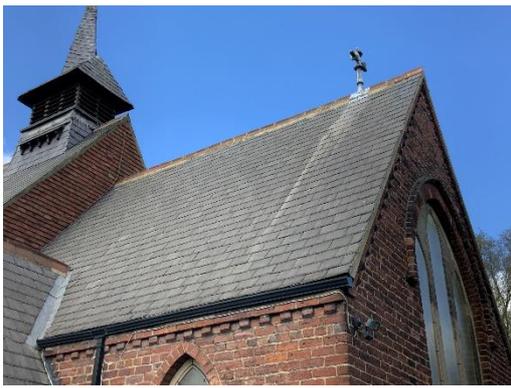
**Roof over the Chancel**

<p><b>Condition</b></p> <ul style="list-style-type: none"> <li>• Generally in good condition. No missing slates, although one or two are slipping and others have chipped corners.</li> <li>• Mortar pointing between ridge tiles is weathering out in some areas. When water gets into the bedding, frost will begin to lift the ridge tiles.</li> <li>• Ridge tile bedding has cracked away at the East gable.</li> <li>• Minor cracking to the mortar verge at the East gable.</li> </ul>	
	<p><b>Repair Needs</b></p> <ul style="list-style-type: none"> <li>• Monitor slates and ridge tiles and refix any which continue to slip, or are blown off.</li> <li>• Monitor cracks in mortar verge and carry out repairs should any fall out before the next inspection.</li> </ul>	<p>M</p> <p>M</p>

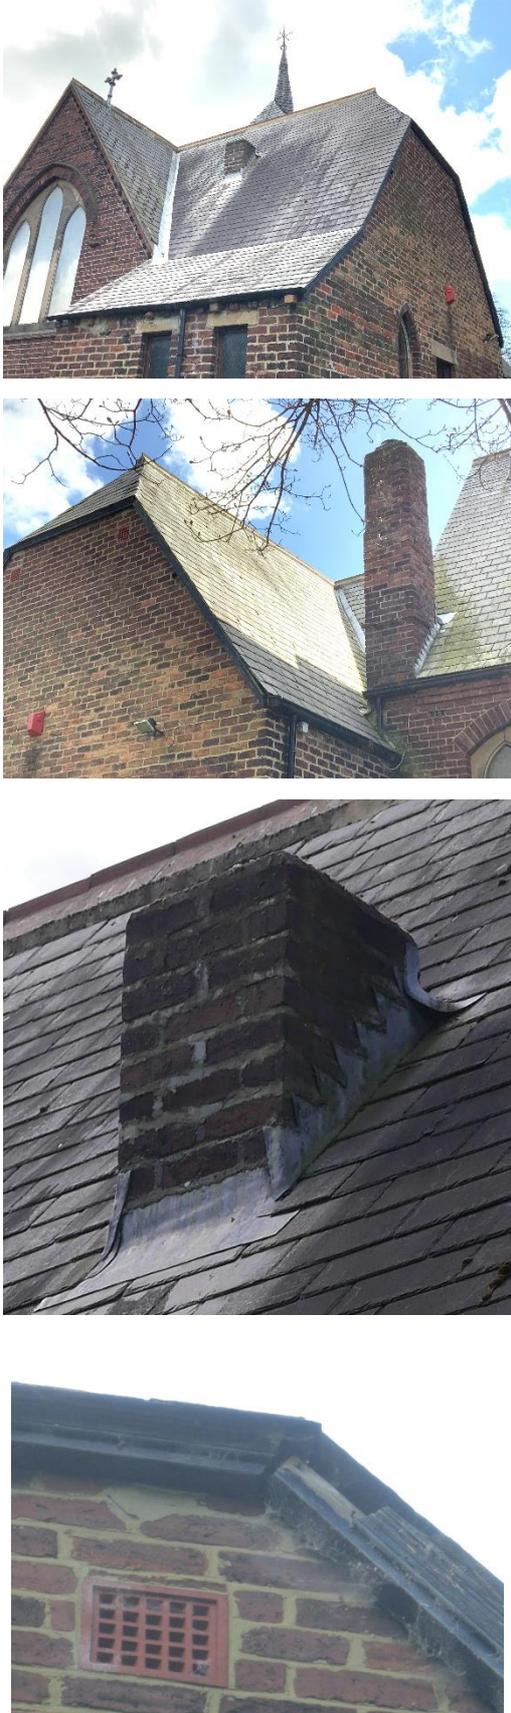
<p><b>Condition</b></p> <ul style="list-style-type: none"> <li>• Generally in good condition. No missing slates, although one or two are slipping and others have chipped corners.</li> <li>• Mortar pointing between ridge tiles is weathering out in some areas.</li> <li>• The pointing to the stub chimney on East slope appears to have been repaired since the last inspection, with plant growth removed.</li> <li>• A short length of timber moulding has come away from the verge leaving roof timber exposed to driving rain.</li> </ul>	
	<p><b>Repair Needs</b></p> <ul style="list-style-type: none"> <li>• Timber moulding on verge should be completed.</li> </ul>	<p>C</p>

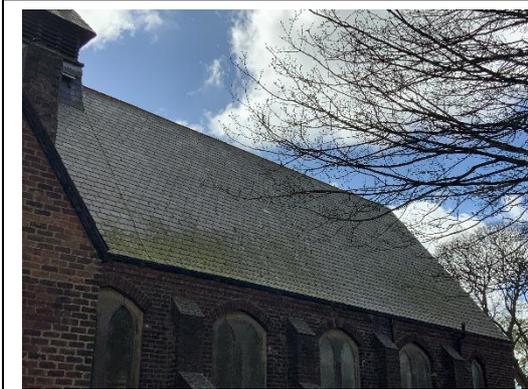
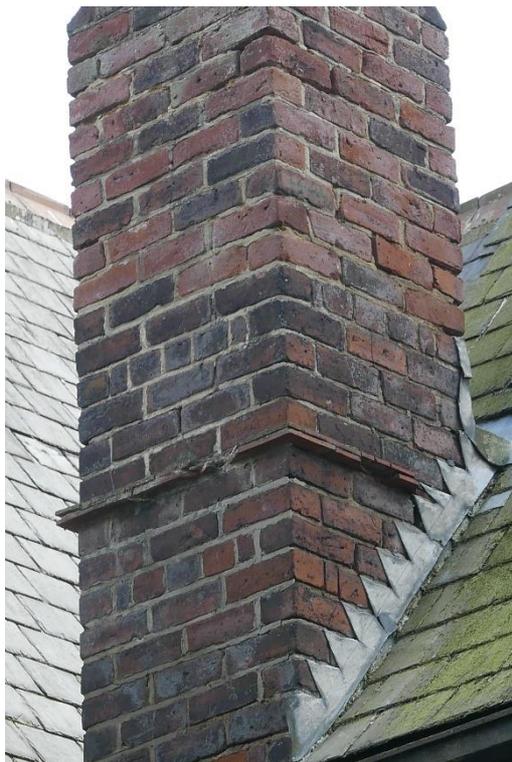
North Pitch of the Nave Roof

- Generally in good condition. No missing slates, although one or two have chipped corners.
- Mortar pointing between ridge tiles is weathering out in some areas.
- Pointing has weathered out of the chimney in some areas. This now warrants attention to prevent any water damage or dislocation.

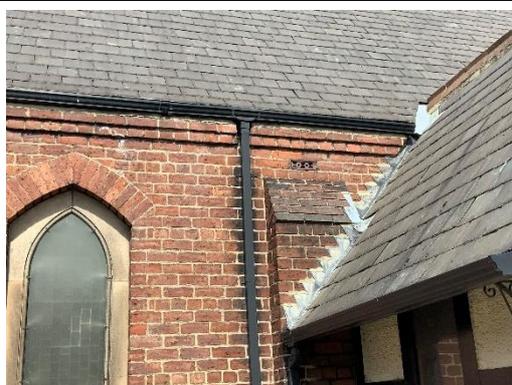
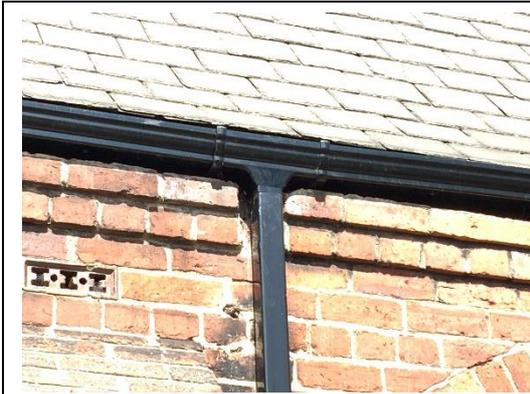
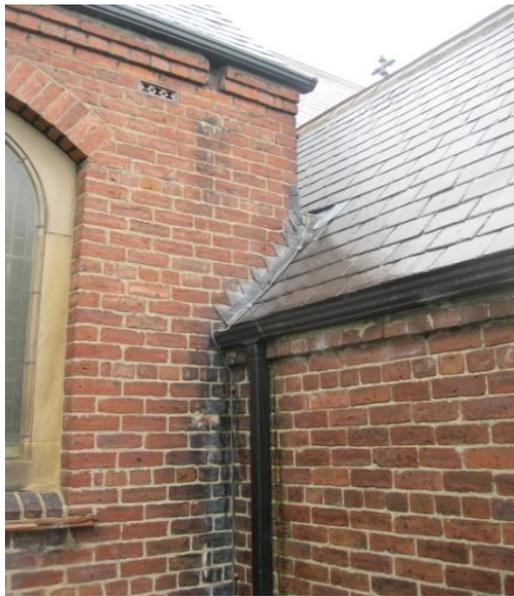
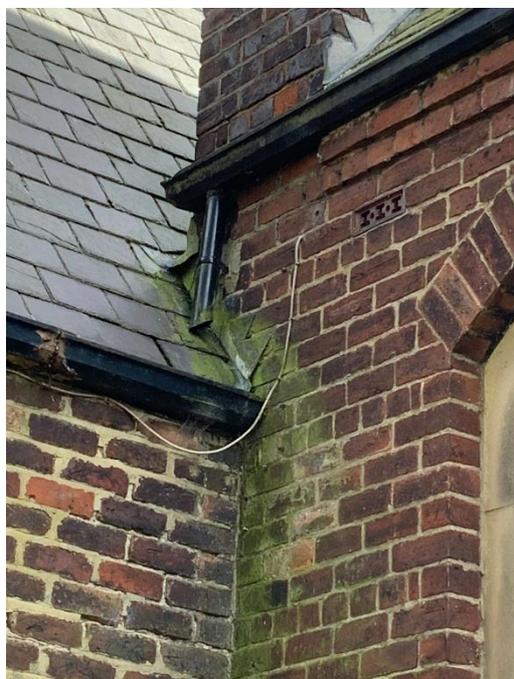
10.2. RAINWATER GOODS AND DISPOSAL SYSTEMS

- The inspection was carried out after several dry sunny days, so it was not possible to see the signs of overflowing gutters. Efflorescence on some areas of brickwork would suggest that there is some leakage from the system.

- It would appear that the cast iron guttering along the south elevation of the Nave has been replaced with black plastic ogee guttering and this deals with the leaking gutters reported in previous inspections.

- This new guttering has also been set to proper falls, avoiding the risk of standing water, which was noted in the last inspection.
- Half of the water from the North pitch of the Nave roof discharges onto the roof of the North Vestry at the base of the chimney stack. This is a risky detail, and it's causing considerable algal growth. The area of roof discharging to the single downpipe on the West elevation of the North vestry will almost certainly overload the gutter and pipe during heavy rain causing spillage onto the wall beneath.

- All leaking gutter joints should be repaired.
- Introduce a new downpipe at the East end of the North Elevation of the Nave, and remove the stub downpipe currently discharging to the North Vestry roof.
- Cast iron gutters, such as those on the North wall of the Nave, should be recaulked and repainted.
- Longer term, the PCC should consider complete renewal of guttering and downpipes. At this time, it will be worth considering the following:

<ul style="list-style-type: none"> <li>○ Introduce a second line of defence such as a high performance felt or DPC between the gutter and the top of the corbel.</li> <li>○ Use continuous seamless aluminium guttering will avoid the risks of leaky joints.</li> <li>○ Downpipes should be reintroduced where they have been removed so that all guttering is adequately drained.</li> <li>○ Introduce a downpipe to the guttering on the North of the Nave to remove water currently being discharged to the North Vestry roof.</li> </ul>	
--	---	--

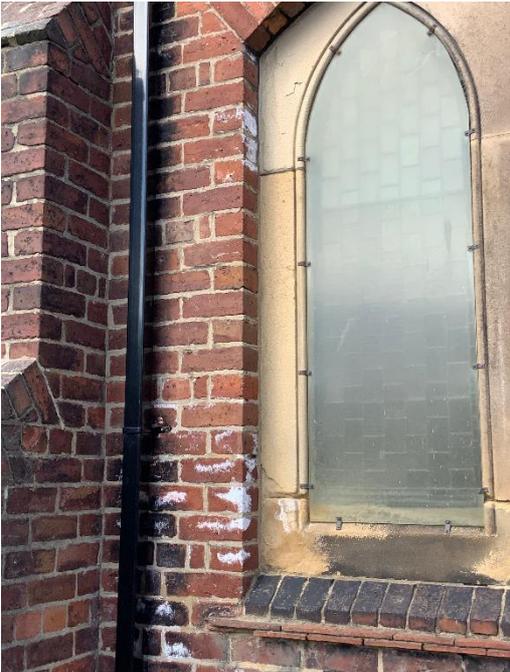
<p><b>Condition</b></p> <ul style="list-style-type: none"> <li>● The saturation and efflorescent noted in the previous report is very noticeable, suggesting that the brickwork is continues to dry out, and perhaps a result of a long dry spell without rain to wash it away.</li> <li>● Pointing is generally in good condition, although there are some small areas needing attention in the longer term.</li> </ul>	
	<p><b>Repair Needs</b></p> <ul style="list-style-type: none"> <li>● Brush off the worst of any remaining efflorescence.</li> </ul>	<p>M</p>

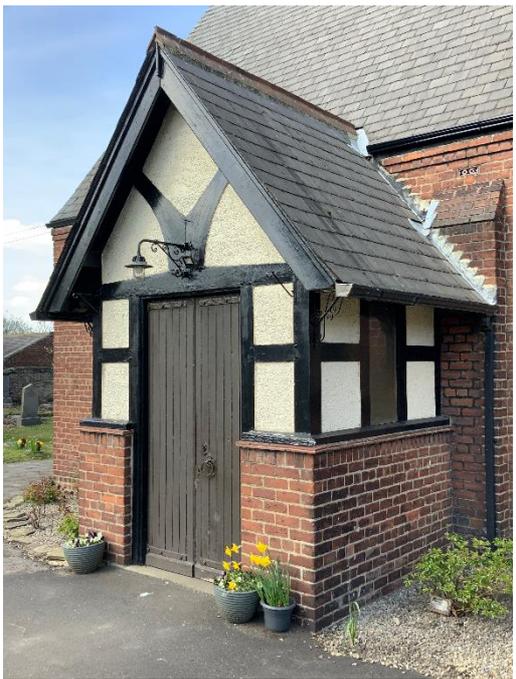
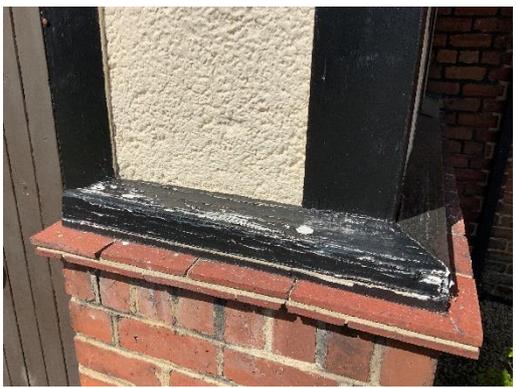
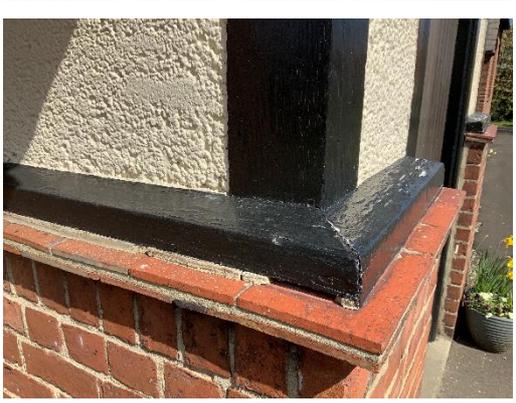
Porch

<p><b>Description</b></p> <ul style="list-style-type: none"> <li>• Half-timbered with roughcast plaster between the timber studs, and then brickwork below a line of creasing tiles under the timber sole.</li> </ul>	
	<p><b>Condition</b></p> <ul style="list-style-type: none"> <li>• The timberwork and plaster have been redecorated recently and looks in good condition, except...</li> <li>• The timber soleplate at half height is exposed to the elements in some locations due to flaking paint, despite being repainted.</li> <li>• The mortar fillet below this sole plate is cracked and pulling away in places, missing in others. This should be replaced.</li> </ul>

<p><b>Repair Needs</b></p> <ul style="list-style-type: none"> <li>• Strip the paint from the timber sole plate to each side of the doorway and repaint using a microporous paint. This will be more breathable and should prevent blistering.</li> </ul>	<p>B</p>

<ul style="list-style-type: none"> <li>• Repair the mortar fillet beneath the sole plate where cracked or missing.</li> </ul>	<p>B</p>

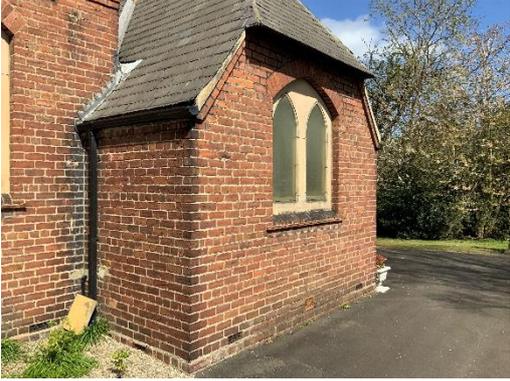
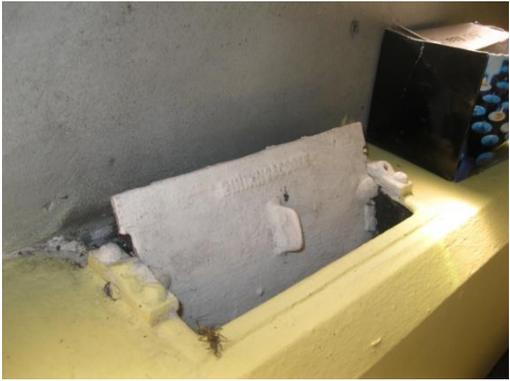
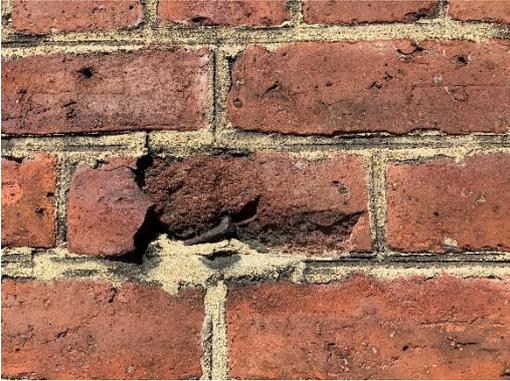
South Vestry

<p><b>Condition</b></p> <ul style="list-style-type: none"> <li>• The pointing has weathered out in some locations at low level, below the DPC line.</li> <li>• The brick damaged by a corroding iron nail on the South Elevation has not deteriorated further since the last report, and no remedial action is warranted unless it degrades significantly.</li> </ul>

<p><b>Repair Needs</b></p> <ul style="list-style-type: none"> <li>• Repoint at low level, using suitable lime mortar.</li> </ul>	D

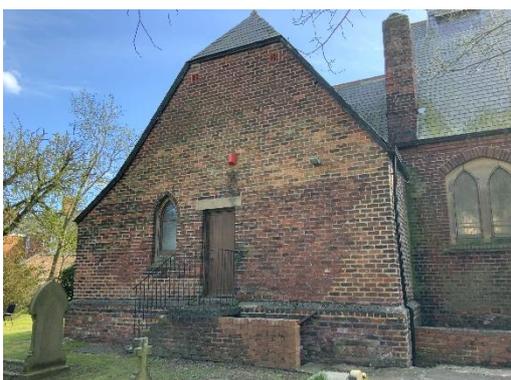
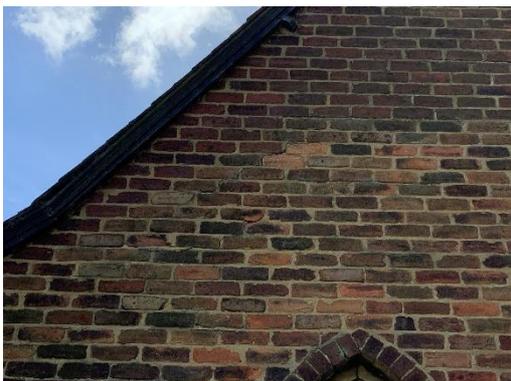
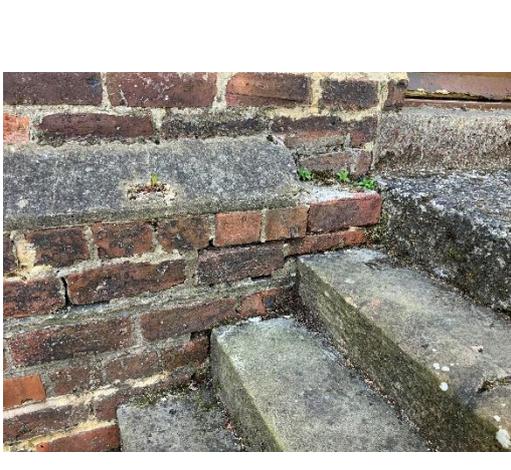
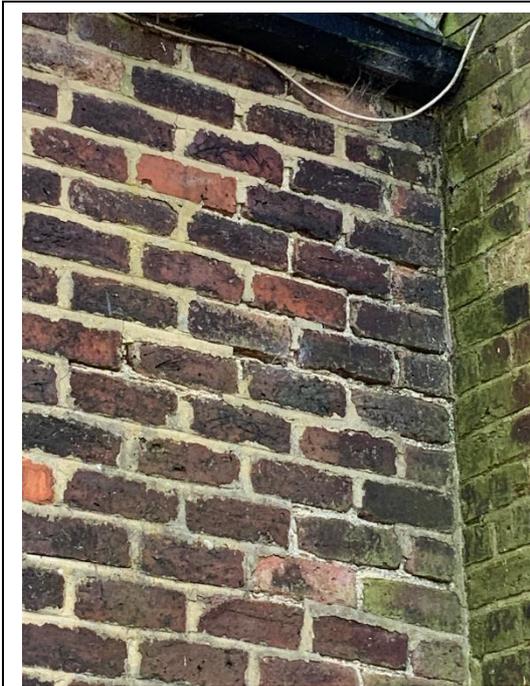
<p><b>Condition</b></p> <ul style="list-style-type: none"> <li>The North Vestry has been poorly repointed some time before the previous report. The buff cement-based pointing is degrading quickly, but there is plenty of the original lime mortar left in the joints.</li> <li>The structural cracks in the North elevation, reported in 2009, are still noticeable close to the eaves, and also above the arched window. They do not appear to be getting any worse.</li> <li>The stone stair up to the Vestry door has some open mortar joints here which would benefit from repointing.</li> <li>The single brick coping that was missing from the low wall beside the steps down to the basement has been replaced.</li> </ul>

<p><b>Repair Needs</b></p> <ul style="list-style-type: none"> <li>Loose or missing pointing should be replaced, using lime mortar, in the following locations to prevent water ingress:             <ul style="list-style-type: none"> <li>East elevation around plinth level close to the downpipes.</li> <li>Open joints close to the eaves on the North Elevation.</li> <li>Walling beside the stone steps, and at the steps down to the basement.</li> <li>Inside corner of the North Vestry and the North wall of the Nave.</li> </ul> </li> </ul>	<p>D</p>

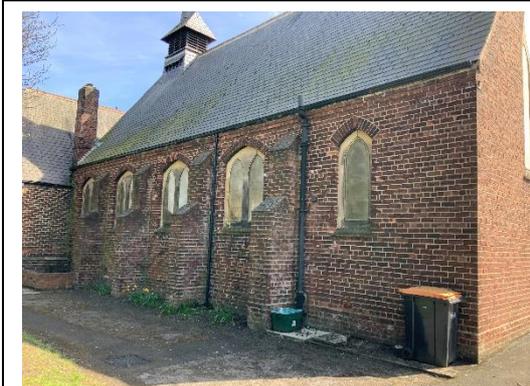
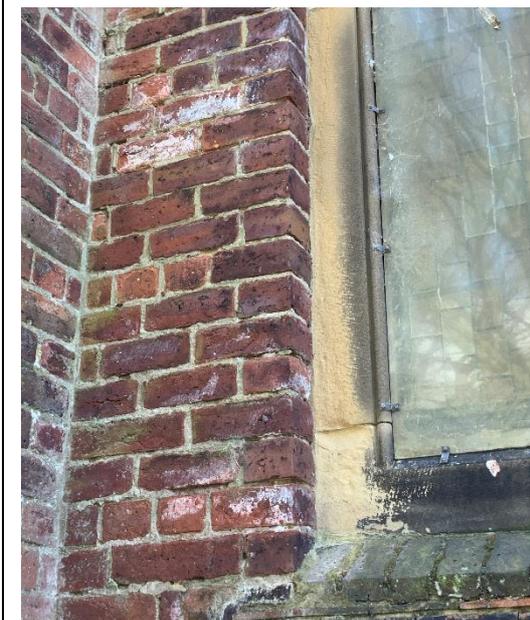
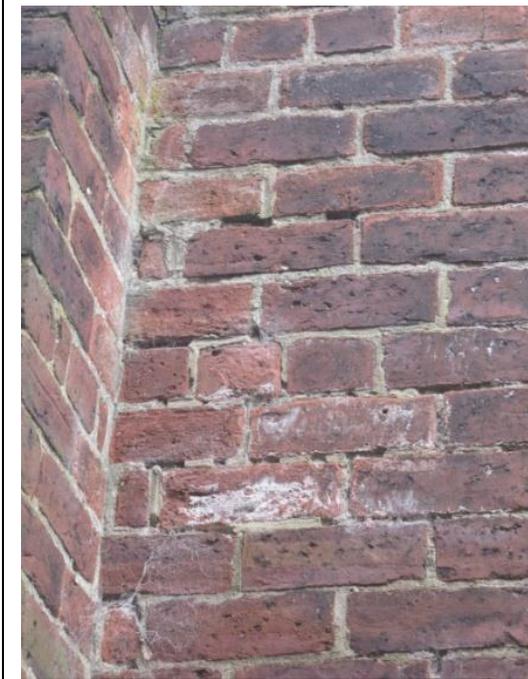
**North Elevation of the Nave**

<p><b>Description</b></p> <ul style="list-style-type: none"> <li>Red brick walling with brick sills, buttresses, corbels and arched window heads. Brick plinth below slate DPC. Air bricks suggest that walling may have an internal cavity.</li> </ul>
	<p><b>Condition</b></p> <ul style="list-style-type: none"> <li>Some large areas of efflorescence are visible on this elevation, suggesting that dampness in the masonry is still a problem, but also perhaps because of a long dry spell without rain to wash it away.</li> <li>One or two locations in need of repointing, including to the region of the rainwater downpipe.</li> <li>Sloped tops to buttresses have been cleared of the plant growth noted in the last inspection.</li> </ul>
	<p><b>Repair Needs</b></p> <ul style="list-style-type: none"> <li>Loose or missing pointing should be replaced using lime mortar. This is needed:                         <ul style="list-style-type: none"> <li>Walling to the left of window W.06.</li> </ul> </li> </ul>

<ul style="list-style-type: none"> <li>○ At plinth level in several locations.</li> <li>● Keep the top surfaces of the buttresses clear of plant growth.</li> </ul>	<p>M</p>
---	----------

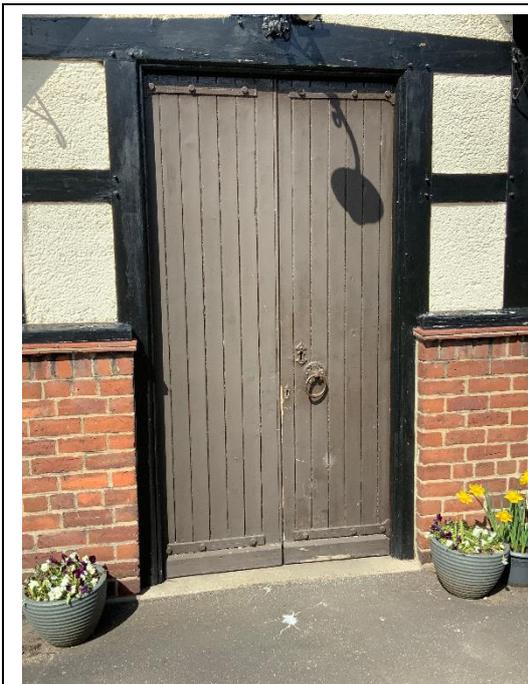
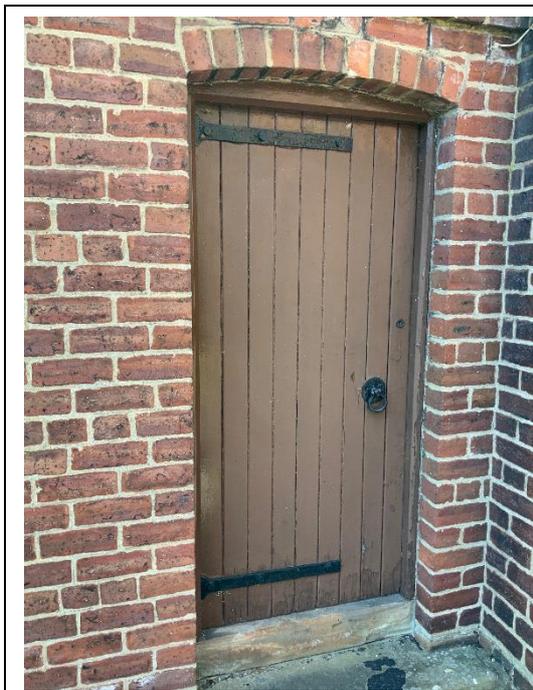
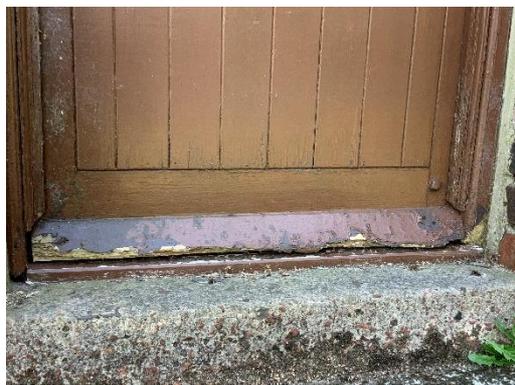
**Exterior Doors**

<p><b>Description</b></p> <ul style="list-style-type: none"> <li>• Porch entrance doors (D.01) are painted timber framed and boarded doors. The doors have bolts top and bottom and an original large mortice lock which is no longer used.</li> <li>• South Vestry door (D.09) and North Vestry door (D.03) are painted timber framed and boarded doors.</li> <li>• Door to the basement heating chamber (D.10) is a painted flush door.</li> <li>• All exterior doors are fitted with mortice locks in working order.</li> </ul>
	<p><b>Condition</b></p> <ul style="list-style-type: none"> <li>• All doors are in reasonable condition although the paintwork and timber is deteriorating in the splash zone (bottom 20-30cm), and the timber frames are degrading slowly at low level.</li> <li>• The main entrance door to the porch (D.01) has been repainted since the last inspection. When it is</li> </ul>

<p>repainted in the future, it would be best to paint the ironwork separately in black gloss paint to highlight its character.</p> <ul style="list-style-type: none"> <li>• The North Vestry door (D.09) in particular is degrading at its base, particularly around the weatherbar, and it would benefit from repair.</li> <li>• The door to the basement heating chamber (D.10) was wet on the day of inspection, but appeared sound.</li> <li>• Latch, mortice locks and bolts are in working order.</li> </ul>	
<p><b>Repair Needs</b></p> <ul style="list-style-type: none"> <li>• Weatherbar to the North Vestry door should be replaced and the door repainted.</li> <li>• Exterior doors would benefit from regular repainting to prolong their lifespan. Flaking paint, particularly at low level, should be removed first.</li> <li>• At some point in the future, the timber frames will require a splice repair to the bottom 30cm of door frame.</li> </ul>	<p>C</p> <p>M</p> <p>D</p>

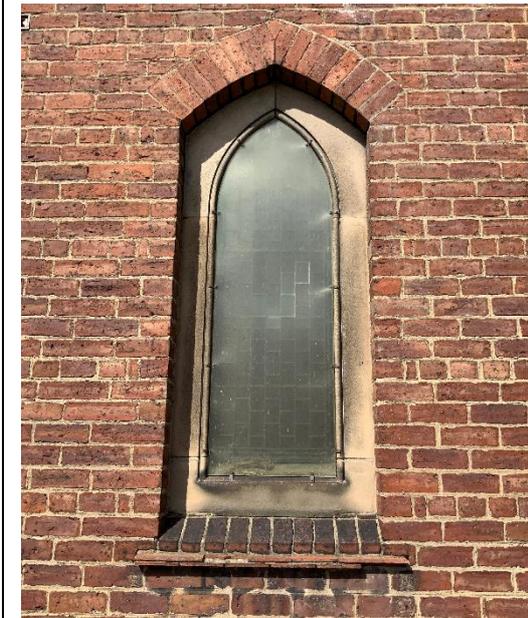
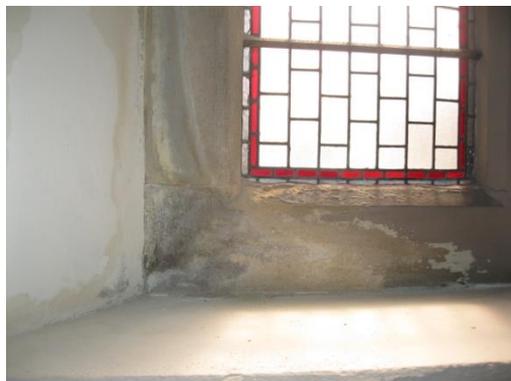
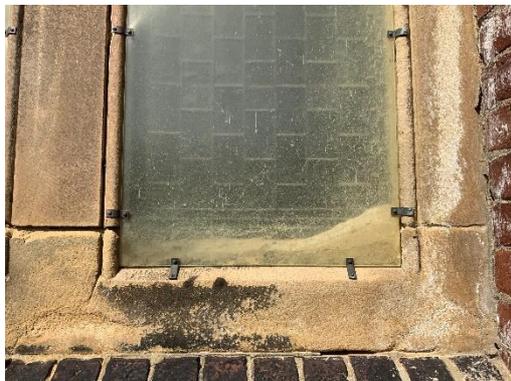
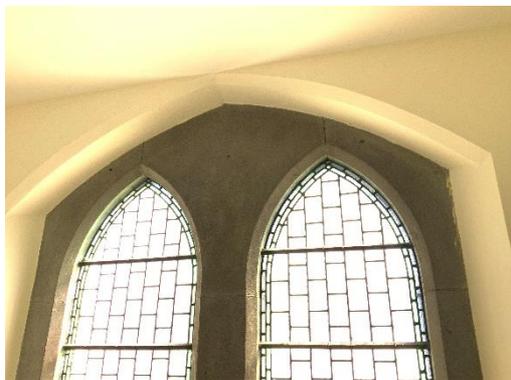
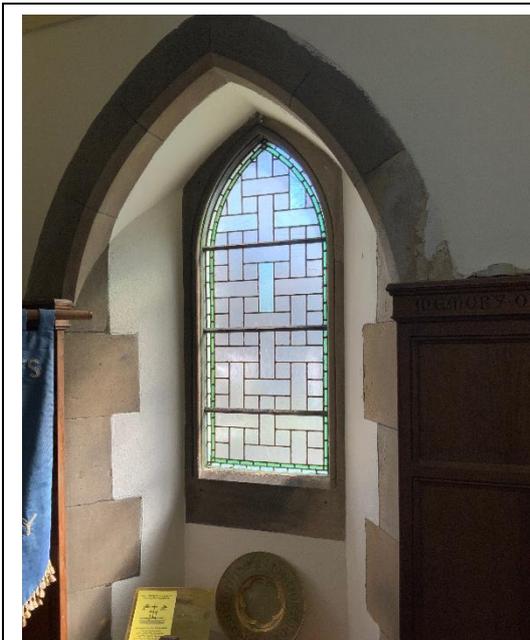
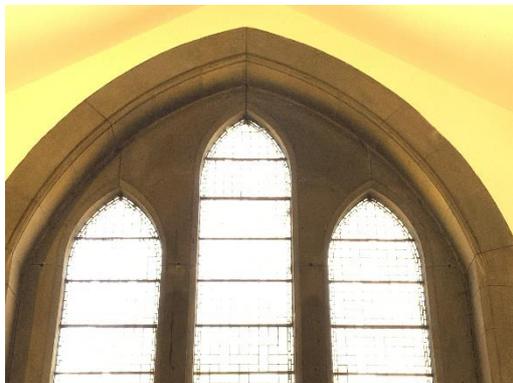
**Windows**

- Many of the stone surrounds are exhibiting delamination of the stone and some blistering caused by dampness in the stone. Externally, this has caused some minor opening up at joints. which would benefit from limited pointing. Internally, although unattractive, I would not recommend painting to conceal this because it may retard the stone drying out process.

- As reported previously, a sizeable piece of the stone surround to the North Vestry window W.09 has come away. Although unsightly, no repair work is proposed.

- Some very small areas of pointing are required to stone surrounds, particular at the windows on the

South elevation of the Nave and Chancel, where stone delamination has occurred unevenly at mortar joints. Use a colour-matched soft lime mortar only. This fiddly work will require a skilled craftsman.

- Clear out the stone dust held behind polycarbonate window protection. I was able to dislodge some using a credit card run around the side, but to clear it properly may require the temporary loosening of the polycarbonate.

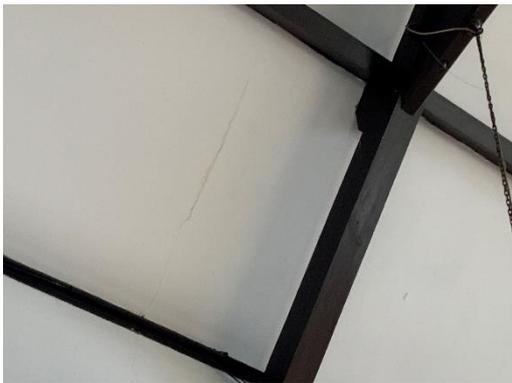
<p><b>Condition</b></p> <ul style="list-style-type: none"> <li>• The 2004 QQ report highlighted that some of the nuts of the straps and bolts holding the trusses together were loose or missing altogether. The inspecting architect at that time concluded that these defects were of a minor nature and that no action was needed.</li> <li>• The ceilings and trusses were all redecorated as part of the community space contract in 2019. One or two of the hairline cracks noted in the last inspection have opened up again, presumably evidence of general movement in the roof structure.</li> <li>• No cracks have opened up in the redecorated ceiling to the Chancel.</li> </ul>

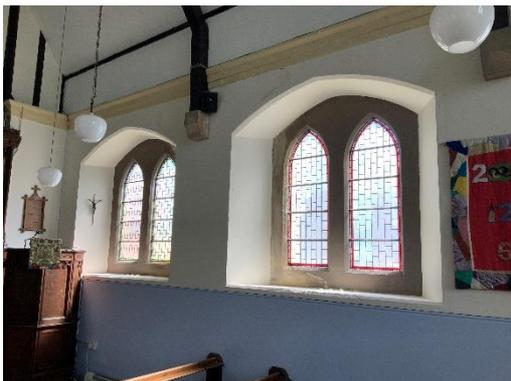
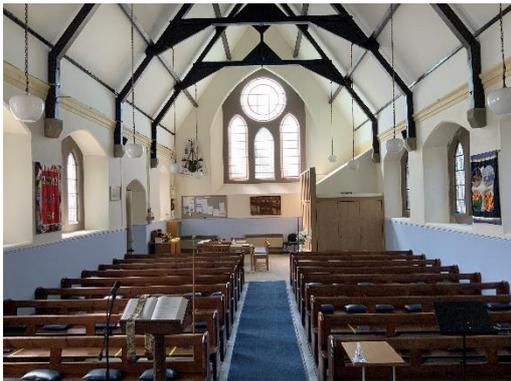
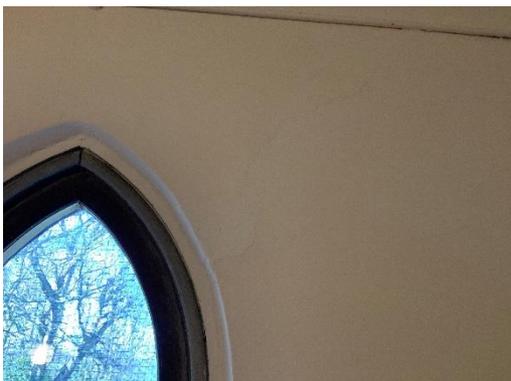
11.3 INTERNAL WALLS

<p><b>Condition</b></p> <ul style="list-style-type: none"> <li>• The walls were all redecorated as part of the community space contract in 2019 are still looking fresh.</li> <li>• The plaster around window W.16, which was suffering from dampness, has largely dried out. A small area of dampness has reappeared above the window but the transformation is excellent.</li> <li>• The cracking in the wall of the North Vestry towards the North East corner is still evident. It looks much better following redecoration, but the hairline crack has reappeared. It does not appear to be getting any worse, but engaging a structural engineer to install telltales would be prudent because a slow worsening of the cracks over time may not be apparent.</li> </ul>

<p><b>Repair Needs</b></p> <ul style="list-style-type: none"> <li>• Engage a structural engineer to install telltales in the North Vestry.</li> </ul>	<p>D</p>

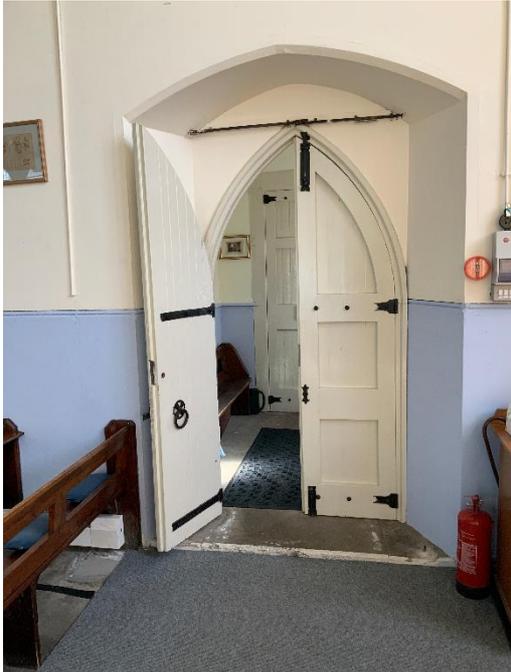
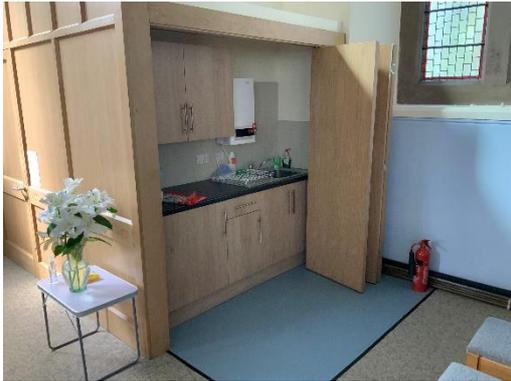
Interior Doors

<p><b>Condition</b></p> <ul style="list-style-type: none"> <li>• Doors generally in sound condition.</li> <li>• The new bi-fold doors to the kitchenette are running smoothly on their track.</li> </ul>	
	<p><b>Repair Needs</b></p> <ul style="list-style-type: none"> <li>• Door to the South Vestry (D.08) would benefit from a coat of paint at some point.</li> </ul>	E

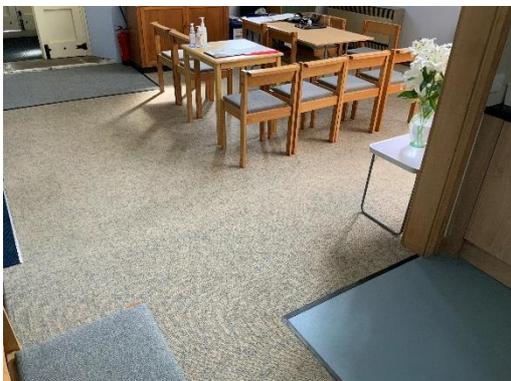
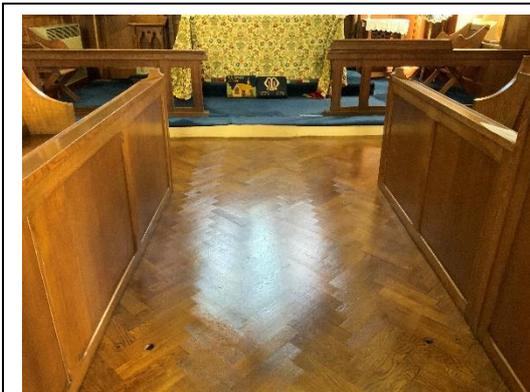
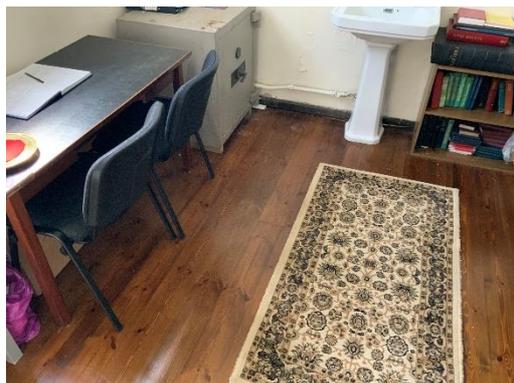
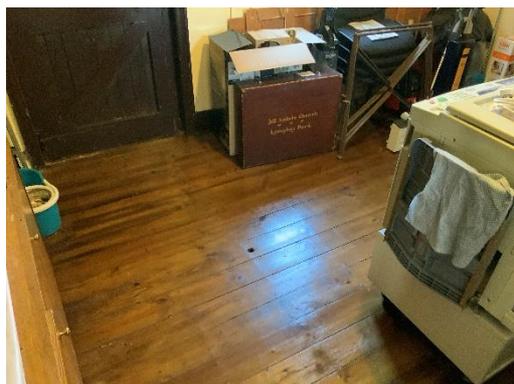
11.5 FLOORS AND PLATFORMS

- One or two cracks in the concrete floor of the Nave are evident, but these are no doubt historical and aren't of any concern.
- The concrete steps between the Nave and the Chancel have been painted, and a small area of carpet installed to the tread.

- No floor boards were lifted in the North and South vestries, and it was not been possible to inspect the sub-floor void.
- The timber floor and joists in the South Vestry were replaced as part of the 2019 community space contract, addressing the movement recorded in earlier inspections. The new floor has been varnished.

- In the North Vestry, the floor beside the WC is soft, indicating decaying boards, which should be investigated. However, this WC isn't used as much now that there is a new accessible WC in the Nave.

- Carry out localised repairs to the floor in the North Vestry around the WC.

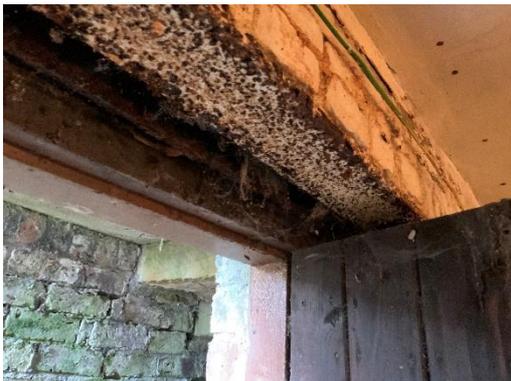
<p><b>Condition</b></p> <ul style="list-style-type: none"> <li>• The fireproof plasterboard ceiling continues to show dampness and flaking paint, particularly above the door, but this does not appear to be getting worse and the board remains sound.</li> <li>• The concrete floor is damp, although no standing water was observed.</li> <li>• The steel RSJ's framing the lowered ceiling below the organ and the RSJ door lintel are all rusting due to the damp environment, and anti-corrosion painting is required.</li> <li>• The exposed heating pipework will benefit from having all joints in the insulation taped up to minimise thermal bypass, helping efficiency.</li> </ul>

<p><b>Repair Needs</b></p> <ul style="list-style-type: none"> <li>• The steel RSJ's need to be wirebrushed and then repainted with a high-quality metal primer and paint.</li> <li>• The joints in the insulation on the heating pipework should be taped up.</li> </ul>	<p>C</p> <p>D</p>

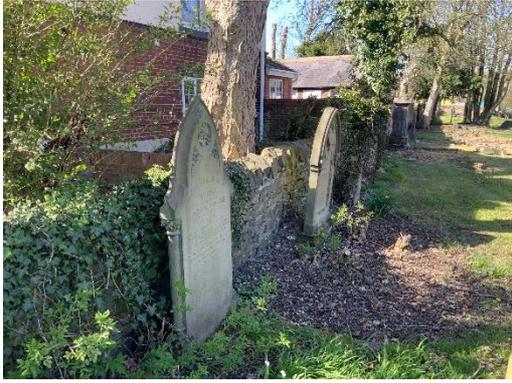
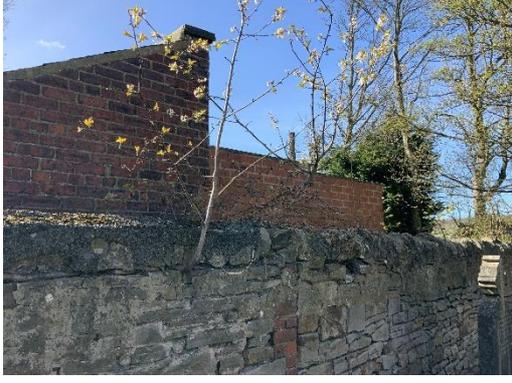
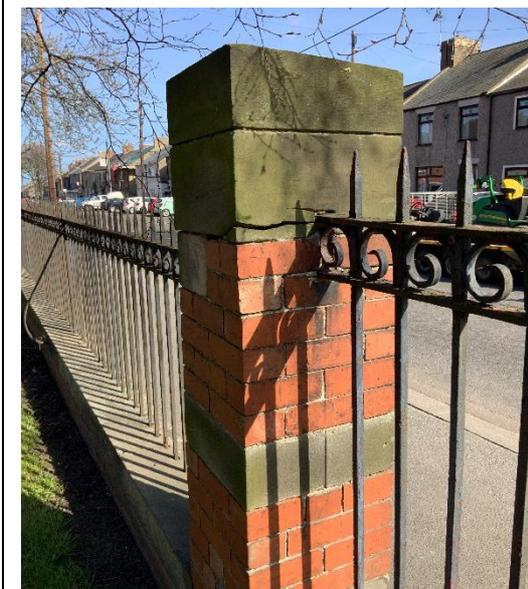
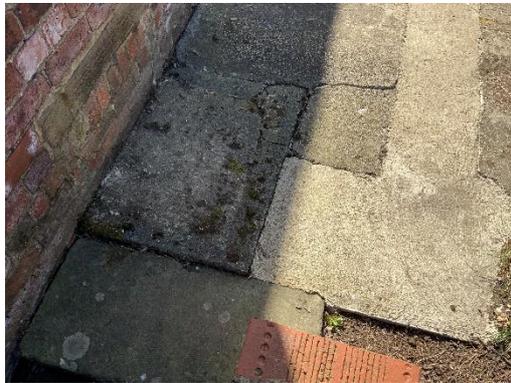
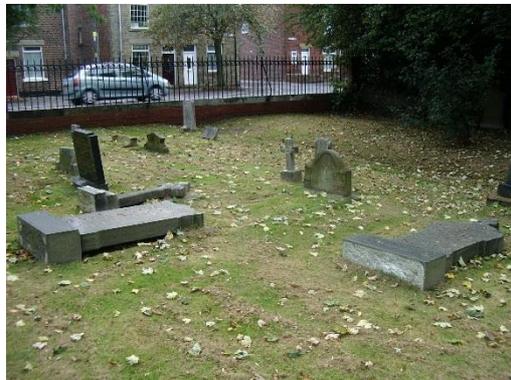
<p><b>Condition</b></p> <ul style="list-style-type: none"> <li>• The large cherry tree on the roadside fence boundary has had all of the limbs removed by the Council who advised the PCC that it was diseased and posed a risk of collapse. The council appear to have taken down a number of other trees in the churchyard.</li> <li>• The Western boundary wall near the Vicarage, which had collapsed at the time of the last inspection, has been rebuilt. However, part of it is already leaning over and it should be monitored.</li> <li>• Plant growth continues to damage stone walls, particularly at the copings. See photo as an example of damage being caused.</li> <li>• The Northern and Eastern boundaries are in reasonably sound condition, although plant growth needs to be attended to.</li> <li>• At the Southern boundary to the road, one pier has a badly cracked coping, probably caused by rusting of the ironwork. There doesn't appear to have been any worsening of this since the last inspection so it should just be monitored.</li> <li>• The metal railings to the Southern boundary would benefit from being repainted.</li> </ul>

- Moss and plant growth to the tarmac surfaces have been cleared by the council.
- Concrete flagstones / surfacing at the top of the basement stair needs to be reset – they’re currently a trip hazard, although this is by no means a high traffic area.
