INSPECTION AND REPAIR OF CHURCHES

QUINQUENNIAL REPORT on the

**ST IVES CHURCH
LEADGATE**

Date of report: 23rd September 2020

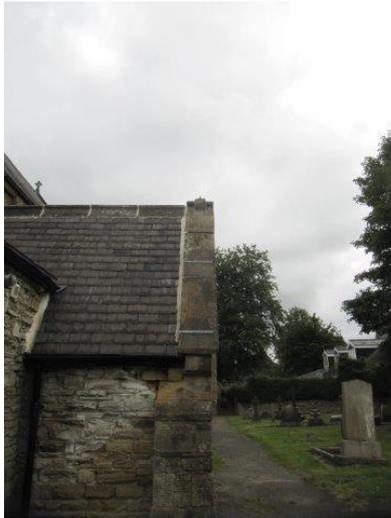
Salts visible to West Elevation of South porch

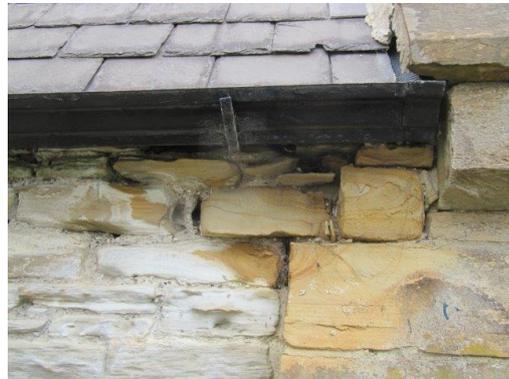
Salts, open joints and weathered stonework to West Elevation of porch

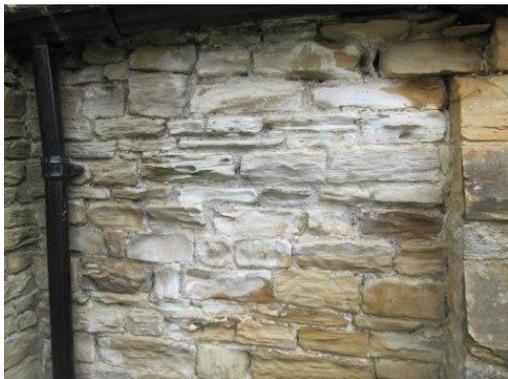
Salts visible to West Elevation of South porch

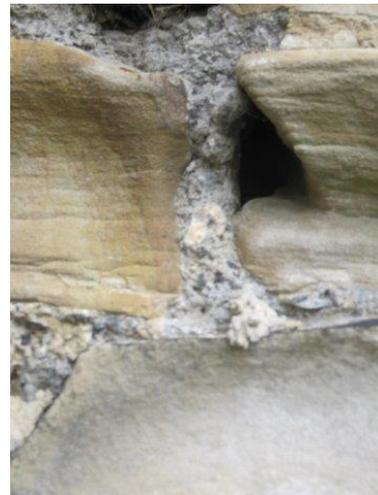
Deep cavity to South Porch wall

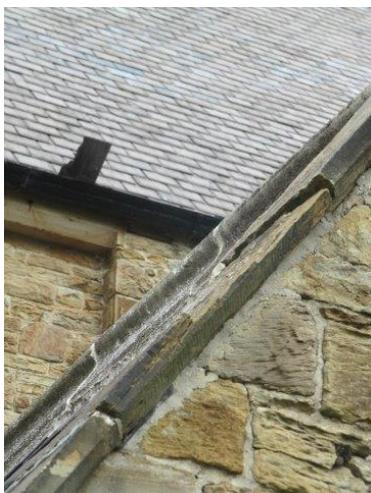
Damaged stonework to water Table of Porch Open joints and loose stonework to porch

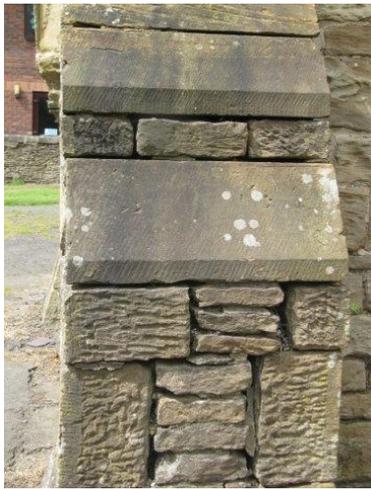
Hungry/open joints to East buttress of porch

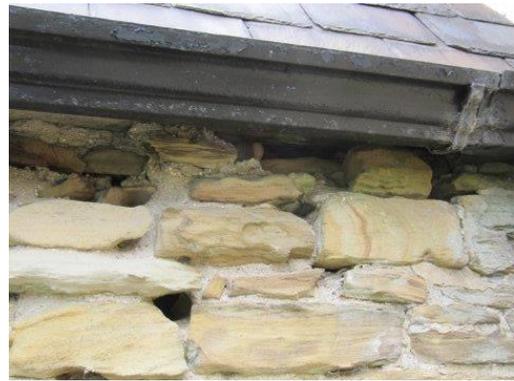
Deep cavities, open joints and weathered and missing stonework to East elevation of porch

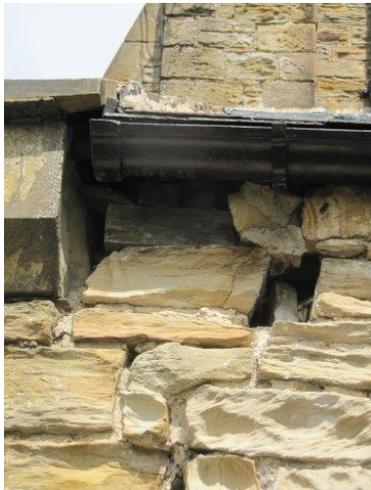
Exposed wall plate and open joints to South elevation of South Aisle

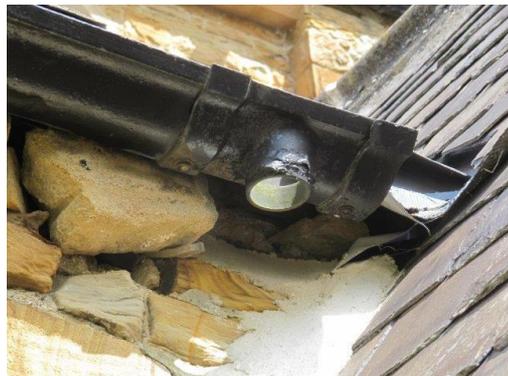
Loose and missing stonework to South Aisle and missing section of downpipe

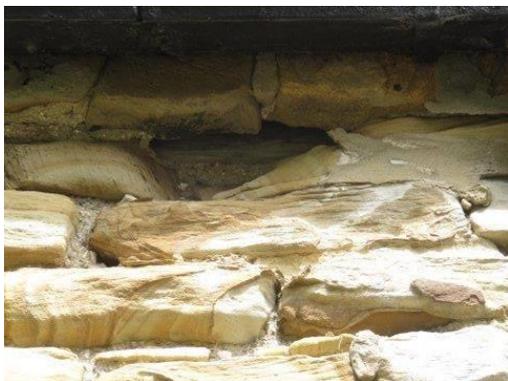
Weathered stonework exposing wall plate and loose/missing stonework to East end of South Aisle

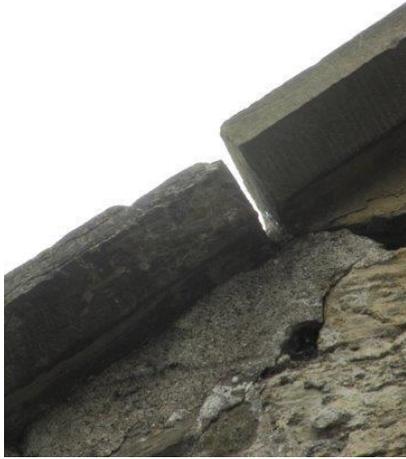
Open joint to water table and cracked mortar under to East Elevation of South Organ Chamber

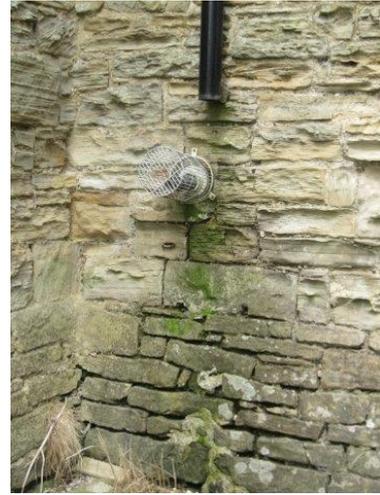
Missing section of downpipe and resultant Algal growth and open joints to South Elevation of Chancel

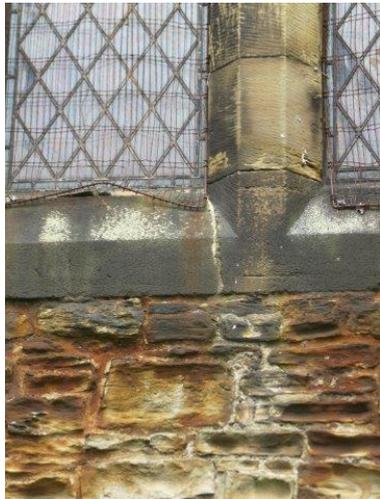
Damaged and rusty window guarding and resultant rust stained wall to Chancel

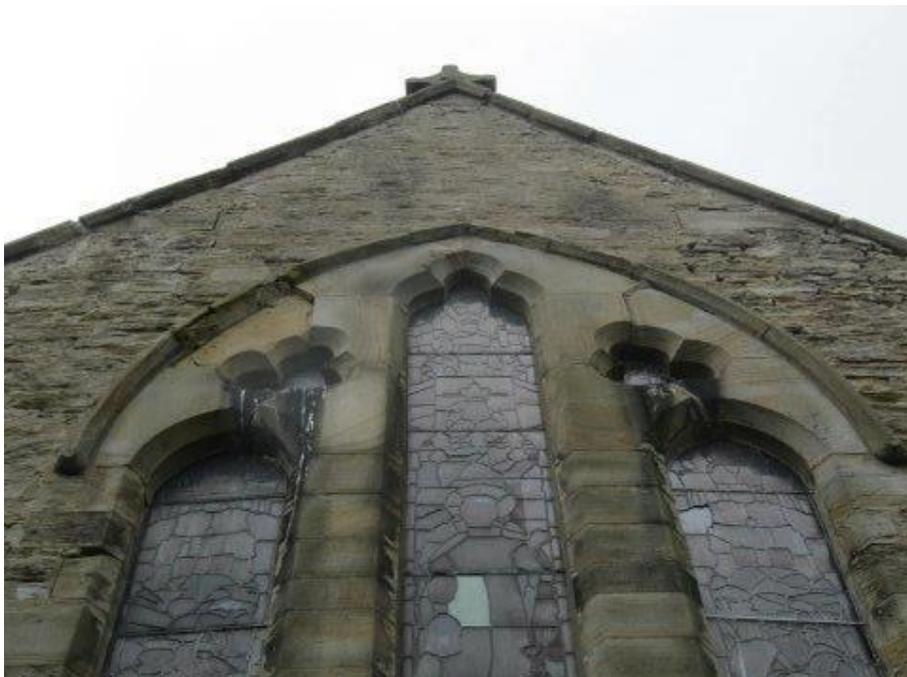
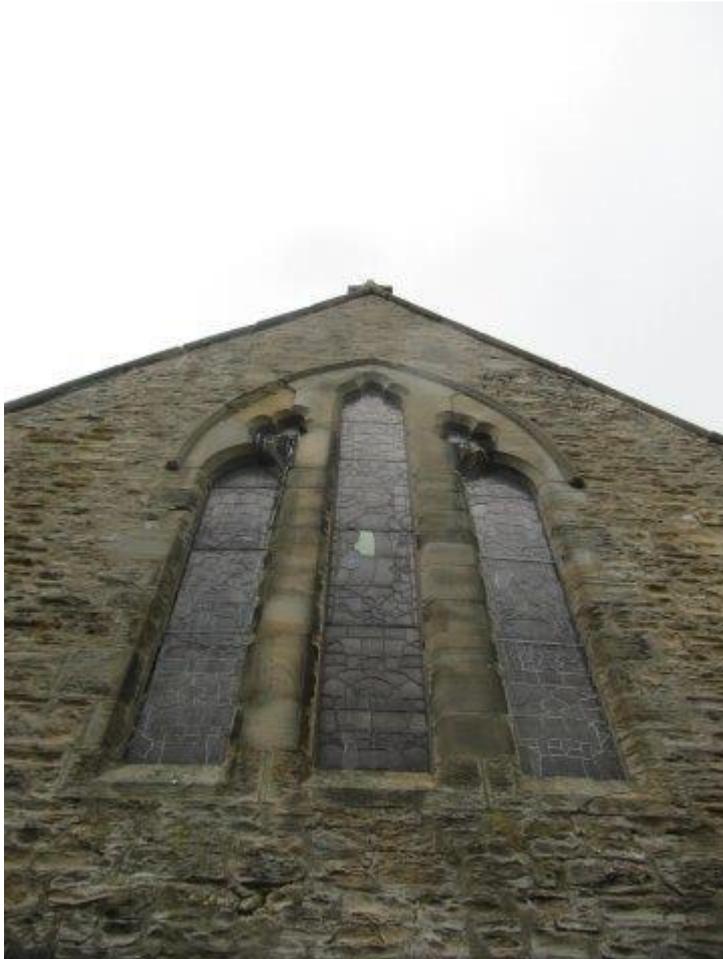
East Elevation of Chancel

<p>8. East Elevation of Chancel</p>	<p>Semi coursed sandstone</p>	<p>Cracking on this elevation and to this end of the church is more significant than other areas. There are two cracks on both the South and North side of the window running up to the top of the gable, significant cracking and movement to the stonework of the window itself and cracking in a number of locations including between the window cill and the ground. The cill is cracked in on place and there is damage to another section that will need closer inspection. One stone to the window surround and associated hood moulding have suffered significant damage and loss of the stone face due to movement and are located at the base of one of the areas of cracking. There are also cracks towards the North and South ends of the wall with two quoins damaged/cracked to the Northern corner. Some sections of the hood moulding appear to possibly be loose or are becoming loose. There are also some localised areas of stonework appearing to be bulging. The bedding of the cross should be checked to ensure that is well secured. The cause of the cracking should be investigated by an engineer and a programme of repairs drawn up as soon as possible to enable a funding package to be pulled together (note – this has now been inspected and the engineers report is appended to this report.</p> <p>The elevation has been pointed with harder mortar in the past, and in some areas the mortar is buttered over the face of the stonework. Some weathered stonework was noted, although generally not as significant and issue as on the Southern elevations and although only isolated stones may require replacement at present, the harder mortar may cause more to erode quicker</p>	<p>An engineer's report has already been received which suggests possible reasons for the movement and recommends options for repair – a copy of this is included in this report. This work should be considered a priority and a repair programme drawn up as quickly as possible to include all structural work and masonry repairs on this an sections of the wall on the North and South side of this elevation, as well as works to the windows. These works will need discussion with many parties, so time will be needed to facilitate this as well as finding sources for funding. High level access is likely to be required to specify the works required</p>	<p>A for starting to prepare a package of works, B to carry out the works</p>

The eastern elevation is a plane wall, without buttresses, it was noted that this was the only wall on the church without buttressing. There are three tall slender windows running from mid height to the apex peak. At the base of the windows there is a noticeable outward bulge to the wall. There is vertical cracking to the stonework either side of the bulge. There was also opening up of masonry joints to the header stones above the windows.

On the returns either side of the wall there are vertical cracks suggesting that the eastern wall is separating away from the rest of the church.

The eastern elevation to this church is bulging and cracked. The most likely cause is wind loading over a sustained period. Additional lateral restraint is required.

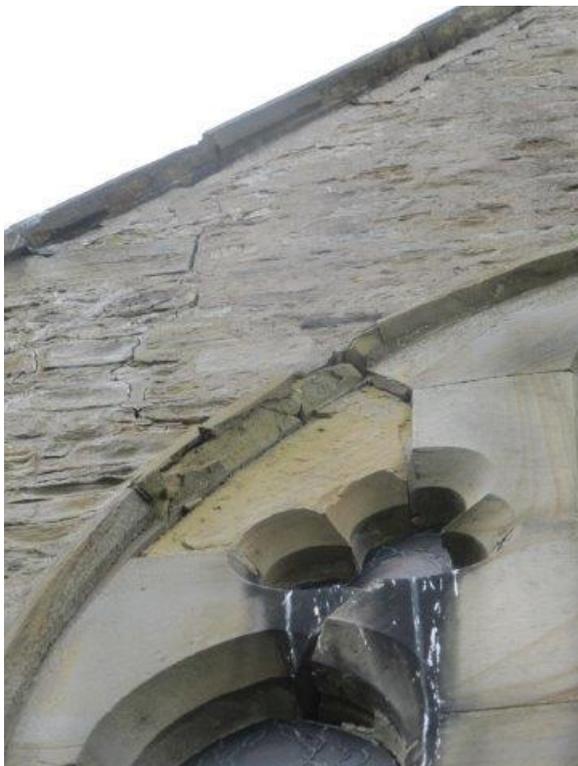
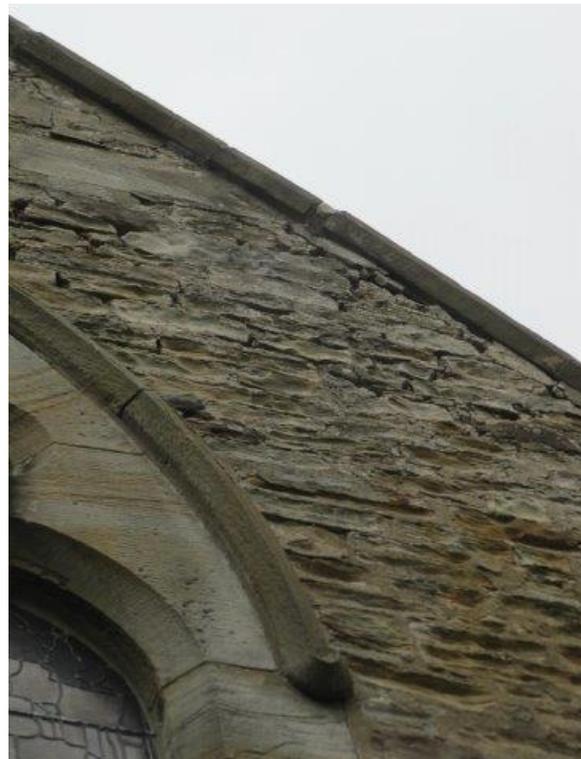
Open joints, cracking and damage to stonework to the east window, East elevation of

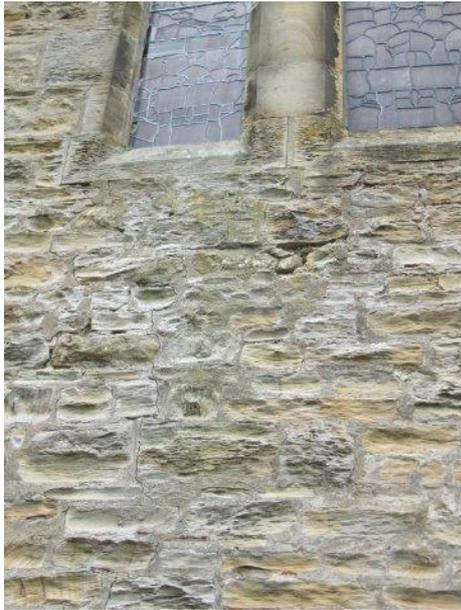
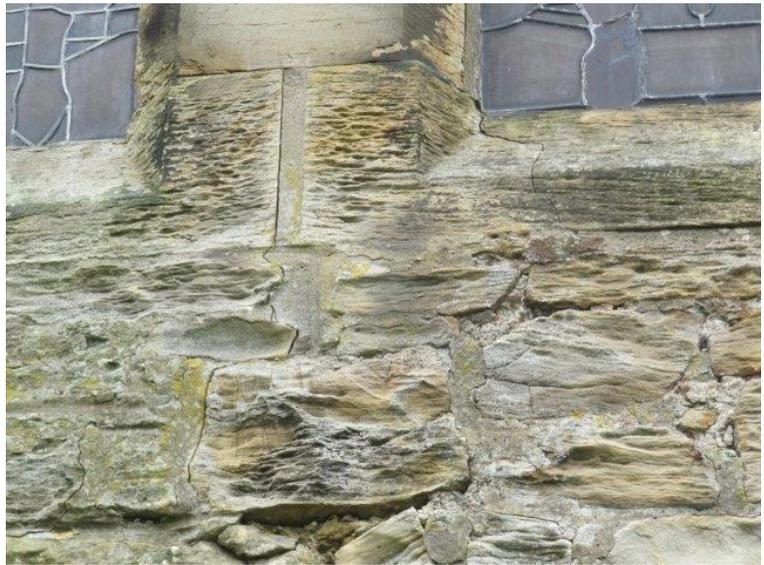
Cracking and missing mortar to East Elevation of Chancel under the window

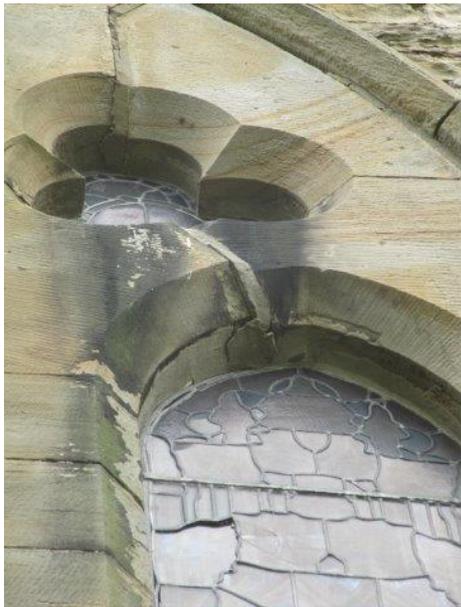
Cracking and loose mortar to east Chancel window

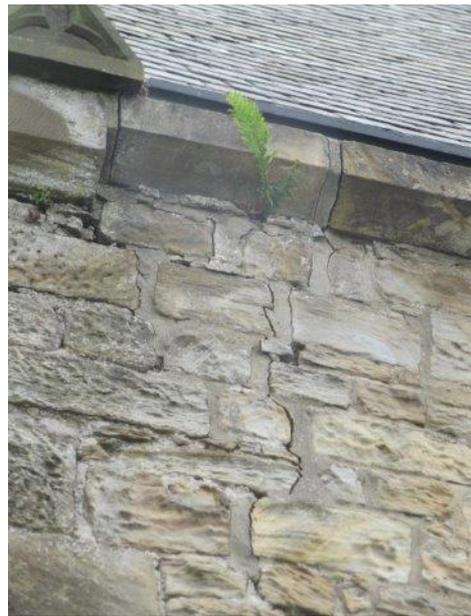
9. North Elevation of Chancel	Semi coursed sandstone	<p>Vegetation growing at the base of the wall (an elder bush) is partly obscuring condition. There is a crack running almost full height towards the Eastern corner and possibly another area of cracking to the left-hand side of the window. There is also a crack to the window head. The stonework is weathered, but generally fairly stable with a relatively small number of stones that might warrant replacement.</p> <p>There are a number of open joints including to the projecting eaves and a sapling is taking hold at the East end at the top of an area of cracking.</p>	<p>Inspect areas of cracking and include all works with the works to repair and stabilise the East Gable</p> <p>Repoint other open joints using lime mortar and replace isolated badly weathered stones</p> <p>Remove elder from the base of the wall and remove or kill roots.</p>	<p>A – repair package B to carry out the works</p> <p>B - C</p> <p>B</p>

Crack and sapling to North Elevation of Chancel

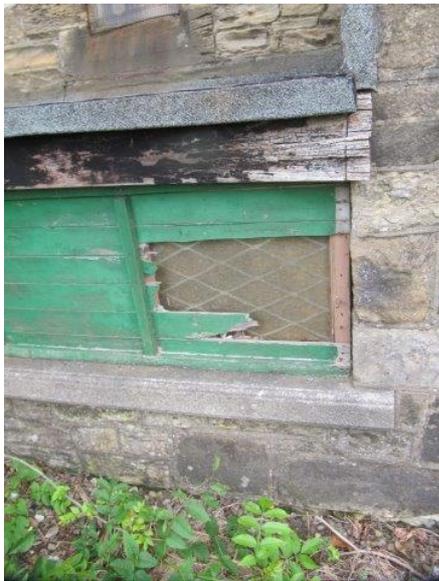
Damaged timber cladding to stairs

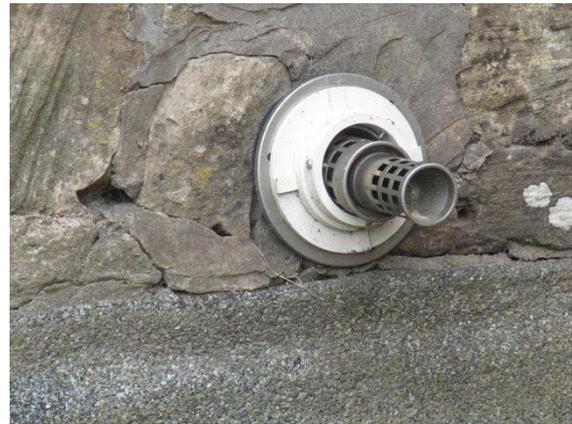
Cracked mortar around heater flue to East of vestry

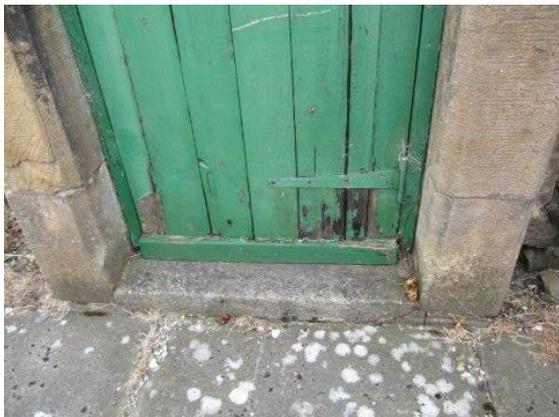
Damaged paintwork to door to old boiler room

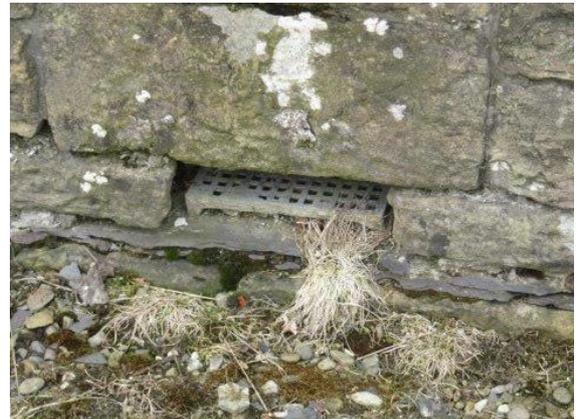
Dislodged vent

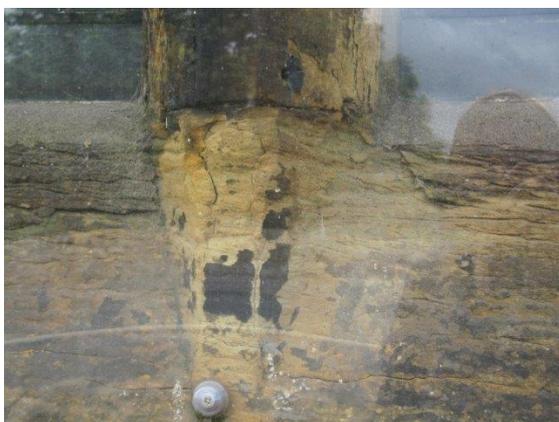
Damage to stonework to mullions of Northern Windows sheltered by window protection

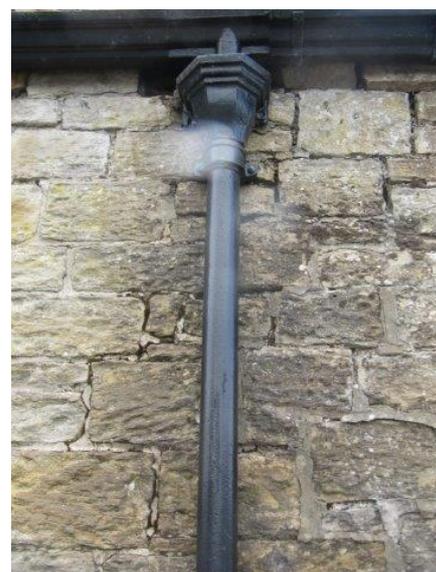
Cracking/open joints to West end of North Elevation of Aisle

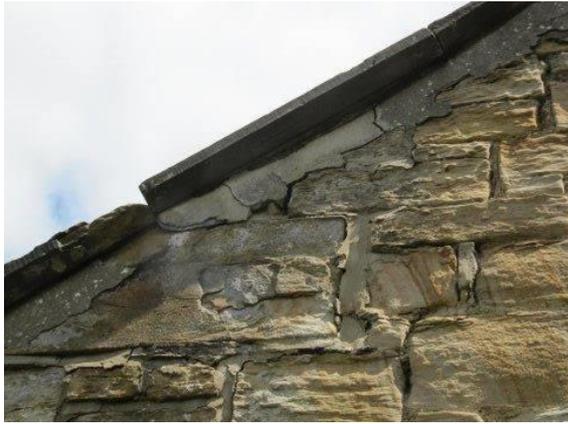
Cracked pointing and open joints to West Elevation of North Aisle

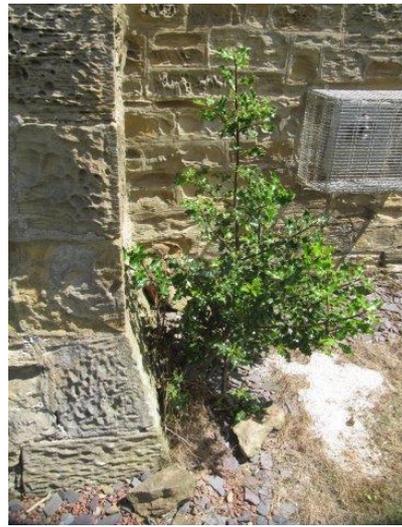
Holly growing at base of west Elevation

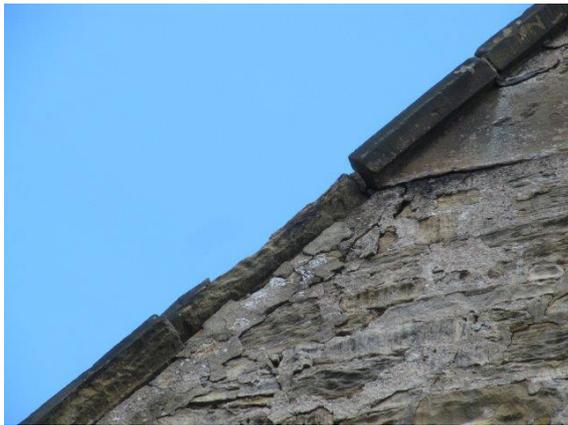
Damaged section of water table, cracking mortar, open joints and weathered stonework to West Elevation of Nave

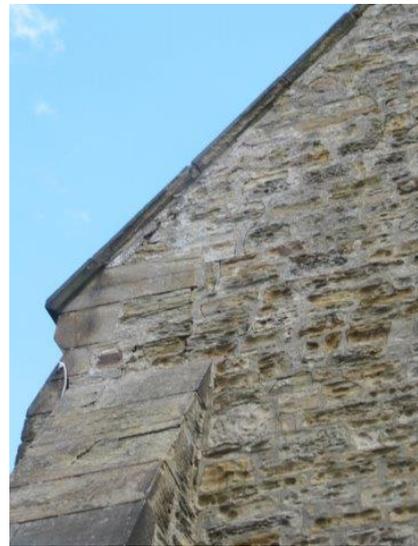
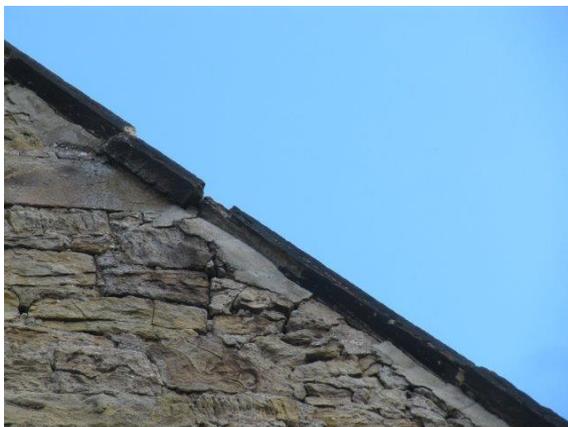
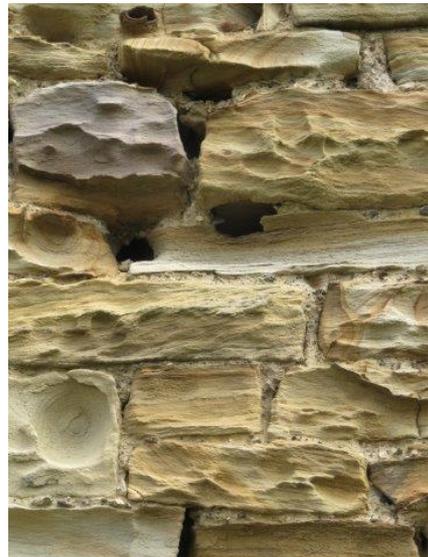
Damaged section of water table, open joints and, cavities and weathered stonework to

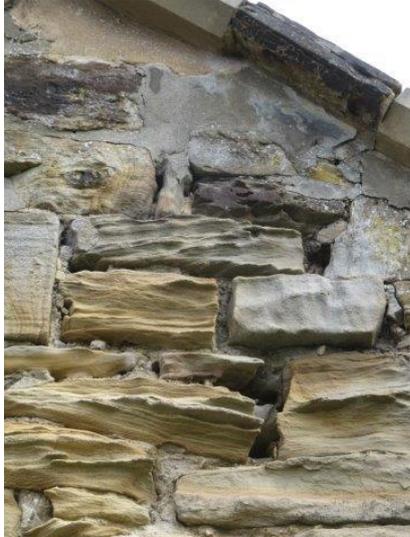
Open joints and cavities to West Elevation of South Aisle

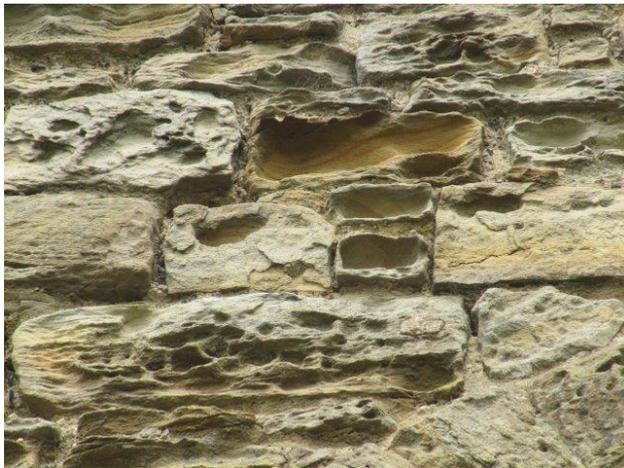
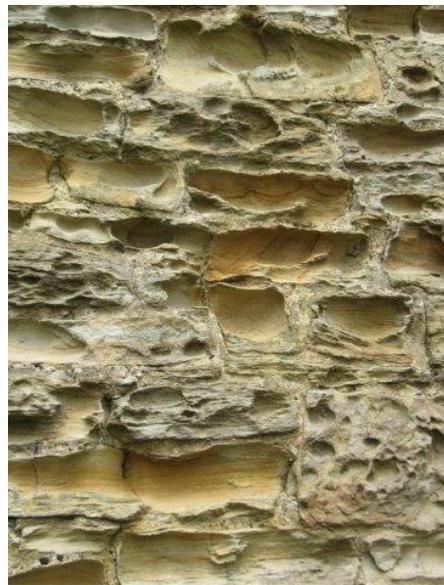
Examples of weathered stonework from two different locations - some of the worst affected stones may need replacing, the extent of this will depend on the depth of stone used, others could be repaired where appropriate using mortar repairs

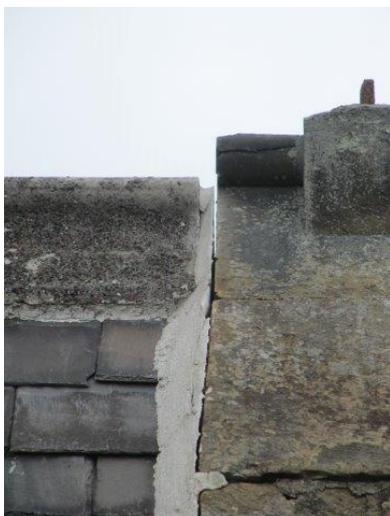
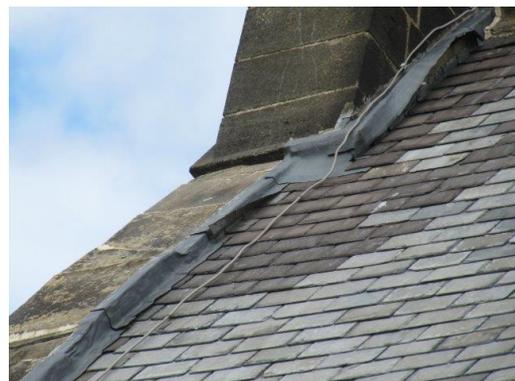
Cracking to side of mortar fillet to porch

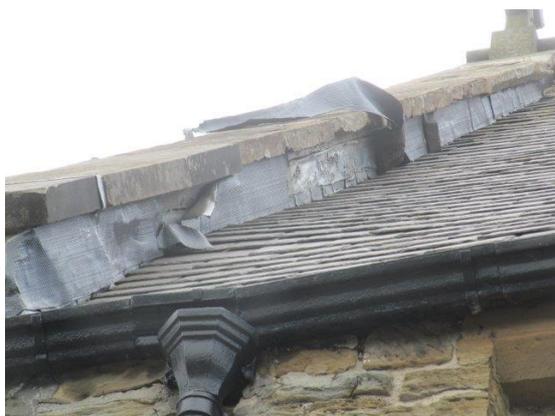
Lifted flashings to Nave roof (South)

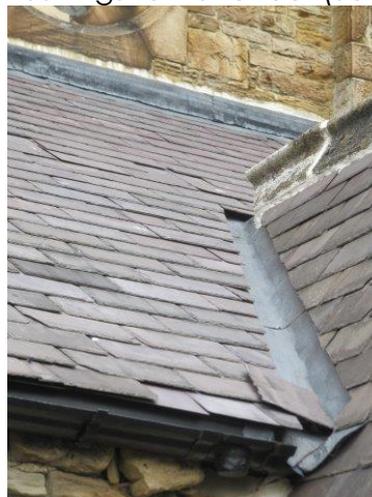
Lifted and damaged flashings to North Nave roof Slipped slates to South Aisle roof

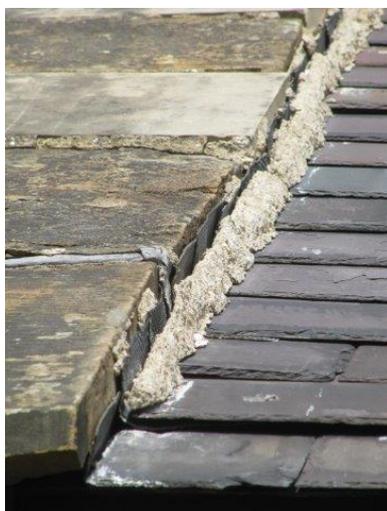
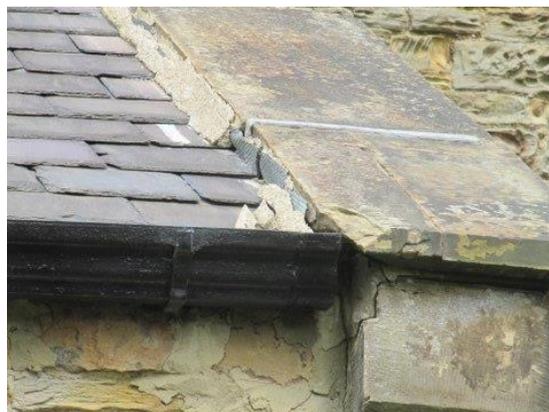
Missing and cracked mortar fillets to roofs on South Elevation

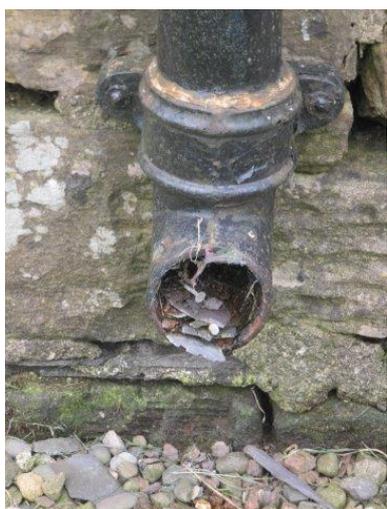
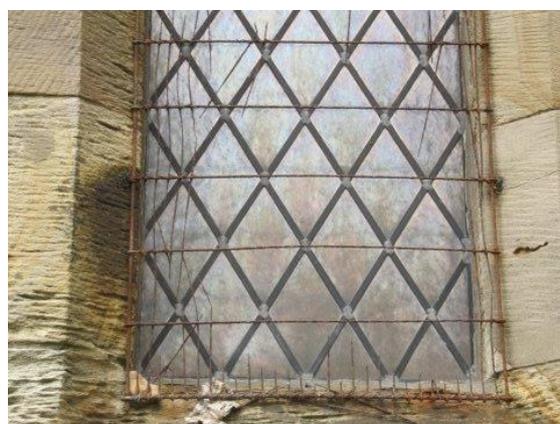
Slate fragments in shoe to downpipe on North Elevation of North Aisle

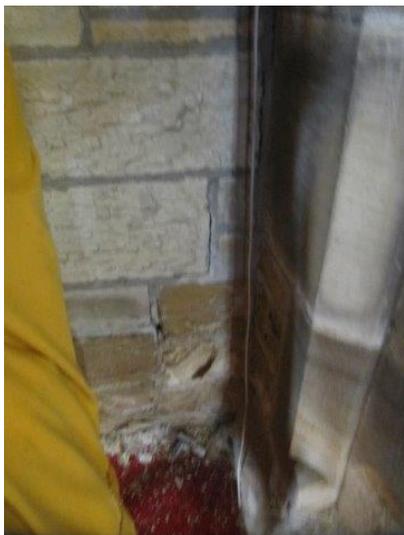
Damaged stonework behind curtain to East wall of North Aisle

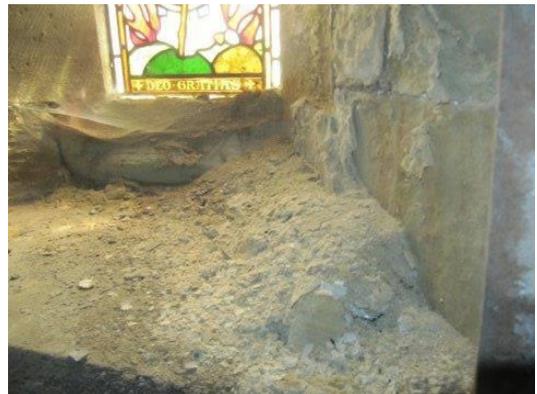
Sanding stonework to South Organ Chamber

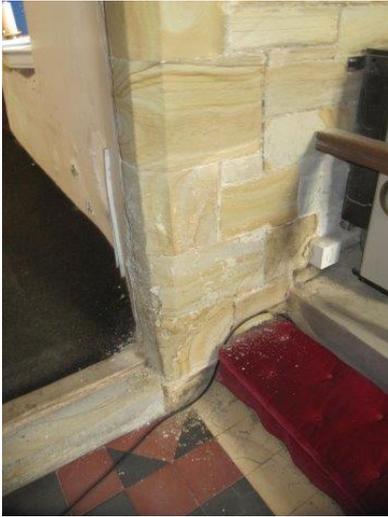
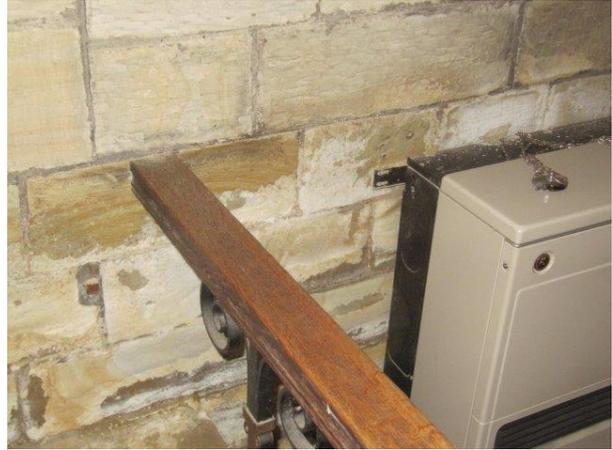
Damaged stonework and salt effervescent to North wall of Chancel

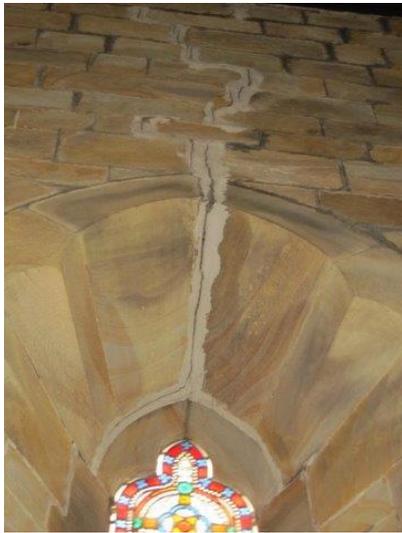
Previously repointed cracking (now opening up) to North wall of Chancel

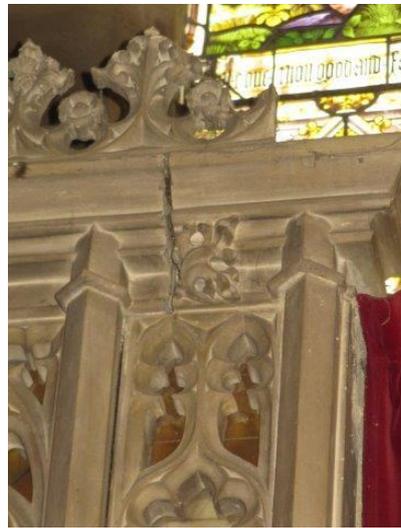
Cracking to carved stonework behind altar

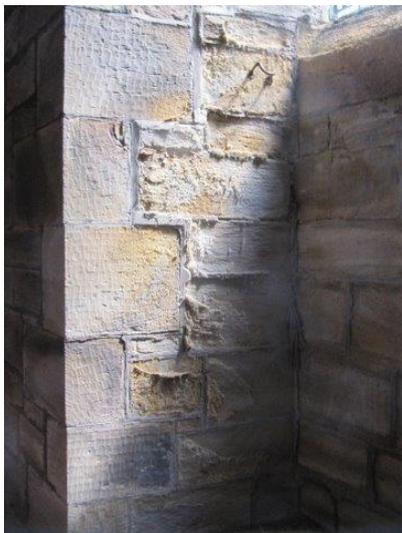
Salts, sanding stonework and loose pointing

to the window reveal on South wall of Chancel

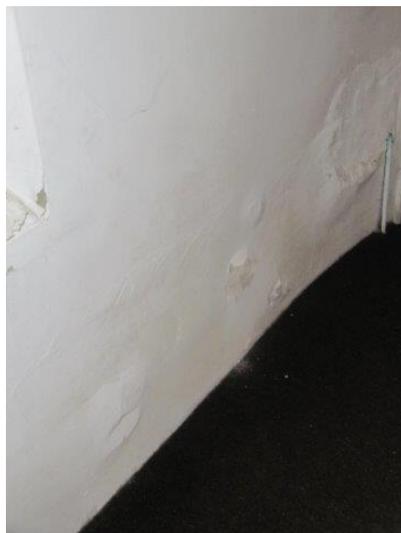
Damaged plaster in Vestry

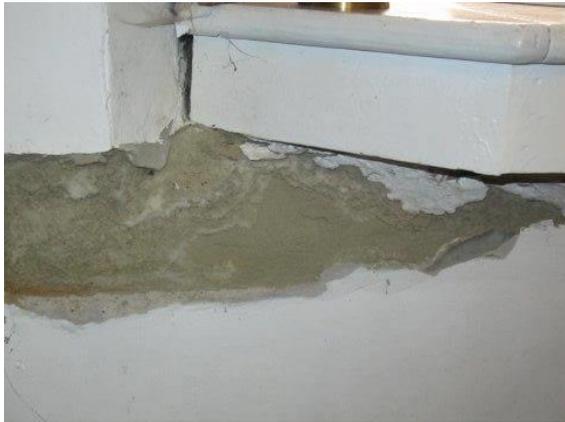
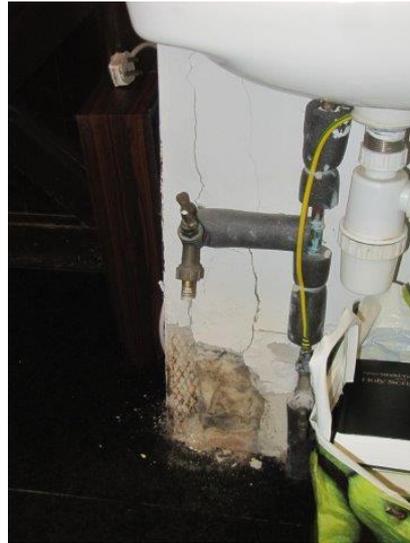
Damaged plaster to North and East walls in Vestry

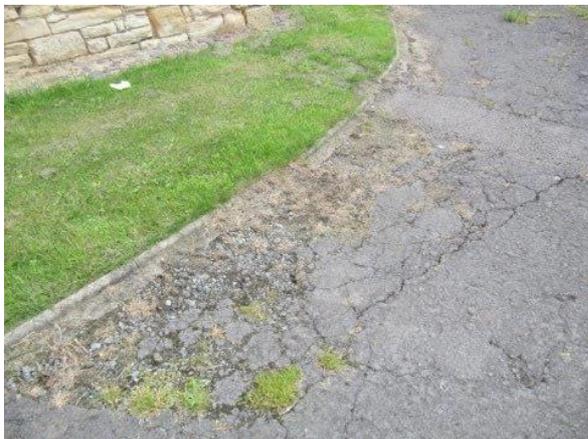
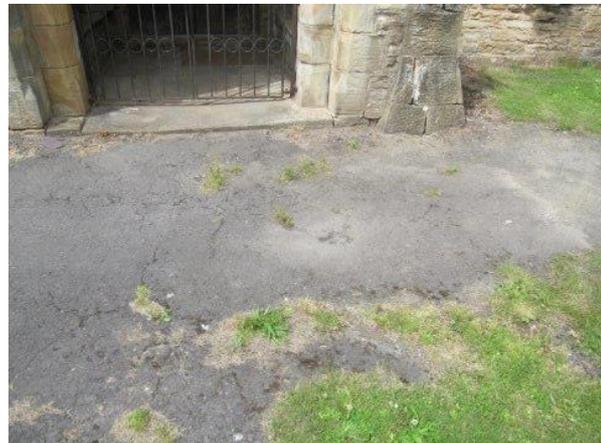
Grass growth and cracked tarmac to West and south side of the church on the main access route

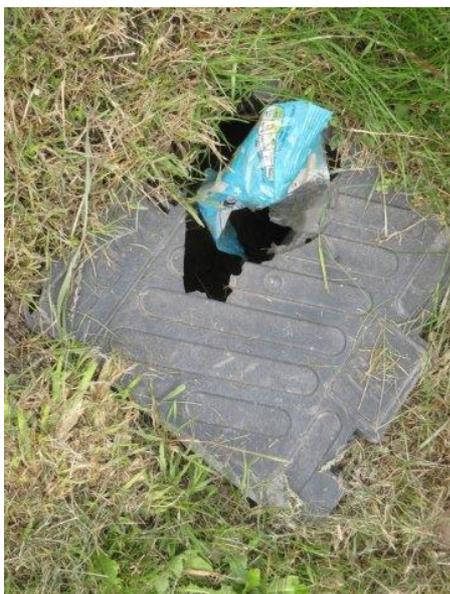
Cracked cover to West of the church
