**INSPECTION OF CHURCHES MEASURE  
DURHAM DIOCESAN CHURCH SCHEME**

**CHURCH OF ST. MARY**

**LONG NEWTON**

**QUINQUENNIAL INSPECTION 2017**

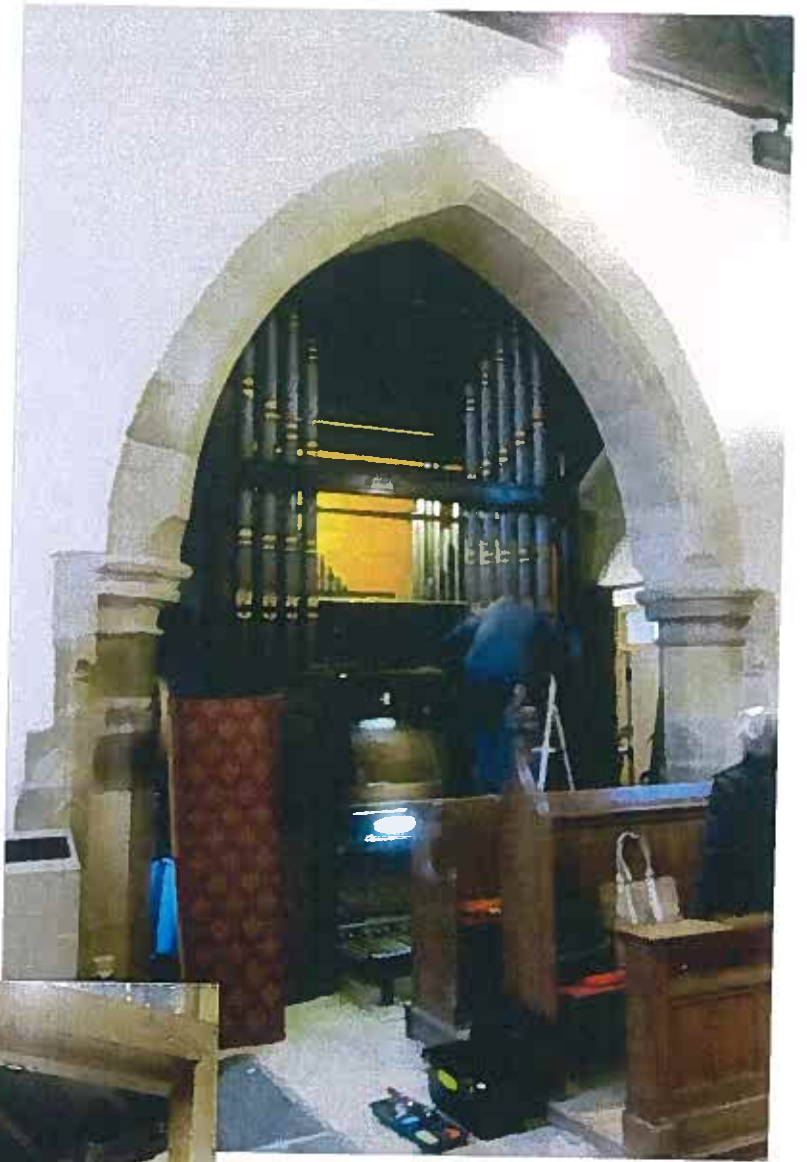
- 22 : Nave looking West to West Gable window and Font
- 23 : Organ renewal in progress.
- 24 : Organ Chamber incorporating electrical switch gear and storage
- 25 : Chancel, Altar and East Gable window
- 26 : Accessible Toilet
- 27 : View from Chancel into Londonderry Chapel
- 28 : Arcade detail between Chancel and Londonderry Chapel
- 29 : Gated entrance to Londonderry Chapel
- 30 : View to Chancel from Chapel
- 31 : East Gable Wall to Londonderry Chapel
- 32 : Coat of Arms stained glass window in West Gable to Londonderry Chapel recently restored
- 33 : Steep flight of steps serving Vault

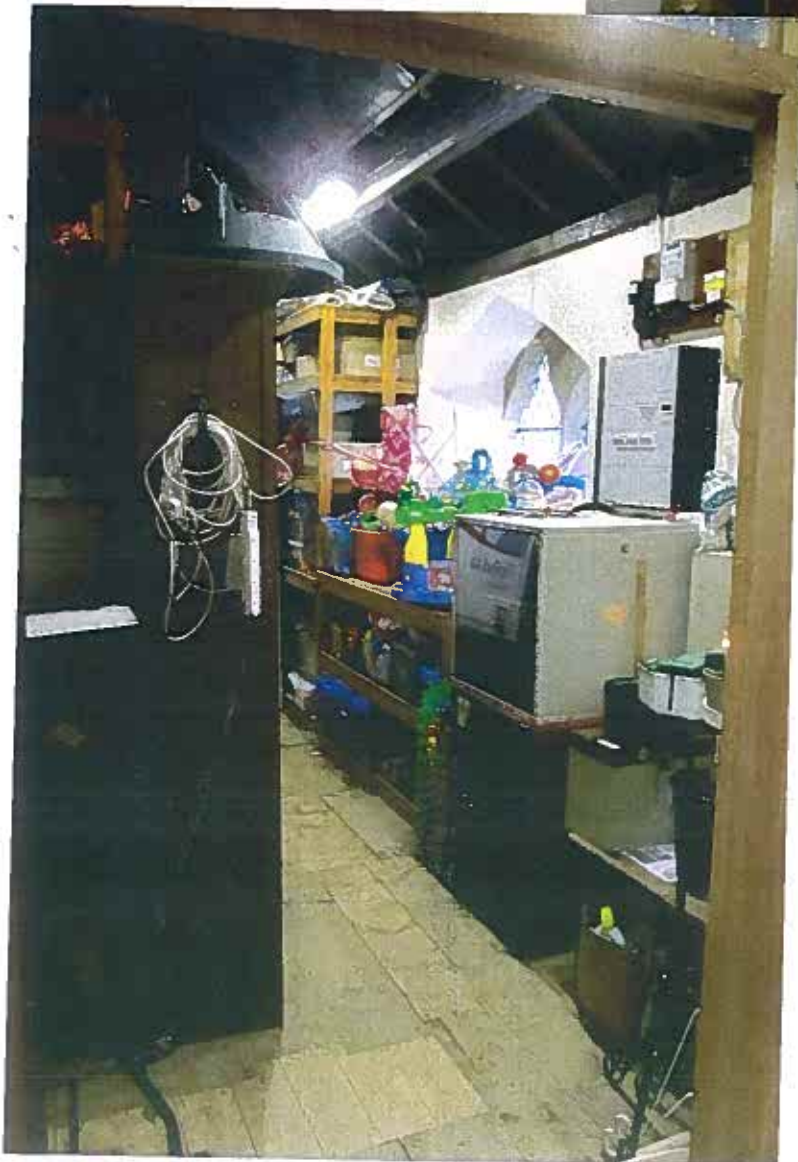
23

**6.2.3 The South Wall** is painted plaster in fair condition incorporating a stone framed window with two lunettes and a small rose above, with clear cathedral glazing. Glazing, leadwork, ferramenta and stonework are all in fair condition. There are additionally 2 marble memorial plaques flanking the window. Both are in fair condition. To the West of the window is a profiled stone arch framing the organ chamber. The arch is in fair condition with evidence of previous distress remedied by the 2008 redecoration. The pipe organ was undergoing renewal and restoration works on the day of my inspection. This was near complete.
