# St John the Evangelist, Lynesack

Quinquennial Inspection

## CONDITION SURVEY 2021

Ian Wells B Arch RIBA AABC

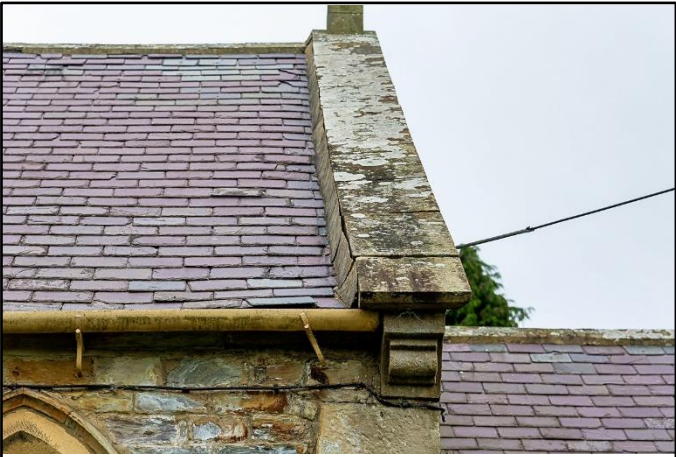
<p>The roof weathering is showing its age. There are significant numbers of misaligned slates. Some slates have slipped, whilst the ridge is reasonably well bedded. The mortar fillets at abutments are all suspect. In the photo above they are delaminating.</p>

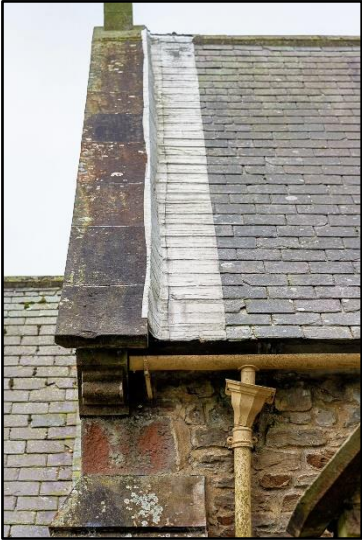
<p>Flash band repairs to mortar fillet and soakers to the north abutment over the chancel arch.</p>
------	----------------	---

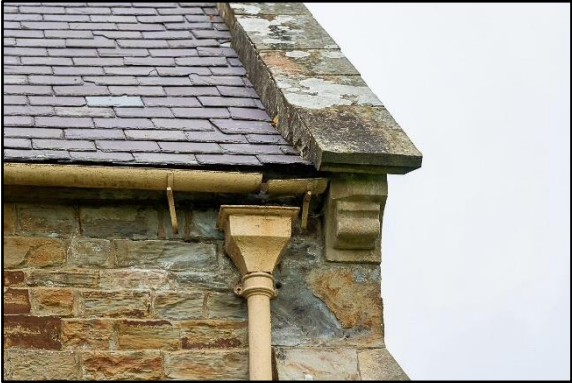
<p style="text-align: center;">The short section of gutter appears loose.</p>

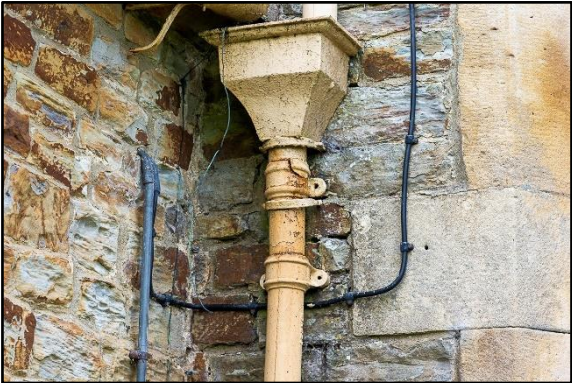
<p style="text-align: center;">A cracked rainwater pipe socket and poor fixings.</p>
3.03	Drainage below ground	<p><b>Surface Water Drainage</b> Large salt glazed gullies with cast grates to each rainwater pipe. There are no inspection chambers associated with the surface water drainage, so it is likely that the below ground drainage runs to the stream on the east boundary.</p> <p><b>Foul Water Drainage</b> The kitchen tea point discharges to a rainwater gully.</p> <p><b>WC Drainage</b> This is a chemical toilet with no drainage connection.</p>

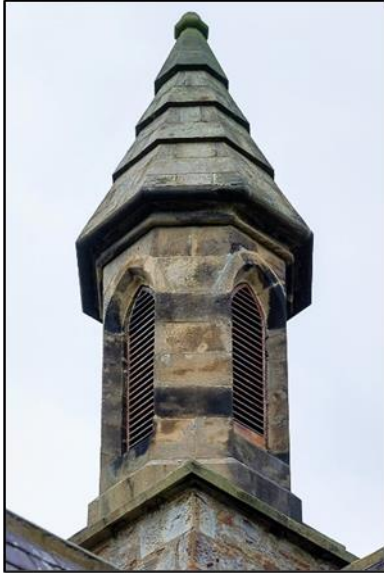
The bellcote from the southeast.

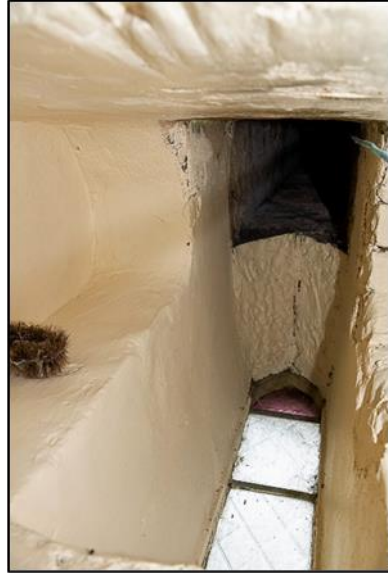
The bell rope shaft from below.

<p>The bell rope shaft is dry and therefore the bellcote is reasonably weather tight.</p> <p><b>Gable Water Tables</b></p> <p>Large sandstone flags supported on kneeler stones. Most of the top face pointing looks in poor condition. There are signs of opening up below the water tables which should be addressed.</p> <div style="text-align: center;">

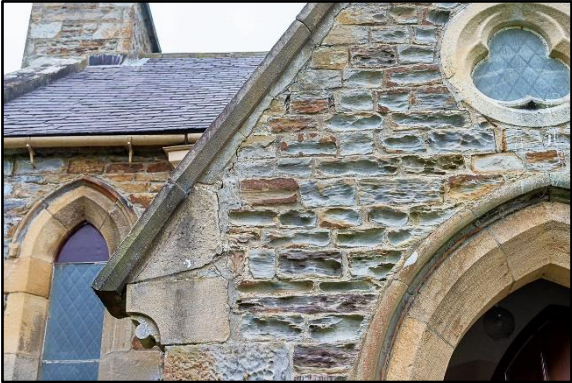
</div> <p>A significant crack is appearing below the south porch water tables.</p> <p><b>Chimneys</b></p> <p>None</p>
--	--	--

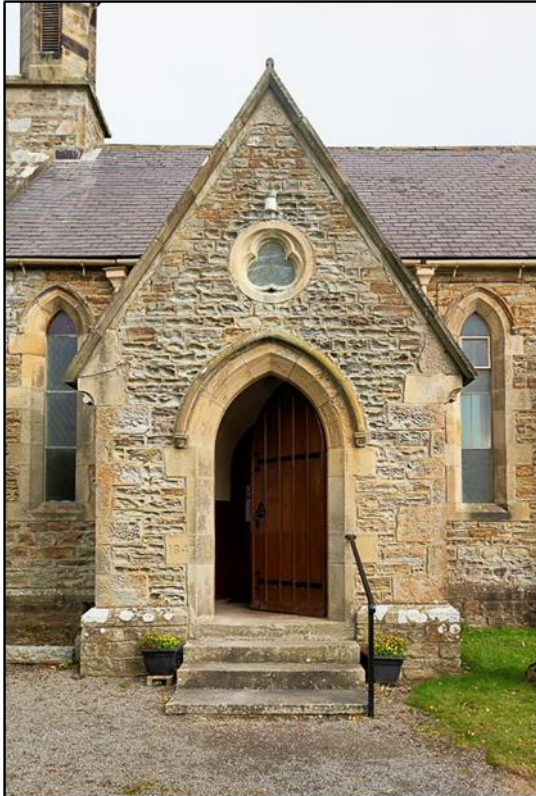
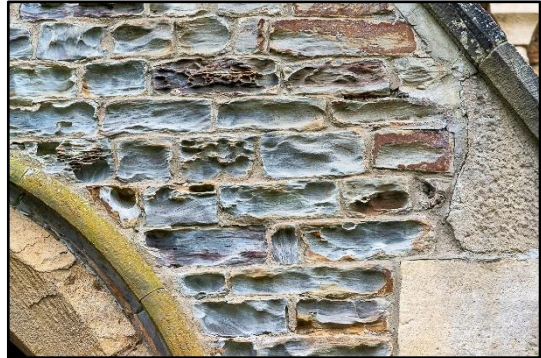
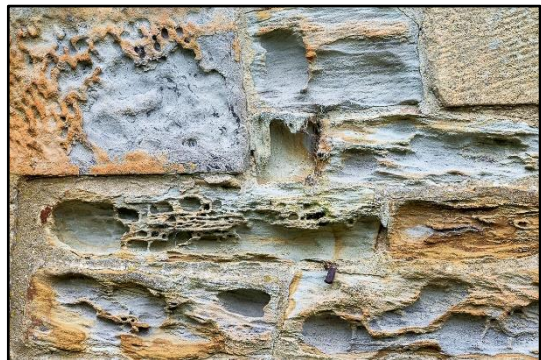
<p>The mortar used on the porch is cement based and therefore overly durable. It has trapped the absorbed water in the wall and this water has been forced to evaporate through the stonework. This evaporation has led to severe erosion of the stone.</p> <p>The recommendations of a stone restoration specialist could be obtained but they will be able to establish whether any of the stone erosion can be consolidated or whether it is more economic to replace the stone faces with visually matching new stone of a more durable quality.</p>
3.06	Timber porches, doors, and canopies	<p><b>Doors to the Porch and Vestry.</b></p> <p>Heavy timber ledge frame and board construction painted red. All in acceptable condition but would benefit from cleaning down and repainting.</p> <p><b>Boiler Room Door</b></p> <p>Timber door in poor condition. Ideally this should be overhauled and redecorated.</p>

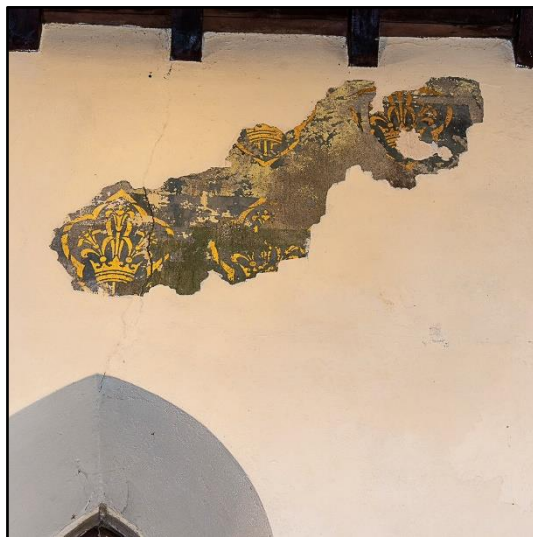
*Chancel looking north.*

I am not sure whether this painted old decoration was not painted over or whether the new paint has peeled off. It is an interesting feature that should be retained.

Note: A fine crack running up from the apex of the arched window. It does not seem to appear on the external face of the wall. Water ingress does not appear to be an issue.

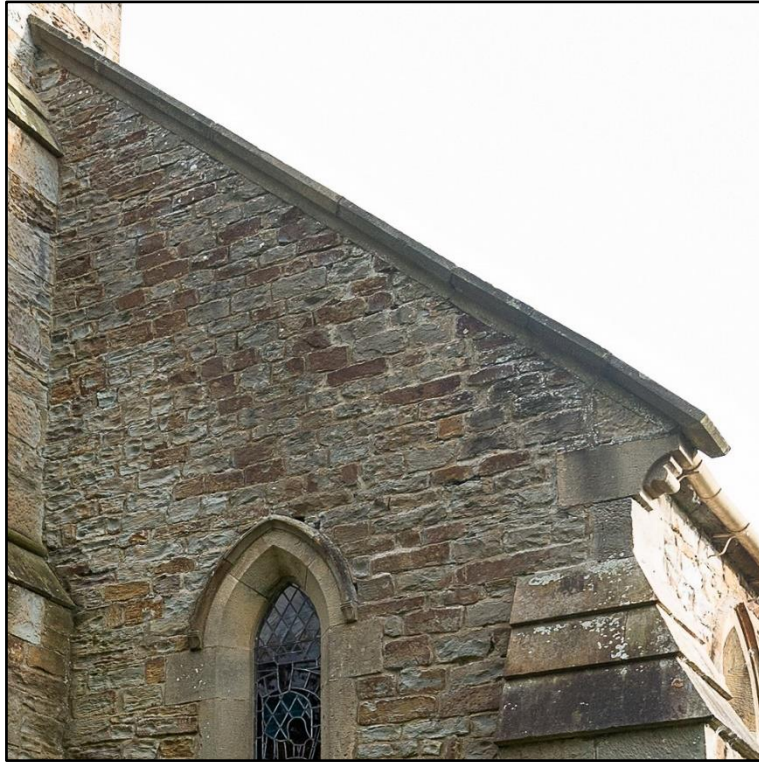
Fissures in the pointing are apparent above the hood moulding of W2 and in the masonry above.

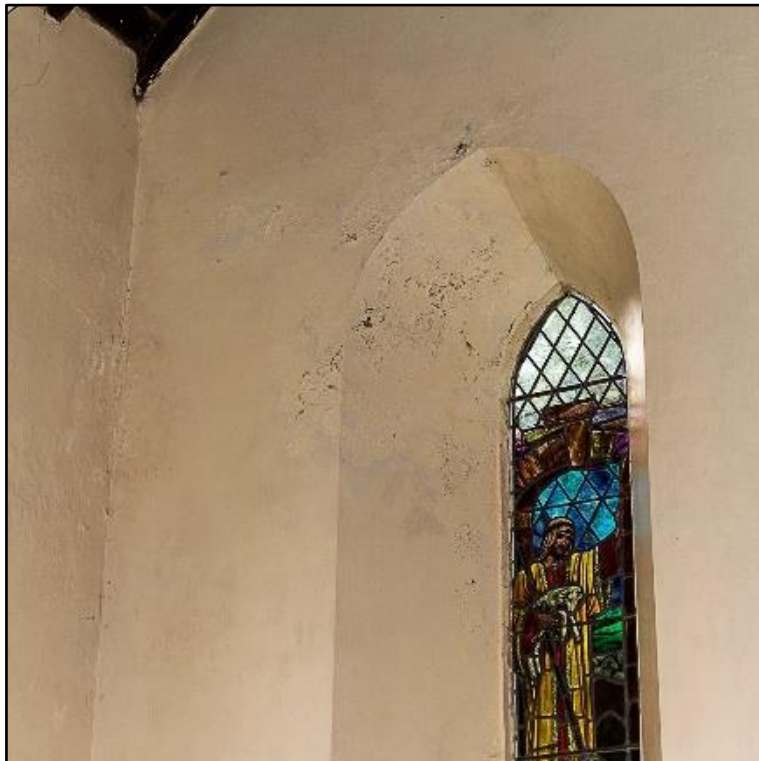
These have resulted in damage to decoration at southwest corner.  
Before redecoration, the external wall should be repointed in lime mortar.

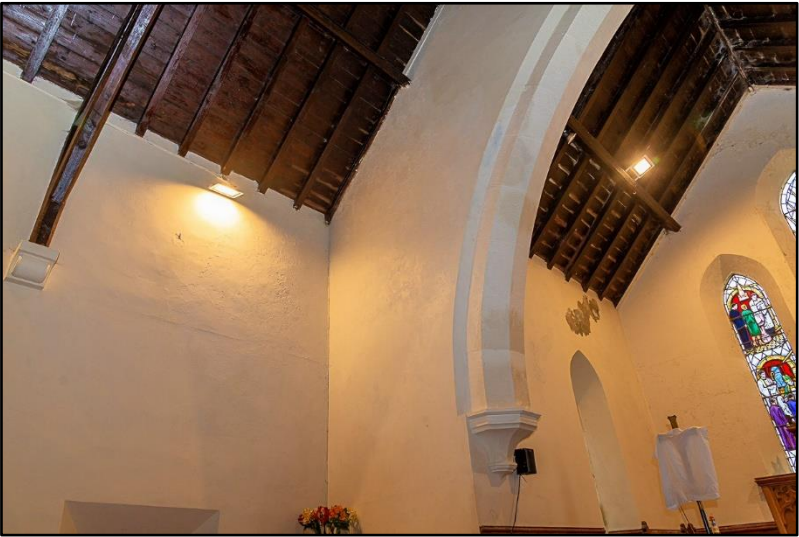
<p>The boarded soffit is stained below the abutment to the chancel arch, below the chancel ridge and on the north chancel pitch below the purlin. This staining suggests water leakage from the roof weathering in the past and possibly currently.</p>

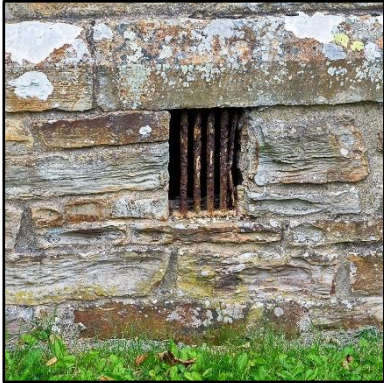
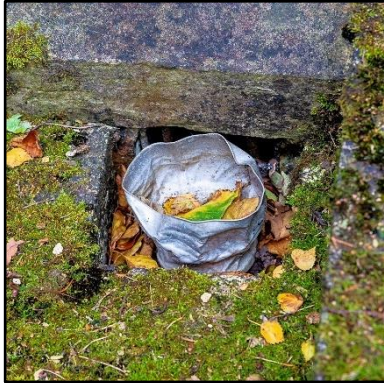
</div> <p style="text-align: center;"><i>South side</i>                      <i>North side</i></p> <p>The grilles on the south elevation are rusting away and the resulting voids would allow mice in. Replace grilles and back up with insect mesh. The ground is significantly higher on the north side and the vents are recessed into the ground. It is essential that these are cleaned out so that they work and are protected by mesh to keep vermin and insects out.</p> <p><b>Chancel Floor</b> These appear to be solid floors laid on back fill. In the chancel the floor finish is encaustic tiles, with stone steps and some timber below the choir stalls. No ventilation is provided in the surrounding plinths. All in acceptable condition.</p> <p><b>Porch floor</b> Stone flags on back fill. No ventilation is provided in the surrounding plinths. All in acceptable condition.</p>

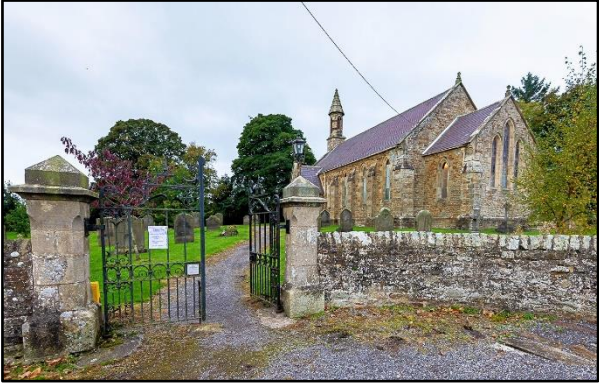
<p style="text-align: center;"><i>East Gate</i></p> <p>The gates would benefit from an overhaul and redecoration.</p> <p><b>Boundary walls</b></p> <p>Local stone in acceptable condition albeit pointed in cement-based mortar. The walls around the churchyard are extensive and I could not check all of them on this visit. A programme of regular maintenance is to be established to prioritise the works.</p>
