Church of St. Cuthbert, Marley Hill

Diocese of Durham
Archdeaconry of Sunderland
Deanery of Gateshead West

Quinquennial Inspection Report
May 2025

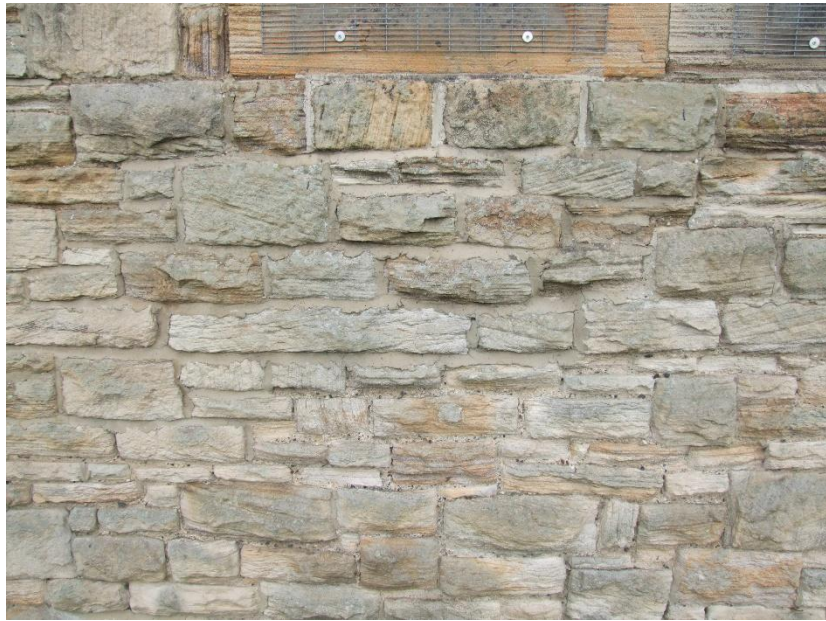
6.1.2	<p><i>South elevation (nave):</i></p> <ul style="list-style-type: none"> • Absence of a projecting sill or drip course has affected mortar joints immediately below window • More significant areas of inappropriate pointing to sections of walling, and high relief stone faces, contribute to difficulty of effective pointing • South elevation typically more vulnerable to weather effects on pointing. Original lime mortar being eroded

P1 (2353):
South elevation nave,
localised inappropriate
pointing, exposed original
mortar with coal

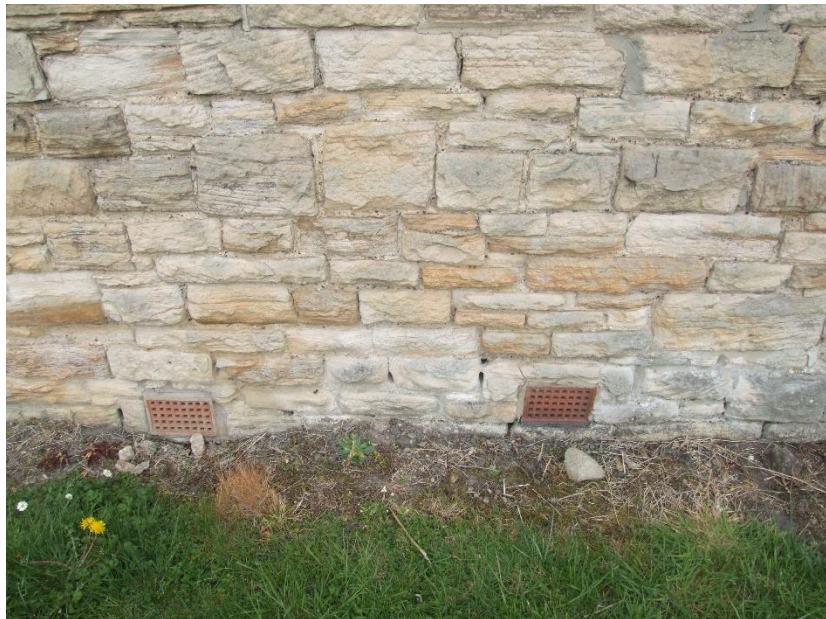
P2 (2352):
South elevation nave,
additional underfloor
ventilation/mortar gaps

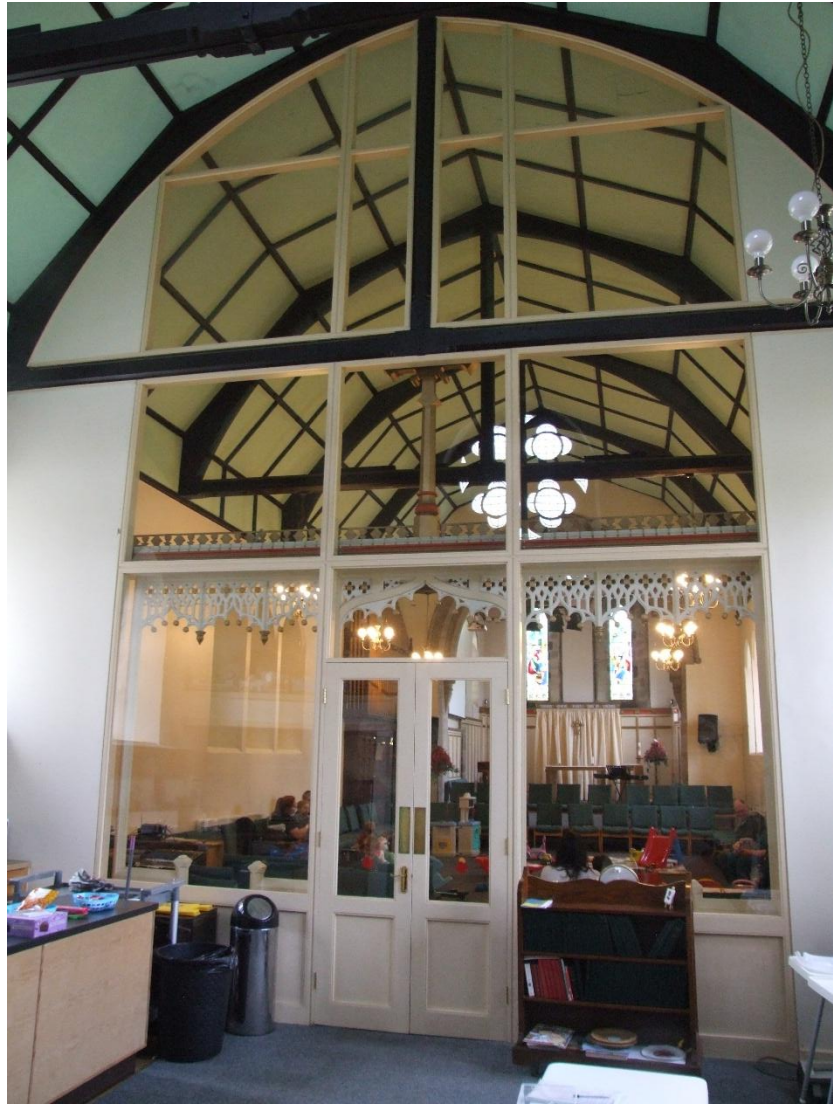
P3 (2456):
Glazed screen between
kitchen/foyer and nave

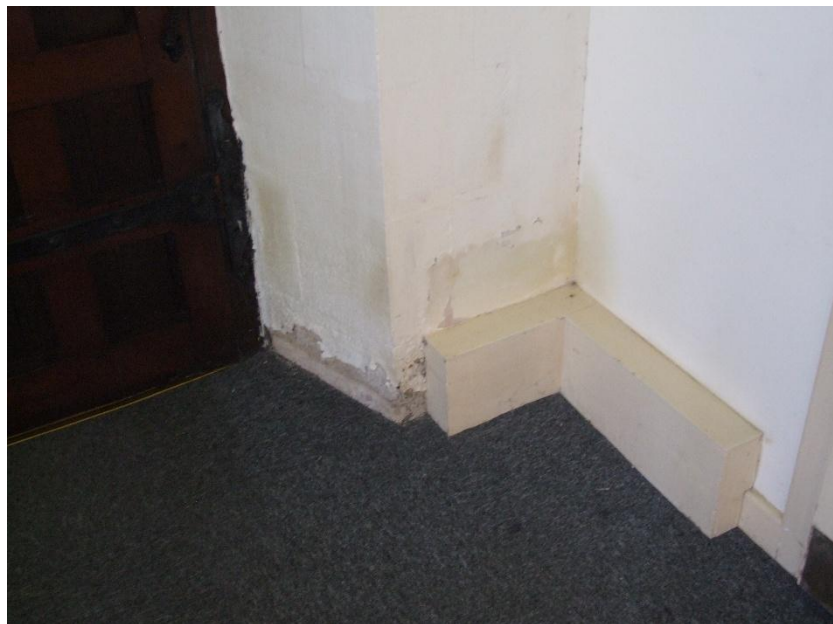
6.2	<p><i>Internal walls:</i></p> <ul style="list-style-type: none"> • Generally painted plaster and in good condition, with timber painted wainscoting to chancel areas • Two areas with issues: <ul style="list-style-type: none"> ○ Hairline cracking above west door and chancel arch ○ Flaking paint, most markedly in north gable (vestry) – this may result from moisture penetration from external wall surface, or more recent paint coatings being incompatible with earlier paint

P4 (2453):
Low level damp/salts to
right hand side of
entrance door

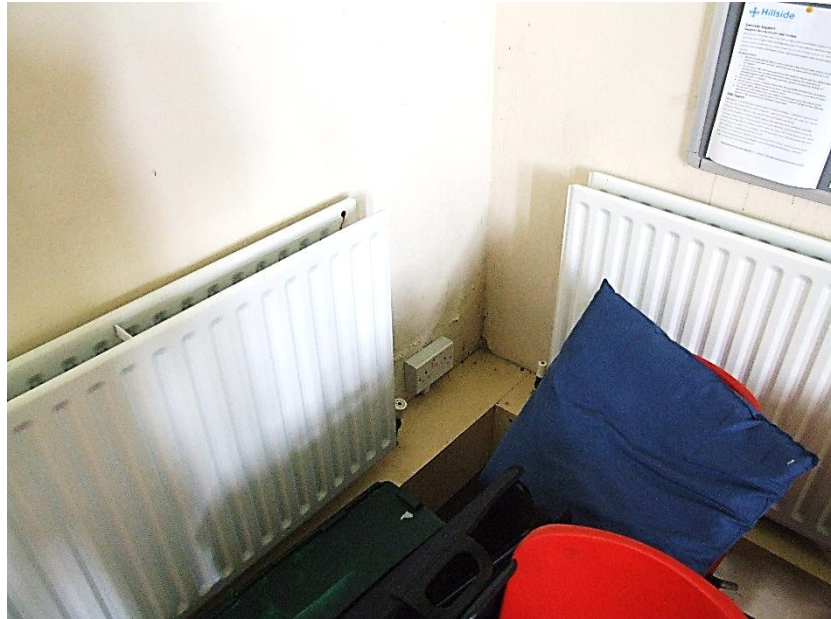
P5 (2458):
Low level damp/salts to
left hand side of
south wall

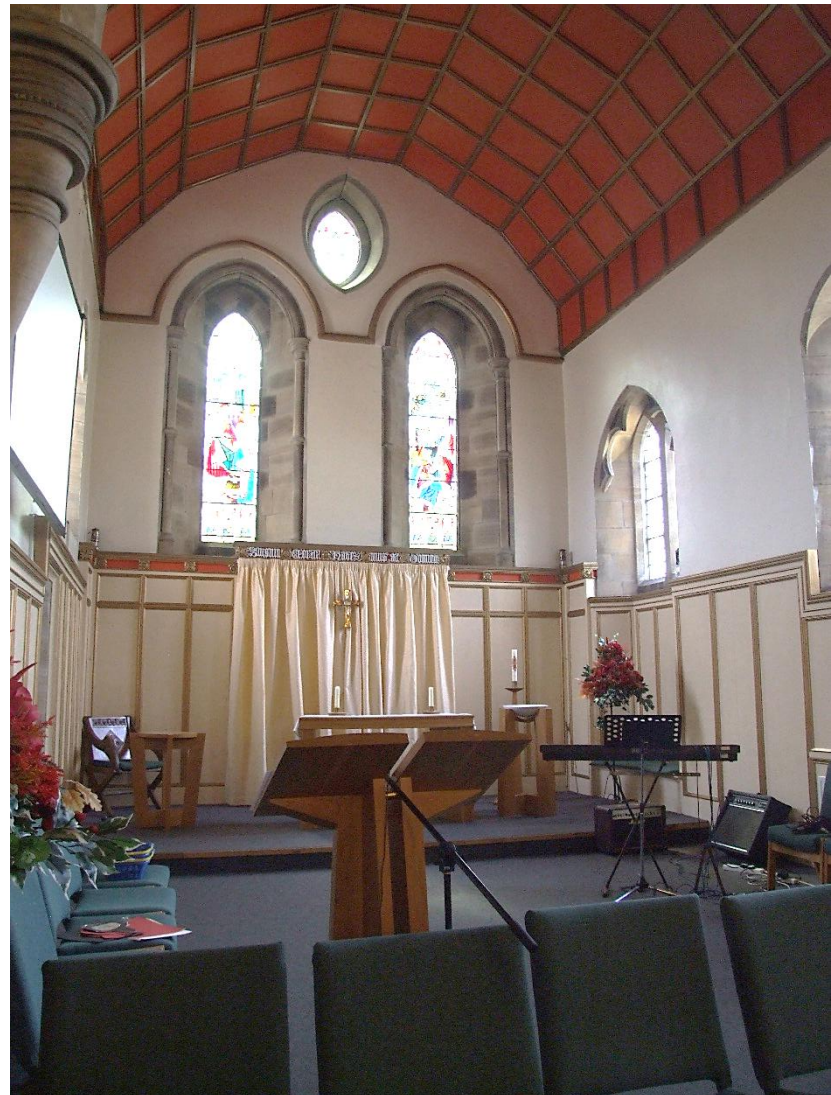
P6 (2465):
Well appointed,
reordered chancel area

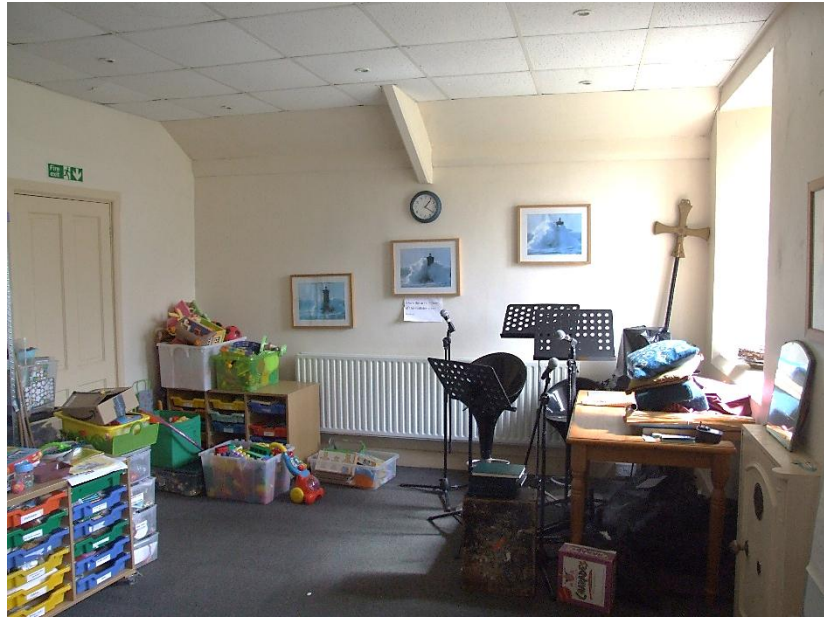
P7 (2474):
Catslide vestry,
historic water staining
to exposed rafter

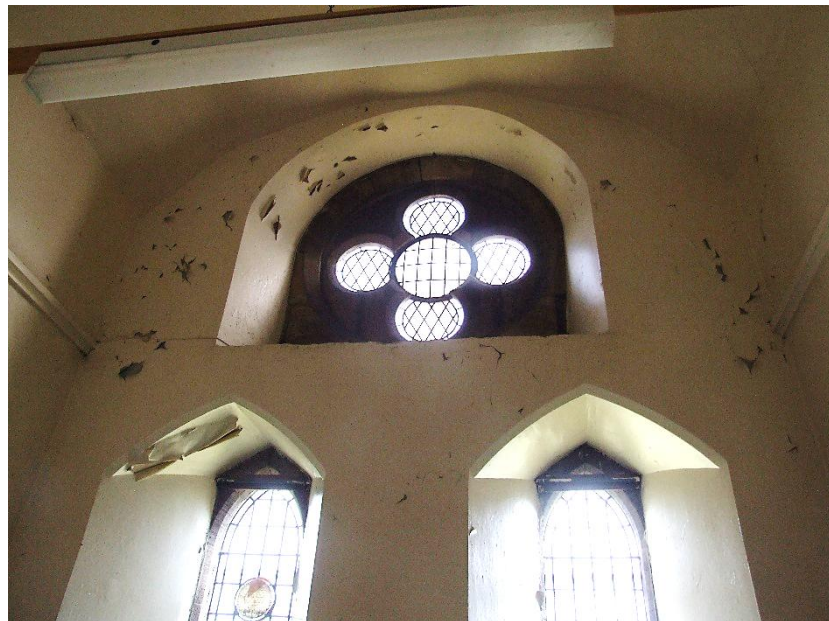
P8 (2476):
Gabled vestry,
peeling paint at high level

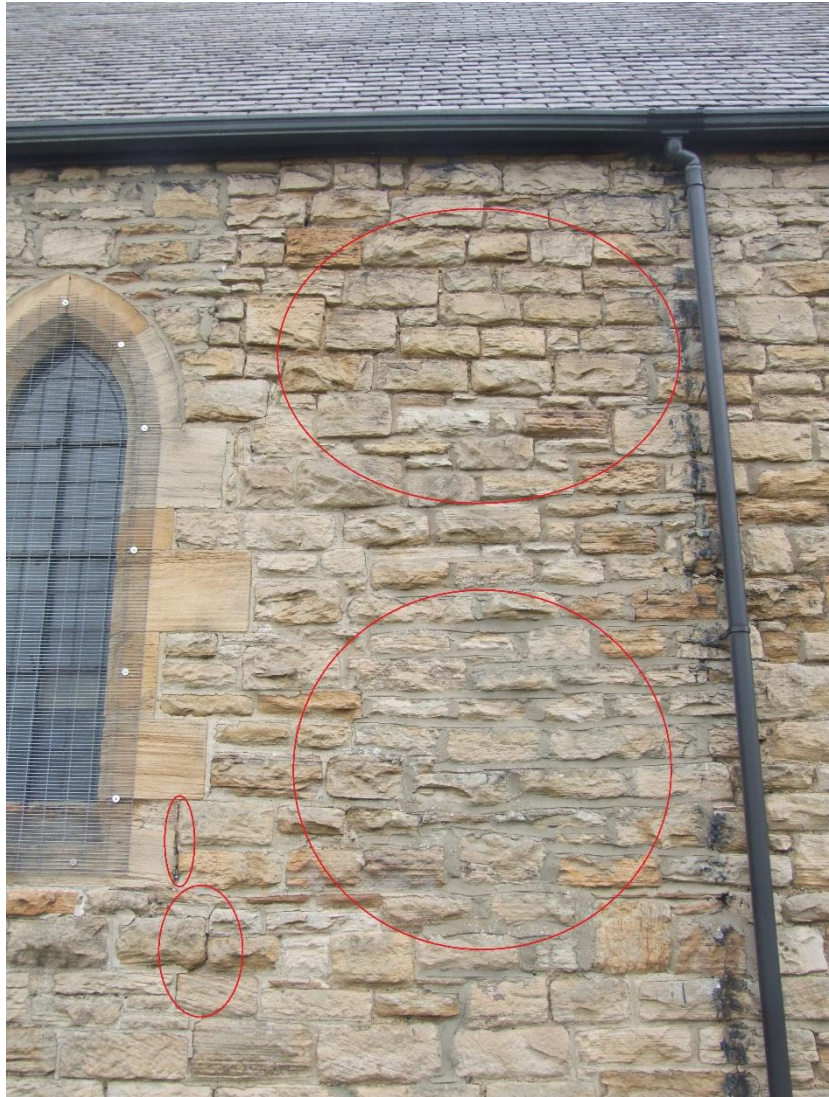
P9 (2509):
South elevation nave,
open jointing/
poor pointing

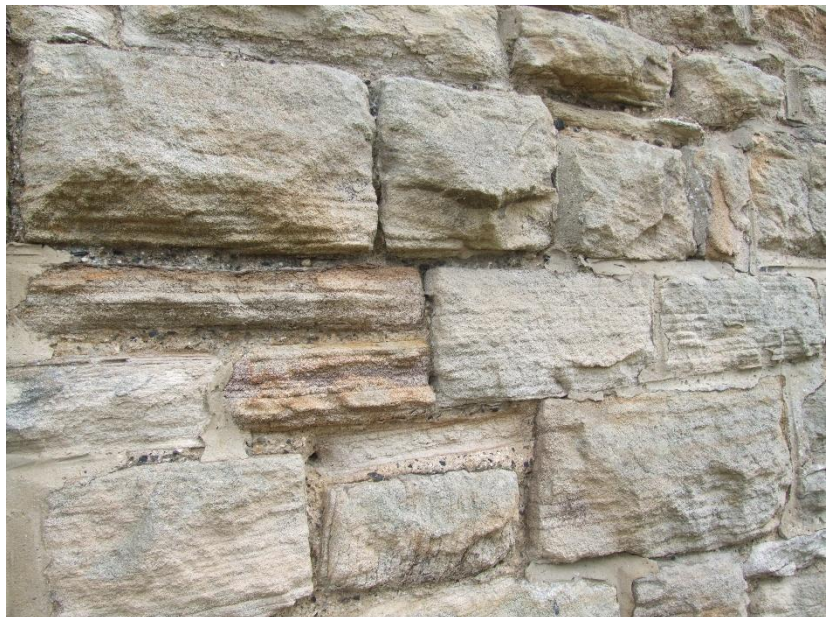
P10 (2517):
Detail of high relief
stone surface and
eroded pointing

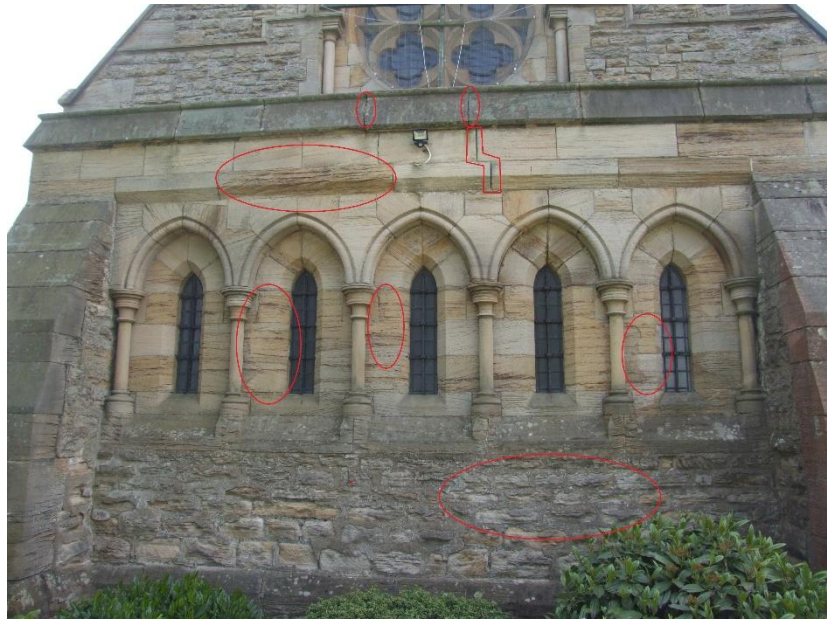
6.1.6	<p><i>Porch:</i></p> <ul style="list-style-type: none"> • Stonework detailing intricate with recessed 5 no. lancets with arcaded colonettes • Eroding bedding planes to dressed walling to lancet surface, rubble stonework below poorly pointed in cement mortar • Rose quatrefoil window above has colonettes to either side with moulded semicircular hoodmould

P11 (2537):
Western porch, eroded
stonework/open joints

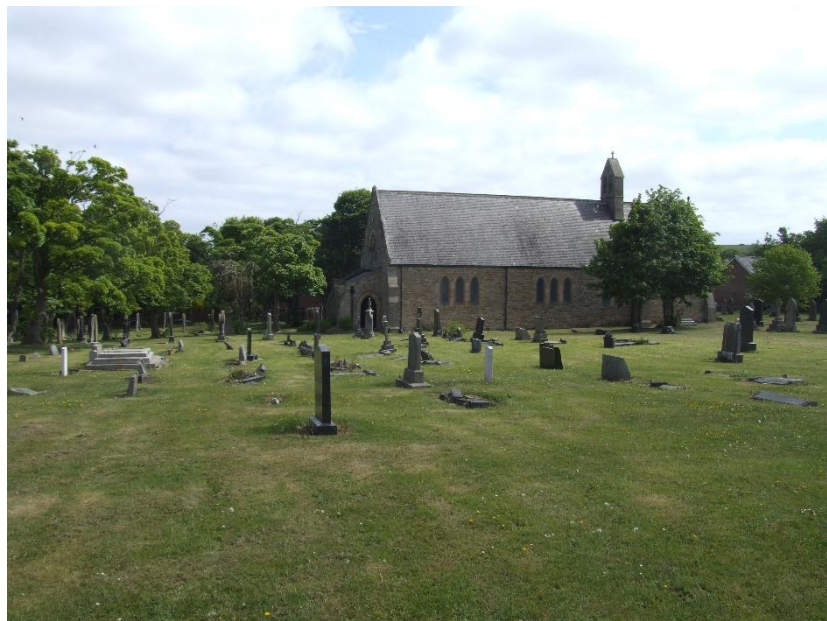
P12 (2539):
Well maintained
churchyard,
southern area
