**Quinquennial Inspection Report
The Church of All Saints', Monkwearmouth
Parish of Monkwearmouth
Archdeaconry of Sunderland
Diocese of Durham**

David Jowett - Architect, BA, DipArch, RIBA
25 Roseworth Avenue
Gosforth
Newcastle upon Tyne
NE3 1NB
Tel: 07788 710 204
email: david@davidjowett-architect.co.uk

11 October 2018

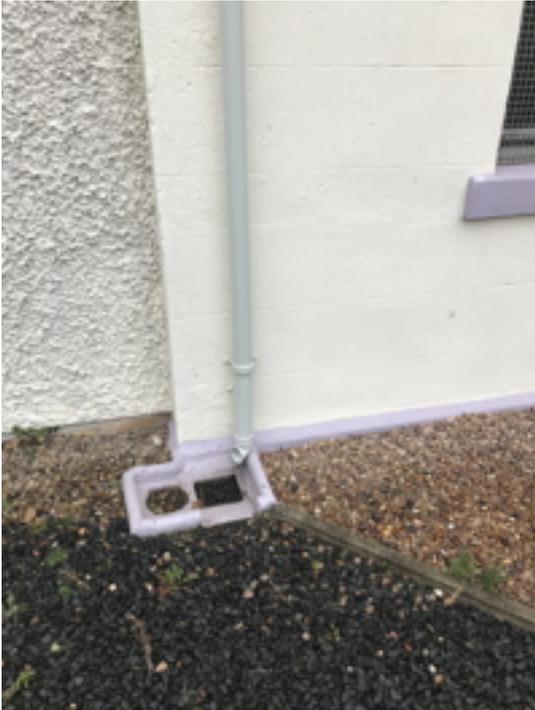
Hall West Wall UPVC Rainwater Pipe

Replace UPVC rainwater pipe with cast iron. £200.00

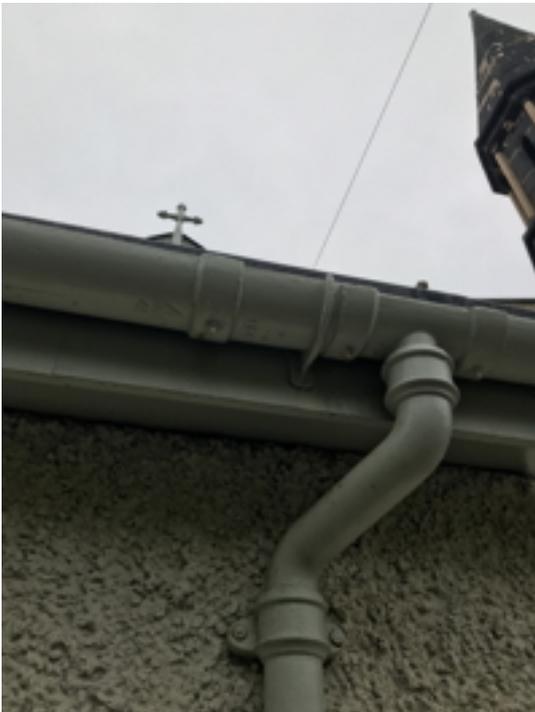
Although the gutters and rainwater pipes to the Hall have been recently decorated there are signs of rust spots.

Rust spots to Hall Gutters and Rainwater Pipes

Category B, Requires attention within the next twelve months

Sand down to remove rust spots to Hall Gutters and rainwater pipes. Treat rust spots with rust inhibiting primer and redecorate. £100.00

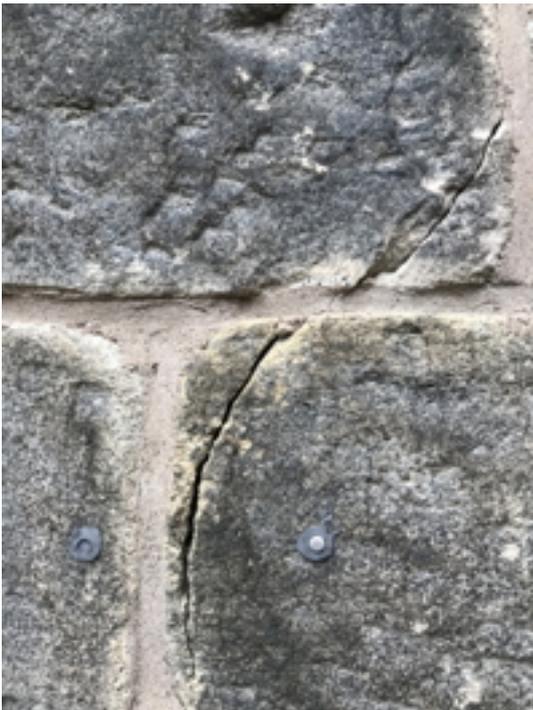
The chancel north wall has a cracking running vertically that has previously had tell-tales now removed.

Crack to North Chancel Wall

Repoint cracking to Chancel north wall and open joints to Nave west wall, north west corner in lime mortar. £750.00

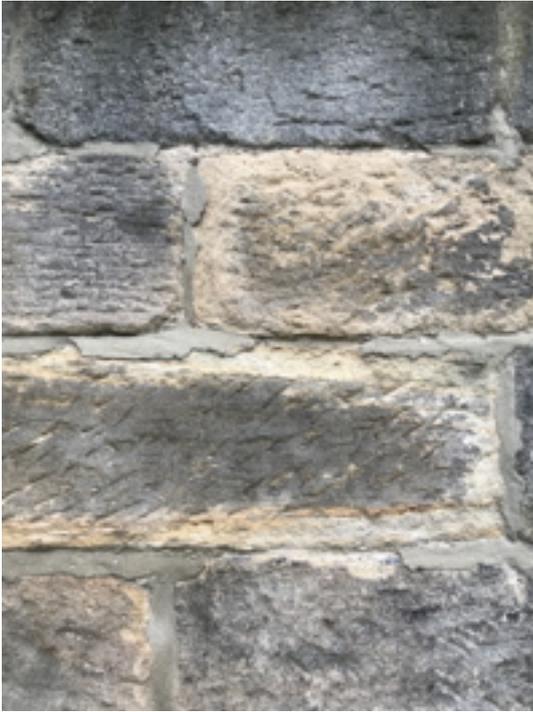
There is evidence of possible cement mortar pointing to small areas of the nave north wall.

Possible cement Mortar pointing to Nave North Wall

Monitor areas of possible cement mortar and existing areas of stone decay and slightly open joints. Delaminating stones should be brushed down and washed with clean water as loose and friable stone holds water that can freeze in cold weather accelerating the delamination. £50.00

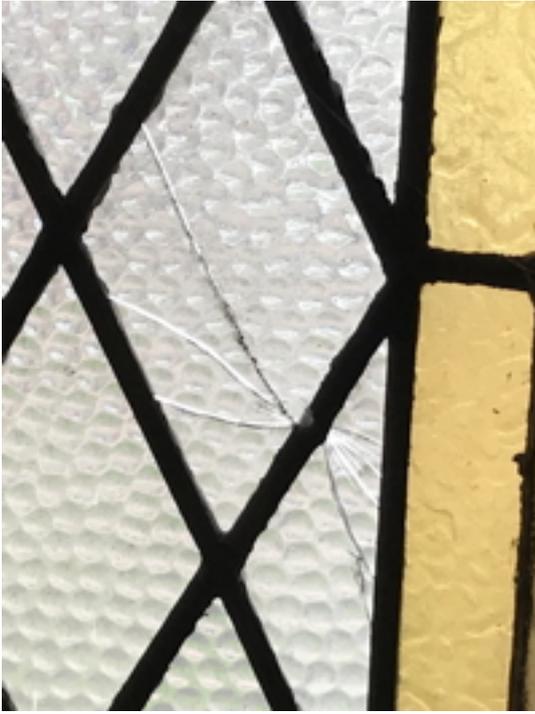
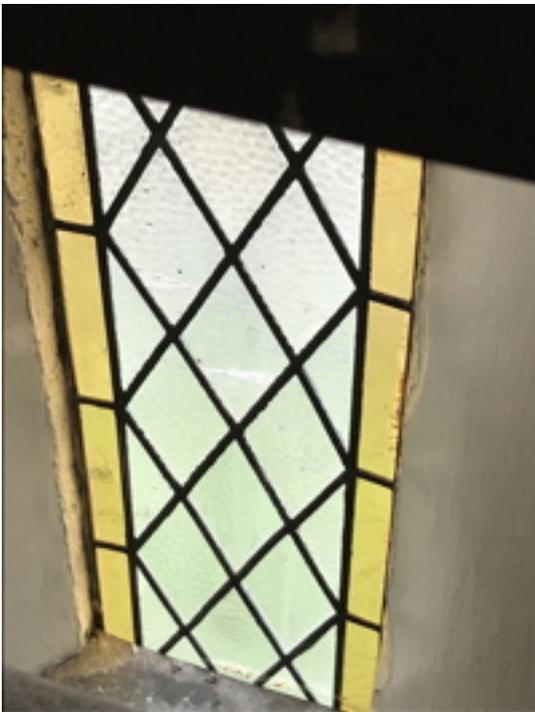
All are in good condition with the exception of 4no cracked panes to the North election visible from the organ loft.

Cracked glass panes visible from organ loft

Replace broken panes. £1,000.00

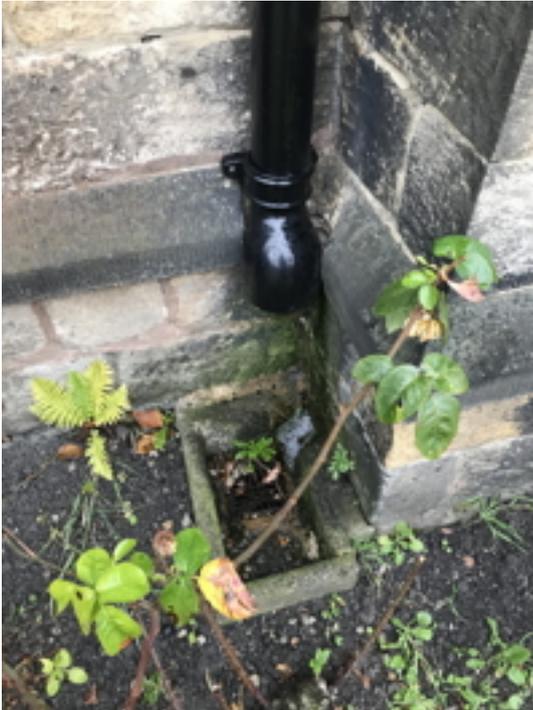
All appears to be in working order although 3 sumps have the first signs of vegetation growing around the gullies.

Vegetation starting to grow around gully

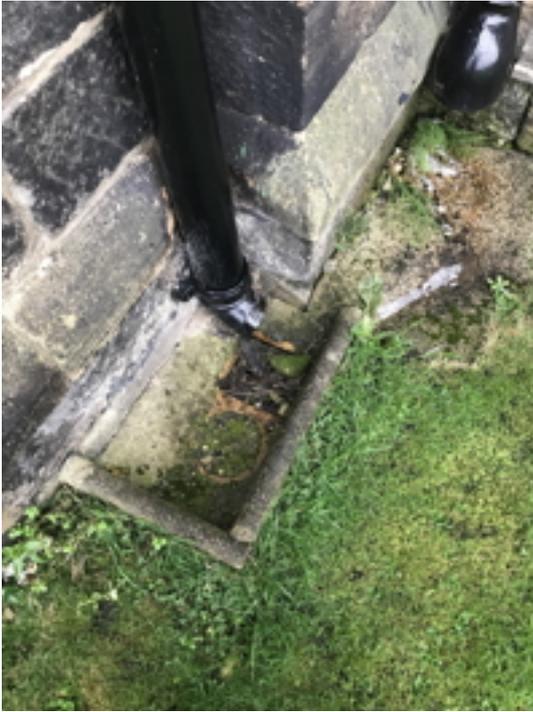
Debris around gully and rainwater pipe discharging over concrete.

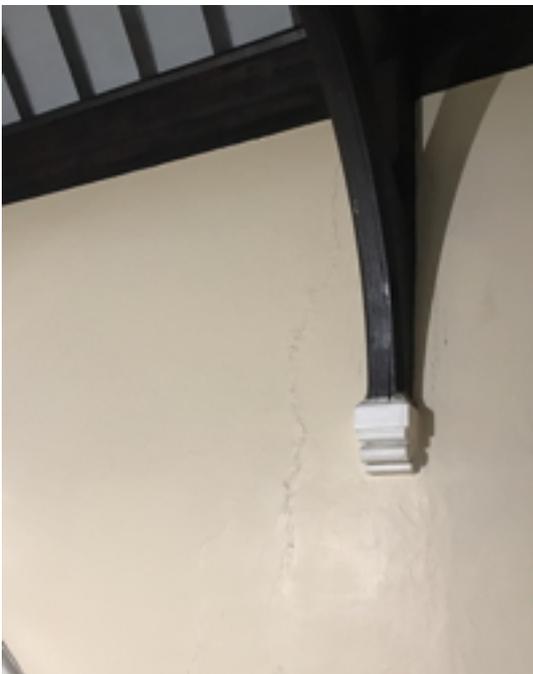
There is a crack to the south wall at high level towards the west end.

Crack to South Wall

Monitor crack in south wall. £0.00

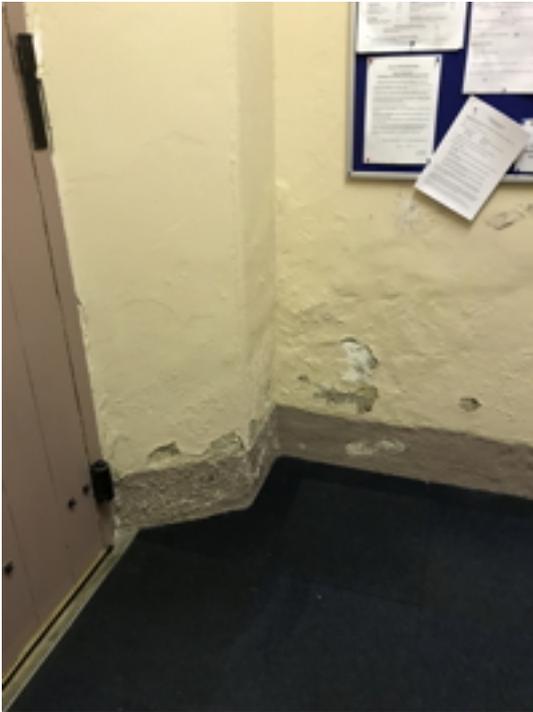
Porch West Wall Damp

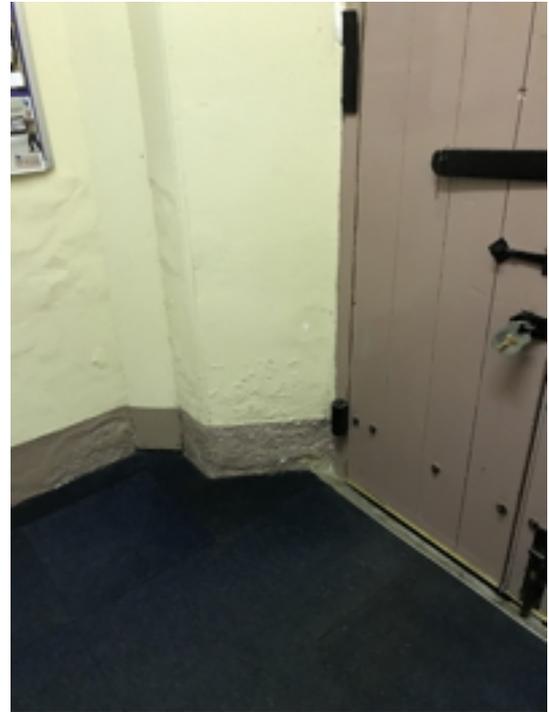
Porch South East Corner Damp

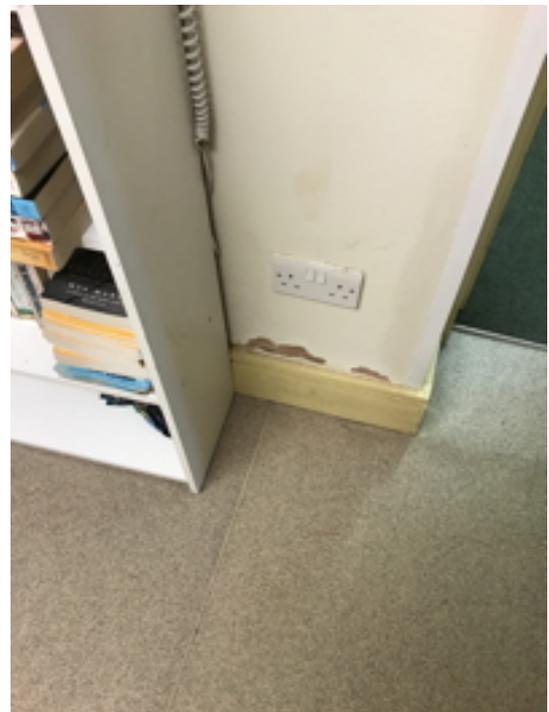
Signs of damp to Meeting Room lower level plaster walls. Here it is possible that the new extensions that have made the original external Meeting Rooms into internal walls are forcing moisture up the walls.

Typical Hall Damp

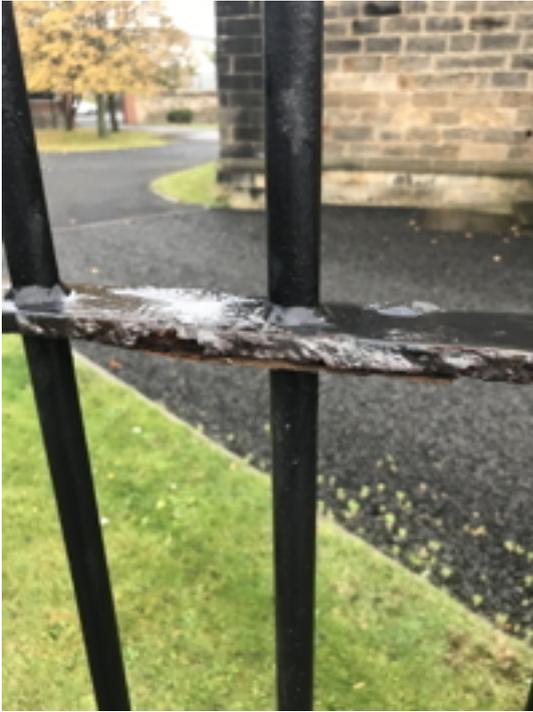
North Wall rails showing signs of advanced rust in places. Churchwarden noted that responsibility for this boundary lies with the adjoining residential development.

Rust to North Boundary Railings

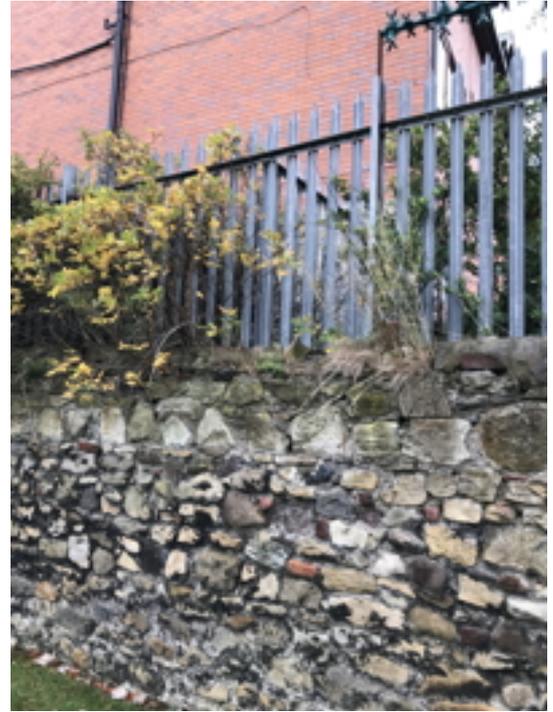
Vegetation to South Wall Copings

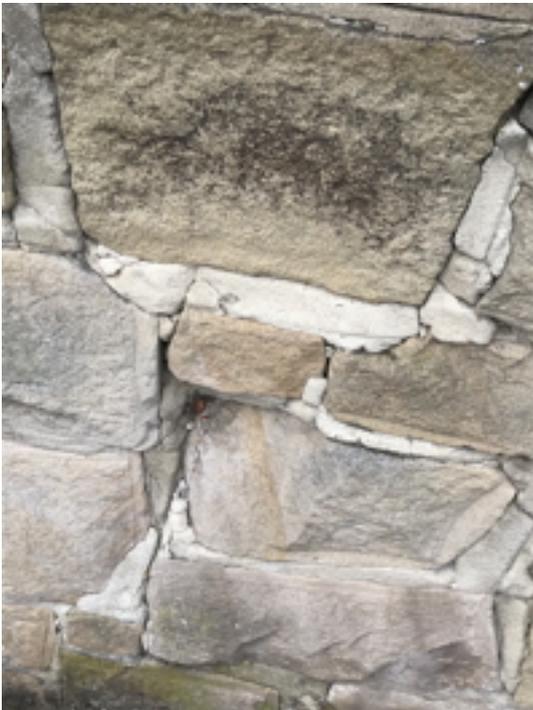
The east boundary brickwork is all in good condition. The lower sections of stonework however are in need of patch pointing.

Loose Pointing to East Wall Stonework

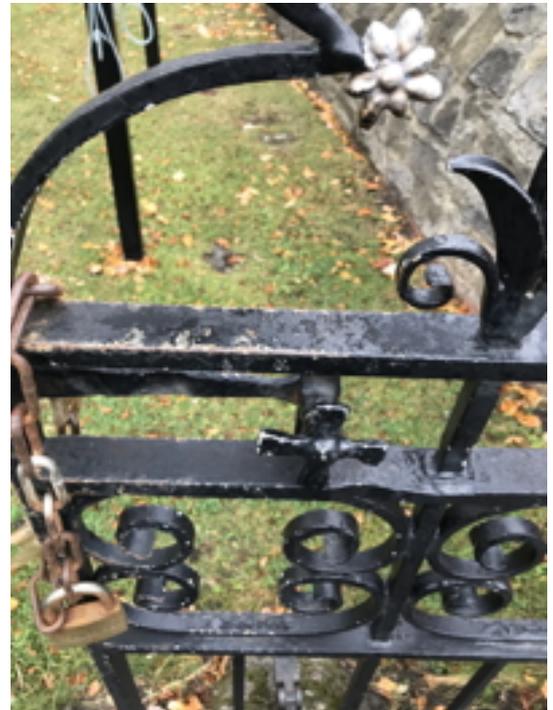
Gates require redecoration.

Gates Requiring Redecoration

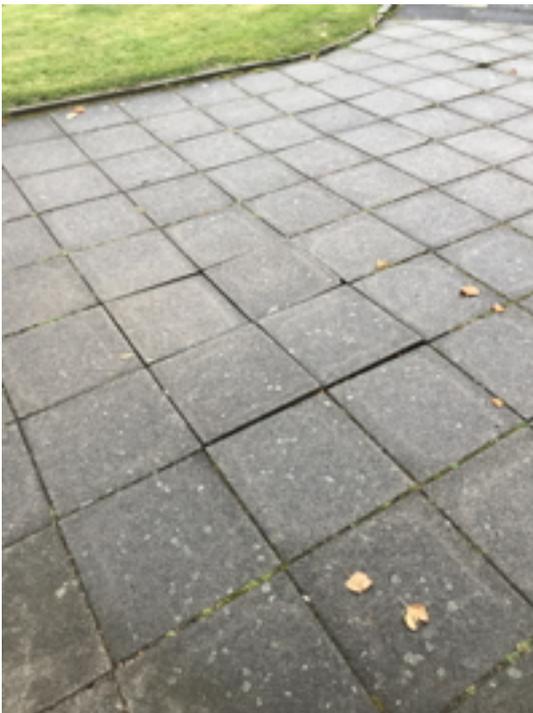
All is in good condition and well maintained with the exception of a small area of paving leading from the entrance gates which has become loose and uneven.

Area of Loose Paving on Driveway to South East Corner

Relay area of loose paving. £500.00
