Church of St. Peter,
Monkwearmouth
1801

The Care of Churches Measure 1991
QUINQUENNIAL REPORT
2018

August 2018

Church of St. Peter, Monkwearmouth
Archdeaconry of Sunderland

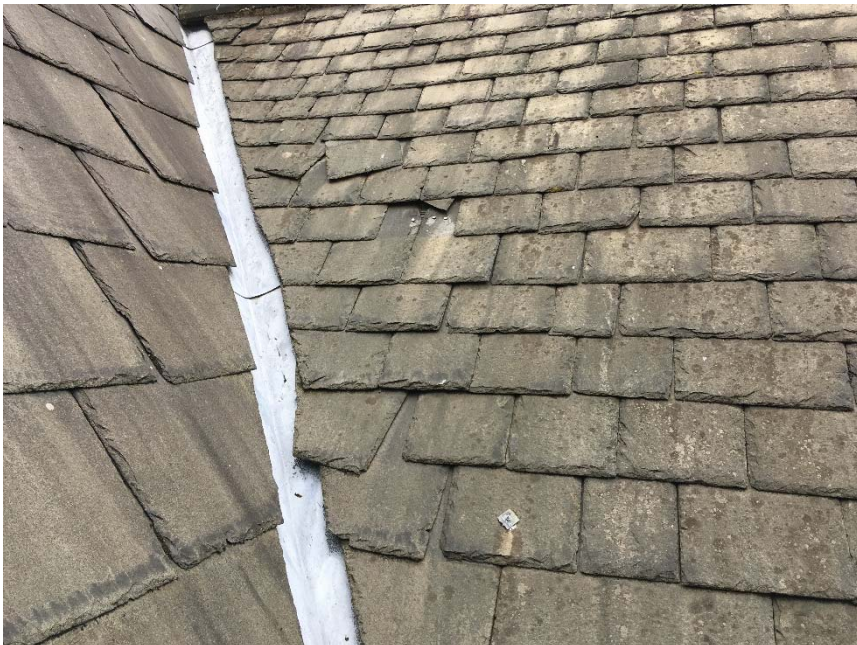
South slope partly re-covered (1986), circa 1876 north slope, has 2No. broken slates. Cut in lead flashings over copings intact. Eaves slates secured centrally along lower edge using large copper nails where not re-covered. Lead gutter to Chancel (1987 – 89) in good condition. 4No. roof windows with condensation between panes. 4No. pitched lead valley linings to North Transept in good condition.

Photo 3
Slipped slates on North Transept valley roof

| 1. | Repair slates abutting Tower, North Transept, Lavatories and Bake House | 800 |

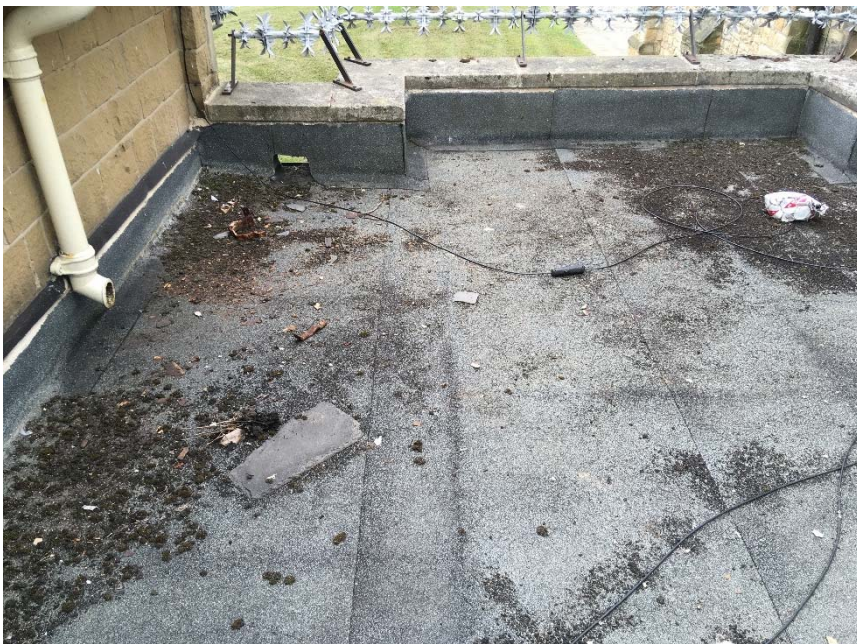
Bitumen felt (2011) with 300mm upstands to wide flat copings with anti-climb deterrent. Good condition though collects debris.

Photo 4
Slate and debris on Bake House link roof

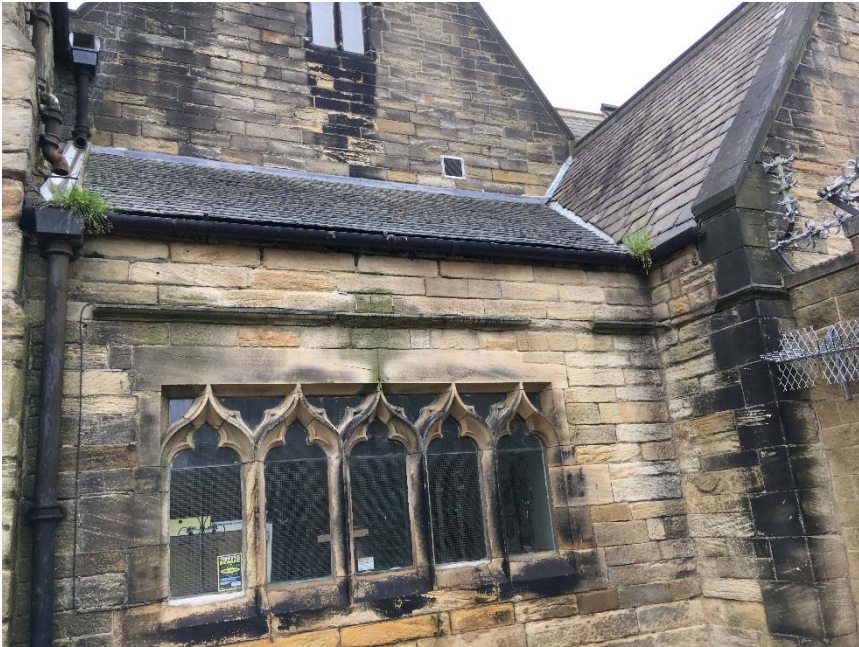
Photo 5
Debris in gutter and eroded mortar and window cills on Vestry

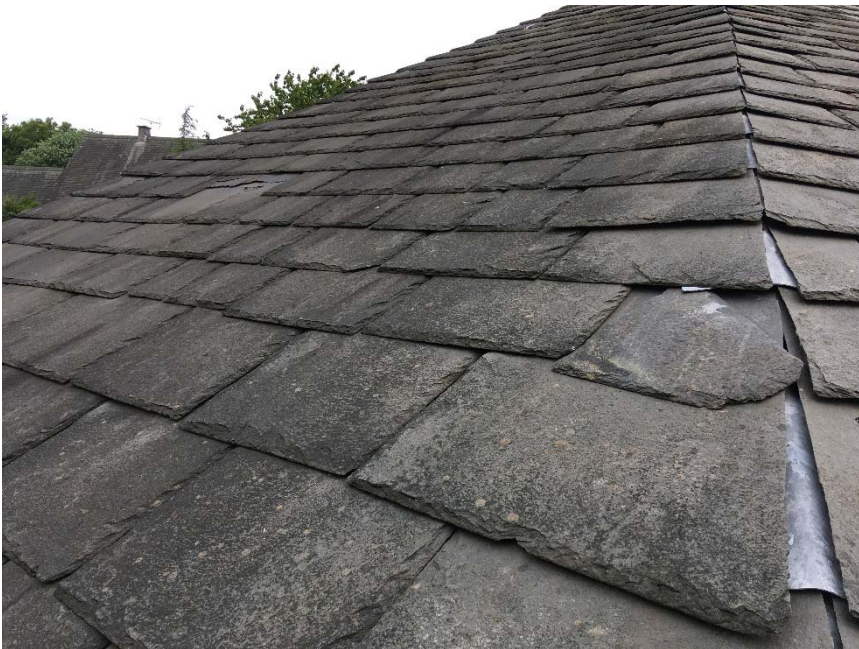
Octagonal roof with mitred hips and raised cupola with large cut slates and timber louvres (1973). Upper roof has missing slate to southeast, repaired with bitumen felt, main roof has 2No. broken slates to west and 1No. to southeast, 1No. lead slate repair to northeast, otherwise in reasonable condition.

Photo 6
Slipped and missing slates on Bake House roof

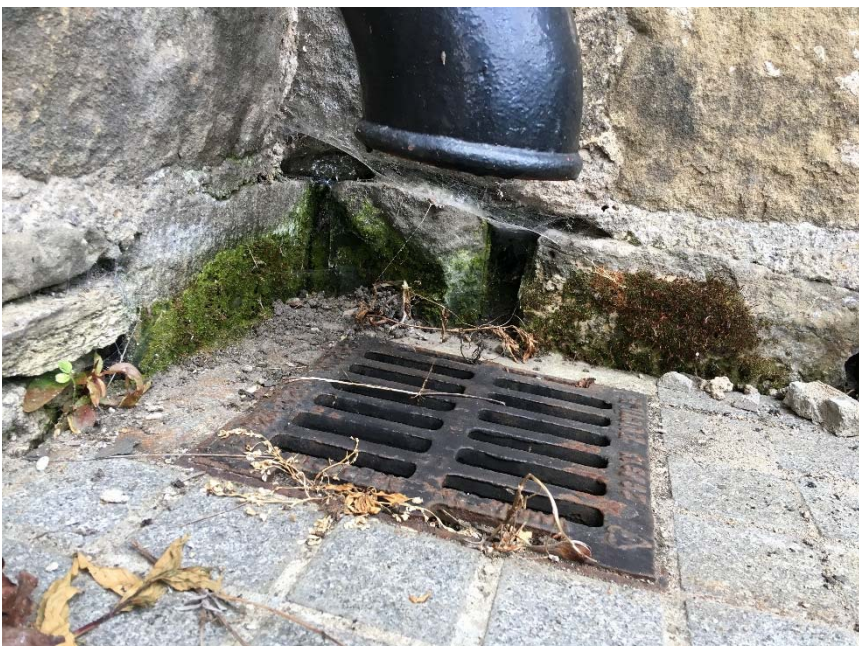
6. 2No. recent iron grates set flush in granite paving on south side of Nave directing water against the walls from where it runs into the building.
7. 1No. blocked grate and 1No. missing grate to Vestry.
8. 1No. blocked grate against north steps causes water to pond on gravel surfaces.

Photo 7
Rainwater runs into building at gullies south side

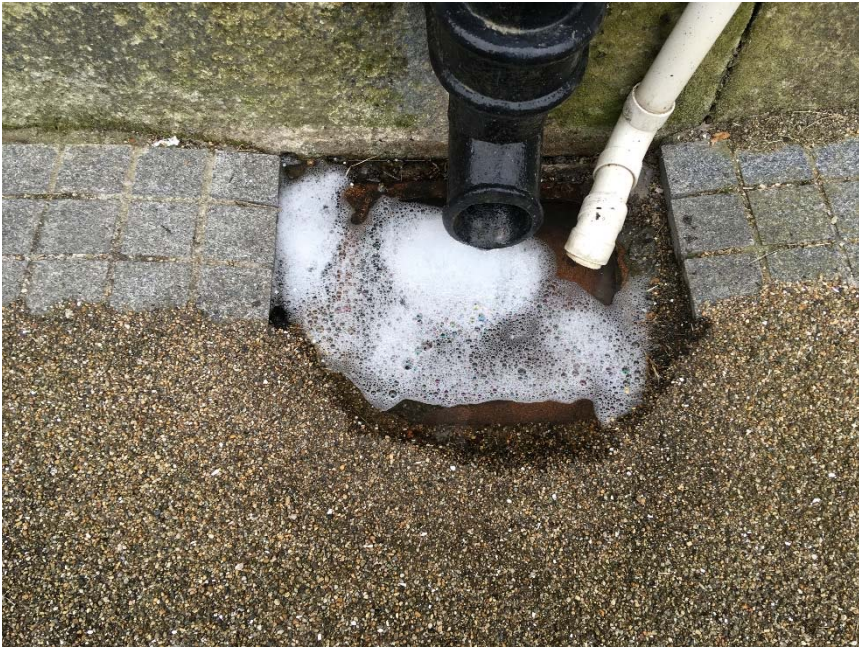
1. Drains appear to run to mains sewers with inspection chamber to north and east. It is not known where the drainage from the south discharges.
2. Terracotta gullies to Bake House in good condition.
3. Salt-glaze gully to Lavatories blocked.
4. Shallow terracotta gully to west side of North Transept appears to overflow adjacent doorway.
5. Salt-glaze gully blocked with gravel on west gable.

Photo 8
Blocked gully to kitchen seeps below
building

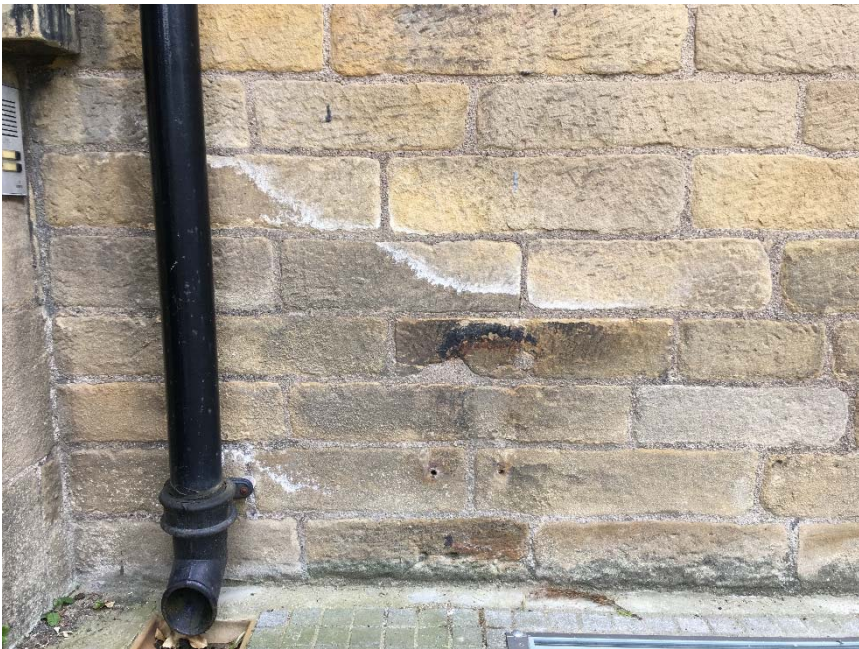
Photo 9
Efflorescence on external North
Transept wall

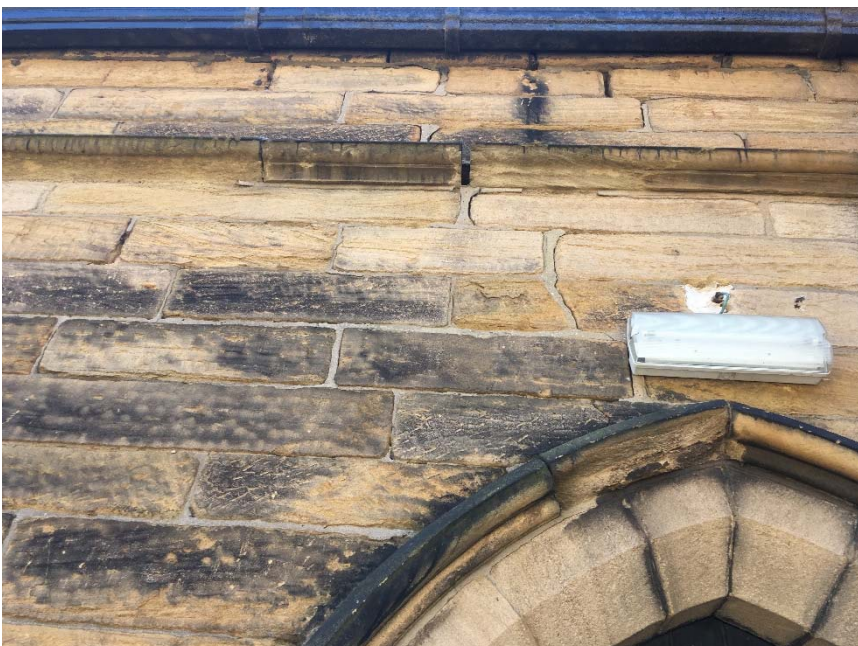
C19th long rectangular blocks, plinth and hoodmould have slight erosion. Also cracking above arched doorway 3-6mm wide and slight erosion of head mould. Cement patch pointing in poor condition, also eroded lime mortar.

Photo 10
Movement and cement patch pointing
over North vestry door

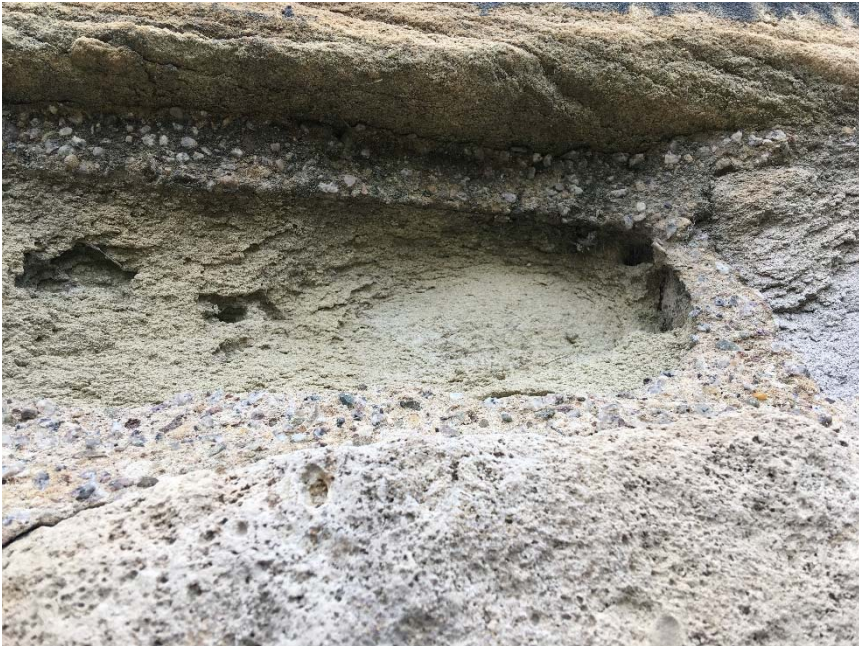
Photo 11
Localised stone decay in gauged
cement pointing

| 1. | Continue replacement of gauged cement pointing with lime | 10000 |

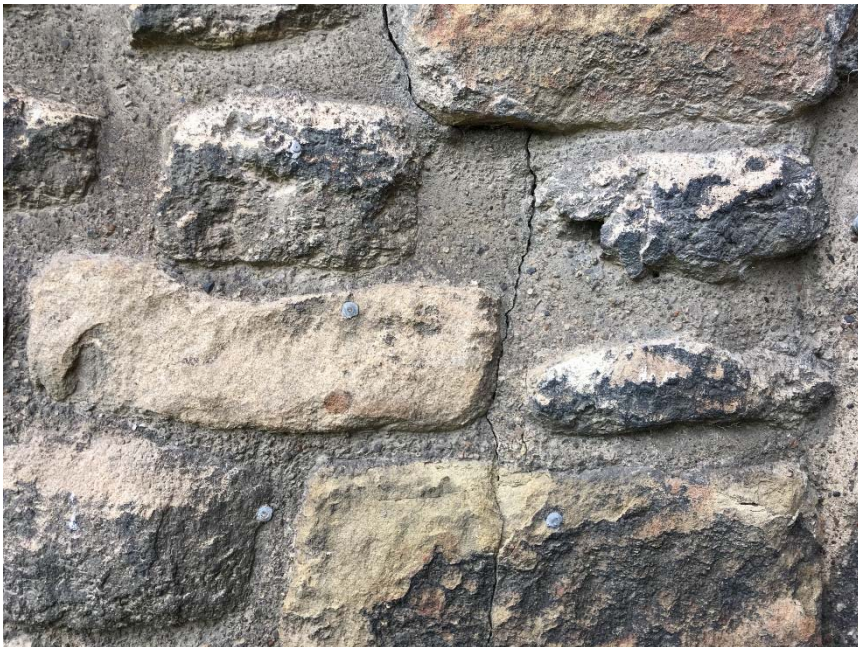
2. Tower north elevation
Anglo-Saxon, five tiers. Lower in coursed small rubble including Marsden and magnesium limestone with wide joints, in reasonable condition, though again reddened by fire. Larger square coursed blocks over in reasonable condition though severely eroded quoins between 4m and 8m height. Gauged cement pointing intact. Cracking starts 4m high and passes through window recess, 4mm wide abutting Nave and 1-2mm wide centrally.

3. Tower west elevation
As north, except vertical crack 6mm wide where it passes through string course at first floor and statue stage. Also cracking of north quoin at first floor 3mm wide. Gauged cement pointing intact.

4. Tower south elevation
As north except several vertical cracks, including 4mm crack above 4m height adjacent Nave gable, a 3mm crack above the arch at ground floor, and a 3mm crack 500mm off Nave gable at 4-6m height, and a 3-4mm crack at the junction of the Nave roof coping running up behind the quoin stones. Gauged cement pointing intact.

Photo 12
Cracking through wide gauged cement
pointing on Tower

| 1. | Monitor cracking in Tower | QI |

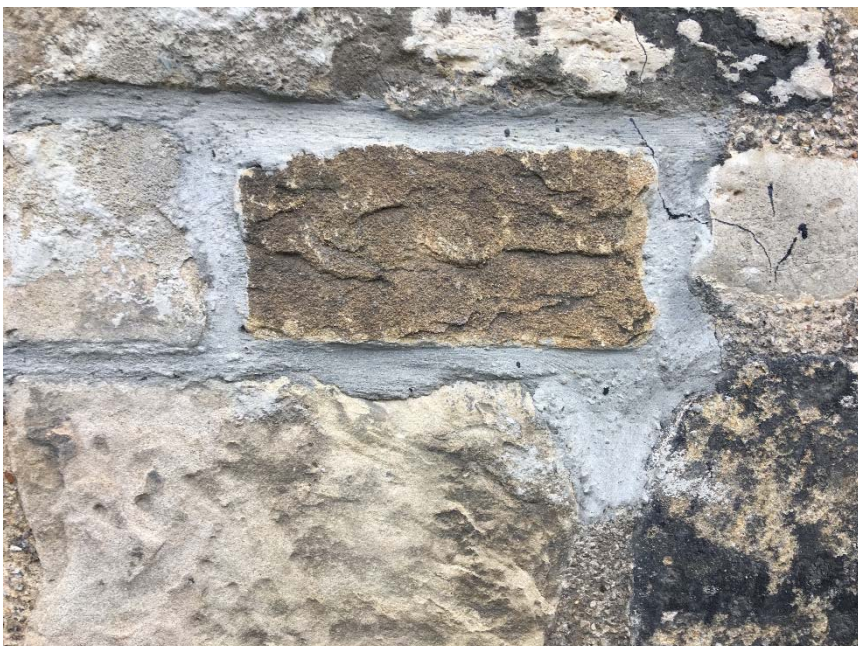
Photo 13
Recent infill stones to former flues in
hard cement mortar

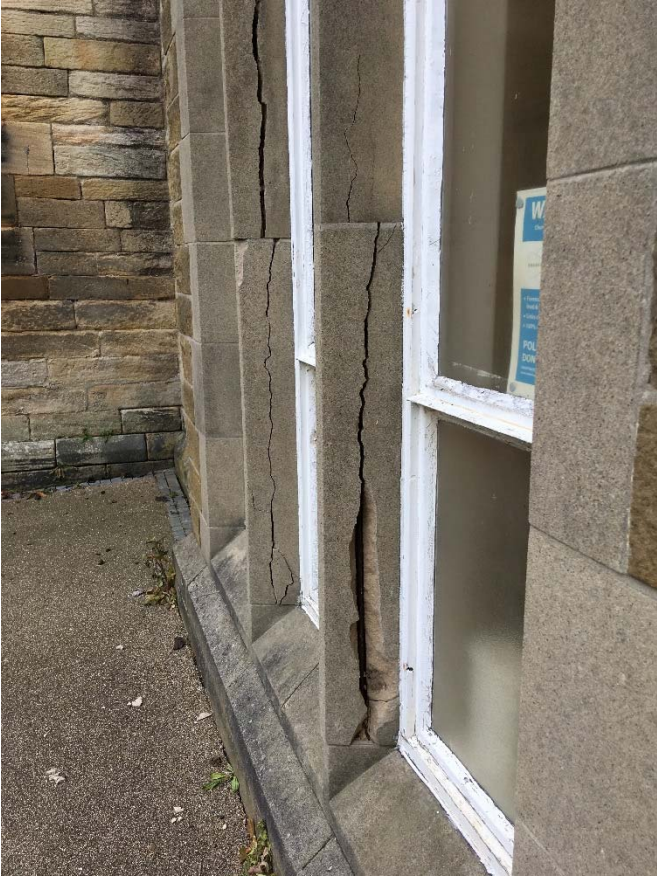
Split-faced sandstone cavity wall with artificial stone surrounds, quoins and plinth (1973). Much vertical cracking also open mortar beds where presumably mild steel fixings are corroding. Artificial stone mullion and window surrounds disintegrating where reinforcement is corroding. Face of mullion in danger of collapse south side of link.

Photo 14
Cracking of artificial stone on Bake
House owing to steel corrosion

| 5. | Remove loose mullions to Bake House link | 60 |

| 2. | Replace mullions between windows to Bake House link | 3000 |

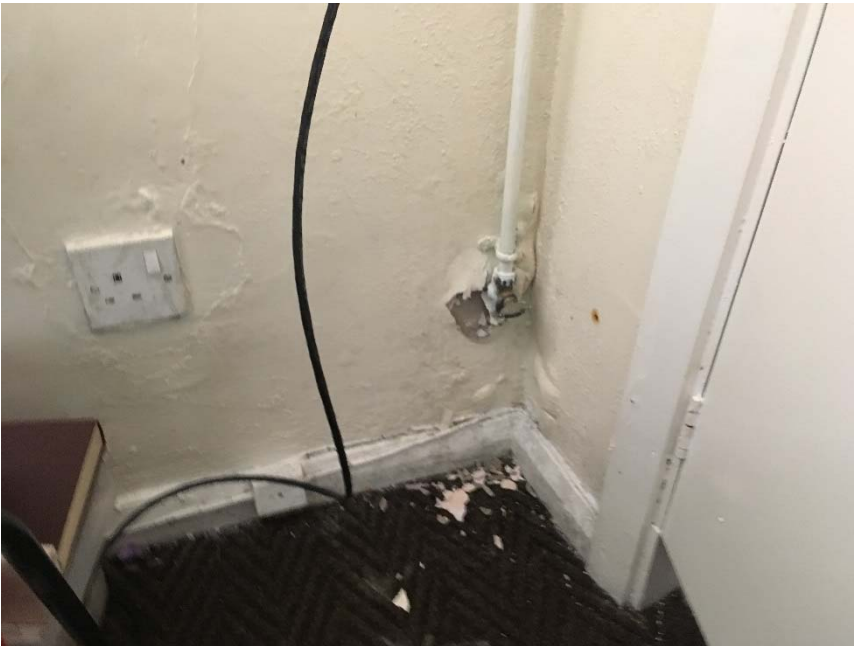
Photo 15
Plaster damage in Vestry due to
blocked hopper externally

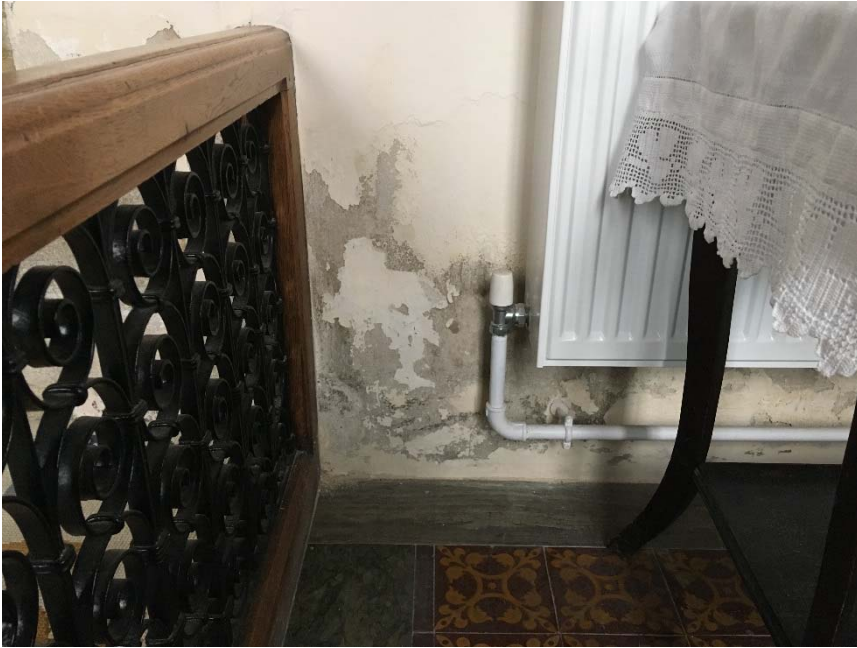
Photo 16
Plaster damage above raised floor in
Sanctuary

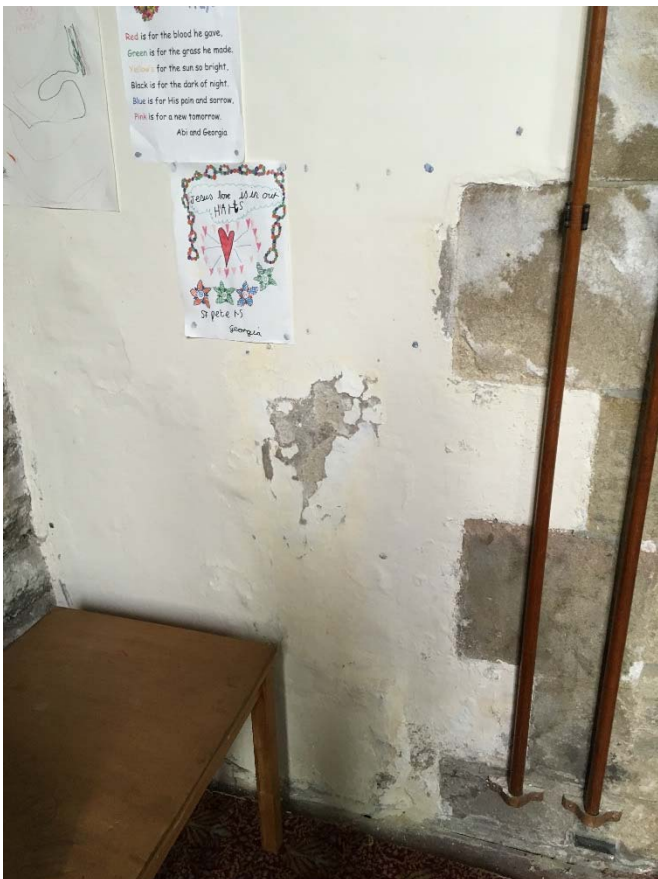
Photo 17
Efflorescence on Nave north wall

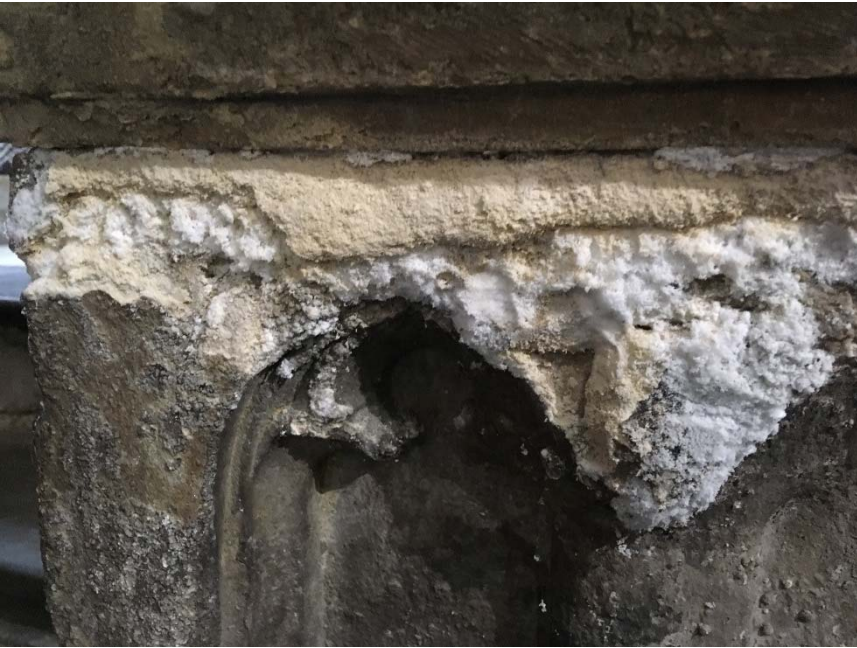
Photo 18
Efflorescence on tomb below Chancel screen

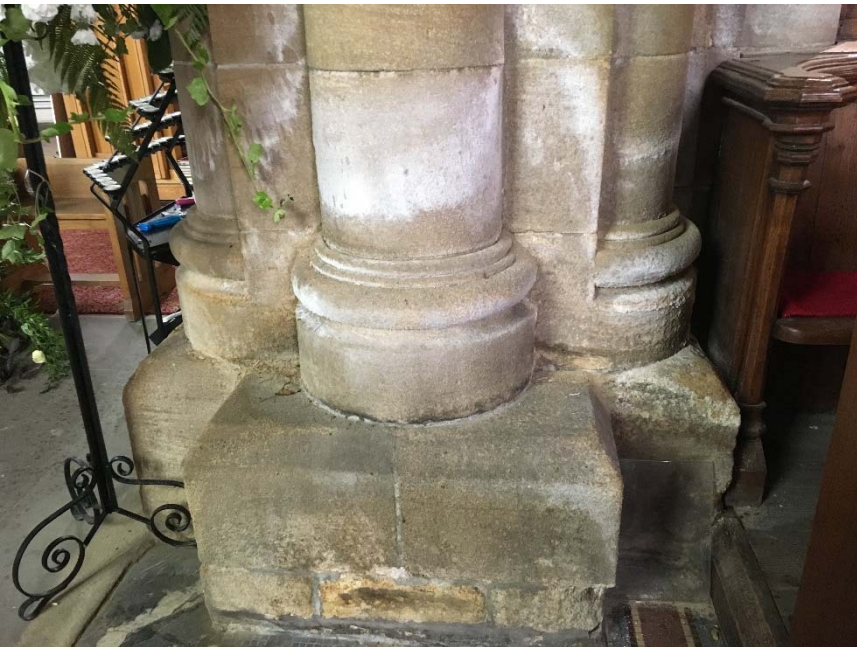
6. Internal ashlar masonry is suffering from extensive efflorescence upto a height of 1500mm on columns, especially on the pier north side of the Chancel arch. This is causing serious damage to the surface of the stone, as well as to the floor finish beneath.

Photo 19
Efflorescence on north Chancel arch pier

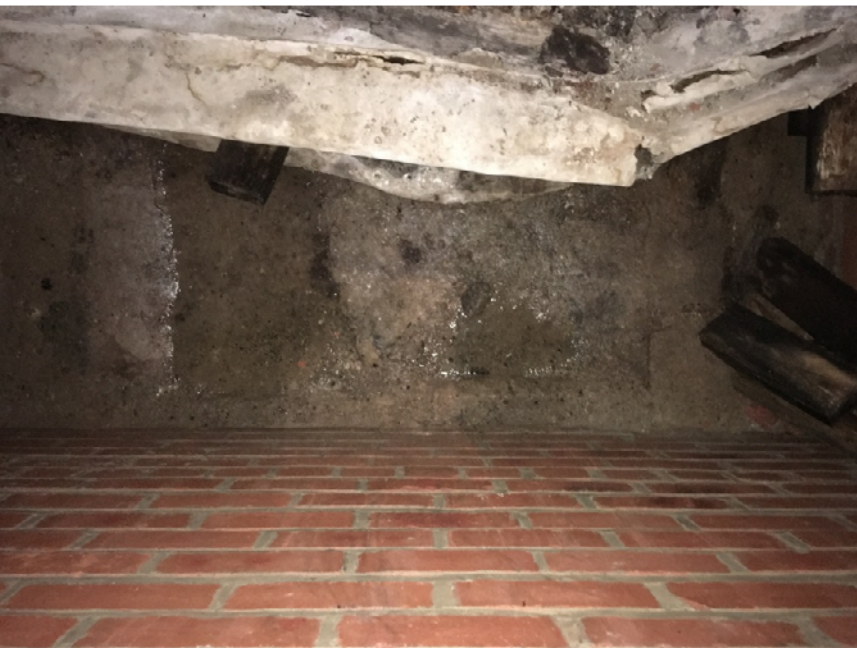
Photo 20
Water standing in chamber below North Transept floor

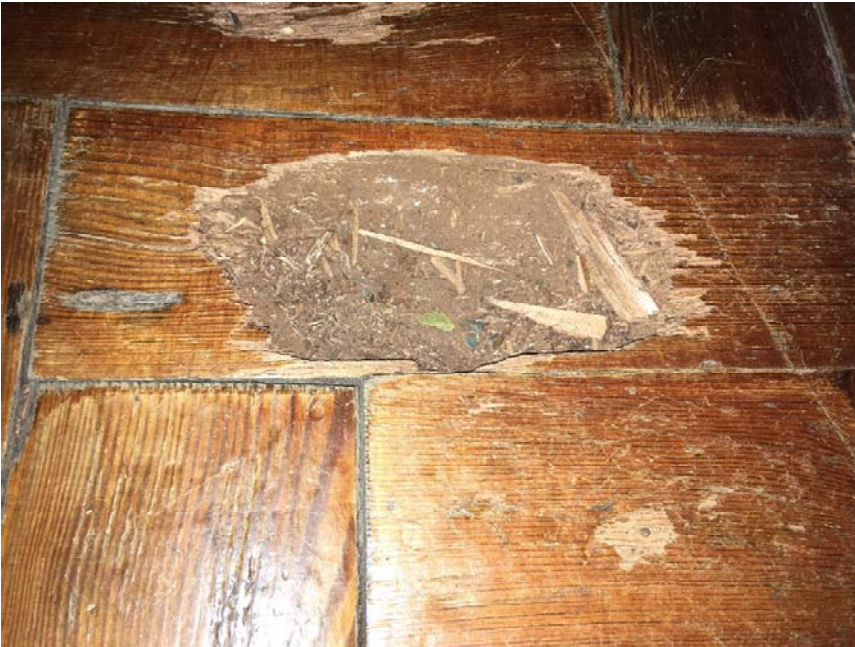
1. Nave and North Aisle have 3No. red-coloured insitu concrete panel circulation aisles with tiled margins. Seating areas are finished in 330 x 100 x 40mm pitch pine parquet blocks. These are generally in a poor condition especially south side where most are rotting on the underside. Many have swollen and lifted leading to an uneven floor.

Photo 21
Rot in woodblock flooring

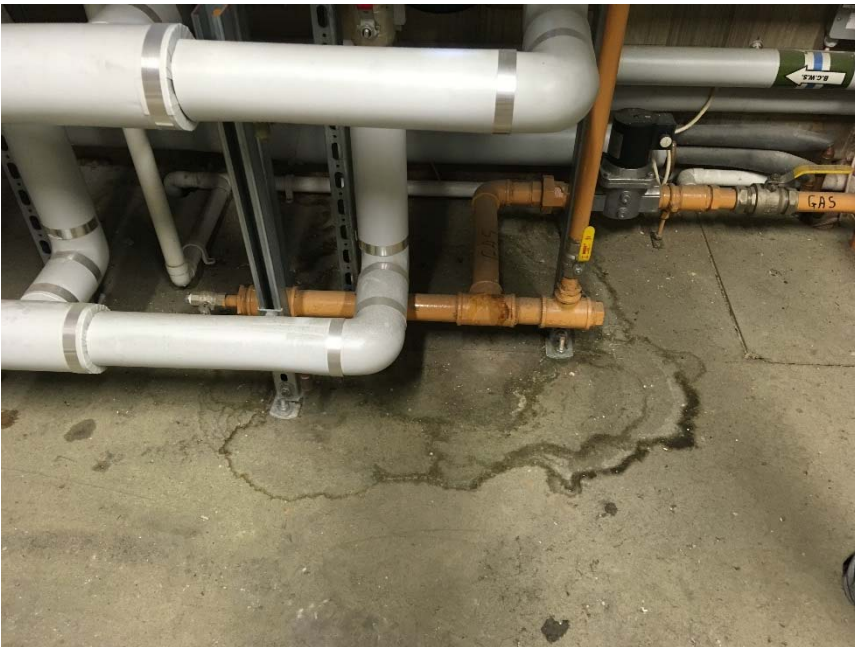
Photo 22
Leak onto chipboard floor below boiler

| 9. | Check boilers for leak onto floor during next service. | 0 |

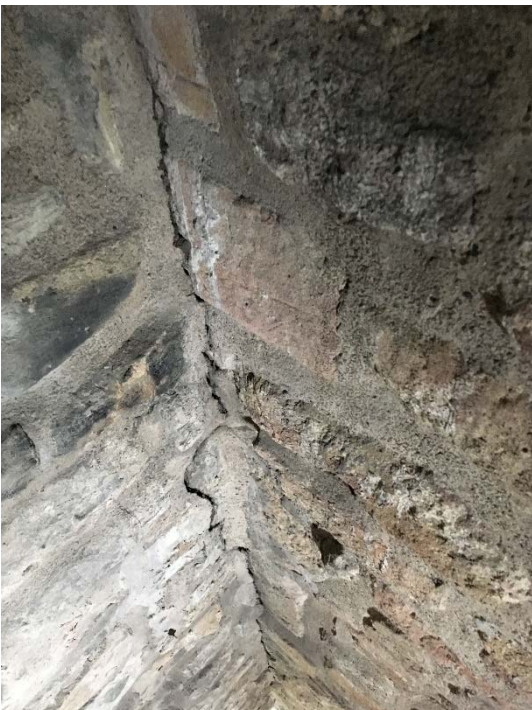
6. Lower intermediate chamber has rubble masonry in good condition except for vertical cracking which is more evident at this level where tell-tales have been installed (1975).

Northeast corner has a 10mm crack mid-height, the lower of 3No. tell-tales has opened 2mm. In the southeast corner a 5mm wide crack widens to 10mm at higher level with 4No. tell-tales all opened around 2mm.

The south wall has two cracks rising vertically and one rising diagonally westwards from the top of the blocked opening at 1.5m height. The east crack is 3mm wide at approximately 3m height and runs down the jamb of the surround to the stone floor. The west crack also runs down the jamb of the surround in 5mm wide, reducing to 2-3mm above.

Photo 23
Vertical cracking within Tower
