# HOLY TRINITY CHURCH, MURTON

10-11 CHURCH LANE, MURTON, SEAHAM, CO. DURHAM, SR7 9RD

**SAMANTHA DIXON**

JDDK Architects Ltd

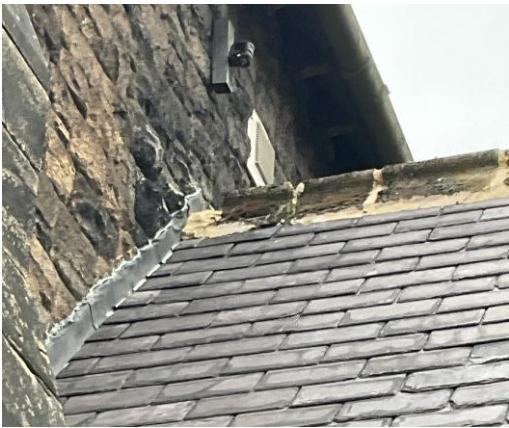
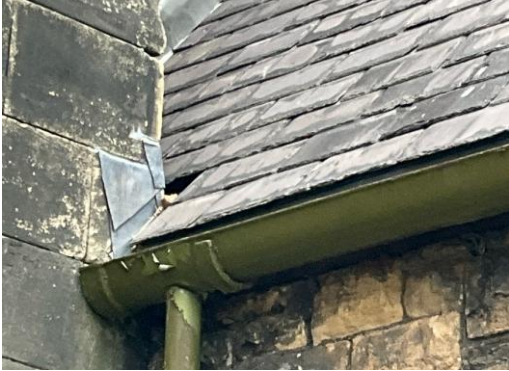
| | <b>Condition</b> <ul style="list-style-type: none"><li>• Ridge tiles look well bedded, possible recent work. Small section of ridge tile appears to missing at junction with nave wall.</li><li>• Flashing appears sound.</li><li>• Possible slate missing at base of west slope next to buttress on both sides.</li></ul> | |

| | <b>Repair Needs</b><br><br>Replace missing ridge tile.<br><br>Replace missing slate adjacent to buttress on both sides of porch roof or provide soaker flashing to cover hole. | B<br><br>B |

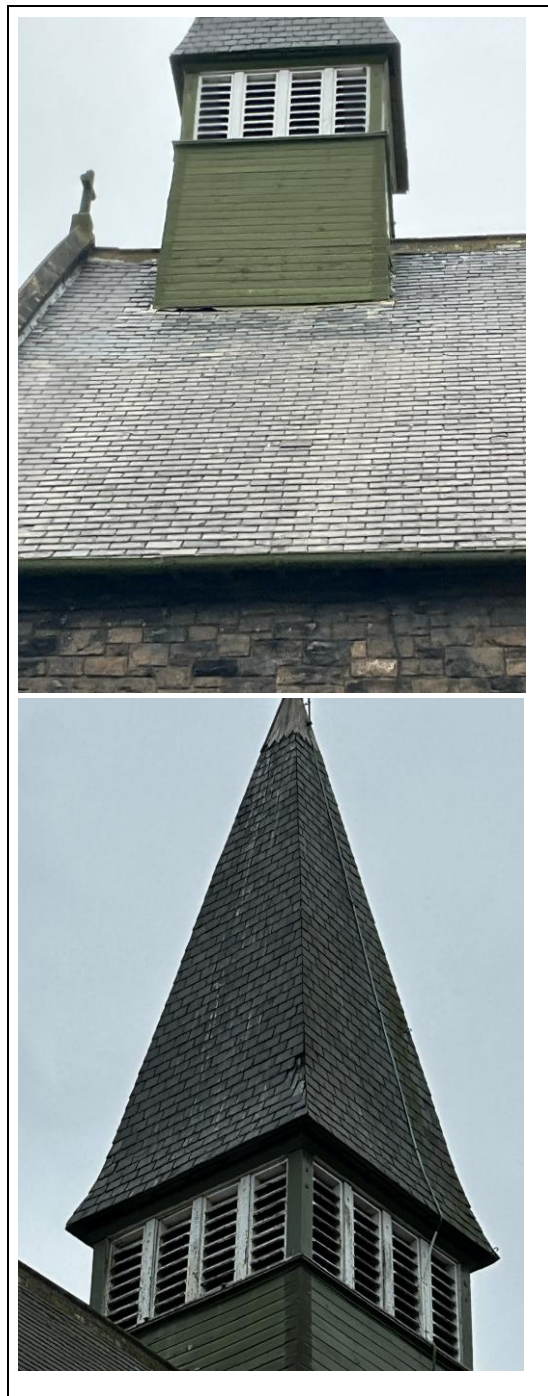
| | <p><b>Condition</b></p> <ul style="list-style-type: none"> <li>• South slope generally fine, a few chipped slates. One slate at high level looks to have slipped.</li> <li>• Section of flashing to base of spire is missing on southern slope.</li> <li>• North slope has a few missing slates and 1 appears to have slipped near spire.</li> <li>• Chimney appears sound.</li> <li>• A few missing slates to corner of spire roof on east slope.</li> </ul> | |

| | <p><b>Repair Needs</b></p> <p>Flashing to be repaired at base of spire.</p> <p>Replace missing slates to spire roof.</p> <p>Replace missing slates and refix slipped slates to main Nave roof.</p> | <p>B</p> <p>B</p> <p>B</p> |

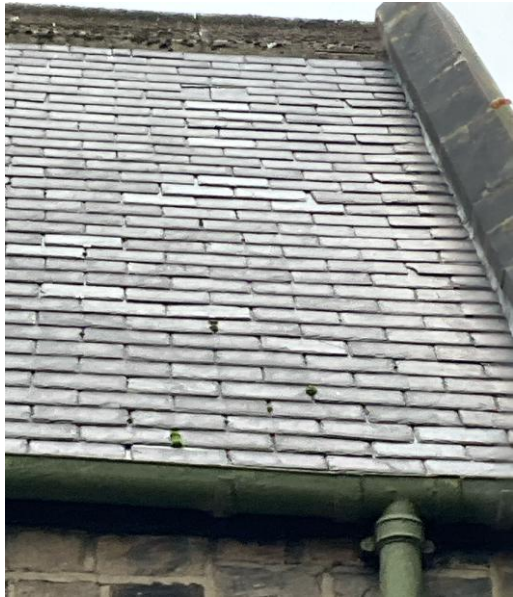
| | <b>Condition</b> <ul style="list-style-type: none"> <li>• Some moss growth on slates.</li> <li>• Ridge tiles appear well bedded.</li> <li>• Slates appear sound. With a few chipped corners.</li> </ul> | |

| | <b>Repair Needs</b> <ul style="list-style-type: none"> <li>• Monitor moss growth and remove with a wire brush if it starts to get excessive.</li> </ul> | M |

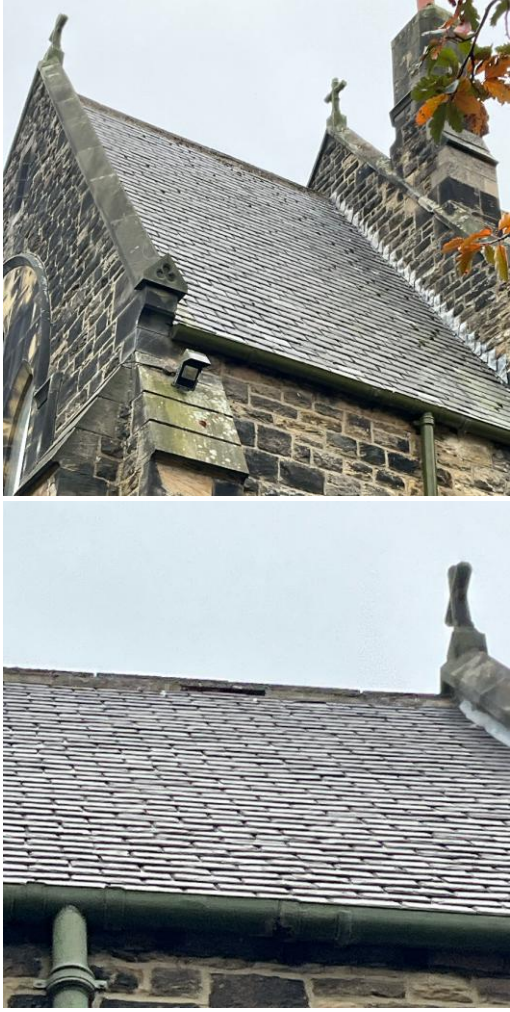
| | <p><b>Condition</b></p> <ul style="list-style-type: none"> <li>• Some moss growth on slates.</li> <li>• Slates appear sound and ridge tiles well bedded</li> <li>• Small area of bedding missing to ridge tile on south side.</li> </ul> | |

| | <p><b>Repair Needs</b></p> <ul style="list-style-type: none"> <li>• Monitor moss growth and remove with a wire brush if it starts to get excessive.</li> <li>• Repoint ridge tile.</li> </ul> | <p>M</p> <p>B</p> |

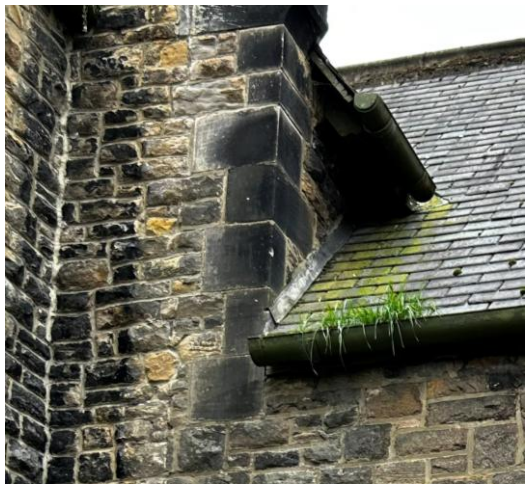
| | <p><b>Condition</b></p> <ul style="list-style-type: none"> <li>• Gutters and downpipes are generally in good condition.</li> <li>• Paint peeling to downpipe to west of porch and at top around gutter.</li> <li>• Gutters to boiler house, north transept and chancel north have vegetation growth.</li> </ul> | |

| | <p><b>Repair Needs</b></p> <ul style="list-style-type: none"> <li>• Clean and remove vegetation from gutters at earliest opportunity.</li> <li>• Redecorate rainwater goods where paint is peeling.</li> </ul> | <p>M<br/>D</p> |

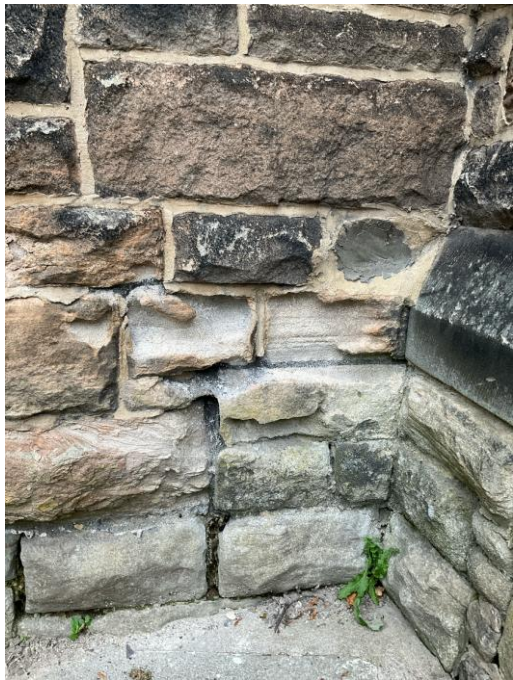
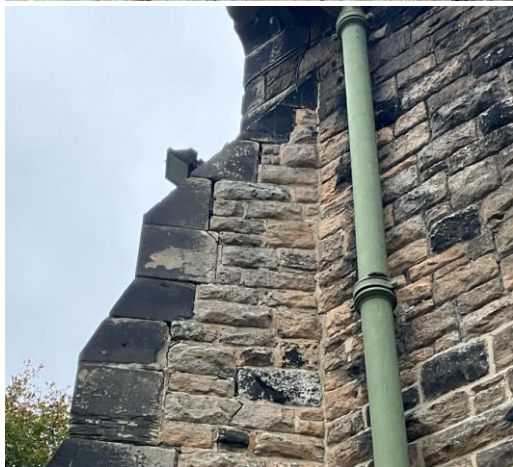
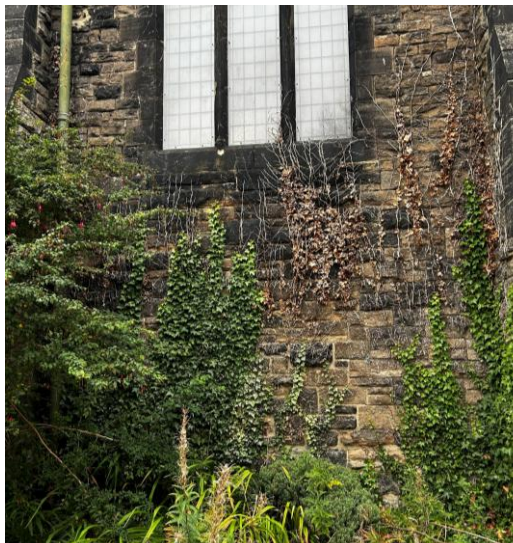
| | <p><b>Condition</b></p> <p><b>South Elevation</b></p> <ul style="list-style-type: none"> <li>• Stone and pointing are generally sound.</li> <li>• Some erosion at base to west of porch next to buttress.</li> <li>• Some areas of pointing missing around buttress ashlars.</li> <li>• Dark staining below windows to east of porch and to buttress ashlars.</li> <li>• Section immediately east of porch has ivy growing up wall.</li> </ul> <p><b>North Elevation</b></p> <ul style="list-style-type: none"> <li>• Stone and pointing are generally sound.</li> <li>• Some staining to window surrounds, buttress ashlars and below windows, particularly below the central window.</li> </ul> <p><b>West Gable</b></p> <ul style="list-style-type: none"> <li>• Stone &amp; pointing are generally sound.</li> <li>• Some staining below windows, to surrounds and buttress ashlars.</li> <li>• Water table appears sound and well bedded.</li> </ul> | |

| | <p><b>Repair Needs</b></p> <ul style="list-style-type: none"> <li>• PCC should consider removing the ivy growth from the stone walls to avoid future structural or moisture issues within the wall.</li> <li>• Re-point areas of missing pointing to the buttresses, using a suitable lime mortar.</li> </ul> | <p>M</p> <p>D</p> |

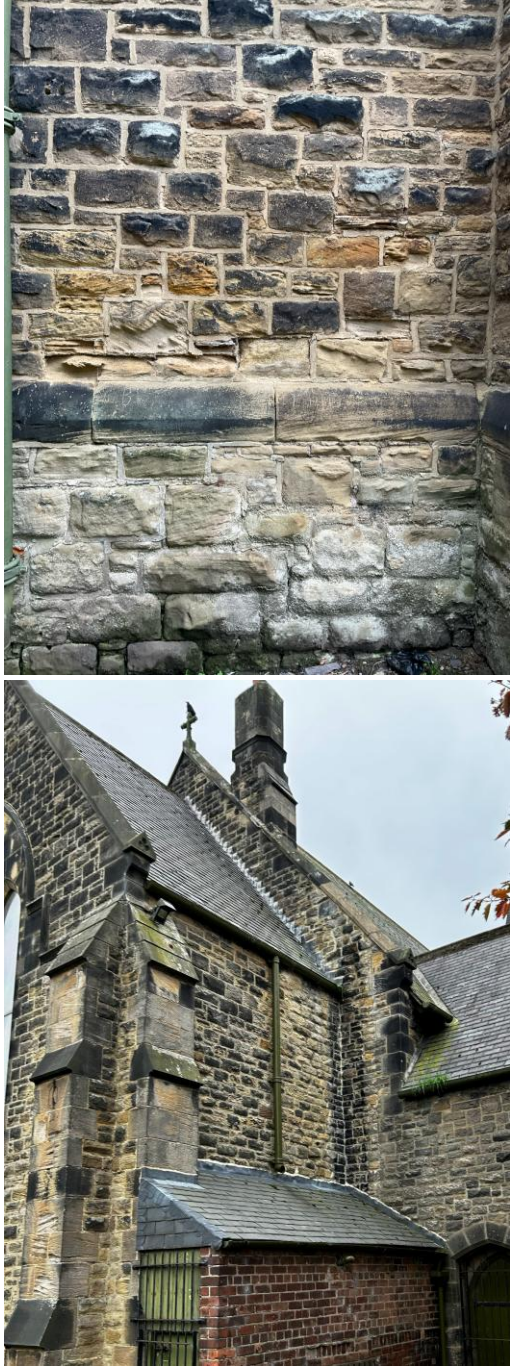
| | <p><b>Condition</b></p> <p><b>South elevation</b></p> <ul style="list-style-type: none"> <li>• Some erosion to stones to south wall around plinth stones.</li> <li>• Pointing appears sound.</li> <li>• Dark staining to buttress ashlar</li> <li>• Some damp around low level stone adjacent to downpipe.</li> </ul> <p><b>East Gable</b></p> <ul style="list-style-type: none"> <li>• Some dark staining to buttress ashlars and window surround and stones below window.</li> <li>• Stone &amp; pointing generally sound.</li> <li>• Water table and cross finial appear sound.</li> </ul> <p><b>North Elevation.</b></p> <ul style="list-style-type: none"> <li>• Dark staining in corner abutment with nave wall. This is likely to be linked to blocked gutters and water run-off over time.</li> <li>• Stone and pointing appear sound.</li> </ul> | |

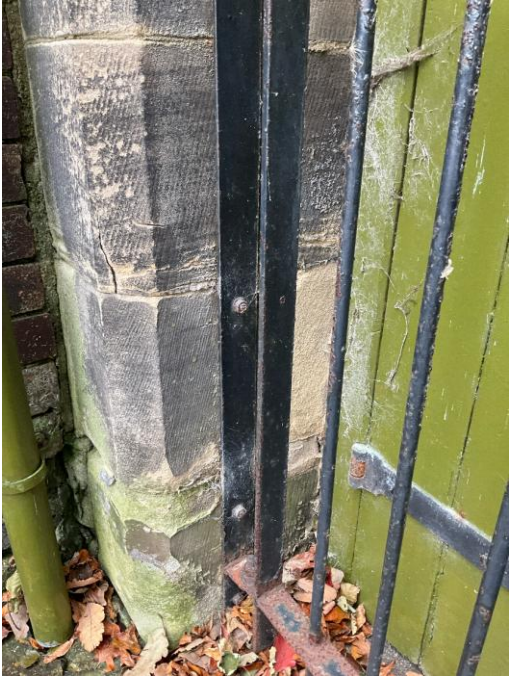
| | <p><b>Condition</b></p> <p><b>East Elevation</b></p> <ul style="list-style-type: none"> <li>• Some damp / efflorescence around vestry door surround.</li> <li>• Stone and pointing generally sound.</li> </ul> <p><b>North Gable</b></p> <ul style="list-style-type: none"> <li>• Joint in window cill stones have parted and missing pointing.</li> <li>• Dark staining to window surround and below window.</li> <li>• Stone generally sound and well pointed.</li> <li>• Gable water table well bedded and appears sound.</li> </ul> <p><b>West Elevation</b></p> <ul style="list-style-type: none"> <li>• Stone and pointing generally sound</li> <li>• Dark staining to quoins in corner.</li> </ul> | |

| | <p><b>Repair Needs</b></p> <p>Repoint open joint in window cill, with a suitable lime mortar.</p> | D |

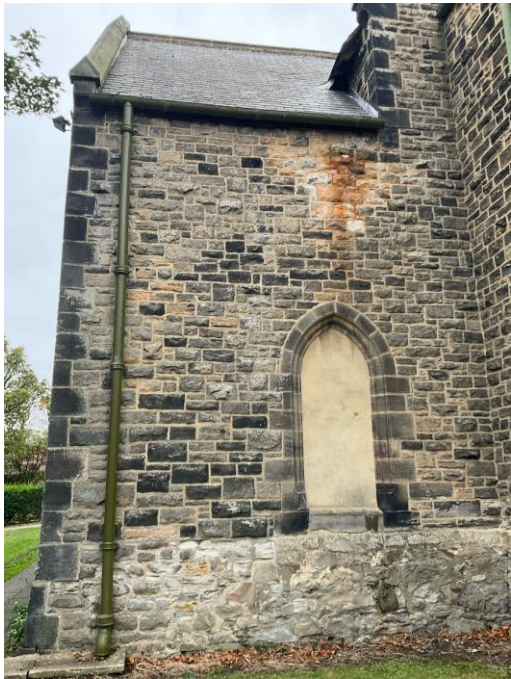
| | <p><b>Condition</b></p> <ul style="list-style-type: none"><li>• Stone and pointing generally sound.</li><li>• Dark staining below south gable window</li><li>• Rust staining to east facade at high level.</li></ul> | |

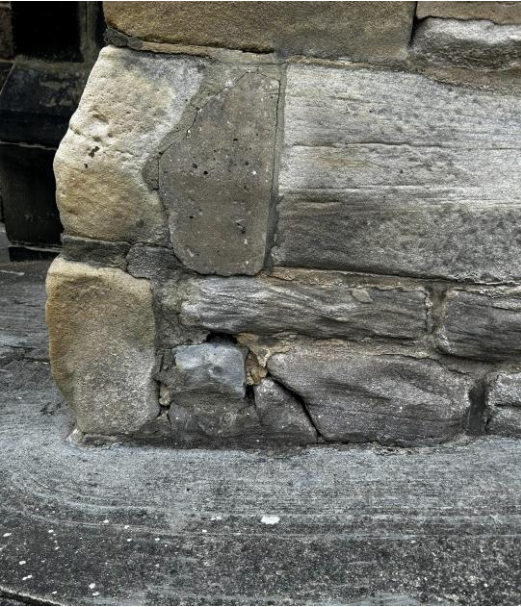
| | <b>Condition</b> <p>Some small areas of pointing missing at low level.</p> <p>Stone generally fine.</p> <p>One area of erosion to low level stone to west of entrance gates.</p> | |

| | <b>Repair Needs</b> <p>Repoint areas of missing pointing with suitable lime mortar.</p> | D |

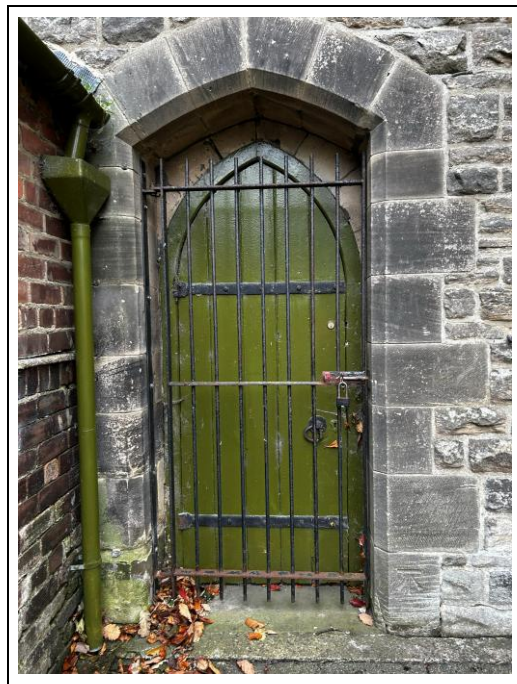
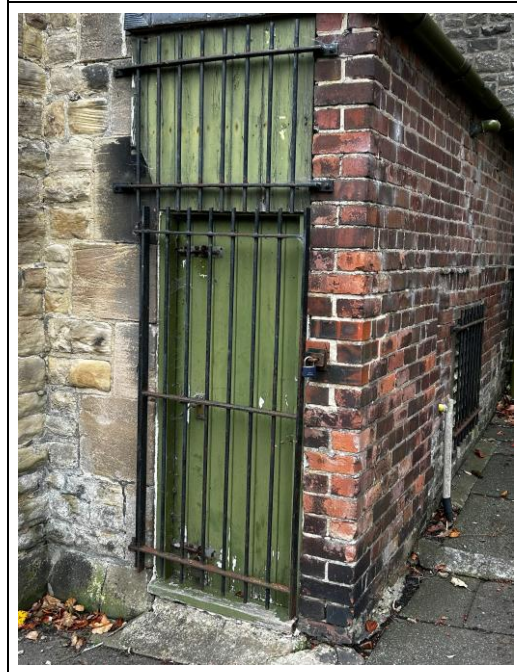
| | <p><b>Condition</b></p> <ul style="list-style-type: none"><li>• Porch door and gates sound.</li><li>• Vestry door is showing some signs of decay at base. This is likely due to the high moisture content in this area.</li><li>• Paint finish to Boiler house door is eroding and peeling on door and cill timber.</li></ul> | |

| | <p><b>Repair Needs</b></p> <ul style="list-style-type: none"><li>• Repaint boiler house door and timber cill.</li></ul> | D |

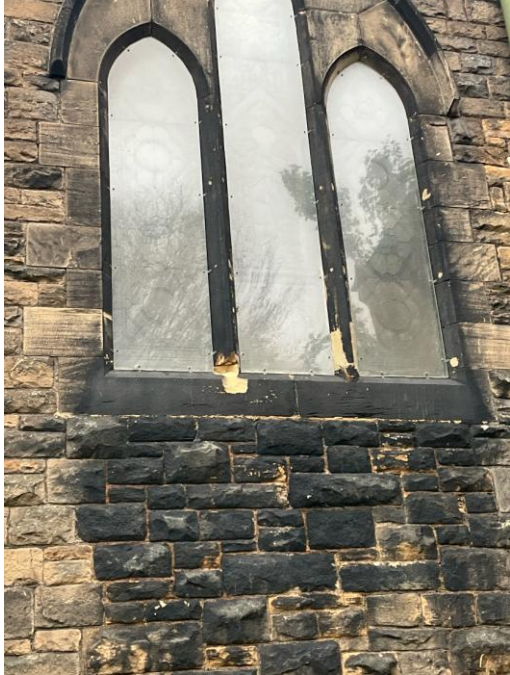
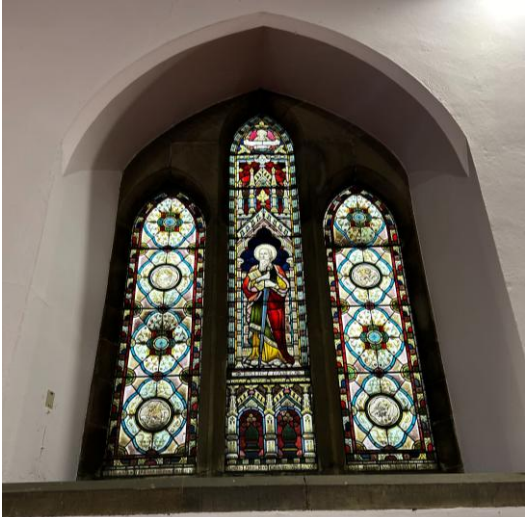
| | <p><b>Condition</b></p> <ul style="list-style-type: none"> <li>• Areas of damage to stone surround on 2 windows east of porch.</li> <li>• Polycarbonate &amp; glazing appears sound.</li> </ul> | |

| | <p><b>Repair Needs</b></p> <p>Monitor damaged stone for further decay.</p> | M |

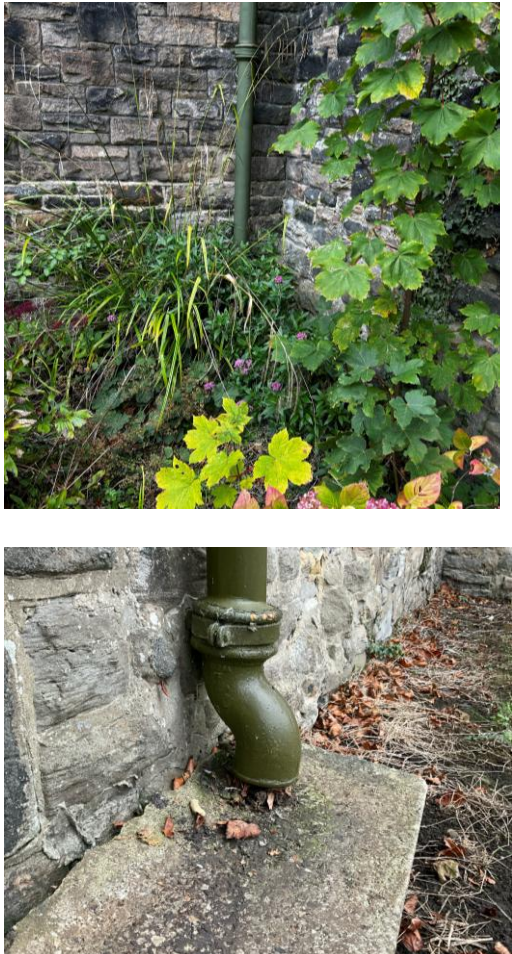
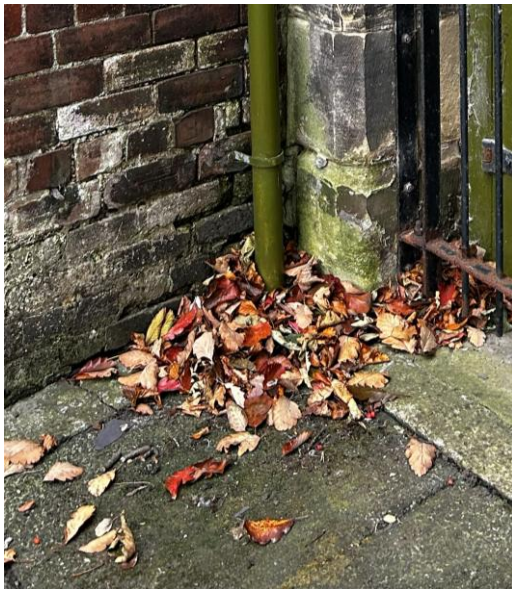
| | <p><b>Condition</b></p> <ul style="list-style-type: none"> <li>Gullies are generally covered with leaves and debris.</li> <li>There is noticeable damp around the vestry external door, which has a down pipe discharging below the ground floor level. It isn't evident whether this is a gully or where the water is discharging too, but there is a lot of leaf and debris at base, which could be contributing to the dampness in the wall.</li> <li>Downpipe to east of south transept appears blocked and discharging onto concrete base.</li> <li>Downpipes to the south façade of the Nave are surrounded by vegetation and inaccessible.</li> </ul> | |

| | <p><b>Repair Needs</b></p> <ul style="list-style-type: none"> <li>Clear gullies of debris and leaves to keep drainage free flowing.</li> <li>Clear vegetation from around bottom of downpipes to avoid blockages.</li> <li>Consider addition of gullies to downpipes currently discharging straight onto concrete to avoid any future issues with water ingress / damp.</li> <li>PCC to consider drainage CCTV investigation survey to establish where the water is discharging too.</li> </ul> | <p>M</p> <p>M</p> <p>E</p> <p>D</p> |

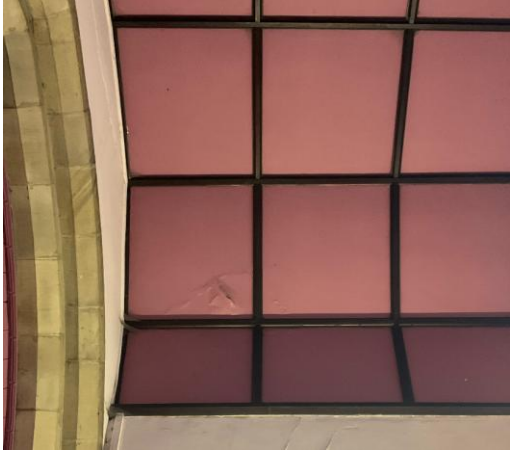
| | <p><b>Condition</b></p> <p>Coffee room, kitchen, WC and porch and lobby areas – ceiling in good condition.</p> <p>Vestry - generally sound with one panel on western side with bubbling paint.</p> | |

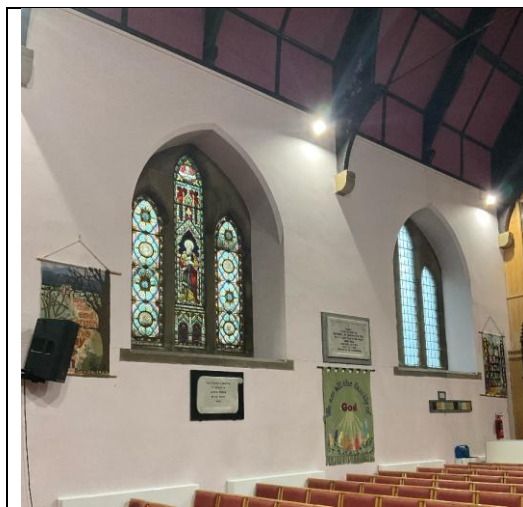
*Southern Wall in Nave*

- Plaster is generally in good condition.
- There is a crack below the western most window on the south wall.
- Paint finish is cracking above radiators along southern side.
- Some hair line cracks in northern wall paint.
- Efflorescence and dampness present at base of arches along northern wall, particularly towards the eastern end. Could be linked to drainage externally.

| | <p><b>Repair Needs</b></p> <p>Monitor dampness and efflorescence around the vestry door and northeast corner of the Nave.</p> | M |

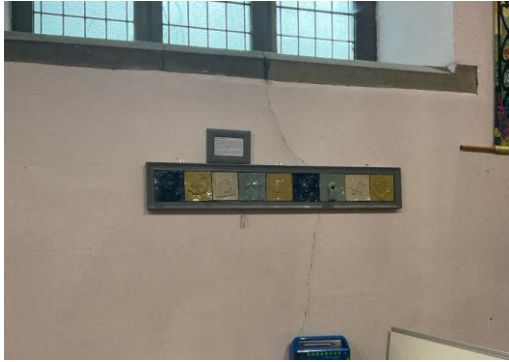
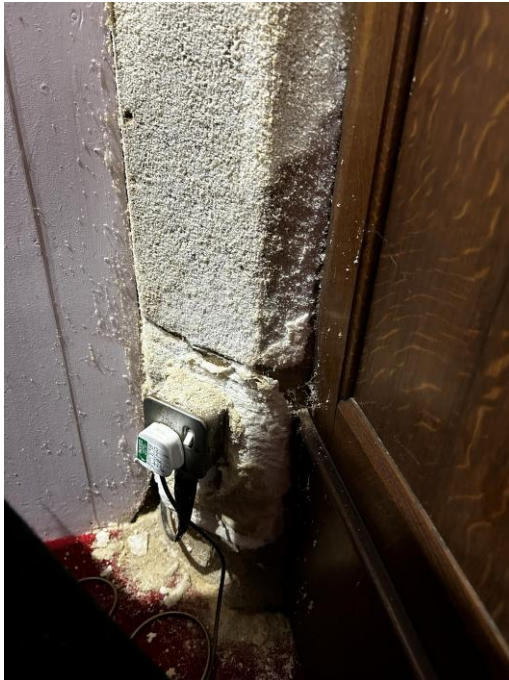
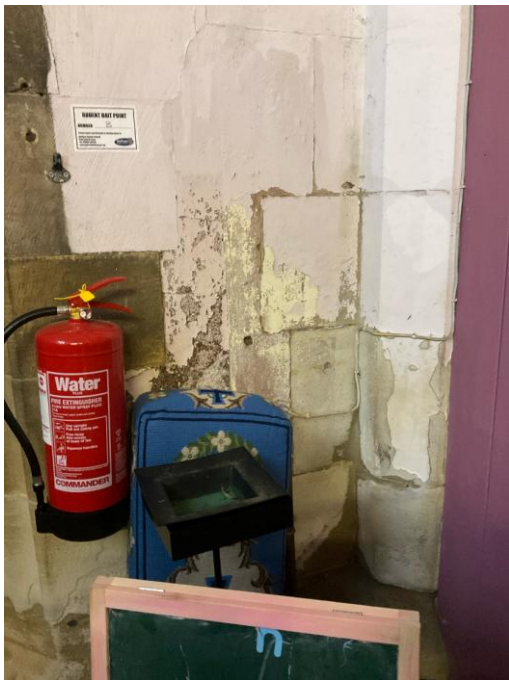
- Walls are generally fine.
- Some cracking on south wall near arch.
- Some cracking to paint either side of reredos.
- Some efflorescence and dampness present to base of Chancel arch on northern side.

- Efflorescence present on stone door surround and decay to paintwork on wall adjacent to external door. Likely to be linked to drainage issues externally in this area.
- Some hairline cracking to north wall at high level.
- Some cracking / bubbling of paintwork to west wall.

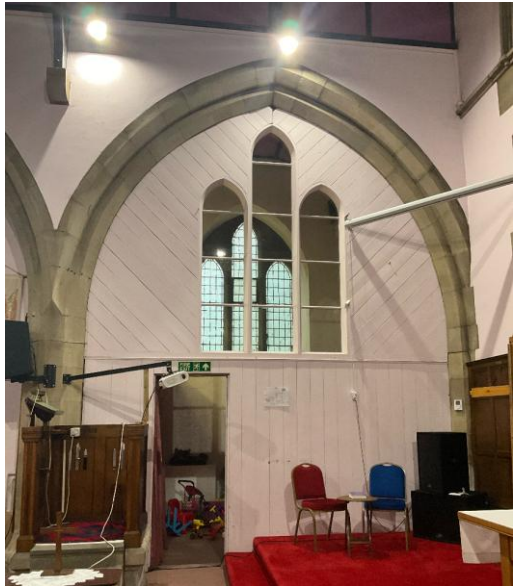
| | <p><b>Condition</b></p> <ul style="list-style-type: none"> <li>• Panelling in chancel is sound.</li> <li>• Glazed softwood screen is sound. Some cobwebs.</li> <li>• Dark oak screen is sound.</li> <li>• Vestry boarded infill- generally sound some marks, chipping to paint at low level.</li> </ul> | |

| | <p><b>Repair Needs</b></p> <p>Repaint vestry panelling.</p> | E |

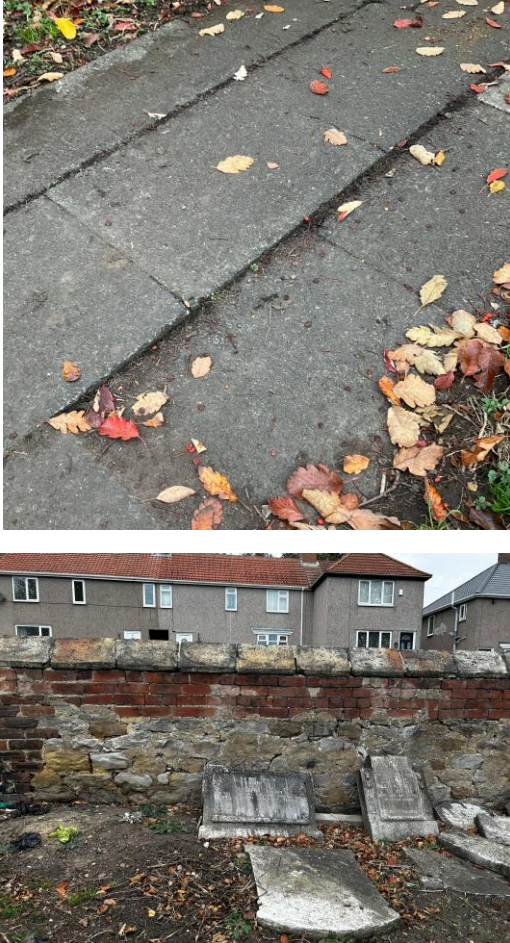
| | <p><b>Condition</b></p> <ul style="list-style-type: none"> <li>• Path adjacent to north transept has a line of slabs that have settled creating a lip between the adjacent slabs, which could become a potential trip hazard.</li> <li>• West boundary wall and fence appears sound.</li> <li>• North boundary has areas of missing render and brickwork is exposed. Otherwise appears well pointed and relatively stable.</li> <li>• East boundary wall and fence appears in reasonable condition.</li> <li>• South fence is sound.</li> <li>• Stone wall fronting road requires some repointing on the roadside.</li> </ul> | |

| | <p><b>Repair Needs</b></p> <ul style="list-style-type: none"> <li>• Depending on maintenance responsibility - Repoint stone wall on road side.</li> </ul> | D |
