St JOHN'S CHURCH NEVILLES CROSS
(305)

QUINQUENNIAL REPORT
on the architect's inspection on

21 April 2022

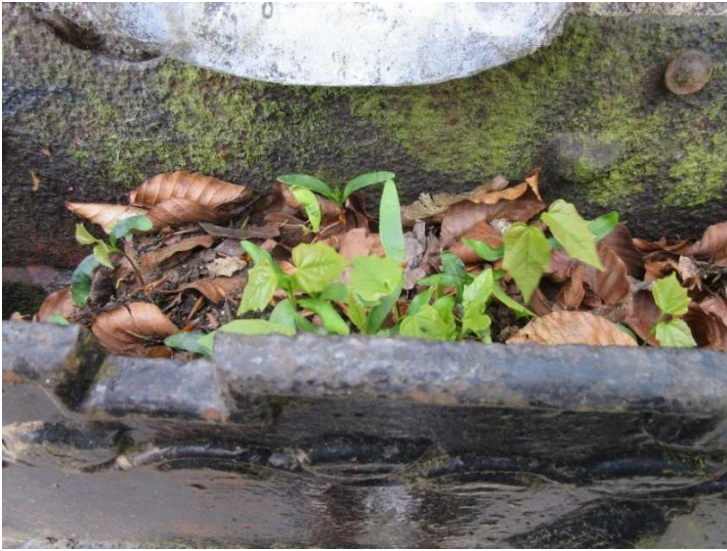
20. Hopper at N valley gutter cleaned out at inspection and should be cleared once a year.

Hopper at N valley gutter before clearance at the inspection

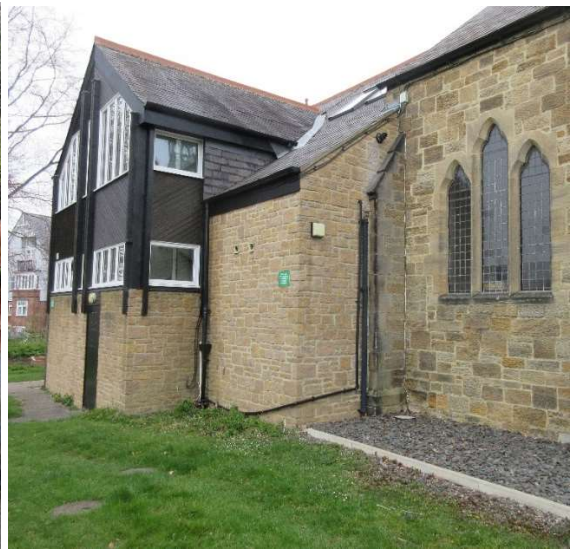
para 21

21. The extension has black aluminium on fascias, to gullies.
Plastic low level hopper at a former water butt at S side cleared at inspection.
A black plastic waste from first floor is unsupported and sags severely.
22. Foul and surface drainage for the whole building to sewer was laid when the extension was built, plastic gullies and cast iron covers on inspection chambers, not opened.

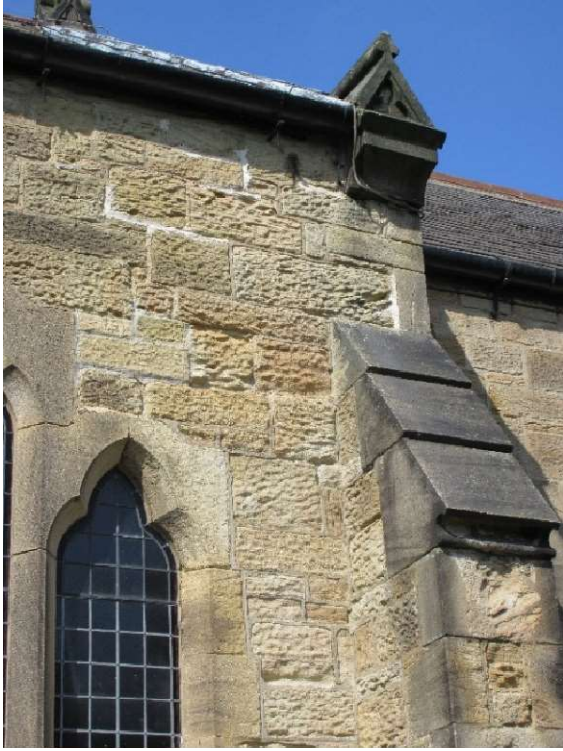
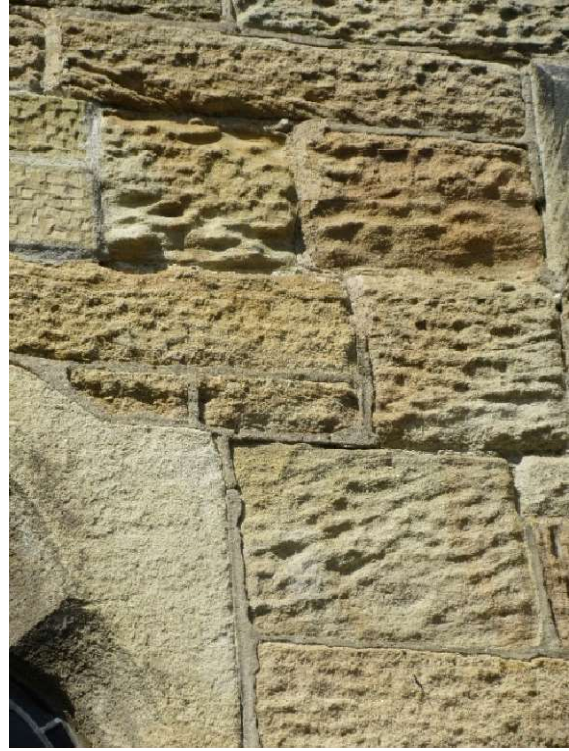
Slight stone decay above R side of E window in the S Nave

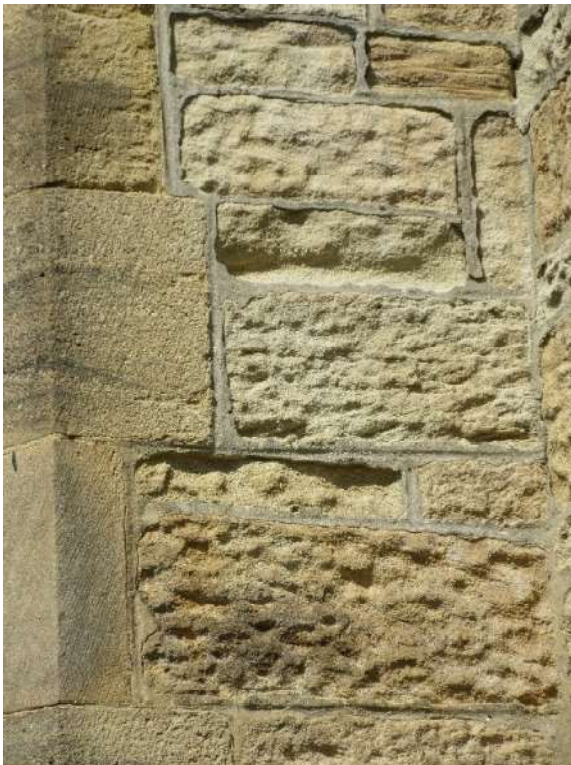
R of the E window in the S Nave

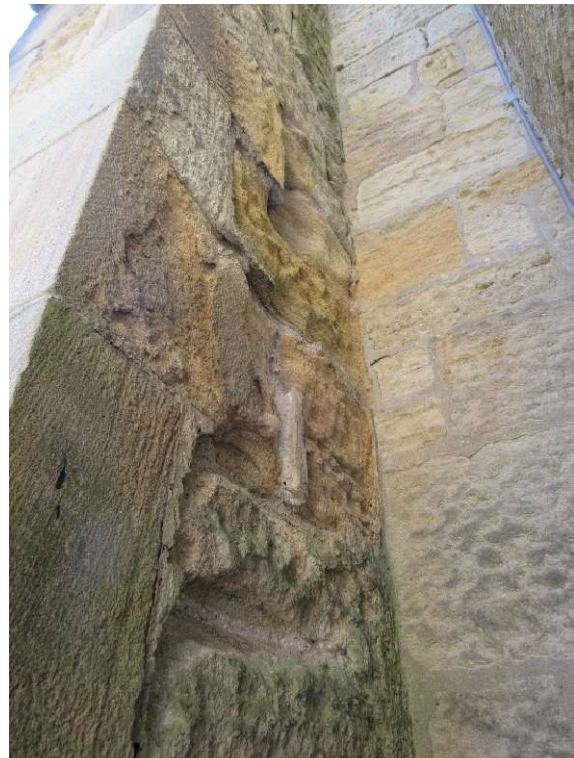
Hidden side of the Nave SE buttress

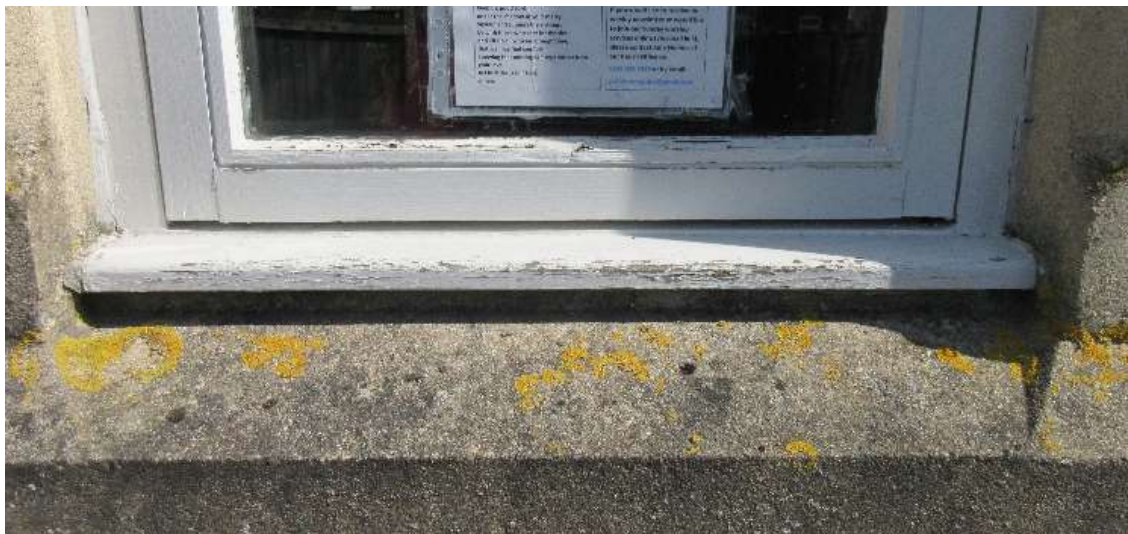
41. A large amount of stained softwood at the Extension – N porch, structural posts, shiplap boarding, doors and N and W window frames. Two windows (N first floor and W ground floor) show rot in their bottom beads, needing either careful joinery replacement (stained hardwood) and staining or general replacement of the whole remaining timber windows in upvc. Otherwise the stain is fair and will need restaining to the original recommended cycle or at least every 7 years (bottom beads and cills more frequent) in the existing colours.

Ground floor W window

Redecorate or bandage and paint or replace cast iron rainwater pipes at Baptistery hopper and Vestry	19
Decide and act on rot in Extension window beads	41, 68

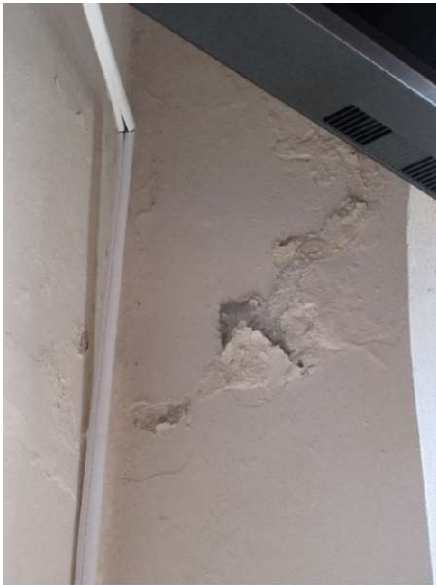
11. The former damp in the Vestry appears solved but there are signs of continuing slight damp at high level in the Baptistery NW corner and at mid level at the Nave SE corner.

56. Church plaster filled and decorated 2007 after most movement stopped but before the large ash tree SE of the church was felled January 2012.
57. In the SE of the Nave hairline plaster cracks remain visible but appear unchanged:
Present hairline cracks:
- between five stones of the Chancel arch S side facing the Nave and the adjacent plaster
- horizontal crack between 1st and 2nd windows from SE corner at level of arch peaks
58. A new defect is a small patch of bursting plaster and paint at the far E end of the Nave S wall behind the present screen fixed to the wall at window arch spring level. Such damage usually shows very local damp penetration. There is no obvious defect outside. Surface decay in two stones at the right level does not appear sufficient cause. It would be wise to check in rain that the gutter over is not leaking or choked.

Clear hoppers and gullies at least once a year	19, 20, 21, 59
Try washing matchboard panelling in Nave	53
Observe possible causes of plaster damage in Nave SE corner	58
Clear cobwebs	60, 65
Any replacement Chancel carpet & underlay must remain breathable	72, 75

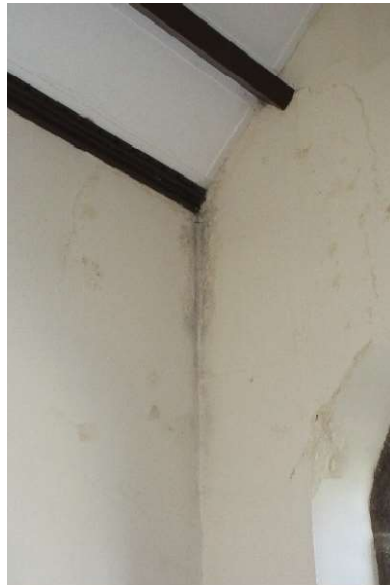
Baptistry NW corner

59. At the Baptistry the top NE and NW corners were replastered and repainted where damaged by damp, after pointing of the watertable and drying over many months. Marks appear again:
- The top NE corner is slightly watermarked without visible damage. No visible cause except blockage of the hopper outside (para 20).
 - The top NW corner has a larger watermark and small points of plaster and paint damage, suggesting some continuing leakage. No clear cause outside. May be condensation – try careful washing (para 15).
60. Cobwebs in places.

Replace missing slate at turret S side	13
Try washing possible condensation (?) from Baptistery NW corner	15, 59
Clip sagging waste pipe S of Extension	21
Check Upper Room upright	93

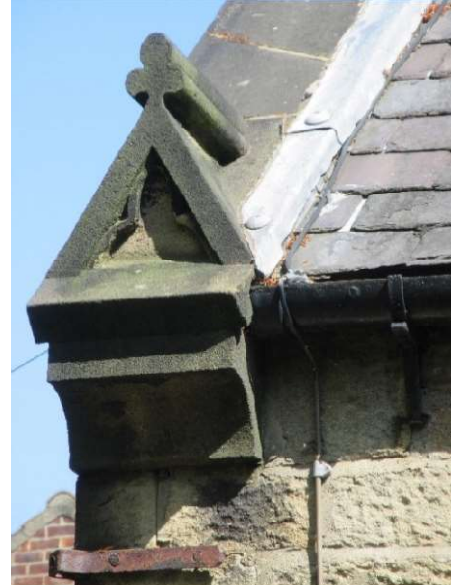
Outside of Baptistry NW corner

15. Baptistery slate sound. At both slopes a lead cover flashing is dressed partly over and pointed down into the stone watertable because the stone is not high enough for flashings under the watertables. Damp plaster visible again at the Baptistery top NW corner despite past resealing of the NW flashing to the stone (para 59). There is no other visible defect so (unless the apparent damp is really condensation and can be washed off) resealing the NE lead to the watertables may be worth trying.

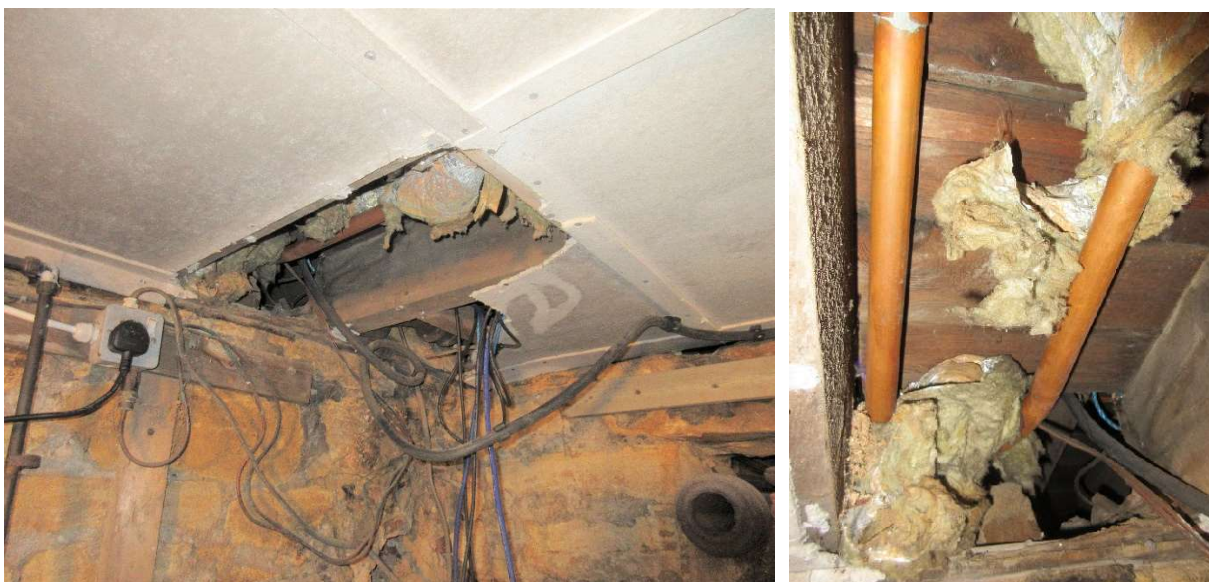
81. Timber E-W joists over on timber wall plates on a bitumen damp course level with the bottom of the outside stone plinths. Ceiling appears to be fire resisting boards with cover strips at the joints. The asbestos survey did not identify the boards as containing asbestos but said there is hazard from loose fibres on the floor (para 2).

82. Holes in two corners of the ceiling show unlagged copper heating pipes in the floor space, one with insulation hanging loose. The pipes are wastefully exposed to the unheated cellar.
